2018

Sawmill Creek Road Transportation Corridor Assessment

AK NPS SITK 2015(2)

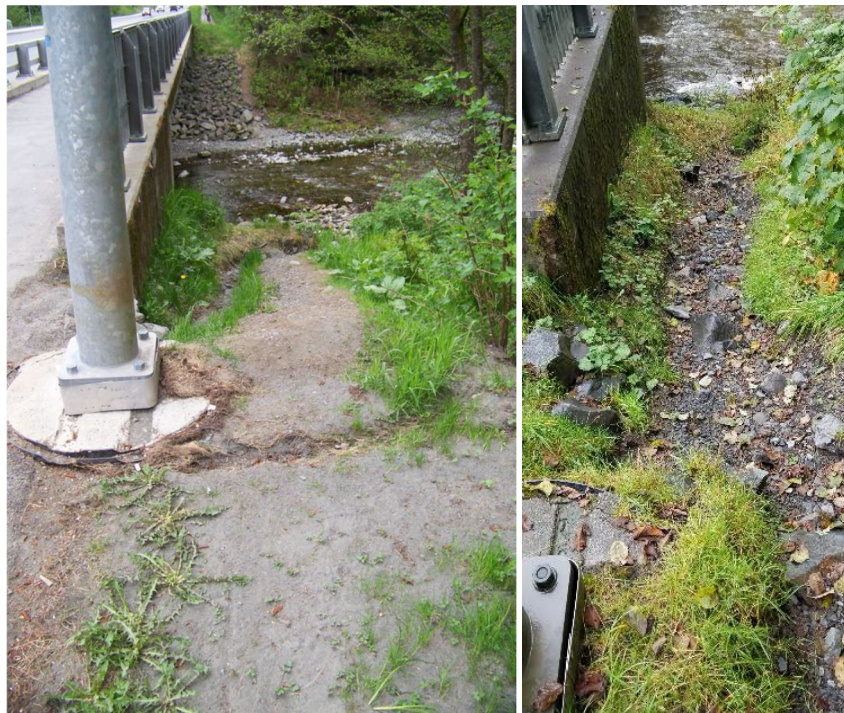
**Figure 8 - (L) Trail connection in 2014. Water started to wear channels into the soil.
Figure 9 - (R) Trail connection in 2018. Trail surface has continued to deteriorate and large rocks are starting to show through. The surface is very loose with uneven footing.**

1. Connection to multi-use trail at Indian River Bridge – An existing walking trail borders the Indian River and provides a connection between the Sitka National Historical Park visitor center and the base of the Indian River bridge. A formal access connection, such as stairs or other hardscaped improvements, between Sawmill Creek Road and the trail below has not been established. The trail connecting to the visitor center is visible at the bottom of the slope adjacent to

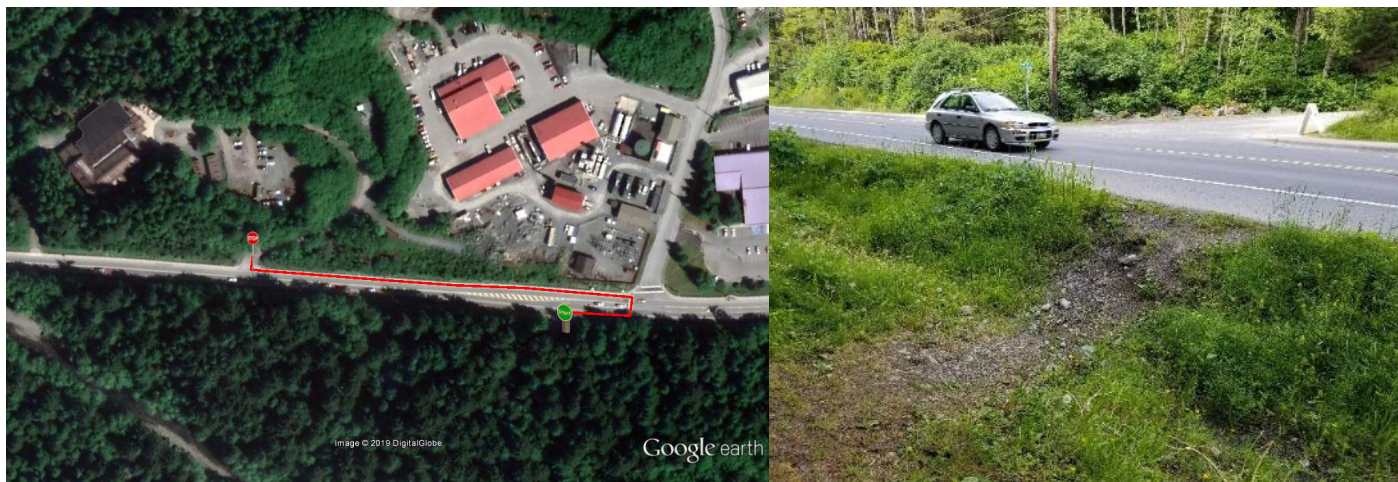
Figure 10 - (L) Intended walking route to Raptor Center. Figure 11 - (R) Path worn into ditch across from Raptor Center entrance.

Evidence suggests that many people travelling to the Raptor Center by foot traverse the roadway in the middle of the block rather than use the crosswalk at Jarvis Street. The intended route for access to the Raptor Center from the national park parking lot consists of turning right on the multi-use path, crossing SMC Road near Jarvis Street, then turning left and following the sidewalk on the north side of the road to the Raptor Center entrance. Raptor Way is the vehicle entrance to the Raptor Center, and is a gravel road without a designated pedestrian path. Instead of taking the desired route, most people are observed turning left out of the parking lot, walking along the multi-use path, and crossing Sawmill Creek Road at the point they can see the entrance. Pedestrians use an informal path worn into the ditch for crossing Sawmill Creek Road from the multi-use path. When visiting the site, many tourists asked our team for directions to the Raptor Center, and were very reluctant to use the Jarvis Street crossing, knowing the Raptor Center was located in the opposing direction. The shortest distance to the destination is certainly the desired option.

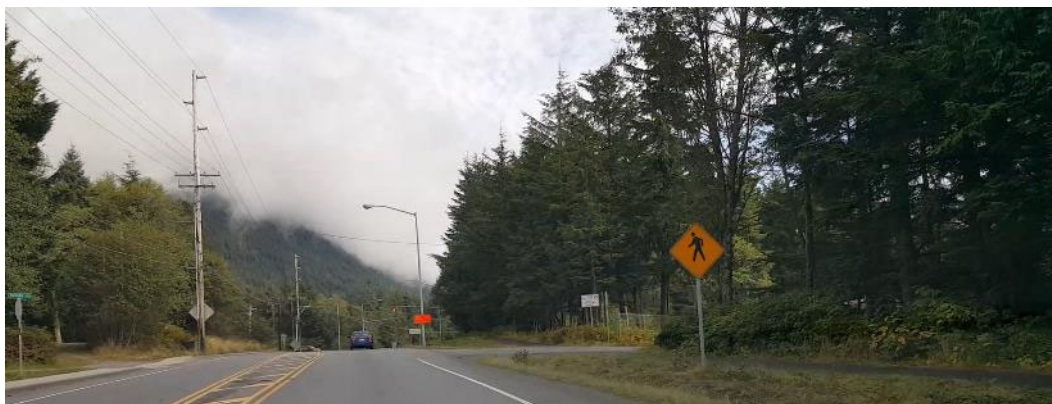
Figure 17 - EB SMC Road approaching Sisters Lane

<p>Observations:</p>	<ul style="list-style-type: none"> - Pedestrian signs in both directions approaching the crosswalk appear to be outdated and are not optionally a fluorescent color; - Signs do not include supplemental “AHEAD” plates.
<p>Improvement Options:</p>	<ul style="list-style-type: none"> - Replace signs with updated fluorescent yellow signs; <ul style="list-style-type: none"> o <i>December, 2021 Update – 2020 project replaced these, unknown if fluorescent or standard yellow.</i> - Add supplemental “AHEAD” plates. <ul style="list-style-type: none"> o <i>December, 2021 Update – 2020 project added this for the eastbound approach but not westbound.</i>

1. Replace the eastbound pedestrian warning sign with a new fluorescent sign and “AHEAD” supplemental plaque or “NEXT ½ MILE” (MUTCD W11-2 with W16-9P or W16-4P). Replace the westbound pedestrian warning sign as well with an “AHEAD” plaque.
December, 2021 Update – completed for eastbound but not westbound. Consider fluorescent yellow for higher visibility against grey skies for future updates.

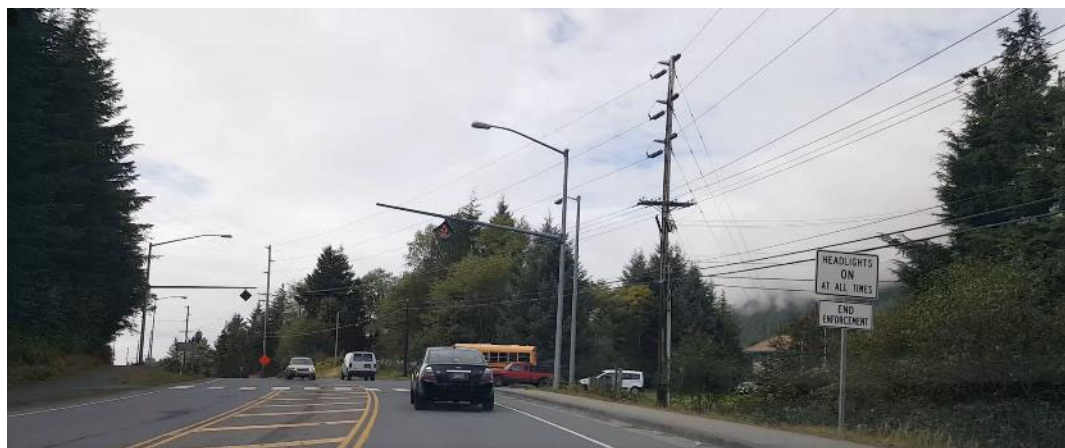
Figure 22 - WB Sawmill Creek Road at Indian River Road

Westbound Observations closer to intersection:	<ul style="list-style-type: none"> - Overhead pedestrian warning light is ineffective. The sign is lit at all times, but is difficult to see during the daytime, and is quite small; - "HEADLIGHTS ON" with supplemental sign was visible and was visibly in good condition. - Center line pavement marking were somewhat worn.
Improvement Options:	<ul style="list-style-type: none"> - Upgrade overhead pedestrian warning traffic control device; <ul style="list-style-type: none"> o Pedestrian hybrid beacon; o Rectangular rapid flashing beacon; o Pedestrian activated signal. o <i>December, 2021 Update – pedestrian warning signs, with push-button activated LED border lights, and down arrows were added for the crosswalk to replace the overhead signs.</i> - Repaint pavement markings <ul style="list-style-type: none"> o <i>December, 2021 Update – pavement markings were reinstalled.</i>

The upcoming DOT&PF project should address other roadway and pavement marking deficiencies noted near this area.

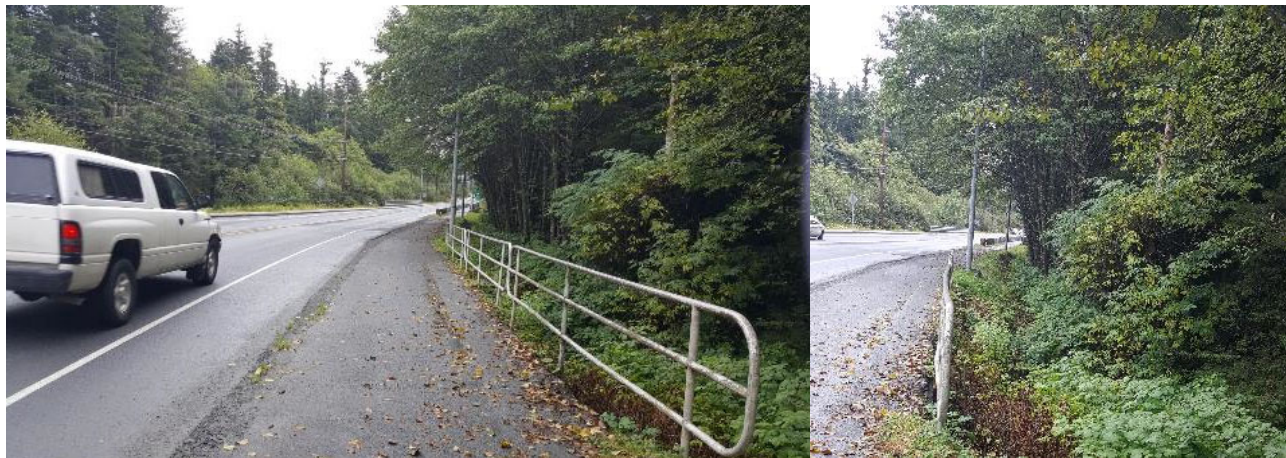
Figure 23 & 24 - EB Sawmill Creek Road approaching Indian River bridge

<p>Observations Approaching Indian River Bridge:</p>	<ul style="list-style-type: none"> - Roadway runoff drains directly onto the shared use path; - No separation between pedestrian and roadway; - Pavement was visibly in poor condition; - Ponding on path causing debris deposits. - Handrail provides delineation and some protection for bicyclists and pedestrians along steep drop-off.
<p>Improvement Options:</p>	<ul style="list-style-type: none"> - Add curb and gutter to Sawmill Creek Road to alleviate the drainage issues on shared use path; - Resurface roadway and replace all pavement markings; - Provide a clear separation between roadway and shared use path by constructing curb and gutter along SMC Road. <ul style="list-style-type: none"> o <i>December, 2021 Update – a recently crash-tested aluminum 42” pedestrian rail/fence may be a good option for shared use path delineation and pedestrian fall accommodations along any steep areas. The existing handrail may or may not be considered crashworthy. For reference, see pg. 181: https://onlinepubs.trb.org/onlinepubs/circulars/ec220.pdf</i> o <i>The 2020 project replaced this handrail with a galvanized steel 42” rail. Unlikely to be cost effective to replace this with the new crash-tested Manual for Assessing Safety Hardware (MASH) Test Level-2 barrier.</i>

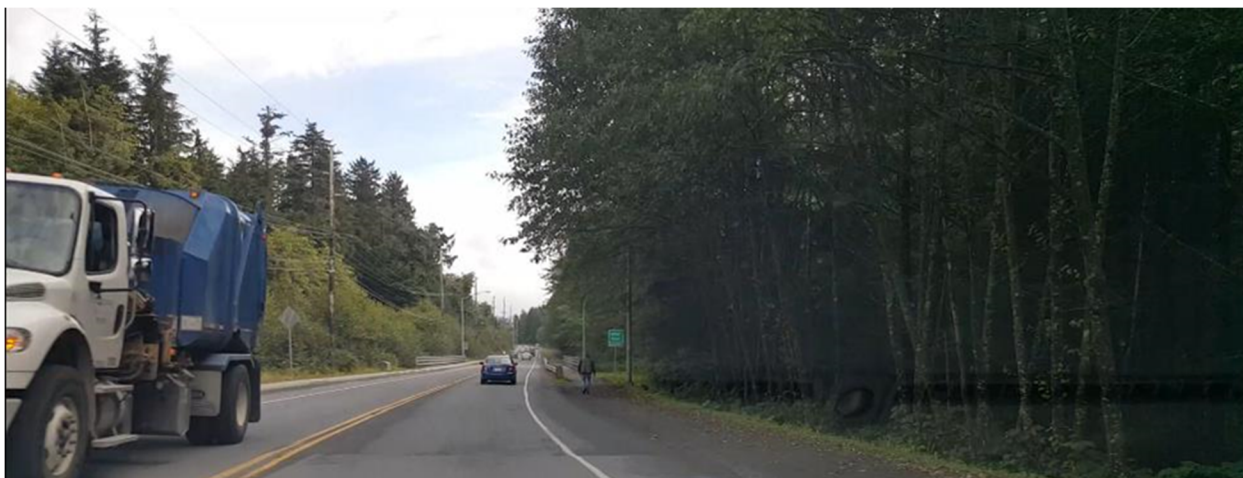
<p>Bridge Rail and Guardrail Observations:</p>	<ul style="list-style-type: none"> - The purpose of the guardrail appears to be to shield the river hazard and provide a transition to the interior bridge rail along the path; - The purpose of the interior bridge rail appears to be to shield pedestrians and trail-users along the bridge. However, the opposite side does not have a similar treatment and much of the shared-use trail is similarly exposed to vehicular traffic.
<p>Improvement Options:</p>	<ul style="list-style-type: none"> - Evaluate guardrail and bridge railing to determine if the existing treatment is appropriate for the location. <ul style="list-style-type: none"> o <i>December, 2021 Update – guardrail height of 28” was maintained. The downstream/opposite side transition rail was modified to match the downstream guardrail height. The terminal grading may have been improved.</i>

WFLHD has no specific short-term improvement recommendations at this location at this time. It is recommended to evaluate the interior bridge rail and guardrail to verify that this is the desired treatment here, given that the opposite side has no interior bridge rail or guardrail.

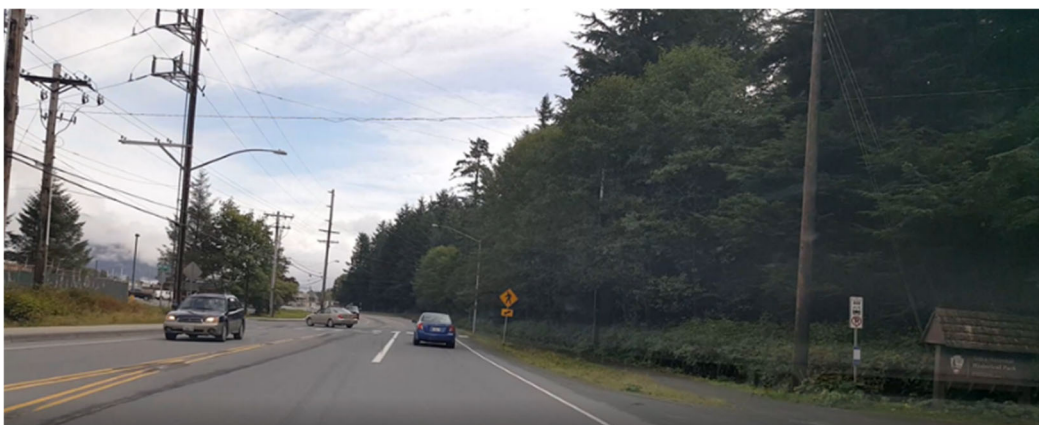
Figure 30 - Sawmill Creek Road EB approaching Jarvis Street

<p>Observations Approaching Jarvis Street Crossing:</p>	<ul style="list-style-type: none"> - Pavement markings approaching intersection are visibly faded; - Pedestrian crossing signing seems old and is not very reflective.
<p>Improvement Options:</p>	<ul style="list-style-type: none"> - Restripe pavement markings; <ul style="list-style-type: none"> o <i>December, 2021 Update – Pavement markings were reinstalled with the paving project.</i> - Check retroreflectivity of existing signs and replace if needed. <ul style="list-style-type: none"> o <i>December, 2021 Update – the pedestrian warning signs were replaced in advance of the crosswalk with “AHEAD” plaques for each direction. The pedestrian warning signs at the crosswalk were replaced, however, the required down arrow plaques may have not been reinstalled. They were not called out specifically in the plans.</i>

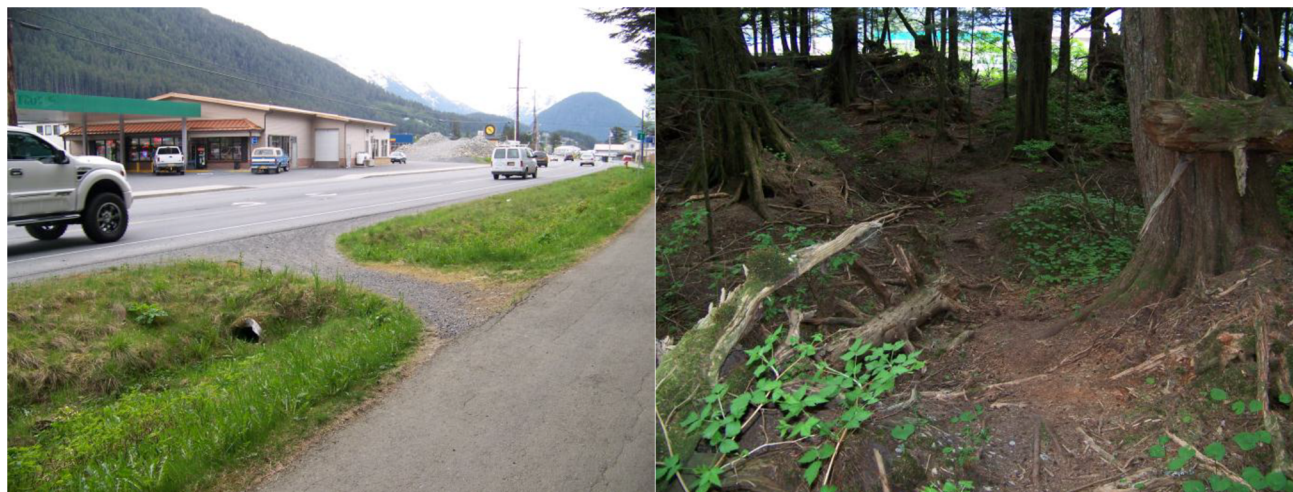
Figure 32 & 33 - EB Sawmill Creek Path Beyond Jarvis Street near East End of Park

<p>Observations near east end of Park:</p>	<ul style="list-style-type: none"> - Pedestrians were observed using a path from Sitka National Park as a quick access to the convenience store on Sawmill Creek Road (as shown in Figure 32); - Pedestrian were observed crossing midblock as indicated by the informal path above in Figure 32.
<p>Improvement Options:</p>	<ul style="list-style-type: none"> - Provide better delineation and/or wayfinding signage to promote crossing at the marked crosswalk at Jarvis Street; - Improve the ditch line and evaluate condition of shared use path. <ul style="list-style-type: none"> o <i>December, 2021 Update – the culvert and gravel path from the shared use path were removed with the 2020 project, likely to discourage crossing at this uncontrolled location. The Park plans to restore the informal path within the Park boundary as well.</i> - Install curb and gutter along SMC Road

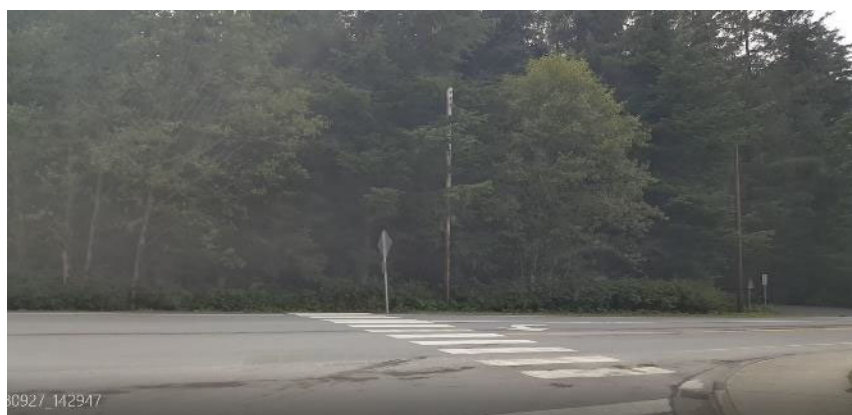
Figure 34 – Jarvis Street facing Sawmill Creek Road pedestrian crossing

<p>Observations from Jarvis Street</p>	<ul style="list-style-type: none"> - Crosswalk pavement markings in poor condition; - Pavement markings are not consistent with one another;
--	--

<p>Looking toward SMC Rd.:</p>	<ul style="list-style-type: none"> - Pavement visibly in poor condition; - Existing curb ramps were not perpendicular to the crosswalks at Jarvis Street and Sawmill Creek Road.
<p>Improvement Options:</p>	<ul style="list-style-type: none"> - Resurface roadway; <ul style="list-style-type: none"> o <i>December, 2021 Update – the resurfacing was completed along SMC and through the return along Jarvis St.</i> - Restripe pavement markings, and ensure markings are consistent with pavement marking plans; <ul style="list-style-type: none"> o <i>December, 2021 Update – pavement markings were reinstalled with the project. The same crosswalk types were used and are likely adequate.</i> - Provide separated curb ramps that are perpendicular to the crosswalk for ADA compliance. <ul style="list-style-type: none"> o <i>December, 2021 Update – new ADA facilities were constructed at Jarvis St. for the crossing across Jarvis St. as well as the crossing across SMC Rd.</i>
