PROPOSED PROJECT SITES

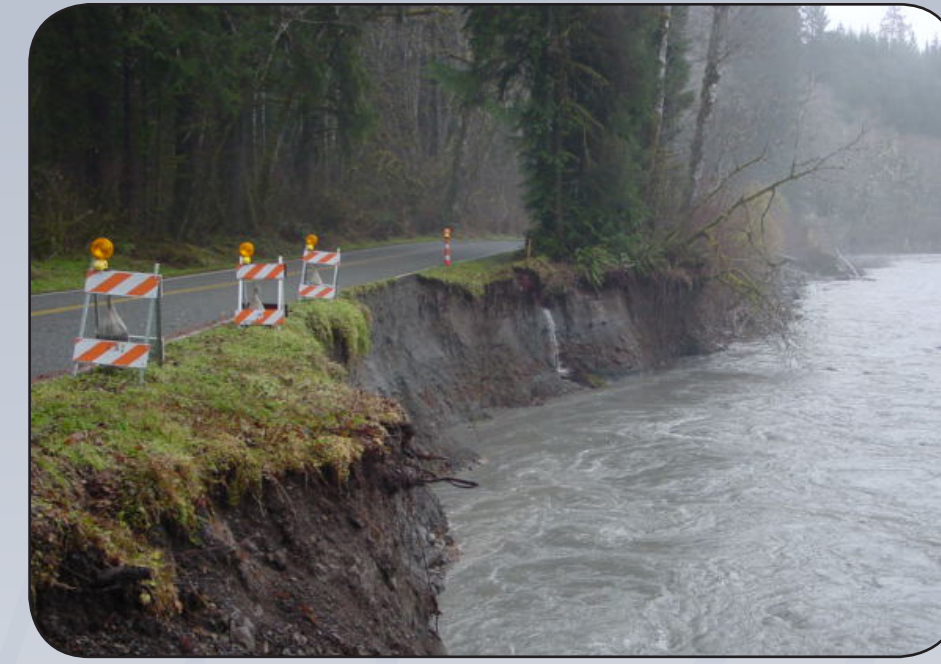
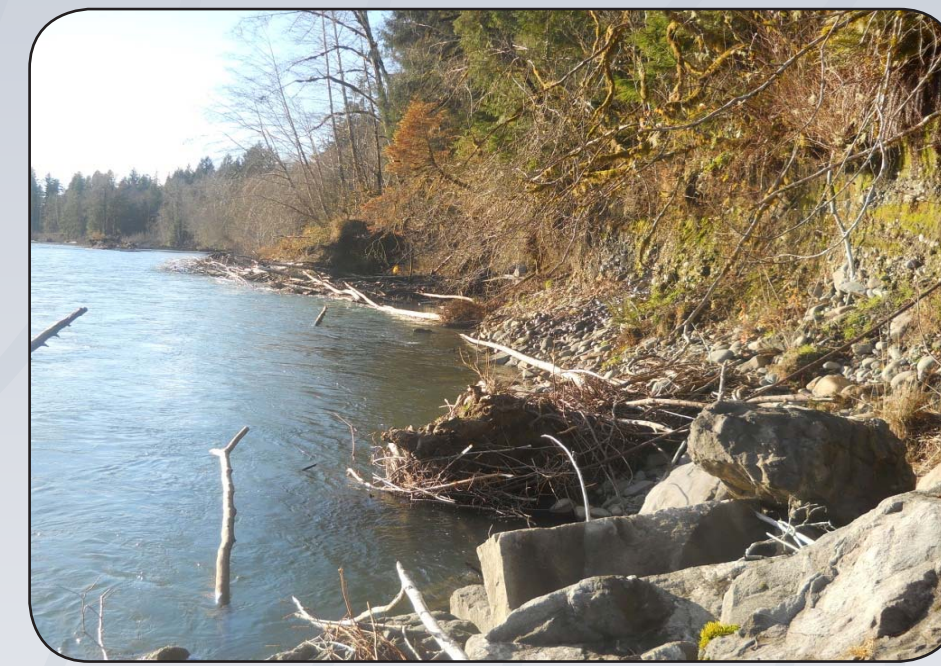
Site C1 Bank Stabilization

- **EXISTING CONDITIONS:** Parallel to outside bank of a river bend; includes approximately 3,900 lineal feet of 2-4' diameter riprap revetment along the apex of the river bend
- **PROBLEM:** 200' section of the 750'-long downstream segment appears less stable than the rest of the site; toe erosion and undermining of stream bank occurring in 3 areas
- **SOLUTION ALTERNATIVES:** 1) Continue maintenance of 860' of stream bank and 200' of downstream revetment segment; 2) relocate the road 100-200' away from river channel edge; 3) stabilize road embankment; 4) minor active river channel shift (engineered log-jam groins or riprap streambarbs); or 5) major active river channel shift

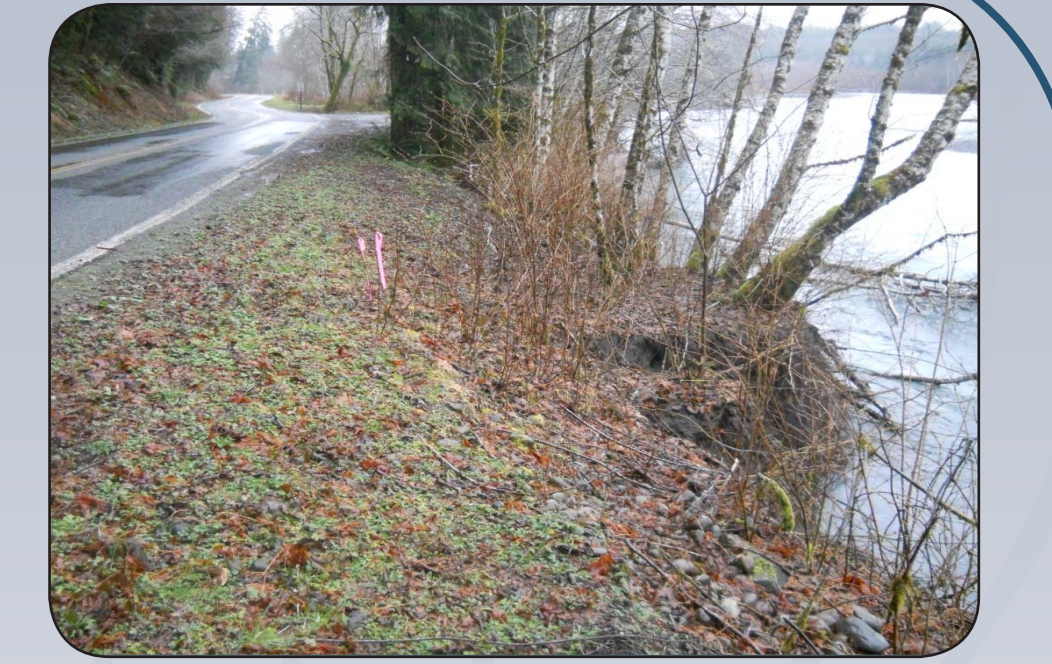
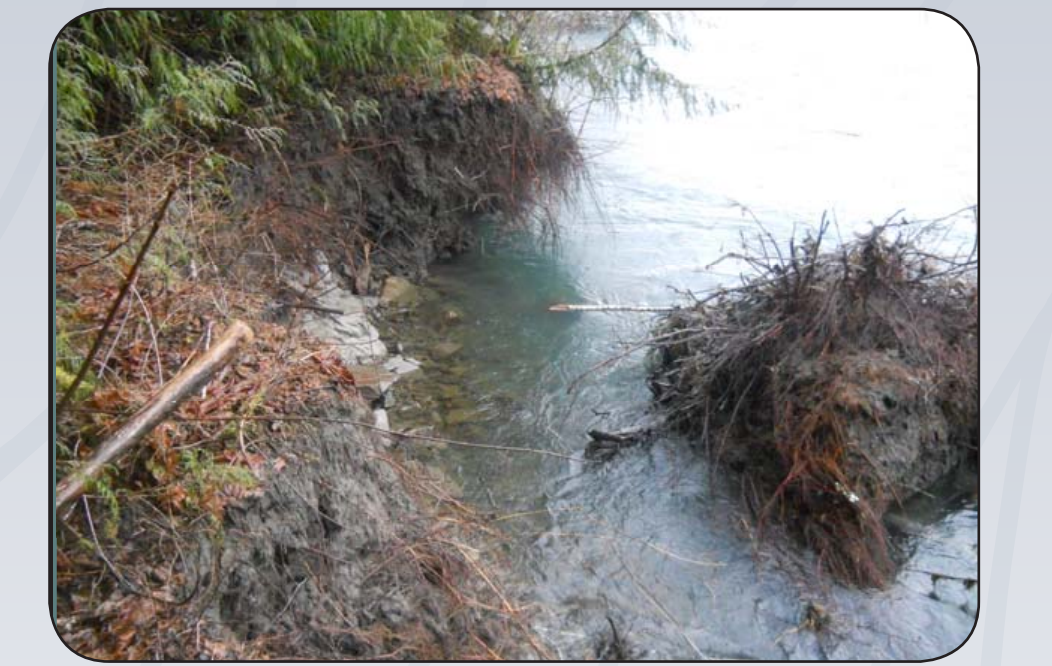
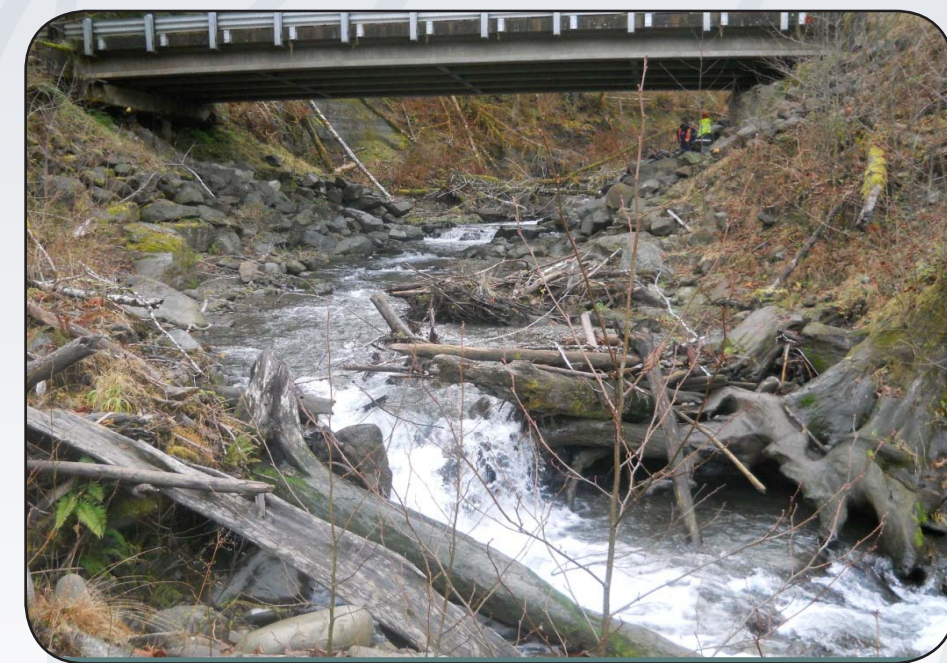
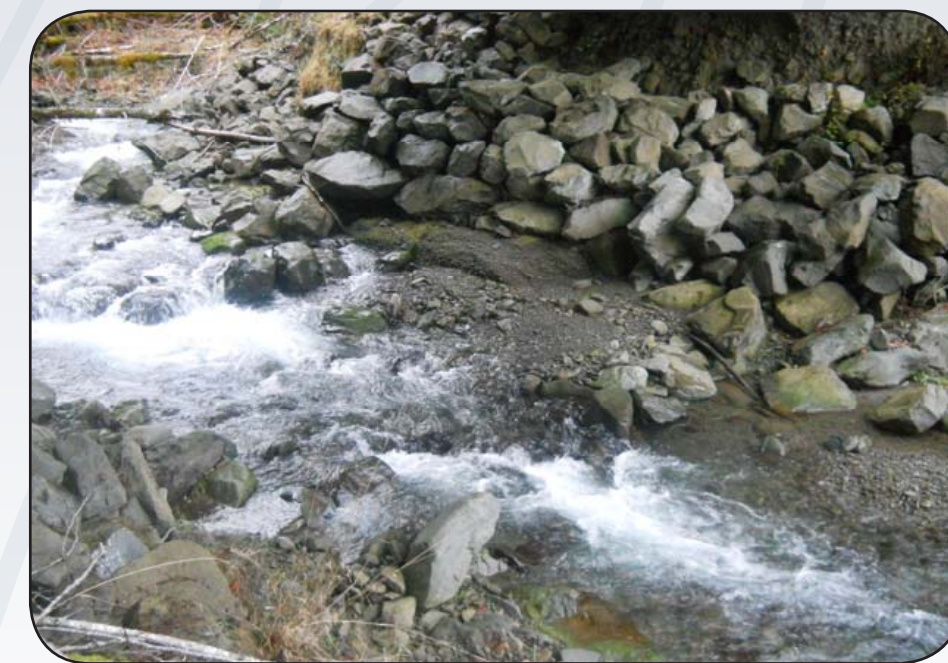
Site C2 Bank Stabilization

- **EXISTING CONDITIONS:** Parallel to outside bank of a river bend; includes approximately 3,900 lineal feet of poorly-placed 2-4' diameter riprap revetment along the apex of the river bend (1,150' included with Site C1)
- **PROBLEM:** Large portion of the downstream segment is experiencing impinging flood flow; toe erosion and undermining of the stream bank; high risk of catastrophic road bank failure
- **SOLUTION ALTERNATIVES:** (1) Continue maintenance (place emergency riprap as needed); (2) relocate 1,200' of the road 100-200' away from river channel (potential landslide risk); (3) stabilize road embankment along approximately 350' of road; (4) minor active river channel shift (engineered log-jam groins or riprap streambarbs); or (5) major active river channel shift

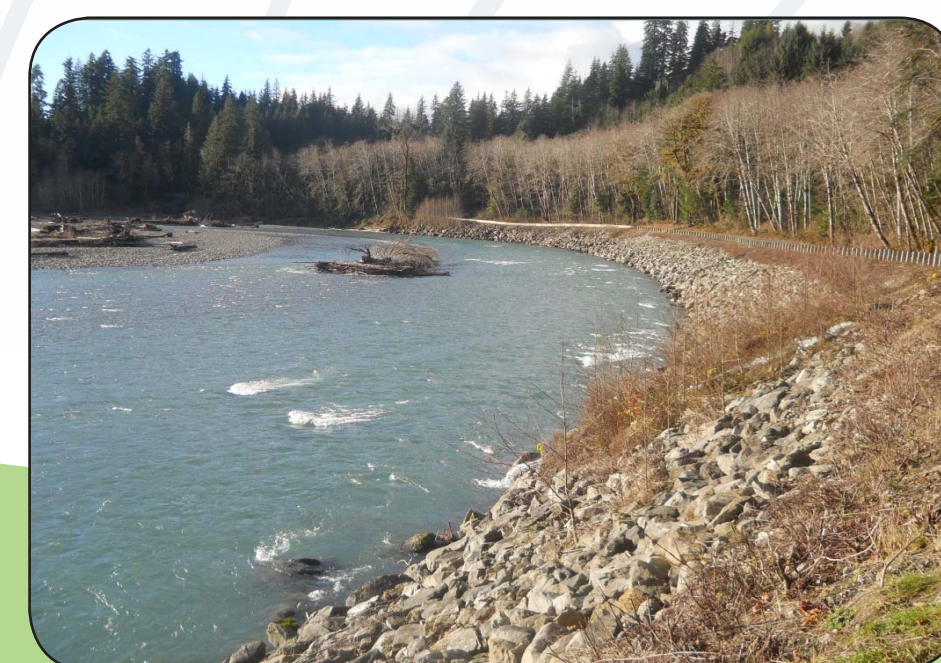
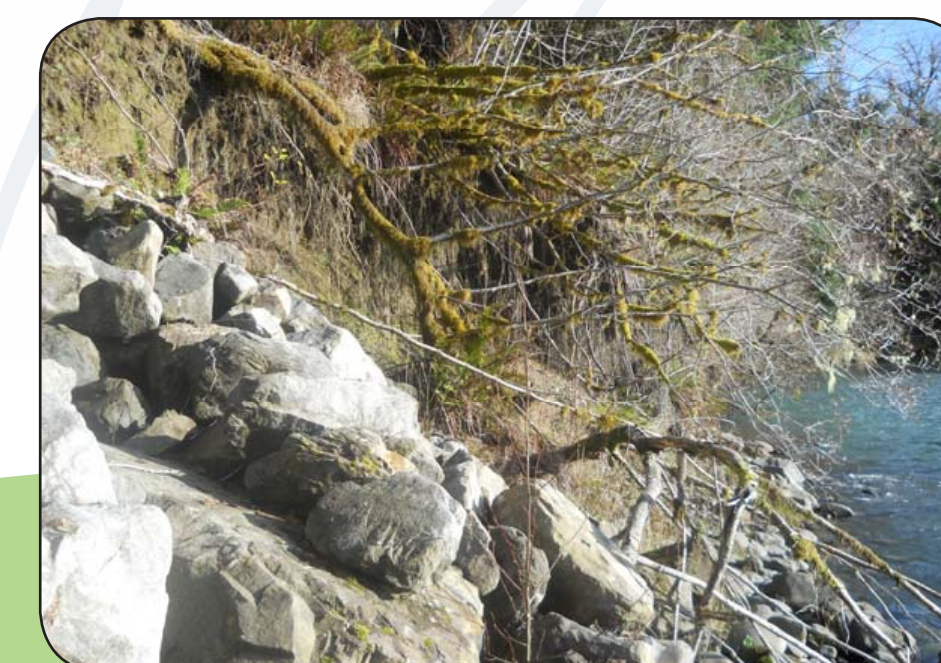
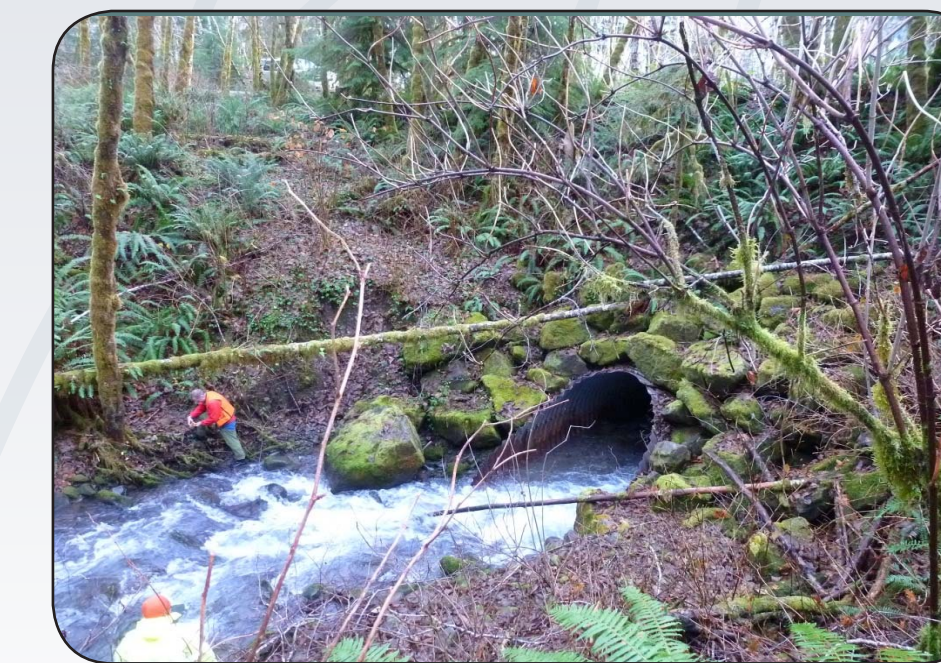
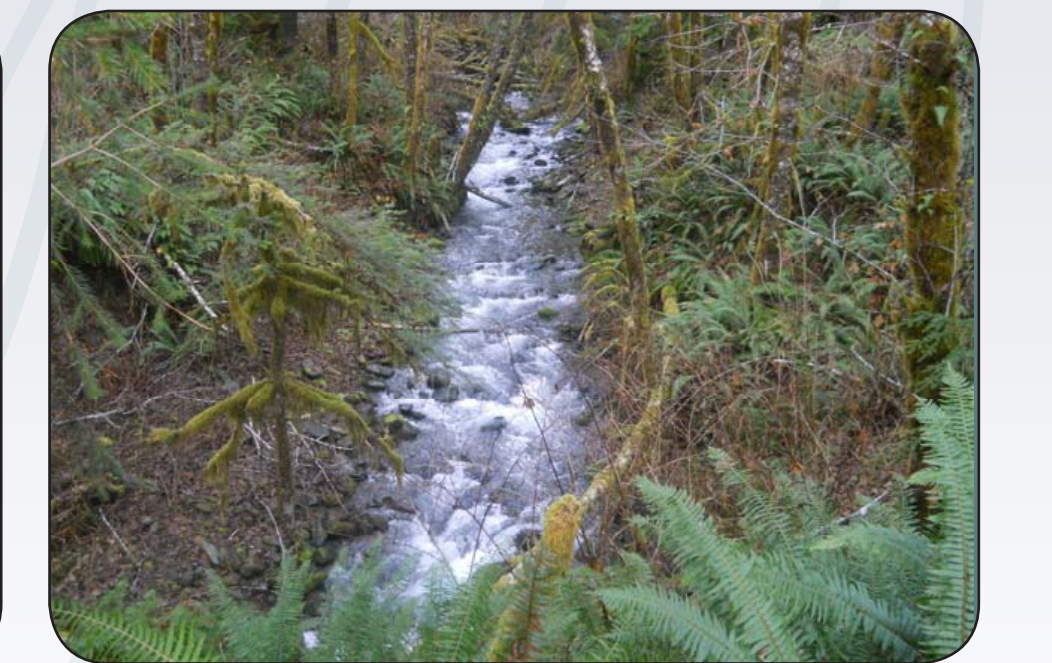
Site C4 Bank Stabilization

- **EXISTING CONDITIONS:** Parallel to outside bank of a river bend; includes approximately 1,300 lineal feet of 2-4' diameter riprap revetment along the apex of the river bend segment
- **PROBLEM:** Rip rap at the maximum point of stream bank curvature and likely experiences high shear stress when floods occur; continued riprap loss could result in revetment dismantling and road damage; low risk of a catastrophic road embankment failure; toe erosion and undermining of the stream bank
- **SOLUTION ALTERNATIVES:** (1) Continue maintenance (emergency replacement of riprap); (2) relocate 2,000' of the road 100-150' away from river channel (would require new bridge location); (3) stabilize road embankment along approximately 800' of road; (4) minor active river channel shift (engineered log-jam groins or riprap streambarbs); or (5) major active river channel shift
