## BRIDGE INSPECTION REPORT

INSPECTION TYPE: ROUTINE

SUN RIVER BRIDGE

STRUCTURE NO. MTA-SR-001

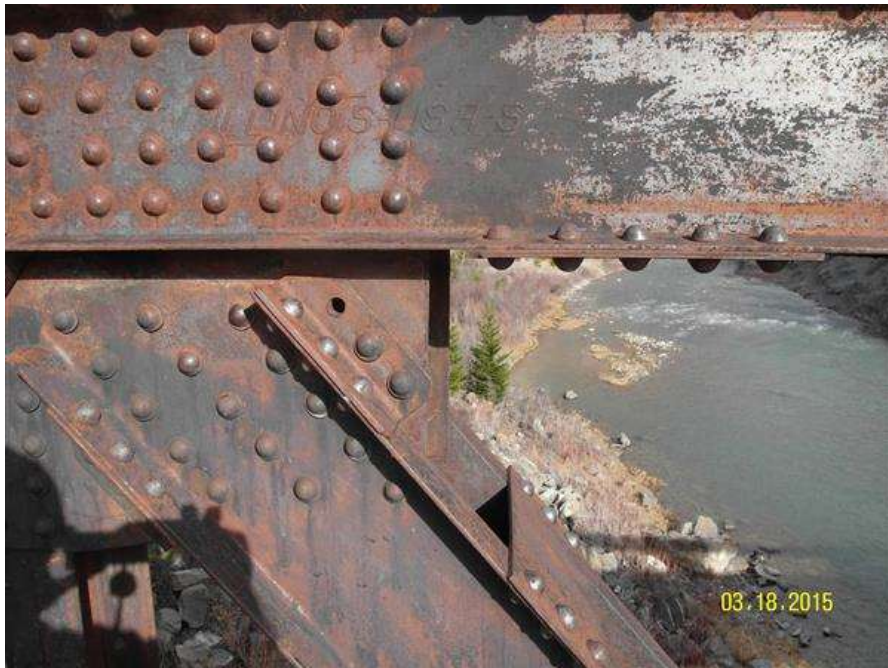
- Some of the bolts and rivets in the top chords of the trusses are loose.
- Bearing devices on the south end of the bridge are covered with dirt and gravel.

PHOTO #2 MTA-SR-001, SUN RIVER BRIDGE, PHOTO BY GARY GRASSEL. VIEW OF A MISSING FASTENER AT THE UPSTREAM SIDE, RIGHT TRUSS, FIRST TOP JOINT FROM THE RIGHT BEARING. (03/18/2015)

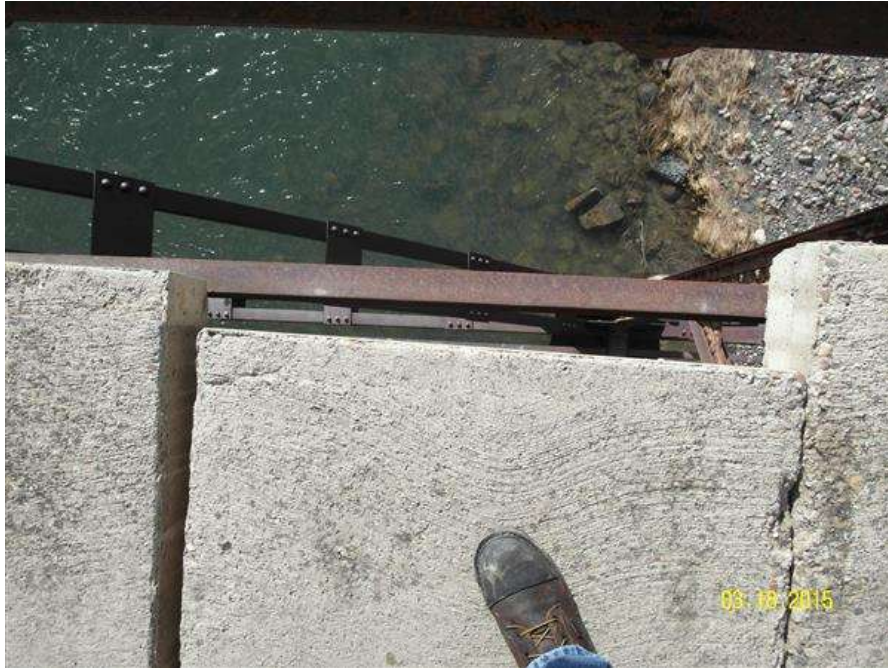
- Load limits and single lane bridge signs need to be posted.
- The precast concrete panels used for decking are free to move on the stringers. Some of the panels have “walked” up or downstream and no longer rest on all of the stringers. The stringers are not restrained by the deck are free to roll under loads.

**PHOTO #3 MTA-SR-001, SUN RIVER BRIDGE, PHOTO BY GARY GRASSEL. THIS PHOTO SHOWS THAT THE PRECAST FLOOR PLANKS ARE NOT FASTENED TO THE SUPERSTRUCTURE BEAM MEMBERS. PLANKS CAN MOVE UPSTREAM OR DOWNSTREAM AND MAY SHIFT A DISTANCE WHERE THEIR USE AS A TRAFFIC SURFACE WILL BE A CRITICAL FAILURE MODE. (03/18/2015)**

4. New recommendation to fasten precast decking members to flanges of supporting beams for securing wearing surface in position and to properly brace compression flange of beams.

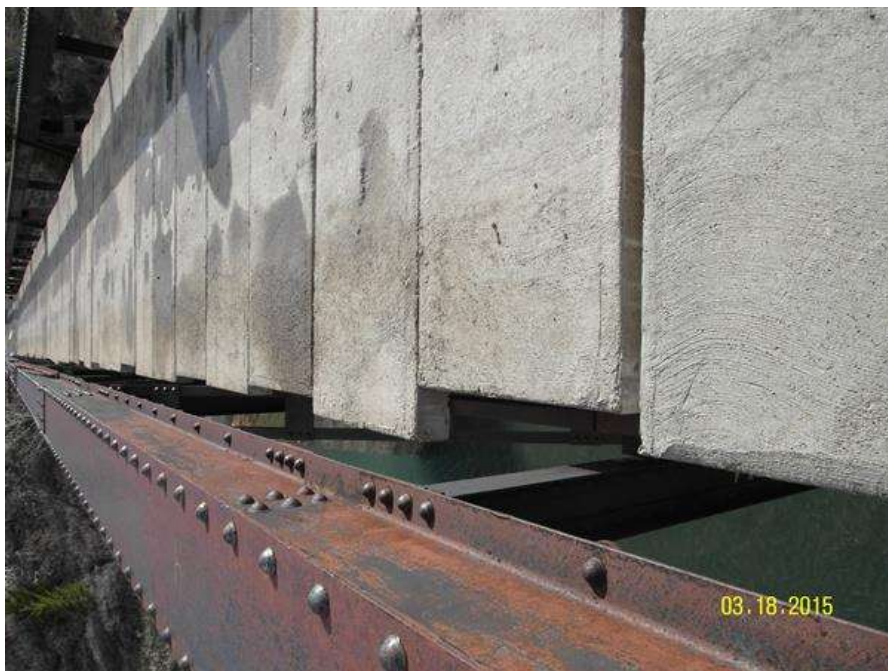
**PHOTO #4 MTA-SR-001, SUN RIVER BRIDGE, PHOTO BY GARY GRASSEL. THIS PHOTO IS A VIEW PARALLEL TO BRIDGE CENTER LINE LOOKING AT THE DOWNSTREAM SIDE OF THE BRIDGE SURFACE. THE PRECAST PLANKS HAVE SHIFTED UPSTREAM AND DOWNSTREAM. RECOMMEND ALL PANELS ARE ATTACHED TO BEAMS AND ADJACENT PANELS TO CREATE NECESSARY DIAPHRAGM. (03/18/2015)**

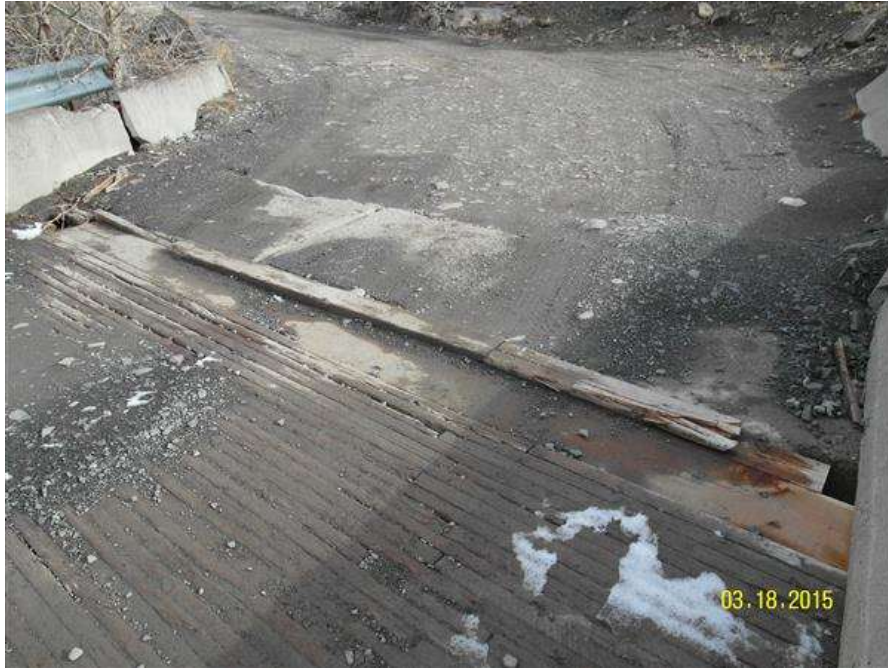
**PHOTO #5 MTA-SR-001, SUN RIVER BRIDGE, PHOTO BY GARY GRASSEL. THIS PHOTO SHOWS THE LEFT (EAST) APPROACH SPAN OF THE BRIDGE. REPAIRS HAVE BEEN MADE SINCE THE LAST INSPECTION. (03/18/2015)**

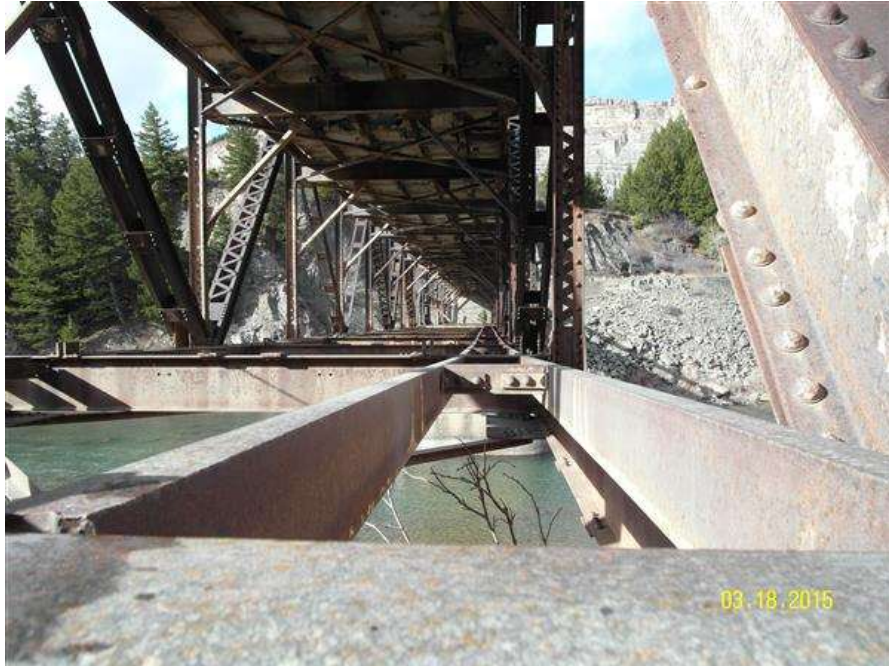
**PHOTO #7 MTA-SR-001, SUN RIVER BRIDGE, PHOTO BY GARY GRASSEL. THIS PHOTO IS A VIEW LOOKING FROM THE LEFT ABUTMENT TO THE CENTER PIER ON THE UPSTREAM SIDE OF THE BRIDGE. NOTE THE SAG IN THE TRUSS APPROXIMATELY AT MID-SPAN OF THE UPSTREAM SIDE ONLY. CONNECTIONS HAVE BEEN INSPECTED BY RECLAMATION CLIMB TEAM AND NOTHING OUT OF THE NORMAL WAS OBSERVED AT THE CONNECTIONS OR MEMBERS. (03/18/2015)**

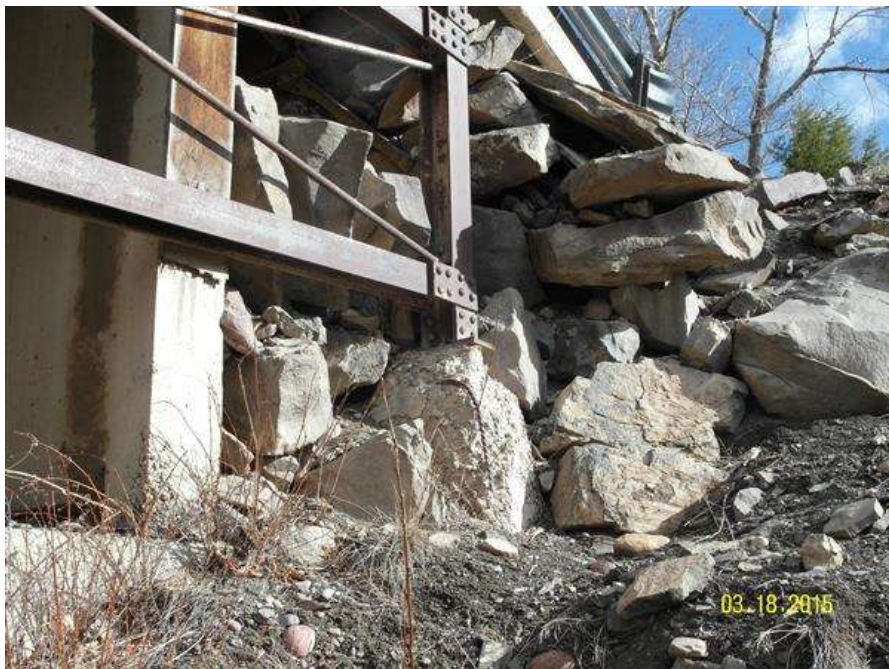
- The concrete footing located on the northeast corner of the approach span is severely deteriorated. Riprap placed within the approach span has added a lateral load to the structure and therefore could displace supporting structure off the footing, leading to failure of approach span.

**PHOTO #8 MTA-SR-001, SUN RIVER BRIDGE, PHOTO BY GARY GRASSEL. THIS IS A VIEW OF THE SUPPORT PIER ON THE LEFT DOWNSTREAM APPROACH SPAN OF THE BRIDGE. RECOMMEND REPLACING THIS EXISTING PIER WITH NEW REINFORCED CONCRETE PIER. (03/18/2015)**

Concrete footing under north approach span needs to be repaired.  
 Precast deck planks must be fastened to steel stringers.

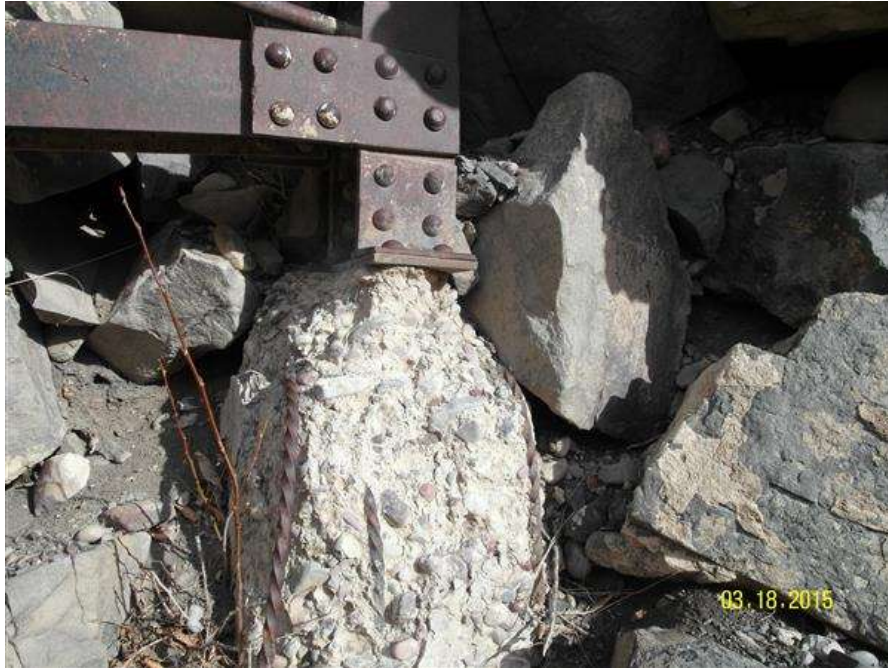
PHOTO #9 MTA-SR-001, SUN RIVER BRIDGE, PHOTO BY GARY GRASSEL. THIS PHOTO IS A CLOSER VIEW OF THE PIER IN PHOTO # 8. (03/18/2015)

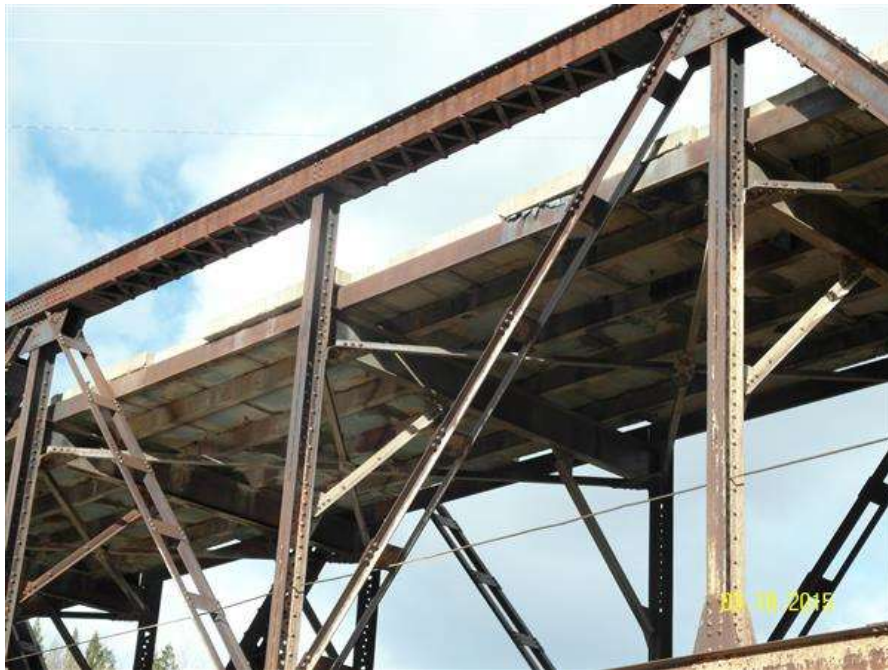
PHOTO #10 MTA-SR-001, SUN RIVER BRIDGE, PHOTO BY GARY GRASSEL. THIS IS A VIEW FROM UNDERSIDE OF THE BRIDGE, NOTE THE PRECAST DECK PLANKS HAVE SHIFTED UPSTREAM AND DOWNSTREAM AND DO NOT PROVIDE LATERAL STABILITY TO STEEL STRINGERS AND THEREFORE SUPPORT BEAMS ARE ALSO FULLY UNBRACED. (03/18/2015)

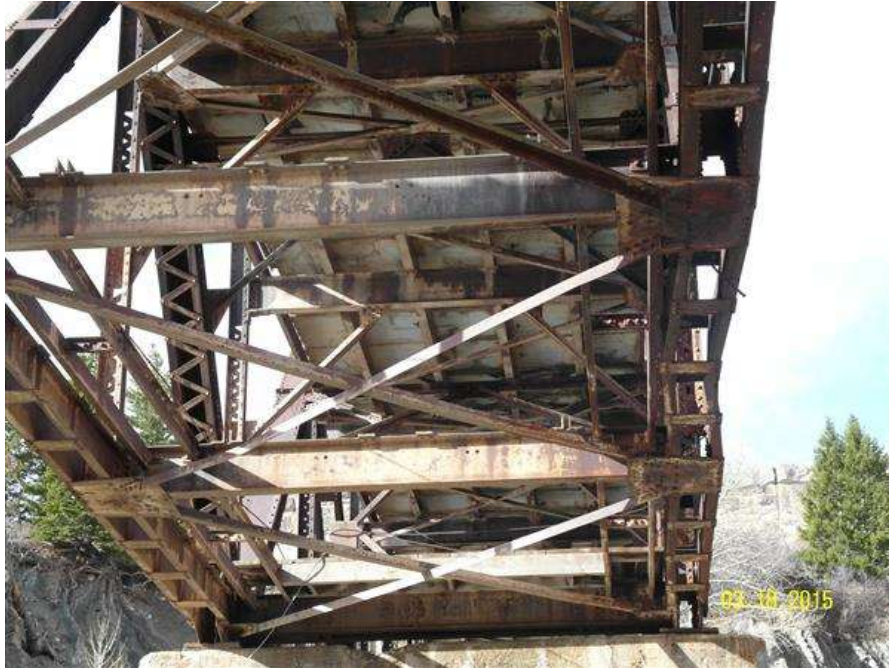
3. Reclamation Climb Team has inspected the damaged area of the bottom upstream cord. No areas of concern were encountered therefore current load rating is still acceptable. (Item #7 above resolved)

**PHOTO #11 MTA-SR-001, SUN RIVER BRIDGE, PHOTO BY GARY GRASSEL. THIS PHOTO SHOWS THE BOTTOM CORD OF THE LEFT UPSTREAM TRUSS. THE BENT LOWER CORD HAS BEEN INSPECTED BY THE RECLAMATION CLIMB TEAM AND NOTHING WAS OBSERVED TO BE IN NEED OF REPAIR. (03/18/2015)**

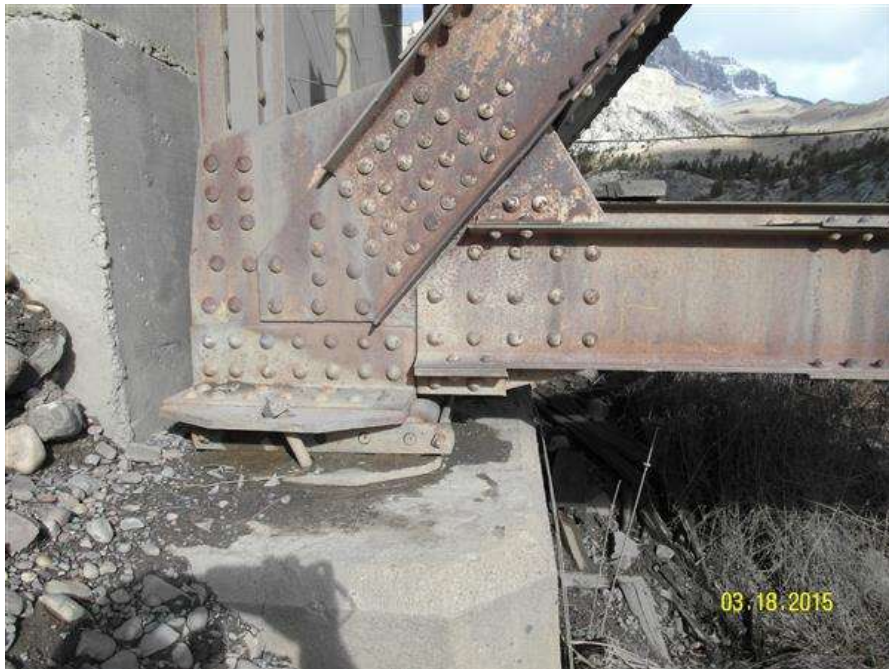
**PHOTO #12 MTA-SR-001, SUN RIVER BRIDGE, PHOTO BY GARY GRASSEL. THIS IS A VIEW OF THE BEARING ASSEMBLY ON THE DOWNSTREAM SIDE OF THE RIGHT TRUSS AND RIGHT APPROACH. NOTE TRUSS ANCHOR BOLT IS BENT AND TRUSS BEARING PLATE COMING OFF THE ROLLERS. (03/18/2015)**

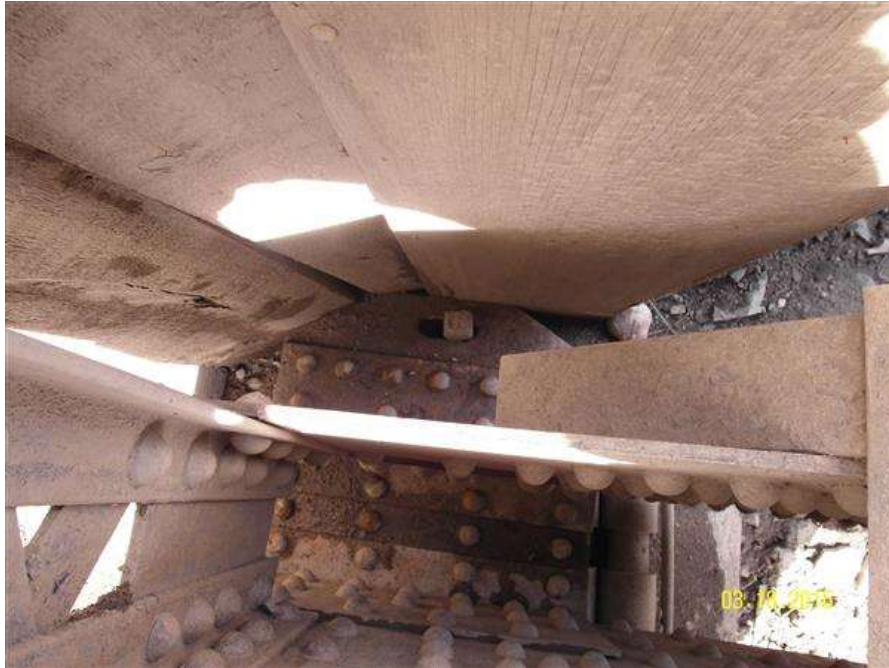
**PHOTO #13 MTA-SR-001, SUN RIVER BRIDGE, PHOTO BY GARY GRASSEL. THIS IS A VIEW OF THE UPSTREAM SIDE AT THE SAME APPROACH AS IN PHOTO #12. THE ANCHOR BOLT IS BENT AND THE BEARING PLATE HAS EXTENDED PAST THE FIRST ROLLER. (03/18/2015)**
