Federal Highway Administration
Every Day Counts
Innovation Initiative

Safety Edge_{SM}
Demonstration Project
Seaford, Delaware

Field Report
January 30, 2011

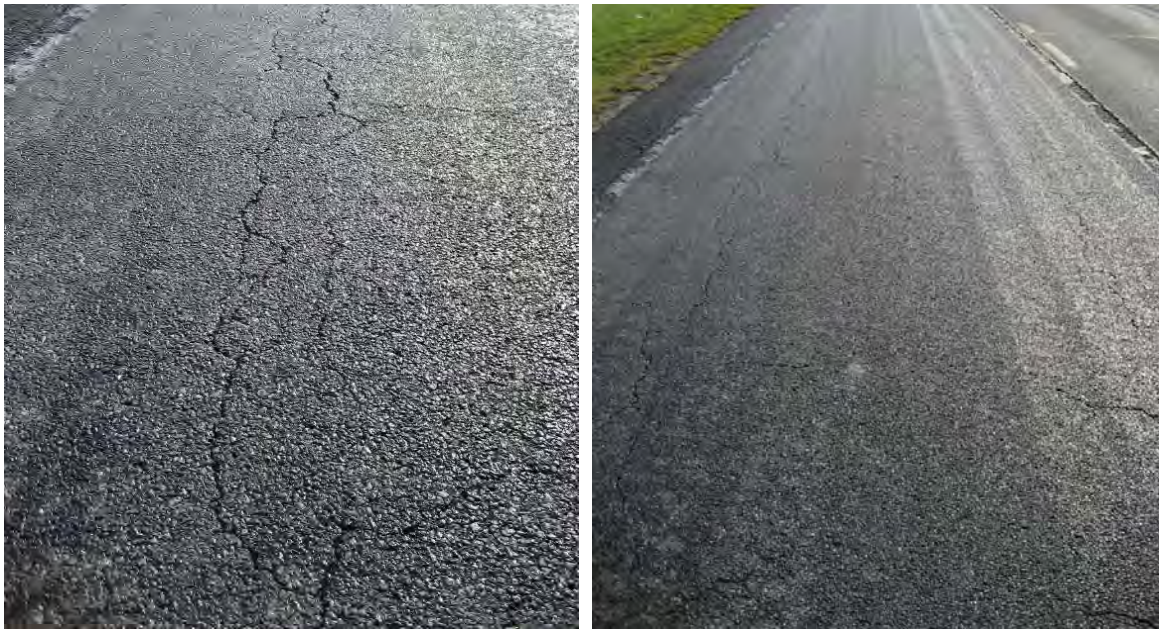
Figure 2. Typical condition of the existing surface (with tack coat applied).

The project consisted of repairing some localized areas with extensive cracking and distortions, widening the roadway by 2 ft, and placing a 2-inch lift of a 9.5-mm WMA mix over the existing HMA pavement. Figure 2 shows the typical cracking and surface condition of the existing pavement along this project. Figure 3 provides a general view of the Figure 2 in WMA overlay and typical cross section of the pavement. In preparation for the WMA overlay, the following activities and repairs were made.

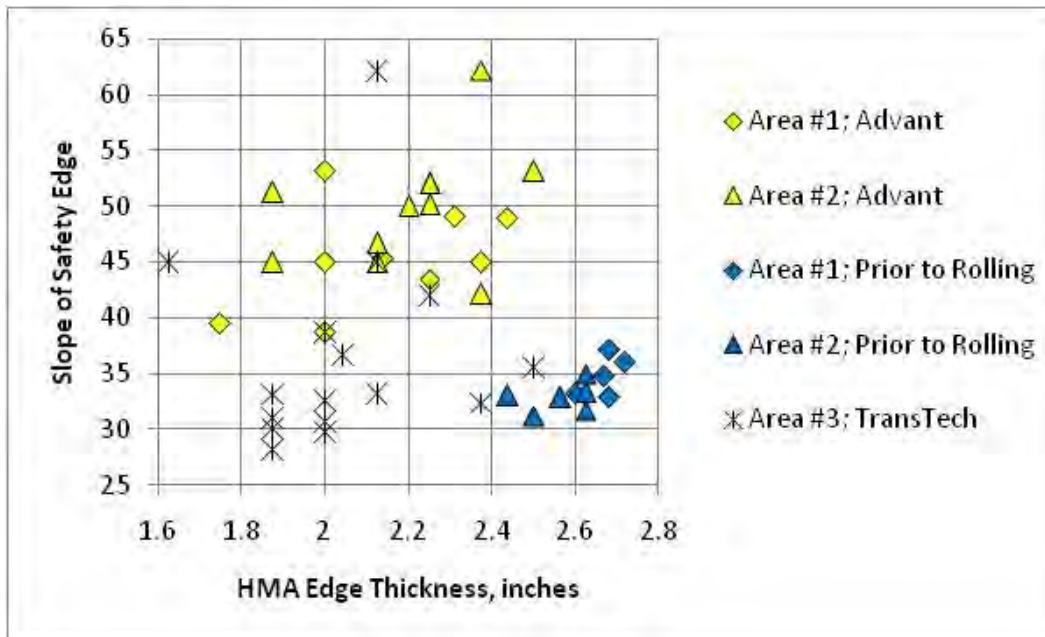
Figure 9. Comparison of the Safety Edge_{SM} slope and thickness of the WMA adjacent to the edge of the HMA overlay.

Safety Edge_{SM} for the three sections. As shown, no correspondence between thickness and the slope of the Safety Edge_{SM} exists.

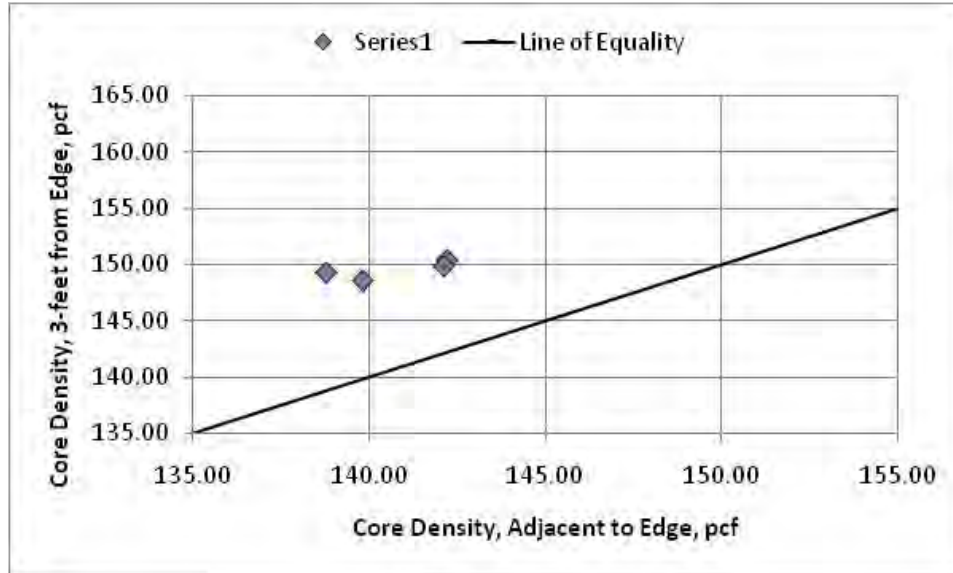
Figure 11. Comparison of core densities adjacent to the edge of pavement and 3 ft from the edge.

A total of eight cores were drilled along the project. Two cores were taken at each station or location; in the same areas where the densities were measured with the Troxler nuclear density gauge. These cores were taken to measure the bulk specific gravity of the WMA for developing a correction factor for the nuclear density gauge readings taken adjacent to the edge and within the center of the mat. Figure 10 shows the location of the cores and nuclear density gauge readings relative to the edge of the WMA mat. Photographs of all eight cores recovered from the roadway are included in the appendix. A summary of these test results; core thickness and bulk specific gravities (saturated surface dry) converted to bulk densities is included in Table A-4 in Appendix A. Figure 11 is a comparison of the core densities taken along the edge and 3 ft from the edge (center of the steel drum breakdown roller) for the Safety Edge_{SM} sections. As expected, densities 3 ft from the edge are higher than along the edge of the mat (unconfined edge).

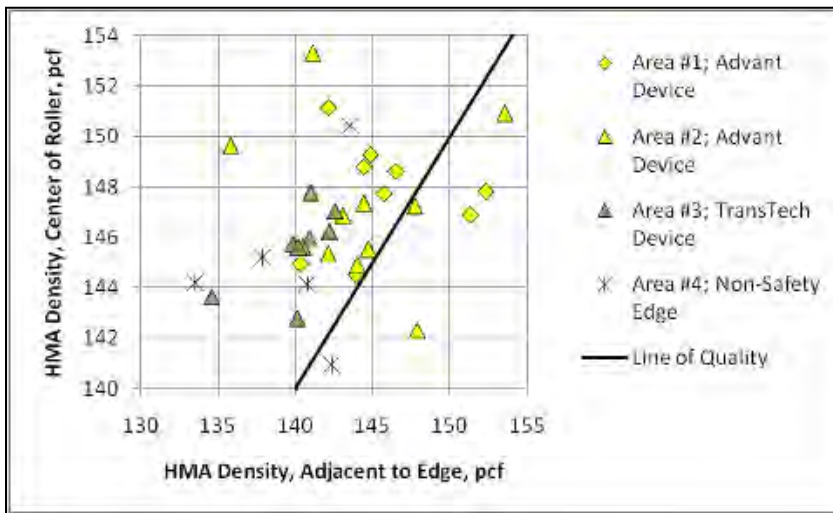
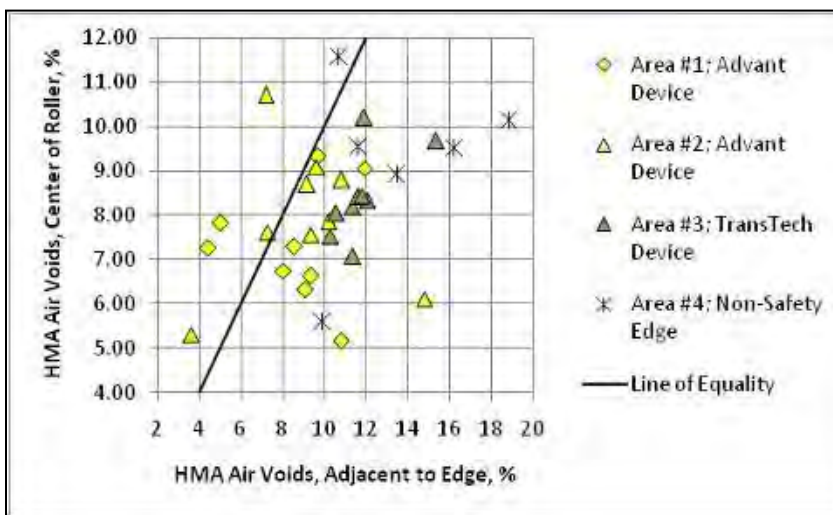
Figure 13. Comparison of the adjusted nuclear density readings and air voids between the areas adjacent to the edge and 3 ft from the edge.

Figure 13 shows a comparison of the adjusted nuclear density gauge readings taken adjacent to the Safety Edge_{SM} and 3 ft from the edge. Figure 13 also includes a comparison of the WMA air voids between both of these areas. As shown, the air voids are higher adjacent to the Safety Edge_{SM}, in comparison to 3 ft from the Safety Edge_{SM}.

Nuclear densities measured in areas adjacent to the edge in comparison to those taken 3 ft from the edge (center of the roller).

Air voids in areas adjacent to the edge in comparison to those taken 3 ft from the edge (center of the roller).

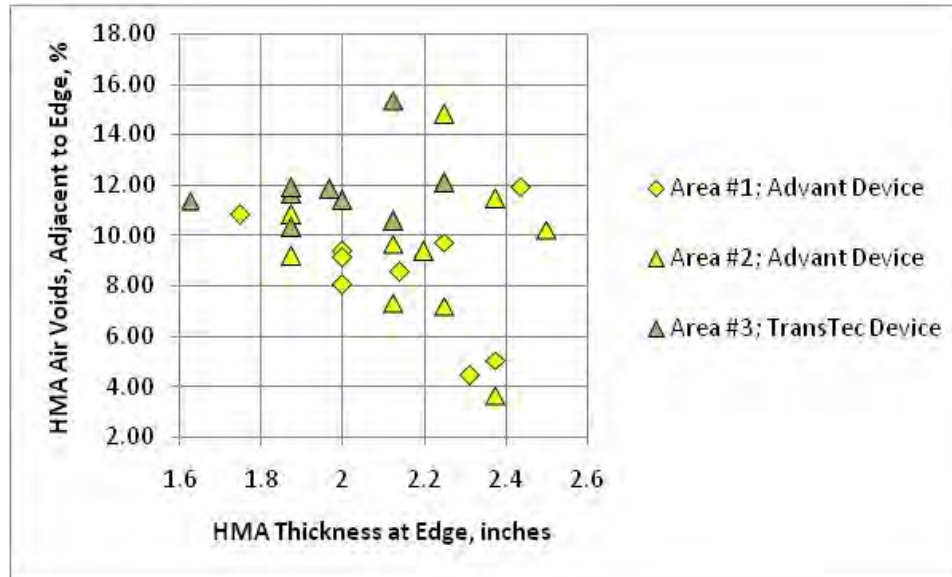
Figure 14. Comparison of WMA thickness at the edge of the mat and WMA air voids.

Figure 9 included a comparison between the WMA thickness (near the Safety Edge_{SM}) and slope of the Safety Edge_{SM}. The thickness of the WMA has little to no effect on the slope of the Safety Edge_{SM}. Figure 14 shows a comparison of the density and WMA overlay thickness. As shown, there is also little correspondence between the overlay thickness and air voids or densities.

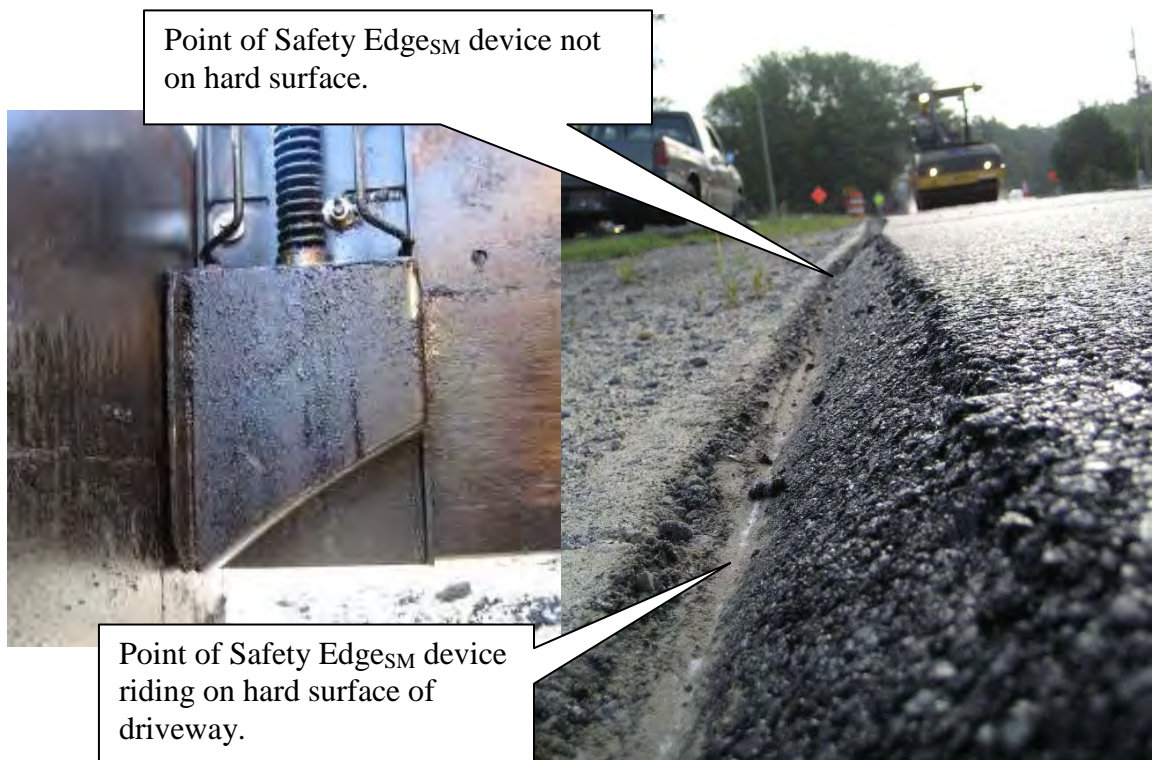
Figure 18. Point of Safety Edge_{SM} scratching the surface of an intersecting driveway.

Both contractor and agency personnel stated the Safety Edge_{SM} device would raise the screed relative to the profile set by the longitudinal ski when paving across intersections or in areas with higher longitudinal profile with hard surfaces. In addition, both commented that it was difficult to get a good tie-in to existing driveways and other hard surfaces. Figure 18 shows the line caused by the tip of the Safety Edge_{SM} device along the edge of pavement over an intersection driveway.

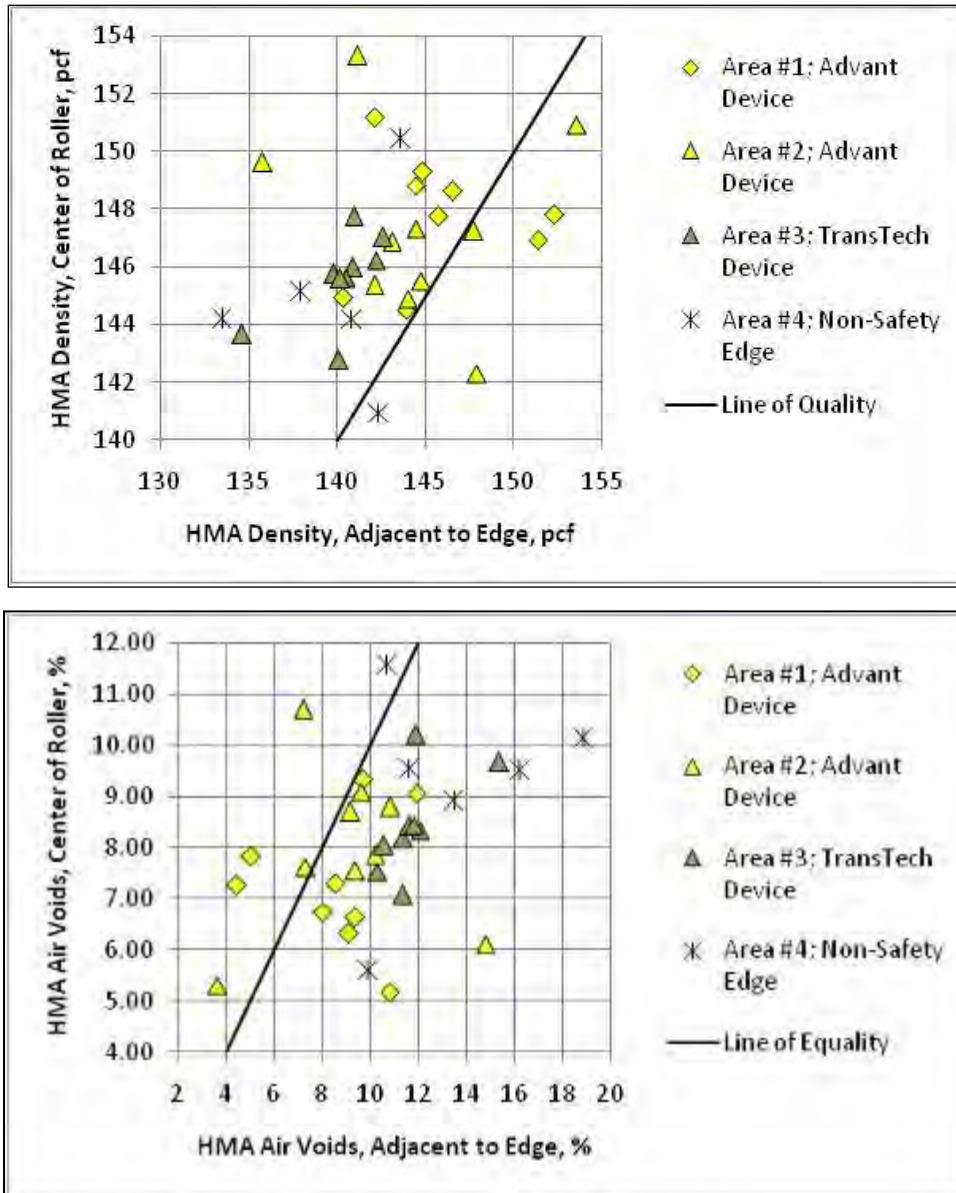
Figure 20. Comparison of volumetric properties between the areas adjacent to the edge and 3 ft from the edge (center of the steel drum roller) for the different sections.

Figure 20 shows a comparison of the adjusted nuclear density gauge readings and air voids adjacent to the Safety Edge_{SM} in comparison to 3 ft from the edge. Table 2 summarizes the average air voids and slopes of the Safety Edge_{SM} for the different sections along this project, and is followed by the following important points from these density and slope measurements:

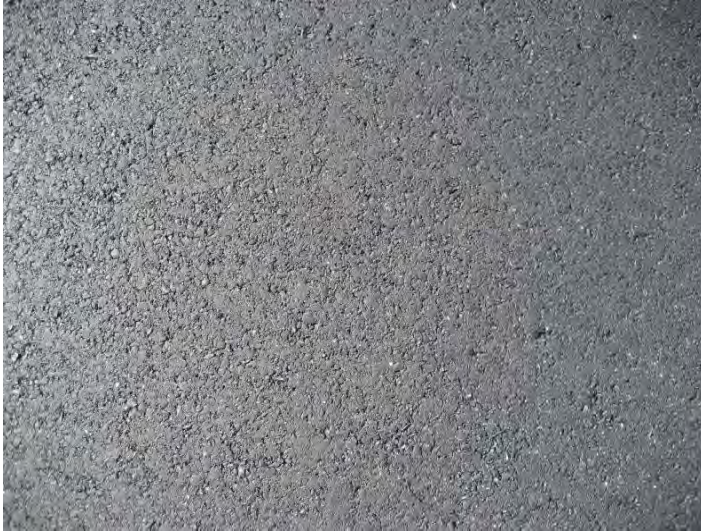
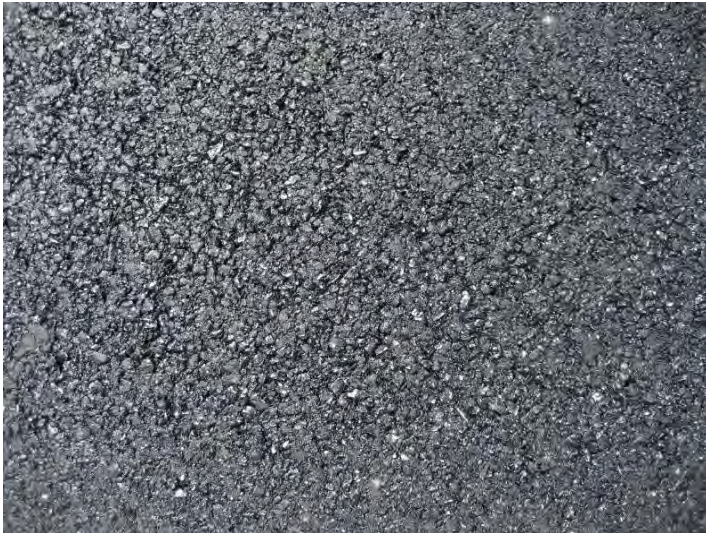
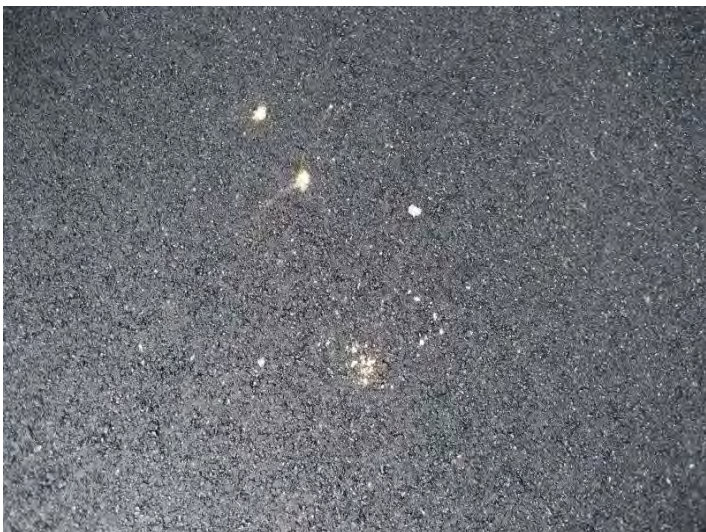
Figure 21. Surface texture of the overlay after final rolling.

The WMA mixture volumetric properties and gradation were considered reasonable. Figure 21 shows the surface texture of the finished HMA mat along different areas of the project; with and without surface defects or surface texture differences. The surface texture and condition were relatively uniform within specific areas of the project. Some agency personnel voiced a concern about the use of some Superpave mixtures; they can be very tender and move under steel wheel rollers.

Example showing an area with a tight surface, fine texture of the mat; small surface voids.

Example showing an area with a coarse surface texture of the mat; large surface voids.

Example showing an area with localized crushed aggregate at the surface of the mat.

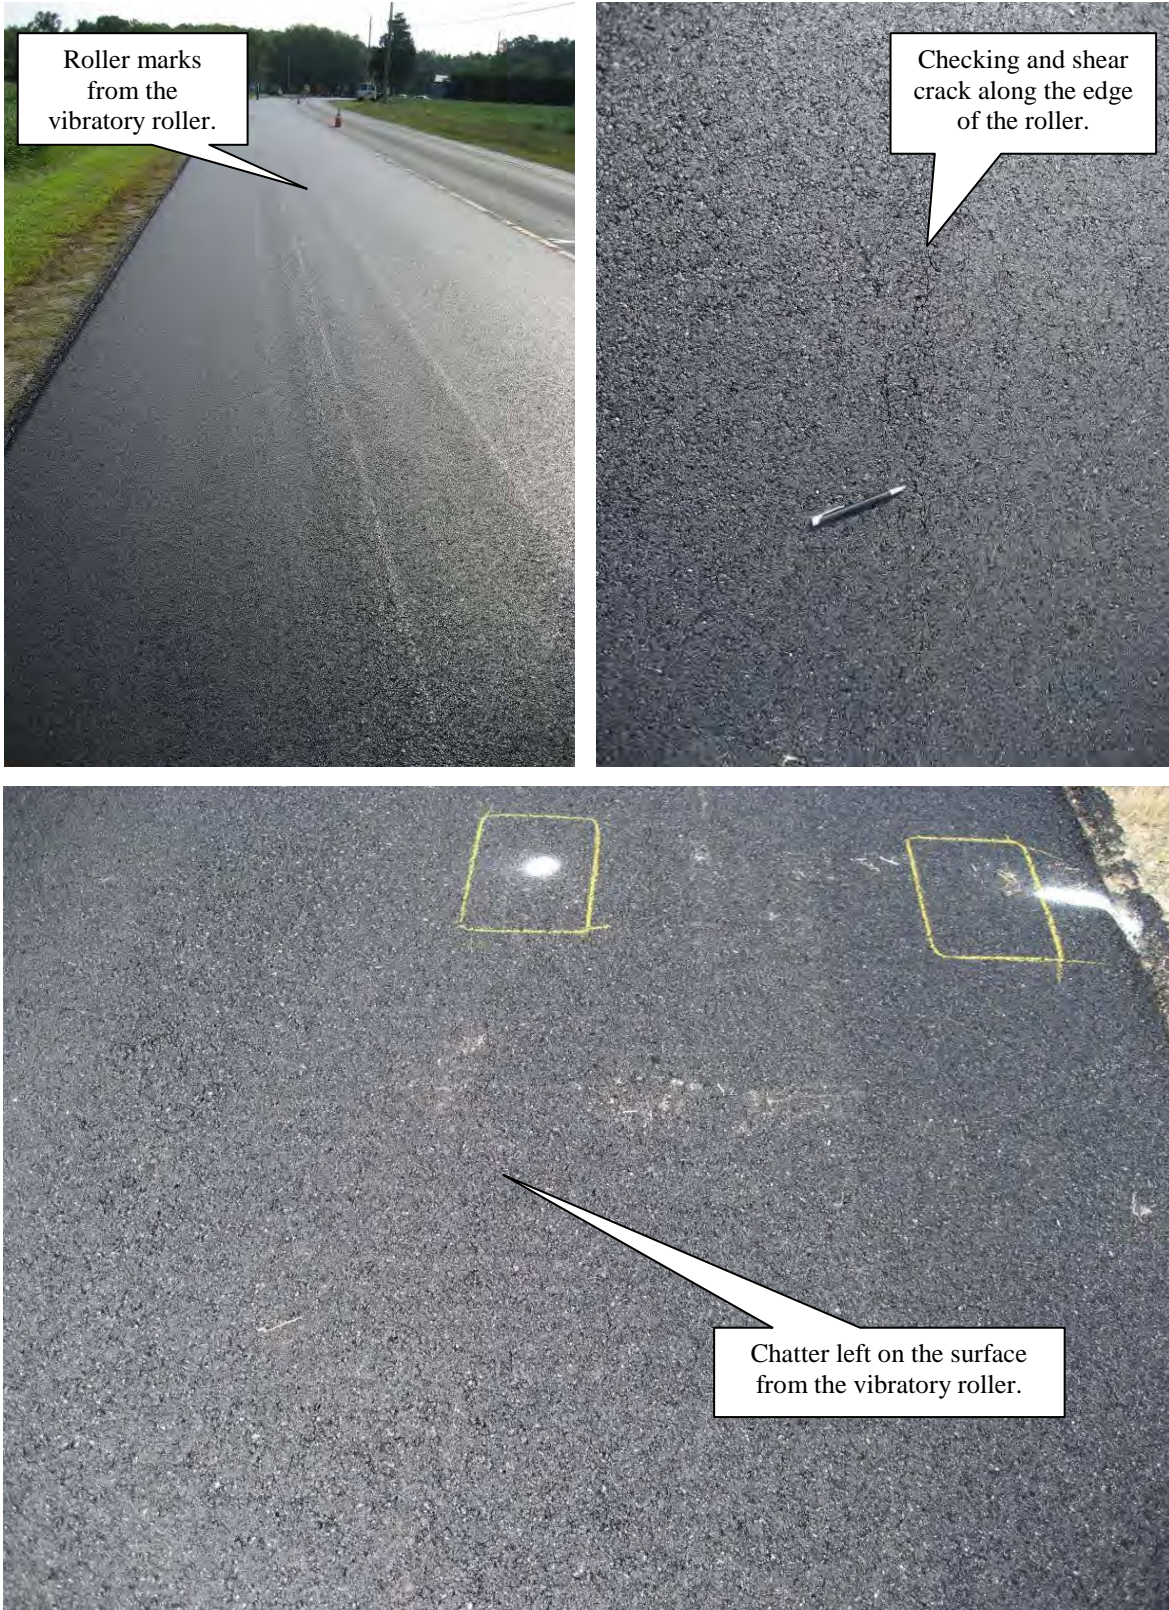
Figure 22. Surface defects observed after rolling.

The WMA mixture did shove and “push out” during the compaction operation, steepening the slope of the Safety Edge_{SM}. The WMA mixture exhibited tenderness under the steel wheel rollers. As an example, roller marks were present after the breakdown roller completed its rolling pattern, checking was observed during the rolling operation, and shear cracks were observed along the roller's edge (Figure 22 shows these examples). Chatter from the Volvo breakdown roller was observed in those areas exhibiting the more severe checking and shear cracks (refer to Figure 22).

The temperature of the WMA delivered to the project site was reported to be approximately 260 °F and 160 to 170 °F during finish rolling. In some cases, the WMA temperature was below 150 °F during the last pass of the finish roller. The WMA temperature could be related to the roller marks being left in the mat, checking and chatter observed in specific areas, and the steeper slopes than planned.

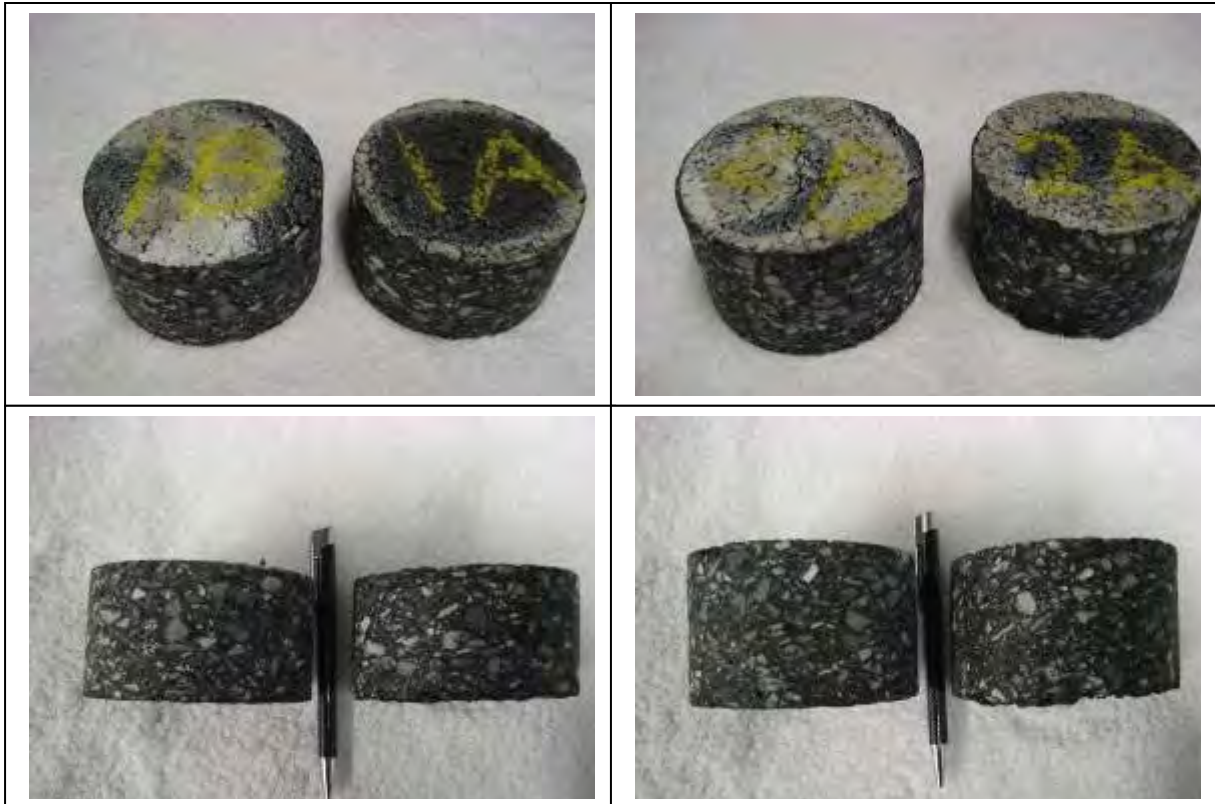
Cores 1B (3 ft from edge)
and 1A (adjacent to edge)

Cores 2B (3 ft from edge)
and 2A (adjacent to edge)

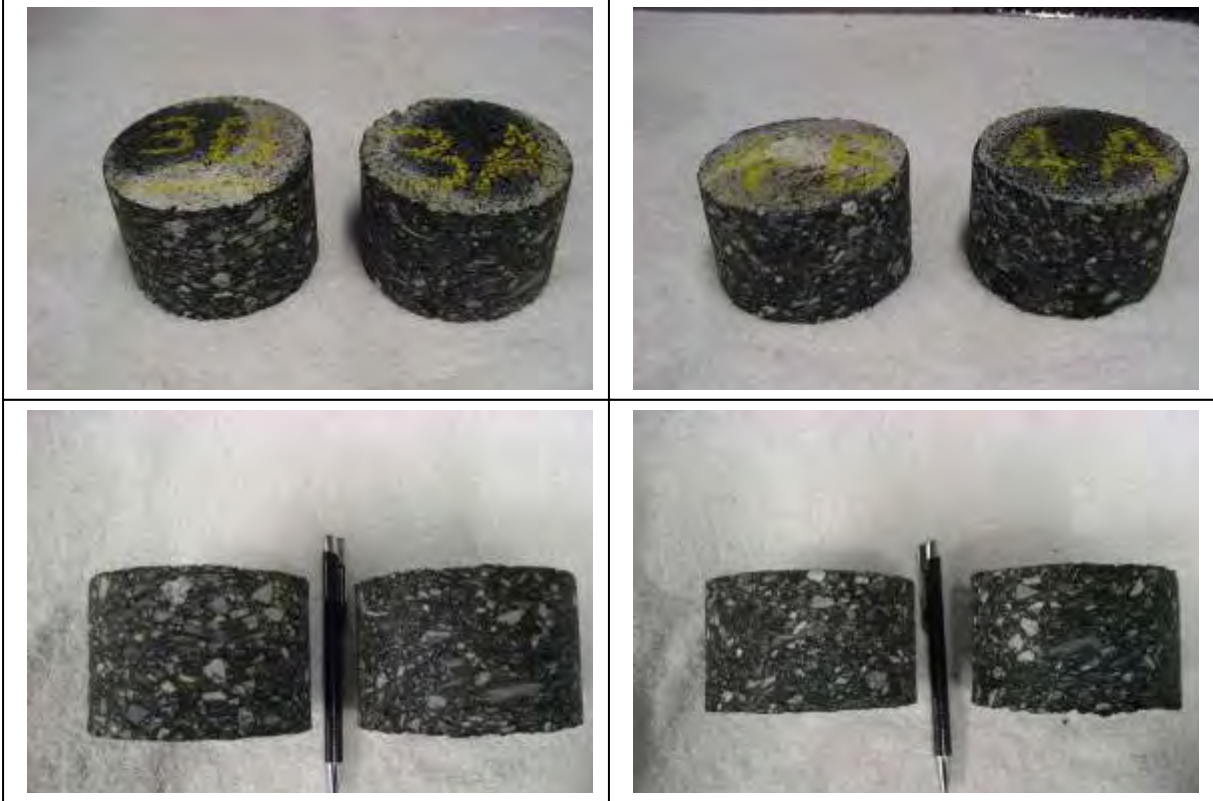
Cores 3B (3 ft from edge)
and 3A (adjacent to edge)

Cores 4B (3 ft from edge)
and 4A (adjacent to edge)
