Federal Highway Administration
Every Day Counts
Innovation Initiative

Safety Edge_{SM}
Demonstration Project
State Route 182
Columbus, Mississippi

Field Report
June 27, 2011

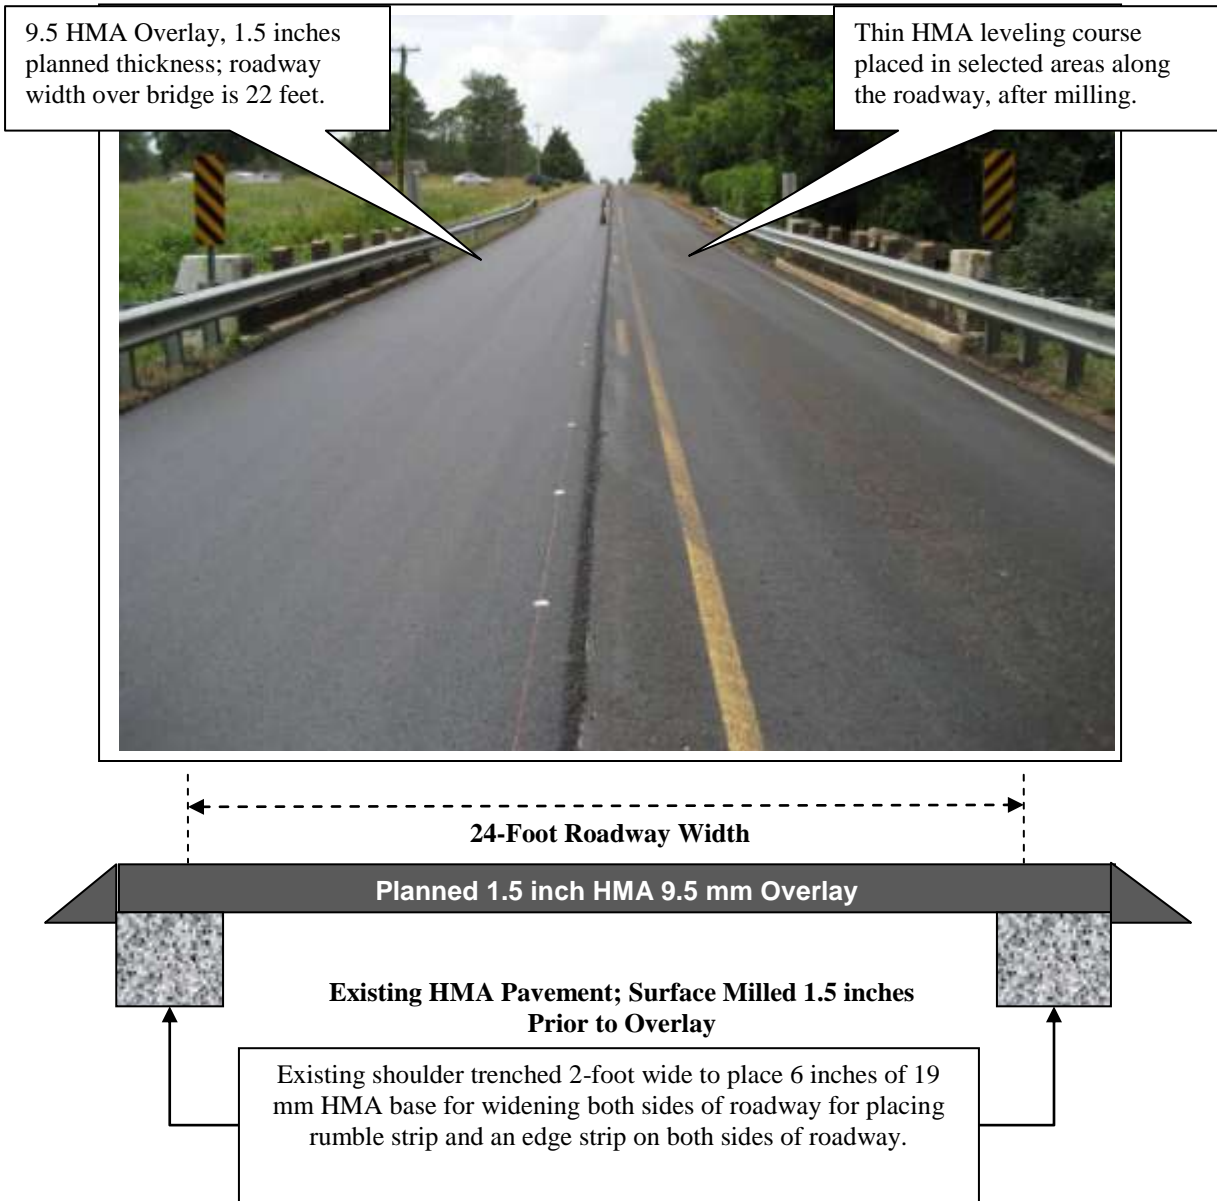
Figure 2. 9.5 mm HMA overlay already placed in one direction and the thin leveling layer placed in opposite direction after milling but prior to overlay placement.

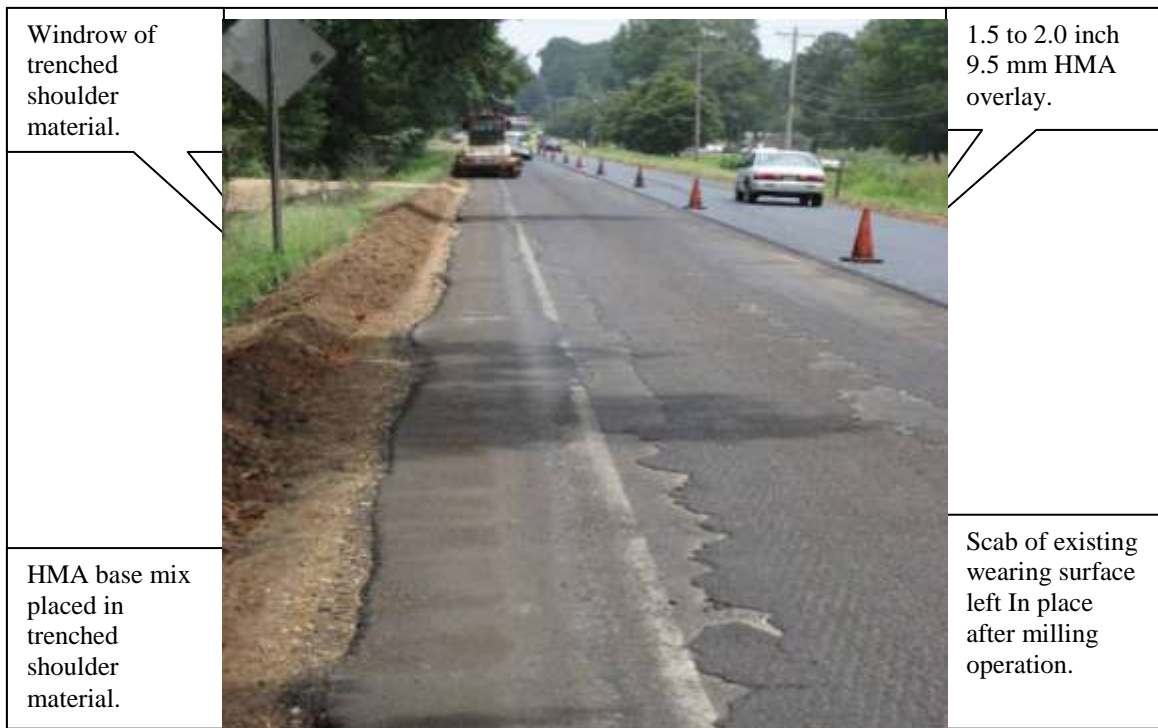
Figure 4. General overview of the existing HMA pavement after milling; minor distressed area (view is towards the east).

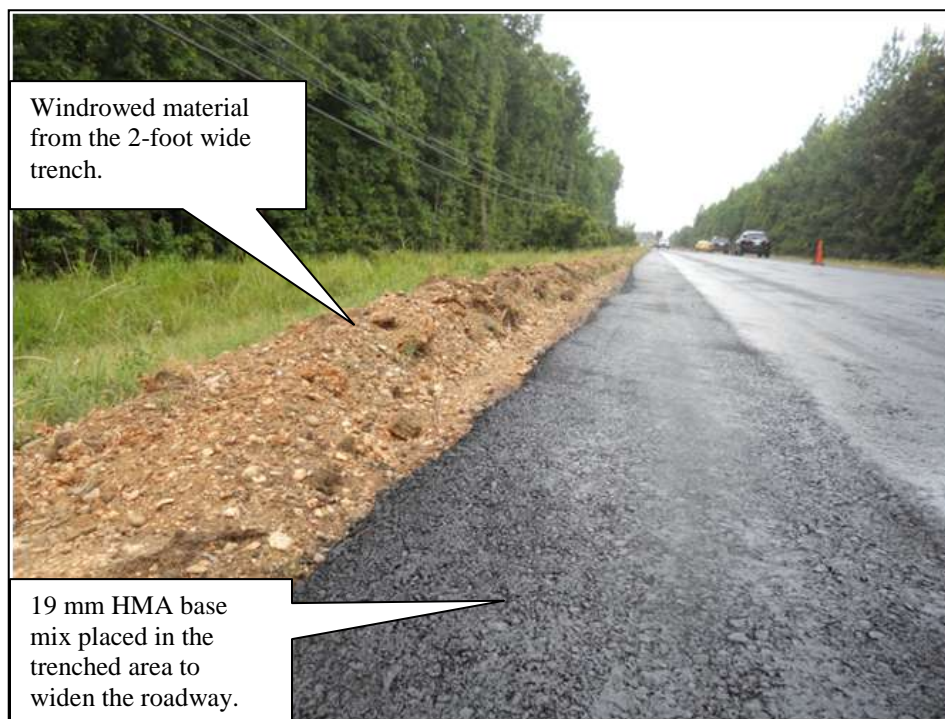
Figure 5. General view of the 19 mm HMA base placed to widen the roadway.

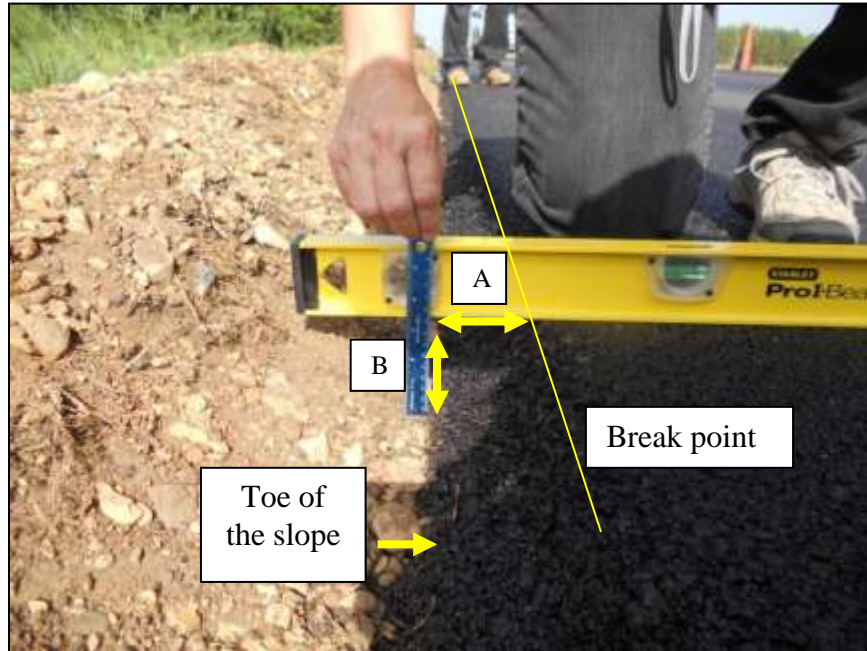
Figure 6. Measurement of the Safety Edges_{SM} angle.

Slope measurements were taken using a straight-edge to measure the width and thickness of the taper of the Safety Edge_{SM} (refer to Figure 6). The average slope of the Safety Edge_{SM} was found to be 37°. All slope measurements are listed in Tables A-1 through A-3 in Appendix A. Only one of the measurements was about 30°. Figure 8 includes a comparison between the slope of the Safety Edge_{SM} after final rolling and thickness of the Safety Edge_{SM} for the two test sections. As shown, there appears to be no correspondence between thickness and the slope of the Safety Edge_{SM}.

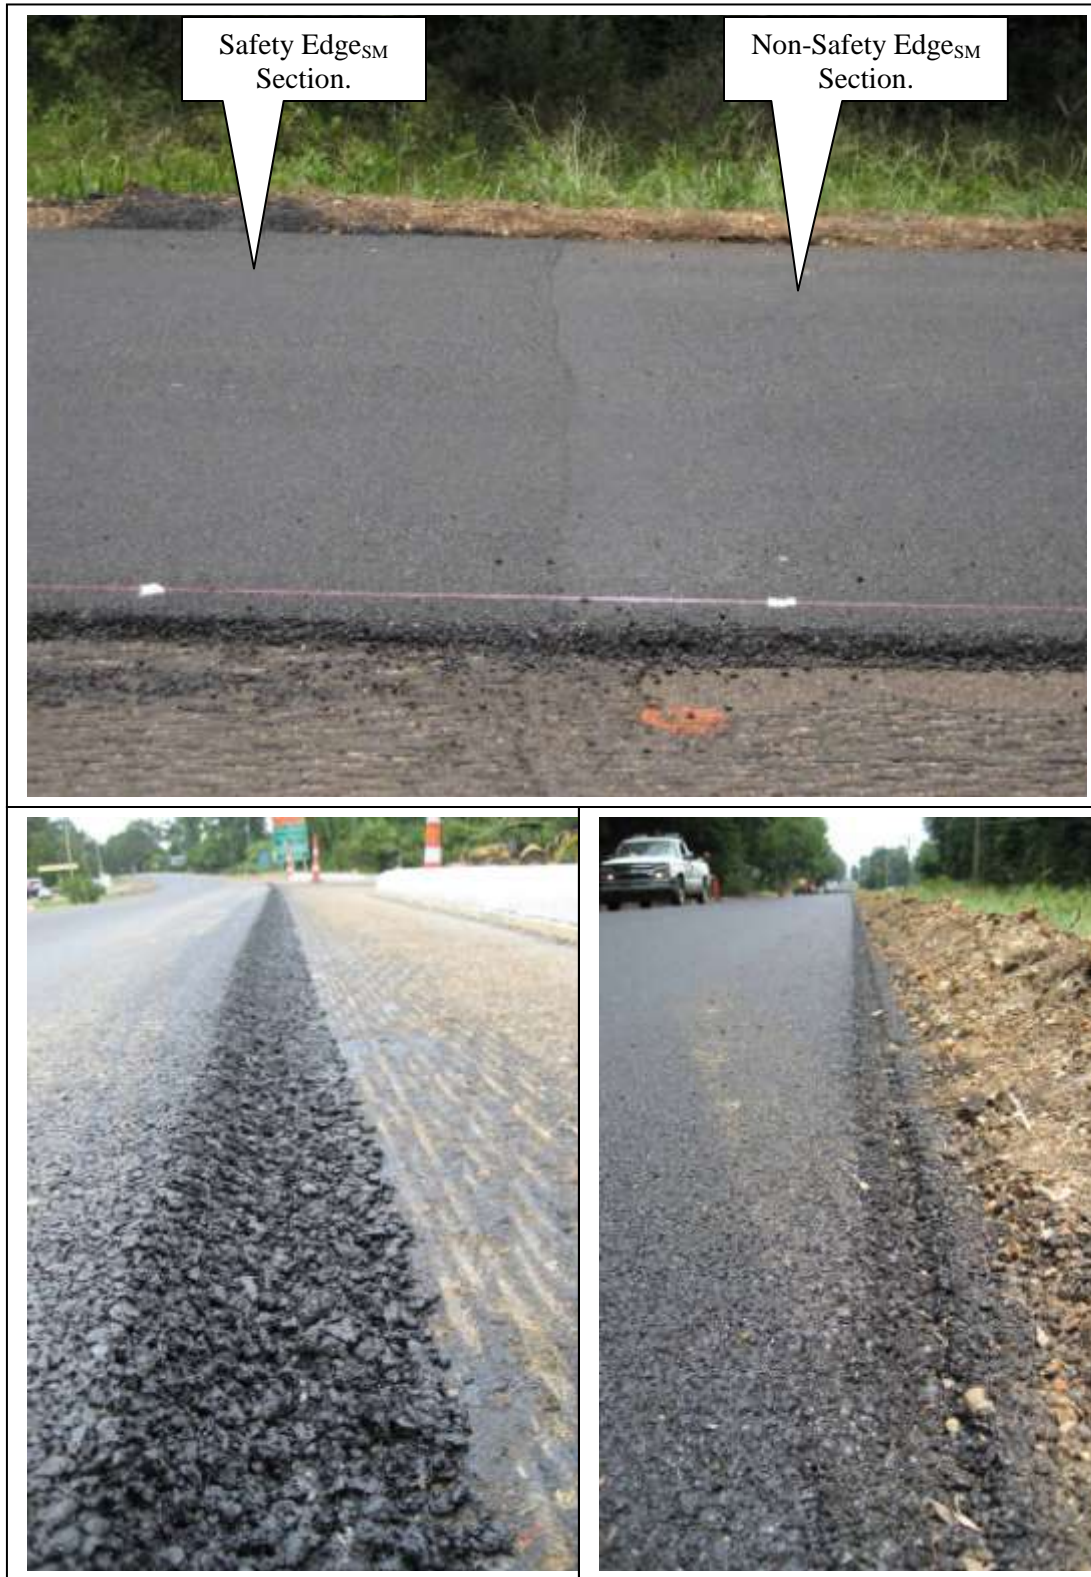
Figure 17 shows the slope and surface texture of the unconfined edge between the Safety Edge_{SM} and non-Safety Edge_{SM} sections.

Figure 17. Safety Edge_{SM} and non-Safety Edge_{SM} sections; different days of paving.

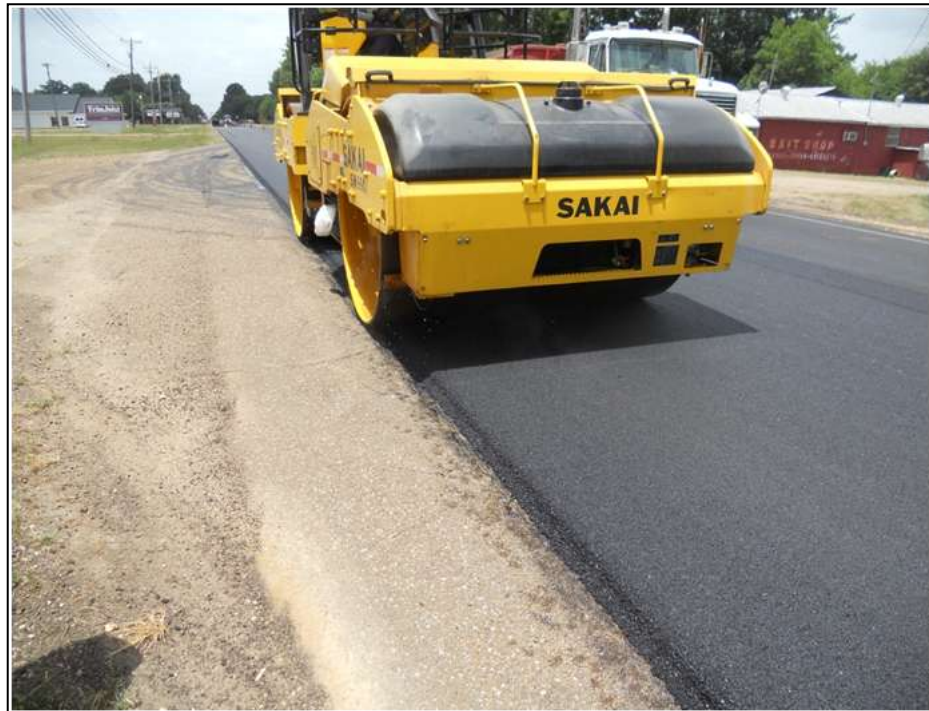
(a) First pass of Sakai roller is 4 to 6 inches over the edge of the mat.

The Safety Edge_{SM} was rolled inconsistently along the project. The rolling pattern used along most of the project, however, was that the first pass of the Sakai breakdown roller was along the Safety Edge_{SM} with the roller extended over the edge of the HMA mat by about 4 to 6 inches (refer to Figures 18 and 20). As noted above, the Sakai roller operator did divert back to initially rolling the mat away from the edge and delayed rolling the edge until the last pass in different locations (refer to Figures 18 and 20). For the initial rolling pattern, the edge of the mat along the Safety Edge_{SM} received only one pass of the breakdown roller. The exact locations of the different rolling patterns were not identified along the project.

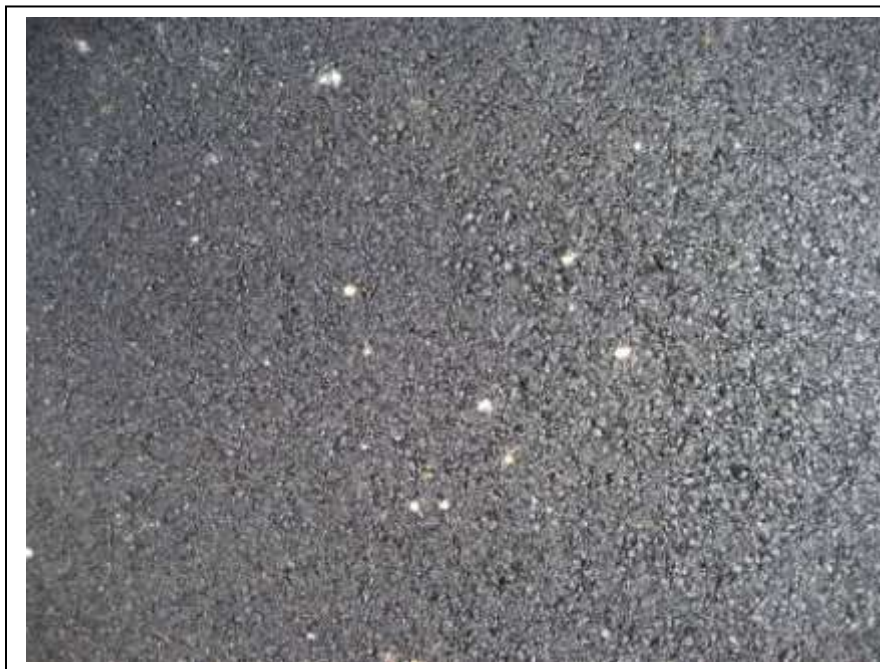
No visual signs of shoving or tearing of the mixture were noted or observed during the compaction operation. In addition, the Safety Edge_{SM} did not shove out, or stand up, during the compaction operation. Figure 21 shows the surface texture of the finished HMA mat along the project. The surface texture and condition was relatively uniform throughout the project.

Figure 21. Surface texture of the 9.5 mm HMA overlay after final rolling.

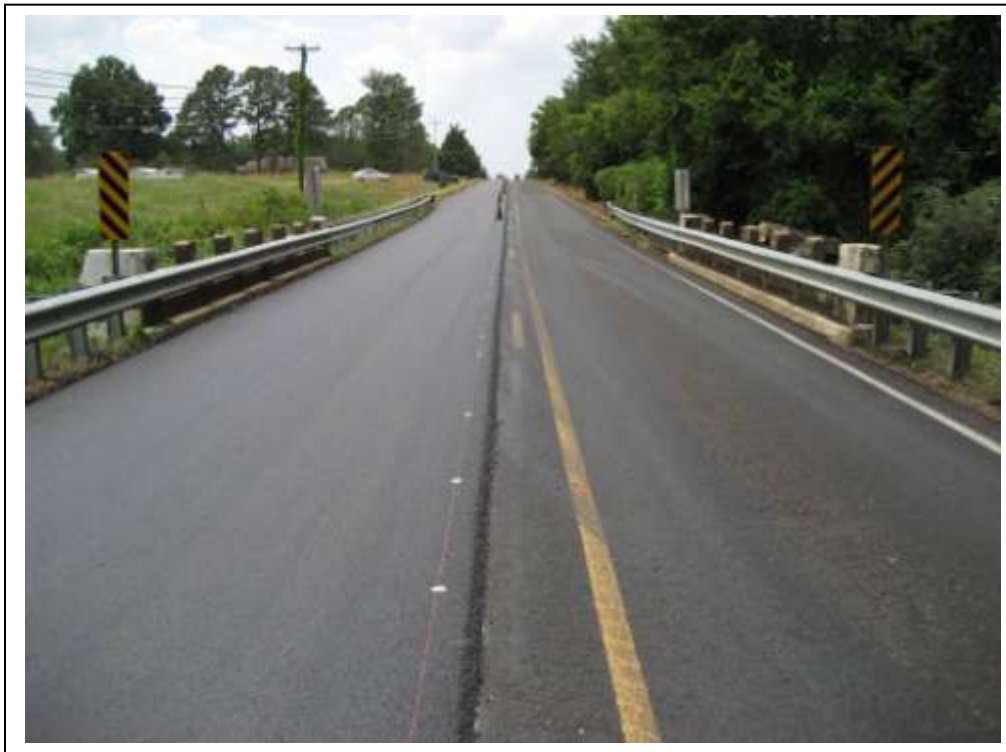
The contractor voiced a concern about being unable to retract the extension on the shoulder side of the paver sufficiently, so that the paver operator would not have to steer the paver closer to the centerline and retract the other extension. Steering the paver closer to the centerline and retracting the other extension could potentially create a longitudinal joint that would be difficult to match and compact (refer to Figure 23).

Figure 23. One of the narrow bridges located on the project (about 22-feet wide).
