Federal Highway Administration  
**Every Day Counts**  
Innovation Initiative

**Safety Edge<sub>SM</sub>**  
**Demonstration Project**  
**Kearney, Nebraska**

**Field Report**  
**May 24, 2011**

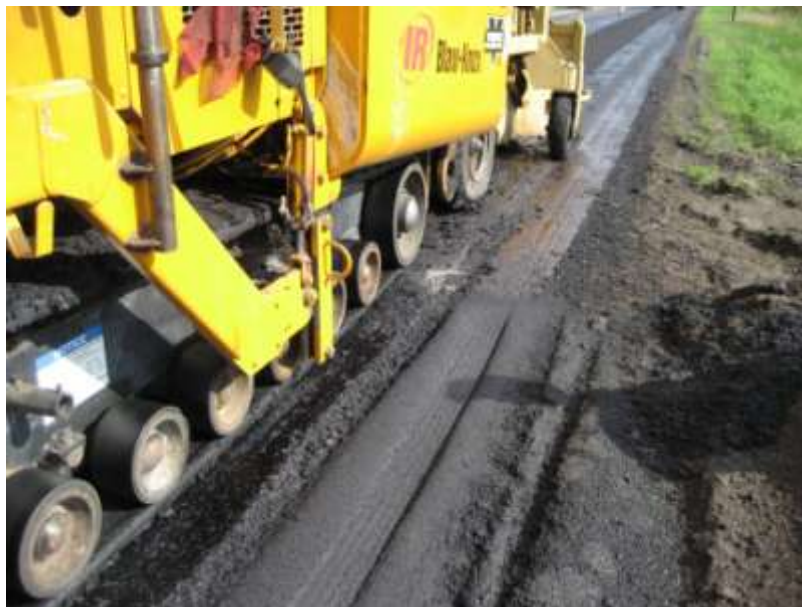
Figure 5. Close-up of the full-depth patch area with surface depressions from the belly-dump trucks and paver.

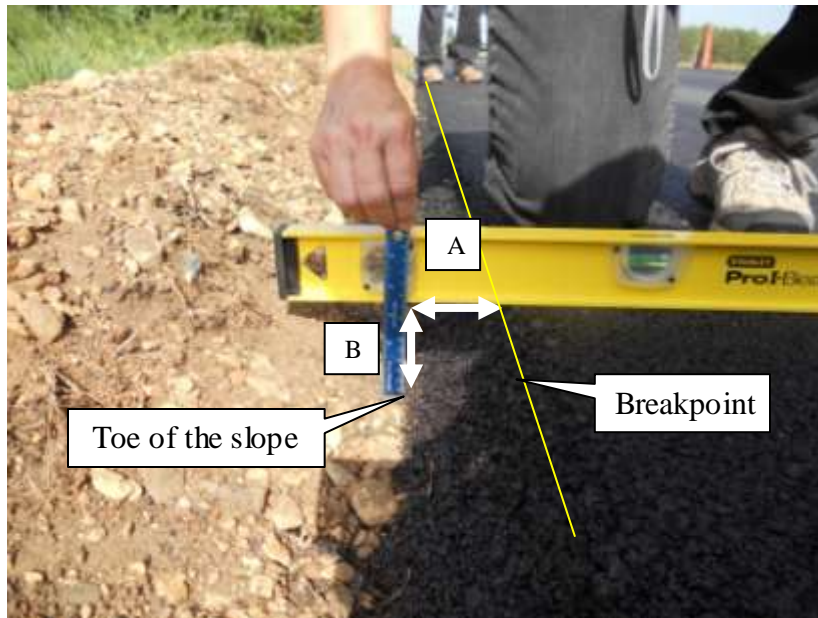
Slope measurements were taken using a straight-edge to measure the width and thickness of the taper of the Safety Edge<sub>SM</sub> (refer to Figure 6). The average slope of the Safety Edge<sub>SM</sub> for all four test sections was found to be 34°. Table A-1 in Appendix A contains slope measurements recorded at each individual measurement location. Figure 8 includes a comparison between the slope of the Safety Edge<sub>SM</sub> after final rolling and thickness of the

Safety Edge<sub>SM</sub> for the four test sections. As shown, there appears to be no correspondence between thickness and the slope of the Safety Edge<sub>SM</sub>.

Figure 6. Measurement of the Safety Edge<sub>SM</sub> slope angle.

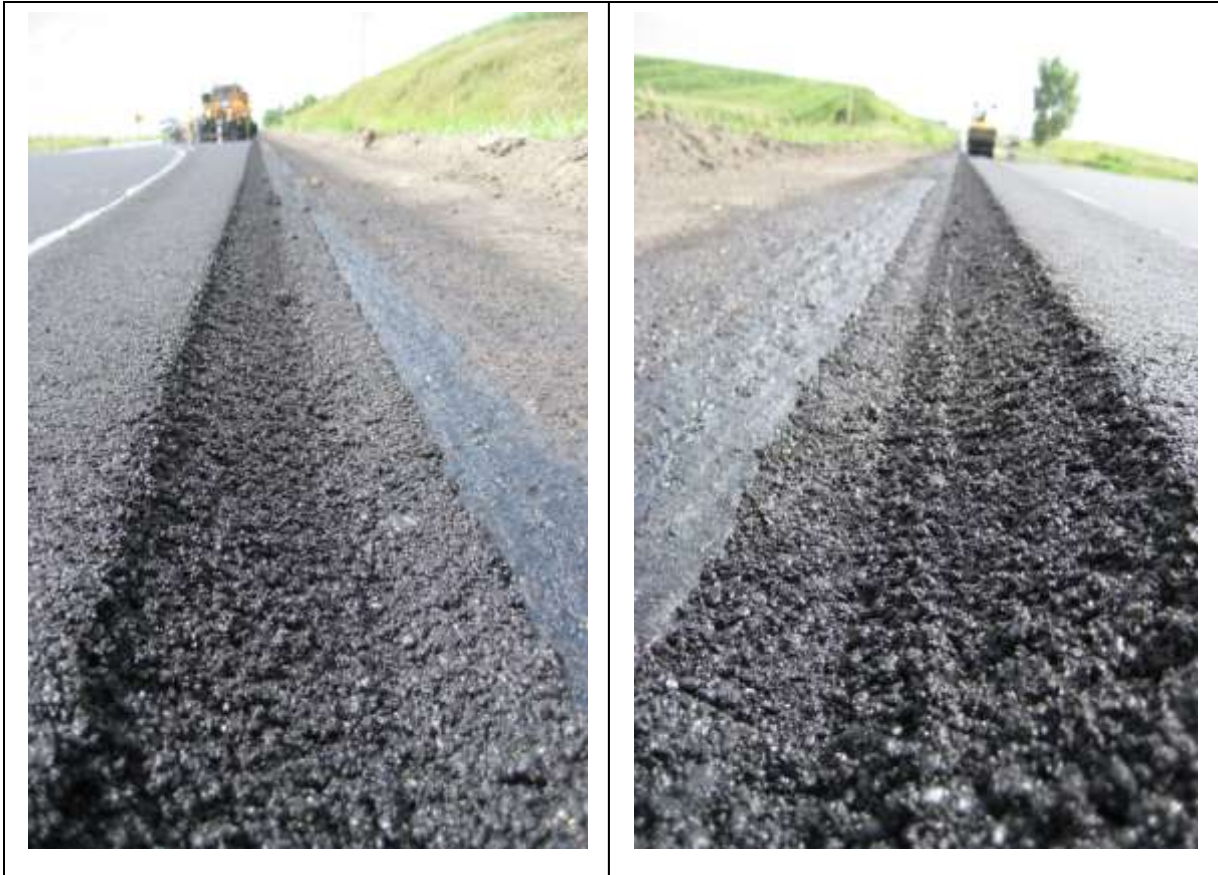
Figure 16 shows the slope and surface texture of the Safety Edge<sub>SM</sub>. The contractor superintendent/owner recommended that the Safety Edge<sub>SM</sub> device be an automated system rather than manually turning the screw to raise and lower the Safety Edge<sub>SM</sub> device.

Figure 16. Typical surface texture and slope of the Safety Edge<sub>SM</sub> sections.

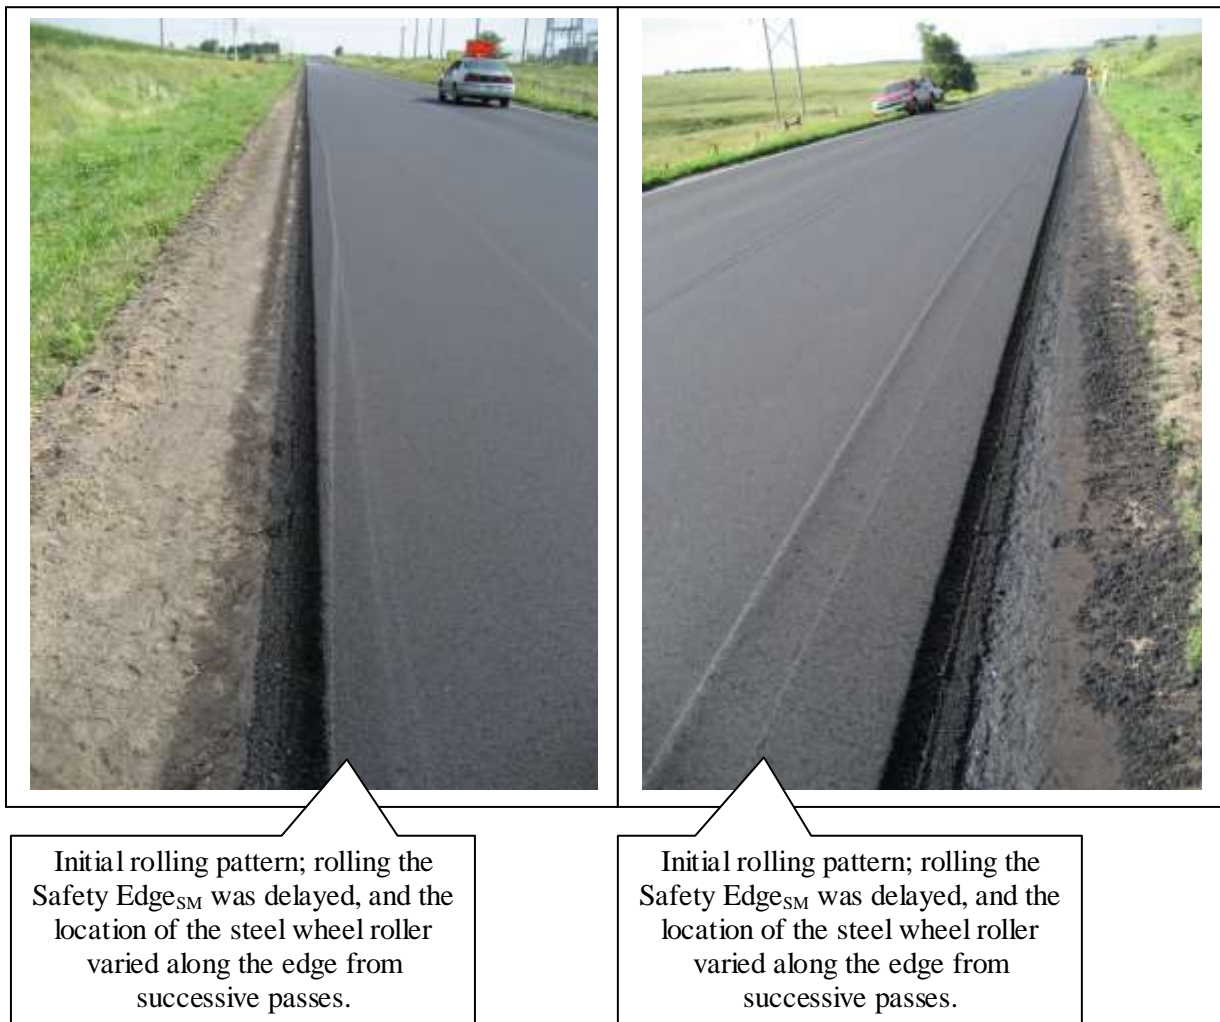
adequate HMA production. Figure 18 shows the variation in the location of the roller's edge along the Safety Edge<sub>SM</sub>.

Figure 18. Initial rolling pattern; edge of the breakdown roller varied along the Safety Edge<sub>SM</sub>, prior to finish rolling.

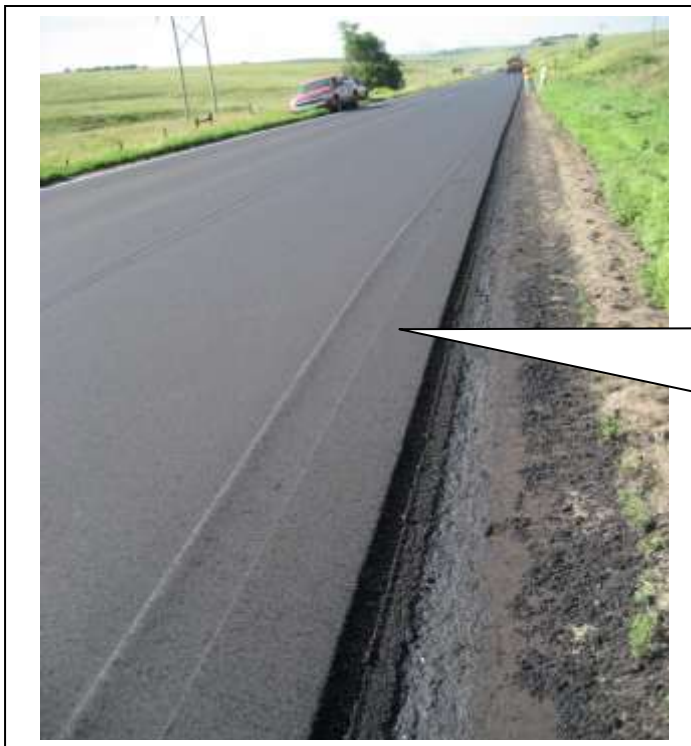
Note the location of the roller's edge for the third pass. This may result in a longitudinal crack with time where the passes were along the same line and the rolling of the edge is delayed.

Figure 20. Rolling the unconfined edge with the vibratory steel wheel roller.

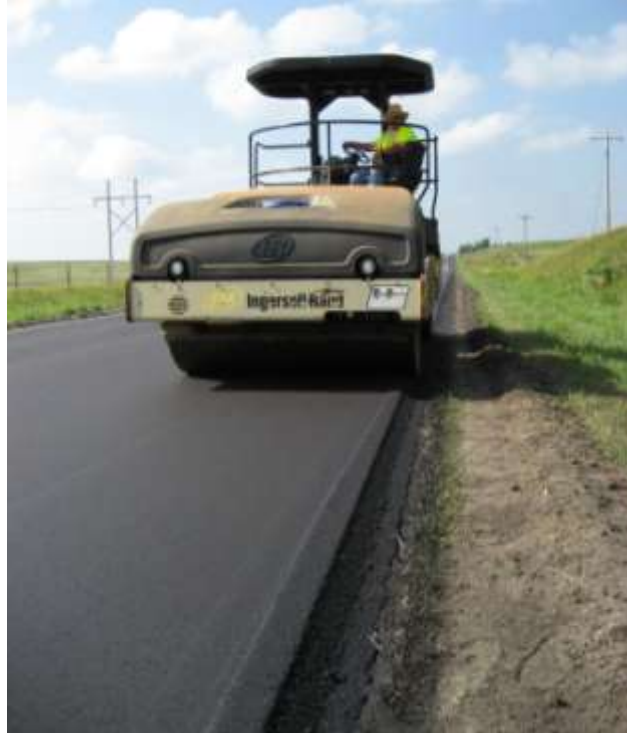
The delay in rolling the Safety Edge<sub>SM</sub> caused the roller operator to increase the speed of the breakdown roller to keep up with the paver. The increase in speed resulted in chatter in localized areas of the mat surface (roller being operated too fast for the frequency selected). The other important point is that the outer edge of the mat (6 to 12 inches from the Safety Edge<sub>SM</sub>) only received one pass of the breakdown roller in some areas prior to the first pass of the Ingersoll-Rand roller (refer to Figure 21).

Figure 21. First pass of the Ingersoll-Rand finish roller along the Safety Edge<sub>SM</sub>.

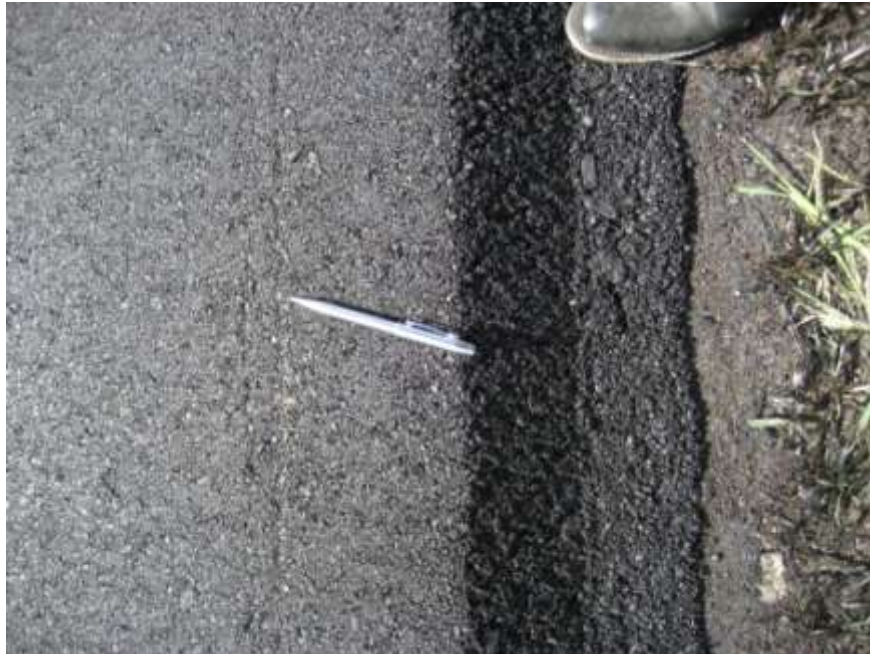
The finish roller appeared to remove most of the chatter caused by the breakdown roller. The finish roller did not eliminate the longitudinal roller mark left by delaying the breakdown roller along the outside edge of the mat (refer to Figure 22). It is expected that this mark will eventually result in a longitudinal crack along the edge of the mat.

Figure 22. Longitudinal mark left by delaying the breakdown rolling of the Safety Edge<sub>SM</sub>; image taken after finish rolling.

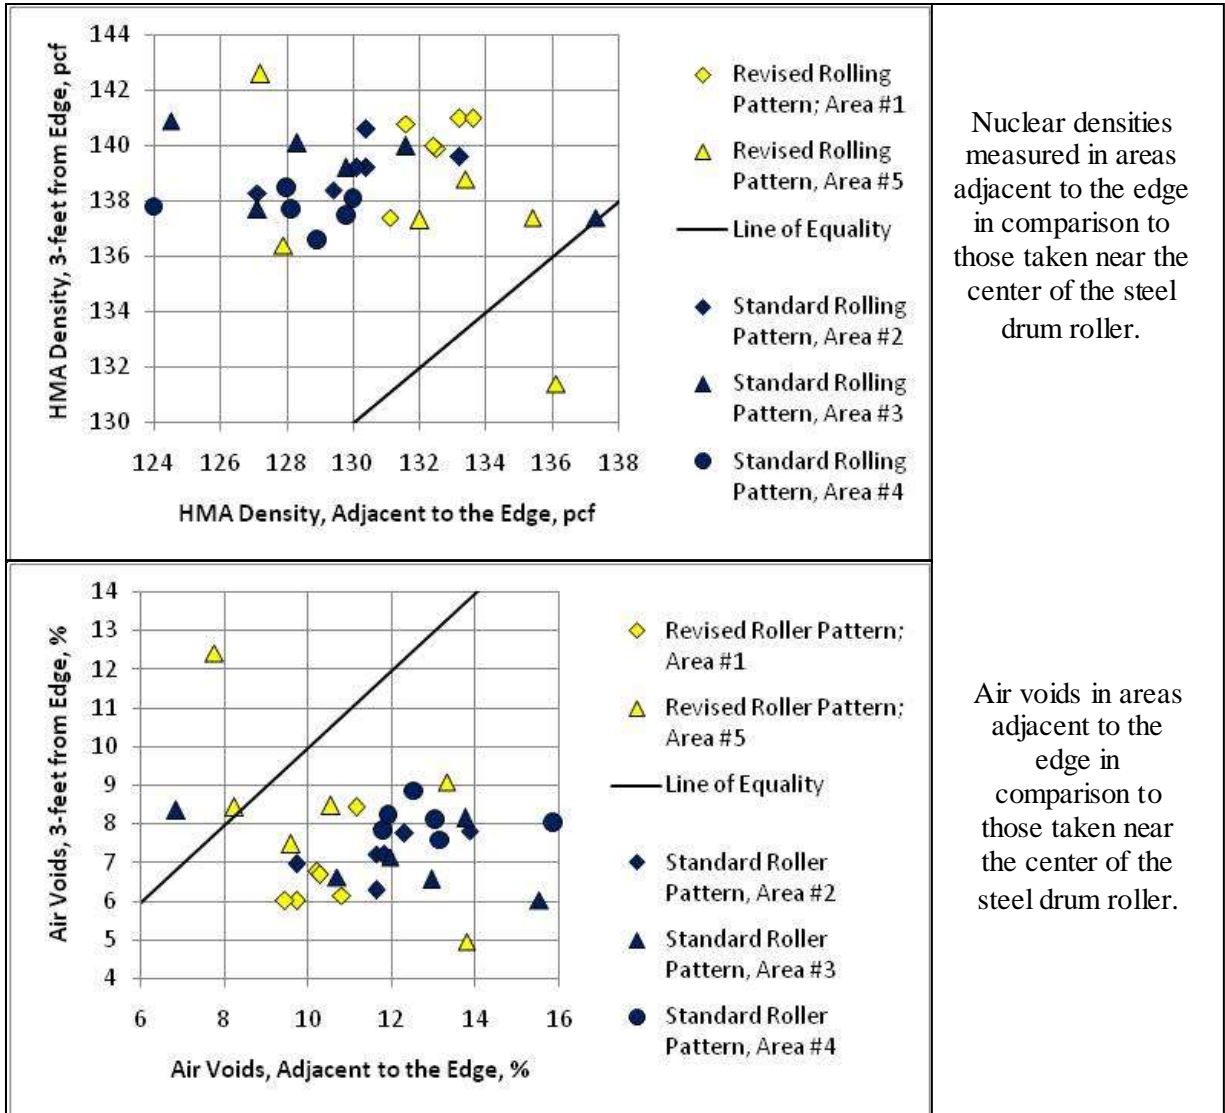
As tabulated above and shown in Figure 23, rolling the Safety Edge<sub>SM</sub> first without delay and extending the edge of the breakdown roller over the Safety Edge<sub>SM</sub> by 4 to 6 inches resulted in lower air voids and higher densities without significantly steepening the average slope of the Safety Edge<sub>SM</sub>, as compared to delaying rolling of the Safety Edge<sub>SM</sub>.

Nuclear densities measured in areas adjacent to the edge in comparison to those taken near the center of the steel drum roller.

Air voids in areas adjacent to the edge in comparison to those taken near the center of the steel drum roller.

Figure 23. Comparison of volumetric properties between the areas adjacent to the edge and center of the steel drum roller for the two different rolling patterns.

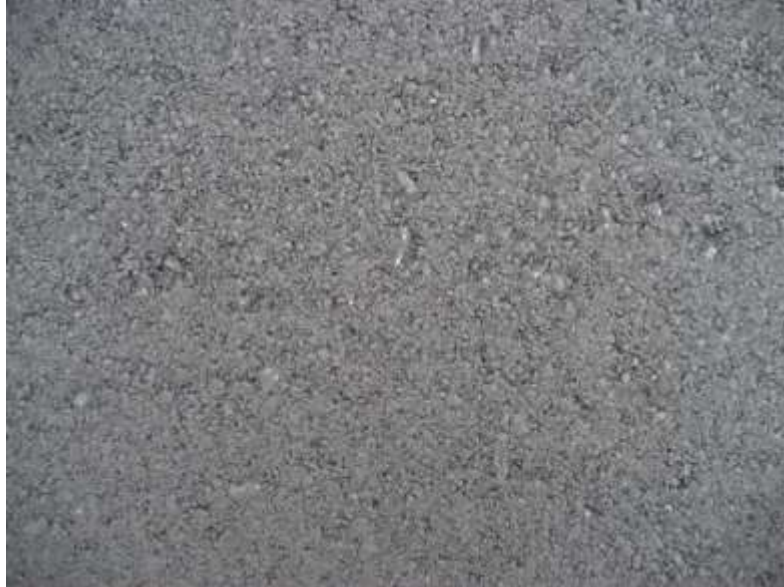
Figure 24. Surface texture of the 12.5 mm HMA overlay after final rolling.

- The 12.5 mm HMA mixture is considered a relatively fine aggregate mixture, and the surface texture was dense. Water beads were observed on the surface after rains that occurred just prior to the demonstration project. This observation indicates that permeability of the HMA overlay is low.

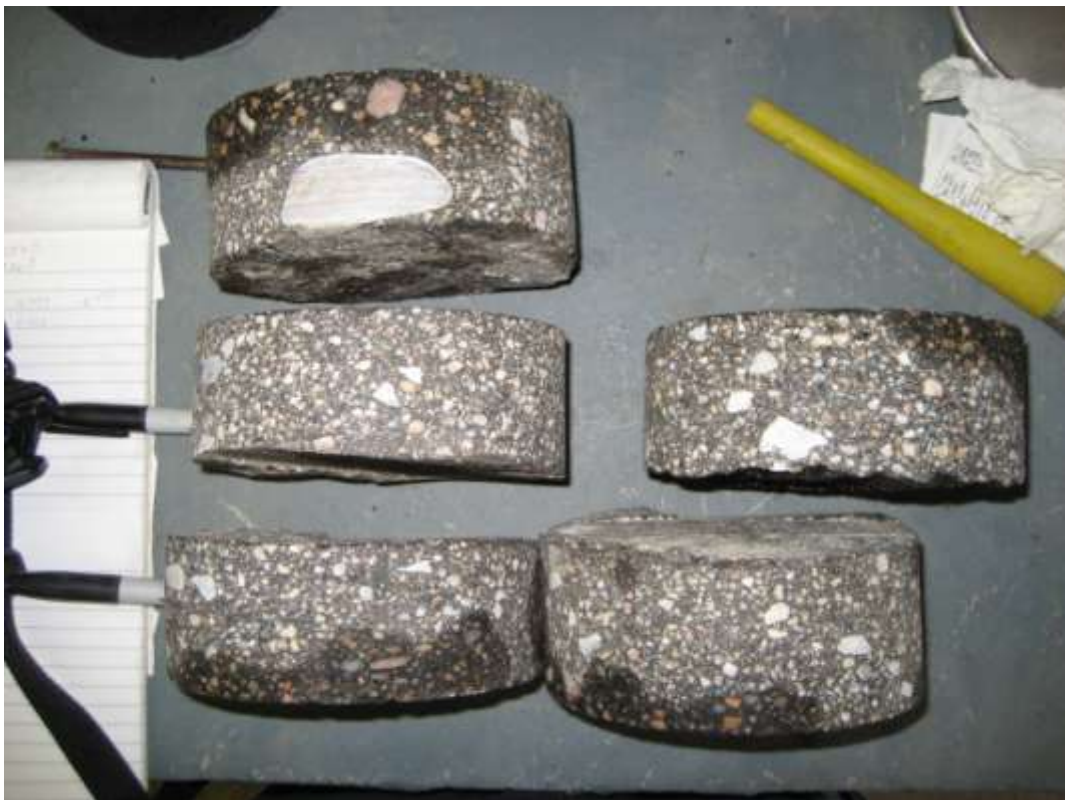
This section of the field report provides a photograph of five of the cores that were recovered for laboratory density testing and visual observations of the mixture along the edge and 3 feet from the edge. No systematic visual differences were noted between the different core sets. Some of the cores did exhibit much larger aggregate than included in the test results for mixture design, quality control and other tests, as shown in the picture for two of the five cores. Larger aggregate would tend to steepen the slope of the Safety Edge<sub>SM</sub>, because those larger aggregate would prevent the finer aggregate particles being nearer the bottom of the slope. Based on visual observations of the Safety Edge<sub>SM</sub>, this is not believed to be the case, with the possible exception in a few localized areas.

Figure A-1. Cores recovered for laboratory density testing.
