Federal Highway Administration
Every Day Counts
Innovation Initiative

Safety Edge_{SM}
Demonstration Project
Elizabethtown,
Pennsylvania

Field Report
May 24, 2011

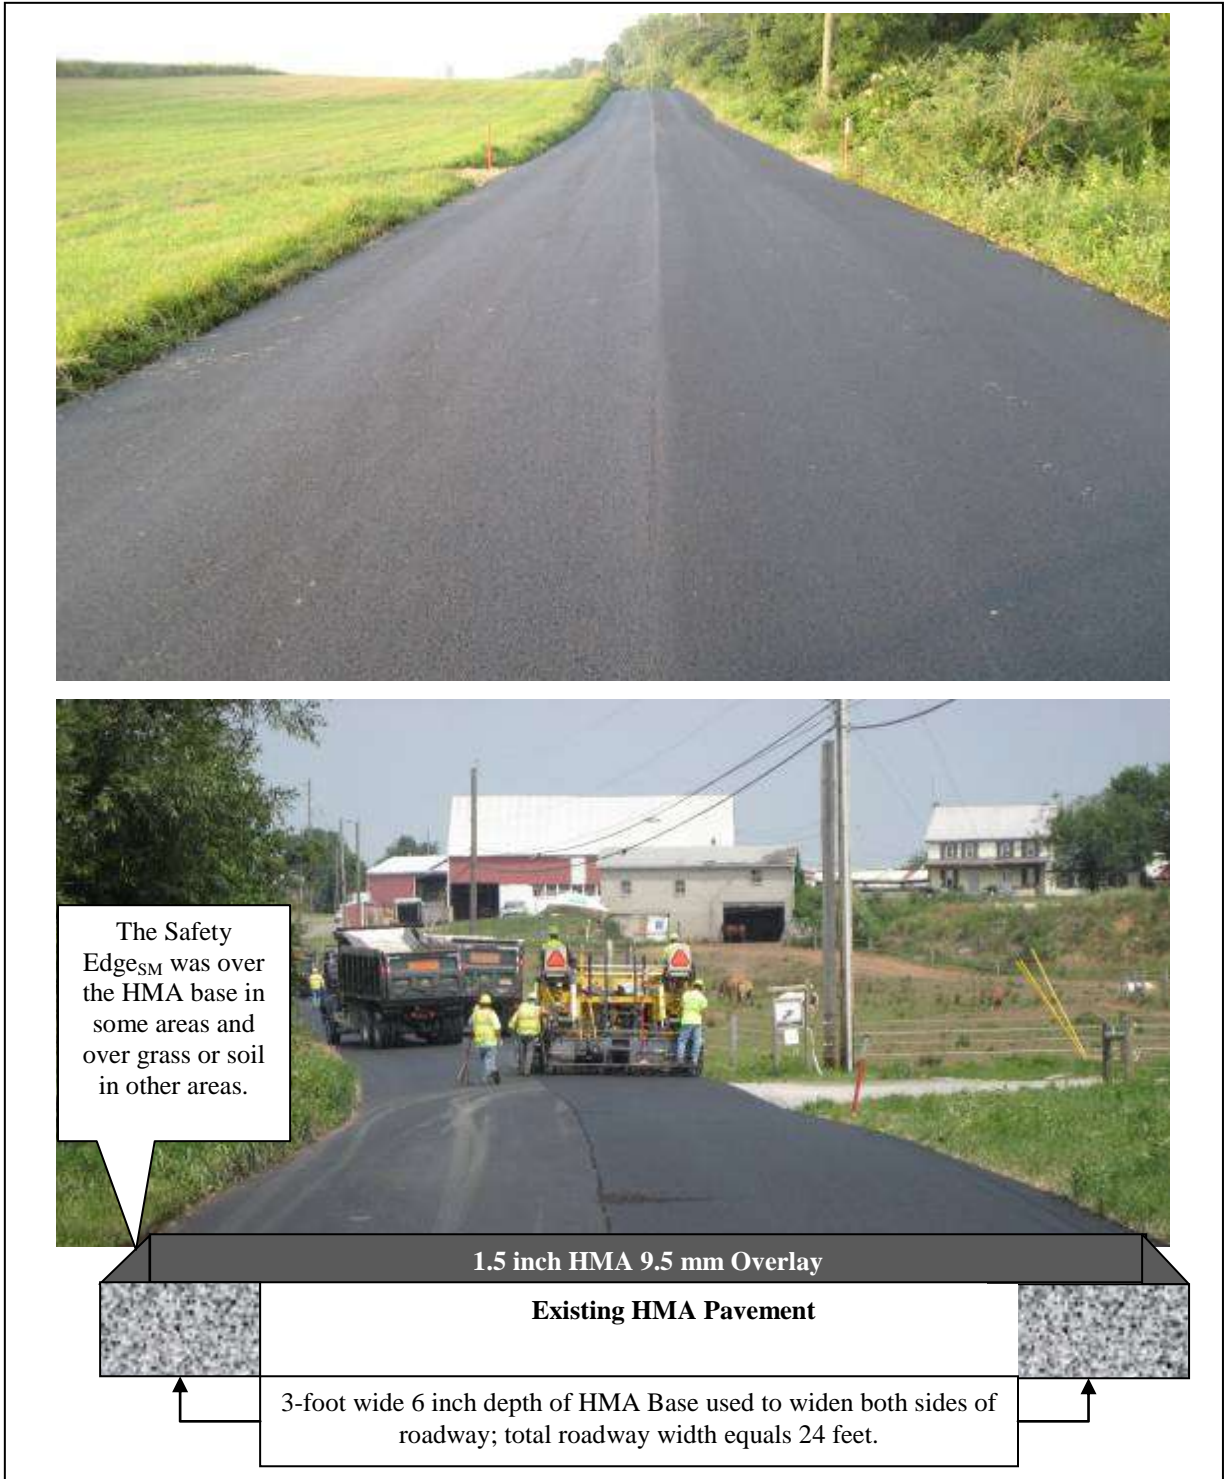
The ditches along the edge of the pavement were generally shallow or almost level with the existing pavement (refer to Figure 2), with the exception of a few areas (refer to Figure 3). An HMA base mix had already been placed on both sides of the road to widen the roadway. Some areas had narrow ditches that were approximately one to two feet in depth, but were covered or hidden in grass.

Figure 2. General overview of the 1.5 inch HMA layer placed along the project and pavement cross section provided by the Pennsylvania DOT.

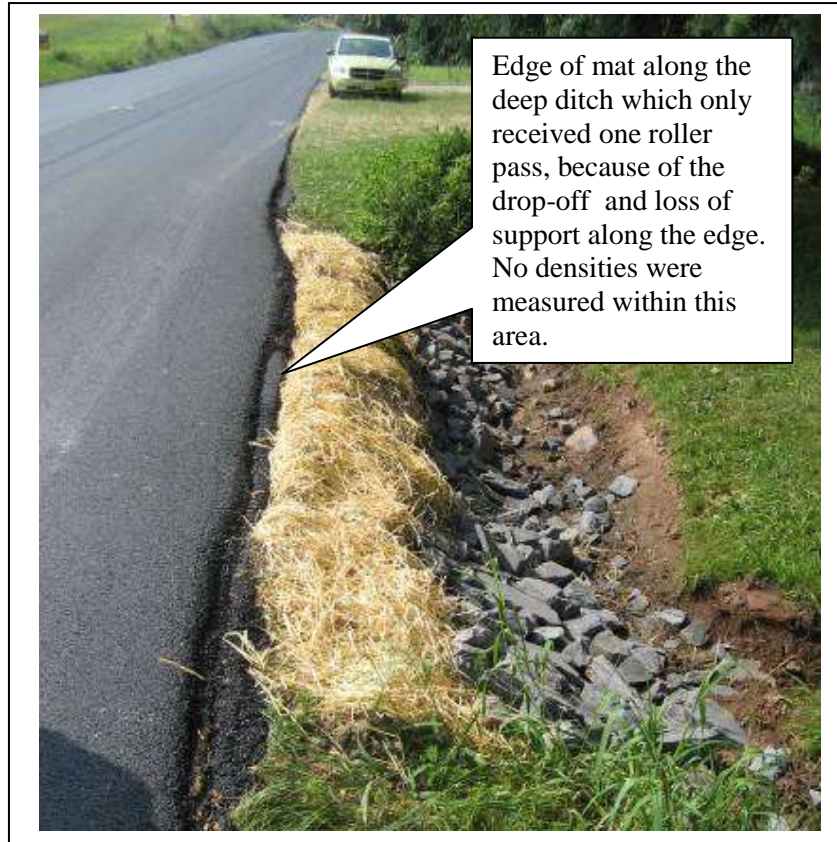
Figure 3. Localized area with deep ditches adjacent to the pavement.

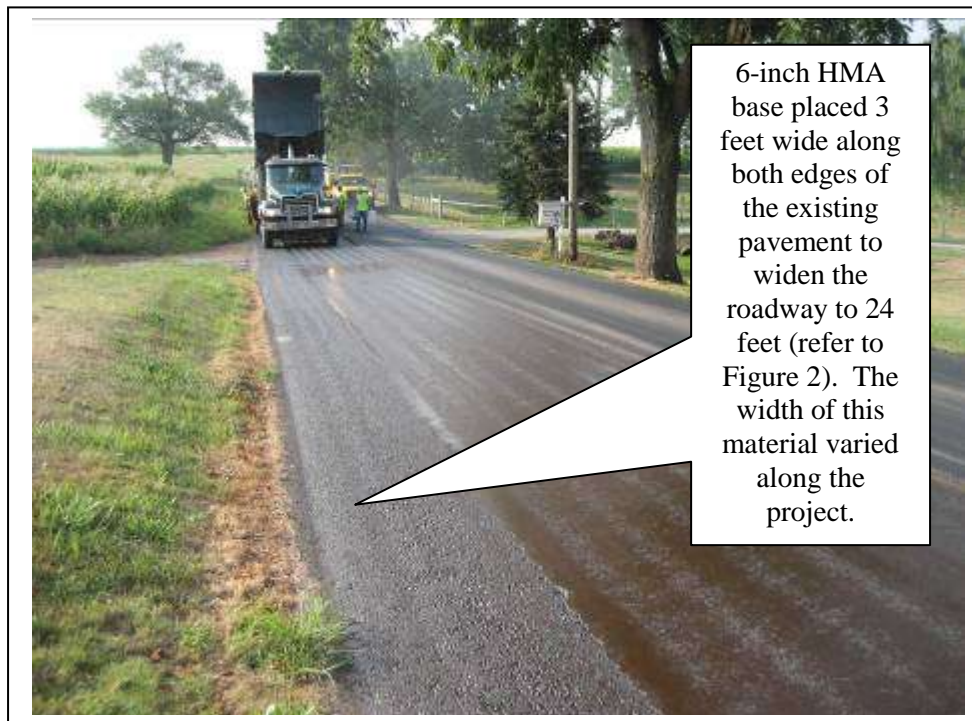
As noted above, the existing pavement was widened on both sides by about 1 foot, by placing an HMA base mix (refer to Figure 4). The HMA base mix had already been placed along the pavement's edge. The surface of this material was rough, as shown in Figures 4 and 5. The width of the pavement varied significantly along the project because of site features and driveways that exist along the project (refer to Figures 3 and 6).

Figure 4. Additional HMA base material placed along each edge of the roadway.

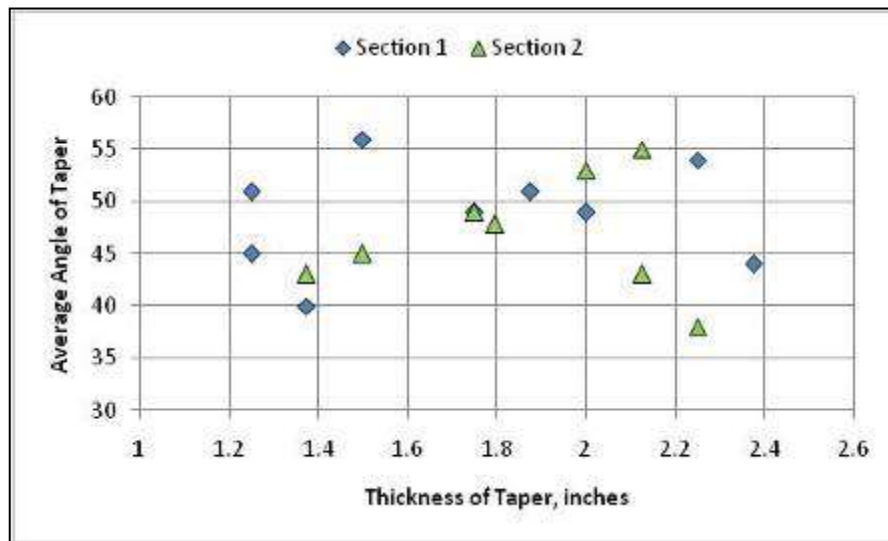
Figure 9. Comparison of the Safety Edges_{SM} slope and mat thickness adjacent to the edge.

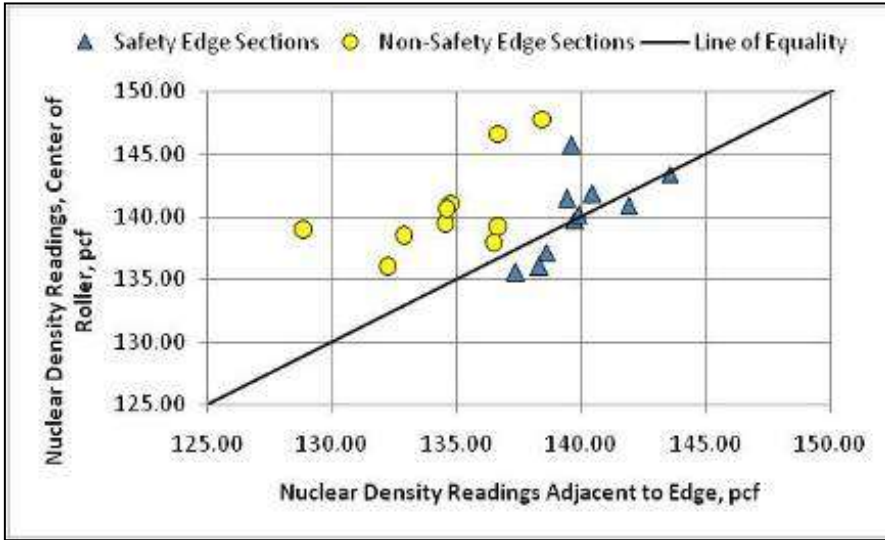
Figure 13 shows a comparison of the adjusted nuclear density gauge readings taken adjacent to the Safety Edge_{SM} and in the center of the vibratory steel wheel roller. Figure 13 also includes a comparison of the HMA air voids between both areas. As shown, the air voids are much higher adjacent to the Safety Edge_{SM}, but are higher than desirable for both areas. The other important observation from this data is that the density is higher and the air voids are consistently lower for the Safety Edge_{SM} sections, in comparison to the non-Safety Edge_{SM} section.

Nuclear densities measured in areas adjacent to the edge in comparison to those taken near the center of the steel drum roller.

Air voids in areas adjacent to the edge in comparison to those taken near the center of the steel drum roller.

Figure 13. Comparison of the adjusted nuclear density readings and air voids between the areas adjacent to the edge and center of the steel drum roller.

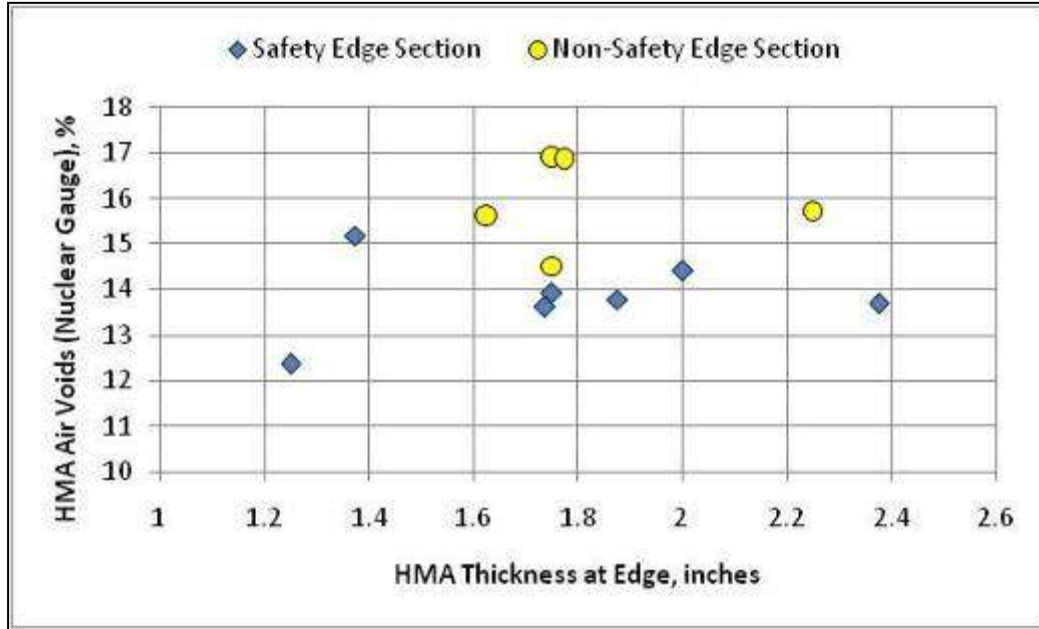
Figure 14 compares the HMA mat thickness (near the Safety Edge_{SM}) and slope of the Safety Edge_{SM}. As shown, the thickness of the HMA mat appears to have no effect or impact on the slope of the Safety Edge_{SM} device.

Figure 14. Comparison of HMA thickness at the edge of the mat and HMA air voids.

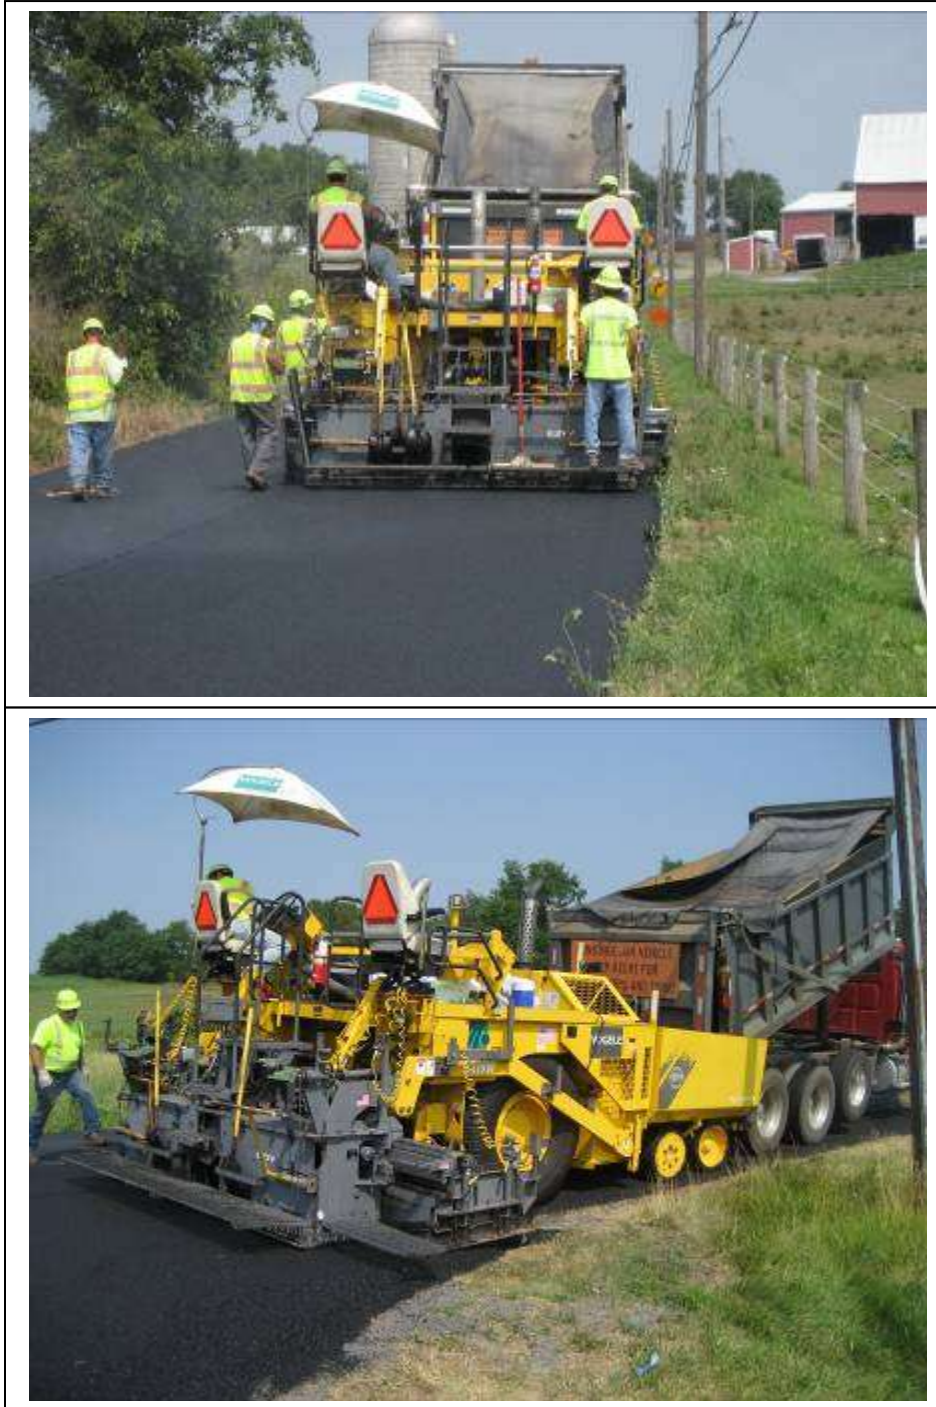
Figure 16. Photo illustrating the edge condition of the pavement.

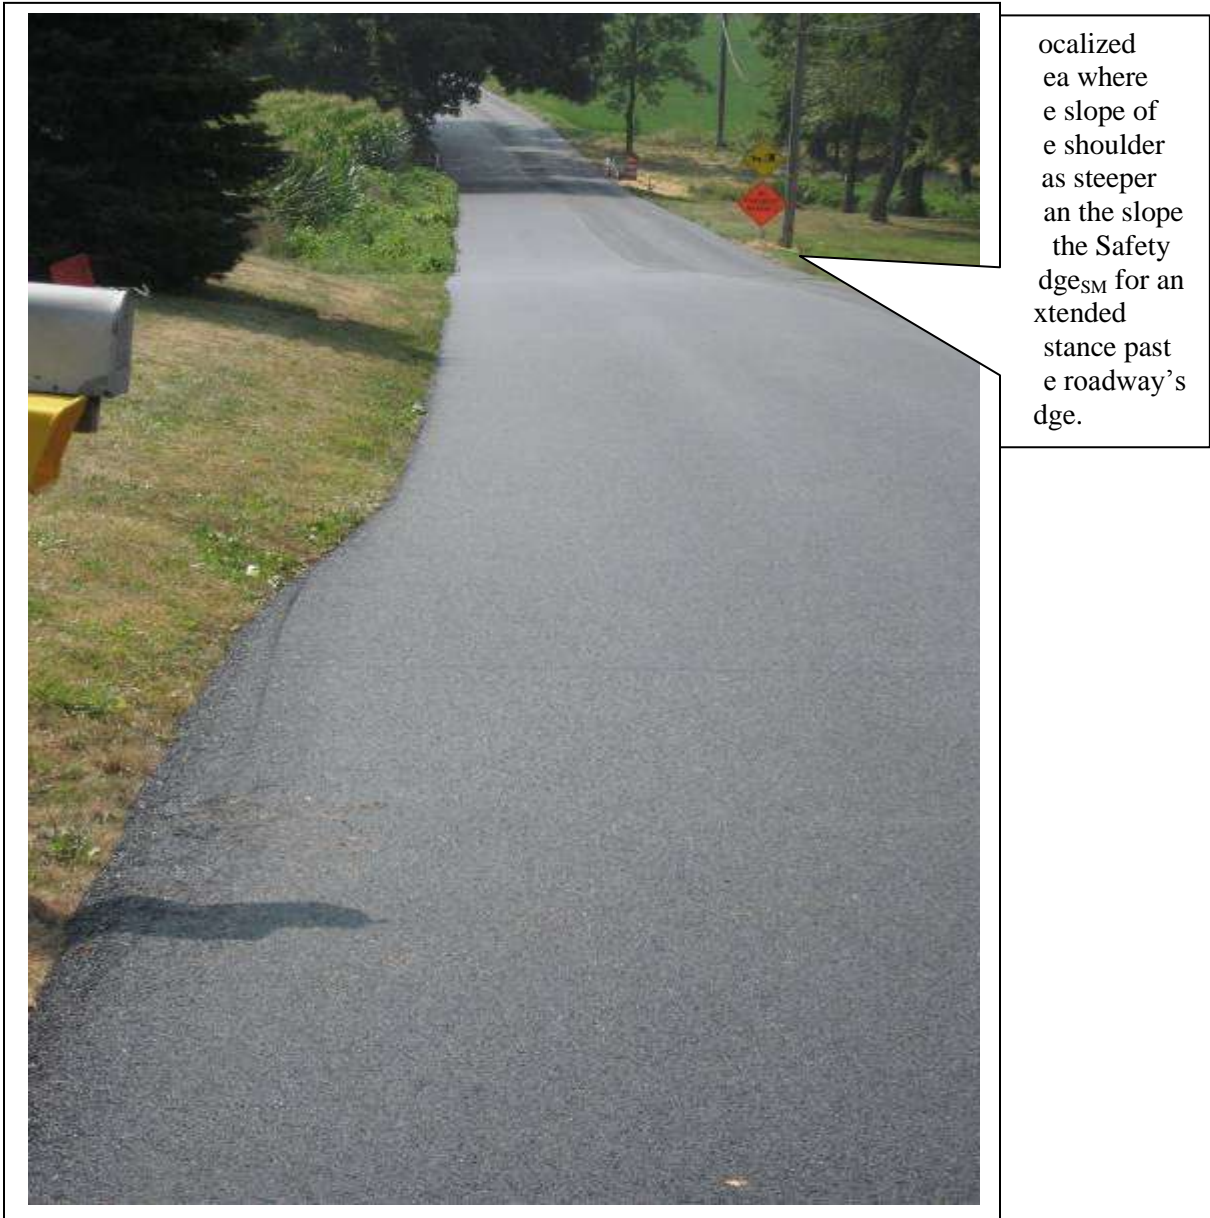
- There were localized areas along the northern portion of the project where the slope of the shoulder was steeper than 30° for an extended distance past the pavement's edge. In these areas, the screed operator did not extend the screed out, but raised the Safety Edge_{SM} device and lowered the screed end plate ski to create a non-Safety Edge_{SM}. This is what the screed operator should do under these conditions. One of these areas is shown in Figure 19.

Figure 19. Area where the slope of the shoulder was steeper than the Safety Edge_{SM} slope.

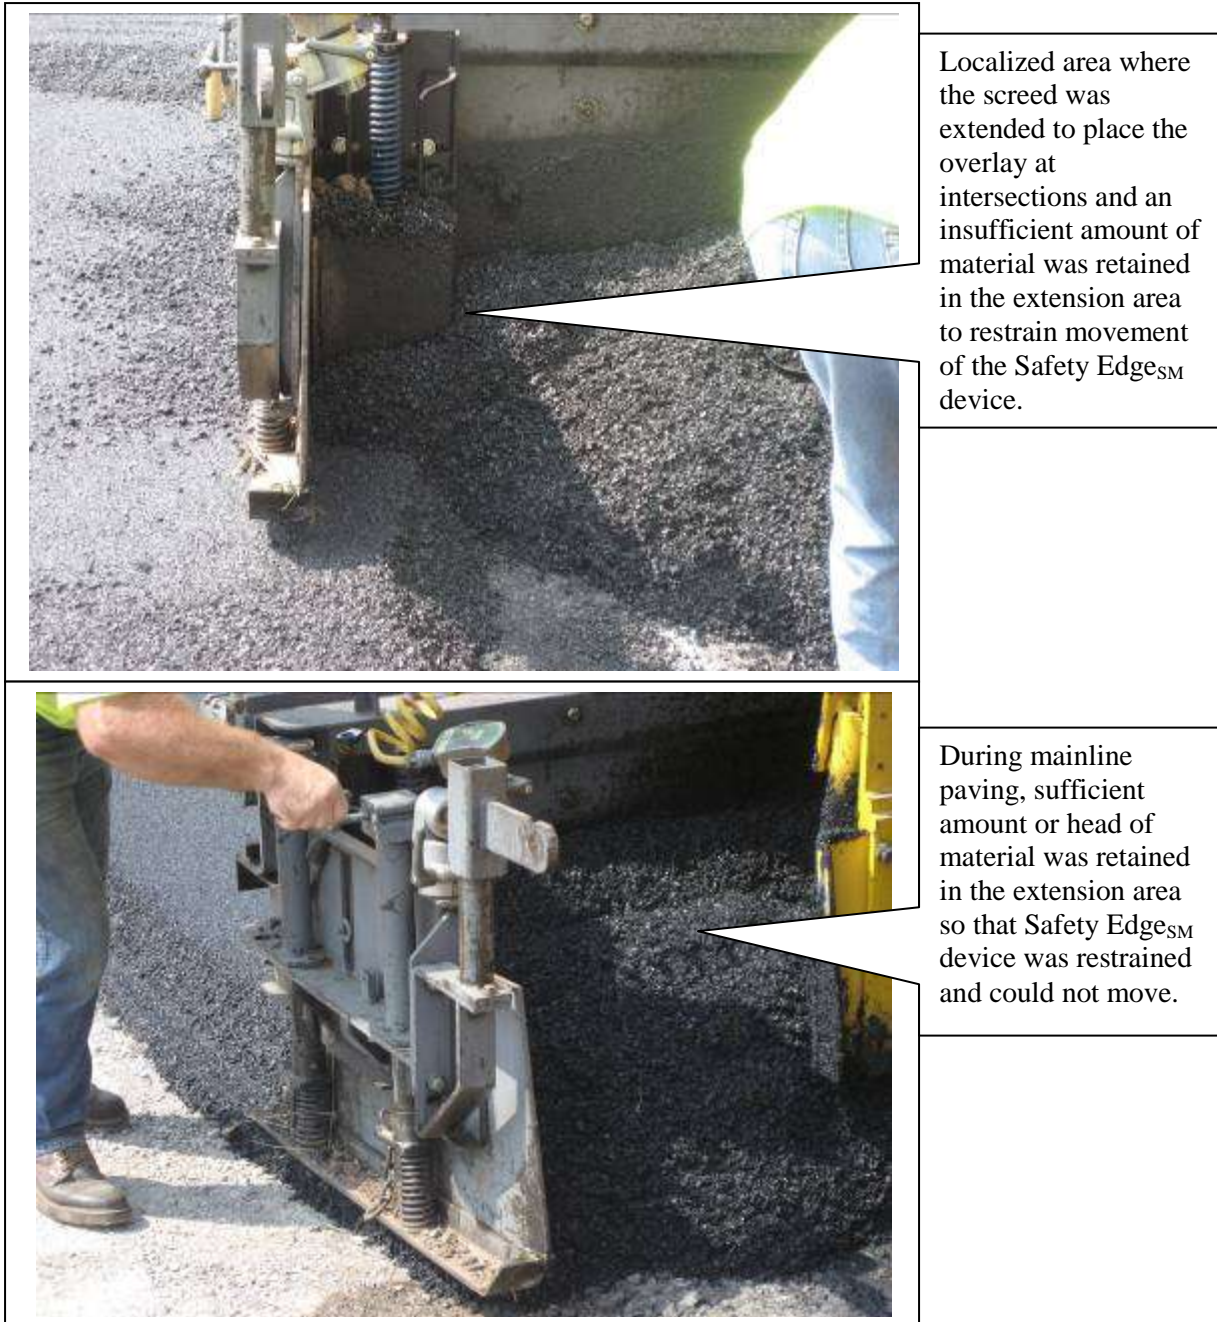
Figure 20. Photographs showing where a sufficient and insufficient amount of head of HMA was retained in the extended auger chamber area.

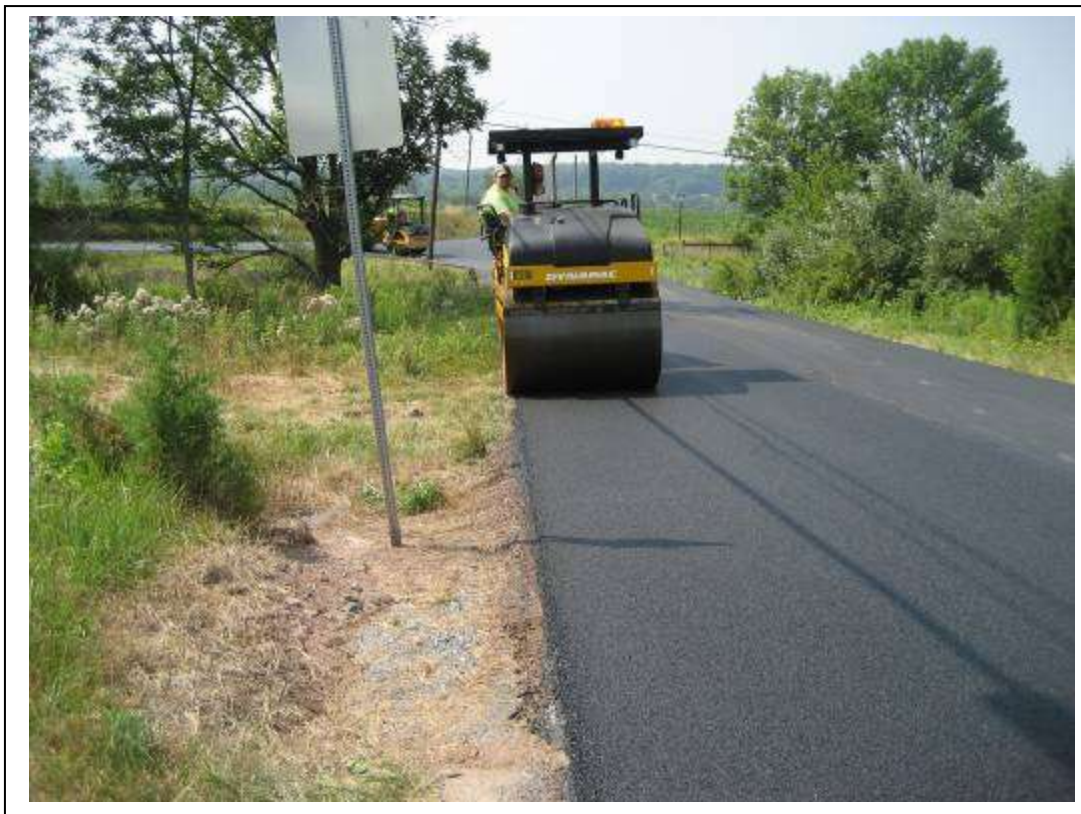
The Safety Edge_{SM} was rolled inconsistently during the project. The majority of the rolling pattern, however, was that the first pass of the breakdown roller was along the Safety Edge_{SM} with the roller extended over the edge of the pavement by about 4 to 6 inches (refer to Figure 22).

Figure 22. Vibratory steel wheel roller used in the breakdown position shown compacting the Safety Edge_{SM} – first pass overhung the edge about 4 inches.
