Hillsborough Street (NC-54) Horne Street to Gorman/Faircloth Street

**Pedestrian Road Safety Assessment
Raleigh, North Carolina
April 21 – 22, 2009**

**Dan Nabors and Frank Gross
Vanasse Hangen Brustlin (VHB), Inc**

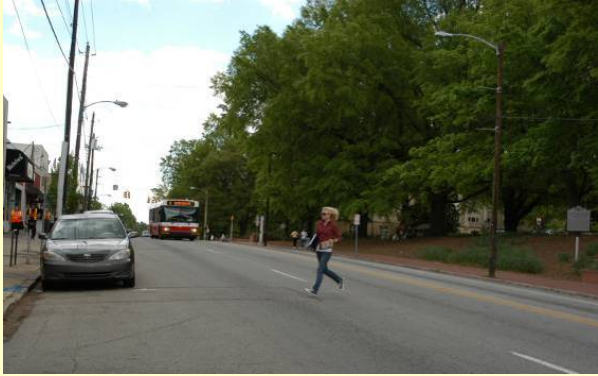
<p>Example of a student crossing midblock between Pogue St. and Horne St. after descending the stairs that provide access between Hillsborough Street and campus.</p>

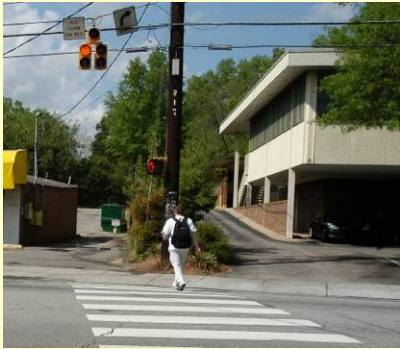
<p>The photo shows an example of a pedestrian crossing Hillsborough Street against the signal.</p>
<p>Failure to yield—the team observed drivers failing to yield the right-of-way to pedestrians when turning.</p>	<p><i>Short-term</i> – Consider enhancing conspicuity of pedestrian crossings through use of signs (see turning vehicle warning sign in photo, top right) and high-visibility pavement markings at signalized intersections.</p> <p><i>Intermediate</i> – Install bulb outs to enhance the conspicuity of crosswalks and reduce the crossing distance for pedestrians. This will be addressed during the Redesign Project from Horne St. to Gardner St.</p>

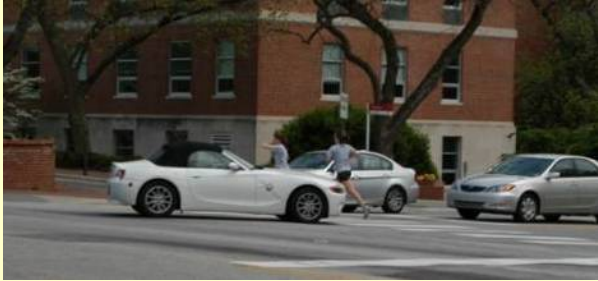
<p>The photo shows an example of a left-turning driver encroaching on the crosswalk where pedestrians are crossing.</p>

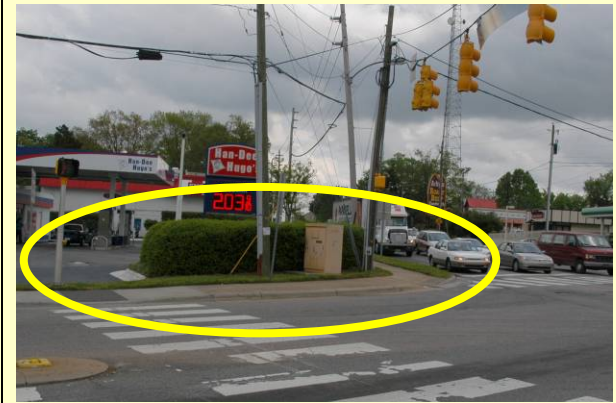
Sight obstructions—sight restrictions are created by unmaintained vegetation, retaining walls, and intersection geometry (i.e., skew). For example:

Vegetation and a traffic control cabinet on the northwest corner of Gorman Street and Hillsborough Street create sight obstructions between vehicles turning right and pedestrians crossing in the crosswalk. This situation is confounded by the placement of the crosswalk away from the intersection where drivers may be less likely to expect pedestrians.

Short-term – Maintain or remove vegetation to enhance visibility of sight triangles at intersections. Vegetation should be low-lying so as to not obstruct visibility of someone using a wheelchair. Relocate crosswalk on the north approach closer to the intersection and ensure the crosswalk is parallel to Hillsborough St.

Long-term – Identify opportunities to improve sight triangles at intersections during future construction projects.

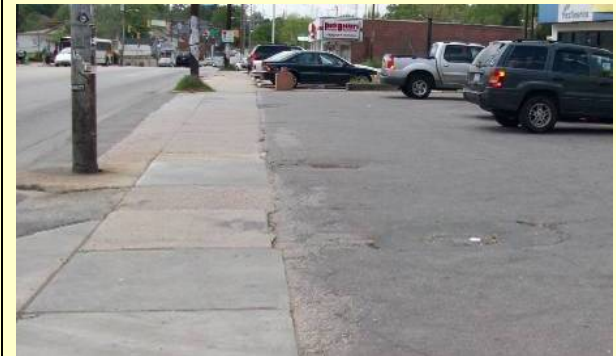
Wide access points—there are access points, particularly along the western end of the study area, that are wide and uncontrolled, allowing vehicles to make high-speed turns from Hillsborough St.

Photo shows a wide access point at the Wolf Mart near the intersection of Hillsborough St. and Dan Allen Dr. Vehicles can cross the sidewalk almost unrestricted through this area.

Intermediate – Consider developing an access management plan to support decisions to close or reduce access points.

Consider making Wolf mart access a right-in near Dan Allen Dr. and right-out to the west. Parking along the storefronts would be converted to pull-in angle parking and a buffer placed on each side of the sidewalk to separate pedestrians from traffic.

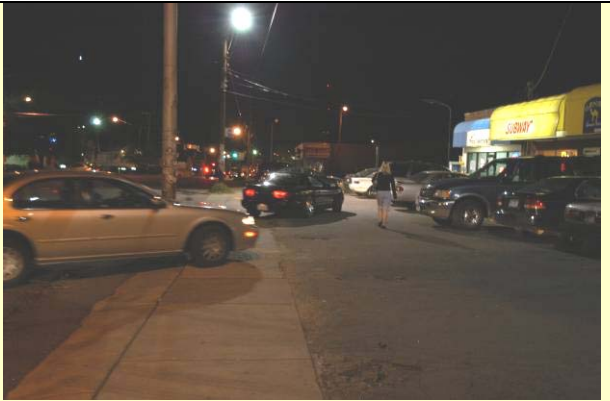
<p>Photo shows the access point at the Wolf Mart at night. There are two vehicles entering at the same time and a pedestrian walking in the driveway.</p>
<p>Left-turning traffic—vehicles turning left between Dan Allen Dr. and Brooks St. conflict with other access points and pedestrians crossing the road.</p>	<p><i>Intermediate</i> – Consider installing a median from Dan Allen Dr. to Brooks St. as part of the Hillsborough Redesign Project. The median will restrict turning movements to right-in-right-out along Hillsborough St, which will reduce the number of potential conflict points. The median island will also provide a pedestrian refuge for pedestrians that choose to cross midblock.</p>

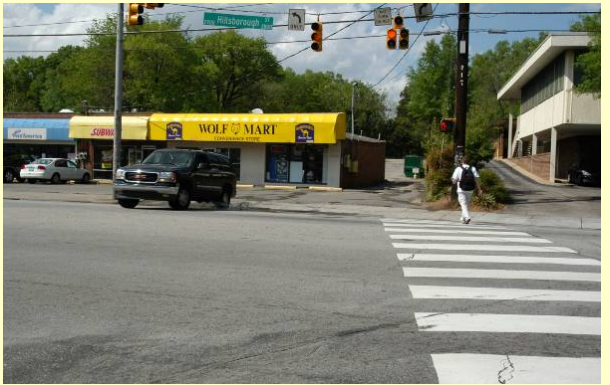
<p>View from Dan Allen Dr. facing northbound. Photo shows the conflicting movements from the Wolf Mart as well as pedestrians crossing Hillsborough St.</p>

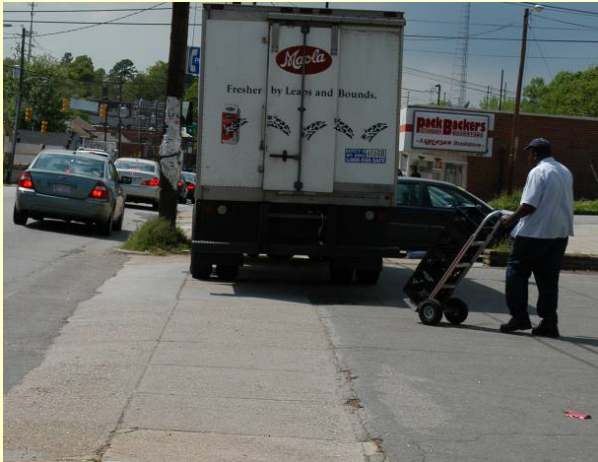
<p>Photo illustrates the lack of delineation to designate and separate pedestrian facilities. A truck is parked on the sidewalk making a delivery to a local business.</p>
<p>4. Inconsistency at Crossings</p>		
<p>Unmarked and misaligned crosswalks— all unsignalized intersections are missing marked crosswalks across the side street. Several crosswalks are not aligned with curb ramps (or vice versa) at signalized intersections.</p>	<p><i>Short-term</i> – Consider installing crosswalks with continental style markings across all side streets.</p> <p>Consider providing high-visibility, continental style markings at signalized intersections.</p> <p><i>Intermediate</i> – Ensure curb ramps align with crosswalks and sidewalks.</p> <p>Ensure that crosswalks are properly aligned with sidewalks and curb ramps and follow direct paths.</p> <p>Missing and misaligned crosswalks will be addressed during the Redesign Project from Horne St. to Gardner St. However, the west crosswalk at Pogue St. will be removed (see Table 2 – Issue 1).</p>

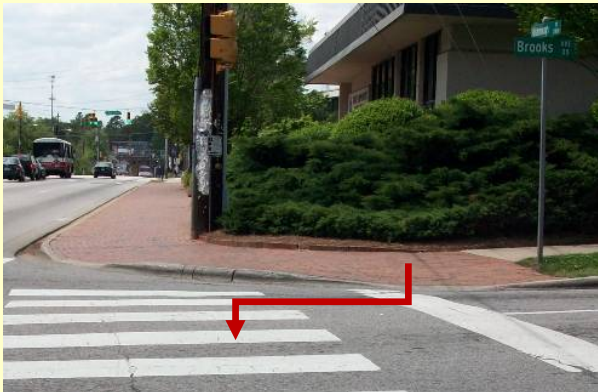
<p>The photo illustrates a misaligned crosswalk and curb ramp at Hillsborough Street and Brooks Avenue. Pedestrians using the curb ramp must enter the road behind the STOP bar before accessing the crosswalk, creating the potential for conflict with vehicles.</p>

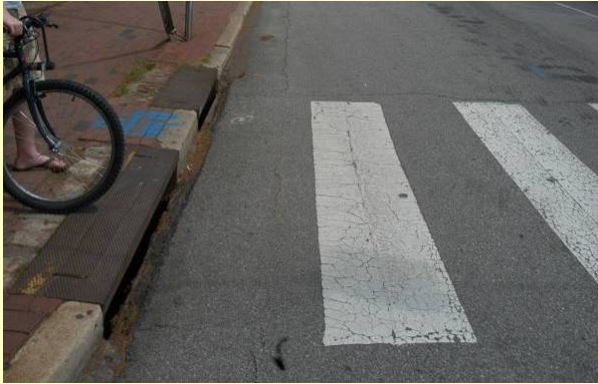
<p>This photo shows a crossing where a crosswalk is provided, but there is no curb ramp to provide access to those with mobility restrictions.</p>

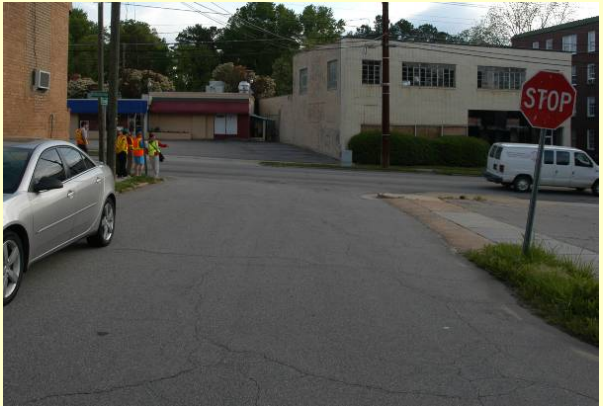
<p>Photo shows an example at the intersection of Hillsborough St and Stanhope Ave where there is no stop bar. Also, the STOP sign is placed too far from the intersection, creating sight distance issues.</p>
<p>Inaccessible push-buttons— Inaccessible and inconspicuous push-buttons were noted in the study area including push-buttons located on the back side of poles. Throughout the study area, push-buttons are inconsistent; some are activated by palm (current ADA approved) while others must be depressed by finger (not currently ADA compliant).</p>	<p><i>Intermediate</i> – Consider upgrading push-buttons with palm-activated buttons and relocating inaccessible push-buttons to more accessible and conspicuous locations. Also consider installing pushbuttons that confirm the press.</p>

<p>Absence of stop bars on side streets—stop bars were not applied on several side streets at unsignalized intersections.</p>	<p><i>Short-term</i> – Install stop bars on side streets to reinforce the stop condition.</p>

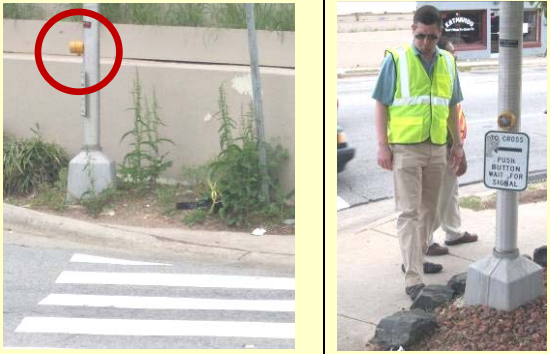
<p>Photos show examples of push-buttons where the placement makes them inaccessible to those with mobility restrictions.</p>

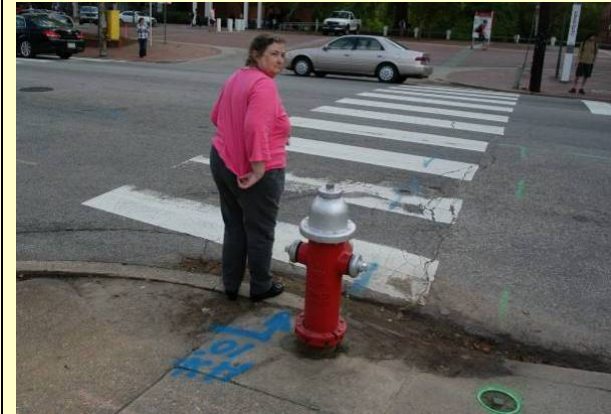
Photo shows where a hydrant is located in the middle of the curb ramp, obstructing access between the sidewalk and crosswalk.

Long-term – Relocate hydrants or curb ramps and crosswalks to provide unobstructed access between the sidewalk and crosswalk.

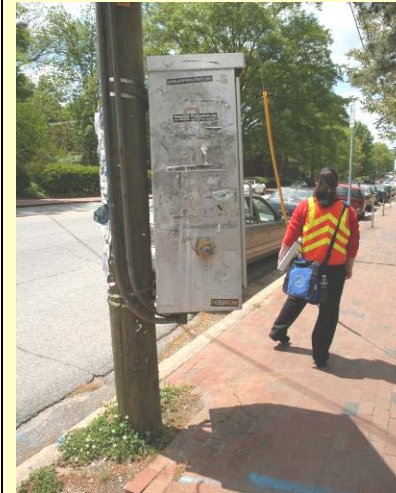
This traffic control cabinet protrudes into the sidewalk which presents a hazard to pedestrians with vision impairments who use a cane for guidance.

Intermediate– Relocate traffic control cabinets and remaining street furniture.

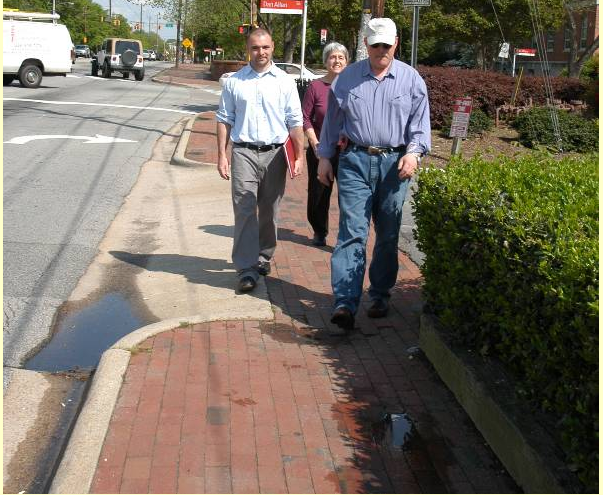
<p>Photo shows a location near Dan Allen Dr. where the sidewalk width is limited by adjacent vegetation and there is no buffer provided between the edge of the sidewalk and the travel lane.</p>
<p>7. Bus Stop Locations and Markings</p>		
<p>Blocked crosswalk—far side bus stops are obstructing crosswalks at the following locations:</p> <ul style="list-style-type: none"> - Hillsborough St. and Horne St. - Hillsborough St. and Shepherd St. 	<p><i>Short-term</i> – While far side crosswalks may be desirable from an operations standpoint, they are obstructing crosswalks in certain locations. Driver training should be employed to ensure that drivers stop at a proper location so as to not obstruct crosswalks.</p> <p><i>Intermediate</i> – Monitor the obstruction of crosswalks by buses and if the problem persists, consider relocating the bus stop signs slightly further downstream.</p>

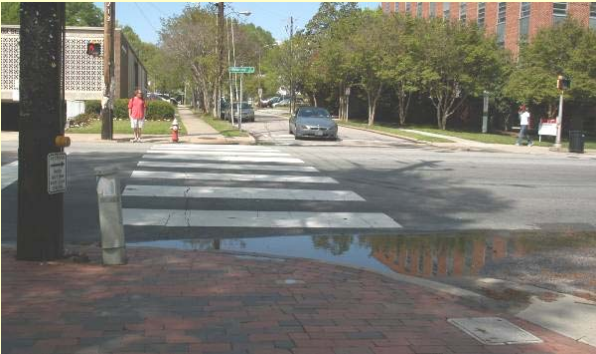
<p>Photo shows a crosswalk at Hillsborough St. and Gardner St. where insufficient drainage led to ponding.</p>

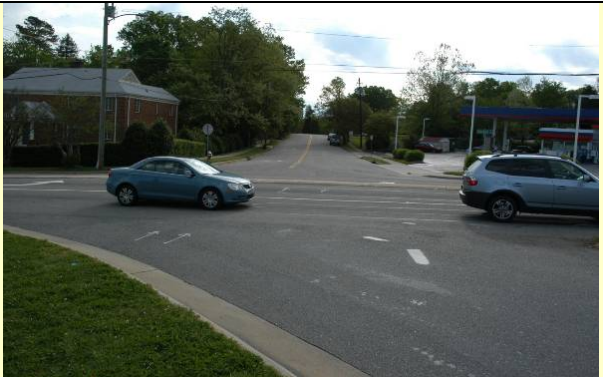
<p>View from existing trail traveling from Meredith College to Clark St. A raised median prevents direct crossing from the trail to Clark St.</p>

<p>pedestrians and bicyclists.</p> <ul style="list-style-type: none"> - Install trail crossing warning signs (see photo, top right) for northbound and southbound drivers at the crosswalk on the north approach. For the southbound approach, an additional sign should be installed at the north end of the median island for those bicyclists traveling from Clark St toward to the trail. - Consider restriping the right-turn lane along Faircloth St (at Clark St) as a bicycle lane to provide access from the crosswalk to the designated bike route on Clark St. This will likely help to keep bicyclists from riding on the sidewalk along Faircloth St. This option should only be considered if right-turn volumes do not warrant the right-turn lane. <p><i>Intermediate</i> – Consider widening the median and providing a cut-through for bicyclists. The median should be wide enough to provide refuge for a bicyclist. If this option is implemented, the trail crossing signs should be moved to the location of the median cut-through. This option would provide a direct path across Faircloth St. from Clark St. to the trail. If this option is pursued, consider adding an extension to the trail from the existing trail to Faircloth St., aligning with the median cut-through to Clark St.</p>

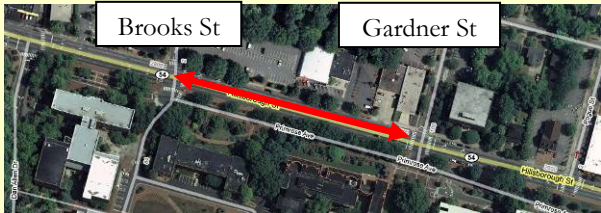
<p>Aerial shows the relatively long distance between Brooks St and Gardner St compared to the adjacent intersections.</p>

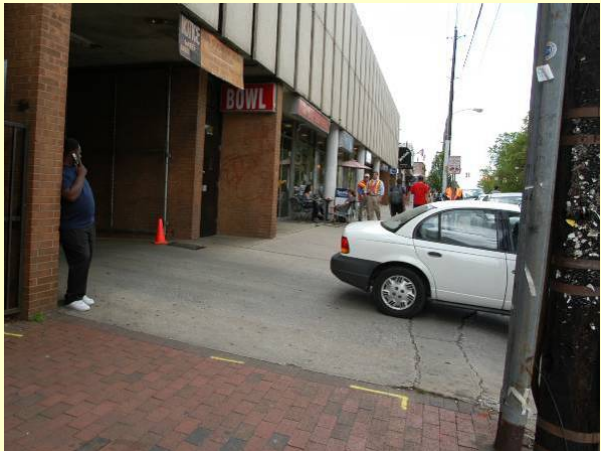
<p>Photo shows a vehicle exiting the parking garage and</p>

crossing the sidewalk. Currently, the driveway crosses the sidewalk as an extension of the garage, rather than the sidewalk crossing the driveway with designated markings for pedestrians.
3. Issues with Traffic Control Devices		
Inconsistent use of pedestrian signals—pedestrian signals are provided at signalized intersections for all crosswalks, but the conceptual design does not show countdown heads.	The host agency indicated that countdown signals will be installed when pedestrian signals are replaced during the Redesign Project. Ensure that countdown signals are installed.	
Missing stop bars—stop bars are not indicated for the side streets at Horne St. and Gardner St.	Ensure stop bars are used to separate conflict points between motorists and pedestrians.
