BRIDGE INSPECTION REPORT

INSPECTION TYPE: ROUTINE

SUN RIVER BRIDGE

STRUCTURE NO. MTA-SR-001

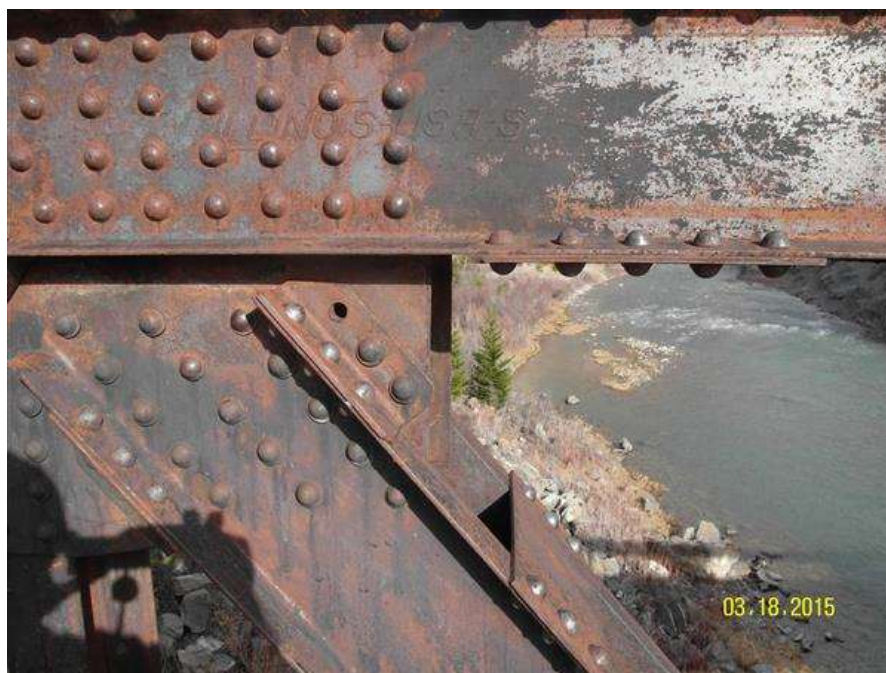
- Some of the bolts and rivets in the top chords of the trusses are loose.
- Bearing devices on the south end of the bridge are covered with dirt and gravel.

PHOTO #2 MTA-SR-001, SUN RIVER BRIDGE, PHOTO BY GARY GRASSEL. VIEW OF A MISSING FASTENER AT THE UPSTREAM SIDE, RIGHT TRUSS, FIRST TOP JOINT FROM THE RIGHT BEARING. (03/18/2015)

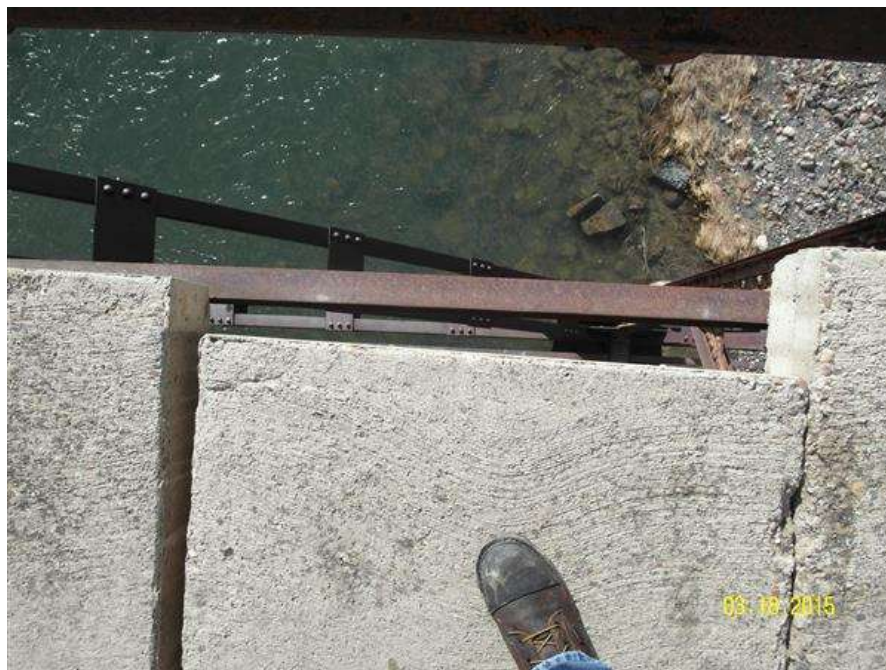
- Load limits and single lane bridge signs need to be posted.
- The precast concrete panels used for decking are free to move on the stringers. Some of the panels have “walked” up or downstream and no longer rest on all of the stringers. The stringers are not restrained by the deck are free to roll under loads.

PHOTO #3 MTA-SR-001, SUN RIVER BRIDGE, PHOTO BY GARY GRASSEL. THIS PHOTO SHOWS THAT THE PRECAST FLOOR PLANKS ARE NOT FASTENED TO THE SUPERSTRUCTURE BEAM MEMBERS. PLANKS CAN MOVE UPSTREAM OR DOWNSTREAM AND MAY SHIFT A DISTANCE WHERE THEIR USE AS A TRAFFIC SURFACE WILL BE A CRITICAL FAILURE MODE. (03/18/2015)

4. New recommendation to fasten precast decking members to flanges of supporting beams for securing wearing surface in position and to properly brace compression flange of beams.

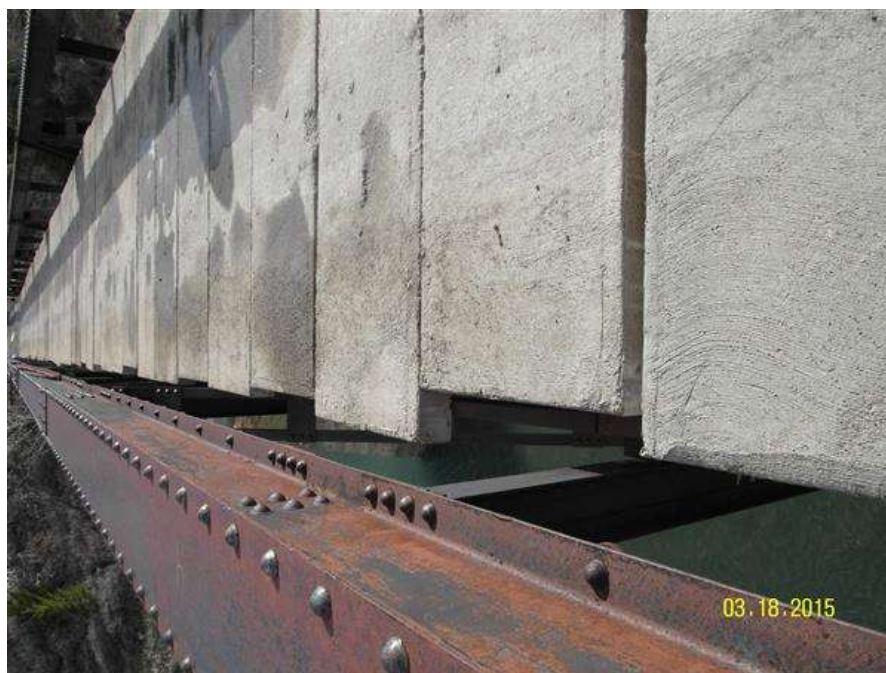
PHOTO #4 MTA-SR-001, SUN RIVER BRIDGE, PHOTO BY GARY GRASSEL. THIS PHOTO IS A VIEW PARALLEL TO BRIDGE CENTER LINE LOOKING AT THE DOWNSTREAM SIDE OF THE BRIDGE SURFACE. THE PRECAST PLANKS HAVE SHIFTED UPSTREAM AND DOWNSTREAM. RECOMMEND ALL PANELS ARE ATTACHED TO BEAMS AND ADJACENT PANELS TO CREATE NECESSARY DIAPHRAGM. (03/18/2015)

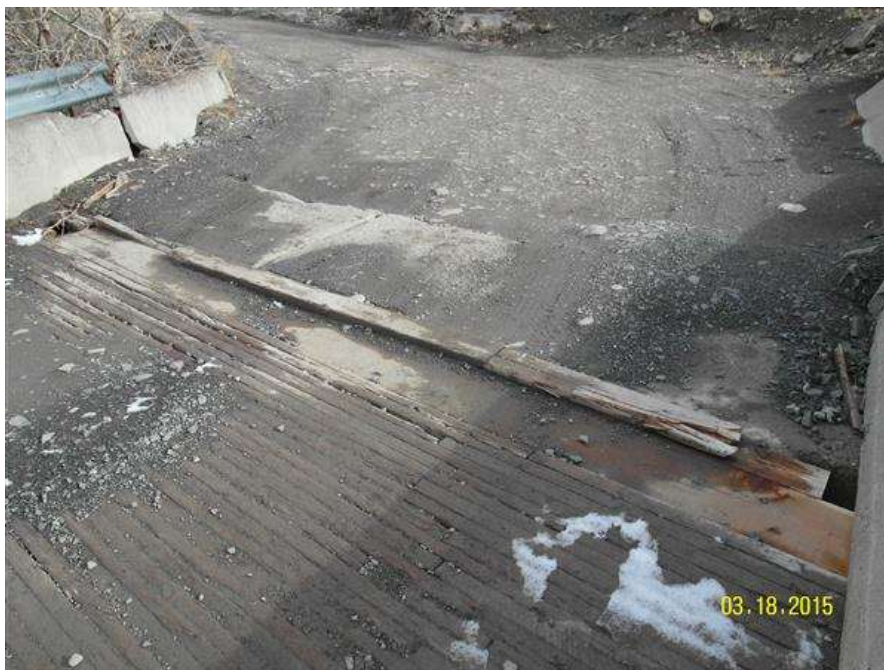
PHOTO #5 MTA-SR-001, SUN RIVER BRIDGE, PHOTO BY GARY GRASSEL. THIS PHOTO SHOWS THE LEFT (EAST) APPROACH SPAN OF THE BRIDGE. REPAIRS HAVE BEEN MADE SINCE THE LAST INSPECTION. (03/18/2015)

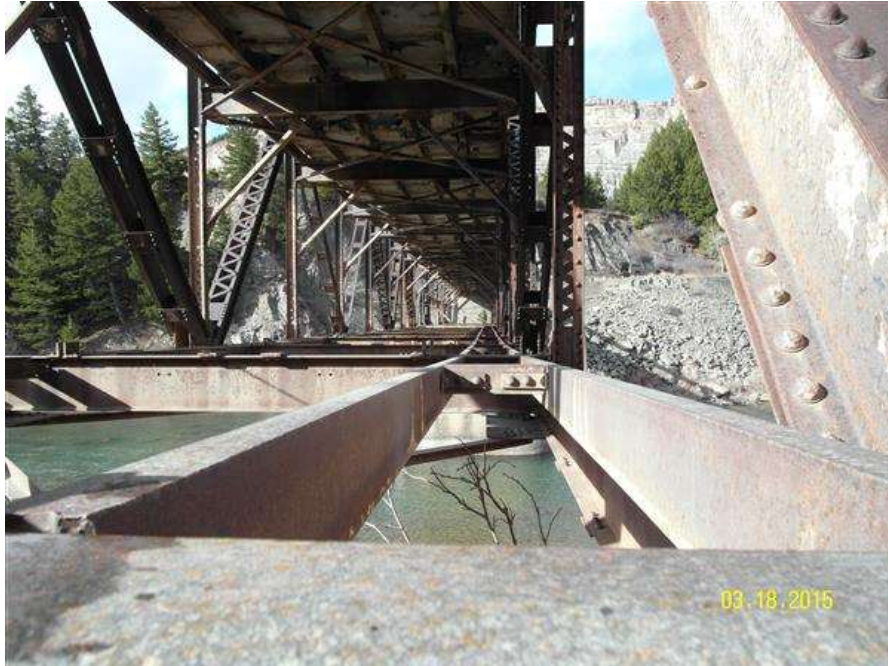
3. Reclamation Climb Team has inspected the damaged area of the bottom upstream cord. No areas of concern were encountered therefore current load rating is still acceptable. (Item #7 above resolved)

PHOTO #7 MTA-SR-001, SUN RIVER BRIDGE, PHOTO BY GARY GRASSEL. THIS PHOTO IS A VIEW LOOKING FROM THE LEFT ABUTMENT TO THE CENTER PIER ON THE UPSTREAM SIDE OF THE BRIDGE. NOTE THE SAG IN THE TRUSS APPROXIMATELY AT MID-SPAN OF THE UPSTREAM SIDE ONLY. CONNECTIONS HAVE BEEN INSPECTED BY RECLAMATION CLIMB TEAM AND NOTHING OUT OF THE NORMAL WAS OBSERVED AT THE CONNECTIONS OR MEMBERS. (03/18/2015)

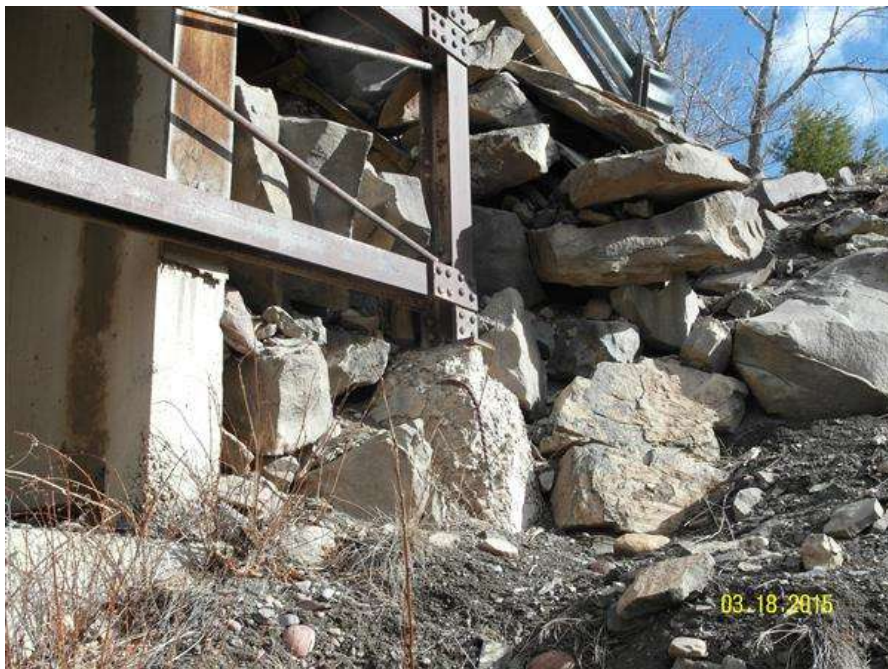
- The concrete footing located on the northeast corner of the approach span is severely deteriorated. Riprap placed within the approach span has added a lateral load to the structure and therefore could displace supporting structure off the footing, leading to failure of approach span.

PHOTO #8 MTA-SR-001, SUN RIVER BRIDGE, PHOTO BY GARY GRASSEL. THIS IS A VIEW OF THE SUPPORT PIER ON THE LEFT DOWNSTREAM APPROACH SPAN OF THE BRIDGE. RECOMMEND REPLACING THIS EXISTING PIER WITH NEW REINFORCED CONCRETE PIER. (03/18/2015)

Concrete footing under north approach span needs to be repaired.
 Precast deck planks must be fastened to steel stringers.

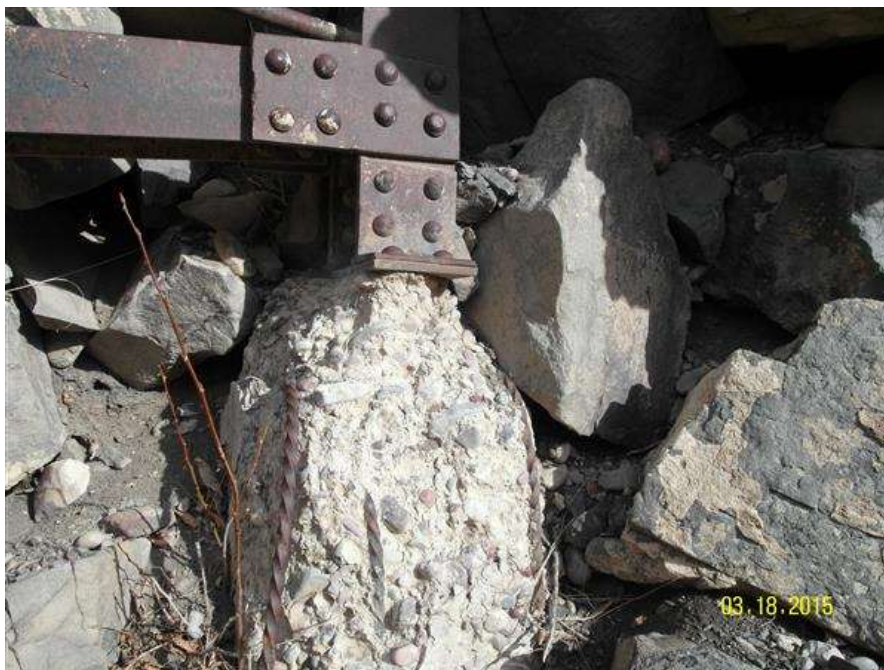
PHOTO #9 MTA-SR-001, SUN RIVER BRIDGE, PHOTO BY GARY GRASSEL. THIS PHOTO IS A CLOSER VIEW OF THE PIER IN PHOTO # 8. (03/18/2015)

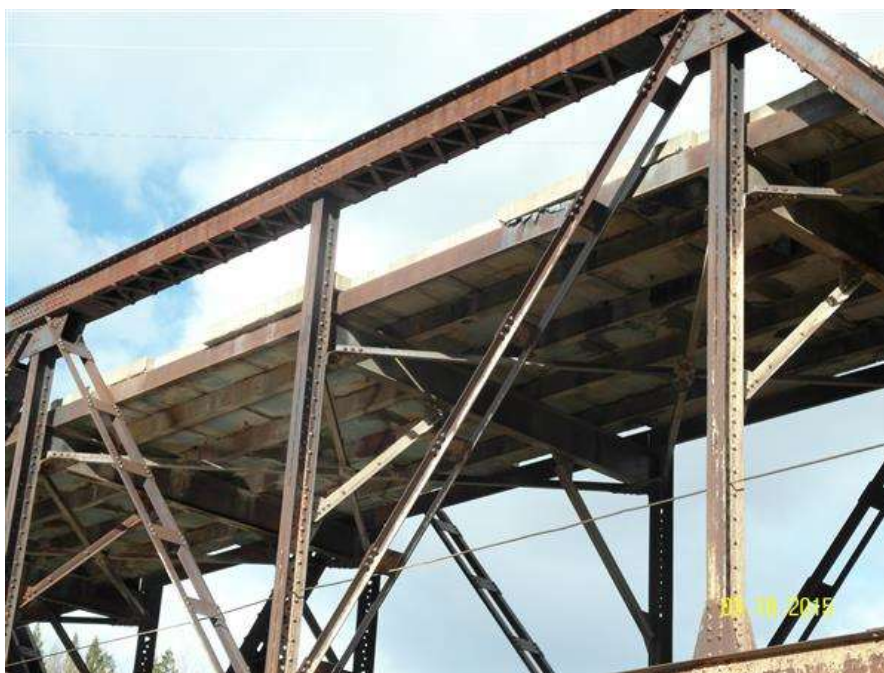
PHOTO #10 MTA-SR-001, SUN RIVER BRIDGE, PHOTO BY GARY GRASSEL. THIS IS A VIEW FROM UNDERSIDE OF THE BRIDGE, NOTE THE PRECAST DECK PLANKS HAVE SHIFTED UPSTREAM AND DOWNSTREAM AND DO NOT PROVIDE LATERAL STABILITY TO STEEL STRINGERS AND THEREFORE SUPPORT BEAMS ARE ALSO FULLY UNBRACED. (03/18/2015)

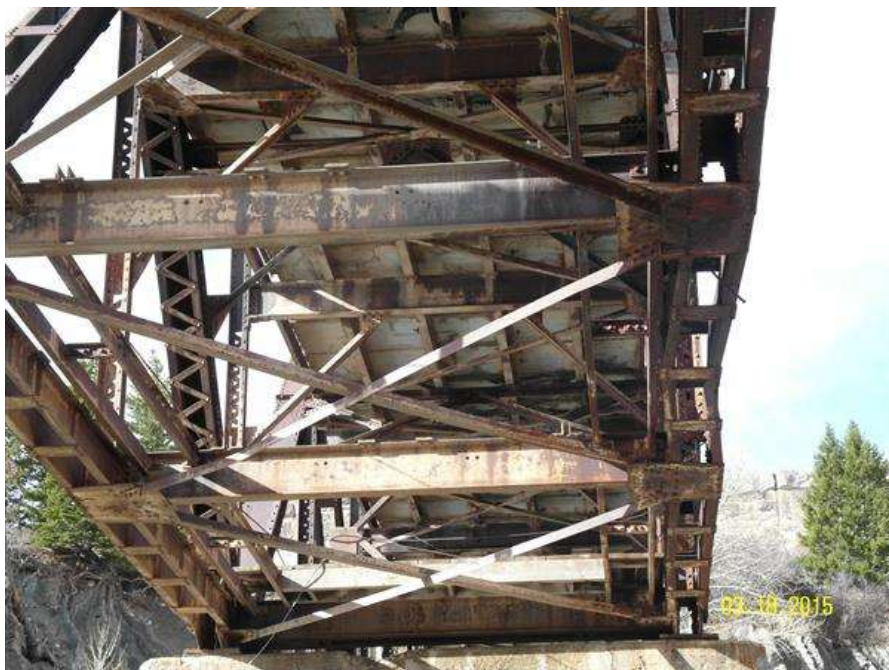
- The bottom chord, upstream side of the north main span has been damaged sometime in the past (possibly in the 1964 flood?).
- The top chords of the trusses are currently being used as the bridge guardrail.

PHOTO #11 MTA-SR-001, SUN RIVER BRIDGE, PHOTO BY GARY GRASSEL. THIS PHOTO SHOWS THE BOTTOM CORD OF THE LEFT UPSTREAM TRUSS. THE BENT LOWER CORD HAS BEEN INSPECTED BY THE RECLAMATION CLIMB TEAM AND NOTHING WAS OBSERVED TO BE IN NEED OF REPAIR. (03/18/2015)

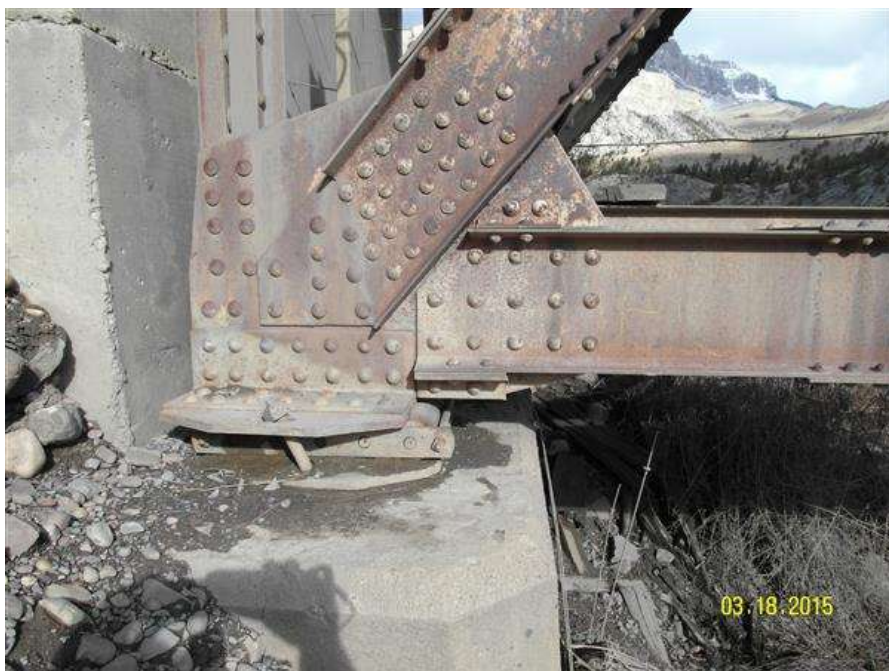
PHOTO #12 MTA-SR-001, SUN RIVER BRIDGE, PHOTO BY GARY GRASSEL. THIS IS A VIEW OF THE BEARING ASSEMBLY ON THE DOWNSTREAM SIDE OF THE RIGHT TRUSS AND RIGHT APPROACH. NOTE TRUSS ANCHOR BOLT IS BENT AND TRUSS BEARING PLATE COMING OFF THE ROLLERS. (03/18/2015)

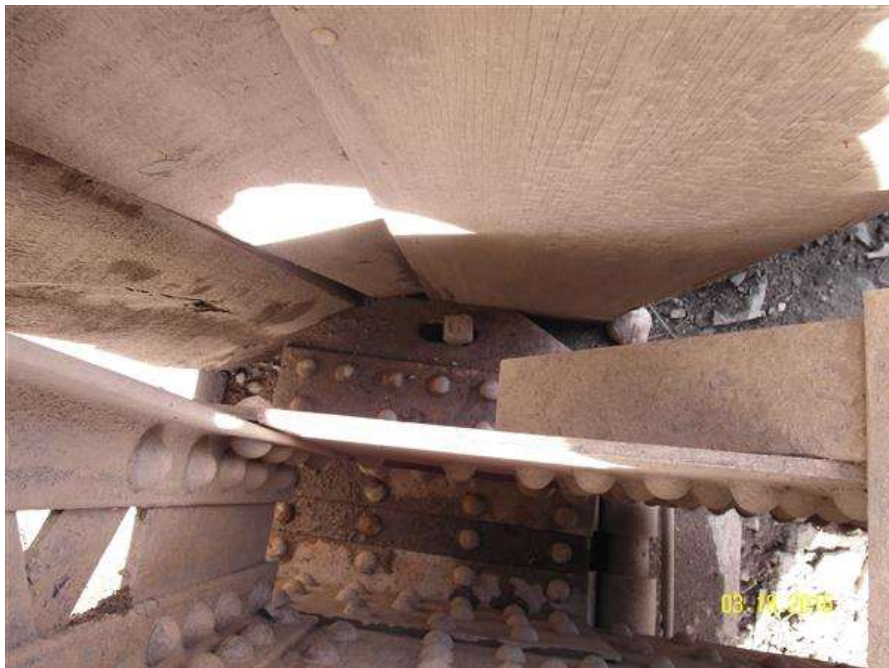
PHOTO #13 MTA-SR-001, SUN RIVER BRIDGE, PHOTO BY GARY GRASSEL. THIS IS A VIEW OF THE UPSTREAM SIDE AT THE SAME APPROACH AS IN PHOTO #12. THE ANCHOR BOLT IS BENT AND THE BEARING PLATE HAS EXTENDED PAST THE FIRST ROLLER. (03/18/2015)
