Performance of Transportation Infrastructure During Kumamoto Earthquakes of April 14 and 16, 2016— A Reconnaissance Report

PUBLICATION NO. FHWA-HRT-22-110

MARCH 2023

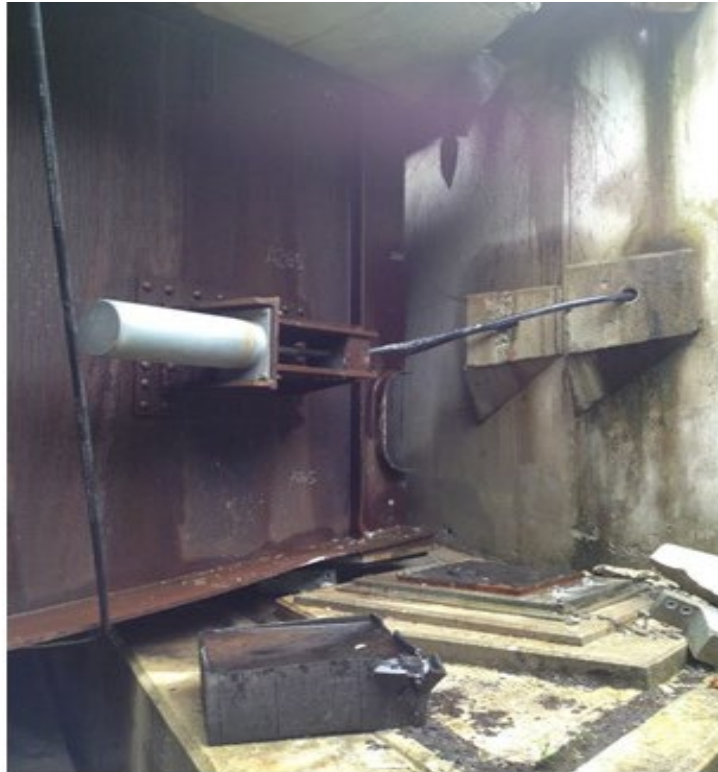
Figure 30. Photo. Failed bearing below girder G1 at abutment A2.

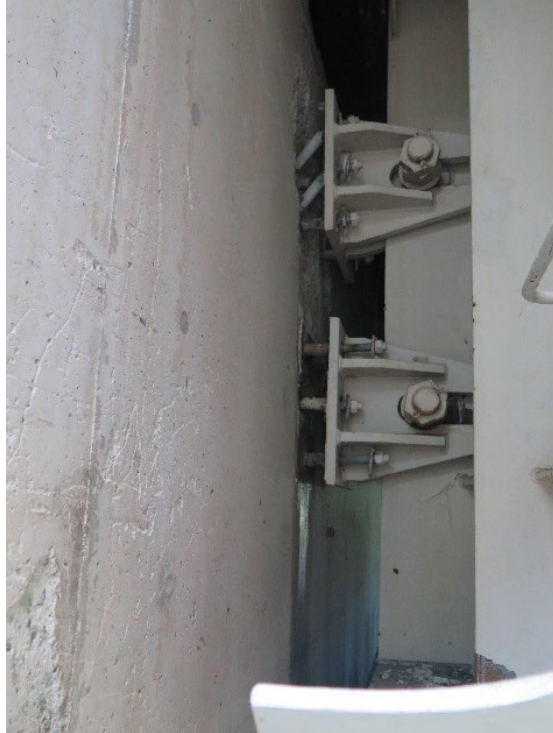
Figure 38. Photos. Damage to steel bearings at abutment A1.

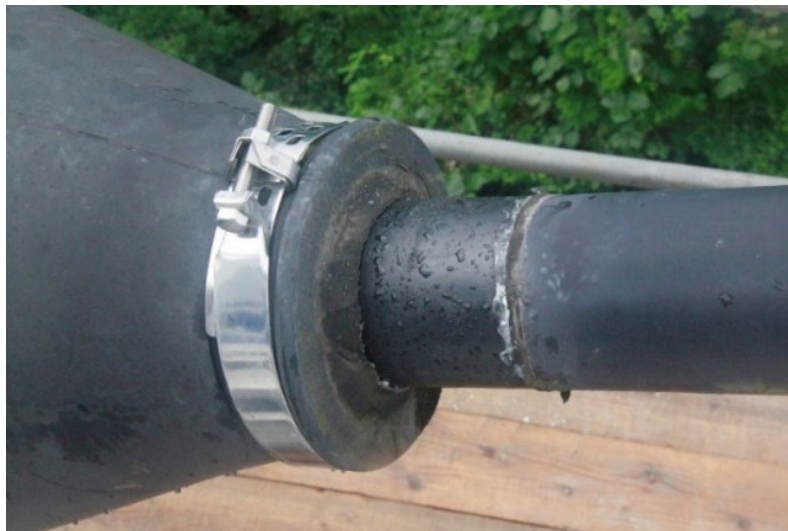
Damage to the cables also occurred (figure 46 and figure 47). On the west side of the long span, a gouge occurred in the high-density polyethylene sheathing on a cable where it appeared to have made contact with a luminaire. The current separation between the luminaire arm and cable appeared to be 3 ft (0.9 m). At least two cables failed, both on the west side of the bridge, one in each span. The failure does not appear to be a complete rupture of the cable and is likely associated with movement of the wedges and anchor plate. This opinion is based on the observed extension in the corrosion protection shielding.

Figure 46. Photo. Cable damage.

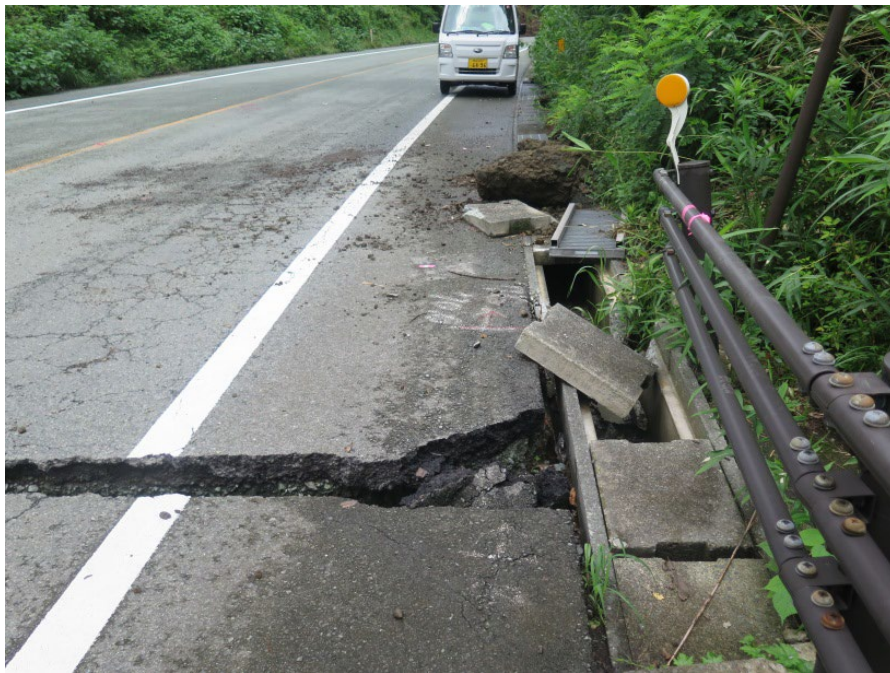
Figure 52. Photo. Close-up view of damaged approach at the west abutment.

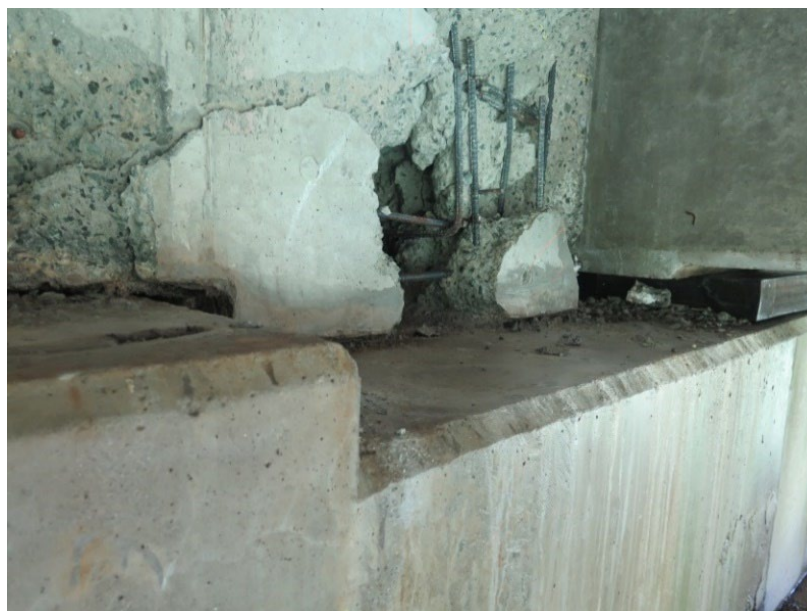
The most severe damage observed in this bridge was the failure of the end diaphragm at the east abutment (figure 56 and figure 57). The longitudinal and lateral movements of the bridge toward the abutment resulted in the failure of the diaphragm.

Figure 56. Photo. Damaged end diaphragm at the east abutment and dislodged timber block from under the second girder from the left.

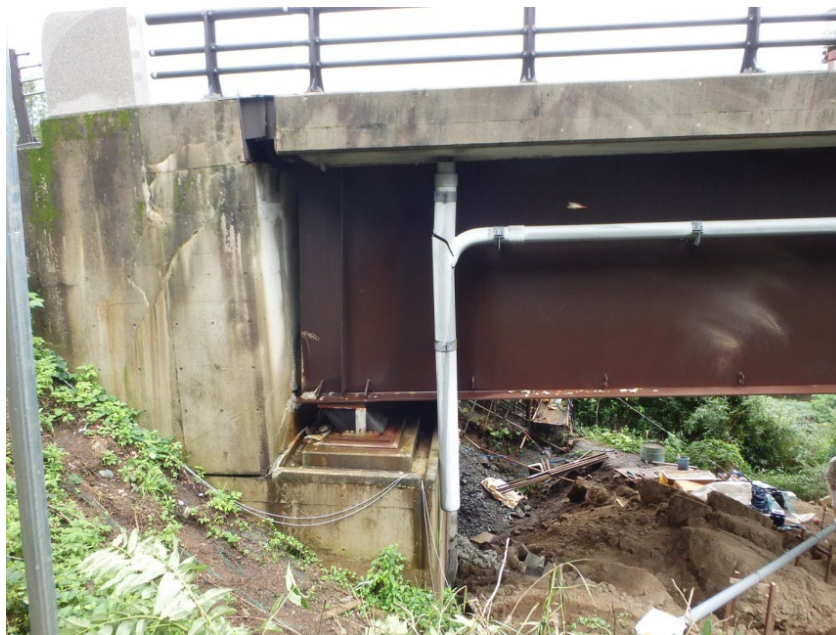
At the west end, damage was predominantly due to ground movement, leading to failure of the approach roadway, abutment rotation, pounding of girders, and bearing distortion (figure 61, figure 62, and figure 63).

Figure 61. Photo. Failure of the west approach.

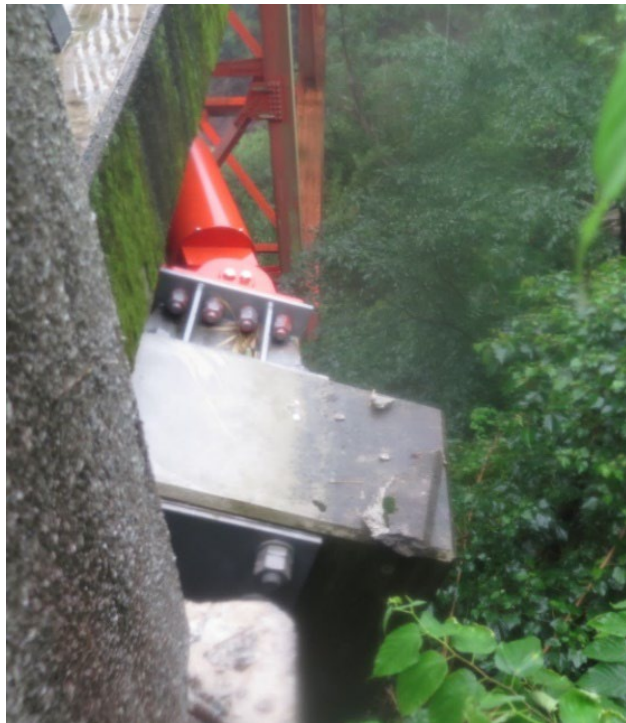
Damage was primarily sustained by the shear keys and back walls at both abutments. Figure 85 and figure 86 show close-ups of shear key failures at both sides of the south abutment. Dampers were secured to the abutments in the upper shear key area. Transverse displacements at the south abutment appear to have broken the keys, rendering the dampers ineffective. Another possible failure scenario is that longitudinal forces in the dampers pulled the keys free and damaged the back wall, but there was no evidence of longitudinal movement in the road joints at either end of the bridge or of damage to the dampers (no oil leakage, mounting bolt yielding, or pin distortion). A more likely scenario is first the transverse failure of shear keys and then anchorage failures in the dampers due to the weakened back wall. This hypothesis is consistent with the angle of the failure plane in the keys as seen in figure 88 and figure 89.

Figure 85. Photo. Damage to the anchorage of longitudinal damper and shear key on the west side of the south abutment.

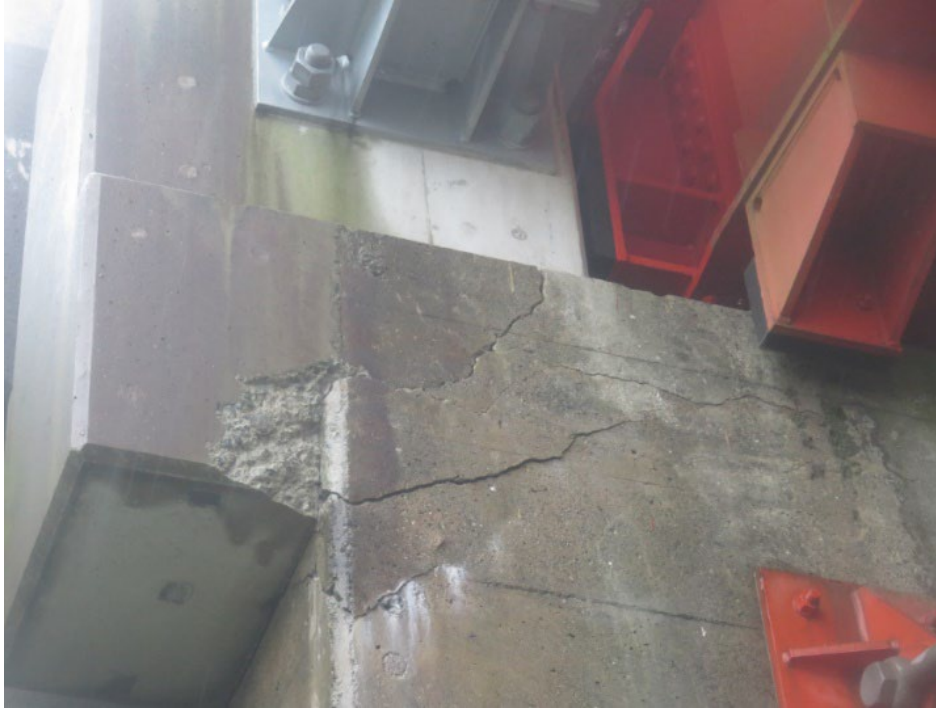
Dampers were still secured at the north abutments. However, shear cracks at both keys were visible (figure 87, figure 88, and figure 89), indicating a high level of transverse demand.

Figure 88. Photo. Damage to the shear key block on the east side of the north abutment.

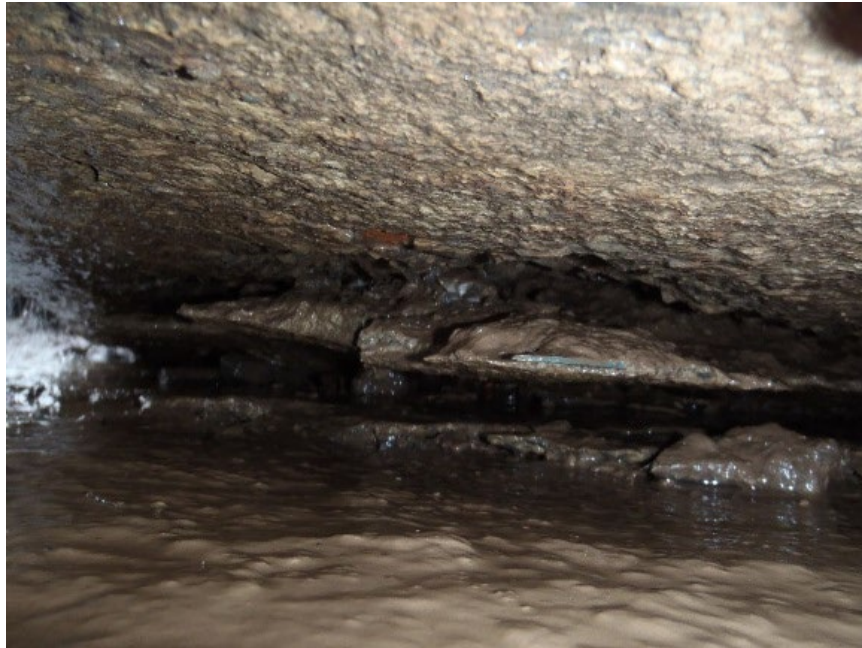
Figure 97. Photos. Gap opening between the bottom of both columns and the top of the pile cap at pier P11 of the east bridge.

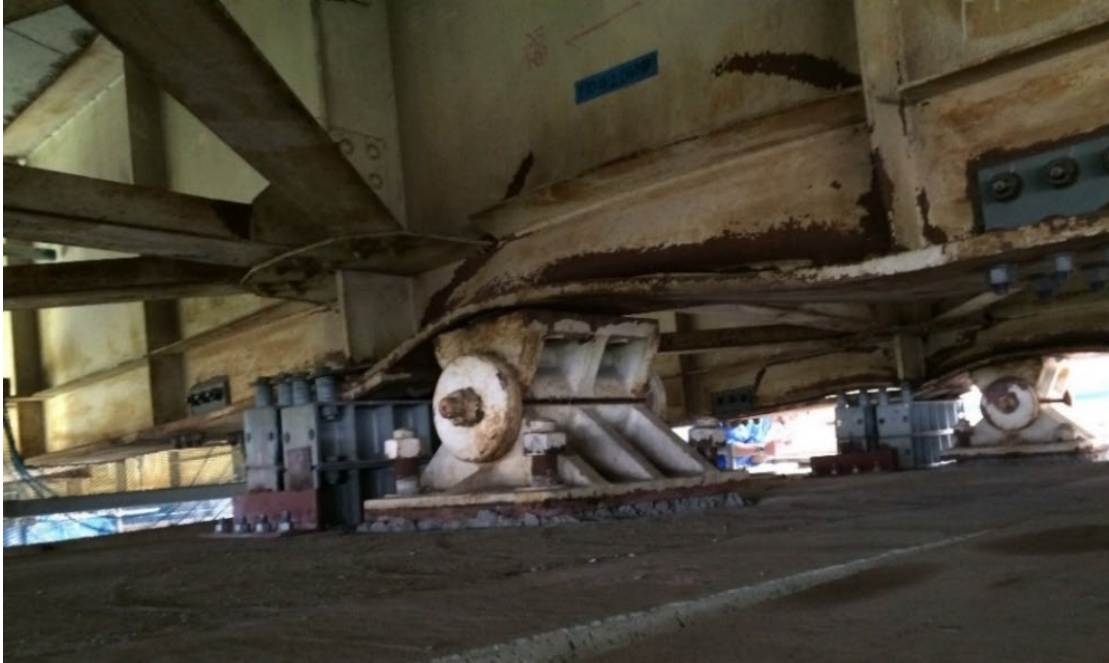
Apart from the damage to the column-to-pile cap connection at pier P11, significant damage also occurred at the bearing connections on the other piers. The superstructure appeared to have “jumped” longitudinally in both directions. There were indentations on both sides of the stiffener. As shown in figure 99, the large longitudinal movement of the bridge deck damaged the bolted connections of the steel bearings to the bottom flanges of the girders. Another consequence of this movement was that the web stiffeners were no longer aligned with the bearings, causing damage to the girder webs and flanges in the vicinity of the bearings. This type of damage was observed in both interior and exterior girders (figure 99 and figure 100). In addition, some bearings were also torn apart (figure 101). However, it appears that the failure of the bearings and/or their connections acted as a fuse, protecting the columns below from damage. As noted in the preceding paragraph, in the only case (pier 11) where the bearings and/or their connections did not fail, the pier below rotated and the pier-to-pile cap connection failed.

Figure 99. Photo. Failed bearing connection under the west girder at pier P10 of the east bridge.

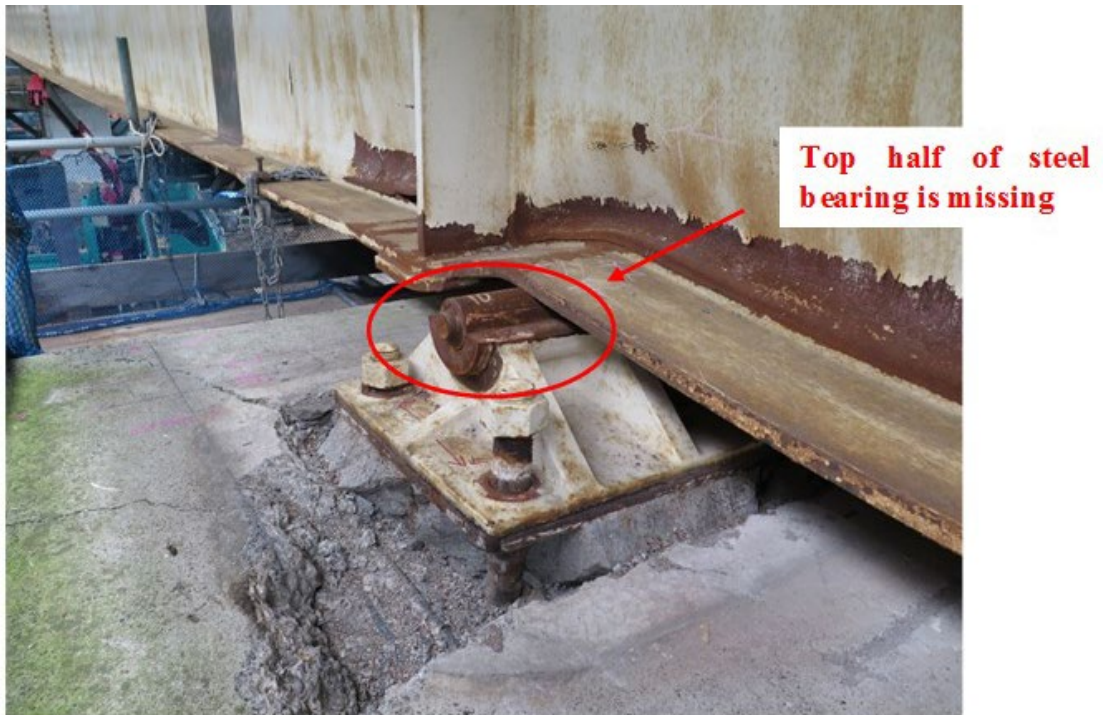
Figure 100. Photo. Failed bearing connections under interior girders at pier P10 of the east bridge.
