LTPP Pavement Maintenance

Materials: PCC Partial-Depth Spall Repair Experiment, Final Report

PUBLICATION NO. FHWA-RD-99-153

OCTOBER 1999

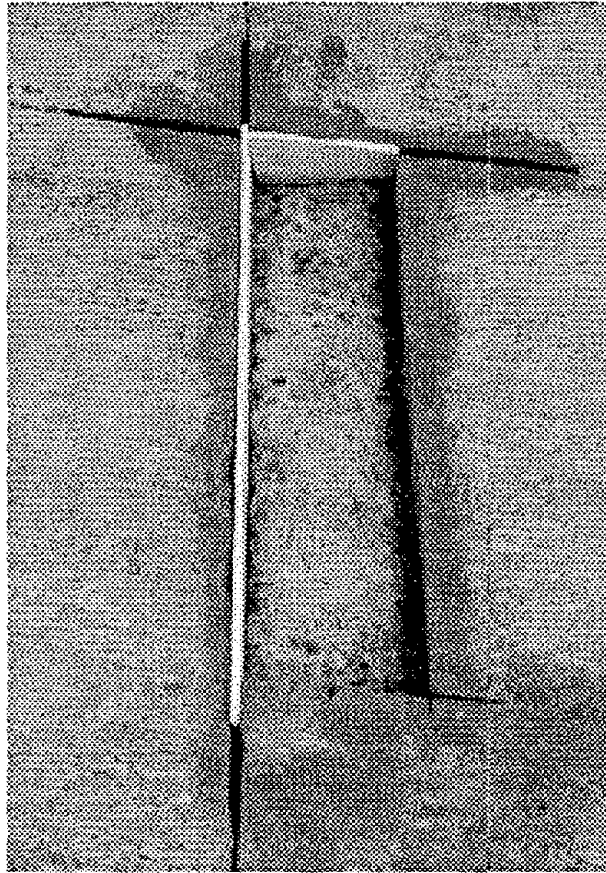
Figure 10. Joint bond-breaker installed at patch edges.

Following the cleaning operation, a joint bond-breaker was placed full-depth in the joints adjacent to repair areas that were to be patched with nonflexible repair materials (i.e., Type III PCC, Duracal, Set-45, Five Star HP, MC-64, SikaPronto 11, and Pyrament 505), as shown in figure 10. The joint bond-breaker consisted of a 102-mm-high, 13-mm-wide, closed-cell polystyrene foam board that was slightly wider than the saw cut. In back-to-back repair areas at a joint, difficulty was encountered in maintaining a true, straight joint line. In locations deeper than 102 mm, it was also difficult to stack the joint bond-breaker to the desired height. Latex caulking was used occasionally to seal any irregularities or gaps between the joint bond-breaker and joint opening in order to prevent repair material from flowing into the joint or crack opening below the bottom of the patch. A joint bond-breaker was not installed in repair areas that would be patched with Percol FL, Penatron R/M-3003, UPM High Performance Cold Mix, AMZ, or Rosco.

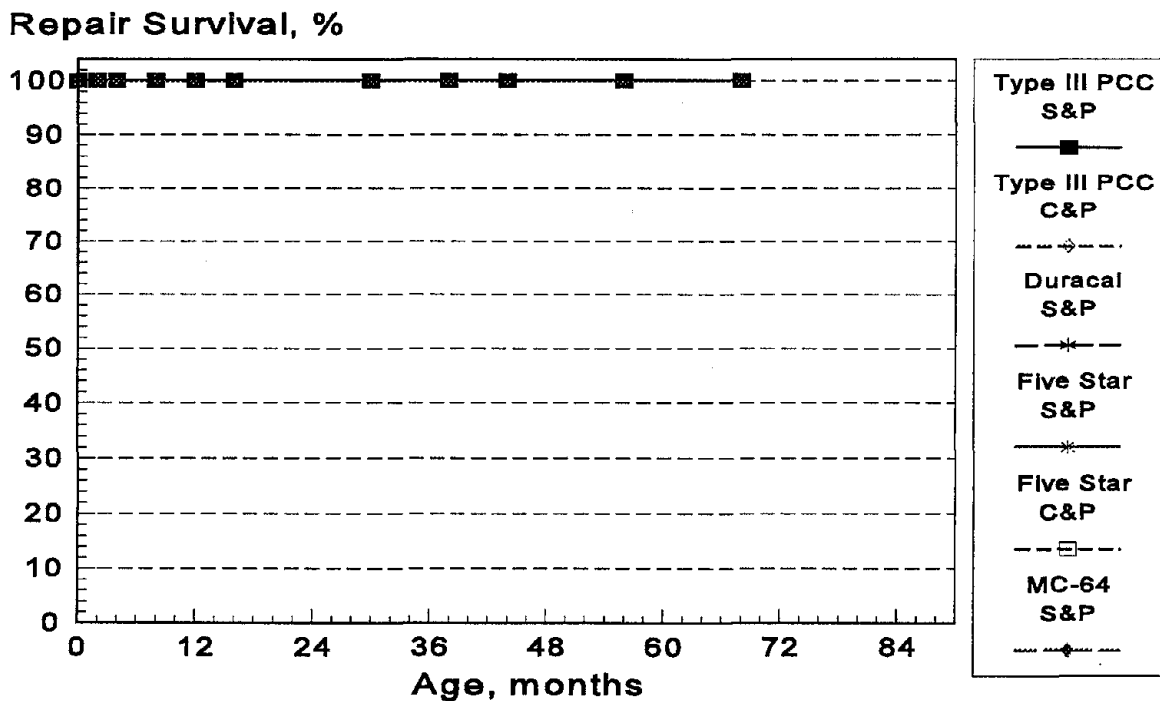
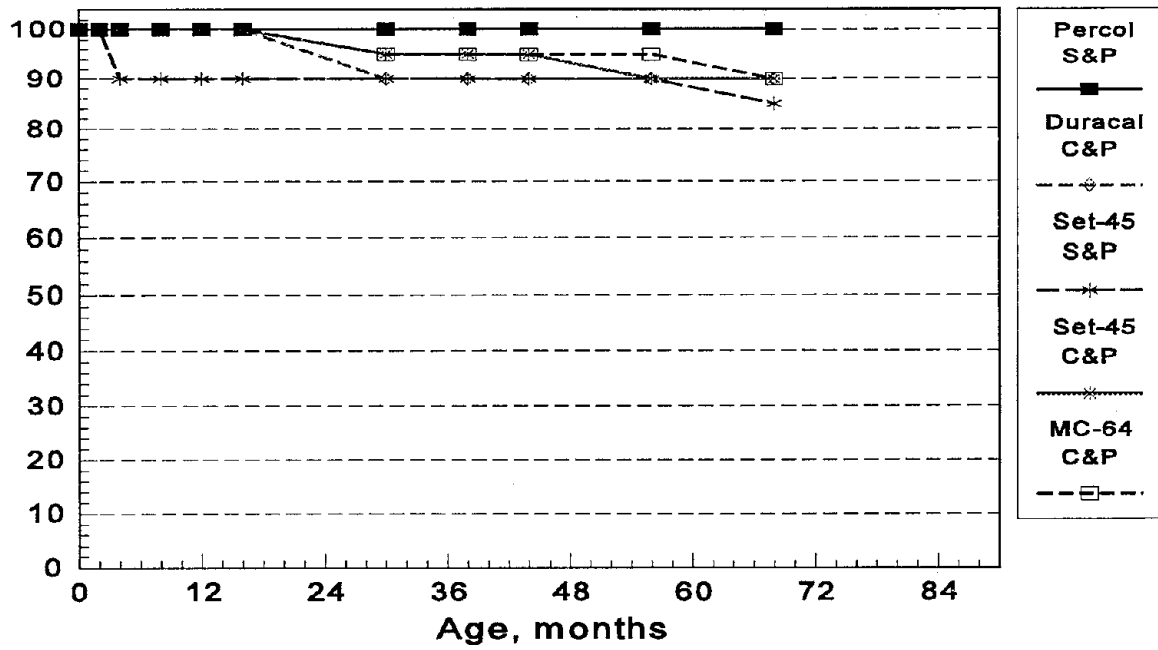
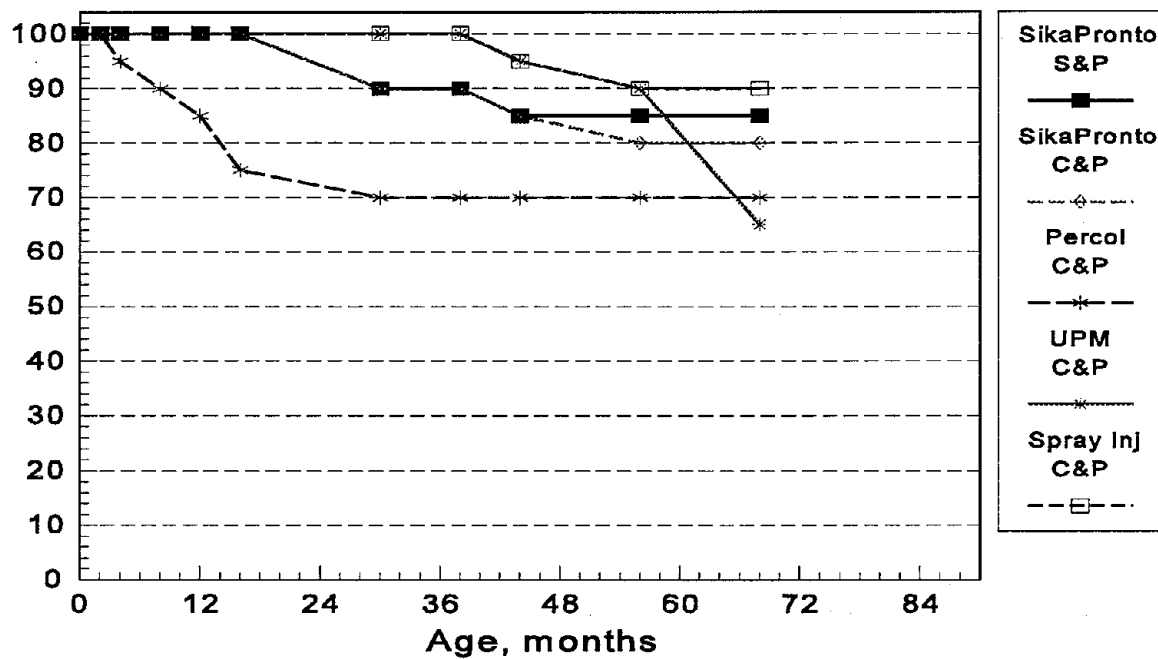
Figure 24. Spall repair survival at South Carolina test site.

The distresses most often observed during the field inspections of the spall repair test sites consisted of cracking of the patches and delamination of the rigid and two-part epoxy repairs from the underlying PCC material. Deterioration of repair edges, aging and raveling of material, cracking, and loss of material pieces were the predominant distresses observed for the bituminous repairs. In many instances, the distresses developed during the initial year after placement and continued to worsen over time as climate and traffic continued to wear on the repairs.
