# LOCAL ROAD SAFETY PLAN

## PALM BEACH COUNTY LOCAL ROAD SAFETY PLAN DEVELOPMENT

Intersection of Lake Worth Rd (FL 802) & S. Jog Road

Rank 12, Intersection ID 1712

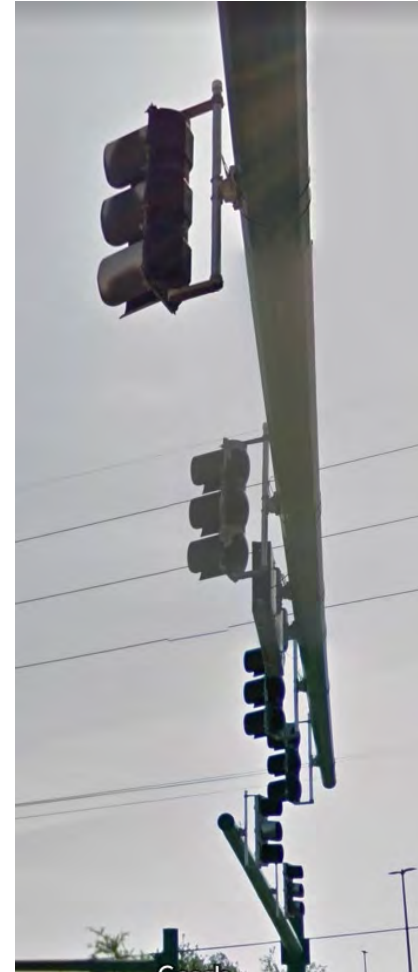
- ❑ Signal heads appear to be outdated (chipped paint) and are inconsistent (based on visual inspection)
  - Some signal heads have LED lenses while some do not
  - EB and WB signal heads have background shields, while NB and SB approaches do not
- ❑ Current signal heads are 12”

Signal heads mounted on the SW corner mast arm  
Source: Google Street View  
Image capture: May 2017

- ❑ Improve Signal Visibility:
  - Install signal background shields on northbound and southbound heads to improve visibility.
  - Install supplemental mast arm-mounted signal heads so that each lane has a dedicated signal head. This included mast arms on the approach side and far side of the intersection.

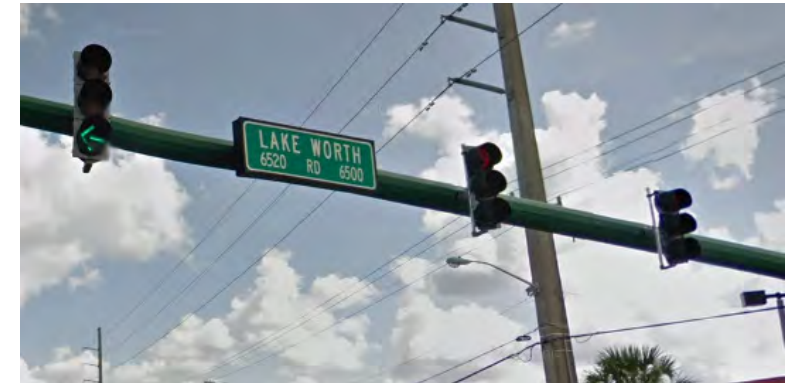
- ❑ There are existing raised markings for all longitudinal markings and a project to implement is not required.

- Note: this upgrade requires a structural analysis of each mast arm/span wire where a signal will potentially be added.
- ❑ Place lane dedication regulatory sign at the beginning and the end of channelizing line per USDOT MUTCD Requirements:

- Place R3-H8ec on northbound, southbound, and westbound (one each)
  - Place R3-H8eb on eastbound
- ❑ Retroreflectivity of the existing signs and markings appears to be in good shape. Upgrading existing signs for retroreflectivity is not recommended.

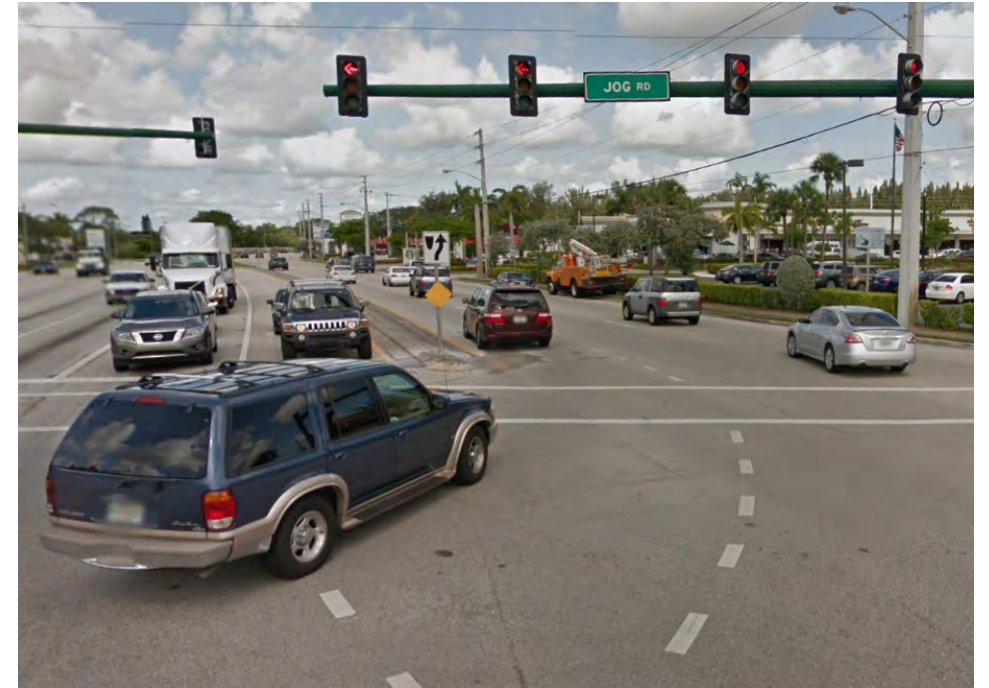
- ❑ 11 crashes involved left turns of which 3 were severe. Specific details on gap acceptance were not available, though they are presumed unrelated given the protected left turn signal timing (assumed based on number of lanes).
  - Storage length of turn facilities is enough to accommodate peak turning movements without through blocking.
- ❑ Turn radius analysis was completed using AutoTurn (design vehicle: WB-62). (Details next figure)
  - It appears concurrent eastbound to northbound and westbound to southbound left turn movements have almost no clearance, which may be slowing down turning traffic. This may be leading to the high level of “Following Too Closely” Crashes (29 crashes).

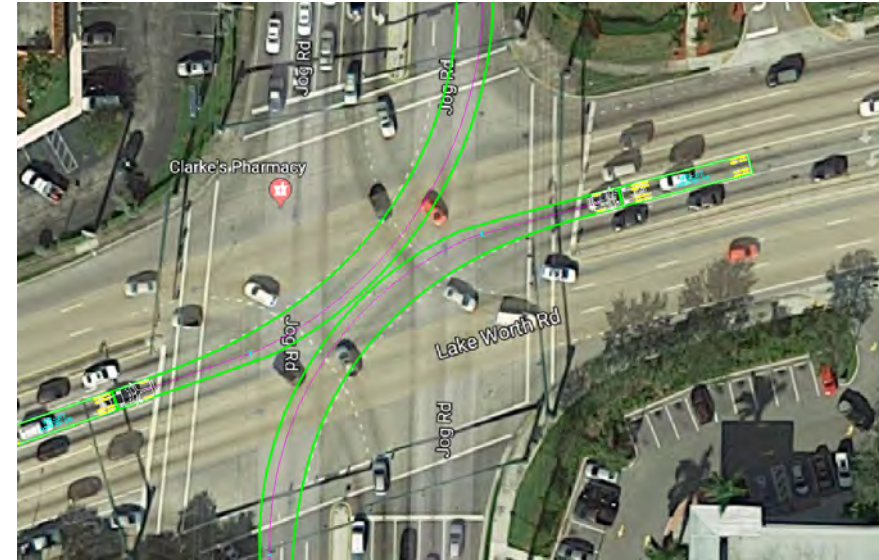
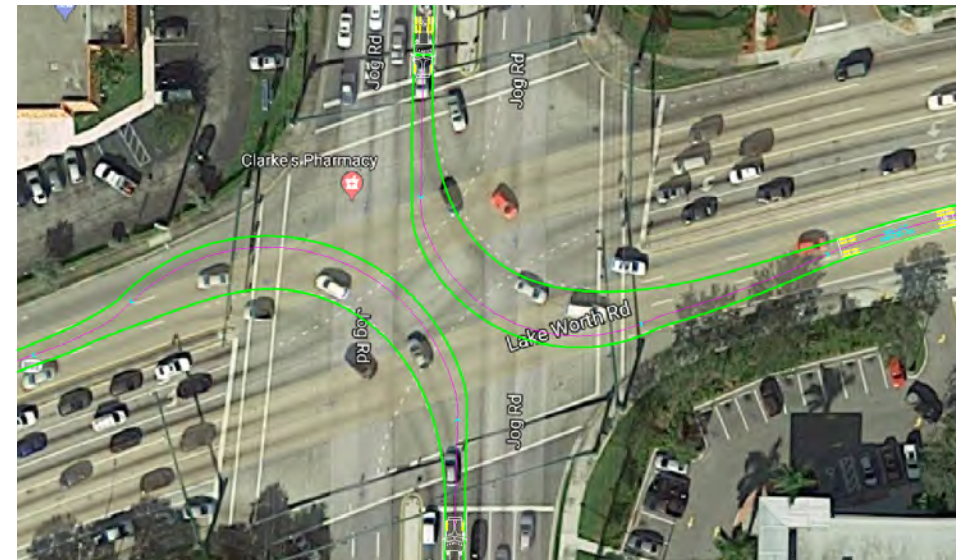
- ❑ Left turn movements on opposite approaches are related to design vehicle WB-62 drafted with AutoTurn. Green path represents total turning width of design vehicle.
- ❑ Signal Phasing improvements
  - Update signal phasing to avoid concurrent protected left turns of opposite approaches, especially on eastbound and westbound approaches.
  - Since there is an urgent care facility 200' east of intersection, and a fire station 0.6 miles west of intersection, and a fire station almost a mile north of intersection, preemption should be utilized.

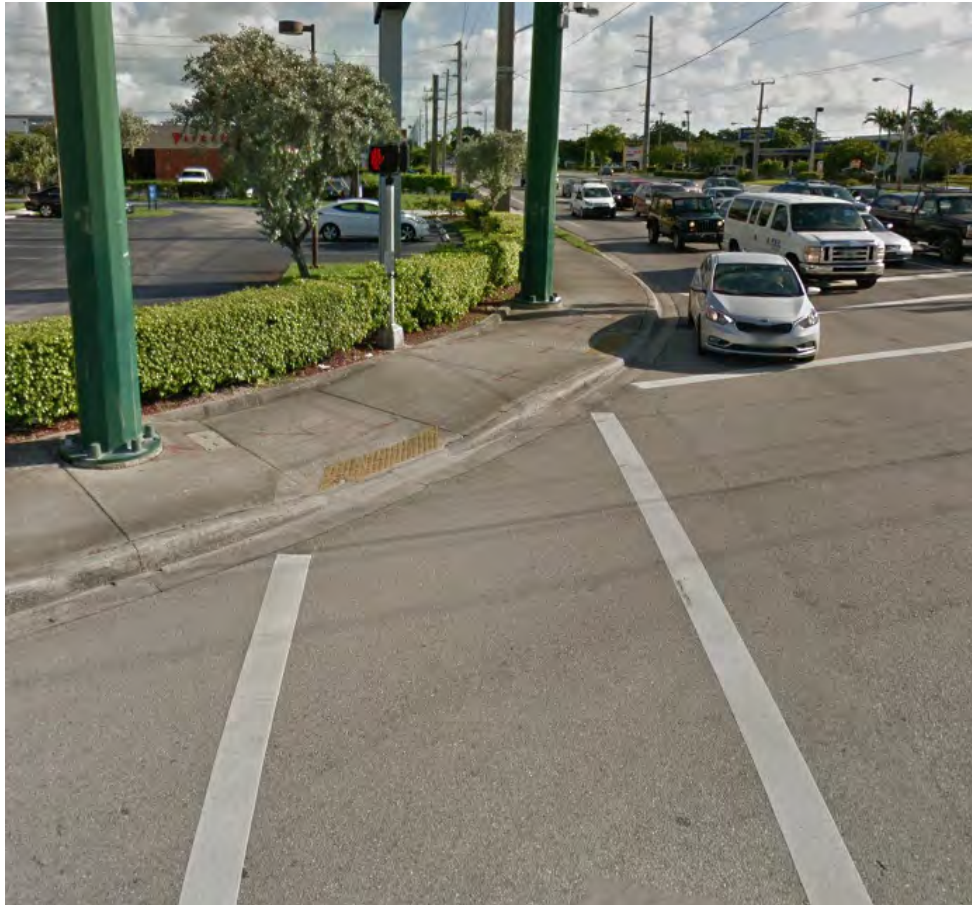
- ❑ The one fatal crash at the site involved a pedestrian. Additionally there is:
  - Evidence of high volume pedestrian traffic
  - Presence of handicapped sidewalk/crosswalk users
  - Two bus stops within 500' on all four legs (totally eight bus stops)
  - Existence of surrounding businesses that generate high volume of pedestrian traffic
  - Crosswalks with long crossing distances (150'-170')
- ❑ Recommended pedestrian upgrades include
  - **Pedestrian countdown timers with pedestrian leading interval signal timing**
  - **Future consideration for raised pedestrian refugee islands** (likely width would have to be taken from lanes and added to median)

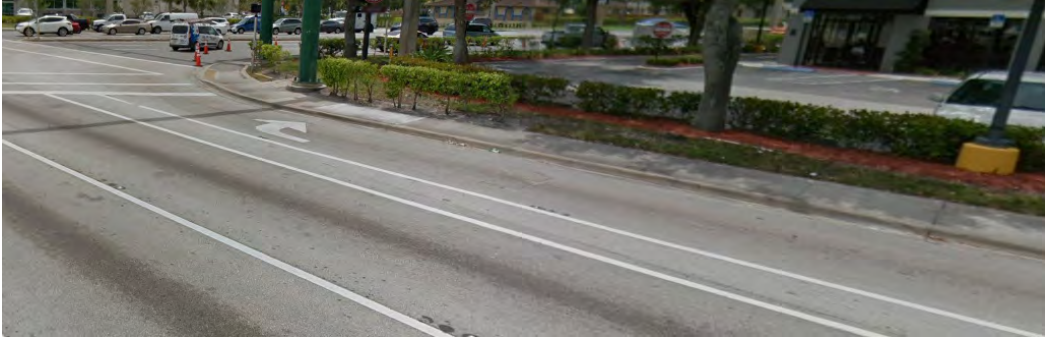
- Bike lanes already exist along all approaches in all directions.
- 5 injury crashes involving bicycles occurred from 2011-2015.
- Proposed bicycle features include **leading bicycle interval signal timing**, and marking the **full bike lane with green markings and white bicycle markings**.
- Advanced bicyclist facilities, like bike bokes and bicycle detectors, should be considered only after lower cost countermeasures do not improve bicyclist safety.
