SUMMARY of Road Safety Audit REPORT

Road Safety Audit on US 29 Albemarle County, Virginia

Date: August 21 – 22, 2007

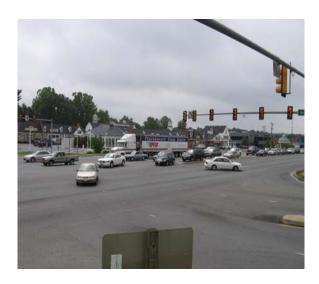
Issue 2: Signing and Pavement Marking

The RSA Team observed worn or missing signs and pavement markings, which may limit driver guidance, especially at night. The team also noticed that lane use signage is inconsistent on mainline and side streets. Additional driver confusion may be caused by obsolete signage that increases visual clutter.

The RSA Team suggests taking measures to improve signing and marking. Existing signing and pavement markings should be reviewed and VDOT should develop an action plan as part of the RSA report. These corrections are relatively low cost and include the maintenance of pavement markings, installation of proper signs, and removal of obsolete signs.

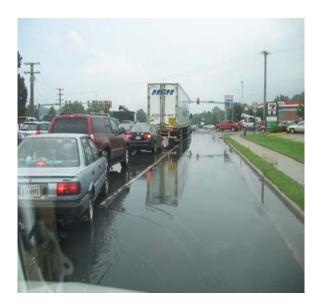
Issue 3: Drainage and Maintenance

Several sections of the roadway exhibited poor drainage due to what appears to be insufficient and improperly placed drainage inlets in the study area. Overgrown roadside vegetation was also found on the corridor, reducing sight distance and blocking guide signs in several locations. Maintenance of pavement may be an issue in some areas of the corridor from pavement rutting along portions of the study section.

Consider measures to improve drainage, including a comprehensive review of the existing drainage structures. Also remove or cut-back vegetation to improve sight distance and sign visibility and ensure the current vegetation maintenance program adequately addresses issues. The Team also suggests reviewing the pavement management plan to determine the next scheduled overlay. Pavement repair (short term) and rehabilitation/reconstruction (long term) can be considered by VDOT.
