TECHBRIEF

Controlled-Environment Testing of UAS Digital Camera Sensor Specifications and Operational Parameters for Bridge Safety Inspections

FHWA Publication No.: FHWA-HRT-21-060

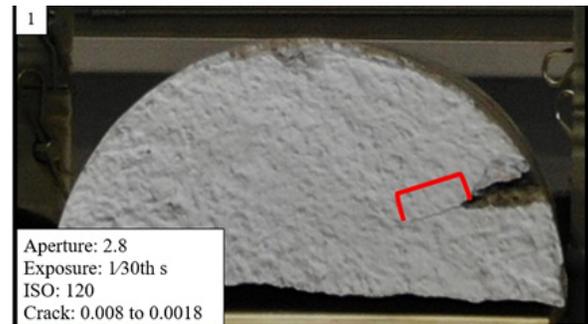
A. Example at 1/30th-s exposure.

Figure 1-A is properly exposed and was taken using automatic settings. Figure 1-B is overexposed, and figure 1-C is underexposed; both were taken using manual adjustments to the exposure settings to provide comparisons with the other settings that were

Image	Aperture	Shutter Speed	ISO
1	2.8	1/30th s	120
2	2.8	1/15th s	1,600
3	2.8	1/100th s	100

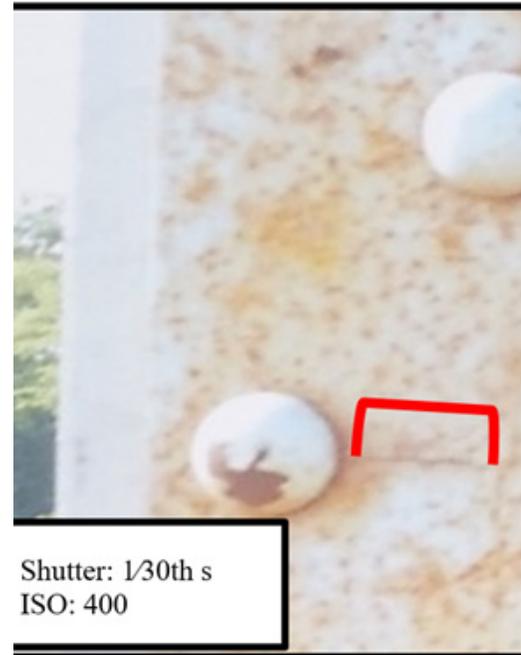
A. Motion blur example with exposure at 1/30th s and ISO set to 400.

A stable platform is very important for the image quality captured (figure 4-A). In the absence of a stable platform, the camera will have difficulty capturing a clear image. The blurring of an image due to aircraft motion (or motion blur) is typically a result of movement of the camera, an improper shutter speed, or a combination of both. Motion blur can also result from the aircraft not being able to stabilize due to winds exceeding UAS operating limits or a denied or unstable GPS signal without a secondary stabilization system, as was the case in figure 4-B.

Multiple images of the bridge defect in figure 4 were captured from 10 ft away; however, approximately 50 percent of the images experienced motion blur at shutter speeds ranging from 1/8th to 1/40th s. The blurred images were attributed to the aircraft's instability due to the lack of GPS stabilization and not being equipped with indoor stabilization capabilities.

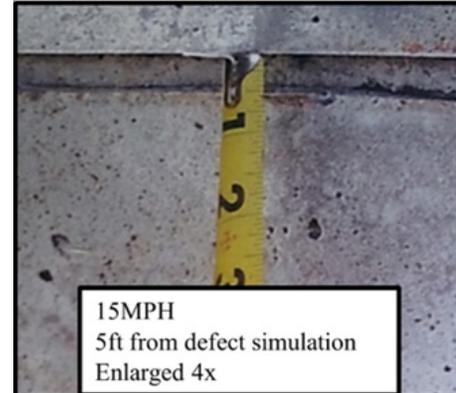
A. Photo taken 5 ft from defect simulation.

Standoff testing was accomplished in sustained winds of 15 mph with minimal effect on the quality of the images collected (figure 5-A through figure 5-C).

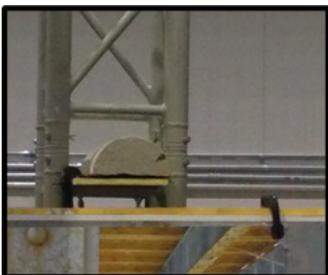
B. Photo from 15 ft with 3× zoom.

Figure 6-A was taken from 5 ft without magnification, and figure 6-B was taken from 15 ft with 3× zoom. These original images look very similar. However, the difference in resolution can be seen when the image undergoes postprocessing enlargement and cropping. The images in figure 6-C and figure 6-D show the same defect enlarged four times from its original size. As can be seen, a lower level of zoom from a closer range produces visibly better results (figure 6-C) than a zoomed image. This difference in image quality should be taken into consideration should zooming be necessary for flight safety.

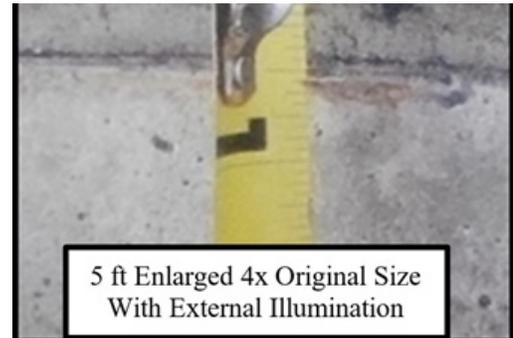
A. Example from 5 ft, enlarged 4× original size, with external illumination.

The images in figure 7 were taken with and without external lighting at distances of 5 and 15 ft. The images show the difference between using the external light source (figure 7-A) and the available lighting (figure 7-B). At such close range, external light adds a great deal to the quality and usability of the image.

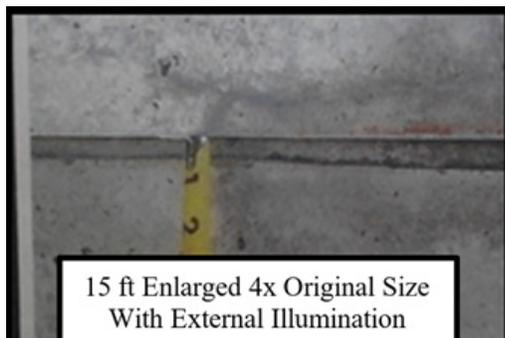
C. Example from 15 ft, enlarged 4× original size, with external illumination.

The image in figure 7-C was taken from 15 ft using the external lighting source, while figure 7-D was taken with available light. A close look at figure 7-C shows that using the external light source from 15 ft away does add a bit of clarity to the image as compared to figure 7-D, but the difference is almost imperceptible. Thus, when needed, external lighting carried by the UAS can improve the image quality when used at a close range; however, based on testing parameters and the external lighting capability of 5,000 lx at 5 ft and 11 lx at approximately 100 ft, external lighting does not offer a significant improvement to image quality beyond 15 ft.
