Stop Sign-Controlled Intersections:

Enhanced Signs and Markings

A Winston-Salem Success Story

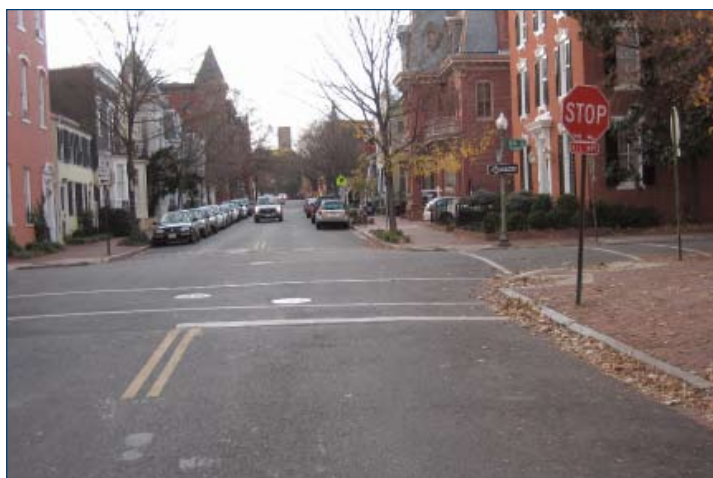
Double-yellow centerline and stop bars added to existing (24-inch) stop sign.

- Placing a short interval of double-yellow centerlines (up to 50-feet).
- Placing stop bars (12-inches wide).

These pavement marking treatments were designed to make the intersection and proper stop position more conspicuous to drivers, and thereby increase the driver alertness to the intersection control. These simple, low-cost countermeasure enhancements significantly reduced injury and overall crashes, as shown in the table to the right. **These countermeasures resulted in an average crash reduction of 52.7 percent and reduced injuries by 70 percent per year.** See Appendix A for a more detailed tabular summary of these treatments.

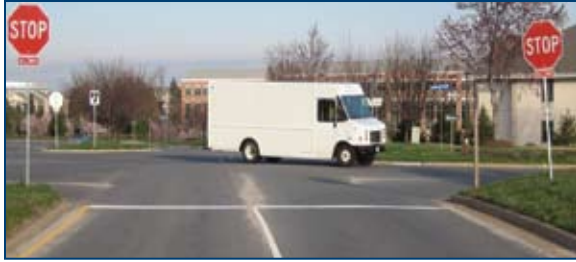
Additional (left and right side of street) and larger (30-inch) stop signs with stop bars.

- Placing an additional stop sign on the left side of the stop approach roadway and use of larger (30-inch) stop signs for the intersection at all stop sign-controlled approaches.
- Placing 12-inch stop bars at all stop sign-controlled approaches.
- Installation of short segments of double-yellow centerlines (up to 50-feet) at two of the approaches (Cherry Street and Greenwich Road).

At these locations the city experienced an average crash reduction of 65.9 percent with injuries down by 65 percent per year as well. See Appendix A for a more detailed tabular summary of these treatments.
