Large Field Test of New Stereo Detection System for the Pedestrian Signal Phase for the Visually Impaired

PUBLICATION NO. FHWA-HRT-12-074

SEPTEMBER 2012

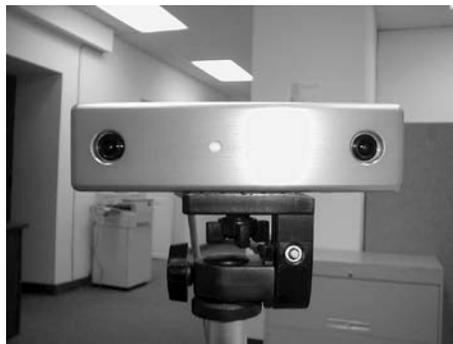
Figure 1. Photo. Commercial stereo camera used for phase I algorithm research.

The SBIR program is divided into two major phases. During phase I, researchers developed and demonstrated the prototype software and hardware that embodied a simplified version of the system. The software was run on top of a real-time operating system to demonstrate the capabilities. The algorithms and software were prototyped and validated using the software program Mathcad. Several unique features identifiable by stereo imaging were validated and utilized to enhance the separate detection of pedestrians from the presence of other moving objects such as cars, motorcycles, branches, dogs, birds, and shadows. A commercial stereo camera (not environmentally hardened) was utilized to develop the concepts and algorithms (see figure 1).

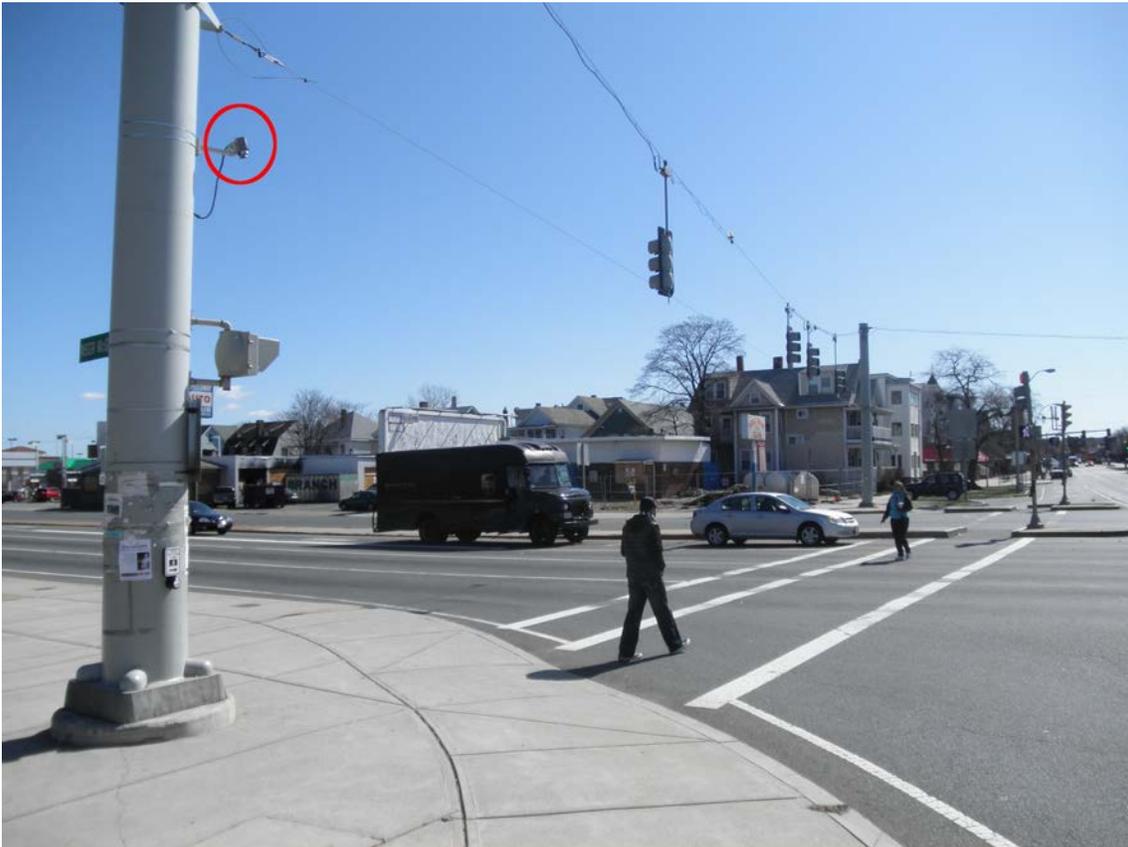
Figure 2. Photo. Stereo camera mounted on a pole above a pedestrian walk signal.

To detect pedestrians waiting at an intersection, the stereo camera must be mounted nearby (approximately 15 ft (4.58 m) above the ground) with a view of the pedestrian(s) in the middle of the stereo images. Figure 2 shows a stereo camera, which is circled in red, mounted to a signal pole.

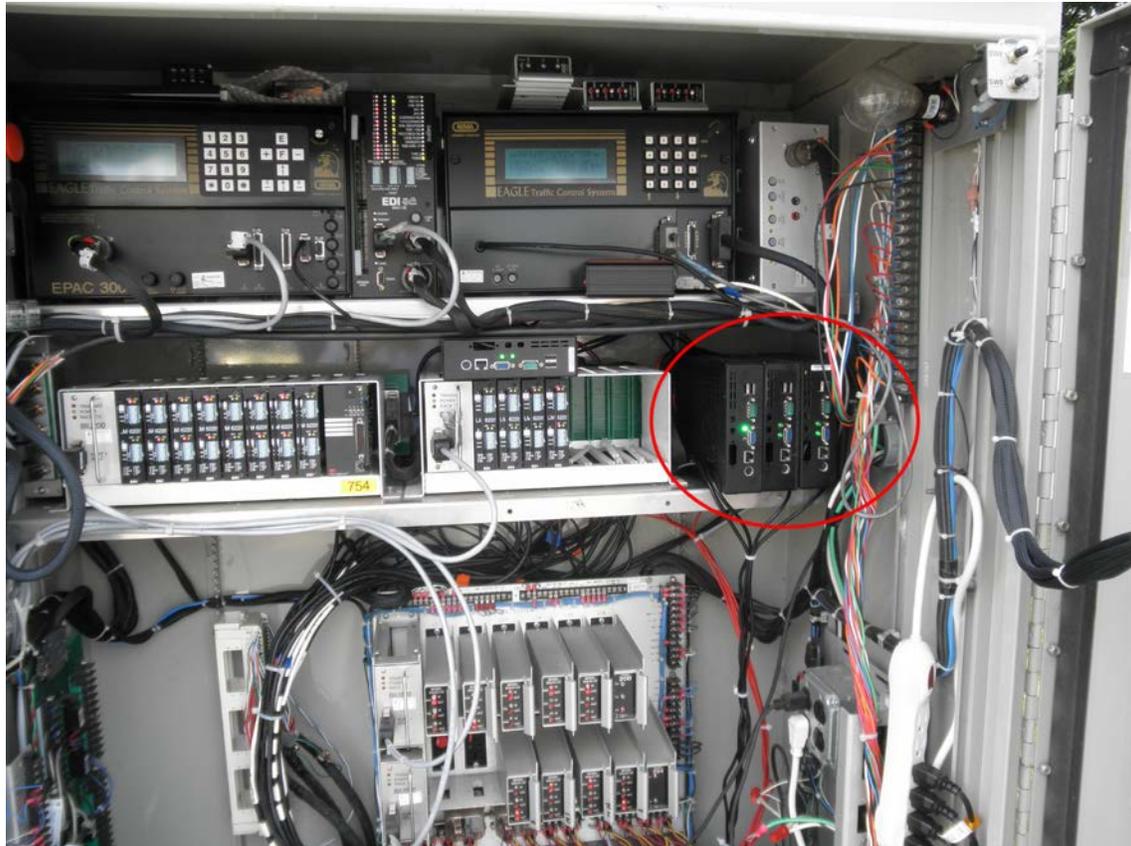
Figure 3. Photo. Four SBCs in a traffic control cabinet.

For the field test, project engineers worked with the local traffic engineers to place the SBC sensor processors in the traffic controller cabinet. Stereo camera images were transmitted to the SBC through video cables and processed for the detection of pedestrians. Each SBC can process images from two stereo cameras. The SBC has an Intel[®] atom processor for lower power consumption and uses Microsoft XP Embedded[®] as the real-time operating system. Separate relay cables were wired between the APS pushbuttons and the SBC for visually impaired pedestrians. All cables were pulled through an underground conduit. Figure 3 shows SBCs, marked by a red circle, placed inside a cabinet. For a typical intersection, there are four SBCs and eight stereo cameras to cover the eight approaches to the four crosswalks.

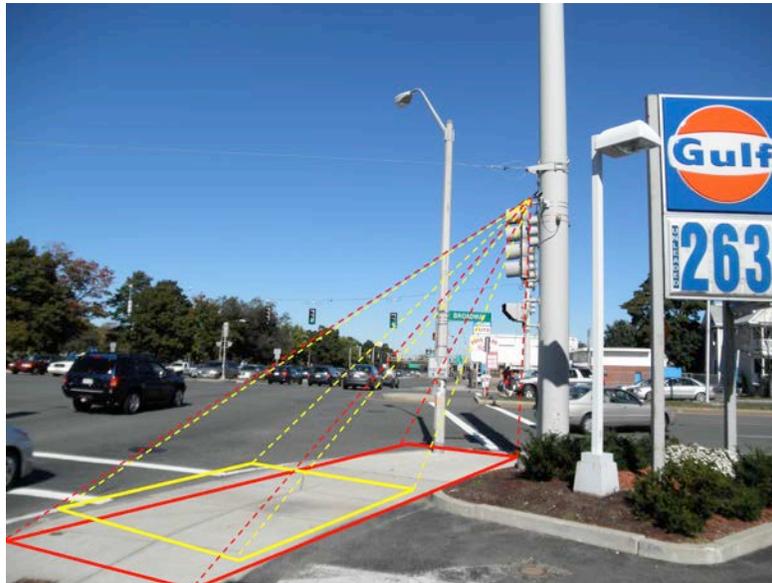
Figure 4. Photo. Two-zone detection architecture for locator triggering and pushbutton actuation.

The automated APS pushbutton actuation zone is outlined in yellow in figure 4. If a pedestrian is detected in this zone, a service call is automatically placed. To be detected, the pedestrian must wait in this zone for 4 to 5 s (configurable). Since a service call is automatically made by the system, the pedestrian does not need to press the pushbutton. However, if desired, the pedestrian can still press the button and hear the APS information message identifying the intersection and the street that is controlled by the pushbutton. False calls in this zone stop and delay traffic. As a result, the number of false calls per day must be very low.

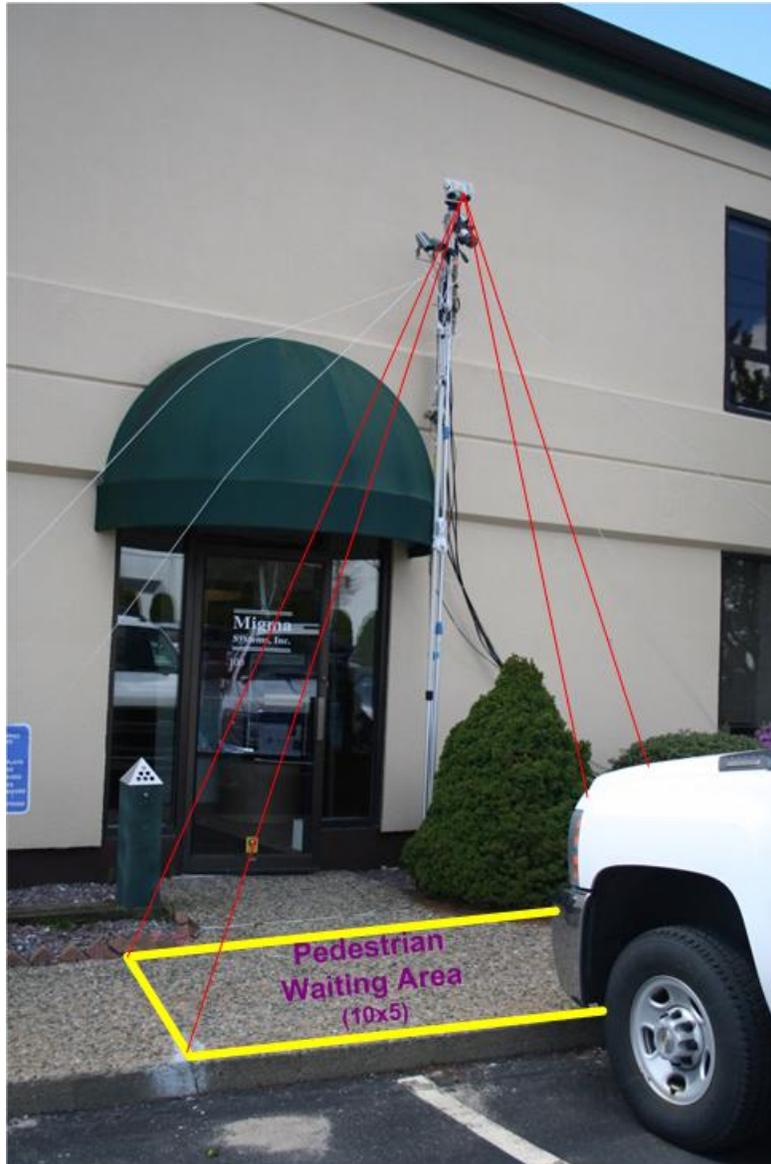
Figure 5. Photo. Simulated pedestrian waiting area test site.

At the start of this large-scale field test, test units were manufactured and tested for stereo alignment. Algorithms were installed in each unit. All stereo cameras and electronics went through rigorous tests at the laboratory field test site outside an office entrance before being placed in the field. Figure 5 shows this test site, which simulates a typical intersection corner. The laboratory site accommodated varying distances between the stereo camera and the ramp. Detection results were evaluated to ensure the quality of the systems for the field test.

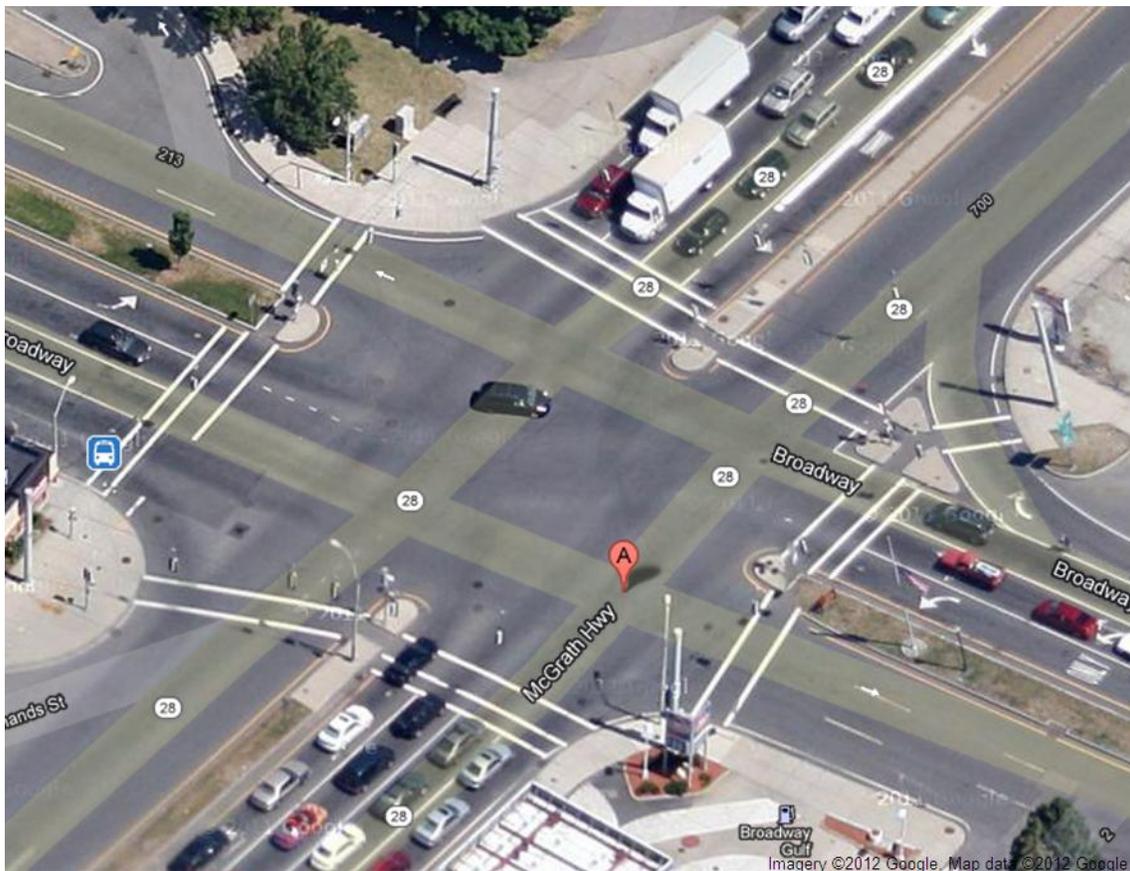
Figure 11. Photo. Intersection at McGrath Highway and Broadway in Somerville, MA.⁽¹⁰⁾

Figure 11 shows a signalized intersection that was selected in Somerville, MA. It is one of the largest intersections in Massachusetts. This intersection is next to a recreational park and residential buildings. Pedestrian volume is high during the daytime and at night.

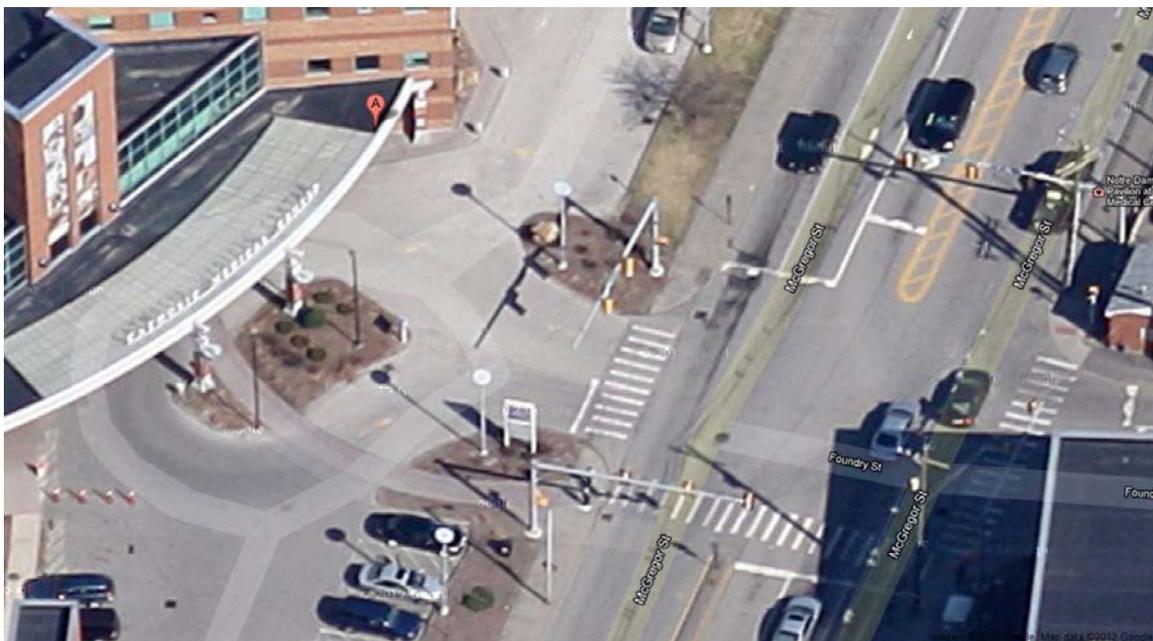
Figure 14. Photo. Aerial view of Medical Center test site at McGregor Street and Foundry Street in Manchester, NH.⁽¹³⁾

The test site in Manchester, NH, is located at the Catholic Medical Center (see figure 14). Since this intersection is primarily used by hospital visitors, the pedestrian volume is extremely high. It is also used by pedestrians who have vision and mobility impairments.

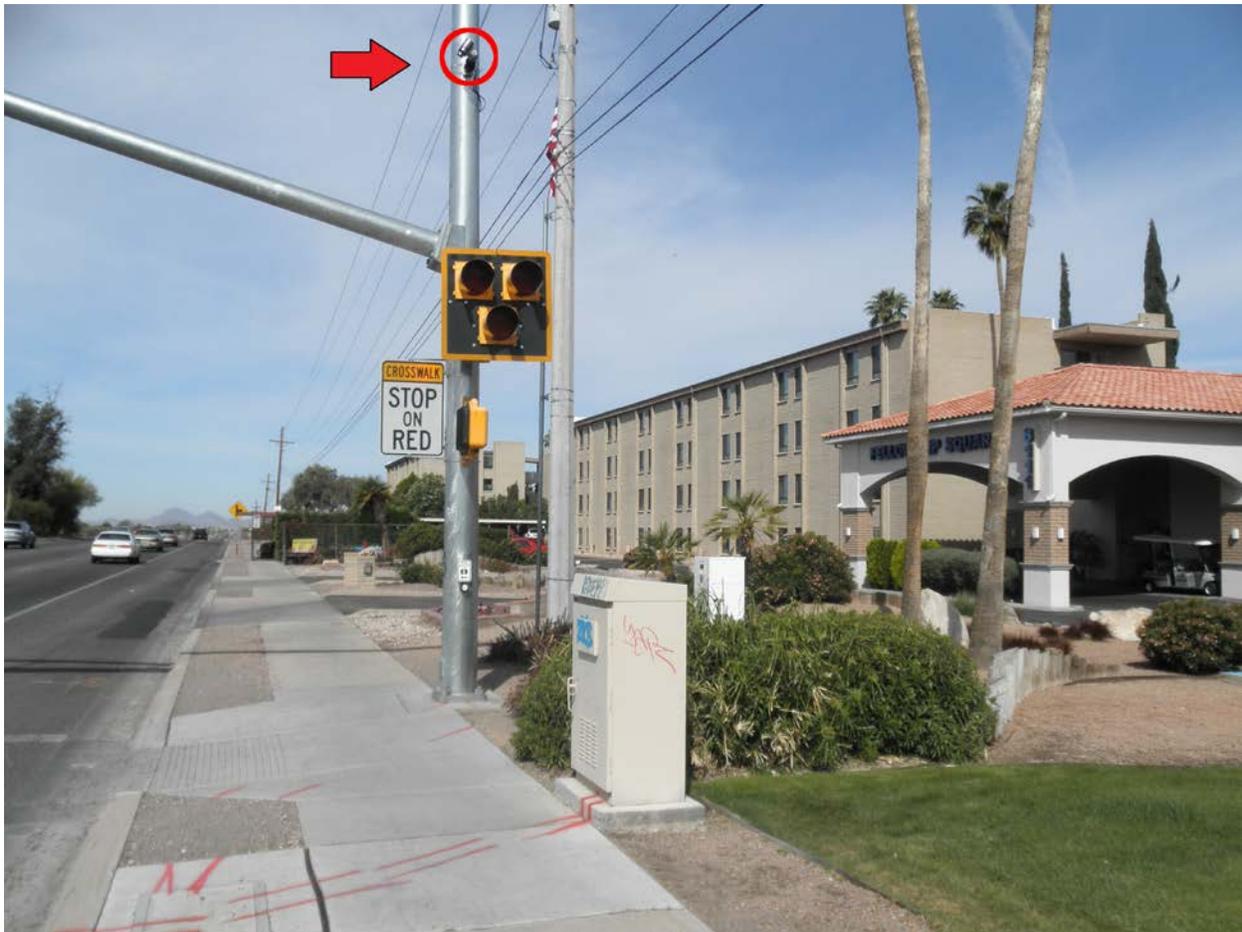
Figure 16. Photo. Operational stereo pedestrian detection system on East Broadway at Fellowship Square in Tucson, AZ.

Figure 16 through figure 29 shows site photos; the stereo cameras are encircled in red.

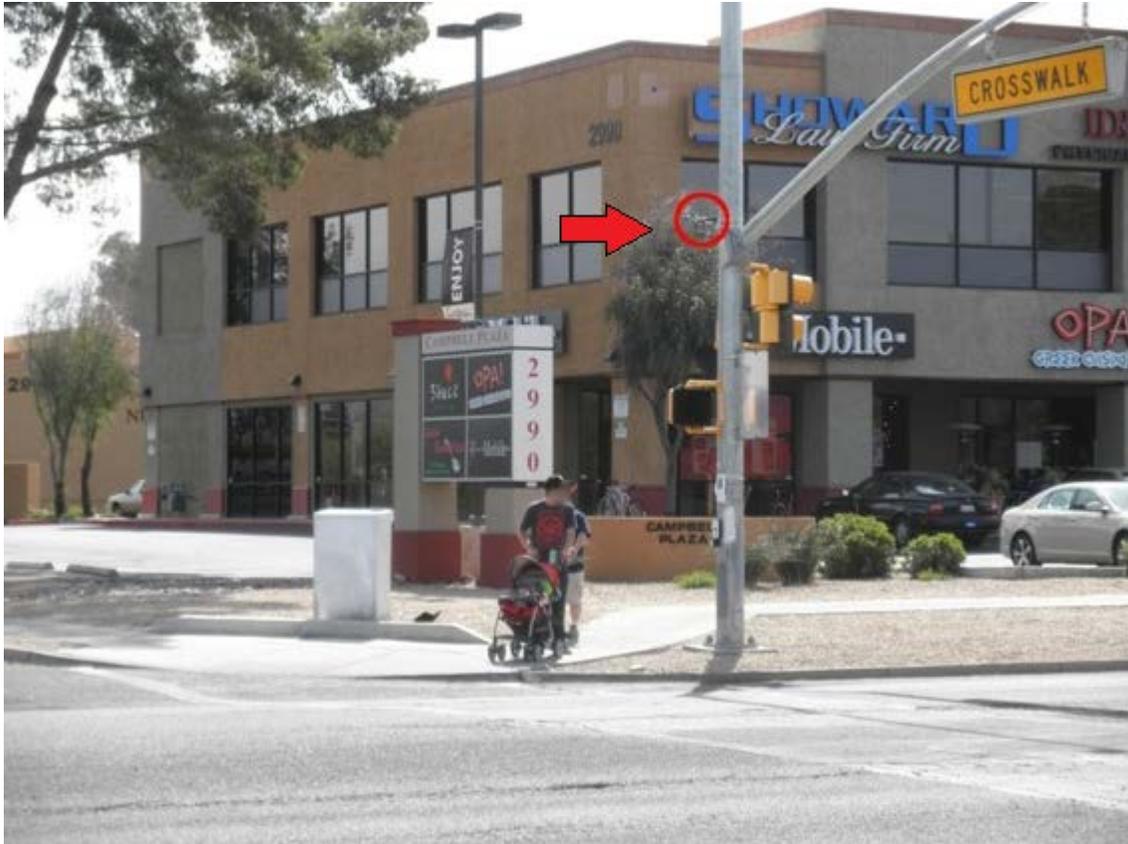
Figure 17. Photo. Operational stereo pedestrian detection system on southeast corner of North Campbell Avenue and East Blacklidge Drive in Tucson, AZ.

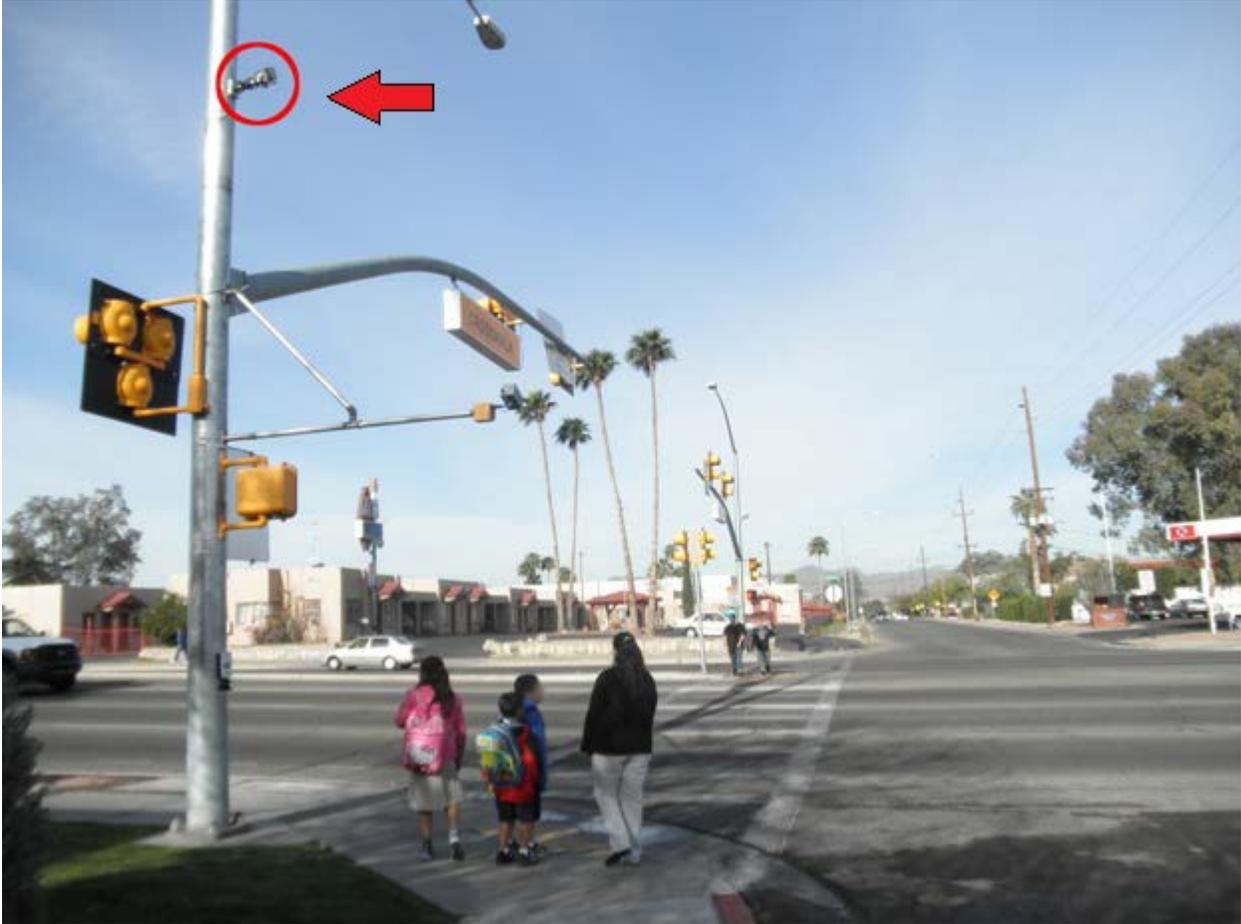
Figure 18. Photo. Operational stereo pedestrian detection system at the intersection of West Kelso Street and North Oracle Road in Tucson, AZ.

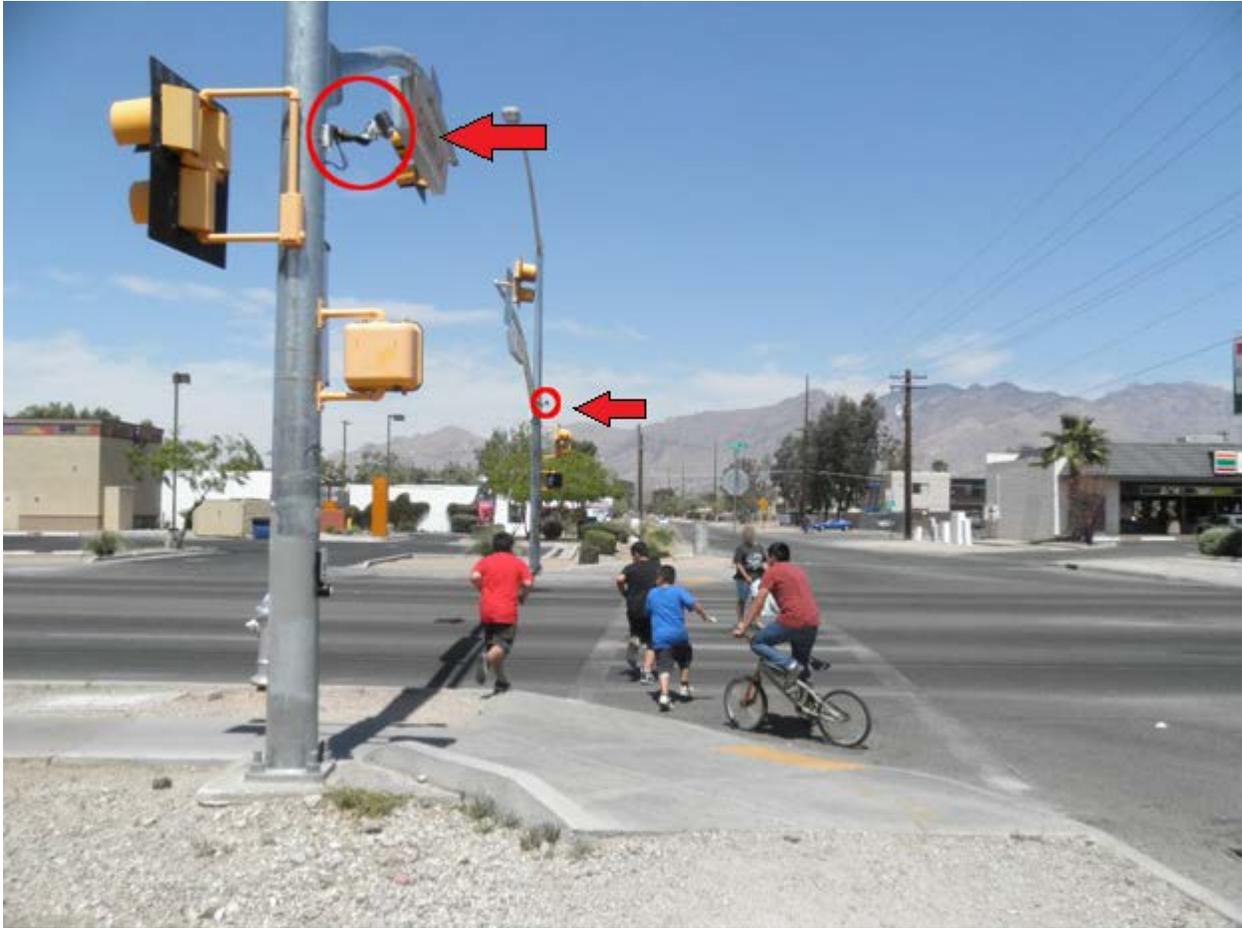
Figure 19. Photo. Operational stereo pedestrian detection system on the west side of the intersection at East Grant Road and North Palo Verde Boulevard in Tucson, AZ.

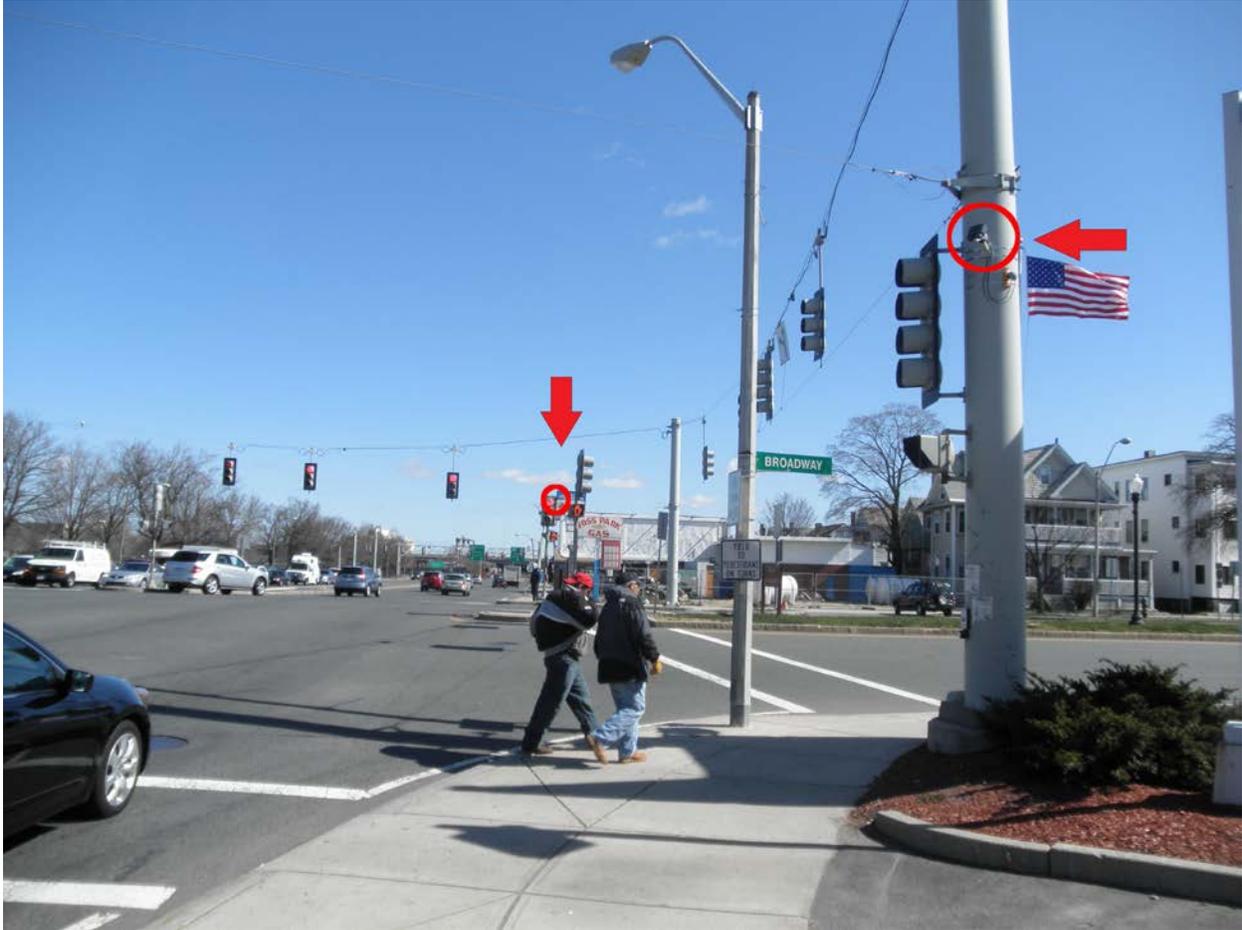
Figure 20. Photo. Operational stereo pedestrian detection system at the intersection of McGrath Highway and Broadway in Somerville, MA.

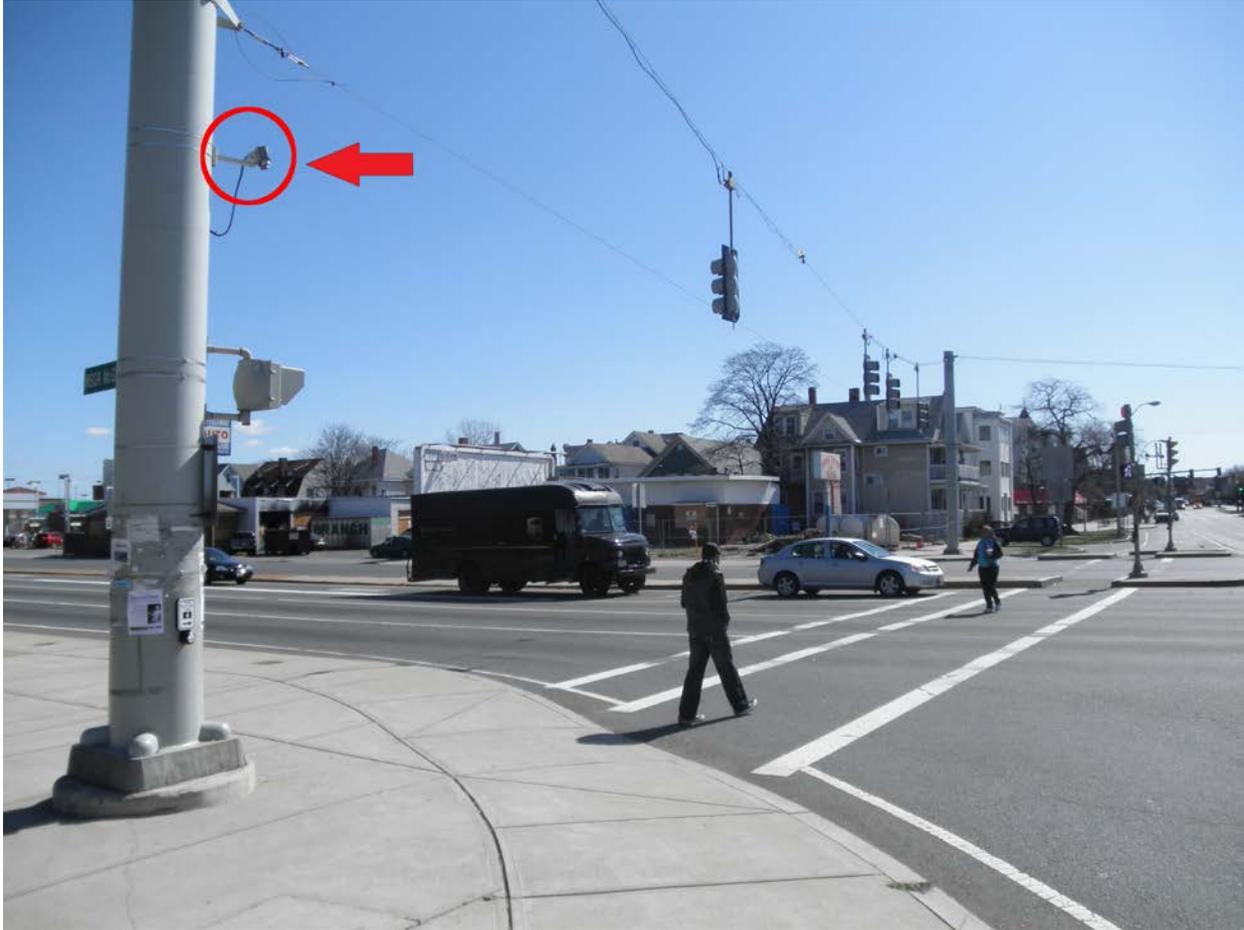
Figure 21. Photo. Operational stereo pedestrian detection system at the north crosswalk across McGrath Highway parallel to Broadway in Somerville, MA.

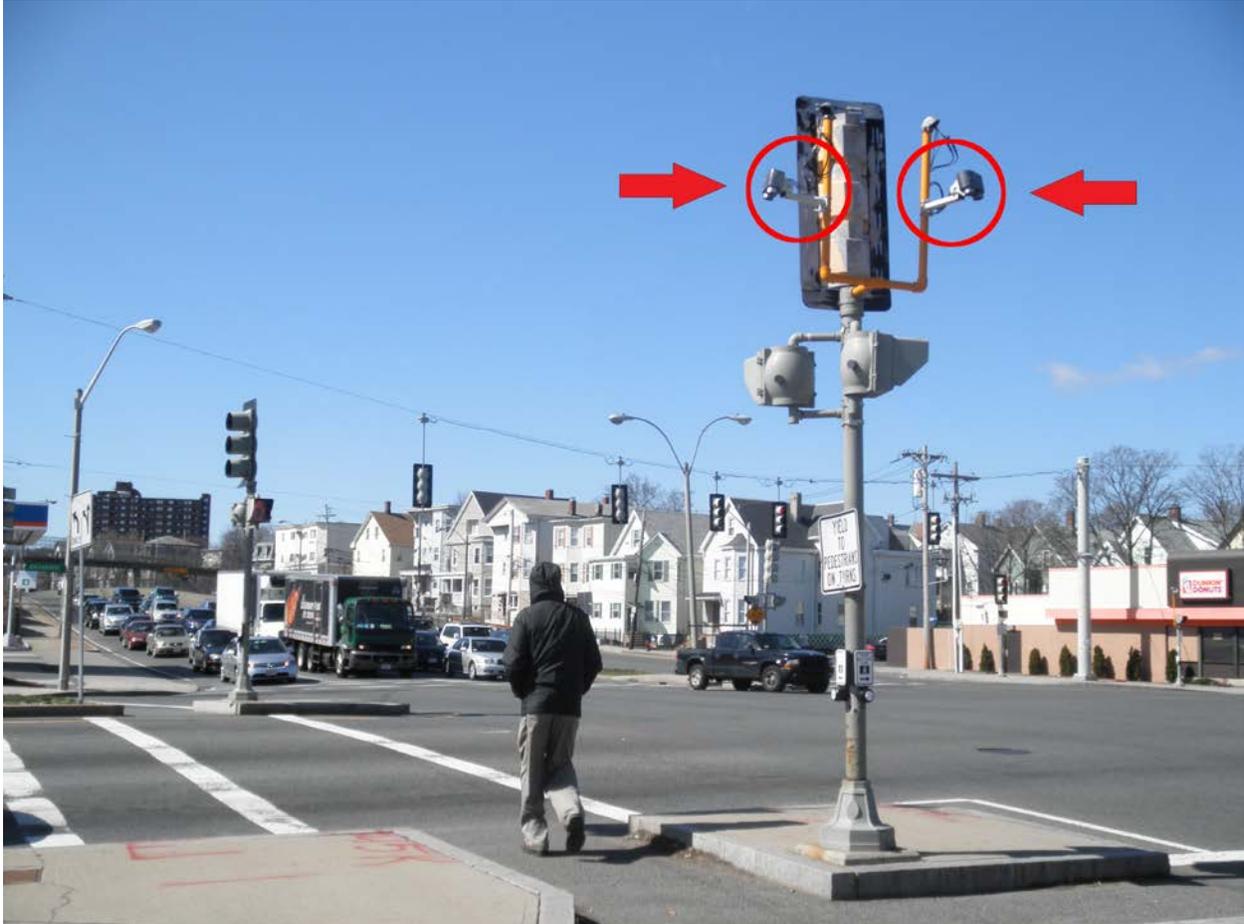
Figure 22. Photo. Two operational stereo pedestrian detection systems on the east side of McGrath Highway parallel to Broadway in Somerville, MA.

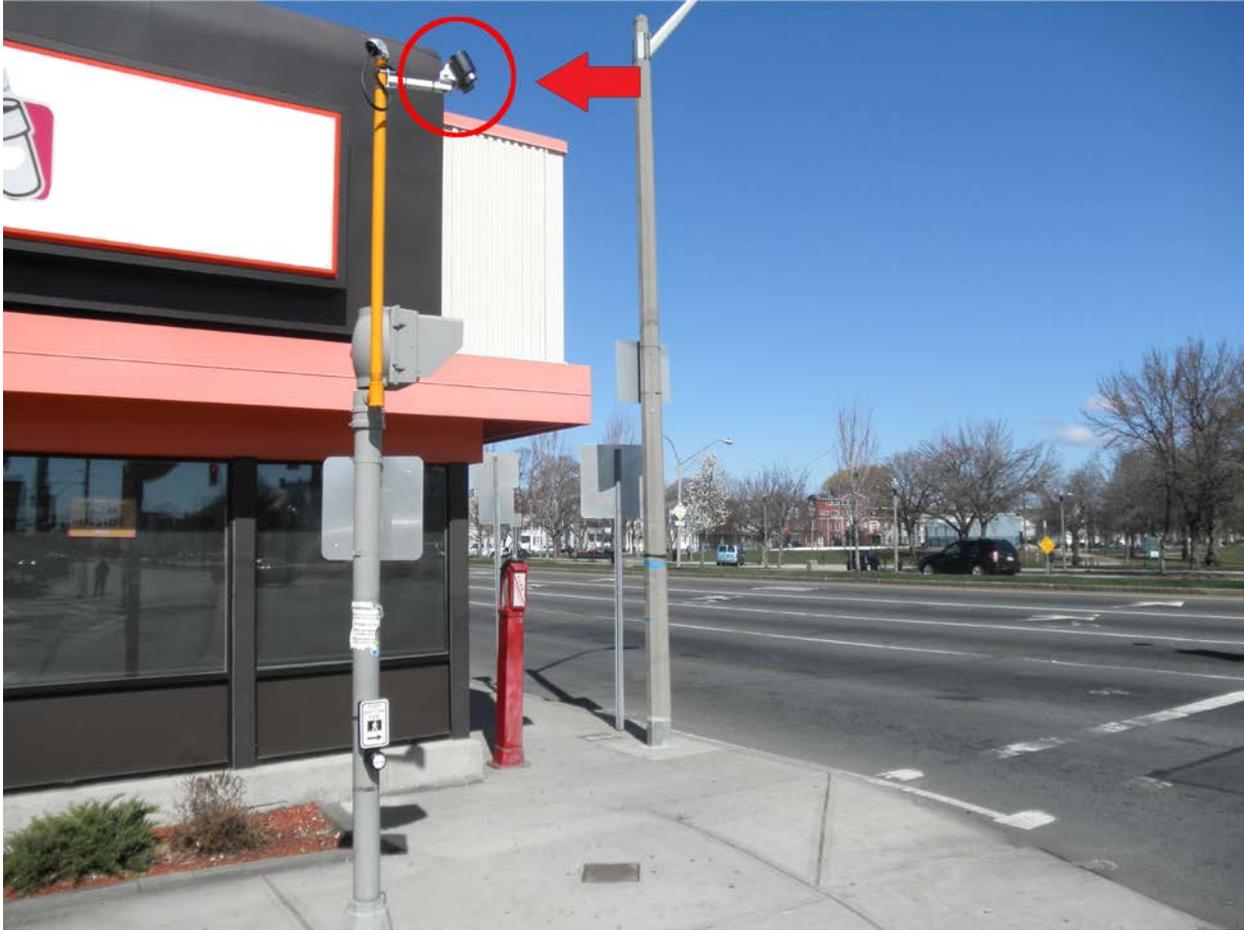
Figure 23. Photo. Operational stereo pedestrian detection system on the south side of Broadway and the west side of McGrath Highway in Somerville, MA.

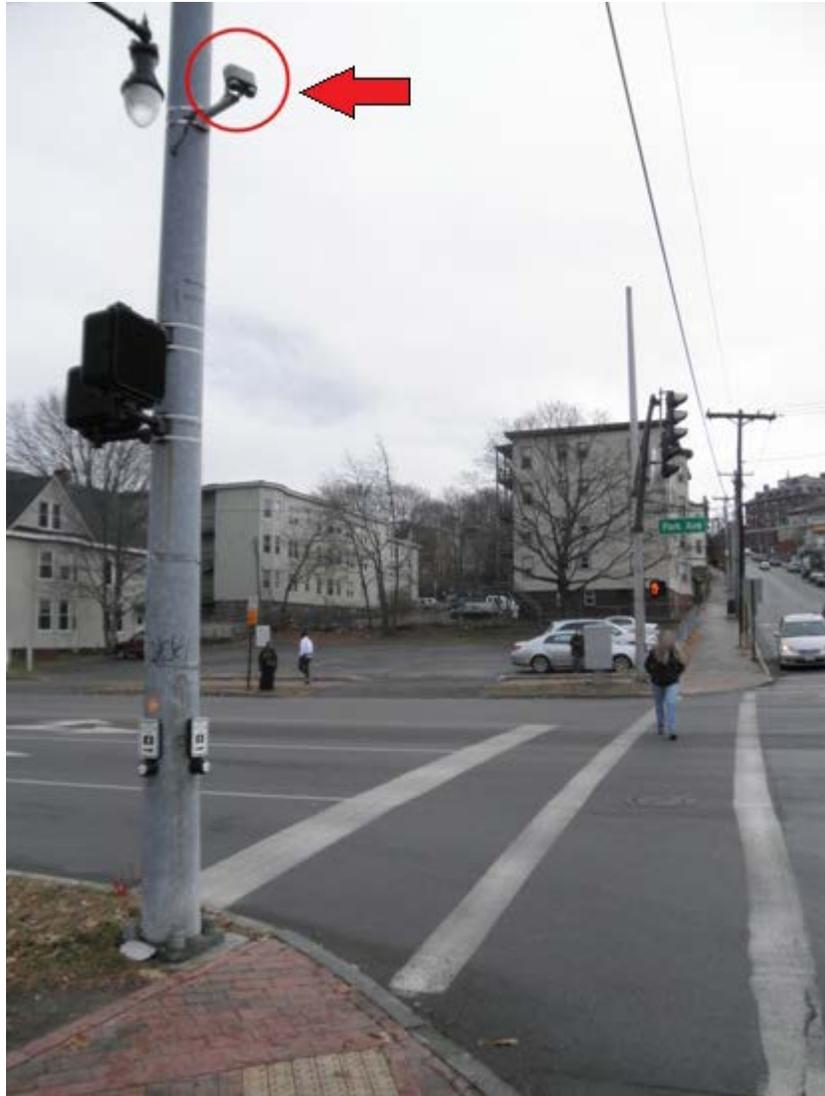
Figure 24. Photo. Operational stereo pedestrian detection system on the northeast corner of Deering Avenue and Park Avenue in Portland, ME.

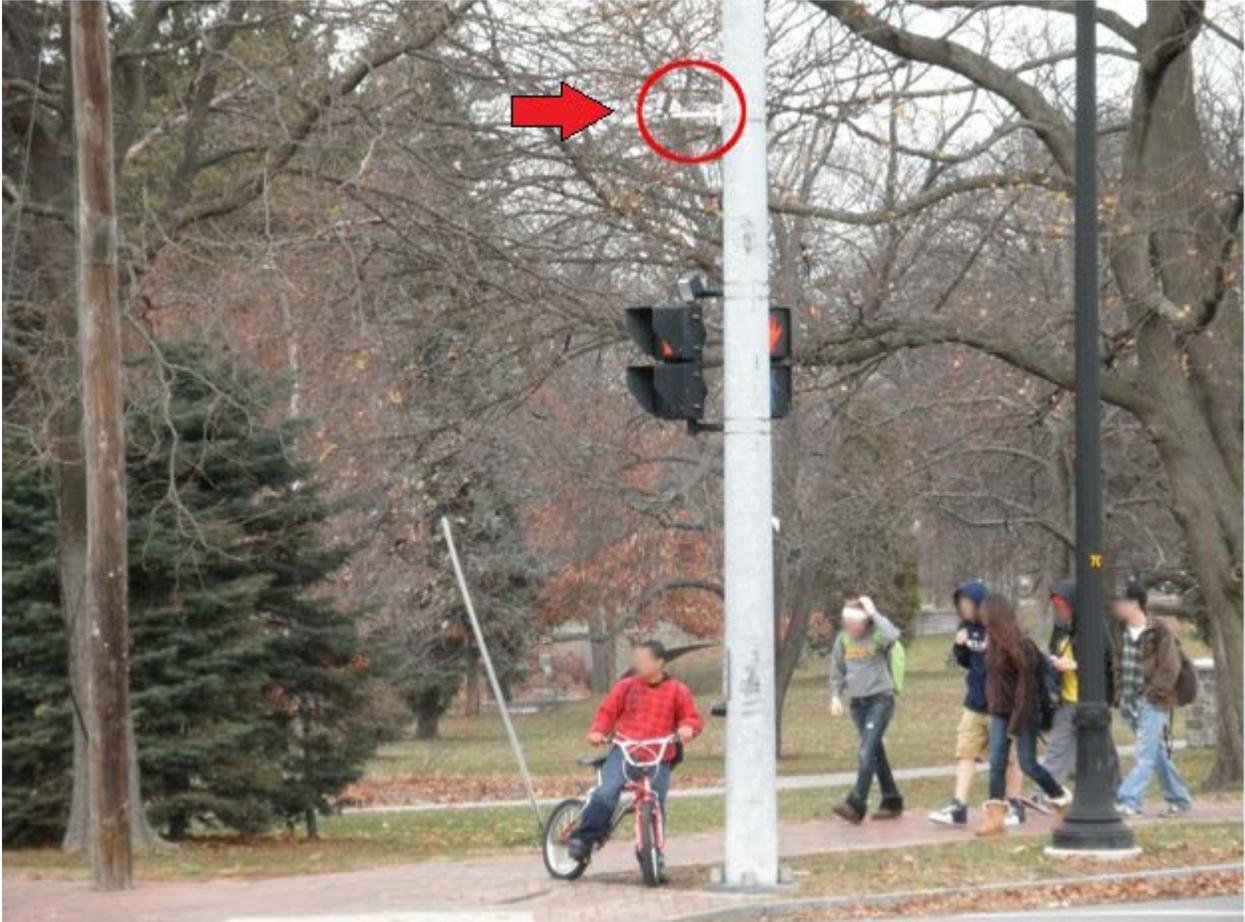
Figure 25. Photo. Operational stereo pedestrian detection system at Deering Avenue and Park Avenue in Portland, ME.

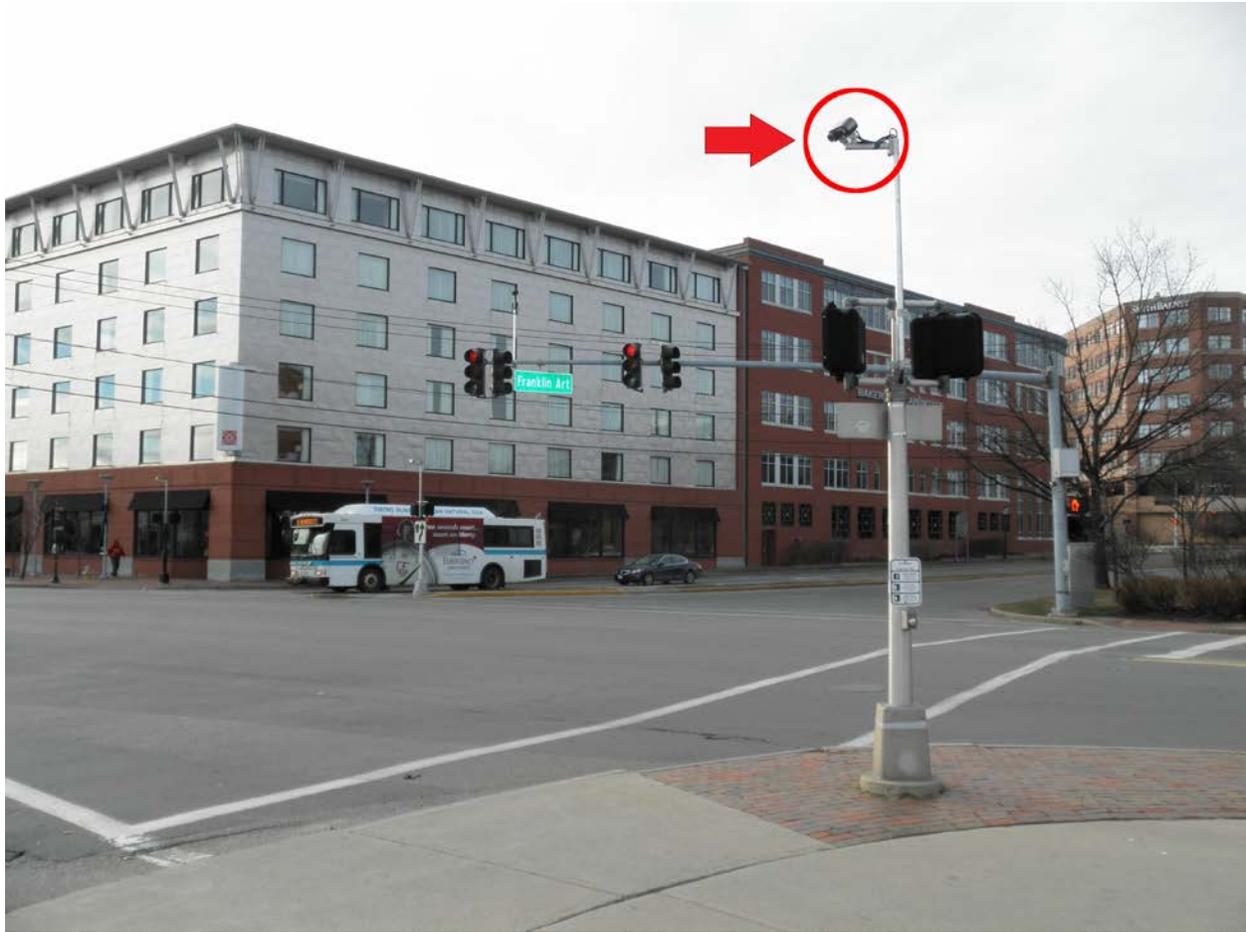
Figure 26. Photo. Operational stereo pedestrian detection system at Franklin Street and Commercial Street in Portland, ME.

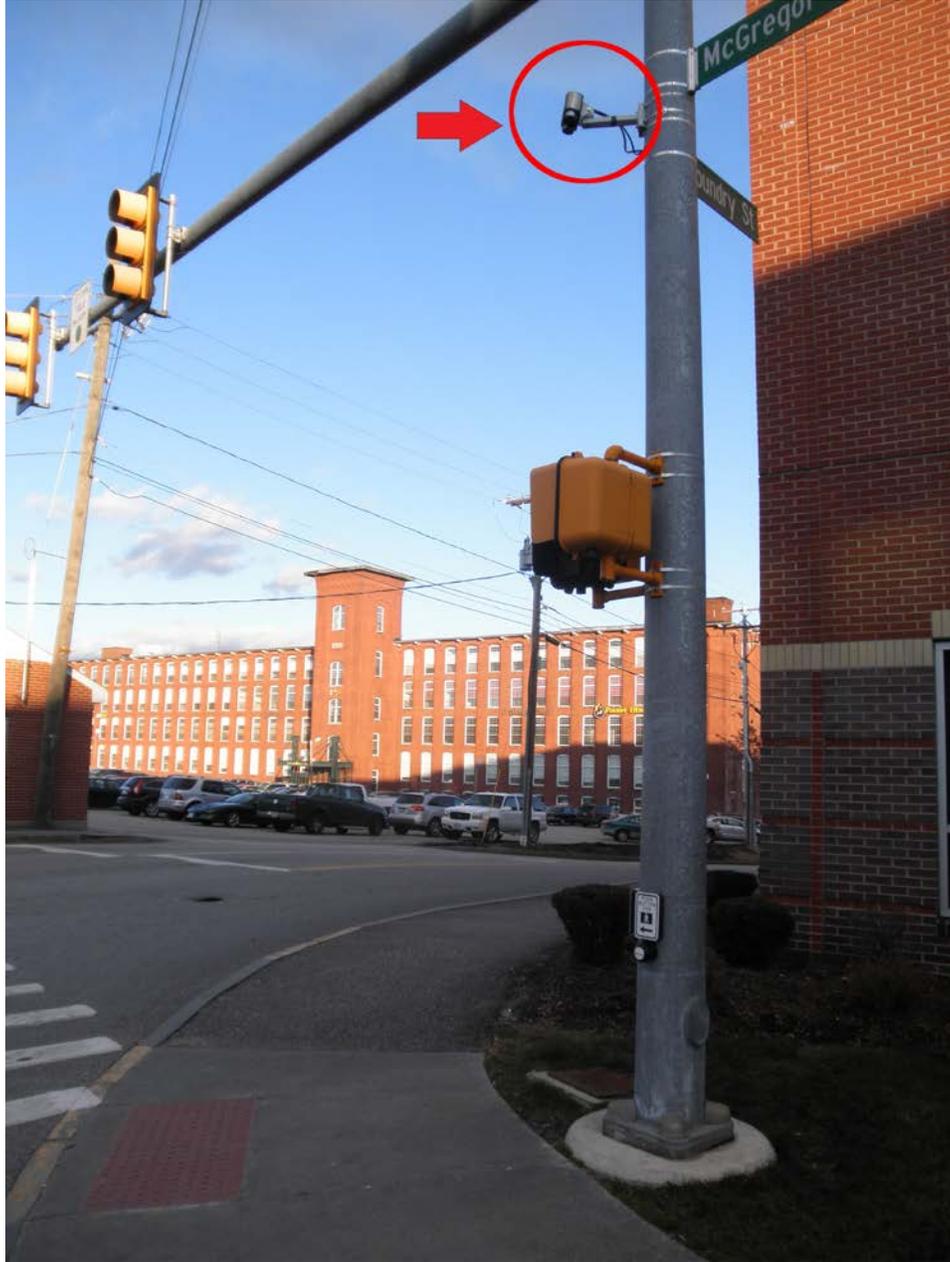
Figure 27. Photo. Operational stereo pedestrian detection system on southeast corner of McGregor Street and Foundry Street in Manchester, NH.

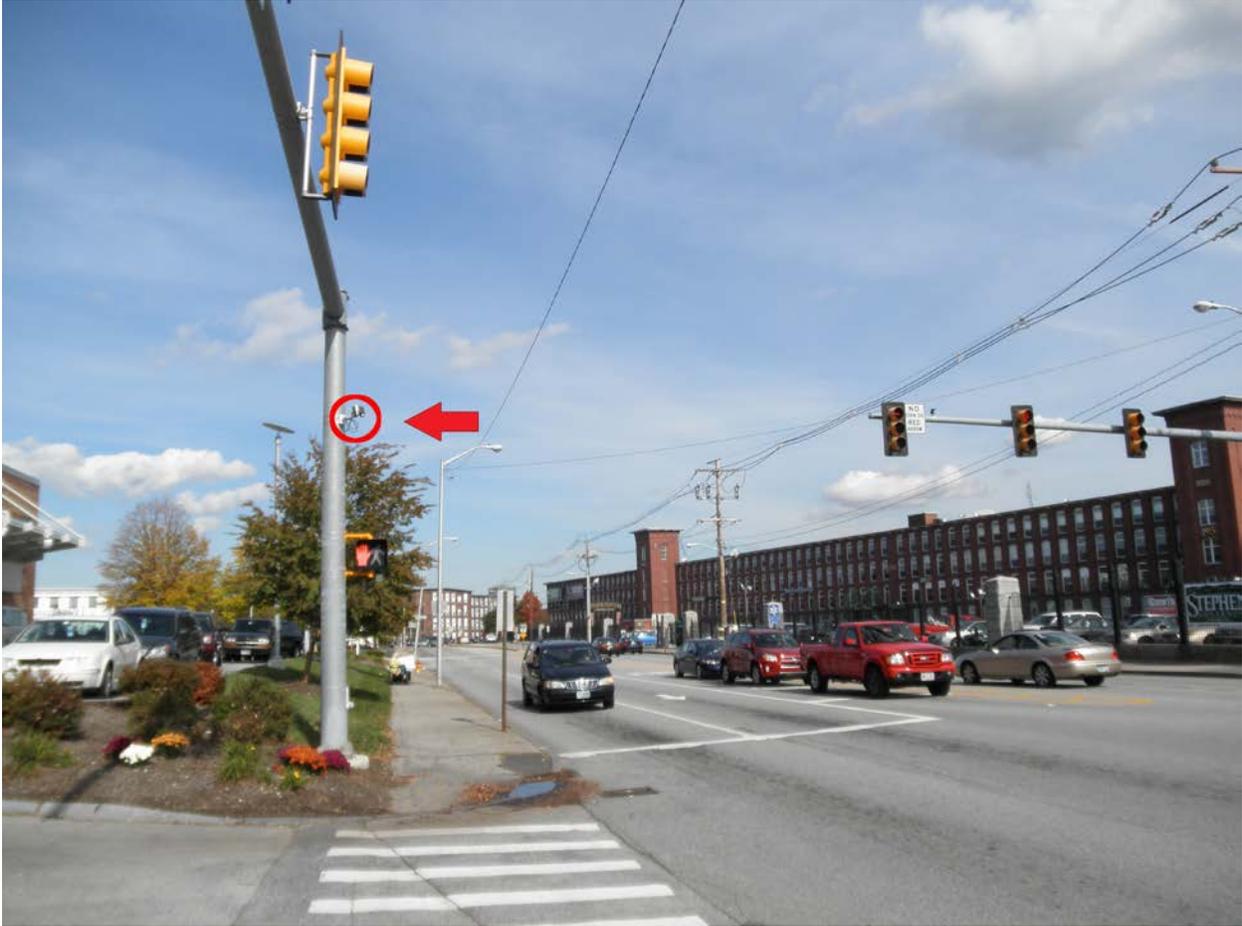
Figure 28. Photo. Operational stereo pedestrian detection system along McGregor Street at Foundry Street in front of Catholic Medical Center in Manchester, NH.

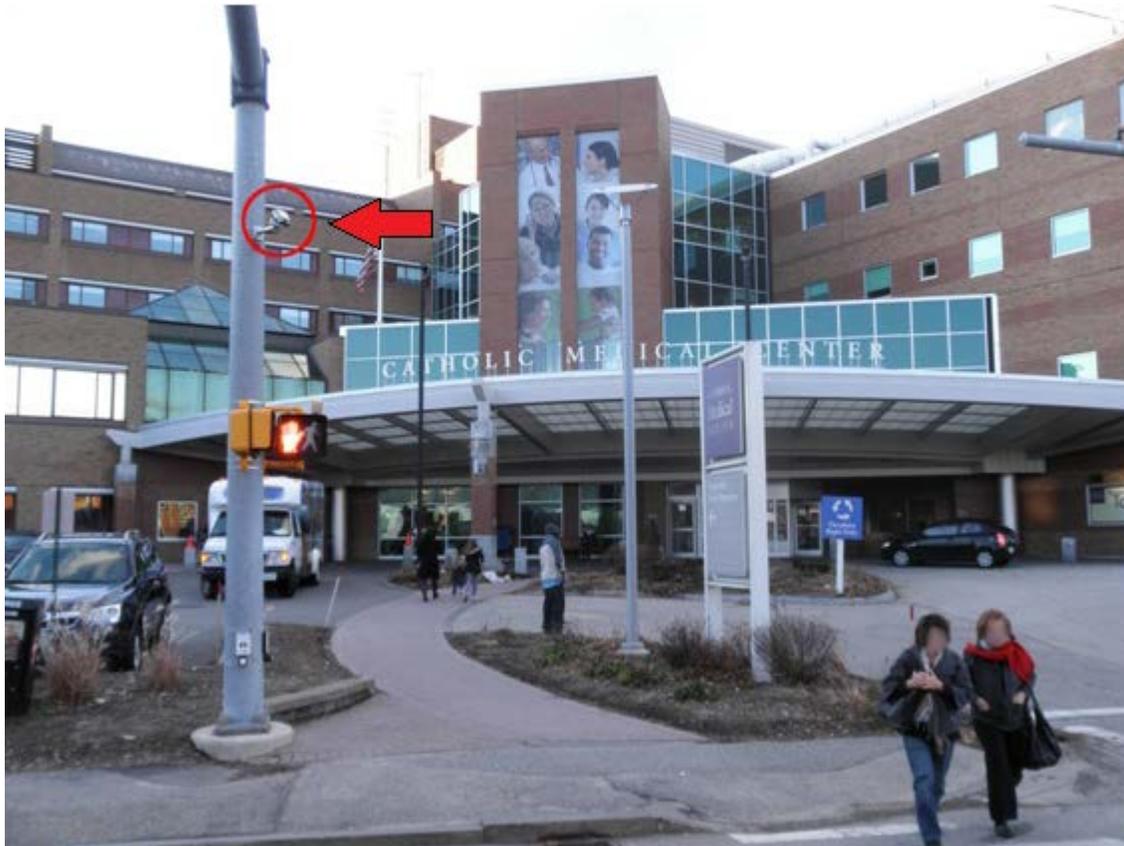
Figure 29. Photo. Operational stereo pedestrian detection system at the west side of McGregor Street at Foundry Street at the Catholic Medical Center in Manchester, NH.
