Large Field Test of New Stereo Detection System for the Pedestrian Signal Phase for the Visually Impaired

PUBLICATION NO. FHWA-HRT-12-074

SEPTEMBER 2012

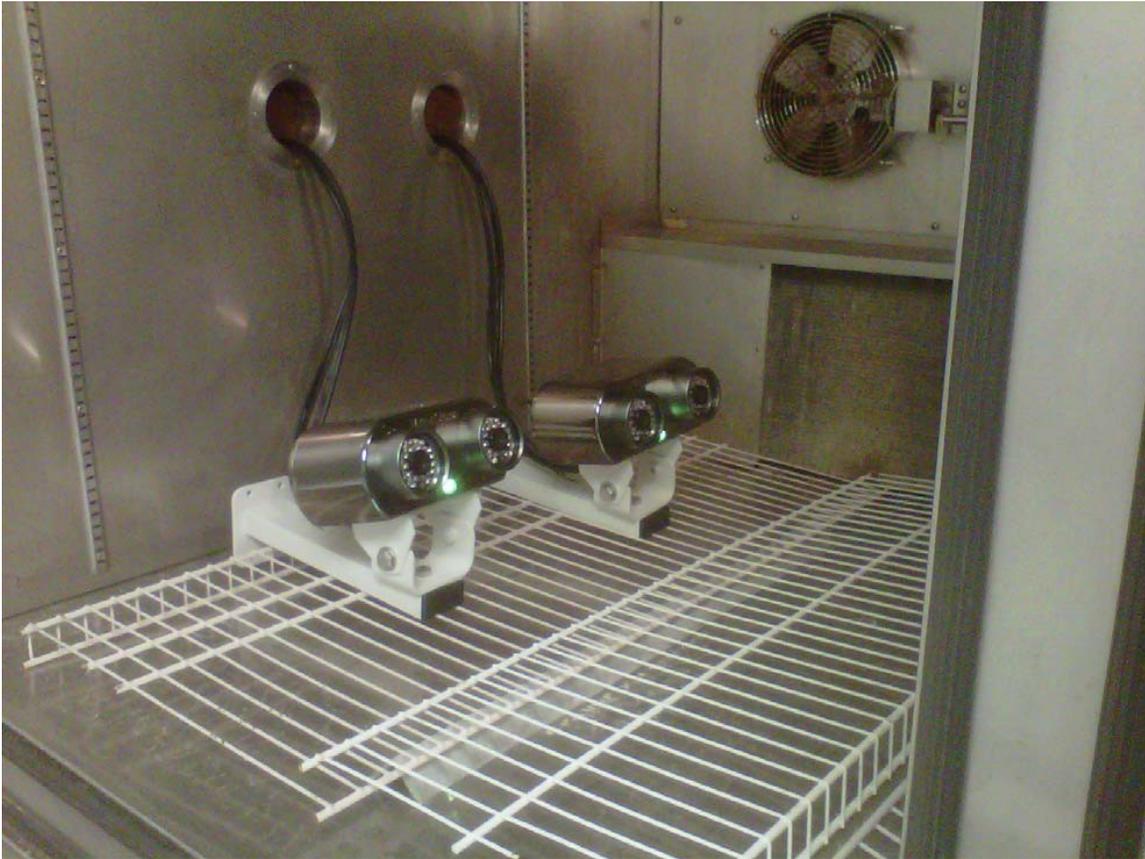
Standard: MIL-STD-810F
Test: 501.4 High Temperature
Photo: MidBlock Cameras in chamber
Test Engineer: Albert Noyes

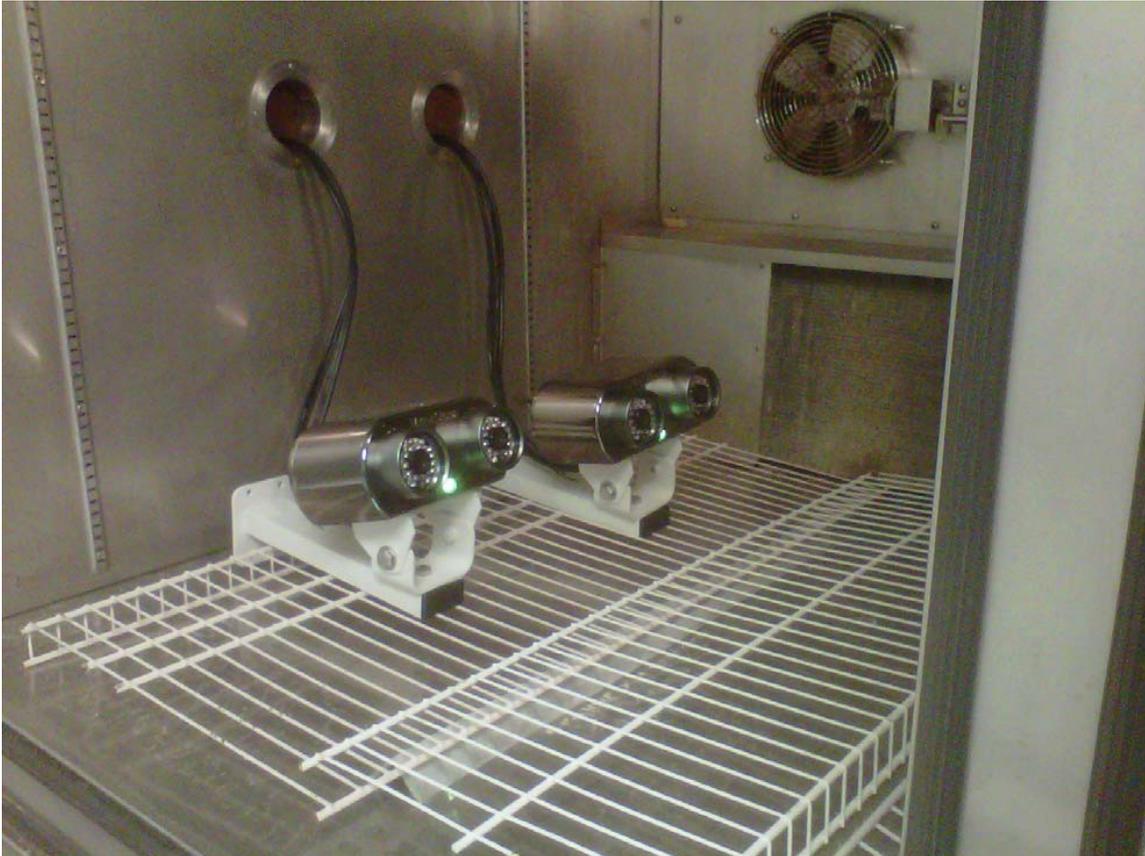
Standard: MIL-STD-810F
Test: 502.4 Low Temperature
Photo: MidBlock Cameras in chamber
Test Engineer: Albert Noyes

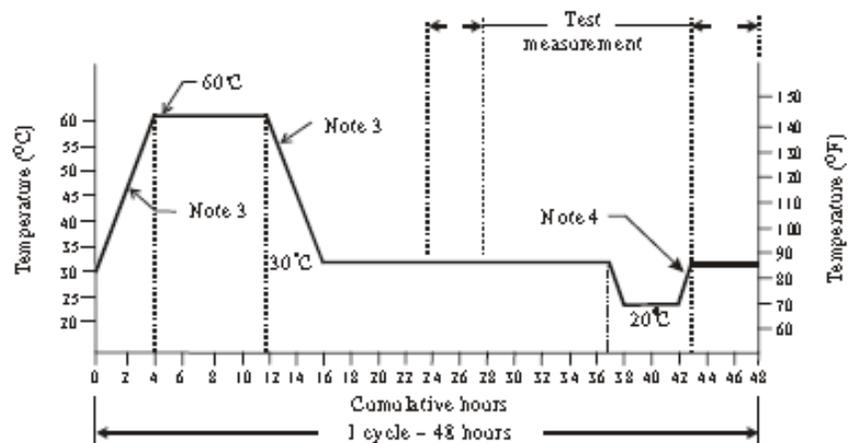
1. During temperature change, use a tolerance of not greater than 3°C (5°F).
2. Maintain the relative humidity at 95 ±4% at all times except that during the descending temperature periods the relative humidity may drop to as low as 85%.
3. Use a rate of temperature change between 30 and 60°C of not less than 8°C per hour.
4. Do not use a temperature increase in this portion of the curve that is less than 10°C per hour.

Step 1. With the test item in the test chamber, adjust the chamber air temperature to the low operating temperature of the test item as specified in the test plan. Maintain at least two hours following temperature stabilization of the test item.

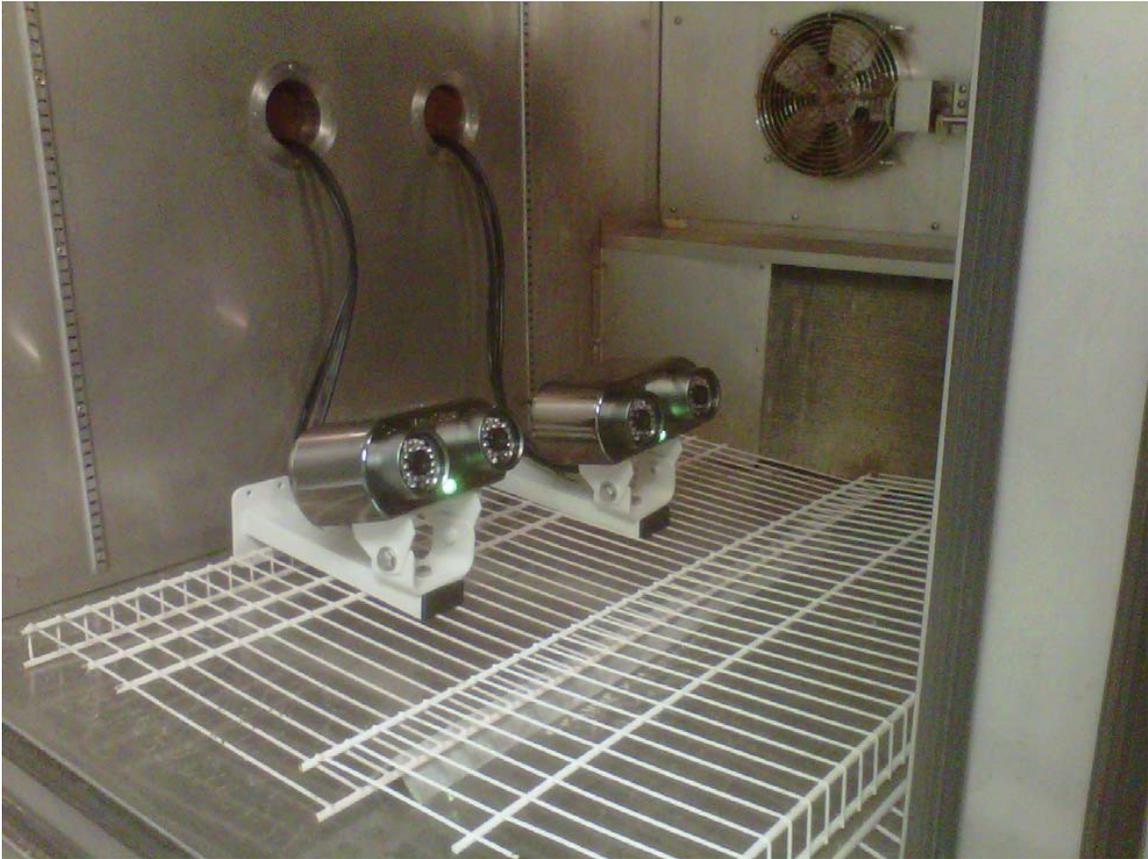
Standard: MIL-STD-810F
Test: 507.4 Humidity
Photo: MidBlock Cameras in chamber
Test Engineer: Albert Noyes

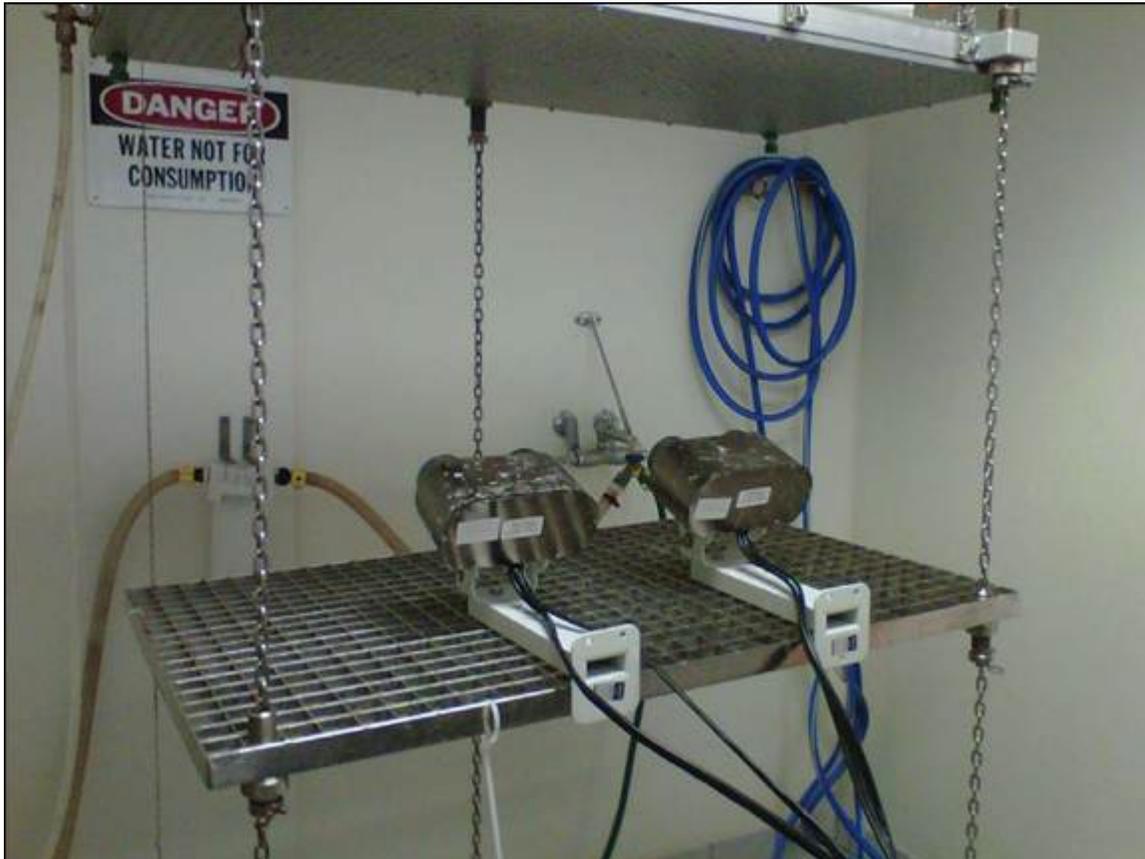
Comark Migma Midblock

Standard: MIL-STD-810F

Test: 506.4 Rain

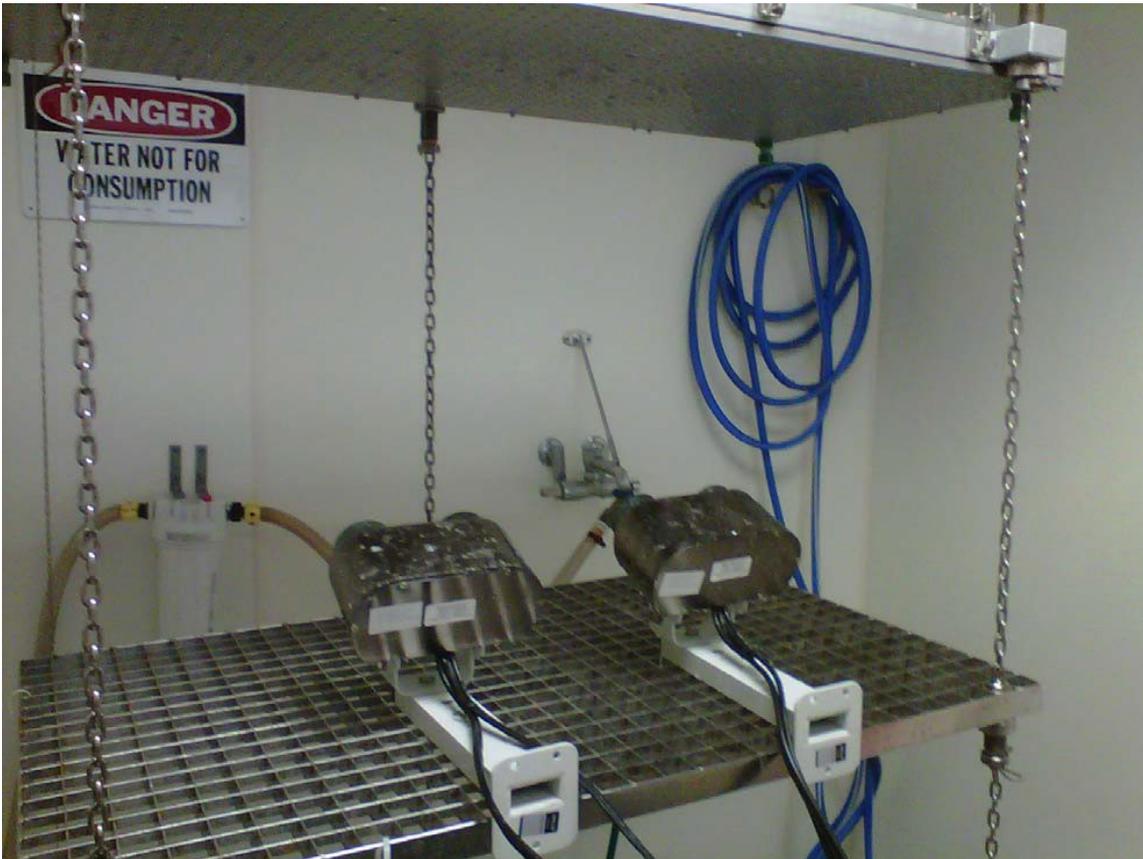
Standard: MIL-STD-810F
Test: 506.4 Rain
Photo: MidBlock Cameras in Rain/SPX chamber
Test Engineer: Albert Noyes

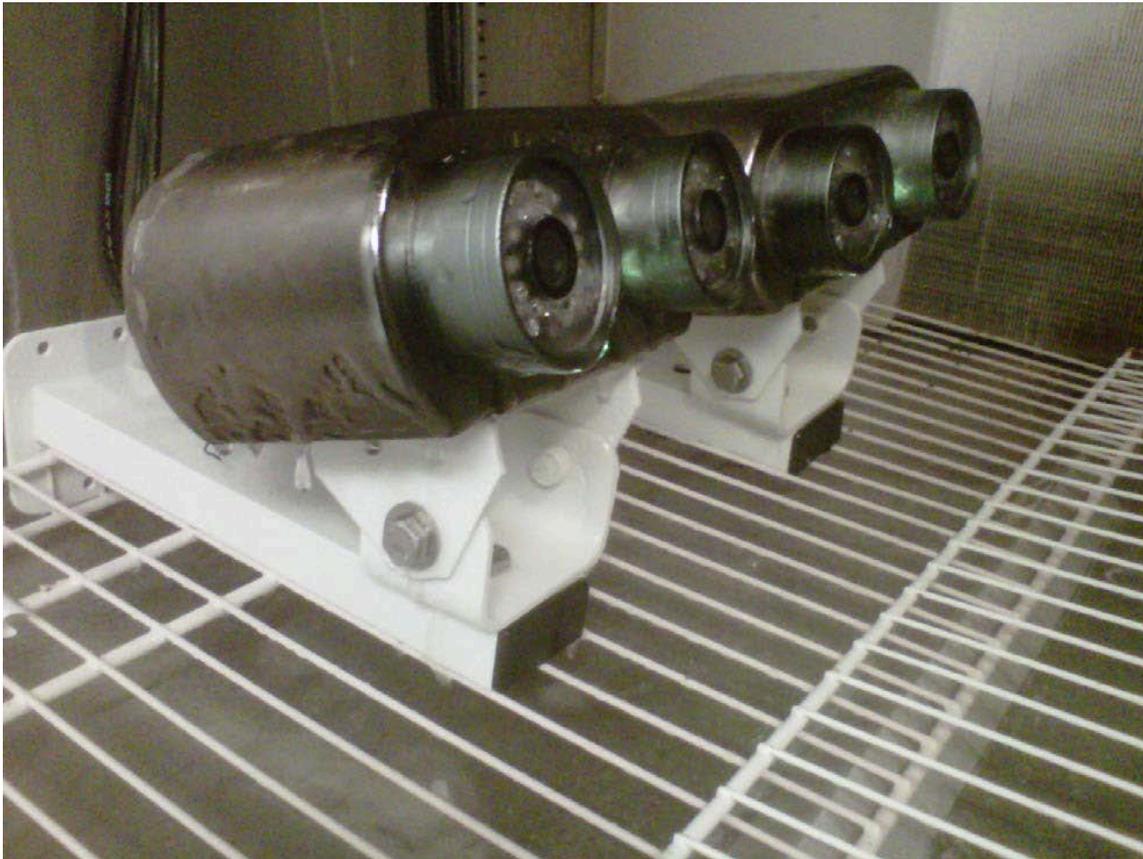
Standard: MIL-STD-810F
Test: 521.2 Icing
Photo: MidBlock Cameras in chamber
Test Engineer: Albert Noyes

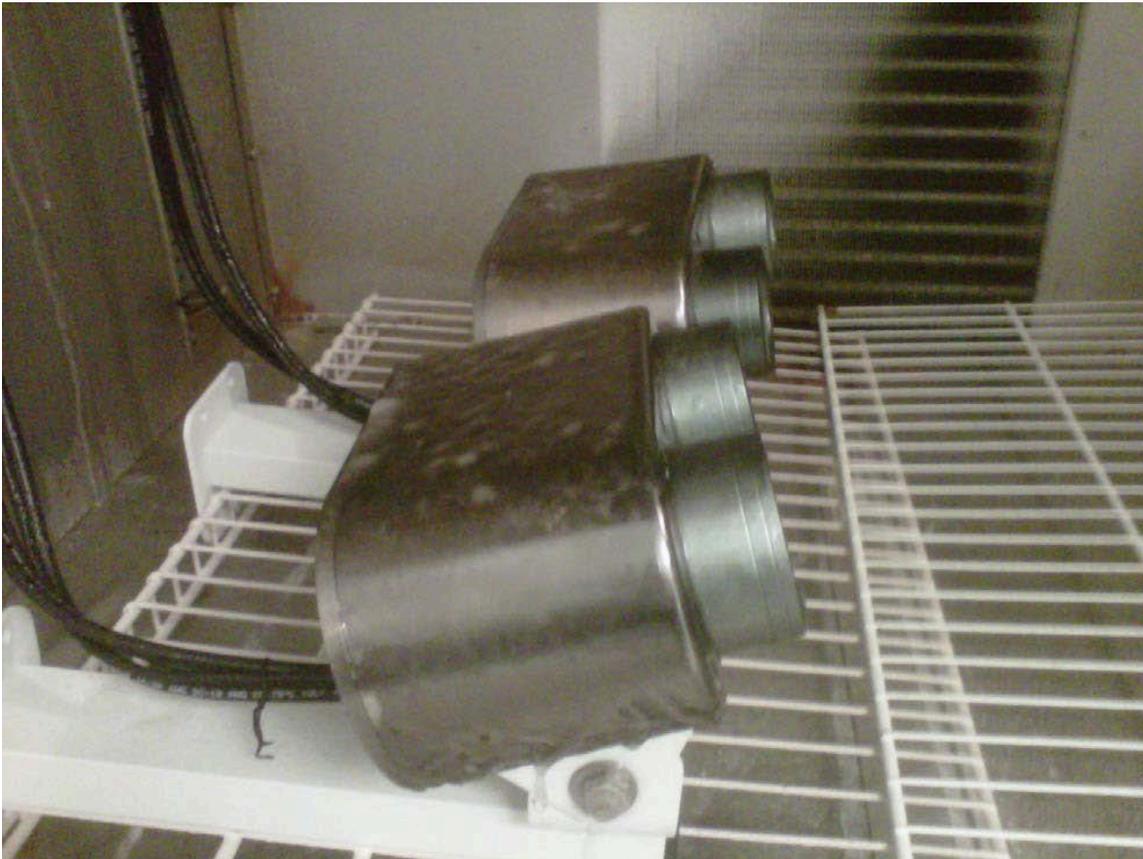
**Comark
Migma Midblock**

**Standard: MIL-STD-810F
Test: 521.2 Icing
Photo: Cameras in Chamber
Test Engineer: Albert Noyes**

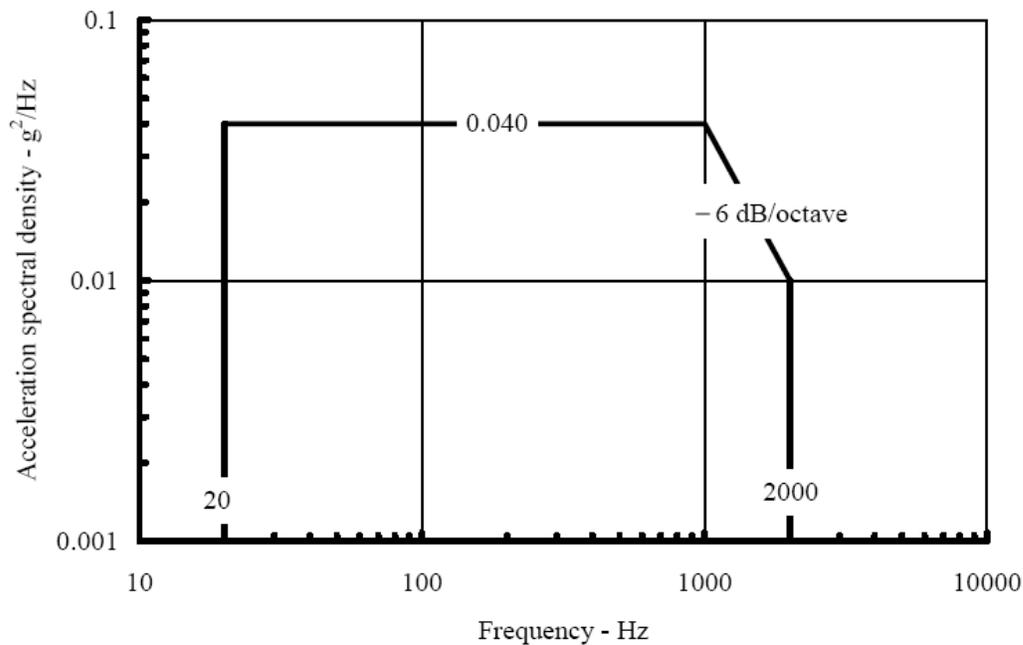
FIGURE 514.5C-17. General minimum integrity exposure.

20 to 1000 Hz.	0.040 g ² /Hz.
1000 to 2000 Hz.	-6 d/B/octave

The test samples were secured to a vibration shaker utilizing attached mounting brackets. The test samples were subjected to a random vibration for one (1) hour from 20 to 2000G's in each of the three mutually perpendicular axes in accordance with Figure 514.5C-17 of the specification and as described below:

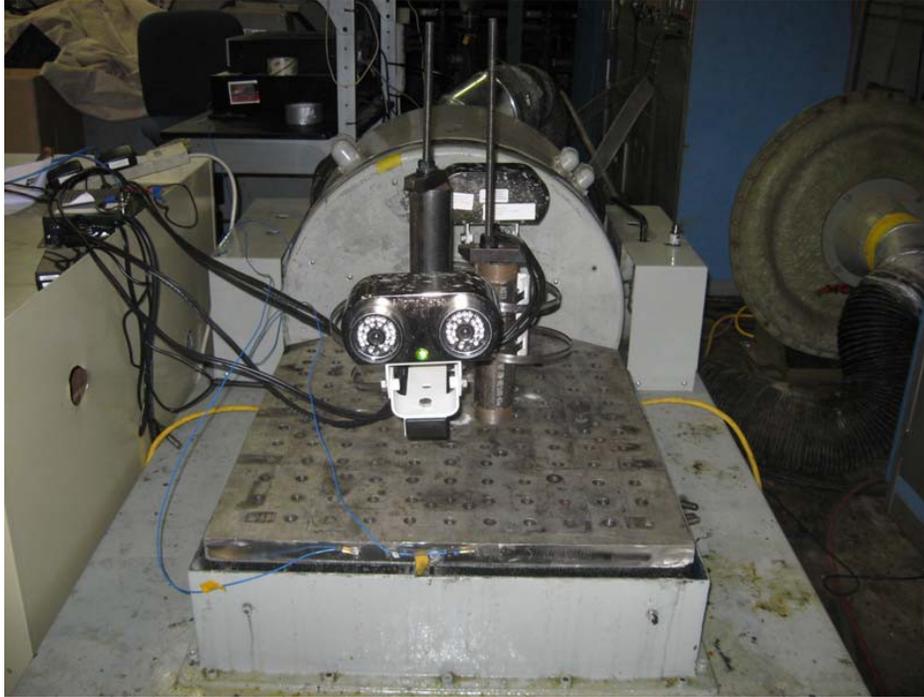
Photograph 1: Test Set Up Fore-Aft Direction

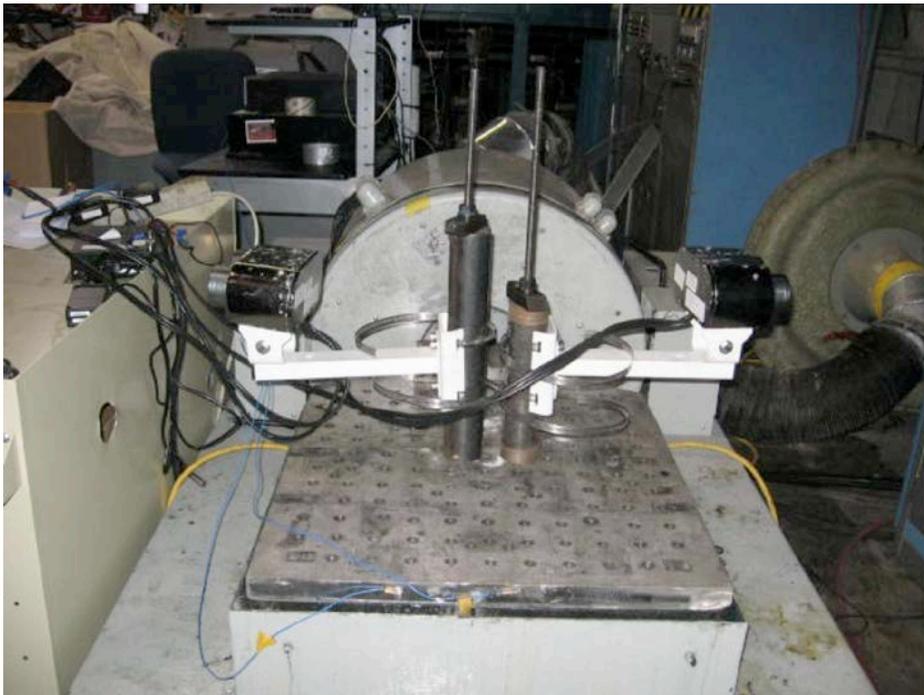
Photograph 2: Test Set Up Lateral Direction

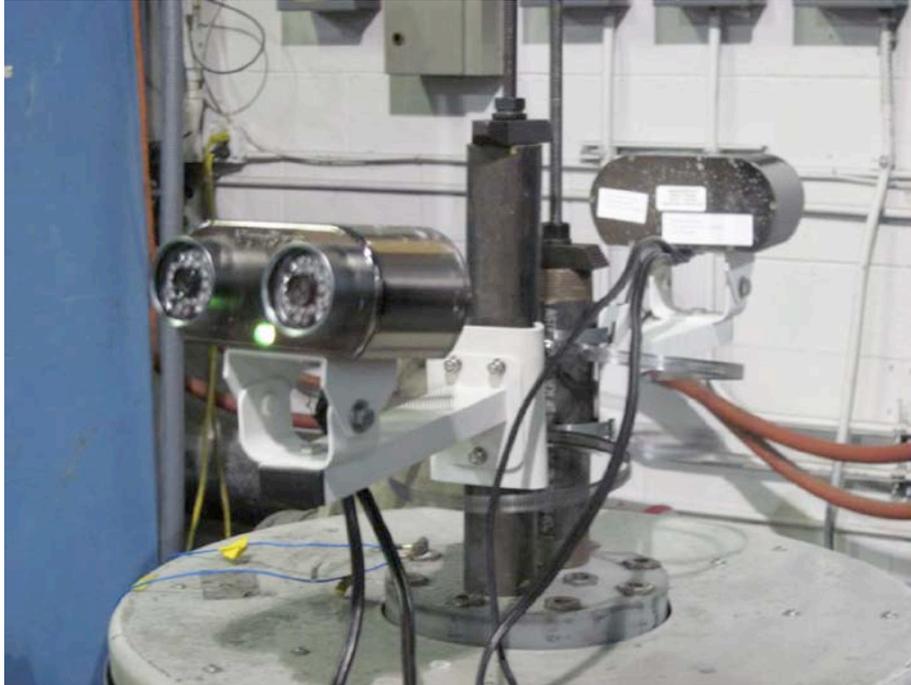
Photograph 3: Test Set Up Vertical Direction

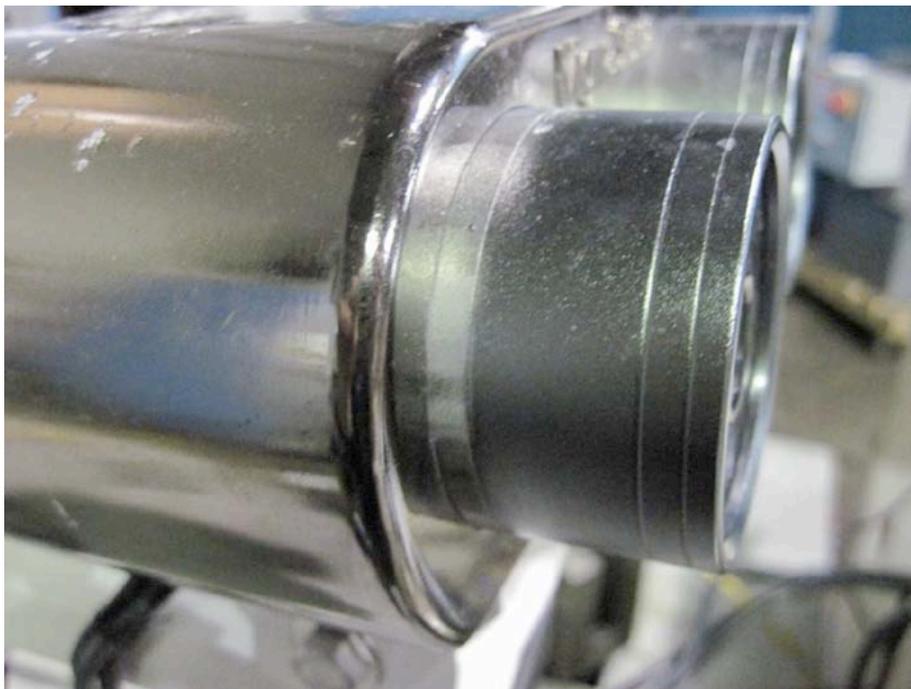
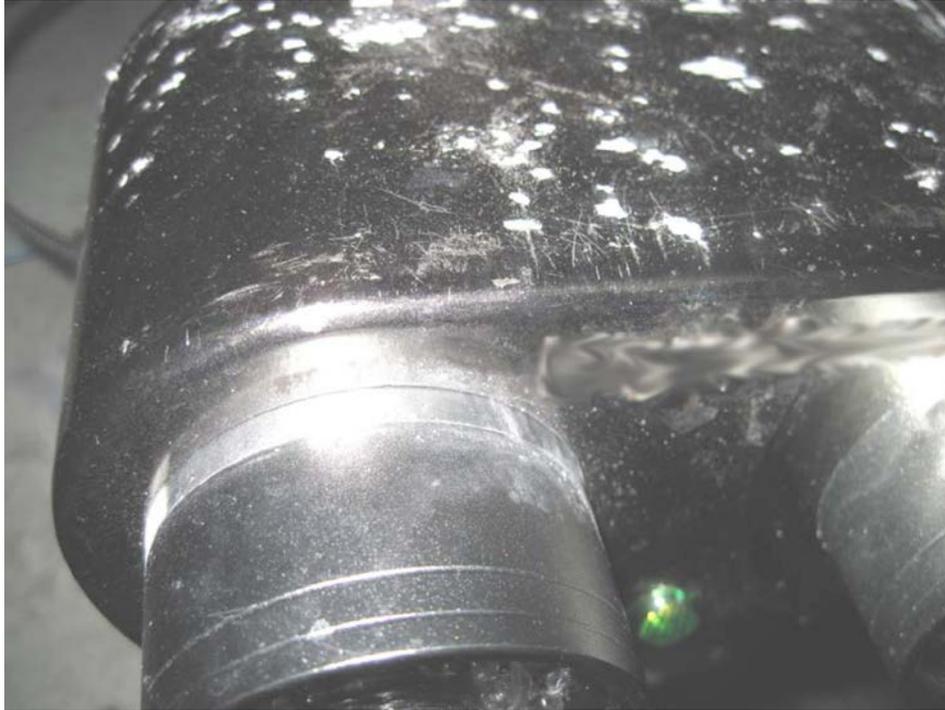
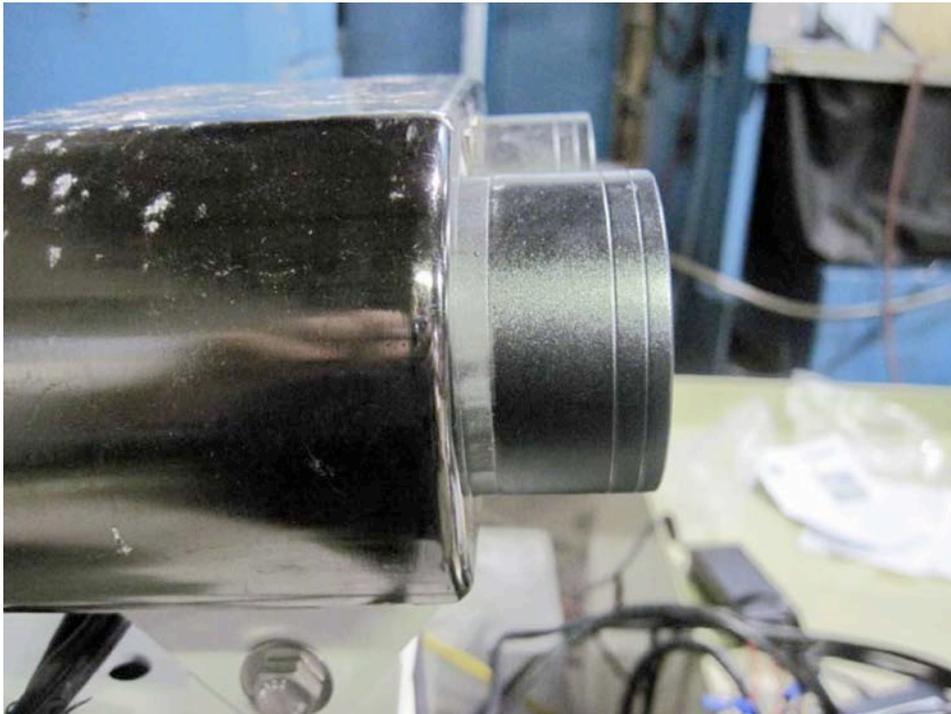
Photograph 4: Loose Lens on Sample 1 Post Vertical Axis

Photograph 5: Loose Lens on Sample 1 Post Vertical Axis

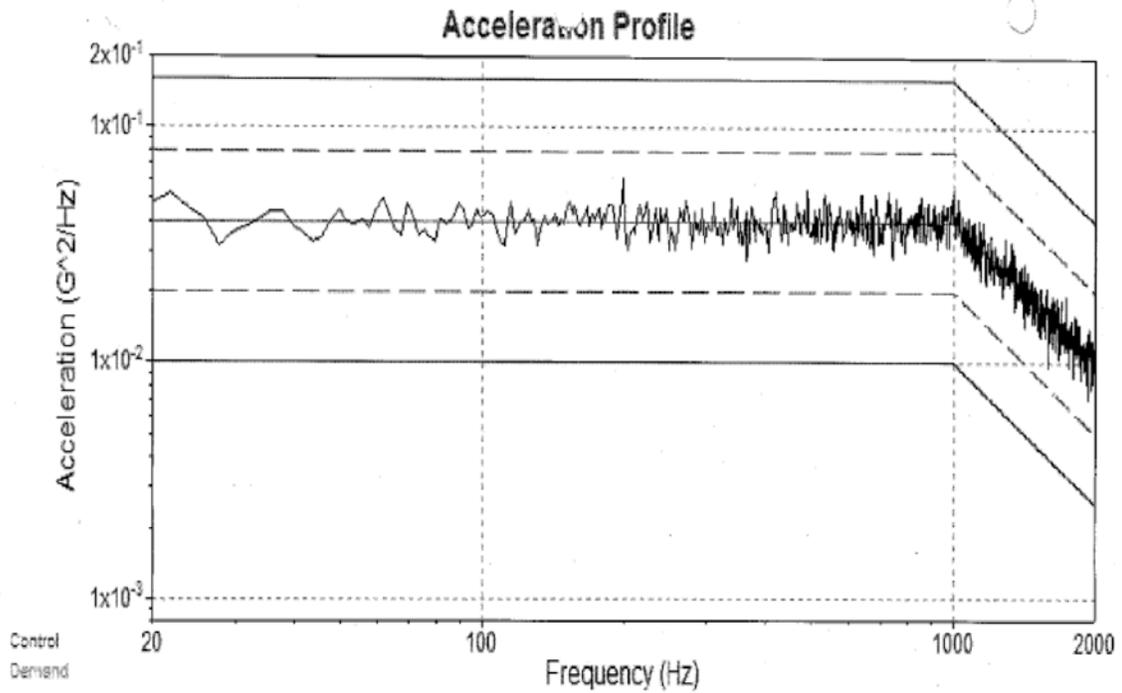
Oct 26, 2010 07:15:18 Level 1) 100 % Output: 0.7169 Volts RMS MIGMA SYSTEMS
Demand: 7.698 G RMS Level Time: 1:00:00 SAMPLE # 1 AND 2 IN
Control: 7.713 G RMS Total Time: 1:00:16 End of Test FORE AFT AXIS

Figure 1: Vibration Plot, Fore- Axis Direction

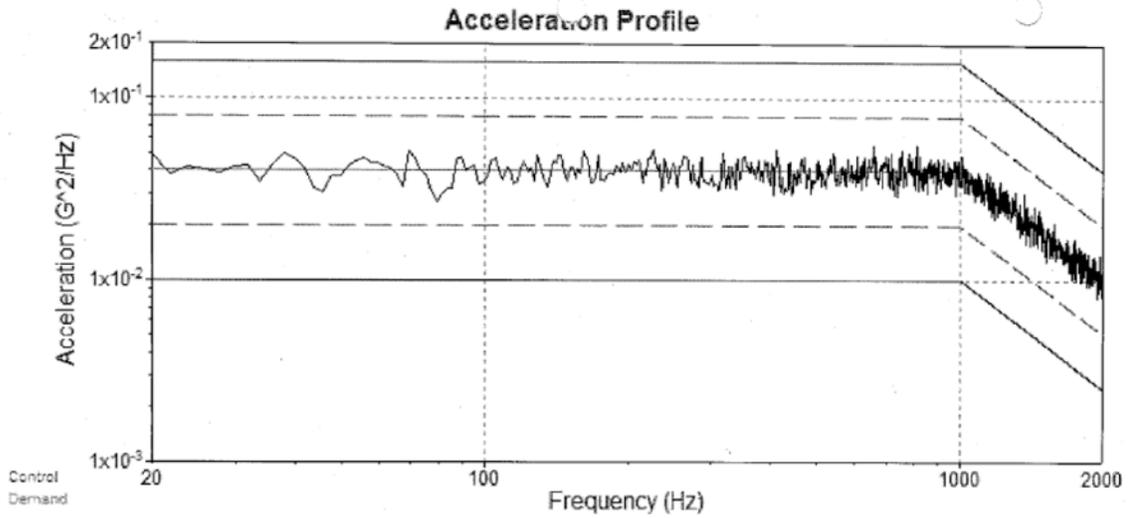
Oct 25, 2010 15:47:09	Level 1) 100 %	Output: 0.7114 Volts RMS	MIGMA SYSTEMS
Demand: 7.698 G RMS	Level Time: 1:00:00		SAMPLE # 1 AND 2 IN
Control: 7.692 G RMS	Total Time: 1:00:15	End of Test	LATERAL AXIS

Figure 2: Vibration Plot, Lateral Direction

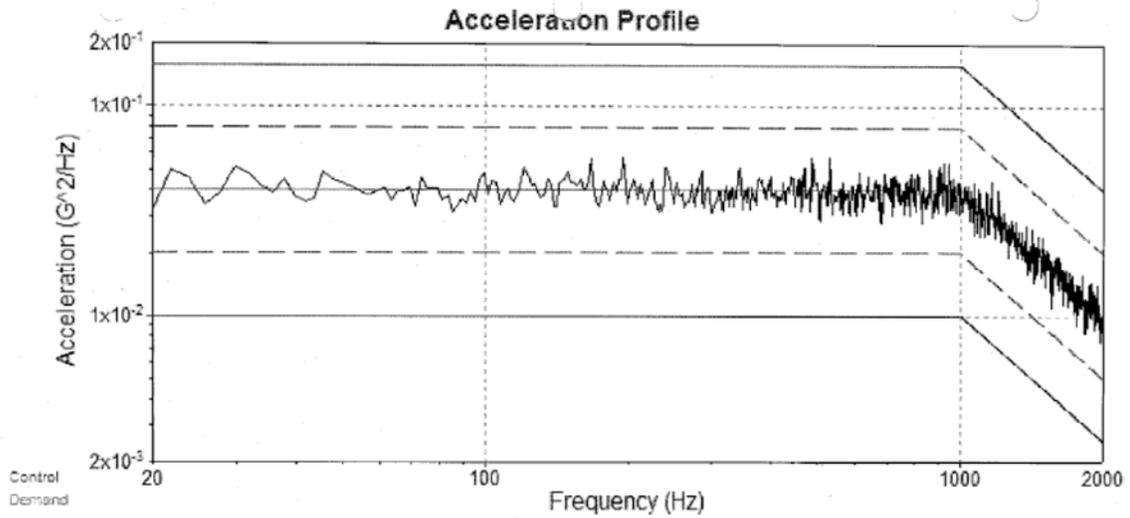
Oct 23, 2010 07:55:56	Level 1) 100 %	Output: 0.6179 Volts RMS	MIGMA SYSTEMS
Demand: 7.698 G RMS	Level Time: 1:00:00		SAMPLE # 1 AND 2 IN
Control: 7.658 G RMS	Total Time: 1:00:16	End of Test	VERTICAL AXIS

Figure 3: Vibration Plot, Vertical Direction
