Exploratory Testing of Stress Corrosion Cracking in Stainless Steels at Low Temperature

PUBLICATION NO. FHWA-HRT-24-132

SEPTEMBER 2024

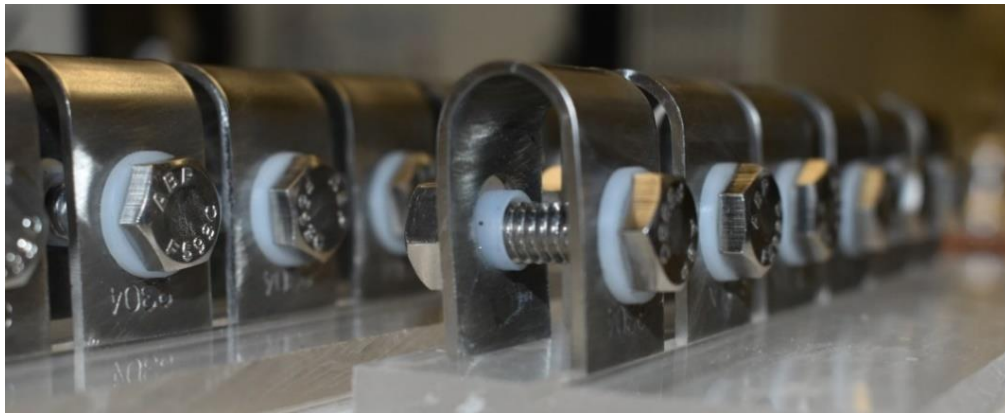
The specimen fabrication process is described in ASTM G30-97.⁽¹⁵⁾ The stock material used for fabricating the specimens was reinforcing bars. The researchers cut a rectangular strip from the bar-shaped stock longitudinally along the direction of rolling using wire electrical discharge machining. The strip was cut into plates with the following dimensions: 1.6 mm (1/16 inch) thick, 19.0 mm (3/4 inch) wide, and 63.5 mm (2-1/2 inch) long (before bending) with two 9.5-mm (3/8-inch)-diameter holes located 12.7 mm (1/2 inch) from each end and centered. Each plate was stamped with the steel grade number for identification. The plate was bent 180 degrees around a 6.35-mm (1/4-inch) radius and then kept in the constrained U-shape with stainless steel fasteners and insulating bushings (figure 1).

Figure 1. Photo. U-bend specimens.

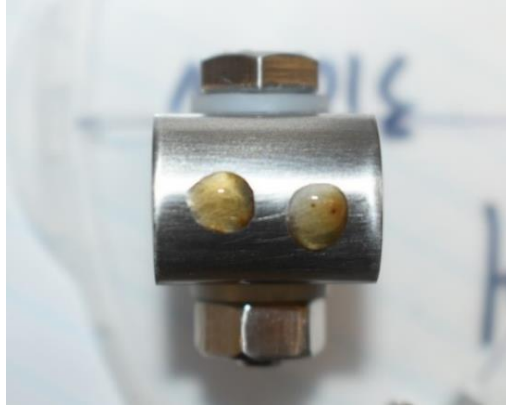
Two 30-μL (0.001-fl oz) droplets of salt solution were placed on the arch of the U-bend, as shown in figure 2. The volume of the droplets was measured with a precision syringe to control the volume. The wetted area by the droplet on the U-bend was about 20 mm² (0.031 in²), but some droplets shrunk to about 12.5 mm² (0.019 in²) due to evaporation.

Figure 2. Photo. U-bend specimen with two saltwater droplets.

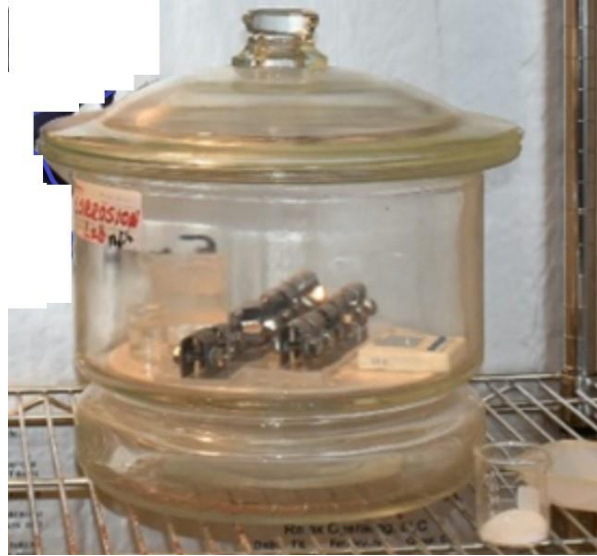
Figure 4. Photo. Desiccator in a temperature-control hotbox.

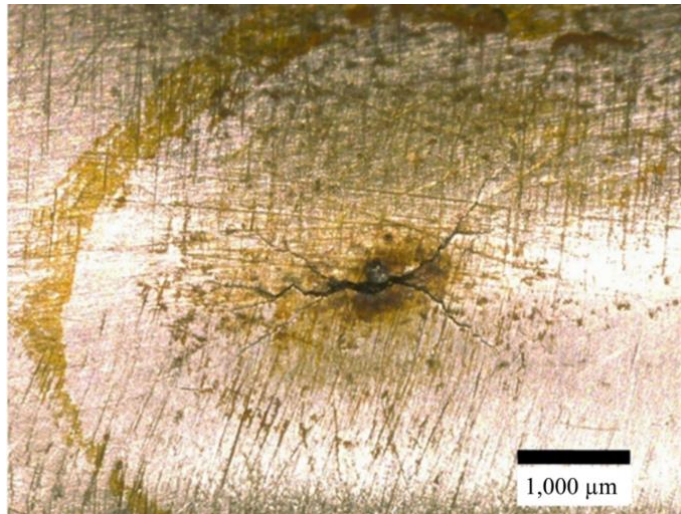
Stress corrosion cracks were found on the specimens of stainless steel grades⁽¹⁾ 304L and 316LN exposed to CaCl₂ and MgCl₂ when the initial microscopic examination was carried out after 8 w of exposure. The cracks were located at the center area of the U-bend (crown or apex of the arch) where the stress was maximized. Cracks initiated from a pit, as shown in figure 11 and figure 12. The crack branched out as it propagated along the crown of the arch. Although no cracks were observed on NaCl-contaminated stainless steels, many pits were developed on the crown of the U-bend, as shown in figure 13.

Figure 12. Photomicrograph. Pits and cracks developed in stainless steel 316LN exposed to MgCl₂ droplet.

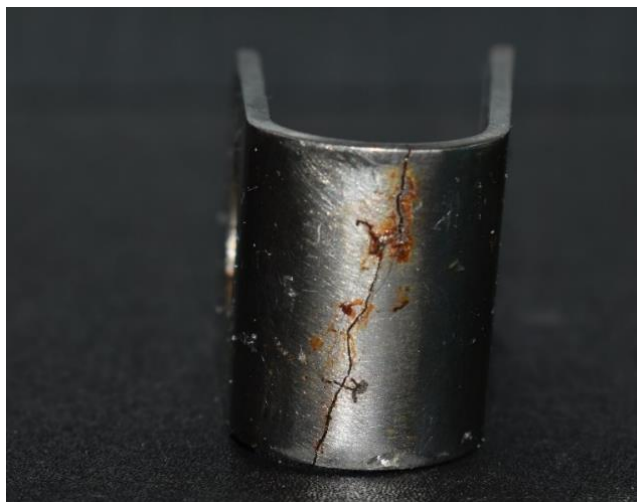
SCC caused severe damage to the austenitic stainless steels⁽¹⁾ 304L and 316LN by CaCl_2 and MgCl_2 . Cracking was more extensive in the 304L stainless steel specimens than in the 316LN ones, as demonstrated in figure 14 and figure 15. Both U-bends were exposed to MgCl_2 for the same period, but the cracks were wider on the 304L specimen. The same pattern was not observed on U-bends exposed to CaCl_2 , as shown in figure 16 and figure 17.

Figure 14. Photo. Cracking through U-bend specimen with high-pH MgCl_2 droplet on 304L stainless steel.

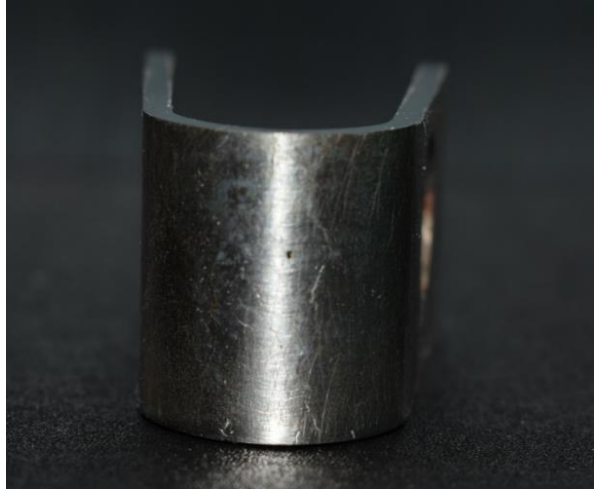
Figure 15. Photo. Cracking through U-bend specimen with high-pH MgCl_2 droplet on 316LN stainless steel.

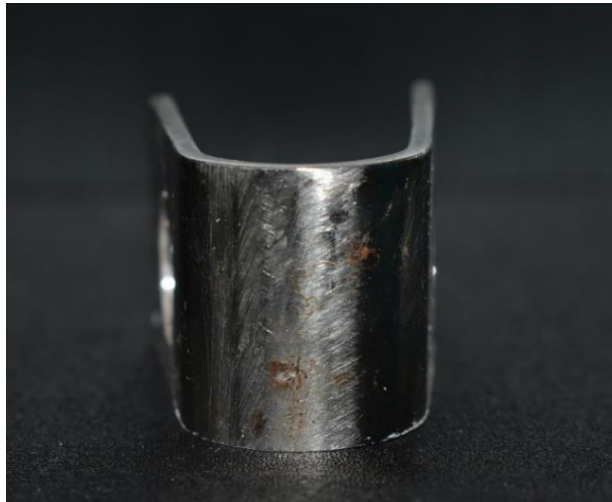
Figure 16. Photo. Cracking through U-bend specimen with high-pH CaCl_2 droplet on 304L stainless steel.

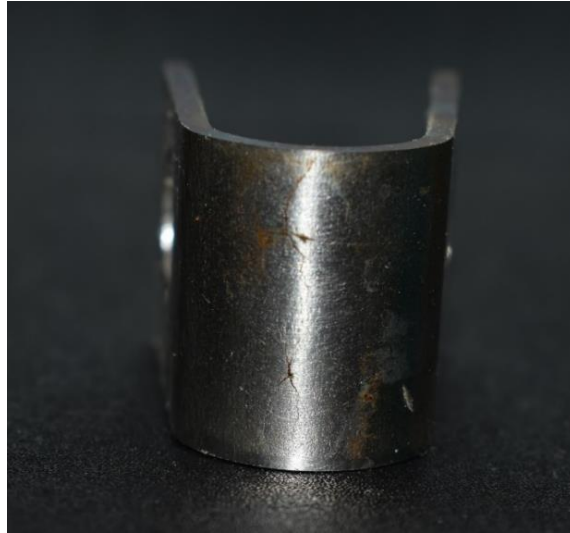
Figure 17. Photo. Cracking through U-bend specimen with high-pH CaCl_2 droplet on 316LN stainless steel.

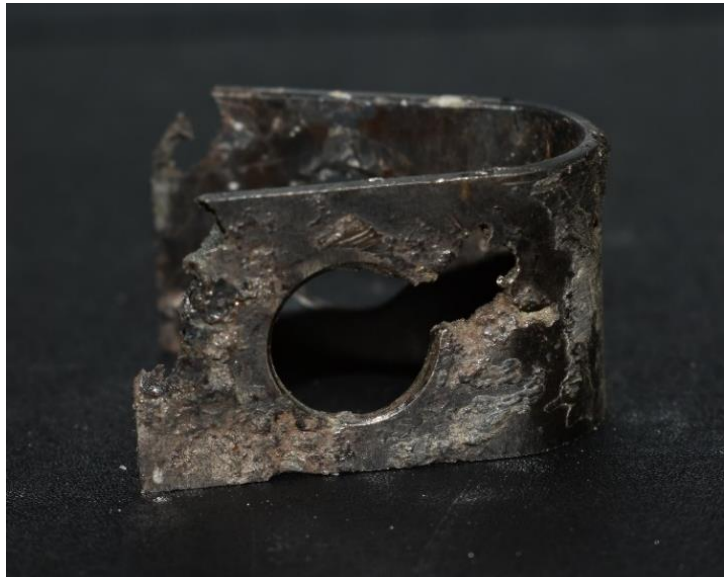
Although stress corrosion cracks were not found on the XM-28 stainless steel,⁽¹⁾ severe pitting corrosion did develop, as shown in figure 24. Pitting corrosion was not limited to the crown of the arch, but also occurred elsewhere, including the legs of the U-bend where stress was low. Metallographic examination did not find any sign of cracks, but deep pits were formed in the stainless steel structure as shown in figure 25, figure 26, and figure 27. After 1 yr of exposure, pitting corrosion perforated the stainless steel, as shown in figure 28 and figure 29.

Figure 28. Photo. Localized corrosion on U-bend specimen with high-pH MgCl₂ droplet on XM-28 stainless steel.

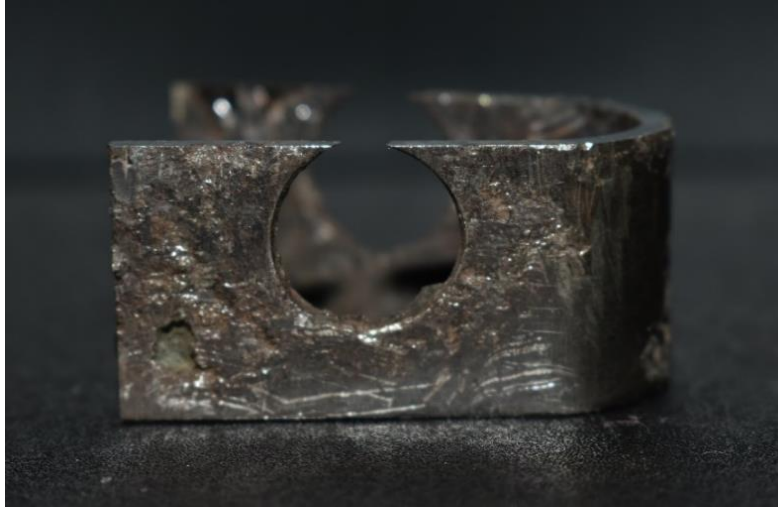
Figure 29. Photo. Localized corrosion on U-bend specimen with high-pH NaCl droplet on XM-28 stainless steel.

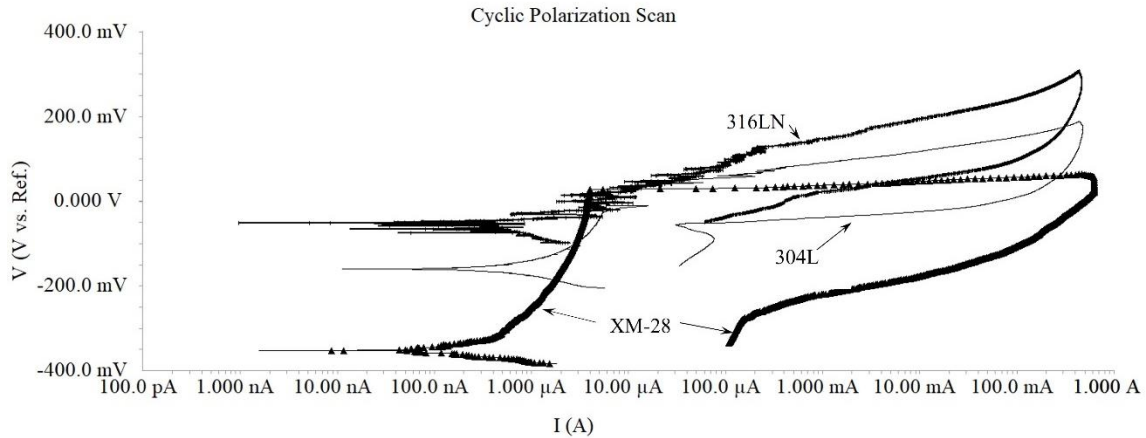
The critical pitting potential was measured following ASTM G61 and ASTM F746. The test was carried out at $50\ ^\circ\text{C}$ ($122\ ^\circ\text{F}$), and the electrolyte was a 3.56-percent (by weight) NaCl solution. Figure 39 presents the results for stainless steels 304L, 316LN, and XM-28. Stainless steel 316LN has the most noble critical pitting potential among the three, while the least noble belongs to XM-28. The critical pitting potential for 304L is slightly more noble than that for XM-28. Figure 40 shows the critical pitting potentials for stainless steels 2205 and 2304. Within the tested potential range, the 2205 curve does not have a potential where the current increases rapidly, meaning pitting corrosion does not initiate. By comparison, stainless steel 2304 has reached its critical pitting potential, and pits initiated on the steel surface. Even so, 2304 has a more noble critical pitting potential than the three steels shown in figure 39.

Figure 39. Graph. Critical pitting potential curves for 304L, 316LN, and XM-28 stainless steels in NaCl solution.
