# Performance of Coarse-Graded Mixes At Westrack- Premature Rutting

Publication No.: FHWA-RD-99-134

June 1998

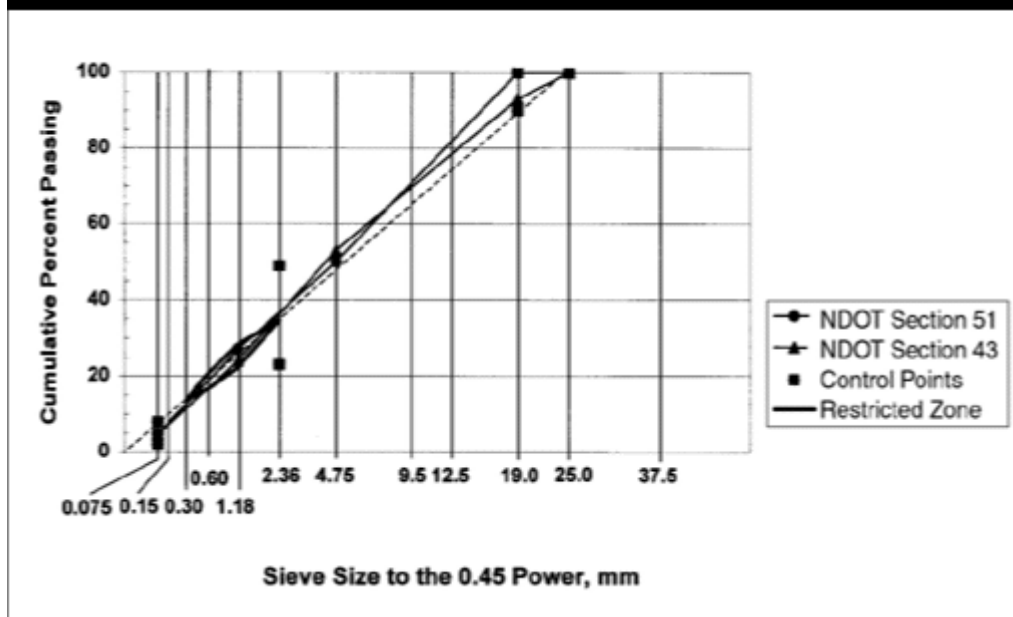
**Figure 3.** Nevada DOT mixes in Sections 43 and 51

The Nevada DOT mixes, Sections 43 and 51, were Hveem-design mixes with an AC-20P modified binder; samples of these mixes were also compacted in the Superpave Gyratory Compactor and the properties of the mixes are shown in table 5. The mixture for Section 43 appeared to deviate significantly from the Superpave volumetric requirements. The mix design data for this section showed 1.7 percent air voids and the in-place cores were measured to have 1.6 percent air voids. Based on the volumetrics, this section would have been expected to rut; however, in-place results (table 6) showed this mix to have less rutting than any replacement section except 51. Section 51 had 4.2 percent air voids at design, with in-place air voids of 6.8 percent. This section had minimal downward rutting (3.6 mm). Visually, the rutting performance of these Nevada DOT mixes was similar to that of the curves (data for the latter is not shown in tables, but is estimated typically to be about 2 mm). Table 6 shows the rutting performance of the 10 sections in the field, as well as the performance of roadway samples from those sections in the various performance-testing devices. Figure 4 shows the distinction between total and downward rut-depth measurements.

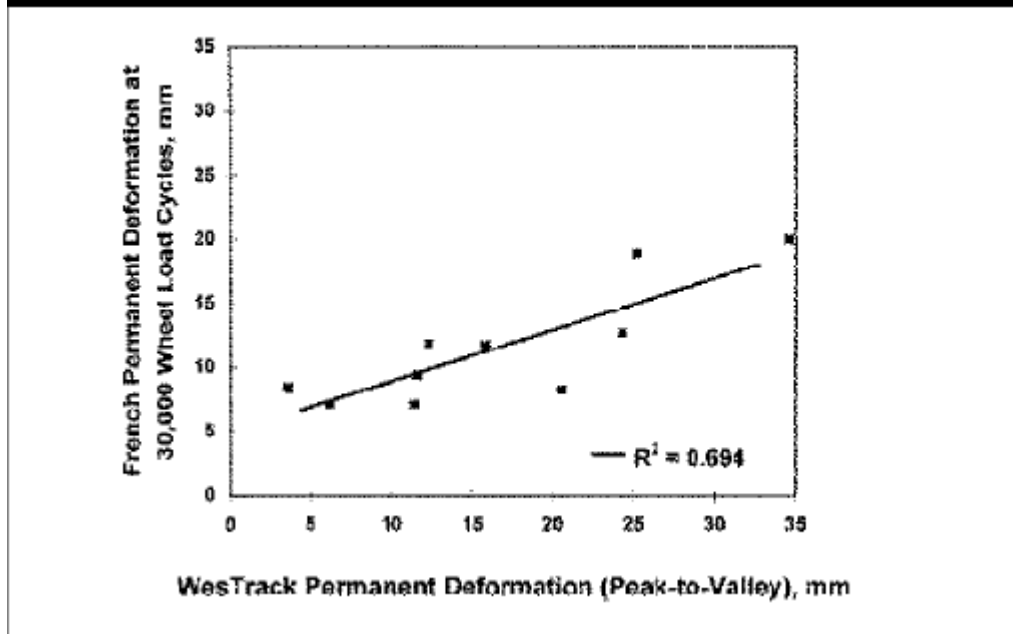
**Figure 5.** French Rutting Tester results vs. WeTrack performance

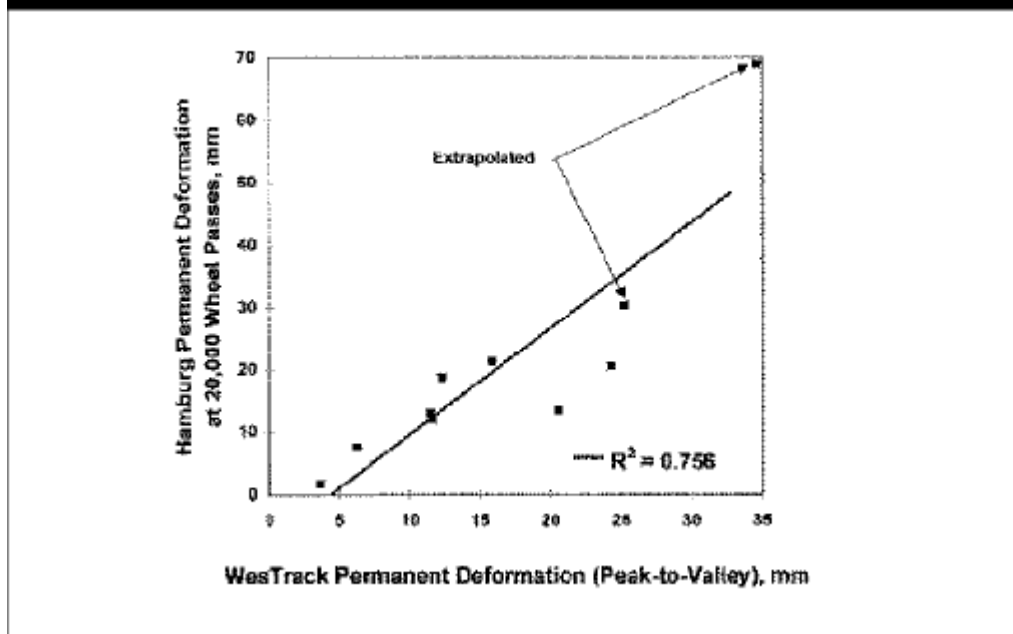
**Figure 6.** Hamburg wheel-tracking test results vs. WesTrack performance

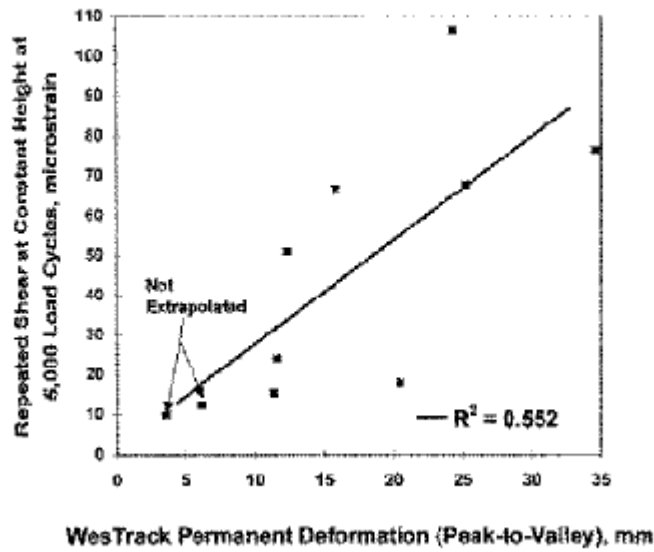
**Figure 9.** Repeated shear at constant height test results vs. WesTrack performance

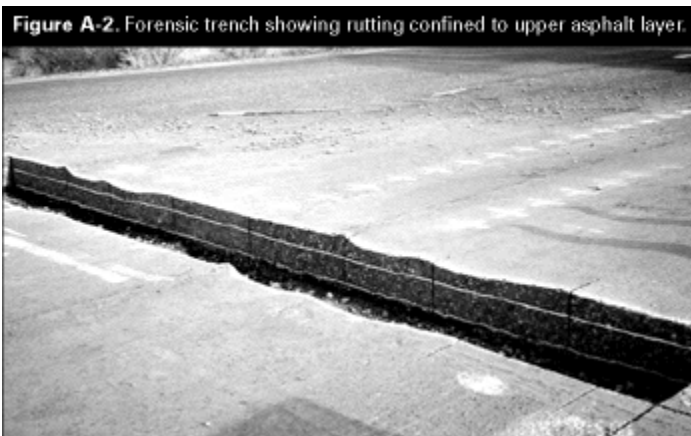
- Mixtures that showed rutting in the summer were the same mixtures that suffered fatigue cracking in the winter. Usually, mixtures that exhibit fatigue cracking do not have plastic deformation.
- The pattern of fatigue cracking developed first with transverse cracks across the wheelpath, followed by longitudinal cracks. Usually, longitudinal cracks are the first sign of fatigue, followed by transverse cracks.
- Plastic deformation in the mixture is shallow, less than 75 mm deep. Usually, plastic deformation disturbs mixture 50 to 100 mm deep.

**Figure A-2.** Forensic trench showing rutting confined to upper asphalt layer

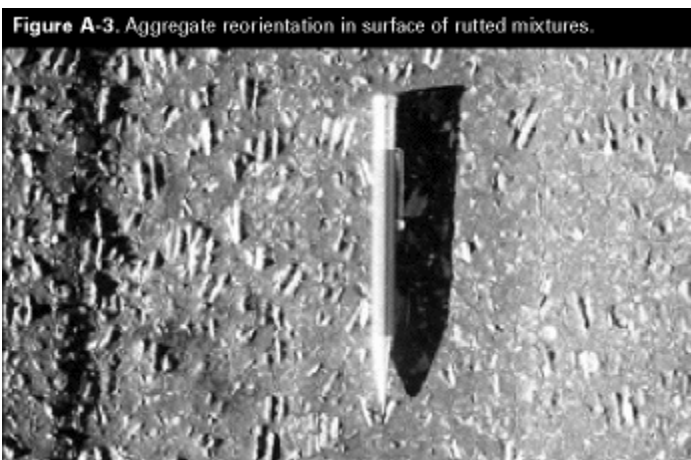
**Figure A-3.** Aggregate reorientation in surface of rutted mixtures.
