U.S. Department of Transportation
Federal Highway Administration

COMPLETE STREETS TRANSFORMATIONS

*Six Scenarios to Transform
Arterials using a Complete Streets
Implementation Strategy*

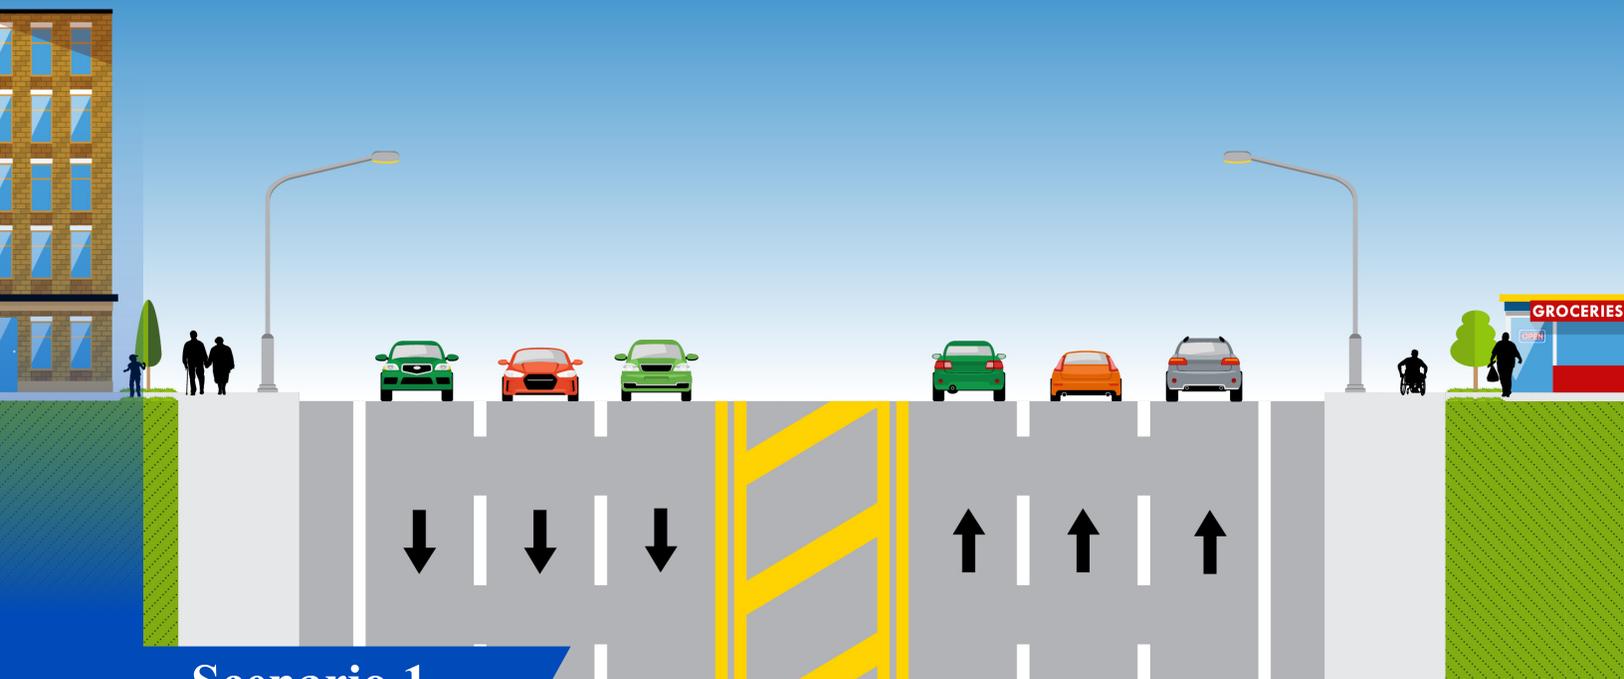
Scenario 1

Suburban 6-lane principal arterial

Understand Context: The cross-section below illustrates a typical arterial street in a suburban context. It has multiple through lanes, with an outside shoulder that is occasionally used by bicyclists. Sidewalks attach to the curb without trees or other separation from motor vehicles. They are frequently punctuated by driveways to allow traffic to enter retail establishment parking lots. Employers, restaurants, shopping centers and grocery stores are located along this corridor, and a university is located nearby, creating demand for short trips that could be made by bicycling or walking. Through public outreach, and a [road safety audit](#), the transportation agency learns that the university population walks and bicycles at high rates, but they find it uncomfortable to access businesses in this corridor. In partnership with the local housing authority, the transportation agency engaged a targeted focus group of residents at an apartment complex. Discussions revealed that many residents rely primarily on walking and public transportation and have concerns about safely crossing the street to access the grocery store. This is due to high-volume, high-speed traffic and the lack of convenient crosswalks and adequate lighting. An analysis of safety data identified the arterial as the location of several of the jurisdiction's pedestrian and bicyclist crash hot spots.

Identify Concerns:

1. With wide lanes and a flush median, many drivers exceed the speed limit. Community members have expressed concerns about walking or bicycling on this route due to **high vehicular speeds and the lack of separation**.
2. Despite standard pedestrian crosswalks and signals at intersections, pedestrians find this street **difficult to cross** due to the many lanes, **distance between crossings, lack of median refuge and poor lighting** at the crosswalks. This includes residents of a low-income apartment complex who must cross the street to catch the bus and to access a grocery store.

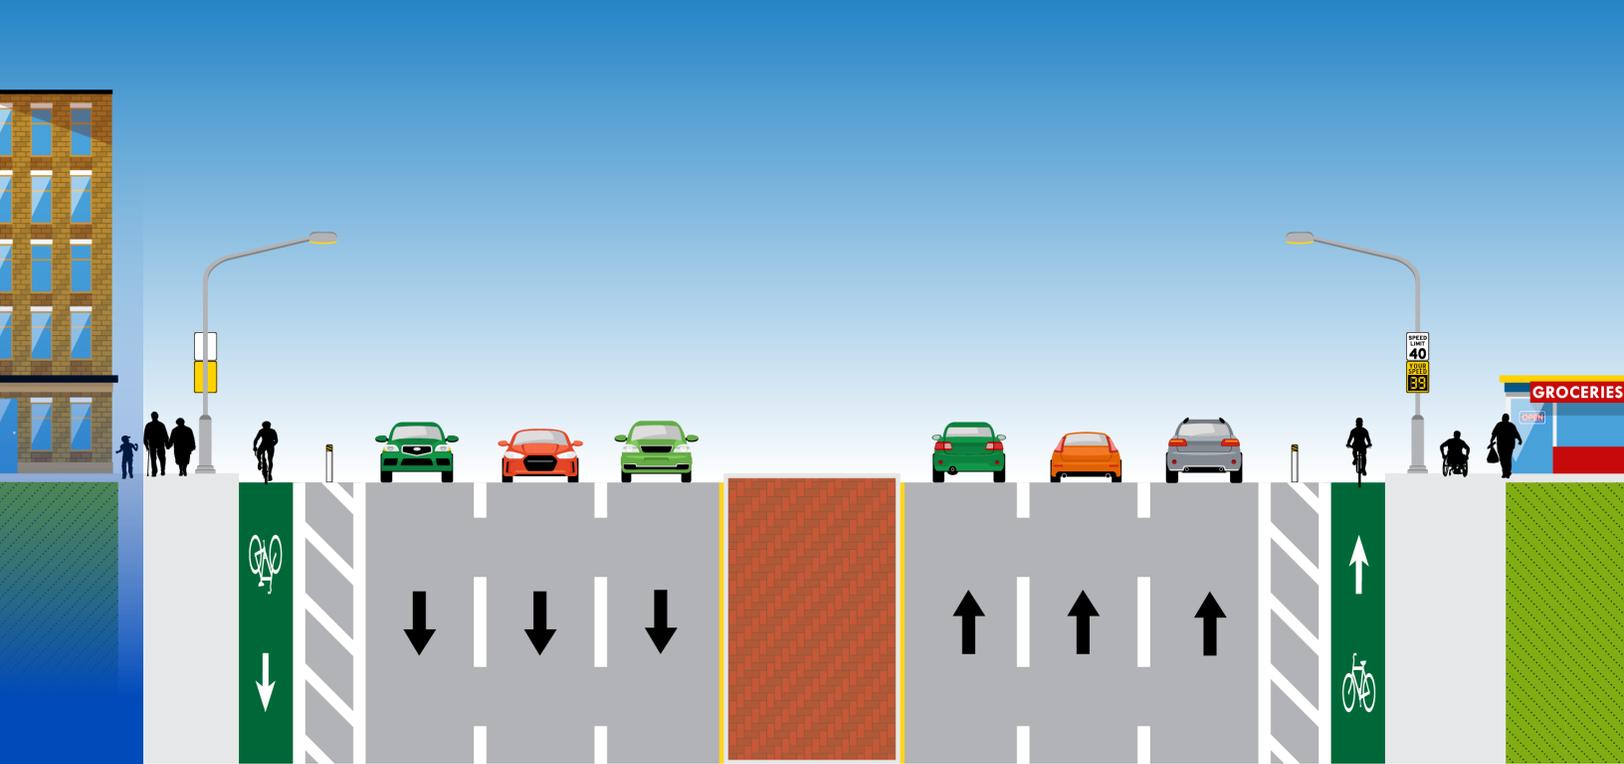
Implement Improvements:

To provide improvements without moving the outside curb, the transportation agency can:

1. Set **appropriate speed limits**. When setting a speed limit, agencies should consider a range of factors that impact safety such as the presence of pedestrians and bicyclists, crash history, land use context, intersection spacing, driveway density, roadway geometry, roadside conditions, roadway functional classification, traffic volume, and observed speeds.

2. Add **speed feedback** signs to remind drivers to slow down and obey posted speed limits.
3. Provide space for a **separated bicycle lane** on each side by eliminating the shoulder and narrowing the travel lanes.

4. Install **green colored pavement** within the bike lanes with [Interim Approval from FHWA](#),⁷ to increase motorist awareness that bicyclists might be present.

5. Install a **wide raised median** so that sufficient space is available to provide median refuge for crossing pedestrians.
6. Ensure **accessible bus stop shelters** enhance visibility and provide protection from the elements.

Evaluate Impacts:

After completing the interim project, the transportation agency evaluated the success of their Complete Streets implementation project and identified additional concerns:

1. Pedestrian **lighting is inadequate** along the roadway and at crosswalks, and pedestrian crossings are still spaced far apart.
2. In-street separated bike lanes improved safety but did not provide a low-stress bicycling facility.
3. Many bicyclists were observed riding **contraflow** in the one-way bike lanes in order to access destinations without having to cross the arterial.

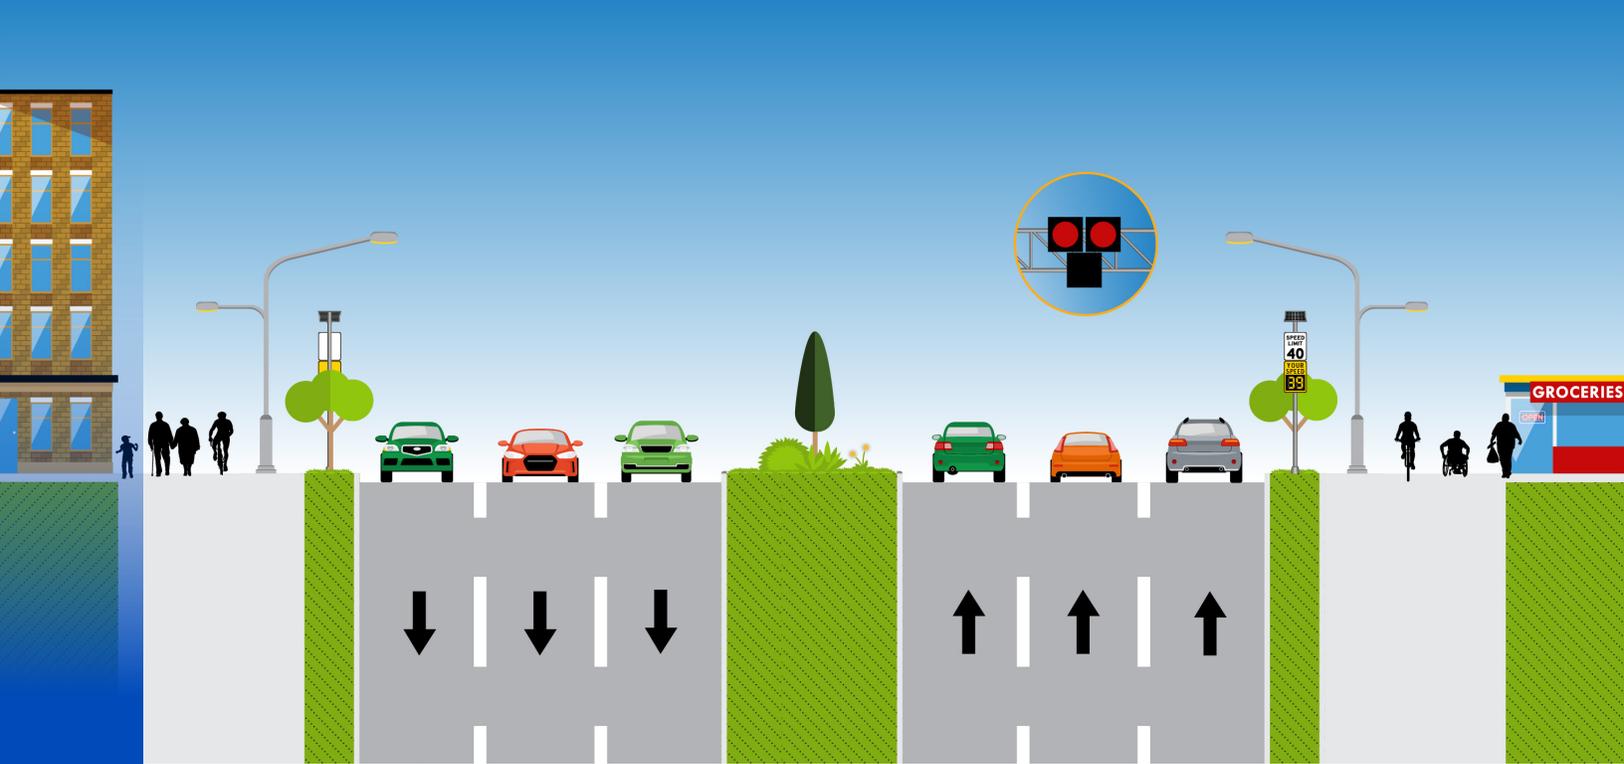
Implement Improvements:

Moving the outside curb, the transportation agency can:

1. Add a mid-block crossing using a [Pedestrian Hybrid Beacon \(PHB\)](#) to provide safe crossing opportunities between intersections where blocks are long and conduct public outreach to educate all users about PHBs.
2. Add visibility enhancements, including lighting, to crosswalks and shared use sidepath to increase the safety and comfort of pedestrians and bicyclists.
3. Narrow the roadway to provide **shared use sidepaths** for pedestrians and bicyclists behind the curb, allowing for safe and comfortable bidirectional travel on both sides of the road.
4. Add **trees** along the median and roadside to provide shade and possible traffic-calming effects.

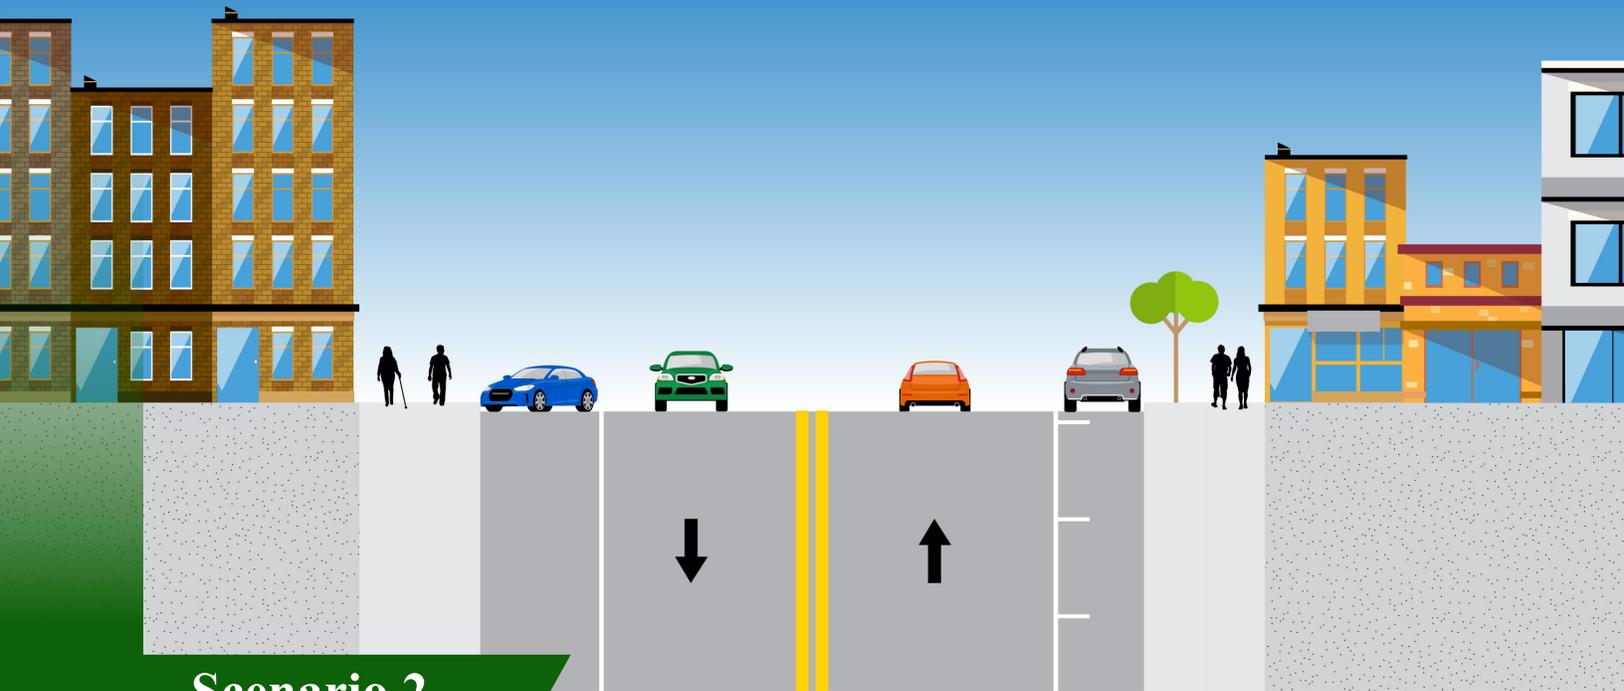
Scenario 2

Urban 2-lane minor arterial

Understand Context: This two-lane minor arterial features wide lanes, sidewalks without separation from the street, head-in angled parking on one side with parallel parking on the other side, and no bicycle facilities. The transportation agency is seeking to increase the number of short trips made by bicycling and walking to reduce congestion, as well as improve safety to meet their Vision Zero goals. During the engagement process, the agency learns that retail businesses want to retain street parking but note that the current parking does not work well for parcel delivery services. Additionally, customer feedback tells them that the street itself lacks any sort of unique character.

Identify Concerns:

1. Wide lanes may encourage **high vehicular speeds**.
2. Pedestrians do not feel safe being so close to the roadway on the side without more **separation** from motor vehicles.
3. **Head-in angled parking** may pose a safety hazard and complicates freight delivery.
4. **Accessible parking spaces** are not available to individuals with disabilities.
5. Bicyclist safety is compromised by the **lack of dedicated space for bicyclists** to travel.

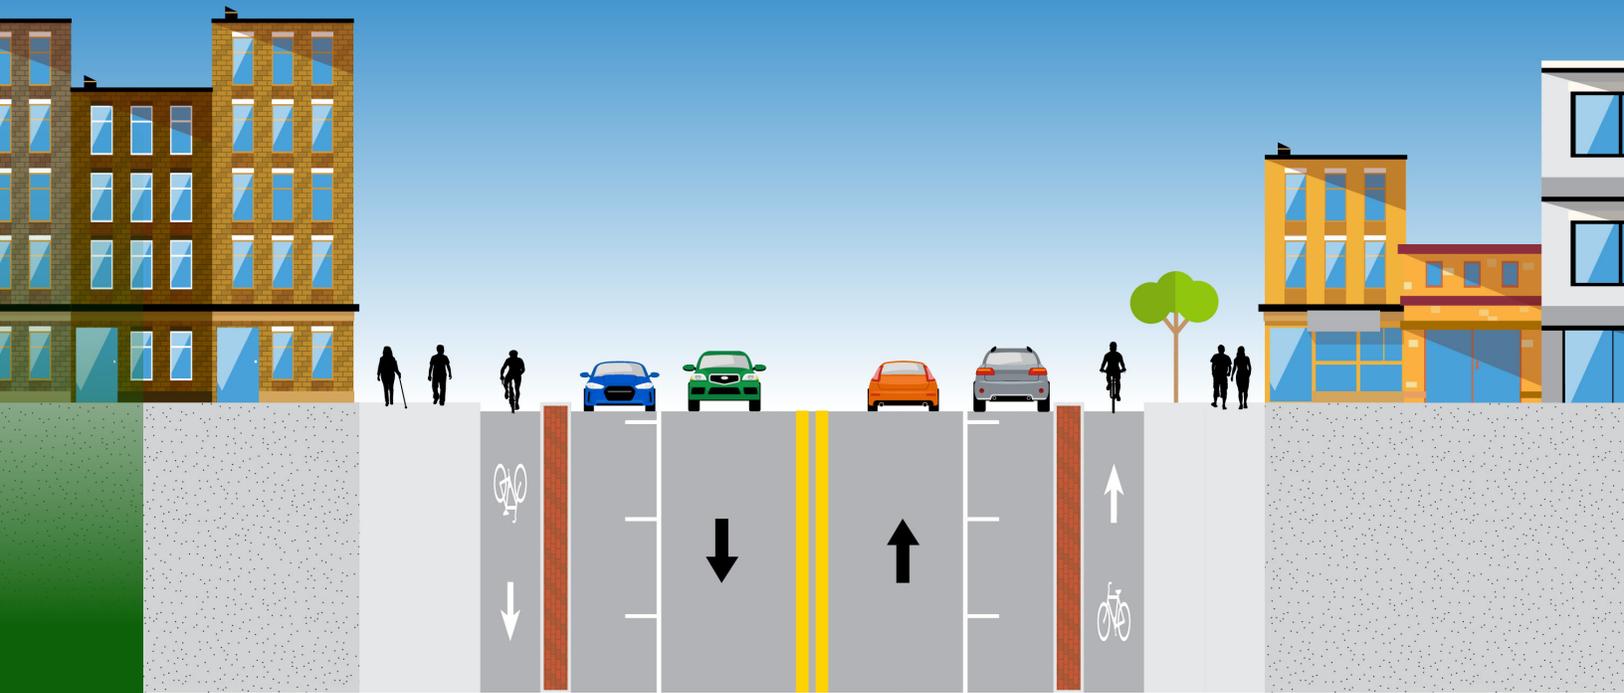
Implement Improvements:

1. **Narrow driving lanes** to reduce vehicle speed.
2. Replace angled parking with **parallel parking** to allow for designation of freight delivery spaces while eliminating the need to back out of a space into traffic.
3. Add **accessible spaces** at the end of the block or on side streets to improve parking options for individuals with disabilities.
4. Add **dedicated bike lanes** in each direction with a **curb separation** from motor vehicles and parked cars to improve safety and comfort for bicyclists and pedestrians.

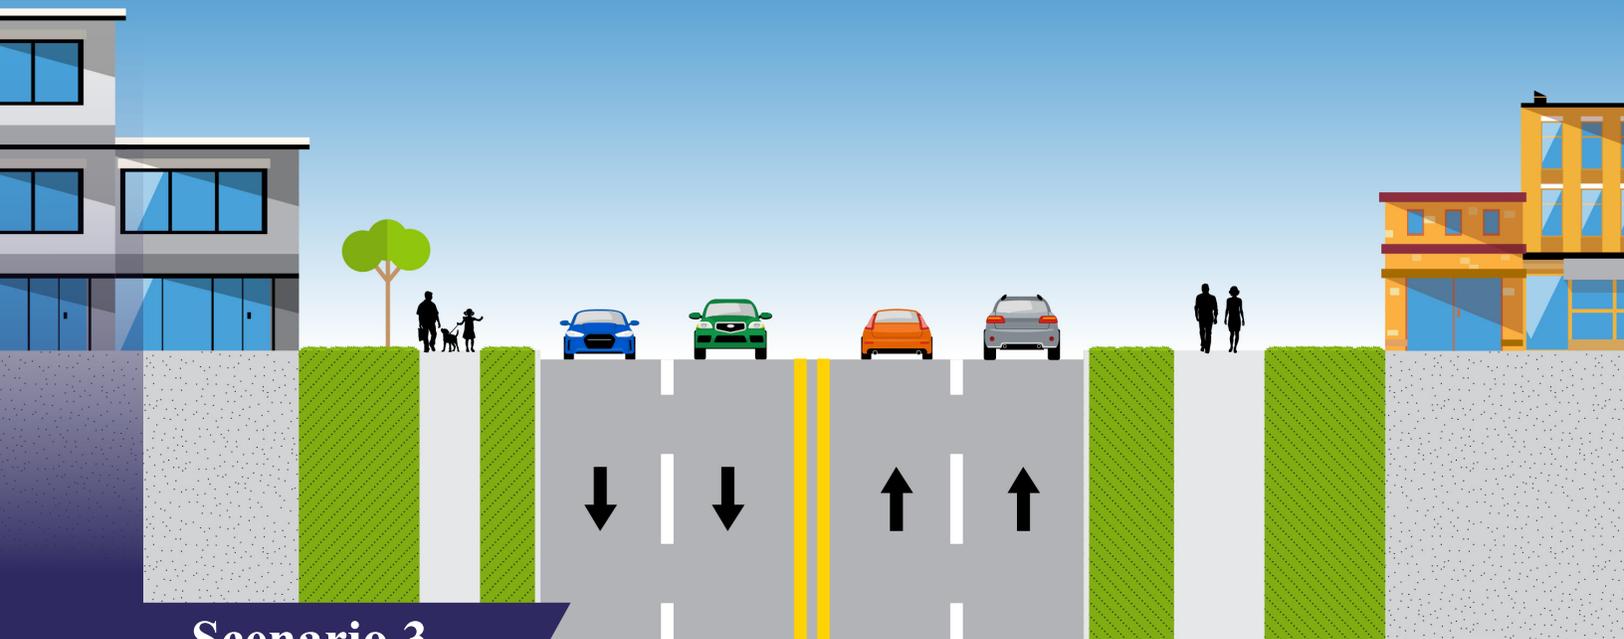
Scenario 3

Urban 4-lane minor arterial

Understand Context: This minor arterial includes four through-lanes that are relatively narrow. There is no dedicated space for bicyclists. Sidewalks in need of repair are present on each side. This minor arterial provides a critical link in the urban grid, connecting separate nodes of residential, shopping, dining, and medical facilities. Traffic volumes are too high to make a lane reduction feasible. However, analysis shows that this segment serves as a critical link in connecting the walking and bicycling networks of two adjacent neighborhoods. At one point along the roadway, an apartment complex for low-income older adults is located on one side of the street, with shops, medical facilities, and a park on the other side. Through targeted public engagement with residents at a community event, the agency learned that older adults cross the street daily to spend time outdoors or access the services, but they feel unsafe crossing. Several residents have been seriously injured in crashes. Many more have had near-misses. Indeed, analyzing crash data, the agency notes that several crashes involving bicyclists and seniors have occurred. Upgrading sidewalks and crosswalks, adjusting signal timing, and providing low-stress bicycling facilities and crossing opportunities could result in a significant increase in walking and bicycling trips and improve safety for all users, particularly the older adults who call this corridor home.

Identify Concerns:

1. **Pedestrians with disabilities** are unable to use the sidewalks because they have not been maintained in good condition.
2. The street is sometimes seen as a **barrier** rather than a connector for these neighborhoods. **Older adult residents** do not feel safe crossing the street.
3. Bicyclists do not feel safe using this road since there are **no dedicated bike facilities** and crashes involving bicyclists have occurred.

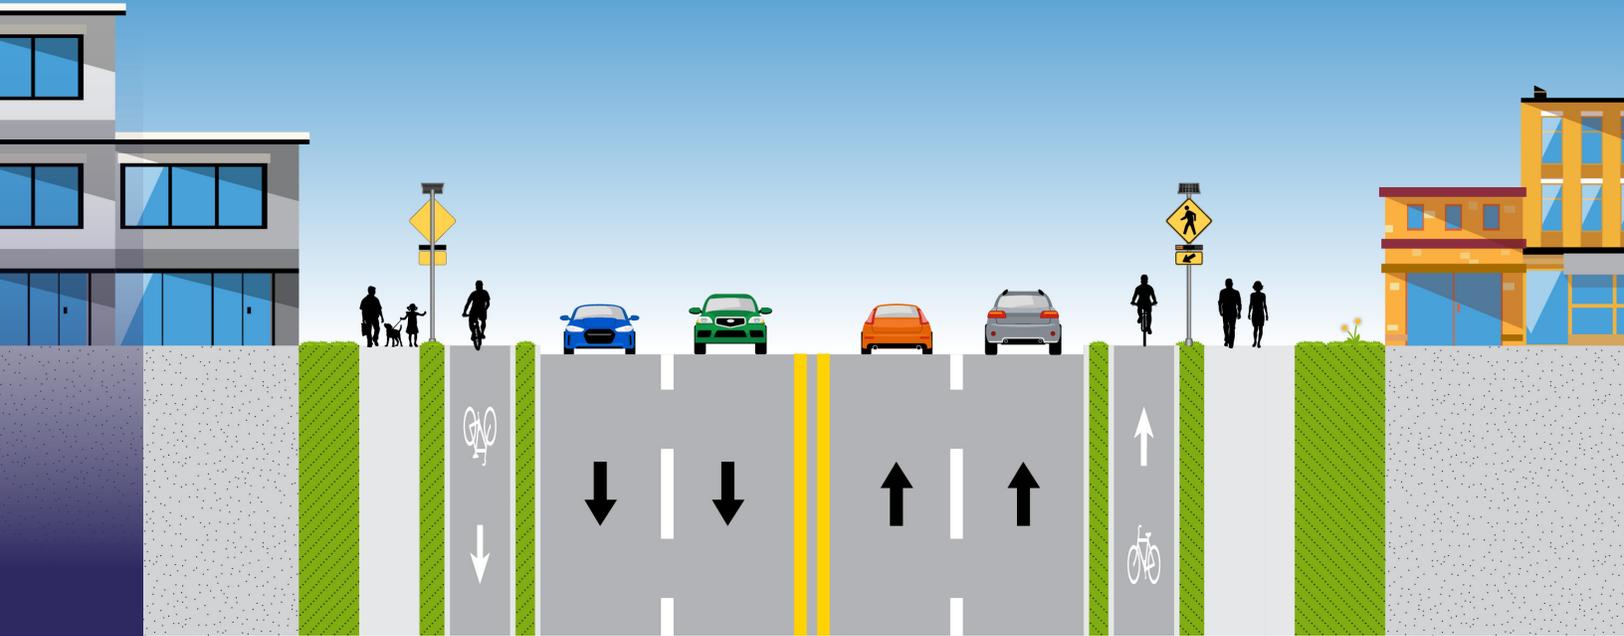
Implement Improvements:

1. Provide enhanced crossings through installation of a [Rectangular Rapid Flashing Beacon \(RRFB\)](#).
2. Reconstruct the [sidewalk](#) to [eliminate barriers to accessibility](#)
3. Provide a vegetative strip between the sidewalk and the bike lanes to provide **separation** and [help pedestrians with vision disabilities](#) detect the edge of the sidewalk.
4. Add sidewalk-level **bike lanes** on each side to provide dedicated, separated space for bicyclists. By keeping the through-lanes the same width, the agency can avoid the expense of moving the curb and drainage.

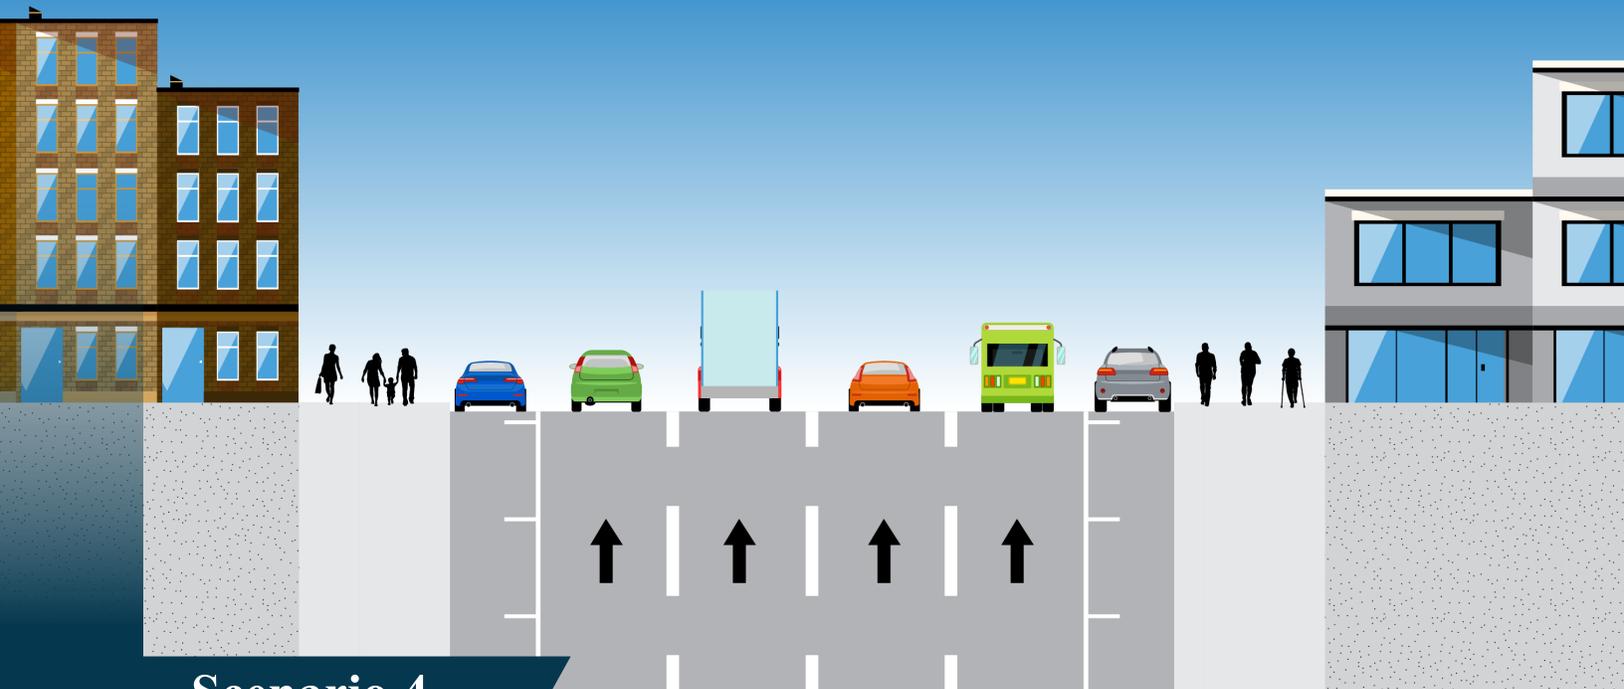
Scenario 4

Urban core one-way principal arterial

Understand Context: This one-way arterial in a downtown urban core has four travel lanes and parking on both sides of the road. The arterial is part of a one-way pair, with a similar arterial carrying parallel traffic in the other direction on the next block. When considered collectively, these paired roads occupy a substantial amount of space. The project's original justification was to prioritize high-speed vehicle throughput serving workers commuting between the suburbs to jobs in the city. Through targeted outreach with community members, the City learned that many downtown residents – particularly those who do not own vehicles – feel isolated from and unsafe finding access to jobs, healthcare, healthy foods, and recreation. The transit agency noted that while the bus route on this roadway is one of the busiest in the City, it has poor on-time performance. To address community needs, the City wants to improve bus service reliability, bus stop access and amenities, and increase transit frequency. The agency also wants to improve conditions for bicycling and walking to make it possible for residents to bicycle and walk more often for short trips and also reduce crowding on buses. The City determined that the community's overall goals for this downtown route are best met by improving bus service reliability and conditions for nonmotorized travel.

Identify Concerns:

1. Sidewalks on both sides are adjacent to the curb and **cluttered** with intermittent utilities that may impede travel for some users; no accessible parking spaces are available.
2. Several bus routes use this heavily congested corridor, and **bus service is unreliable** due to traffic delays, including trucks stopping for deliveries.
3. There are **no dedicated bicycle facilities** in this high-traffic corridor.
4. As with many multilane one-way streets, **speed** in the general-purpose travel lanes often exceed the posted speed limit.

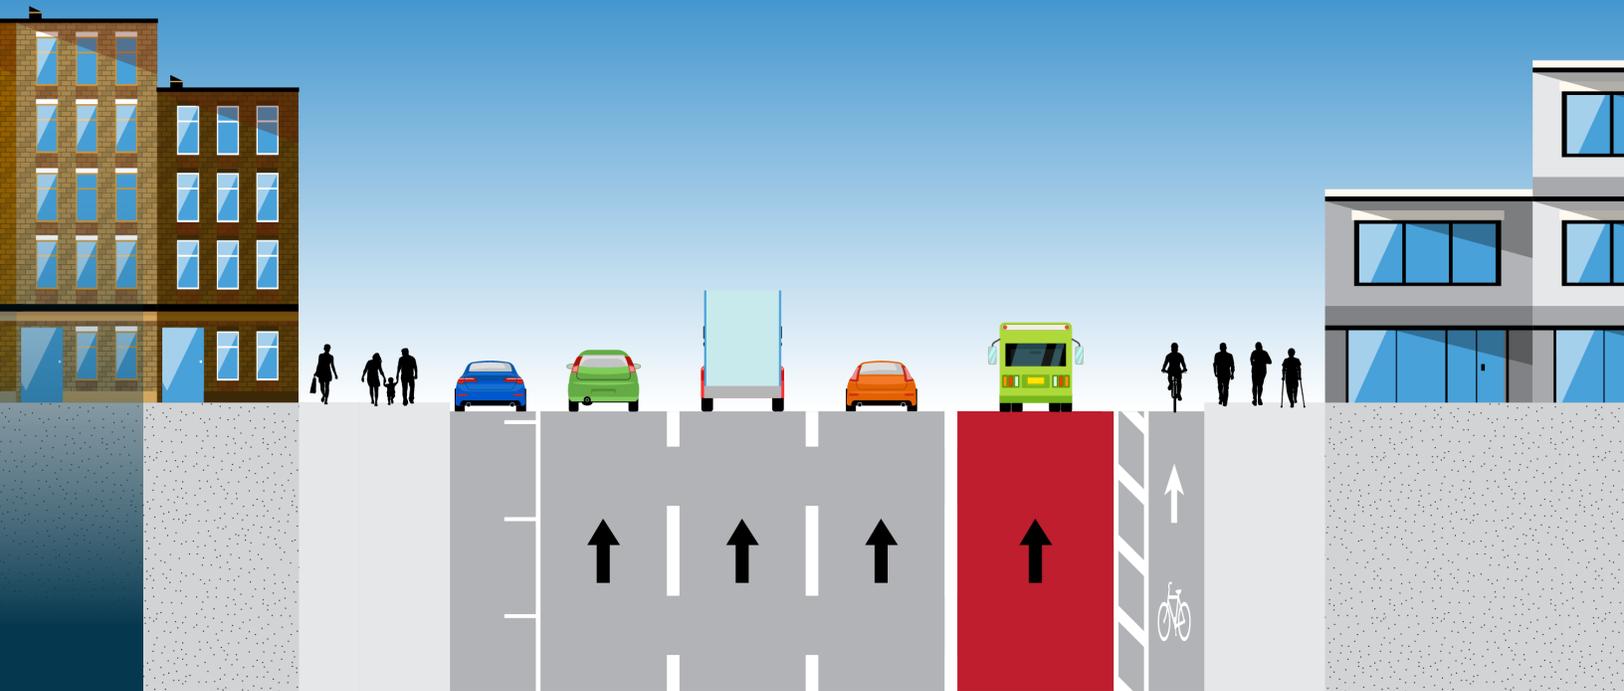
Implement Short-Term Improvements:

Maintaining overall curb-to-curb width, the transportation agency can:

1. Relocate easily movable fixtures to provide a more predictable pedestrian space on both sidewalks, while maintaining utilities.
2. Add **accessible parking spaces** at either the end of the block or on side streets.
3. Re-allocate one travel lane for **exclusive use as a bus lane** to improve the on-time performance of bus routes and increase transit frequency. The transportation agency received **Interim Approval from FHWA** to install red colored pavement within the exclusive bus lanes.
4. Designate some **loading/unloading zones** to meet anticipated demand for freight deliveries in this busy corridor.
5. Repurpose parking on one side of the street as a **buffered bike lane** to encourage residents to bicycle more for short trips and to improve access to transit.

Evaluate Impacts:

1. Vehicular **Speed** continues to exceed the posted speed limit.
2. **Contraflow bicyclists** use the one-way facility to shorten their overall trip length.
3. Buses must **pull into the bike lane** to reach the curb at stops.
4. Bicyclists have to pass the bus using the remainder of the bus lane.

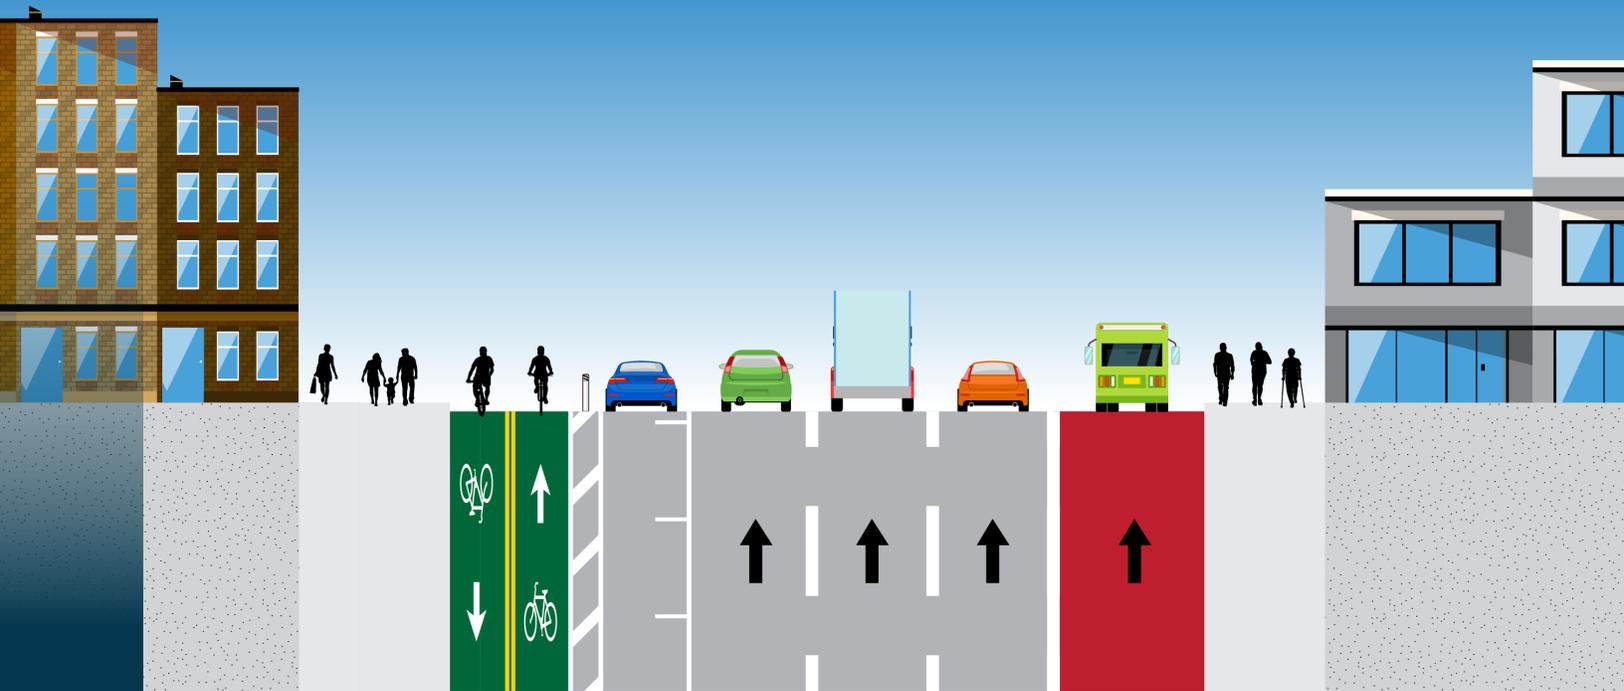
Implement Option A for Long-Term Improvements:

1. Install [Speed Safety Cameras](#) to decrease speeds and improve safety for all users.
2. Provide a **2-way separated bike lane** on the left side of the street to avoid conflicts with transit operations. Install green colored pavement within the bike lanes, with [Interim Approval from FHWA](#).
3. Modify **traffic signals** to accommodate the 2-way separated bike lane.
4. Provide special attention to **operations and sight distance** at intersection, alley and driveway crossings for contraflow movements.
5. Install **bike signal faces and signs**, with [Interim Approval from FHWA](#), and include street name signs to serve contraflow bicyclists.

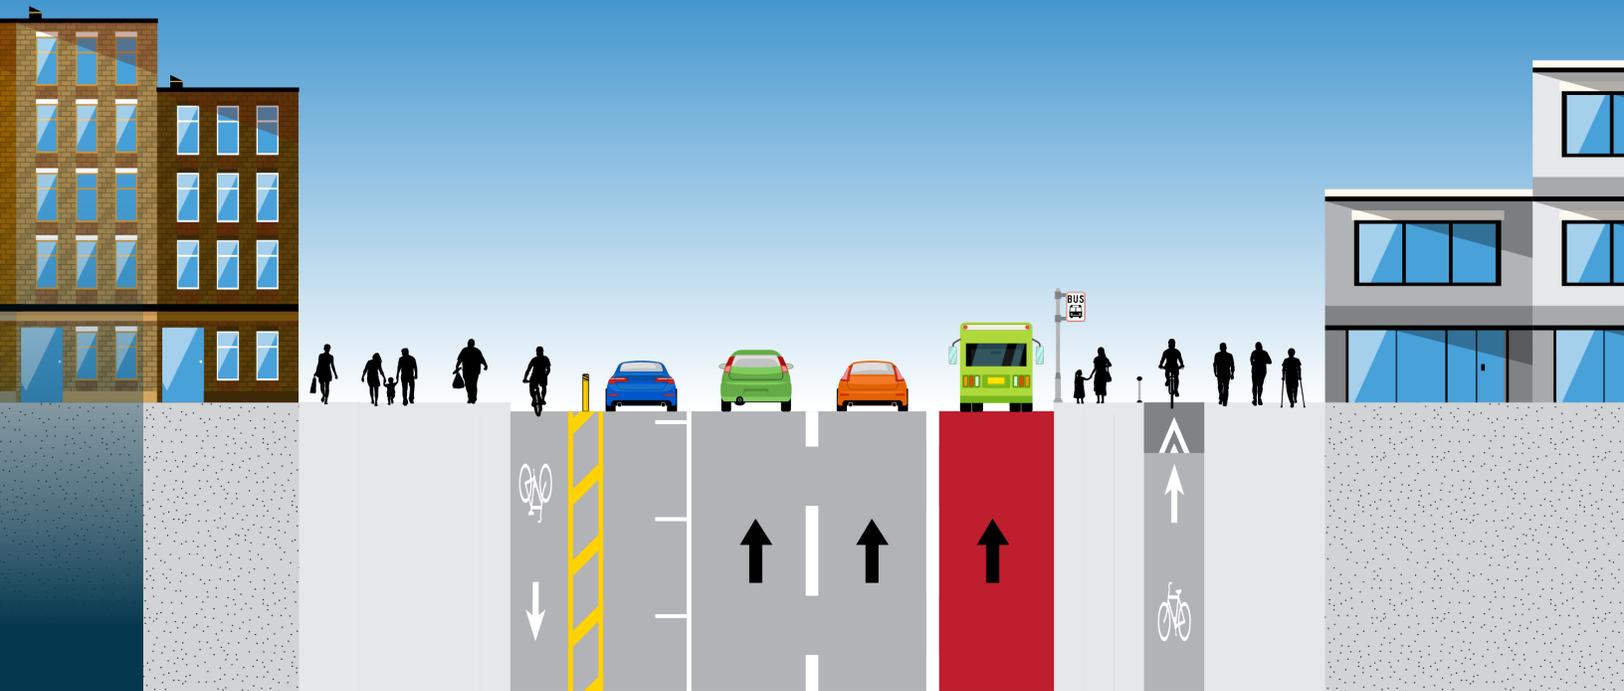
Implement Option B for Long-Term Improvements:

1. Remove an additional through lane to further **prioritize bicycling** and gain space for improved transit facilities needed to support increased ridership.
2. Build a **floating bus island** in the vicinity of bus stops by narrowing the bike lane.
3. Raise the bike lane where pedestrians cross to access the bus stop to reinforce that bicyclists must **yield to pedestrians**.
4. **Provide a contraflow bike lane** on the left side of the roadway, so that bicyclists can easily access businesses, employers and transit stops located on this route.

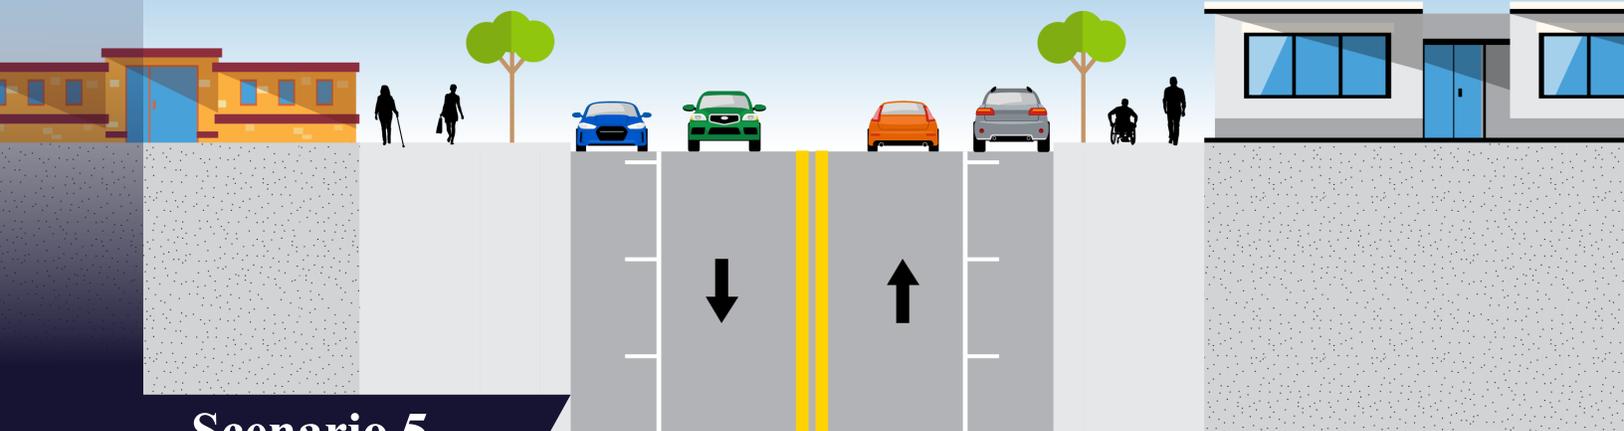
Scenario 5

Rural 2-lane minor arterial Main Street

Understand Context: This two-lane arterial has one lane in each direction with parking on both sides of the street. It functions as the Main Street in a rural town. This highway is a numbered U.S. Route on the National Highway System that passes through several small rural towns located about 30 miles from a major metropolitan area. There are several local businesses along the route, and residential properties are located within a few blocks on either side of this Main Street. The business community wants changes that support their business district. And residents want traffic calming measures implemented to make the street easier to cross and to reduce travel speeds.

Identify Concerns:

1. Pedestrians find it difficult to cross the street because of **high speed** vehicular traffic.
2. Sidewalks exist but there are **no facilities for bicyclists**.
3. Lack of accessible spaces.

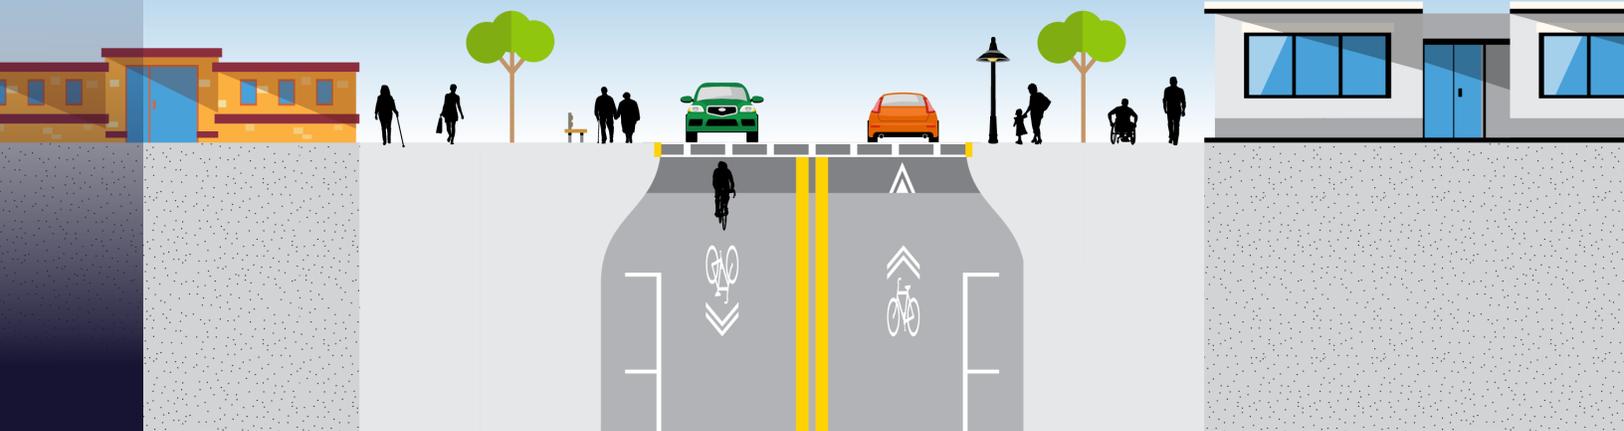
Implement Improvements:

1. Re-evaluate and set **appropriate speed limits**.
2. Add **curb extensions** at each intersection, and at some midblock crossing locations, to shorten pedestrian crossing distances to just two lanes. These measures also help reduce travel speeds in the corridor.
3. Add a mid-block **raised crosswalk** to calm traffic speeds and allow pedestrians to cross at-grade with the sidewalk.
4. Add **accessible spaces** at either the end of the block or on side streets.
5. Add signage to indicate entry to business district and to indicate bicycles will share the road.
6. Dedicated facilities for bicyclists are not added but riding in a shared lane with traffic is more comfortable due to the resulting **reduced travel speeds**.

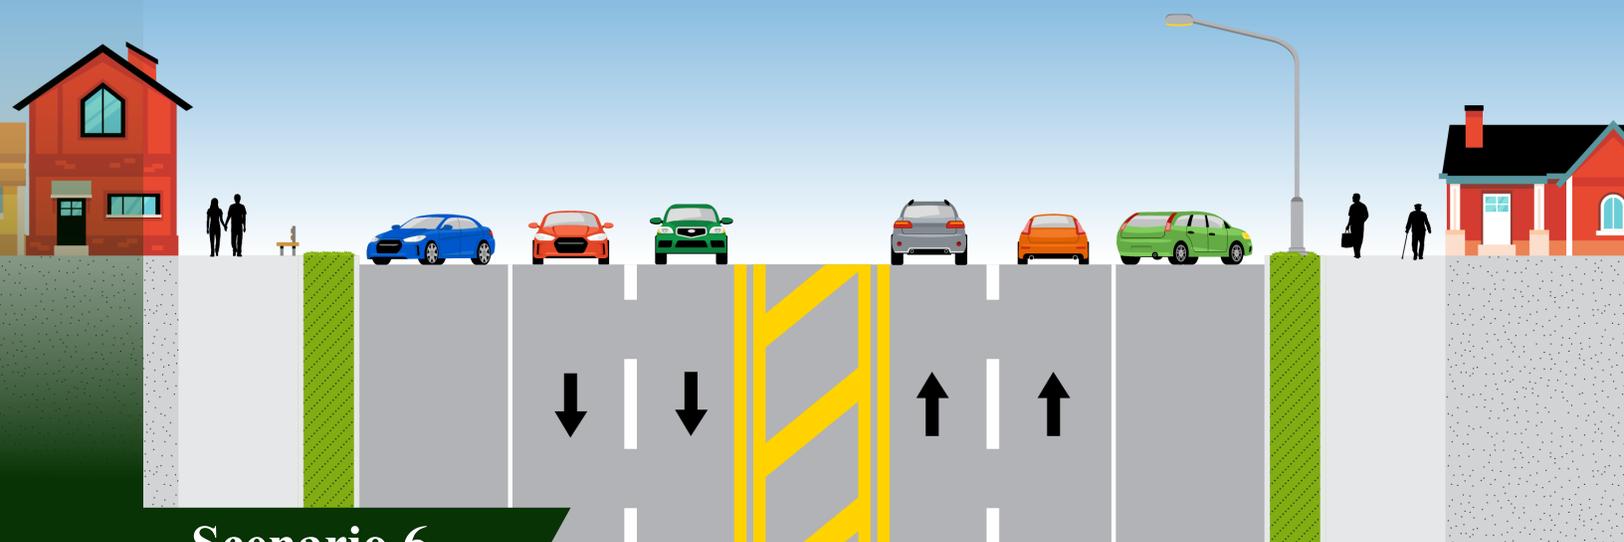
Scenario 6

Rural 4-lane principal arterial Main Street

Understand Context: This four-lane highway is the main street in a thriving rural town with a population of 11,000 people. A tourist location, the street is lined with restaurants, shops and other destinations. Community leaders have reached out to the State Department of Transportation (SDOT), who owns this highway, to request improvements that better support the needs of the community. After extensive outreach, the SDOT has agreed to reconstruct the highway to better serve the needs of local businesses and residents and implement a “road diet.”

Identify Concerns:

1. The flush median is too narrow for a turn lane, and not marked for that purpose, so traffic waiting to make a **left turn** blocks the left through lane.
2. Bicyclists do not feel safe using this route due to the **lack of bike facilities**.
3. The wide lanes and flush median induce **high travel speeds** exceeding the 30-mph speed limit.
4. Pedestrians find it **difficult to cross** this wide roadway, even at intersections.
5. Drivers have difficulty **safely backing out** of head-in angled parking spaces due to the lack of visibility to the travel lanes.
6. People with disabilities have difficulty reaching the streets' attractions.

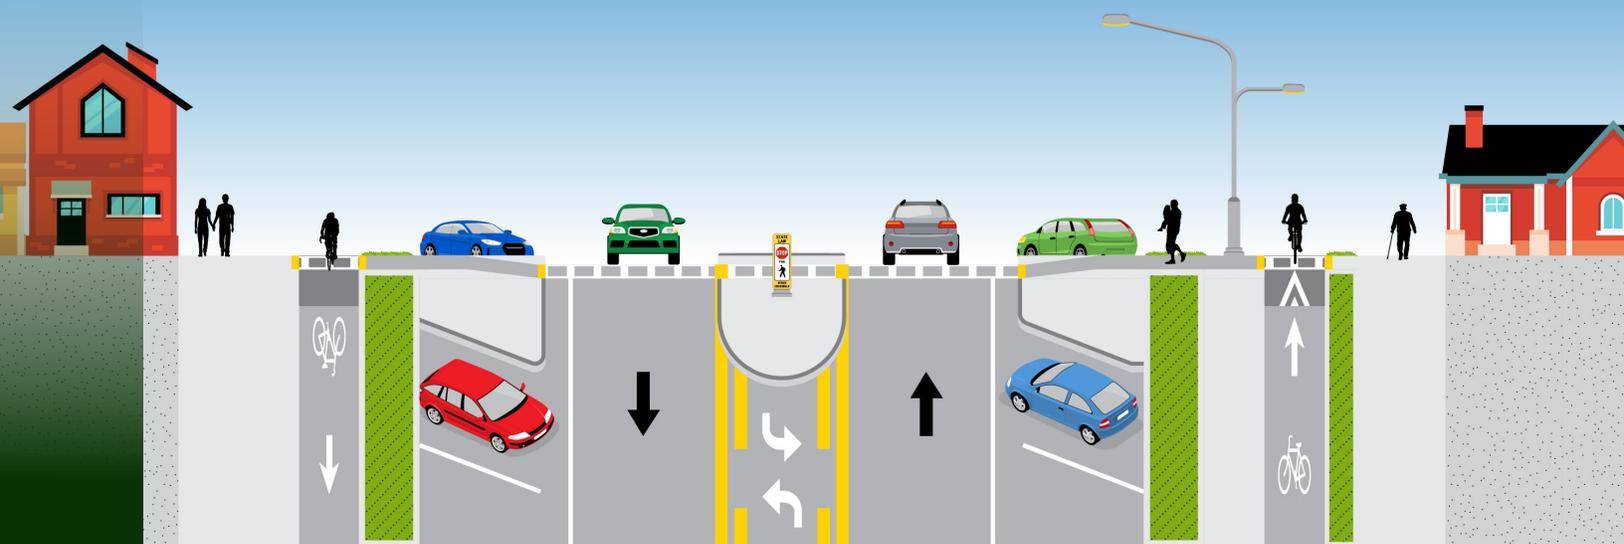
Implement Improvements:

1. Implement a **road diet**, repurposing two through lanes to:
 - a. Add a **two-way center left turn lane** to facilitate turning traffic with **raised median refuge islands** at intersections and other crosswalks.

- b. **Add a bike lane** in each direction, with ample separation from the parking lane to allow shoppers to load their vehicles without interfering with bicyclist travel. Raise the bike lane at midblock crossings to improve yielding to pedestrians. These changes will help reduce crossing distance for pedestrians and reduce speeds.

2. Build **bulbouts** (or curb extensions) at intersections and mid-block crossings to shorten the crossing distance for pedestrians.
3. Retain angled parking but convert to **back-in parking** to improve safety and visibility.

4. Provide accessible parking spaces with wide access aisles to accommodate vans with wheelchair lifts.
5. Make accessibility improvements to sidewalks and crossings.

6. Improve **lighting** for pedestrians and drivers.
7. Provide loading/unloading zones to accommodate freight deliveries
