# Current Research at FHWA Coatings and Corrosion Laboratory

Office of Research, Development, and Technology  
Federal Highway Administration (FHWA) Coatings and Corrosion Lab  
Current Activities—2022

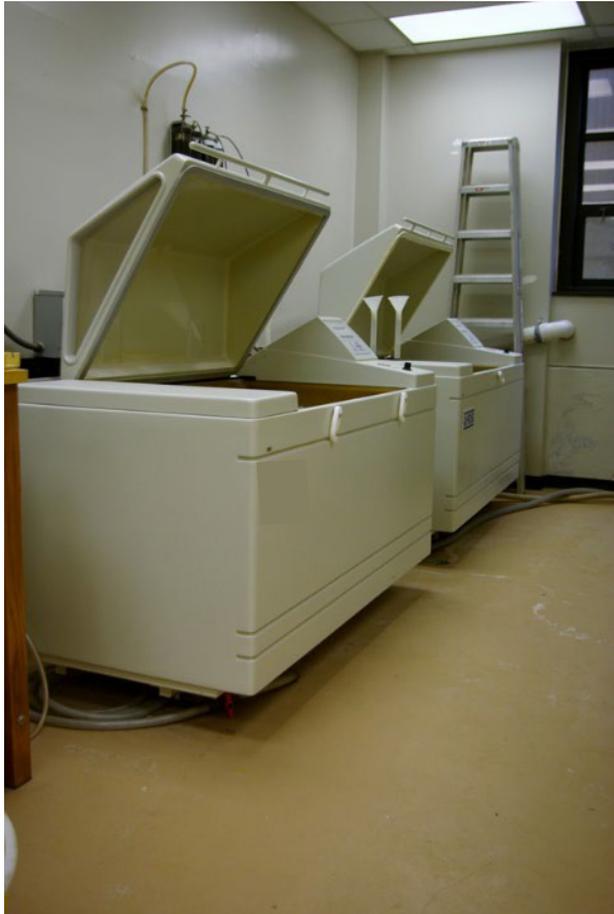
Salt fog chambers

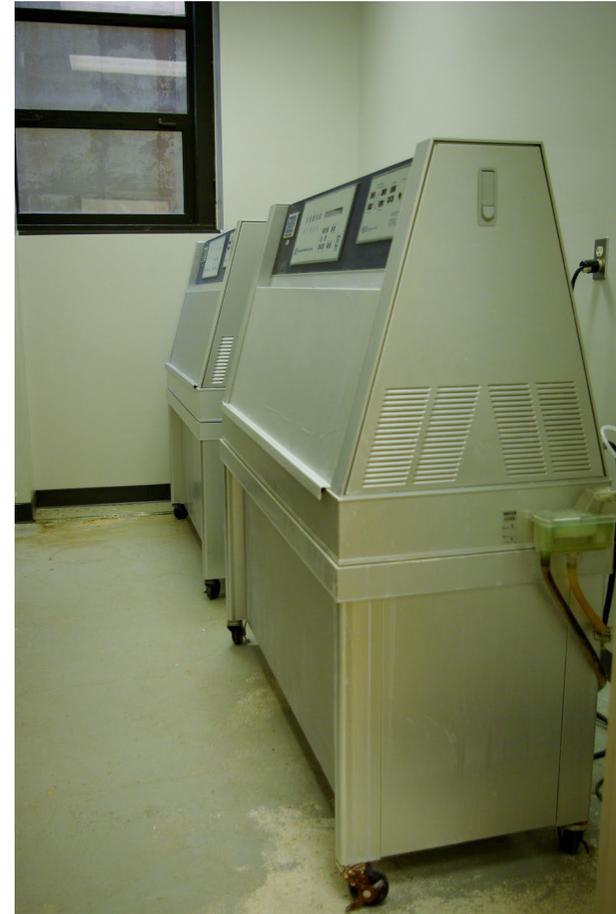
UV chamber

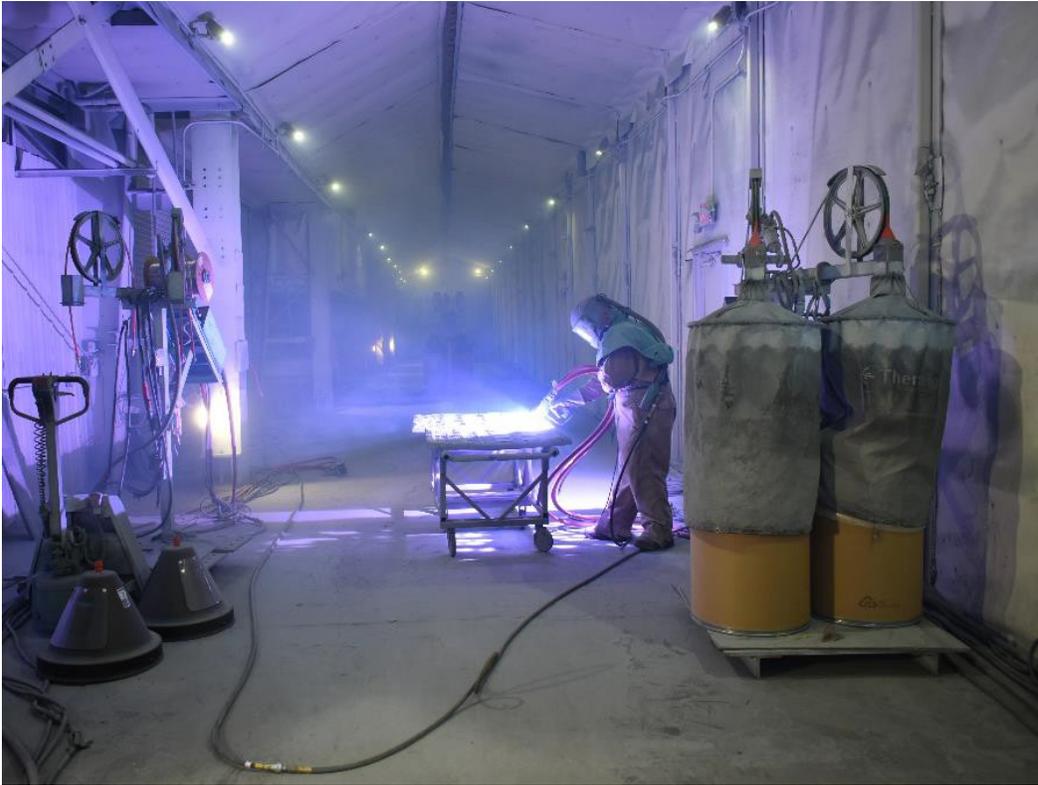
Thermal spray operation

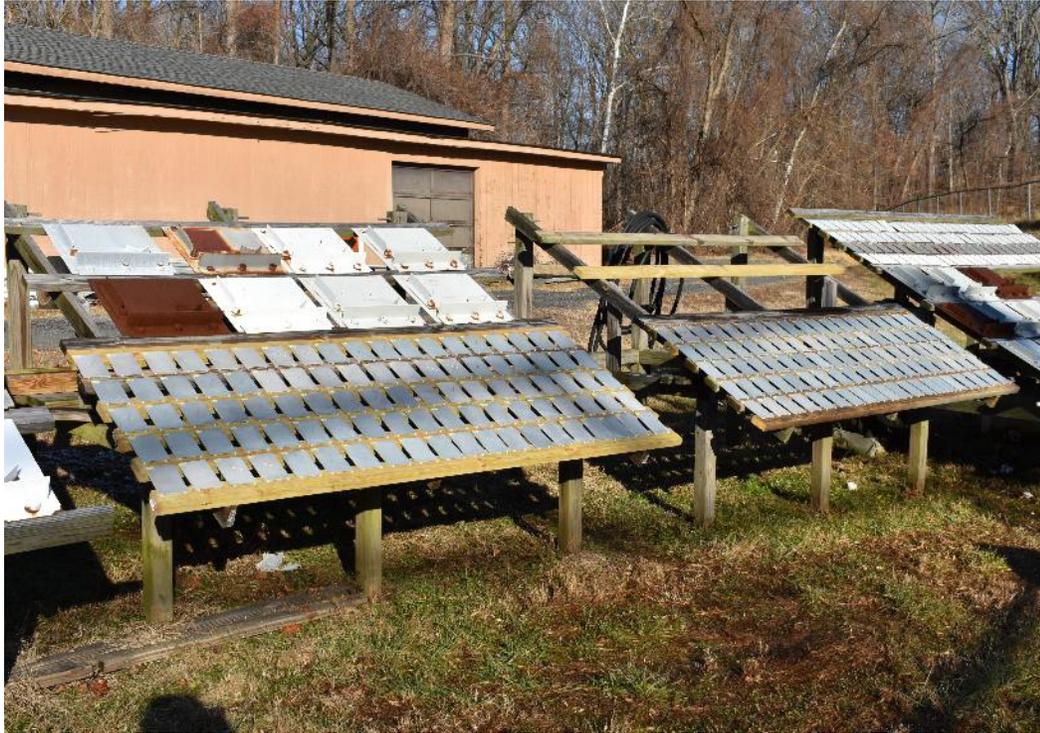
Outdoor exposure

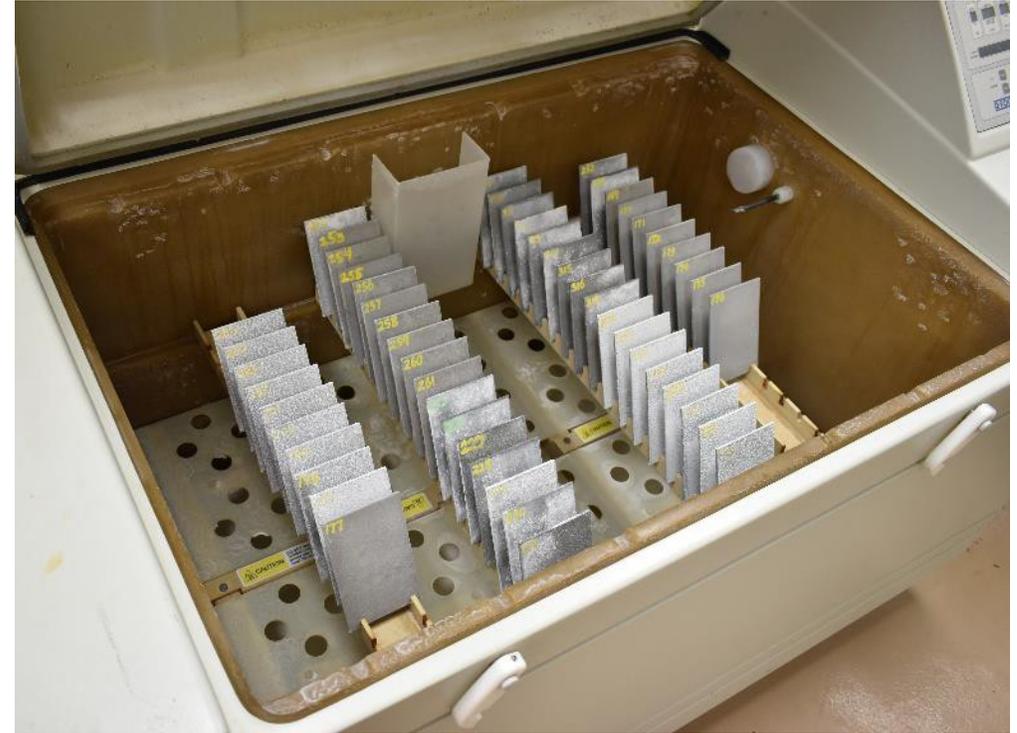
Panels in salt-fog chamber

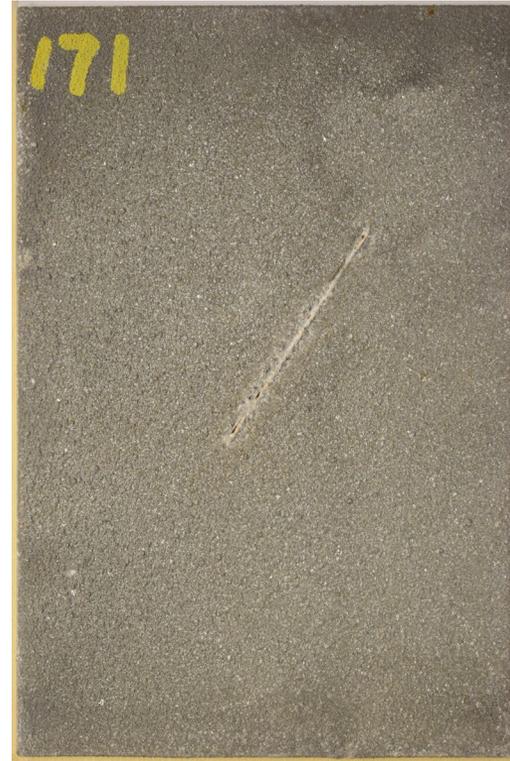
Aluminum coated

Coated panels after 10 ALT cycles

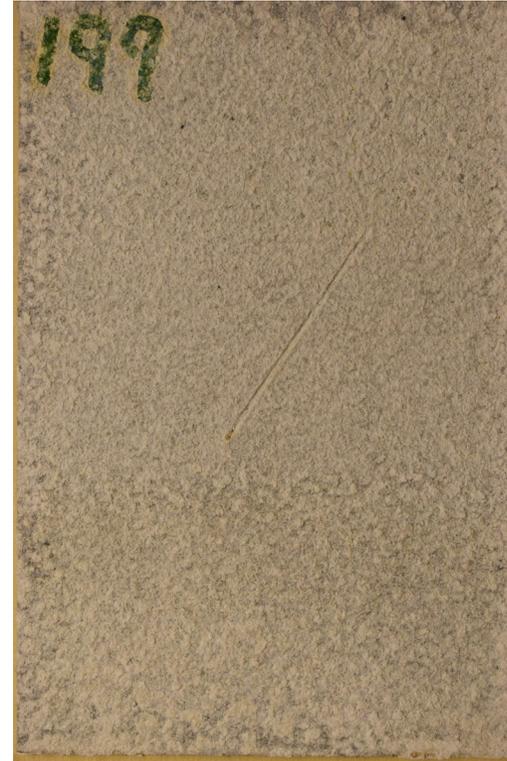
Zinc coated

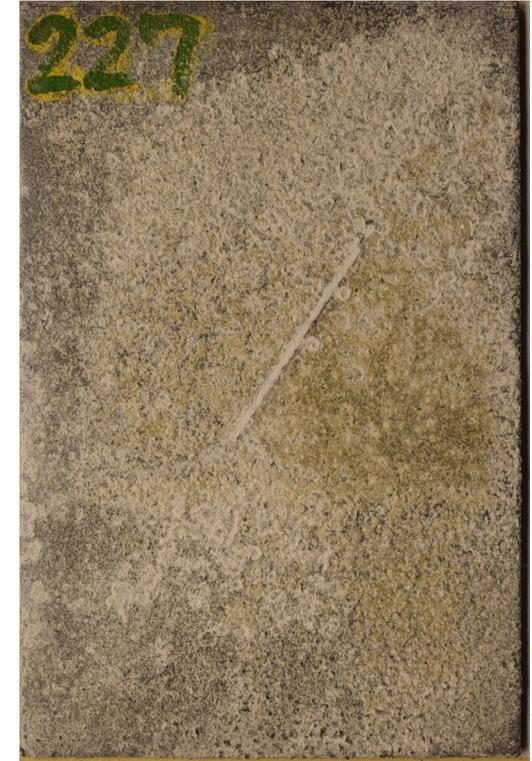
Aluminum-zinc coated

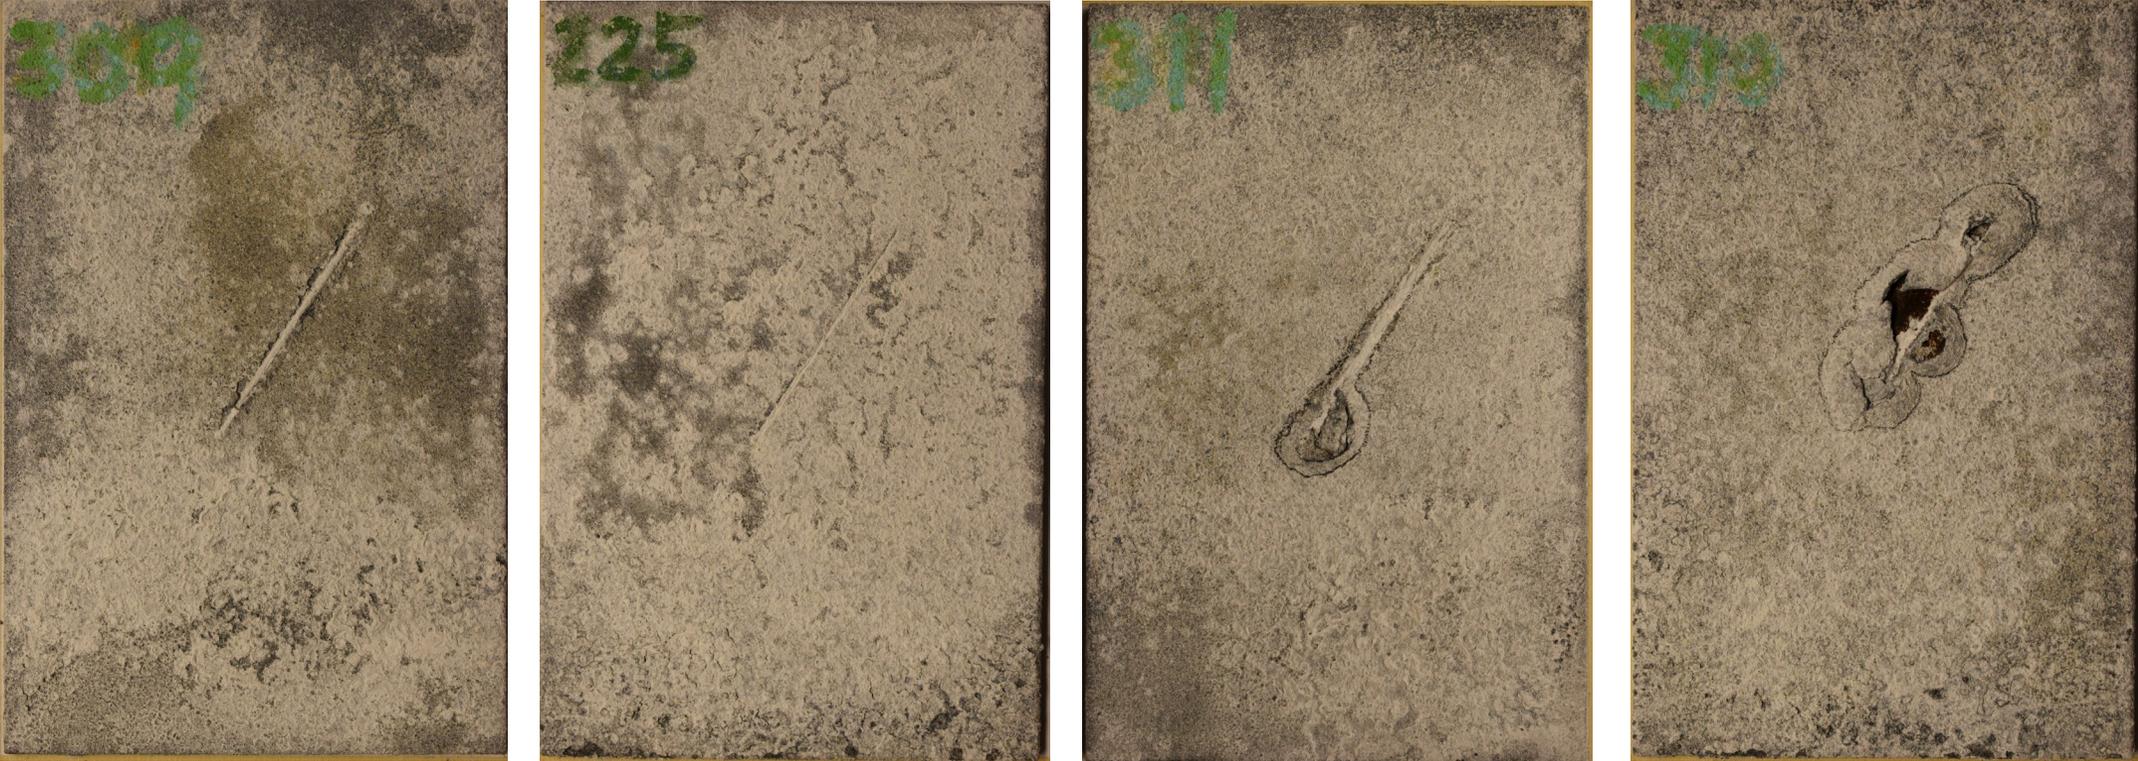
Aluminum-zinc coated panels showing coating failure after 10 ALT cycles

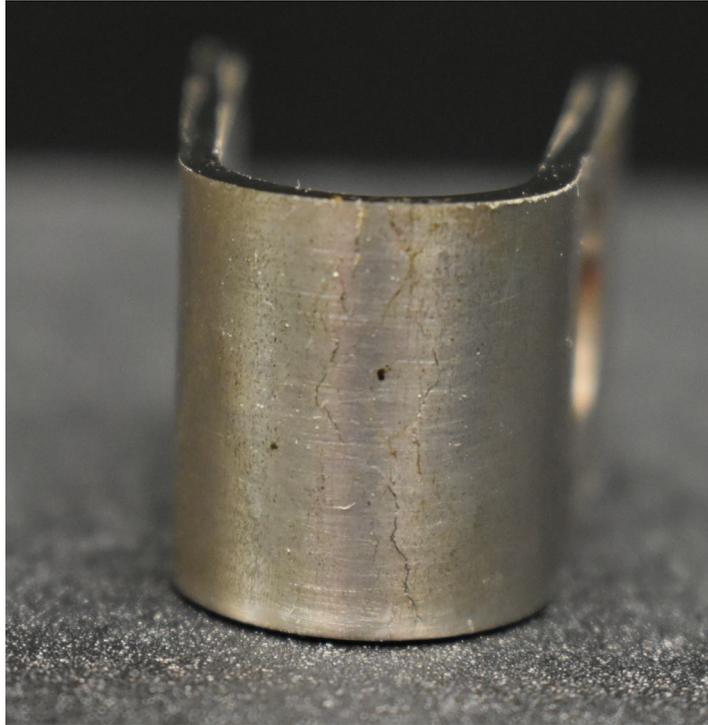
SCC in 316LN SS due to magnesium chloride

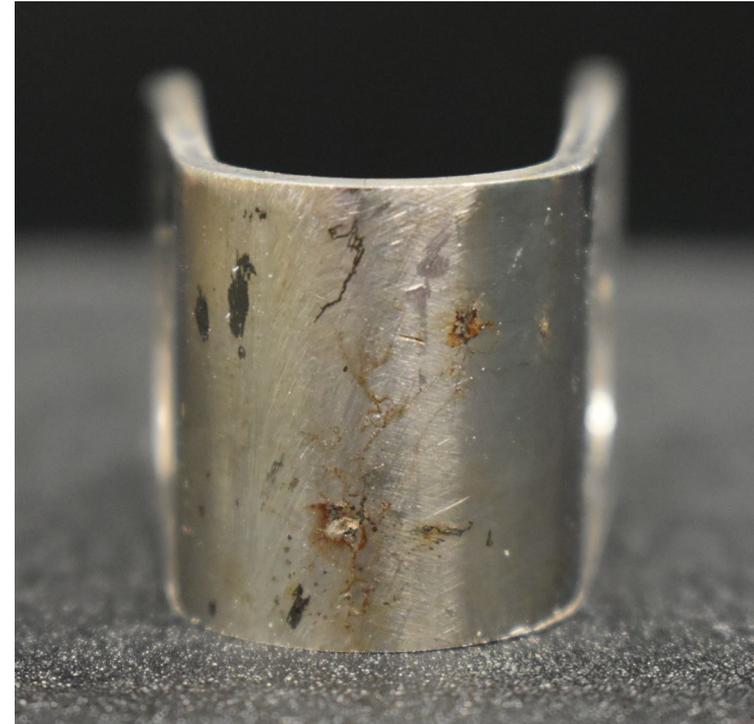
SCC in 304L SS due to calcium chloride

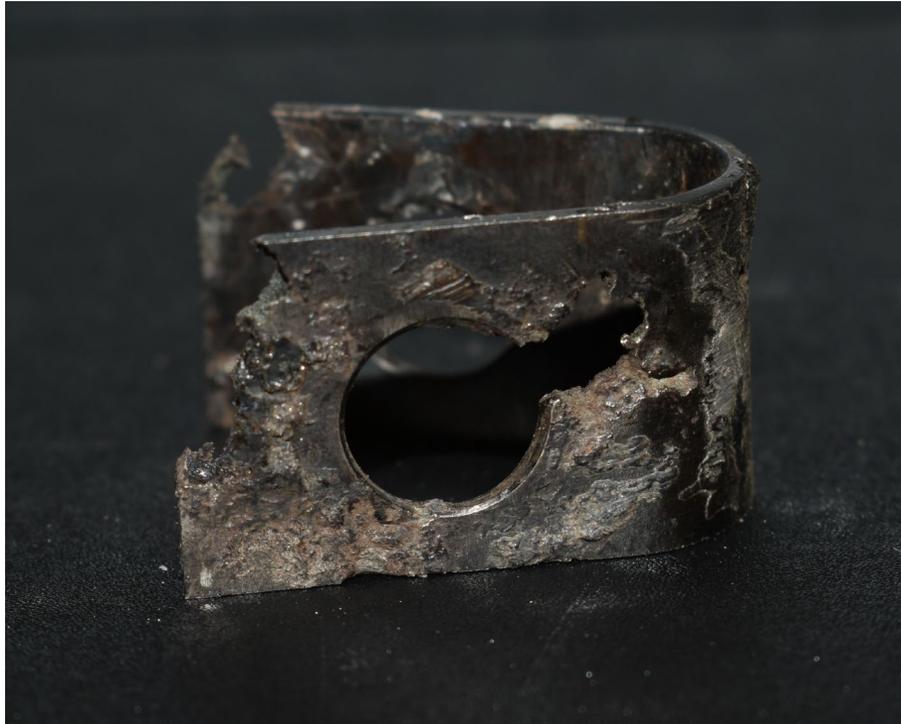
XM-28 in magnesium chloride

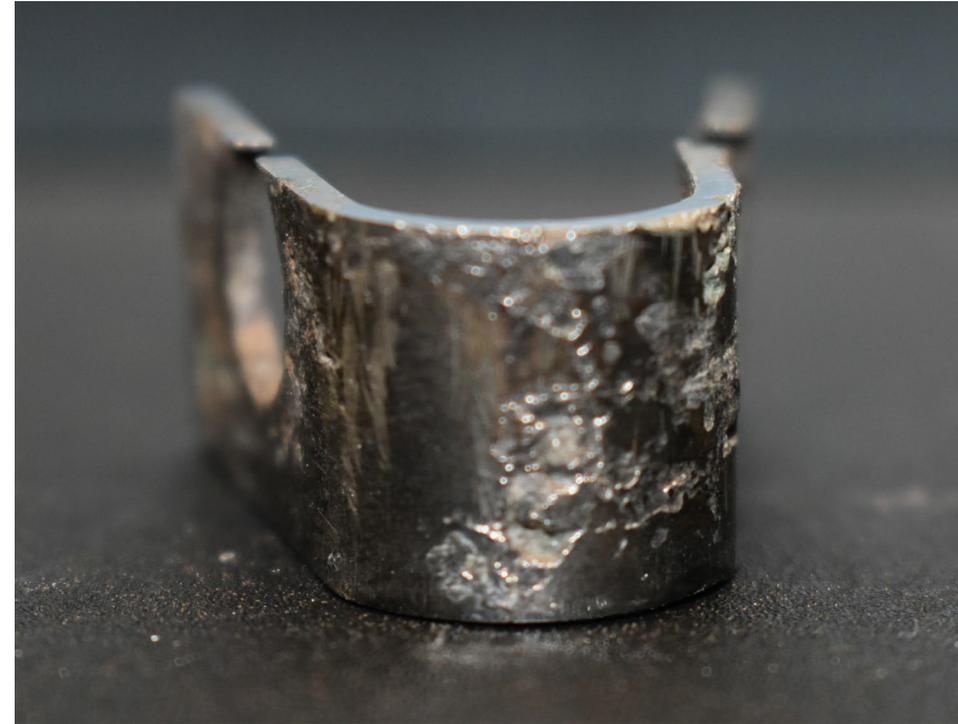
XM-28 in sodium chloride

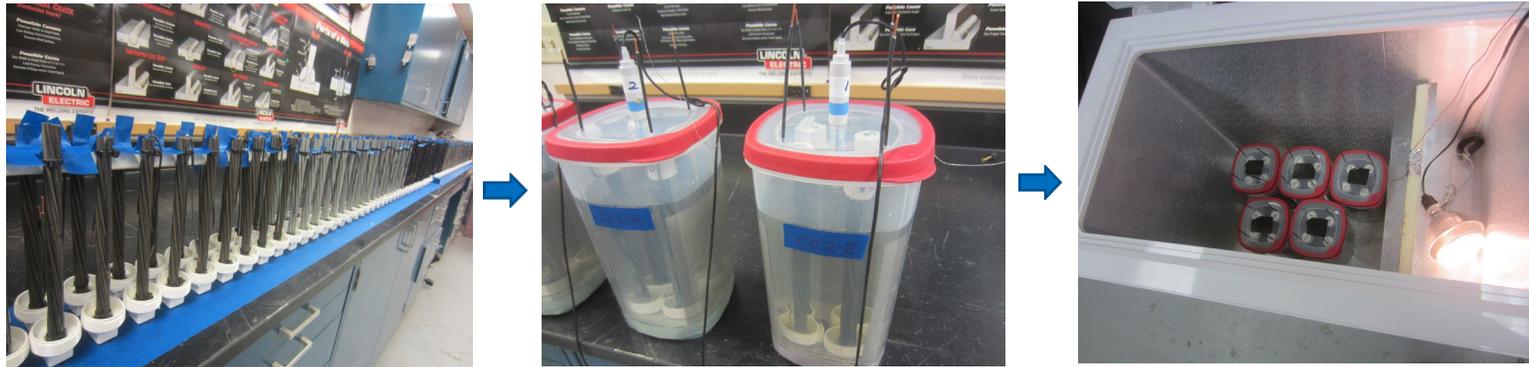
Corrosion resistance testing in simulated pore water and bleed water

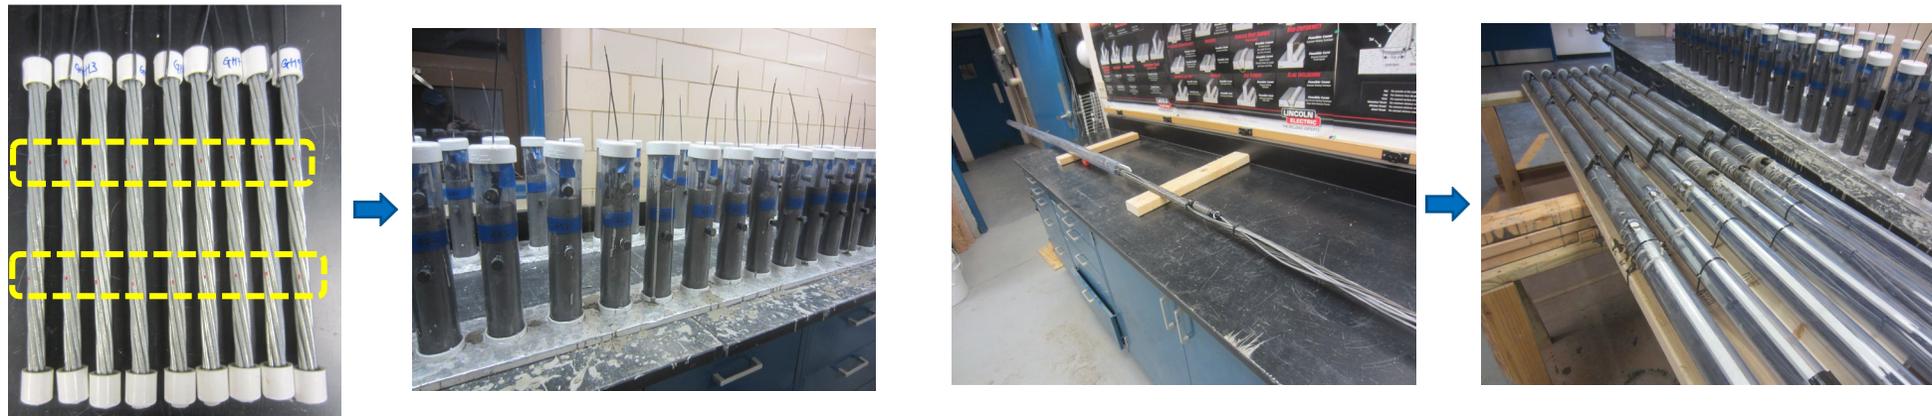
Corrosion resistance testing in real grout

Evaluation of corrosion mitigation methods
