**San Francisco PedSafe Phase II
FINAL IMPLEMENTATION REPORT AND EXECUTIVE
SUMMARY**

Pedestrian Safety Engineering and Intelligent Transportation System-Based Countermeasures
Program for Reduced Pedestrian Fatalities, Injuries,
Conflicts and Other Surrogate Measures

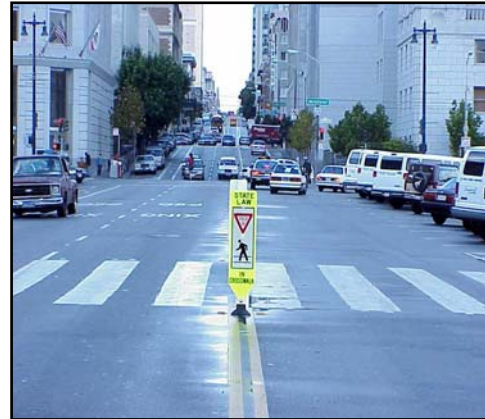
MUTCD R1-6 In-Street Pedestrian Crossing Signs (also known as impactable “Yield To Pedestrians” (YTP) signs) are intended for use at uncontrolled (unsignalized) crosswalks to remind drivers of laws regarding pedestrians’ right-of-way. They are more noticeable than roadside signs and may also exert a minor traffic-calming effect by effectively narrowing the inside lanes slightly. Dimensions and color: 12” x 44”, fluorescent yellow green diamond sheeting with 10” x 24” white high intensity sheeting insert. Overall height is 47 inches. The signs can be installed with either a portable or fixed base.

Careful consideration of turning movements, lane width and bus routes are important in determining the location for sign installation. Installation on a raised median island is preferable to installation directly on the roadway with only a double yellow split or painted island. Signs were often knocked down and/or damaged by cars, trucks and buses hitting them. The signs must be placed carefully, taking into account car and truck turning movements and lane widths, in order to reduce damage to the signs. San Francisco experienced high damage rates to signs located near left turn paths of intersections.

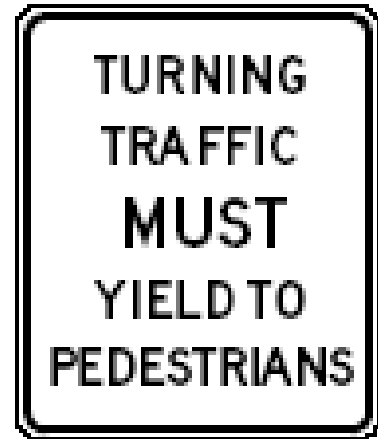
To remind drivers who are making turns to yield to pedestrians, particularly at signalized intersections where right turn on red (RTOR) is permitted and pedestrian crosswalks are marked, a “Turning Traffic Must Yield To Pedestrians” (R10-15) sign may be used. For application of these signs San Francisco selected intersections with higher levels of conflicts between turning vehicles and pedestrians and higher pedestrian collision rates from left-turning vehicles. Dimensions and color: standard size is 30” x 36” with black legend on white retro-reflective background. Some cities, such as San Ramon (CA) and San Francisco have used their own versions of these signs in the past. San Ramon’s sign was more distinctive than the MUTCD and included red and black text. In San Francisco the MUTCD-compliant signs were installed at eight intersections.

Some signs were not installed on the correct signal/streetlight poles or were not angled 45 degrees to turning traffic. Also several of the signs appeared to have been struck by turning trucks as they were loosened from their fasteners.

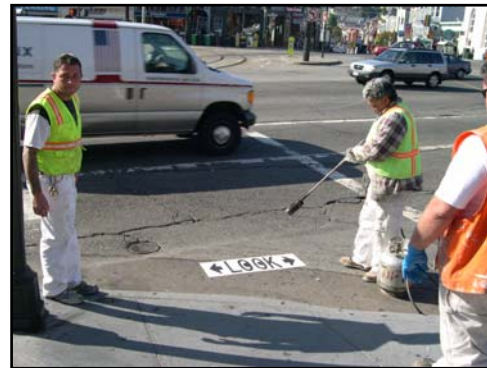
Pavement stencils are an inexpensive alternative to the electronic “animated eyes” signals countermeasure that was eliminated from the PedSafe study due to the lack of an available vendor to provide a combined animated eyes/countdown signal. The “LOOK” stencils remind pedestrians to look for cross and turning traffic before leaving the curb and entering the roadway. The stenciled images consist of opposing left- and right-pointing arrows with the word “LOOK” centered between them. These stencils are applied to the roadbed facing the sidewalk along the gutter line.

The word “LOOK,” in twelve-inch letters with left- and right-pointing arrows, is dye-cut into solid black and solid white pavement marking material. The two "O"s have small eyeballs on the inside of the letters to help advertise the intended message. The letters and arrows are interchanged with the background material to provide black-on-white and white-on-black messages, resulting in no wasted material. San Francisco also used bilingual, custom-made “LOOK” signs with both English words and Chinese characters.

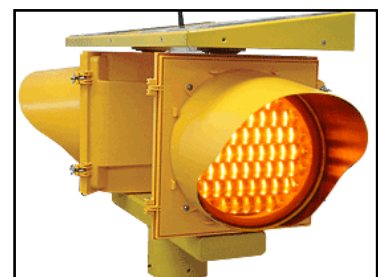
Push Button Activated Flashing Beacon (16th and Capp)

Two types of flashing beacons were studied at two intersections. At 16th & Capp, the beacon was push button activated and at Mission & Santa Rosa it was activated by infrared automatic detection. Results showed a substantial increase in vehicle yielding at both intersections. The countermeasure also produced a reduction in vehicle/pedestrian conflict and a reduction in pedestrians being diverted and/or trapped.

Pedestrian crossing signs and push button signs may require replacement due to vandalism or cleaning due to graffiti. The solar powered flashing beacon rechargeable battery may need to be replaced every 3-5 years under normal operating conditions.

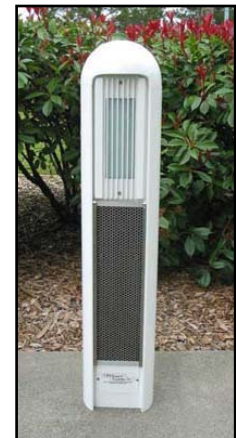
The Mission Street and Santa Rosa Avenue location is a T-intersection previously used to test in-pavement crosswalk lights prior to the PedSafe project. The crosswalk lights were removed due to malfunctioning caused by water collecting in the light fixtures and poor microwave detector performance. This study location was selected because of the need for a warning device to increase driver yielding to

Infrared detectors were used to activate a flashing beacon. For the east crosswalk approach, two above ground bollards were installed. At the west crosswalk approach, one bollard was replaced with an in-surface activation device (ISAD), due to concern that a full-height bollard would be subject to knockdown by turning vehicles.

After installation we received reports of a malfunctioning flashing beacon. After inspection by our signal shop, it was determined that the malfunction was caused by a combination of a bad wire connection and vandalism (graffiti sprayed across the infrared detection signal). The signal shop was able to repair the wire connection and clean the infrared detection area to correct the problem.

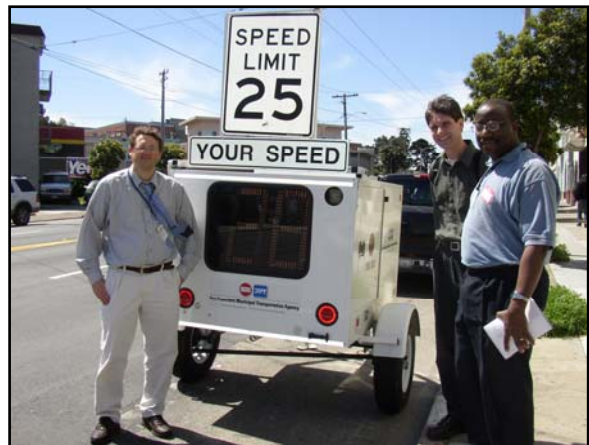
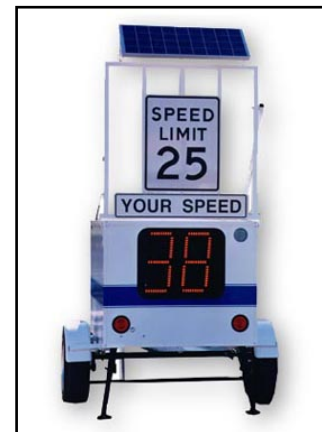
Portable Changeable Message Speed Limit Signs, also known as “radar speed trailers,” are used to deter speeding. Radar speed trailer signs display the speed of oncoming traffic and flash LEDs when a vehicle exceeds the posted speed limit. A speed limit sign is included on the trailer. Above a user-selected maximum, the sign “blanks out” to avoid enticing drivers into exhibitions of speed. Speed data is recorded using a customized, portable computer located in the trailer and downloaded onto a desktop computer using SmartStat software.

The Portable Changeable Message Speed Limit Sign was deployed at approximately 50 locations spread across seven zones throughout the city of San Francisco with higher rates of pedestrian collisions. Radar Portable Changeable Message Speed Limit Signs are often deployed along major arterials, or near college and school campuses.

During the implementation phase the NEC computer had to be returned to the vendor, Kustom Signals, Inc., for repairs. At another stage during trailer deployment the display board was damaged due to vandalism and was again returned to the vendor for repair.

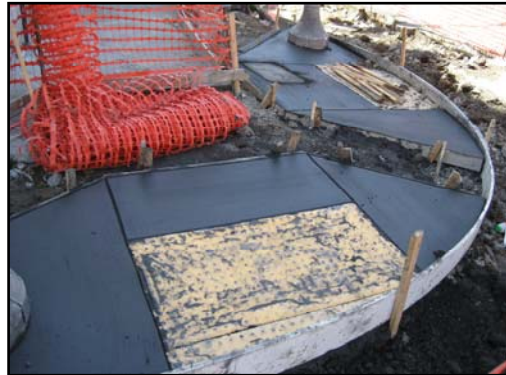
ADA curb ramps are curb cut outs that facilitate easier crossing, in compliance with the Americans With Disabilities Act of 1990. Deficient curb ramps were replaced and detectable warning strips installed at one intersection for the PedSafe study. These measures included shortening a gas station driveway that intruded into a major crosswalk, replacing it with a curb ramp built to comply with new ADA standards, including the use of truncated or tactile dome mats (colored plastic mats with raised domes on their surface which serve as cues signaling the boundary between the street and sidewalk for the visually impaired). Curb ramp improvements benefit all pedestrians by making street crossing more accessible to elderly pedestrians, children, and pedestrians with strollers, not only pedestrians with physical impairments. The Pedestrian and Bicycle Information Center is a good resource for design guidelines and standards for pedestrian improvements, particularly for designing improvements in compliance with The Americans with Disabilities Act (ADA).

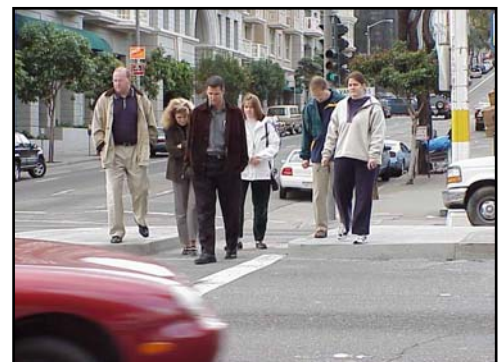
Median refuge islands provide a safe retreat for pedestrians crossing wide, multilane streets with long crossing distances. The islands encourage pedestrians to wait before completing crossing, rather than rushing across traffic. The islands also act as a traffic calming device by forcing left-turning vehicles to reduce their speeds to make shorter

radius turns. Median refuge islands were installed at two signalized intersections, prioritized by curb-to-curb crossing width, multiple lanes, high pedestrian volumes, and history of pedestrian collisions caused by turning vehicles.

The design and construction of median refuge islands followed local, state, and federal guidelines and standards, including recommended minimum size requirements (AASHTO guidance: 50 square feet) and the use of white reflective paint and T-markers at ends of median islands, if necessary, to reduce the likelihood and extent of collision damage to the islands.

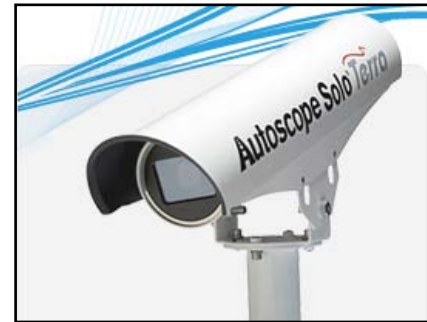
Automated video detection of pedestrians was installed to provide up to 3 additional seconds of crossing time for pedestrians who were predicted not to reach the curb before traffic was released. Detection zones were grouped into south curb, center, and north curb zones. As a pedestrian crosses the street, a video camera mounted on a utility pole detects the pedestrian crossing into each zone. If a pedestrian is detected at a time and location predicting that the pedestrian will not reach the curb before the light turns red, the signal will extend the solid Red Hand (Don't Walk) and green ball up to 3 seconds. When such an extension is made, a compensating reduction in the Walk phase is made on the next cycle so that the cross street does not lose overall green light time. The video detector was installed at one crosswalk at the intersection of 9th and Howard Streets.

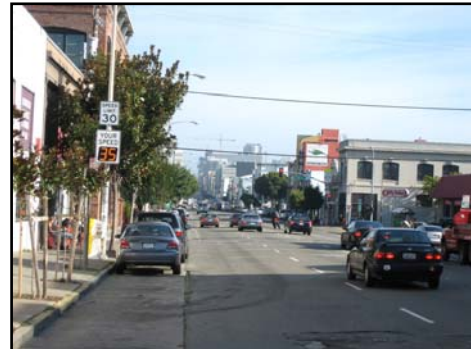
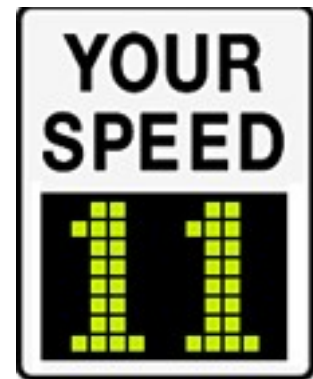
Fixed Changeable Message Speed Limit signs (also known as driver feedback signs, radar speed display signs, or variable message signs) are interactive signs, generally constructed of a series of LEDs that display vehicle speed as motorists approach. Their purpose is to make drivers aware of their current speed and to encourage those who are speeding to slow down to the legal limit. They are used as a traffic calming device in addition to or instead of physical devices such as speed humps.

Four Changeable Message Speed Limit signs were installed, two at each of two locations; west of Castro on Market Street and near the newly-relocated Bessie Carmichael School in the South of Market neighborhood. The precise installation locations were selected because they had been identified as areas where speeding was a problem, and also because the utility poles to which they were mounted offered convenient electrical service for the signs. Changeable Message Speed Limit signs display the speed of oncoming traffic and flash LEDs when a vehicle exceeds the posted speed limit. Above a certain maximum, the sign “blanks out” to avoid enticing drivers into exhibitions of speed. Speed data were downloaded using a Palm Pilot PDA with Bluetooth software. The signs were installed mid-block near the four locations shown in Table 3.12-1.

Street light poles needed to be surveyed to determine whether appropriate electrical wiring and service points were available for connection to the fixed radar speed signs. In addition to being located where electricity was available, the signs also needed to be placed at strategic locations (e.g., not too close to intersections or to visual distractions). Some of the selected locations did not have adequate electrical service points so alternate locations had to be found for the installations. At some of the locations, the growth of nearby trees blocked visibility of the signs, requiring tree branches to be trimmed, and at one location the radar speed sign had to be relocated to a different street light pole location not blocked by foliage.

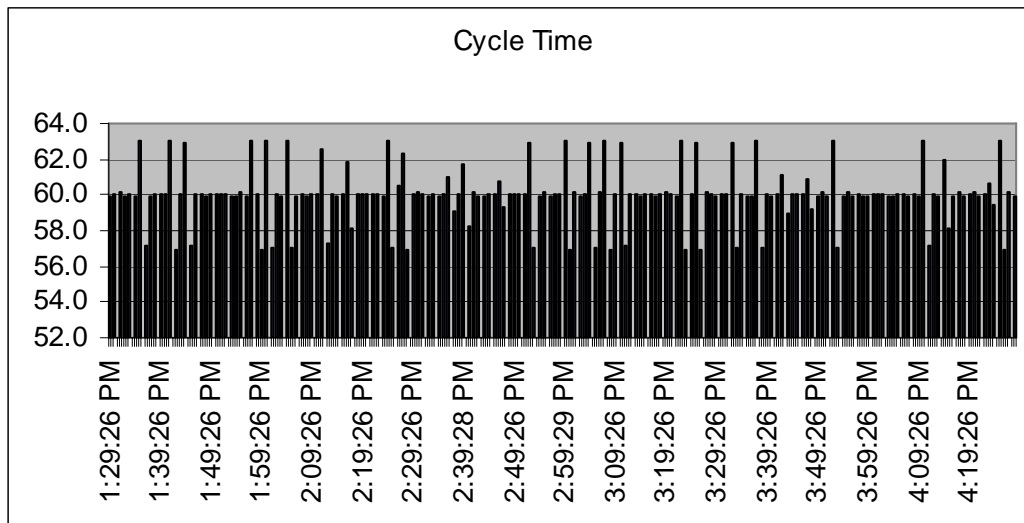
Figure 4.2-4
Pattern of Cycle Lengths

The manual results are consistent with findings by Econolite that during a typical 3-hour afternoon period, there was an extension over 1 second in length for 14% of the cycles. (See Figure 4.2-4.) The signal timing was set so that an extension was followed by a compensating reduction in the Walk phase of the next cycle to maintain the average 60-second cycle. In the figure, the bars exceeding 60 seconds indicate triggering of the timing extension, while bars shorter than 60 seconds indicate the compensating reduction in time during the following cycle. The figure suggests that the extension logic was successfully implemented.

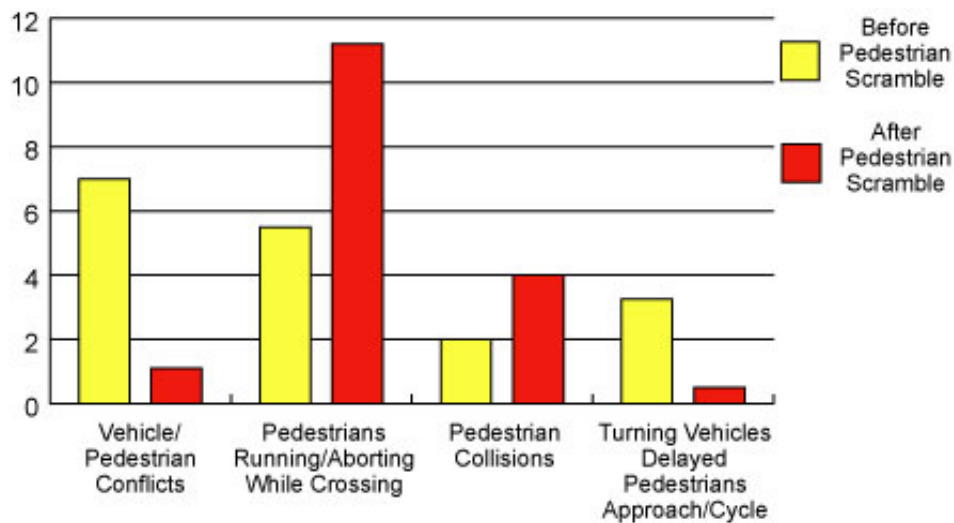
Impact of Pedestrian Scrambles on Pedestrian Safety and Convenience

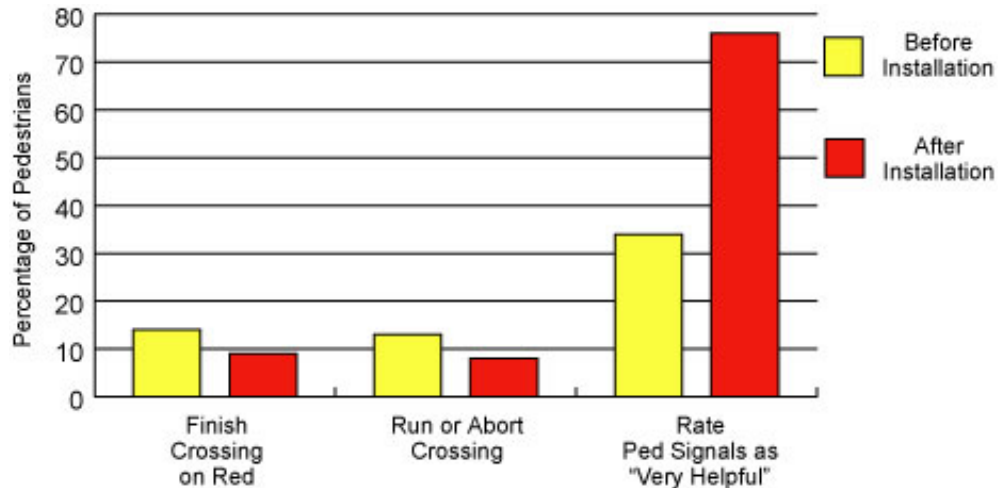
Figure 4.3-2
Pedestrian Countdown Signals Pilot Project: Impacts on Behavior and Attitudes

Pedestrian countdown signals were responsible for statistically significant improvements in pedestrian behavior and attitudes. Pedestrians finishing crossing in the red phase decreased from 14% to 9%. The proportion of pedestrians running or aborting their crossing decreased from 13% to 8%. The proportion of pedestrians finding the pedestrian signals "very helpful" increased from 34% to 76%. (See Figure 4.3-3.)
