U.S. Department
of Transportation
**Federal Highway
Administration**

March 8, 2018

- Big Sandy MASH

Name of system: Big Sandy MASH
Type of system: Crash Cushion
Test Level: MASH Test Level 3 (TL3)
Testing conducted by: KARCO
Date of request: September 14, 2017
Date initially acknowledged: September 20, 2017

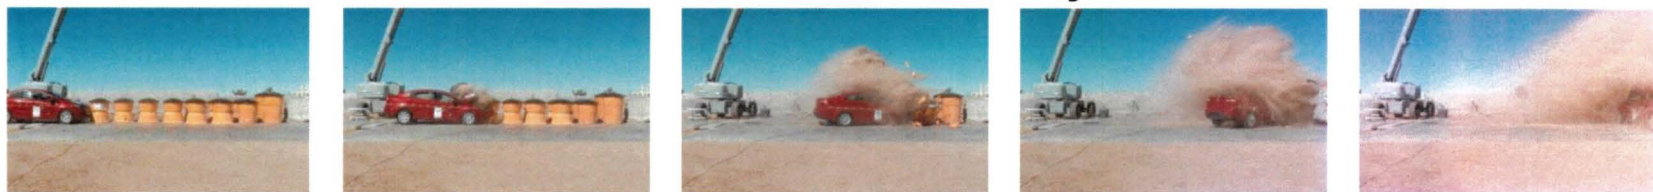
Figure 2 Summary of Test 3-40

MASH Test 3-40 Summary

General Information	
Test Agency.....	KARCO Engineering, LLC.
KARCO Test No.....	P37027-01
Test Designation.....	3-40
Test Date.....	03/06/17
Test Article	
Name / Model.....	Big Sandy
Type.....	Crash Cushion
Article Length.....	28.1 ft. (8.6 m)
Installation Length.....	49.1 ft (15.0 m)
Road Surface.....	Concrete
Test Vehicle	
Type / Designation.....	1100C
Year, Make, and Model.....	2013 Kia Rio
Curb Mass.....	2,538.6 lbs (1,151.5 kg)
Test Inertial Mass.....	2,464.7 lbs (1,118.0 kg)
Gross Static Mass.....	2,638.9 lbs (1,197.0 kg)

Impact Conditions	
Impact Velocity.....	63.11 mph (101.57 km/h)
Impact Angle.....	0.5°
Location / Orientation.....	Offset 16.9 in (430 mm) towards the passenger side
Kinetic Energy.....	328.2 kip-ft (444.9 kJ)
Exit Conditions	
Exit Velocity.....	N/A
Exit Angle.....	N/A
Final Vehicle Position.....	66.3 ft (20.2 m) downstream
	55.3 ft. (16.9 m) left
Vehicle Snagging.....	None
Vehicle Pocketing.....	None
Vehicle Stability.....	Satisfactory
Maximum Roll Angle.....	3.7°
Maximum Pitch Angle.....	3.6°
Maximum Yaw Angle.....	107.8°

Occupant Risk	
Longitudinal OIV.....	23.6 ft/s (7.2 m/s)
Lateral OIV.....	0.3 ft/s (0.1 m/s)
Longitudinal RA.....	-13.3 g
Lateral RA.....	3.5 g
THIV.....	23.6 ft/s (7.2 m/s)
PHD.....	13.3
ASI.....	0.68
Test Article Deflections	
Static.....	N/A
Maximum Debris Field.....	33.7 ft. (10.3 m) left
	110.8 ft. (33.8 m) forward
Vehicle Damage	
Vehicle Damage Scale.....	12-FC-4
CDC.....	12FDEW3
Maximum Intrusion.....	Windshield

Required Test Number	Narrative Description	Evaluation Results
3-32 (1100C)	Not applicable for non-redirective crash cushion	Non-Relevant Test, not conducted
3-33 (2270P)	Not applicable for non-redirective crash cushion	Non-Relevant Test, not conducted
3-34 (1100C)	Not applicable for non-redirective crash cushion	Non-Relevant Test, not conducted
3-35 (2270P)	Not applicable for non-redirective crash cushion	Non-Relevant Test, not conducted
3-36 (2270P)	Not applicable for non-redirective crash cushion	Non-Relevant Test, not conducted
3-37 (2270P)	Not applicable for non-redirective crash cushion	Non-Relevant Test, not conducted
3-38 (1500A)	Not applicable for non-redirective crash cushion	Non-Relevant Test, not conducted
3-40 (1100C)	<p>The Big Sandy Array was positioned offset a quarter of the vehicle's width toward the passenger side. The offset position examines the risk of exceeding occupant risk values, vehicle instability, and vehicle yaw movement. The test was conducted using a commercially available 2013 Kia Rio 4-door sedan with a test inertial mass of 2464.7 lbs (1118.0 kg). The vehicle was in good condition, was free of major body damage, and was not missing any structural components. The bumpers were standard equipment and were not modified for this test. Based on CarFax reporting there was no recorded history of major accidents, was not a salvage titled vehicle, not involved in flooding, or fire. The test vehicle impacted the front 200 lb (90 kg) combo barrel in the array at a velocity of 63.11 mph (101.57 km/hr) and at an impact angle of 0.5° resulting in the barrel fracturing into pieces and dispersing the contained sand. As the test vehicle intruded further into the array the sand barrels that came into contact with the vehicle fractured into pieces and dispersed the contained sand. The vehicle rotated about its yaw axis before coming to a controlled stop 66.3 ft (20.2 m) forward and 55.3 ft (16.9 m) to the left of the initial impact point. The vehicle remained upright throughout the impact event. The test vehicle's occupant compartment was not penetrated and measurable in cab deformation was deemed acceptable. The maximum roll and pitch angle did not exceed 75° and occupant risk values were within limits per MASH specifications for Occupant Impact Velocity (OIV) and Ridedown Acceleration (RA).</p>	PASS

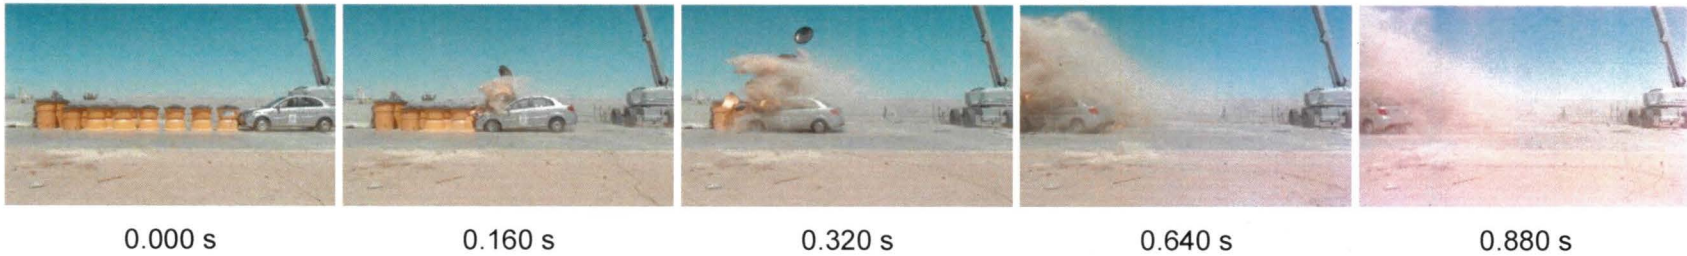
Figure 2 Summary of Test 3-42

MASH Test 3-42 Summary

General Information	
Test Agency.....	KARCO Engineering, LLC.
KARCO Test No.....	P37115-01
Test Designation.....	3-42
Test Date.....	4/14/17
Test Article	
Name / Model.....	Big Sandy
Type.....	Crash Cushion
Article Length.....	28.1 ft. (8.6 m)
Installation Length.....	59.1 ft (18.0 m)
Road Surface.....	Concrete
Test Vehicle	
Type / Designation.....	1100C
Year, Make, and Model.....	2011 Kia Rio
Curb Mass.....	2,307.1 lbs (1,046.5 kg)
Test Inertial Mass.....	2,401.9 lbs (1,089.5 kg)
Gross Static Mass.....	2,572.8 lbs (1,167.0 kg)

Impact Conditions	
Impact Velocity.....	66.58 mph (107.15 km/h)
Impact Angle.....	5.2°
Location / Orientation.....	1.0 in (25 mm) right of the vehicles centerline
Kinetic Energy.....	355.9 kip-ft (482.6 kJ)
Exit Conditions	
Exit Velocity.....	N/A
Exit Angle.....	N/A
Final Vehicle Position.....	48.8 ft (14.9 m) downstream 3.6 ft. (1.1 m) left
Vehicle Snagging.....	None
Vehicle Pocketing.....	None
Vehicle Stability.....	Satisfactory
Maximum Roll Angle.....	5.0°
Maximum Pitch Angle.....	-3.2°
Maximum Yaw Angle.....	28.8°

Occupant Risk	
Longitudinal OIV.....	23.6 ft/s (7.2 m/s)
Lateral OIV.....	2.0 ft/s (0.6 m/s)
Longitudinal RA.....	-14.5 g
Lateral RA.....	2.8 g
THIV.....	23.6 ft/s (7.2 m/s)
PHD.....	14.5
ASI.....	0.8
Test Article Deflections	
Static.....	N/A
Maximum Debris Field.....	54.6 ft. (16.6 m) left 105.3 ft. (32.1 m) forward
Vehicle Damage	
Vehicle Damage Scale.....	12-FC-3
CDC.....	12FDEW2
Maximum Intrusion.....	Windshield

3-42 (1100C)	<p>The Big Sandy Array was positioned at a nominal angle of 5° with the center of the test vehicle. The angle position examines the risk of exceeding occupant risk values, vehicle instability, capacity to absorb sufficient impact energy, and the Big Sandy's ability to bring the vehicle to a safe controlled stop. The test was conducted using a commercially available 2011 Kia Rio 4-door sedan with a test inertial mass of 2401.9 lbs (1089.5 kg). The vehicle was in good condition, was free of major body damage, and was not missing any structural components. The bumpers were standard equipment and were not modified for this test. Based on CarFax reporting there was no recorded history of major accidents, was not a salvage titled vehicle, not involved in flooding, or fire. The test vehicle impacted the front 200 lb (90 kg) combo barrel in the array at a velocity of 66.58 mph (107.15 km/hr) and at an impact angle of 5.2° resulting in the barrel fracturing into pieces and dispersing the contained sand. As the test vehicle intruded further into the array the sand barrels that came into contact with the vehicle fractured into pieces and dispersed the contained sand. The vehicle rotated about its yaw axis before coming to a controlled stop 48.8 ft (14.9 m) forward and 3.6 ft (1.1 m) to the left of the initial impact. The vehicle remained upright throughout the impact event. The test vehicle's occupant compartment was not penetrated and measurable in cab deformation was deemed acceptable. The maximum roll and pitch angle did not exceed 75°. Occupant risk values are within limits per MASH specifications for Occupant Impact Velocity and Ridedown Acceleration.</p>	PASS

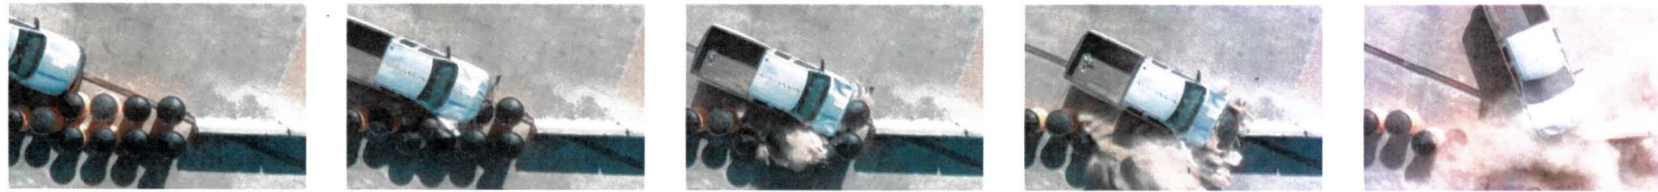
Figure 2 Summary of Test 3-44

MASH Test 3-44 Summary

<p>General Information</p> <p>Test Agency..... KARCO Engineering, LLC. KARCO Test No..... P38019-01 Test Designation..... 3-44 Test Date..... 01/05/18</p> <p>Test Article</p> <p>Name / Model..... Big Sandy Type..... Crash Cushion Article Length..... 28.1 ft. (8.6 m) Installation Length..... 49.1 ft (15.0 m) Road Surface..... Concrete</p> <p>Test Vehicle</p> <p>Type / Designation..... 2270P Year, Make, and Model..... 2013 RAM 1500 Curb Mass..... 4,784.0 lbs (2,170.0kg) Test Inertial Mass..... 4,995.6 lbs (2,266.0 kg) Gross Static Mass..... 4,995.6 lbs (2,266.0 kg)</p>	<p>Impact Conditions</p> <p>Impact Velocity..... 61.26 mph (98.59 km/h) Impact Angle..... 19.9° Location / Orientation..... Center of vehicle to corner of backup structure Kinetic Energy..... 626.7 kip-ft (849.7 kJ)</p> <p>Exit Conditions</p> <p>Exit Velocity..... N/A Exit Angle..... N/A Final Vehicle Position..... 18.2 ft (5.6 m) downstream 6.2 ft. (1.9 m) left</p> <p>Vehicle Snagging..... None Vehicle Pocketing..... None Vehicle Stability..... Satisfactory Maximum Roll Angle..... -6.1° Maximum Pitch Angle..... 5.2° Maximum Yaw Angle..... -43.1°</p>	<p>Occupant Risk</p> <p>Longitudinal OIV..... 35.8 ft/s (10.9 m/s) Lateral OIV..... 4.3 ft/s (1.3 m/s) Longitudinal RA..... -23.3 g Lateral RA..... 4.0 g THIV..... 35.8 ft/s (10.9 m/s) PHD..... 23.3 g ASI..... 1.45</p> <p>Test Article Deflections</p> <p>Static..... N/A Maximum Debris Field..... 30.9 ft. (9.4 m) left 83.7 ft. (25.5 m) forward</p> <p>Vehicle Damage</p> <p>Vehicle Damage Scale..... 12-FC-5 CDC..... 12FDEW3 Maximum Intrusion..... Floorpan</p>

3-44 (2270P)	<p>The Big Sandy Array was positioned at a nominal angle of 20° and the center line of the impacting vehicle was directed at the corner of the barrier. The vehicle impacted the crash cushion 14.63 ft (4.4 m) from the barrier and 2.44 ft (0.743 m) from the center line of the vehicle. Two 3-44 tests were run. One conducted with freestanding barrier and one with permanently anchored barrier</p> <p>For the test with freestanding barrier (Report TR-P36301) a 2012 Ram 4-door truck was used with an inertial mass of 5004.4 lbs (2270.0 kg), at an impact velocity of 60.32 mph (97.07 km/hr), and at an impact angle of 20.2 °. The vehicle rotated in a clockwise direction about the vertical axis and came to a controlled stop 26.7 ft (8.1 m) forward and 2.4 in (61 mm) from the impact point.</p> <p>For the test with anchored barrier (Report TR-38019) a 2013 Ram 4-door truck was used with an inertial mass of 4995.6 lbs (2266.0 kg), at an impact velocity of 61.26 mph (98.59 km/hr), and at an impact angle of 19.9 °. The vehicle rotated in a clockwise direction about the vertical axis and came to a controlled stop 18.2 ft (5.6 m) forward and 6.2 ft (1.9 m) from the impact point.</p> <p>For both 3-44 tests the truck contacted the first double row of 700 lbs (320 kg) barrels approx. 13.5 ft (4.1 m) from the front of the Big Sandy System. The first impacted barrels fractured dispersing the contained sand. As the vehicle intruded further into the array all the barrels rearward fractured and dispersed the contained sand.</p> <p>The CIP was defined in specifications in MASH for test procedures for Gating Non-Redirective Crash Cushions. The trucks were free of major body damage and based on CarFax there was no recorded history of major accidents. For both tests the truck remained upright, and did not exhibit vaulting. The maximum roll and pitch angle did not exceed 75°. The occupant compartments were not penetrated and there were no measurable in cab deformation beyond the allowed limit defined in MASH.</p>	PASS

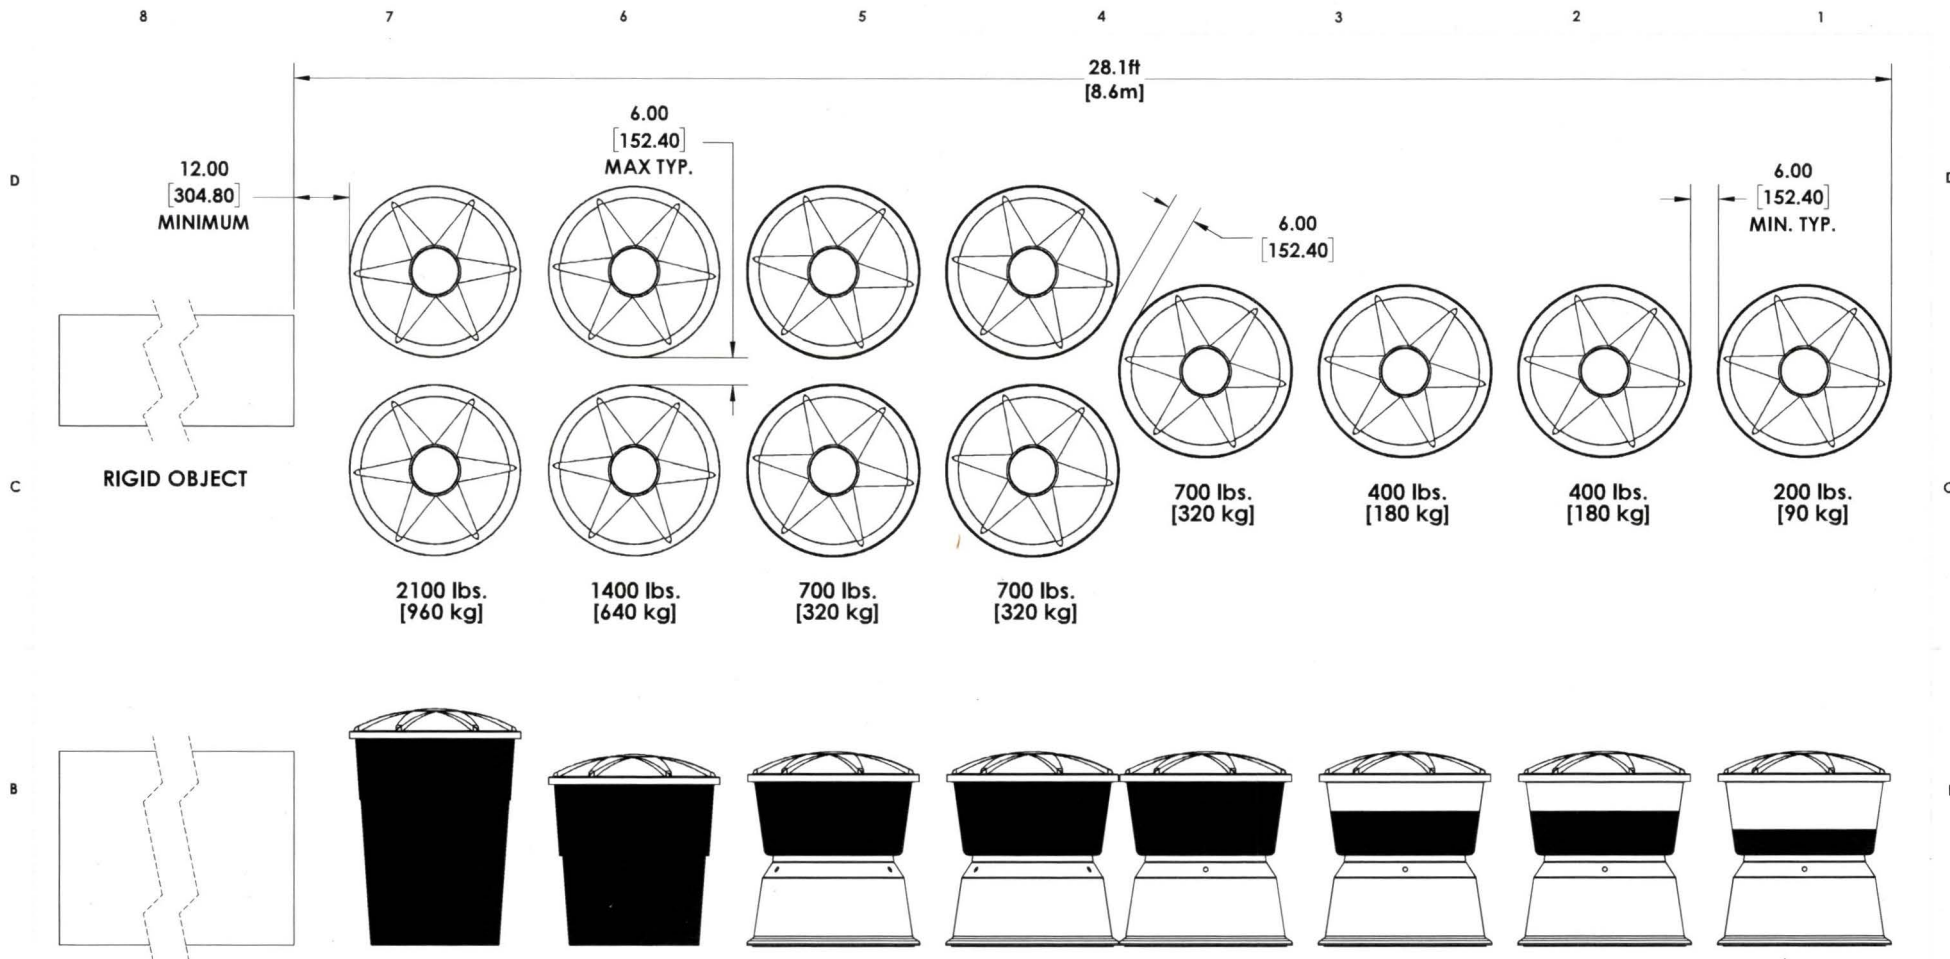
DWG. NO.
200-100

TITLE:
**Big Sandy
 12 Barrel Array**

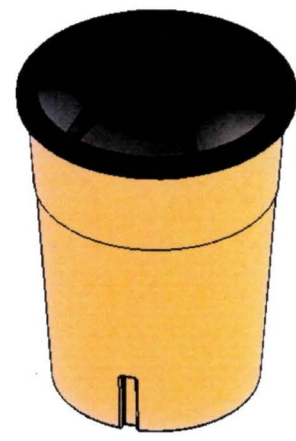
DWG. NO.
200-103

Exploded View

Assembled View

TITLE:
Big Sandy 2100 lbs. Barrel

The Big Sandy barrels come in three configurations 2100 lb. (960 kg) barrels with an overall height of 52.5 in. (1333.5mm), 1400 lb. (640 kg) barrels with an overall height of 40.75 in. (1035mm), and a two-piece combo barrel consisting of a pedestal base, and an upper canister. When assembled, the hour glass shaped combo barrel has a height of 40.3 in. (1024mm). Combo barrels have three molded in marks designating three weight demarcation fill levels. The bottom mark designates a fill level of 200 lbs. (90kg) of sand. The middle mark designates 400 lbs. (180kg) of sand. The top mark designates 700 lbs. (320 kg) of sand. All Big Sandy barrels utilize the same 37 in (940 mm) diameter snap on lid.

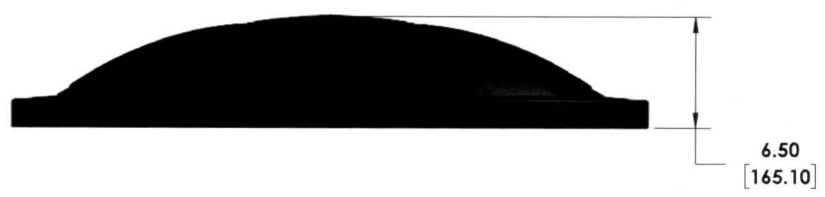
DWG. NO.
200-104

2. Material: Black Polyethylene Plastic
 1. Units: Inches [mm]
 NOTES: UNLESS OTHERWISE SPECIFIED

TITLE:
Big Sandy Lid

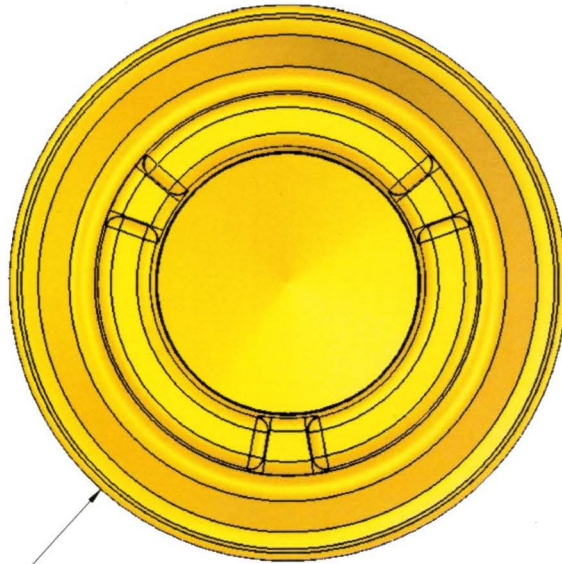
DWG. NO. **200-106**

∅ 37.00
939.80

20.00
508

2. Material: Yellow Polyethylene Plastic
1. Units: Inches [mm]
NOTES: UNLESS OTHERWISE SPECIFIED

TITLE:
**Canister, Big Sandy
Combo Barrel**
