# Planning for Safe Routes to School Pedestrian Road Safety Audit

Hancock Elementary School  
Norristown, Pennsylvania

February 2008

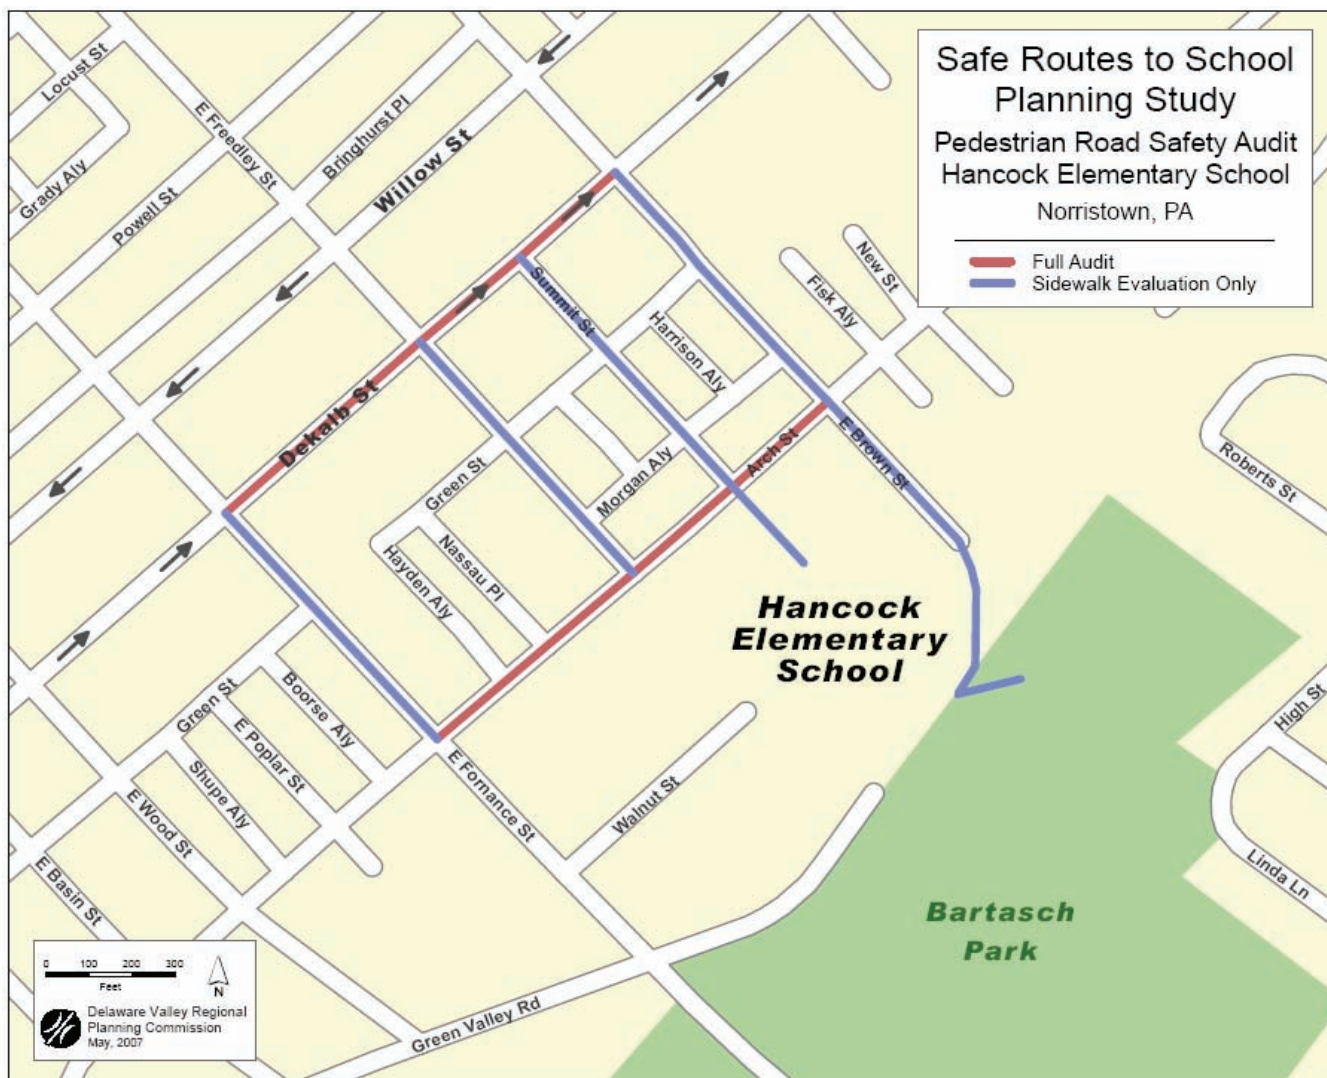
**Figure 1: Street map of study area**

DeKalb and East Fornance streets are 45 feet wide. East Freedley and Arch streets are 40 feet wide. East Brown Street is 35 feet wide. All of the streets audited have on-street parking, and all are two-way with the exception of DeKalb Street which is one way northbound. Speed limits, posted at 35 mph on DeKalb Street and 25 mph on Arch and East Fornance streets, are not posted on E. Freedley, Summit and Brown streets. On no street does the daily traffic volume exceed 10,000 vehicles (see Table 1, opposite, for study area traffic counts). SEPTA's Route 98 bus, Norristown to Plymouth Meeting Mall/Willow Grove, operates on DeKalb and Willow streets, hourly off-peak. There are no bus shelters on the route within the study area.

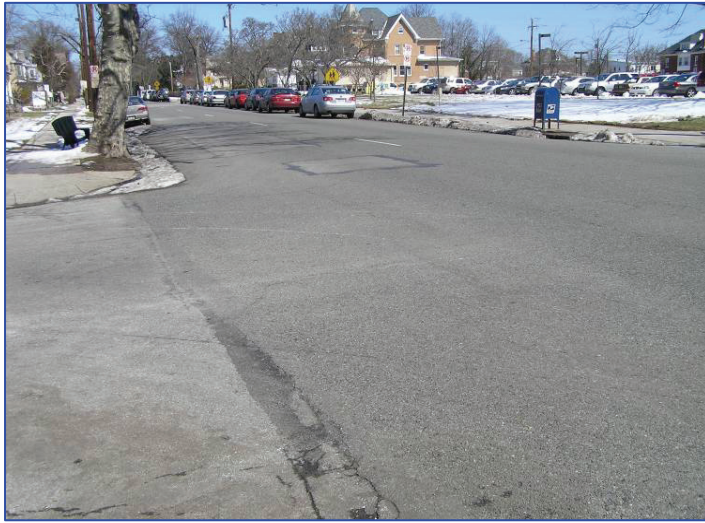
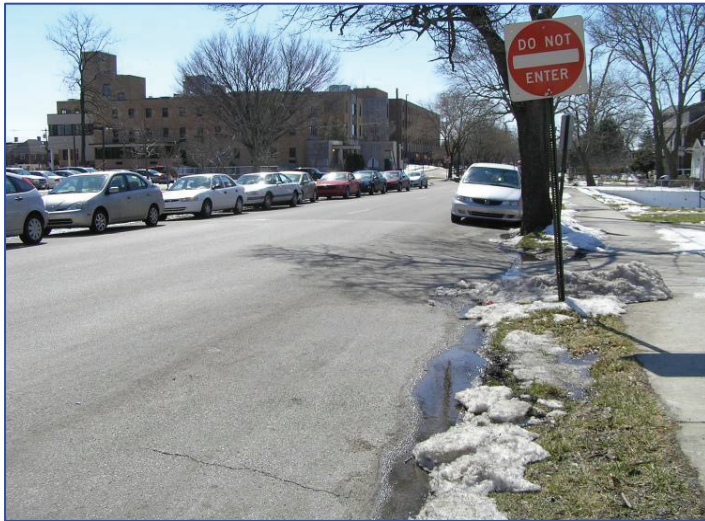
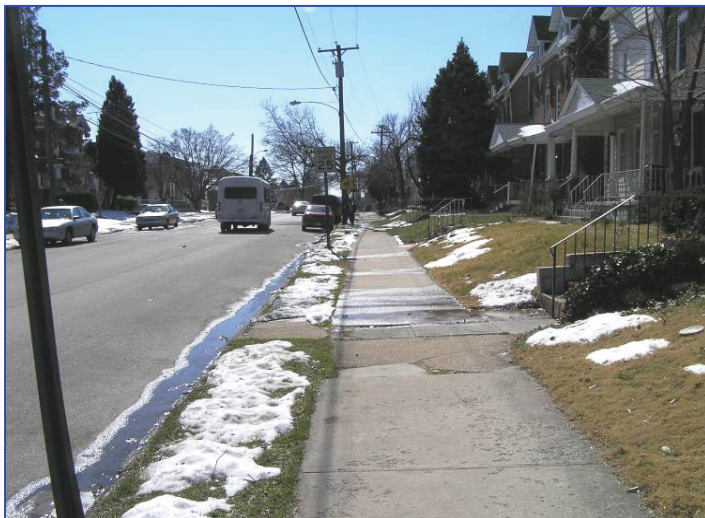
**Top:** Dekalb Street (US 202) looking north from E. Freedley Street.

**Middle:** Dekalb Street looking south from E. Freedley Street

**Bottom:** Arch Street looking south from E. Brown Street

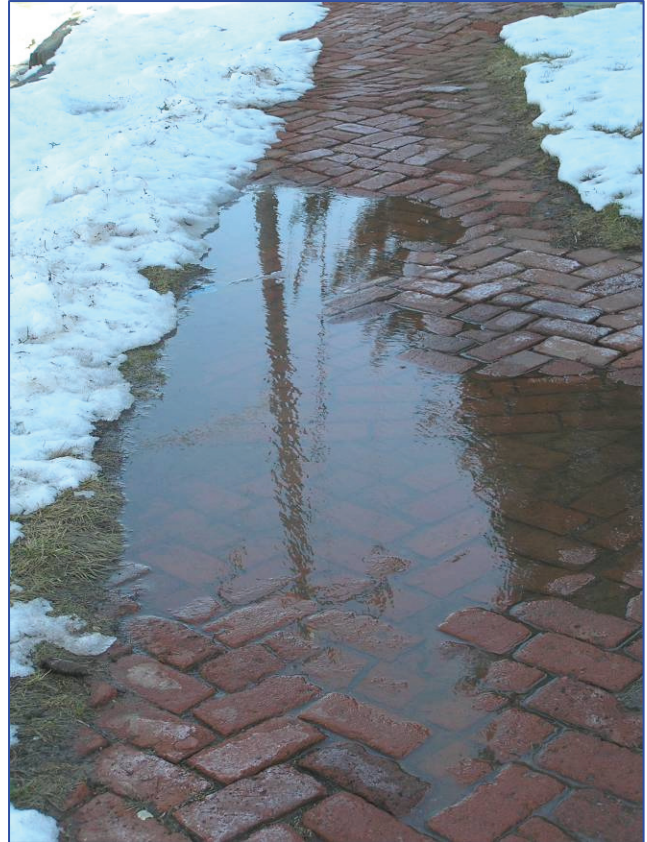
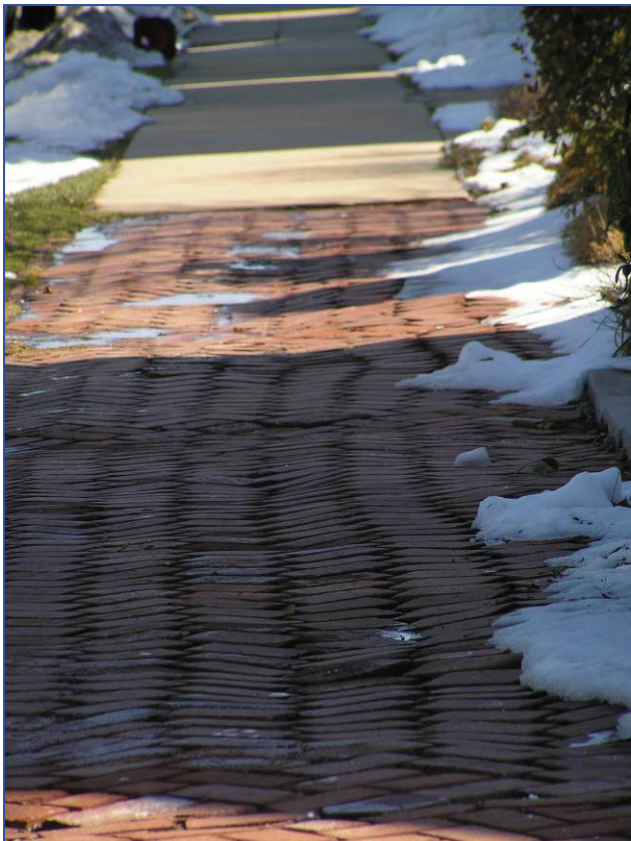
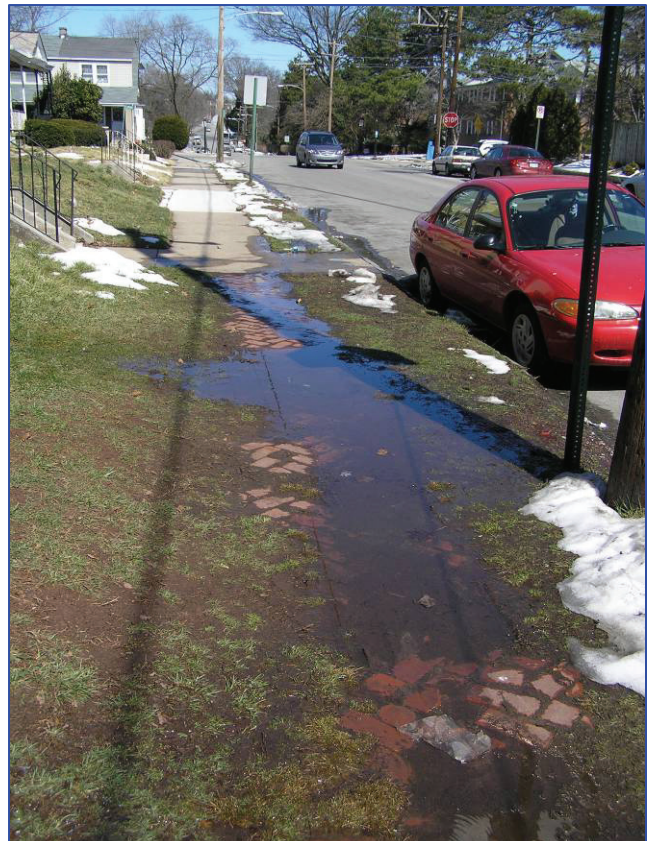
**Right:** Ponding on uneven brick sidewalk, E. Brown Street, south side, between Green Street and Morgan Alley

**Bottom right:** Ponding on uneven, deteriorated brick sidewalk, Arch Street, west side, between E. Brown and Summit streets.

**Below:** Uneven brick sidewalk, E. Brown Street, south side

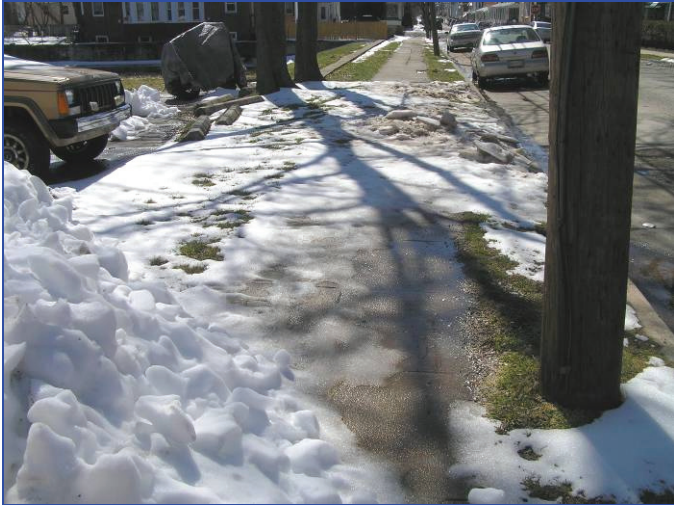
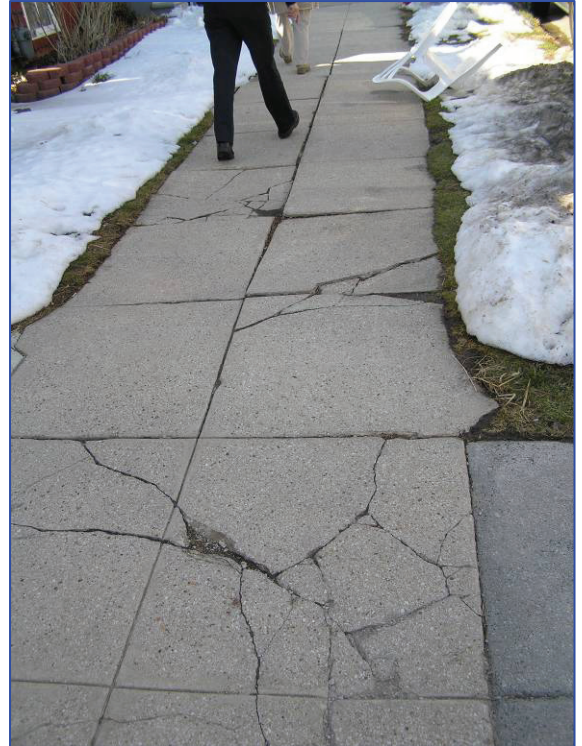
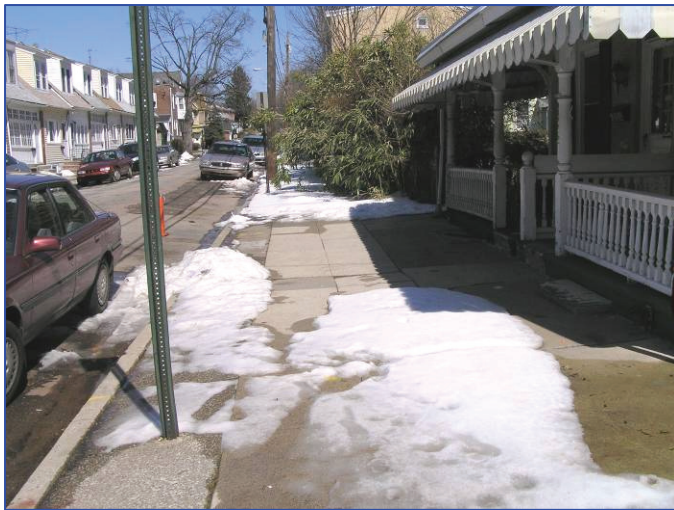
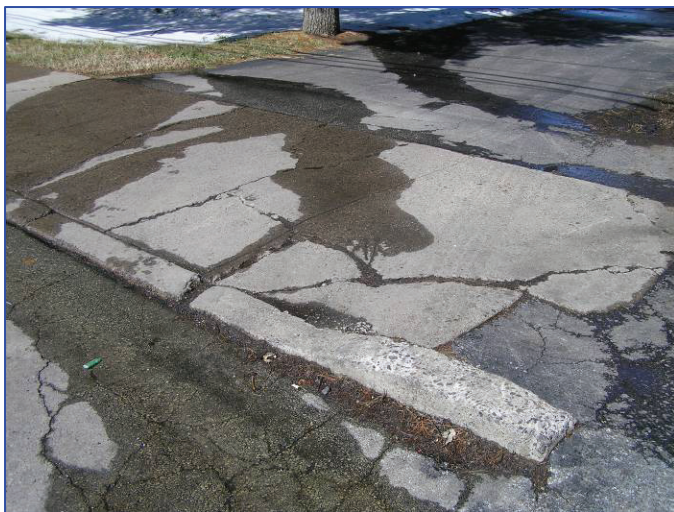
**Top left:** Sidewalk used for snow storage, Willow Street, east side, between E. Freedley and E. Fornance streets

**Center left:** Sidewalk obstructed by snow and vegetation, Willow Street, east side, just north of E. Freedley Street.

**Above and bottom left:** Broken sidewalk pavement, E. Brown Street

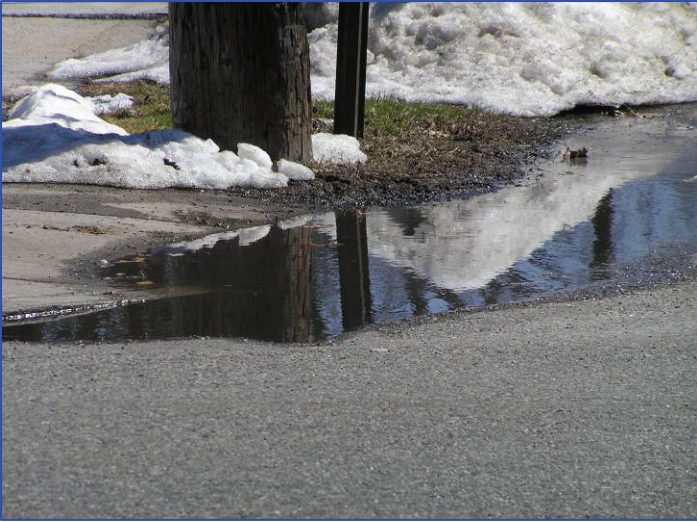
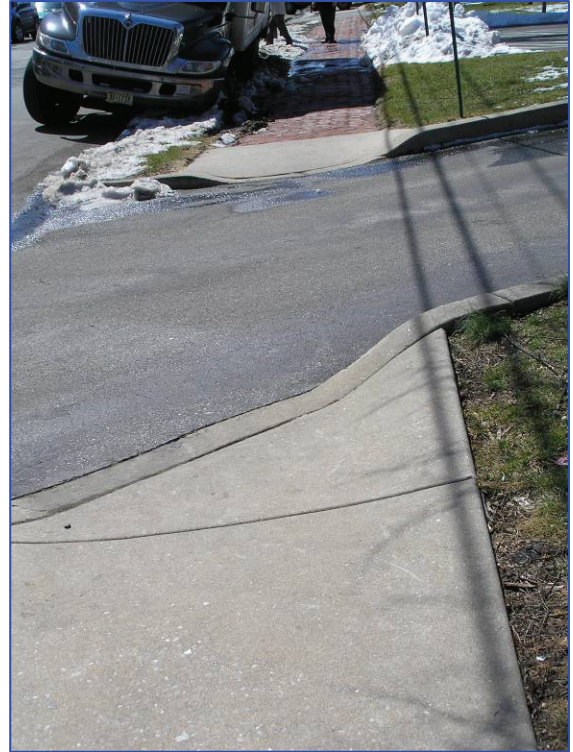
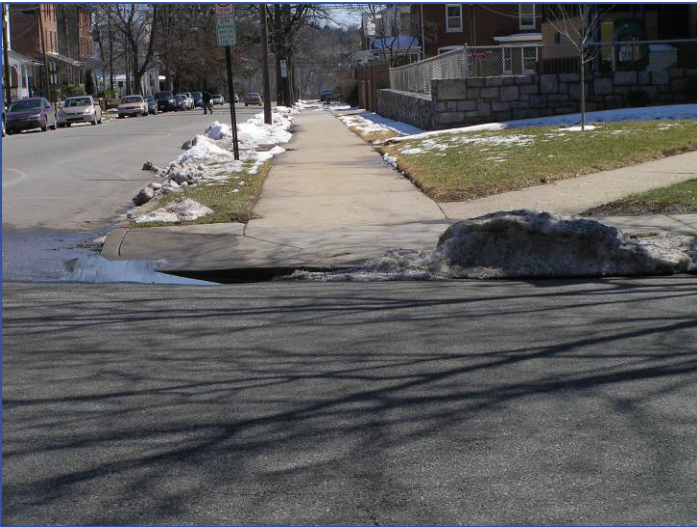
Poor drainage along the curb was observed at several locations, but was noted as a particular concern at the intersection of Summit Street. Snow and ice plowed from the street and from parking areas was found obscuring sidewalks and wheelchair ramps.

Dekalb Street. **Top and bottom left:** ponding at base of wheelchair ramps. **Above:** unmarked crosswalk of parking lot entrance; truck mired in the buffer strip can be seen in the background.

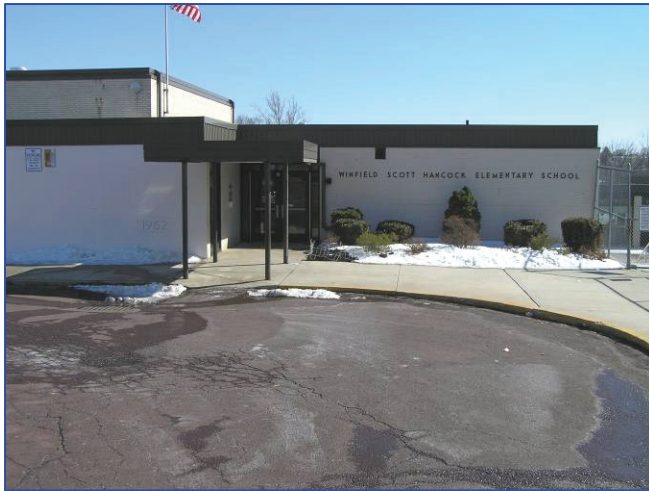
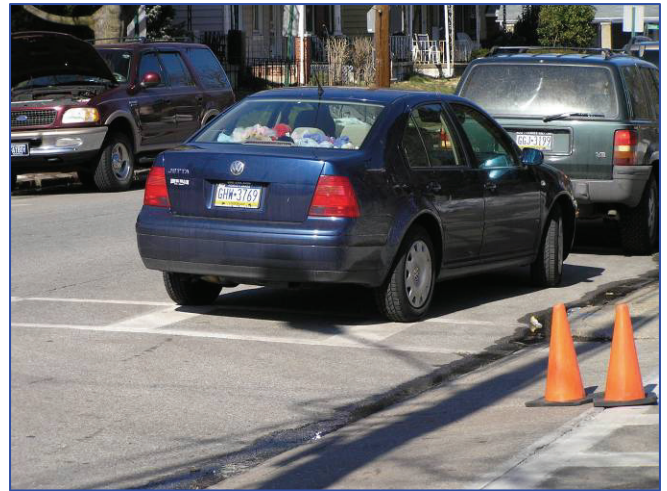
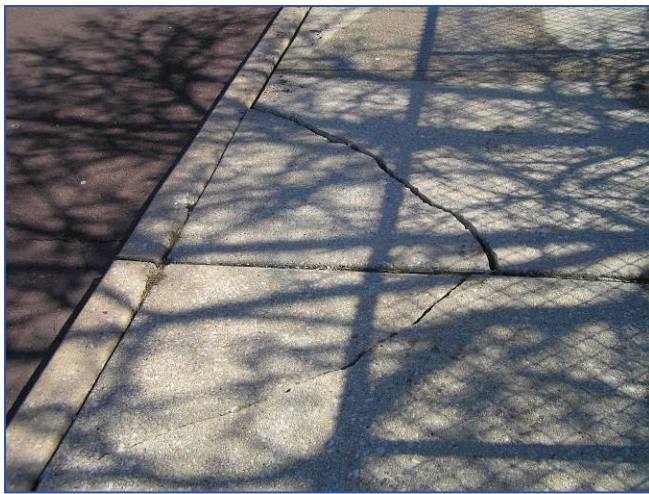
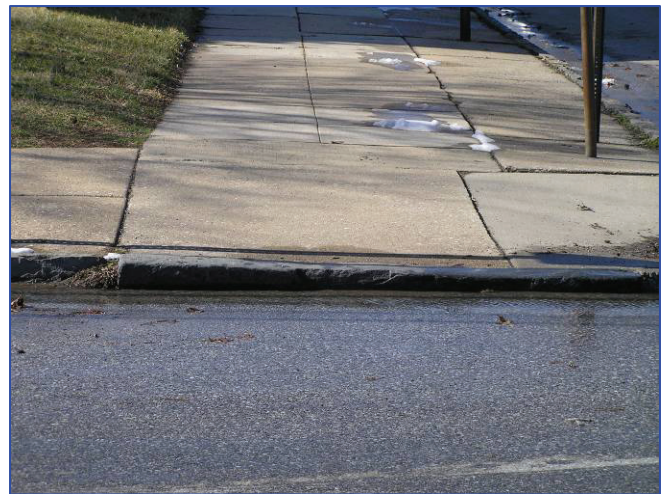
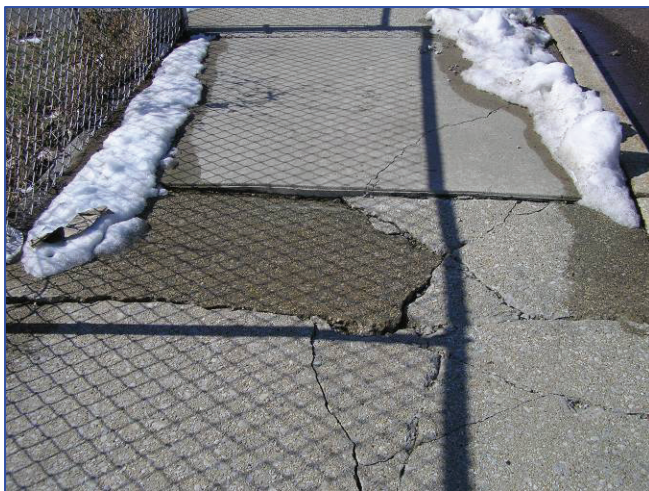
One parent illegally parked in a crosswalk at Summit and Arch streets while picking up a child from school.

**Middle and bottom left:** broken pavement along school entrance walkway

**Top right:** Car parked illegally in crosswalk during school dismissal

**Above:** No wheelchair ramp, southwest corner of E. Freedley and Arch streets

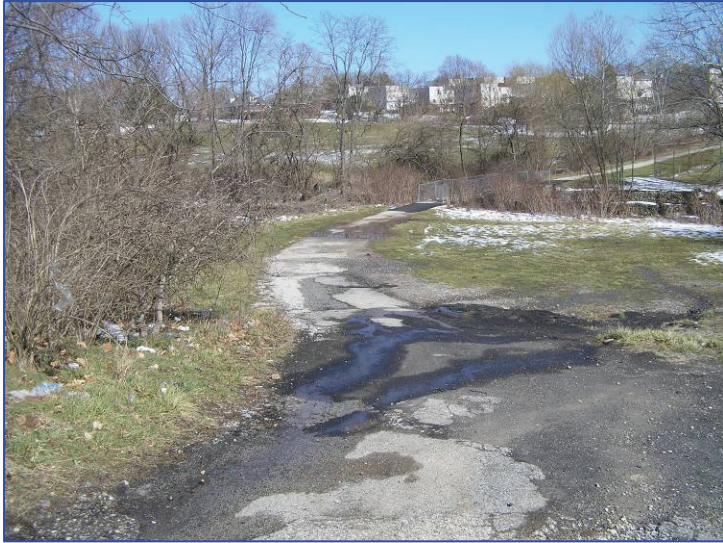
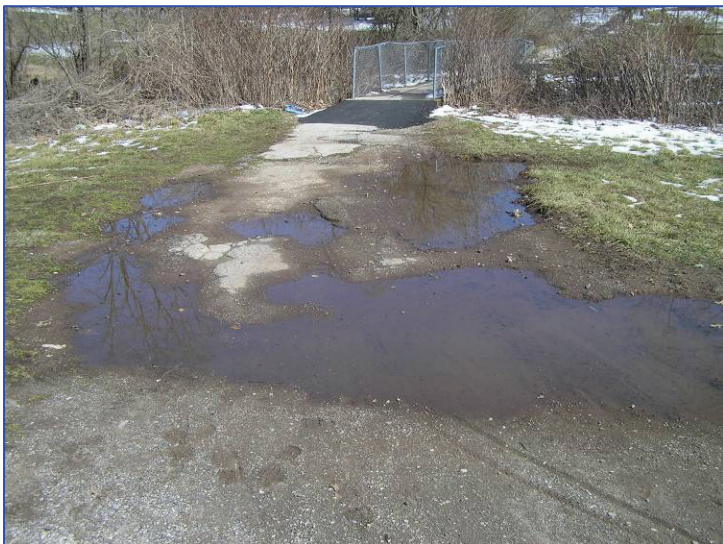
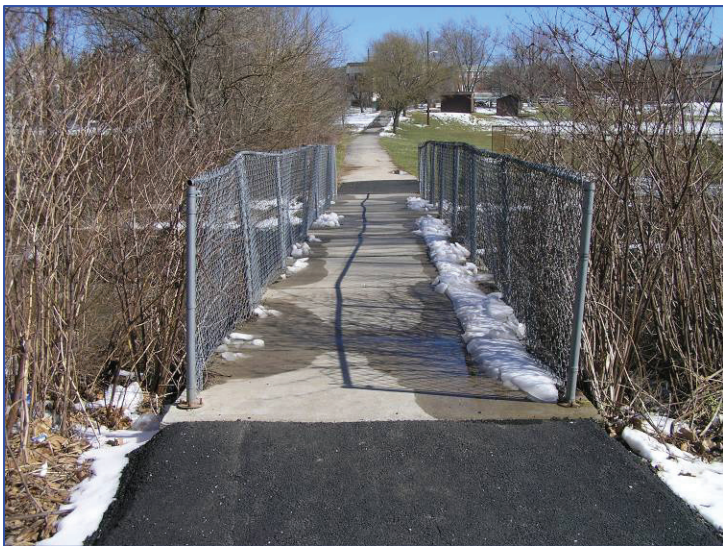
The same sidewalk conditions found on Dekalb and Arch streets, including broken pavement, deteriorated and uneven brick sections, poor drainage and substandard wheelchair ramps, were found on East Brown, East Freedley and Summit streets. Sidewalks on East Fornance Street, including the sidewalk fronting the Montgomery County Health and Human Services Center, were in good condition. The western half of the pathway linking the school with the neighborhood on the far side of Bartasch Park is in poor condition.

**Left:** Pathway connecting Hancock Elementary School with High Street across Bartasch Park, progressing eastward from the top to the bottom photo.

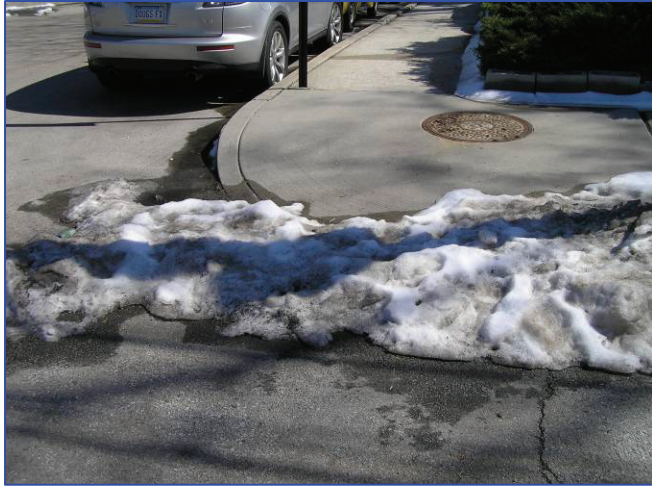
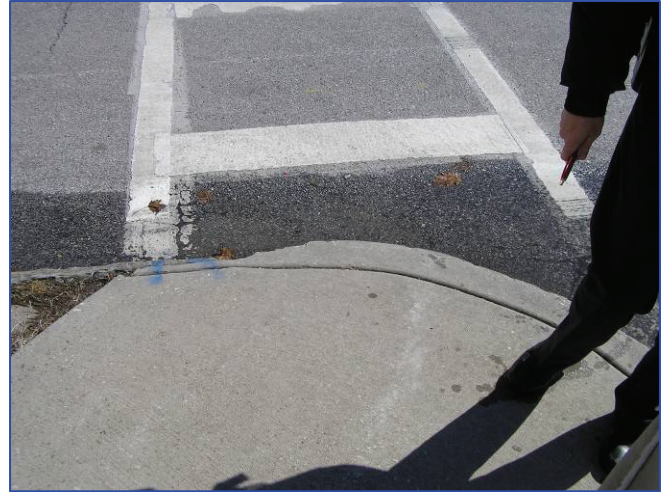
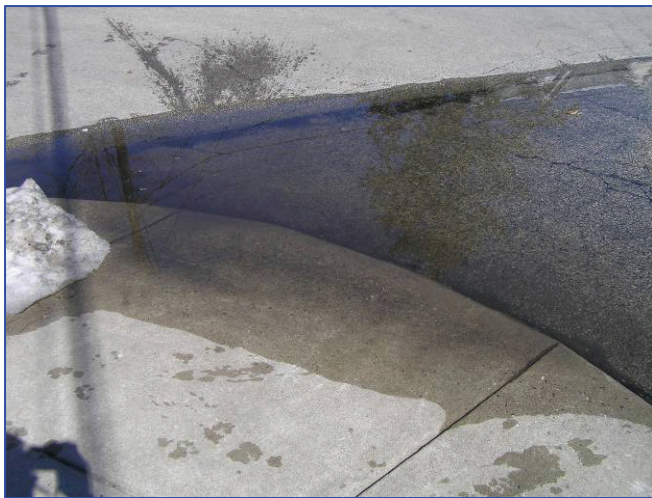
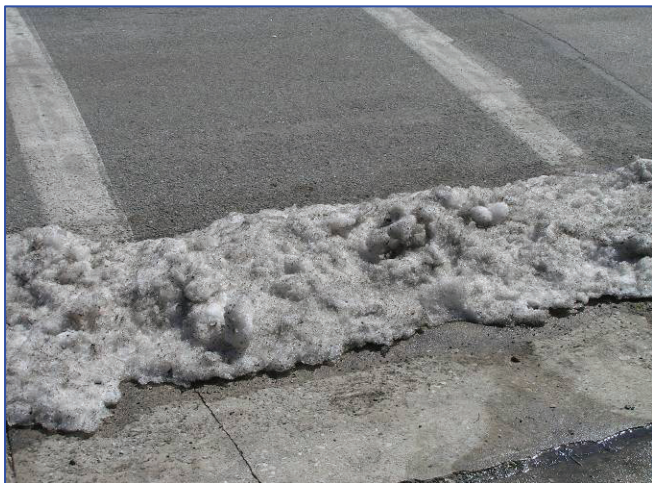
Crosswalk markings were found faded or completely worn away. Approach warning signs are old and obsolete. Wheelchair ramps, in many locations, were found to be not flush at the base with the street pavement, and all of them lack tactile warning devices for the visually impaired.

**Left:** Ponding and uncleared snow obstruct wheelchair access, Dekalb Street, various locations

**Above:** This wheelchair ramp is not compliant with ADA regulations because the base is not flush with the roadway, making wheelchair passage difficult; also, there is no tactile warning device for the vision-impaired.

- Refurbish and upgrade marked crosswalks with longitudinal markings and florescent yellow-green advance warning signs throughout. Install signs with flashers on Dekalb Street.
- Install overhead signal mast arms and pedestrian signal heads at the Dekalb/East Fornance Street intersection.
- Repair or replace sidewalks throughout.
- Upgrade wheelchair ramps to current standards, including tactile warning devices. Install additional ramps as required.
- Reconstruct curbs. Improve drainage in gutters at crosswalks and on sidewalks.
- To calm traffic and increase pedestrian visibility and conspicuity, install curb extensions (bulb-outs) at crosswalks on Dekalb Street
