Walkways

A walkway is any type of defined space or pathway for use by a person traveling by foot or using a wheelchair. These may be pedestrian walkways, shared use paths, sidewalks, or roadway shoulders.

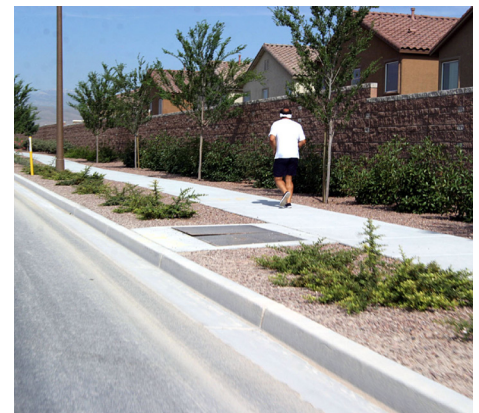
Example of a sidewalk in a residential area. Source: pedbikeimages.org / Burden

Well-designed pedestrian walkways, shared use paths, and sidewalks improve the safety and mobility of pedestrians. Pedestrians should have direct and connected network of walking routes to desired destinations without gaps or abrupt changes. In some rural or suburban areas, where these types of walkways are not feasible, roadway shoulders provide an area for pedestrians to walk next to the roadway, although these are not preferable.

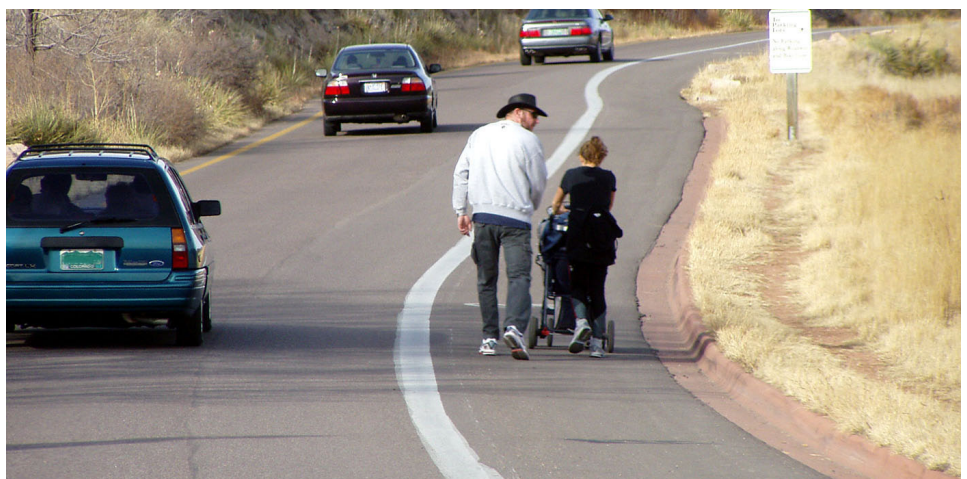
Paved shoulder used as a walkway. Source: pedbikeimages.org / Burden
