**Consultation for Repairs to the Puerto Rico State Road 9966
Rio Grande, Puerto Rico**

Federal Highway Administration
Eastern Federal Lands, Highway Division

Puerto Rico State Historic Preservation Office
P.O. Box 9023935
San Juan, PR 00902 3935
Phone: (787) 721-3737
Fax: (787) 721-3773

April 2025

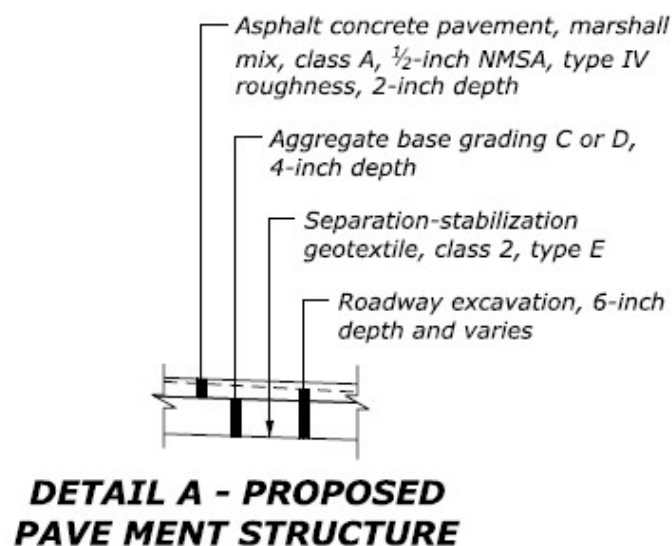
Figure 2. Snippet of undertaking's plans showing the asphalt reconstruction details.

One of the most visible damages to be repaired along the PR-9966 is its surfacing. Water runoff and effects of extreme weather events have created a vast quantity of potholes causing difficulties for navigating the road. The undertaking aims to reconstruct the surfacing of the road on its entirety. The repair action calls for the scraping of existing asphalt and subsurface aggregate until reaching native soil. A geotextile mesh will be placed to separate the natural soil surface from the new construction. 4 inches of new aggregate and 2 inches of asphalt pavement will be laid on top of the geotextile to form a new roadbed (Figure 2).

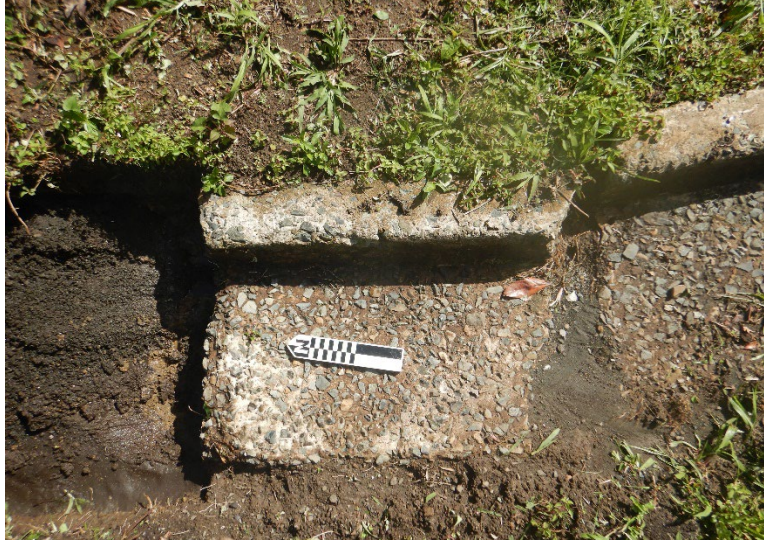
Figure 3. Plan view of current curbs & gutters along the PR9966.

The current curbs and gutters along the PR-9966 are made up of a poured concrete (Figure 3) and date to the original road construction. Time and wear have caused some damages to these features causing some of them to not function to capacity, which has compounded the water erosion issues suffered by the road. The undertaking seeks to replace these gutters with new concrete features in kind (Figure 4). These new curbs and gutters will help manage and divert water away from the roadway with the hope of preventing further erosion issues.

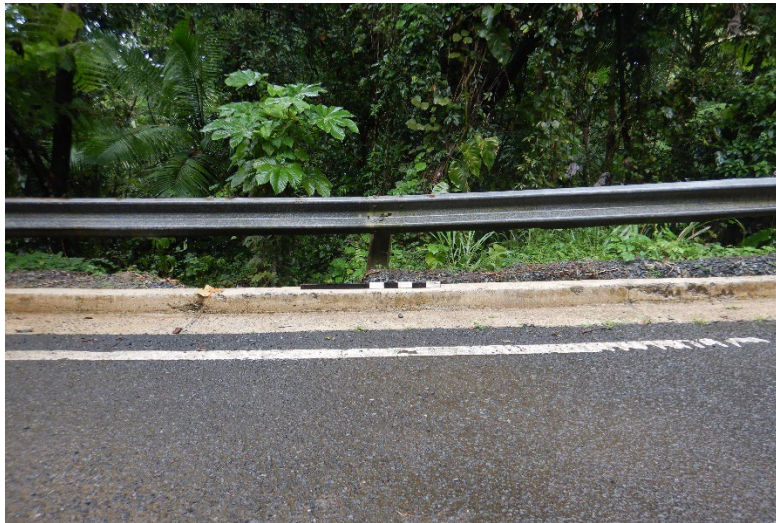
Figure 4. Example of new concrete curbs & gutter design.

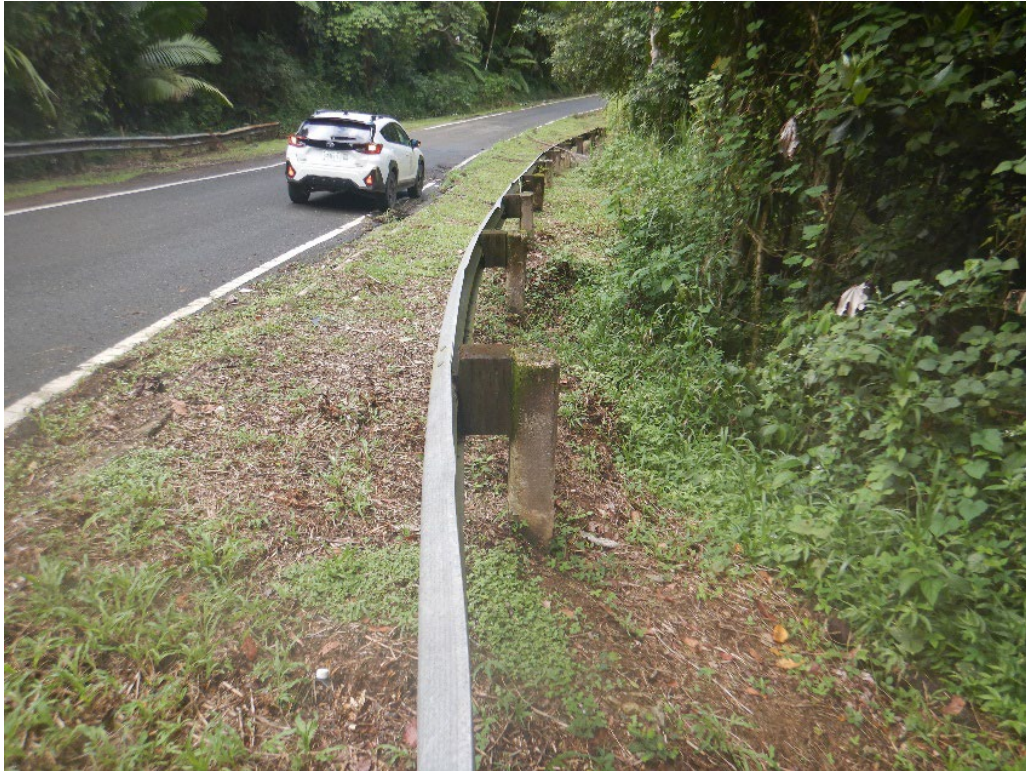
Figure 5. Current guardrail system along the PR9966 road.

PR-9966 presents a non-continuous system of guardrails dating to the original construction of the road, with slight updates. The system is made up of galvanized steel rails directly attached to concrete posts or galvanized steel rails with wooden block dampers that link them to the concrete posts (Figure 5). This guardrail system has sustained damage throughout time due to the falling of trees and car accidents (Figure 6). This has caused for the steel rails and concrete posts to get bent beyond repair requiring replacement. In some sections, landslides caused by extreme weather events have destroyed part of the system (Figure 7). These guardrails will be removed to make way for the new ones to be installed. The undertaking aims to install a *Midwest Guardrail System (MGS)*. This system is composed of steel beams spaced at 25 feet intervals attached to steel posts with rubber dampers. These new guardrails will upgrade the safety system of the road to current highway standards.

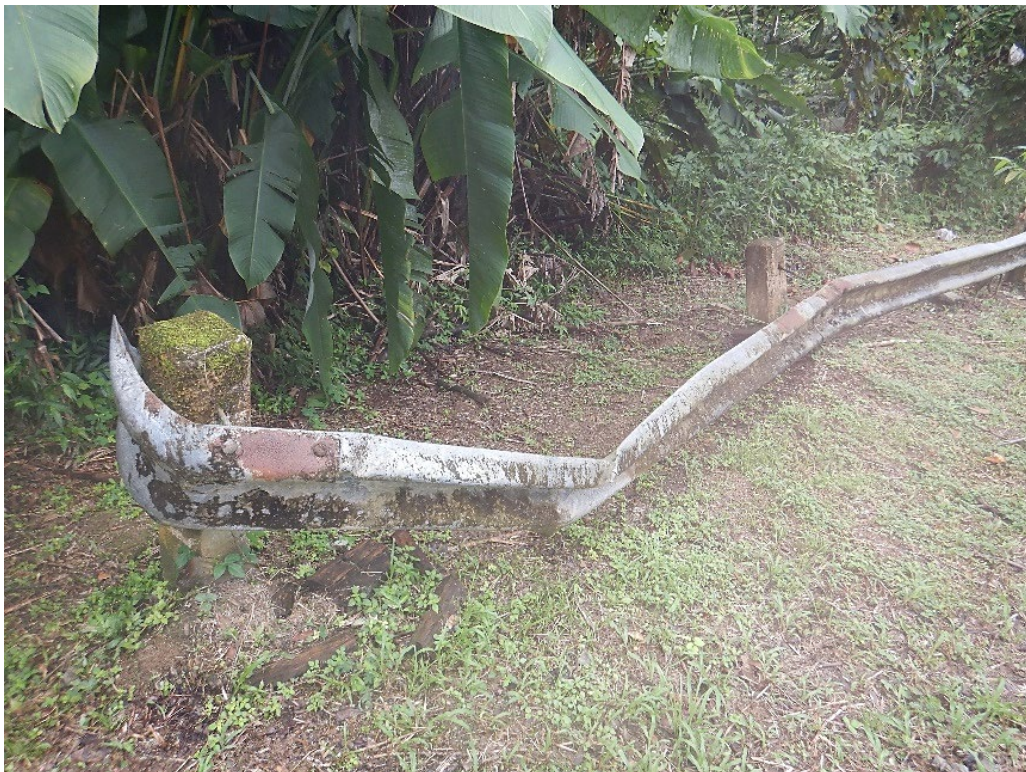
Figure 6. Example of damage to steel beams of the current guardrail system.

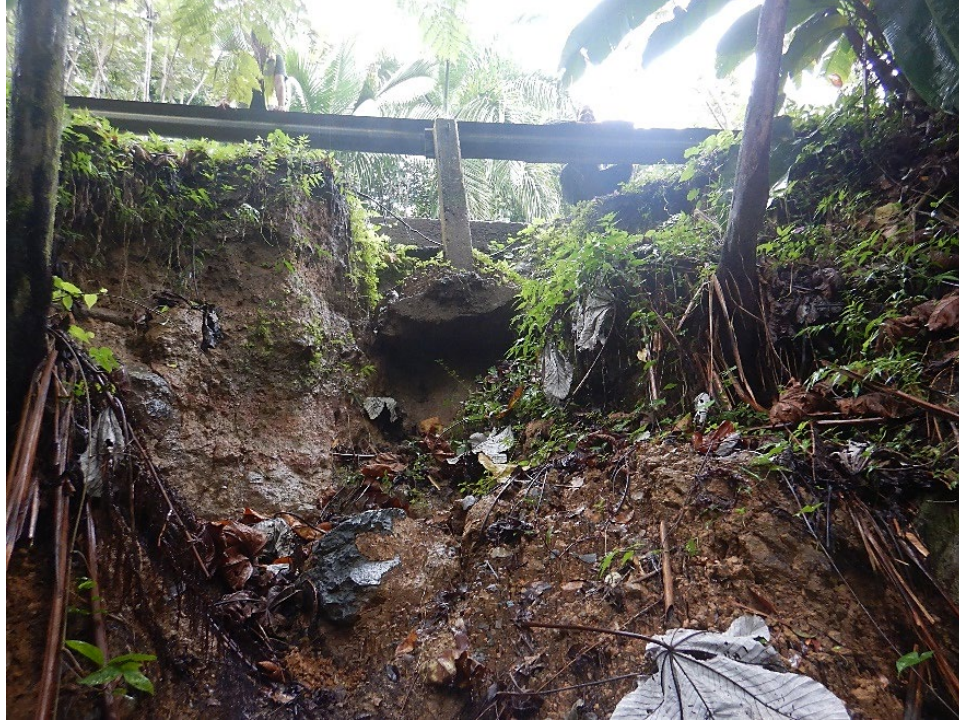
Figure 7. Guardrail damage caused by a landslide.

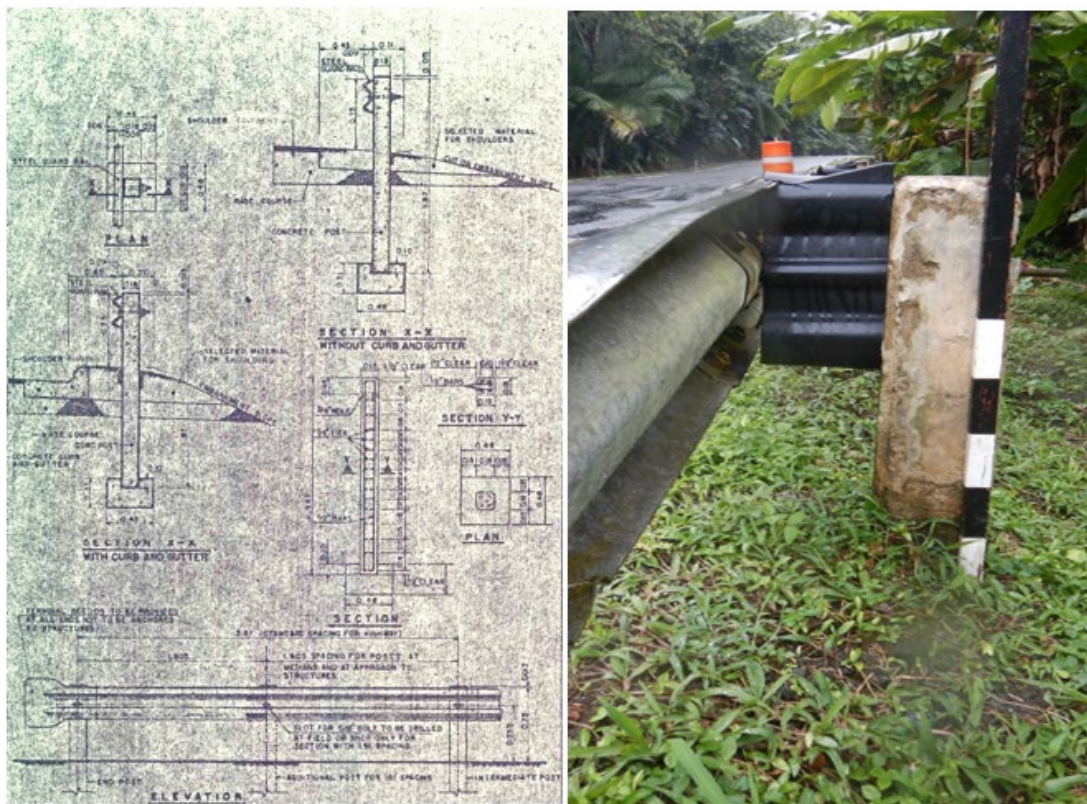
Figure 13. Guardrail details on 1966 plans; guardrail section in PR9966.

Construction records outline that the road was built following the Telford Road method for the base foundation for the road with an asphalt pavement surface. The construction also implemented the edification of road features including the construction of bridges, culverts, ditches and guardrails. Most of these relied on the use of cast in mold or mass-produced features such as prefabricated concrete pipes and pre-casted guardrail posts. The use of these industrially mass-produced elements was typical for the post war period and was widely adopted and implemented as the standard throughout the nation. The use of these industrial materials has been extensively documented within the structural developments and modifications to road, trail and recreation infrastructure in the forest for the mid-20th century period. As such the utilization of standard designs and standardized materials contrasts greatly with the first period of infrastructure development at El Yunque that took place during the New Deal Era, and which relied almost entirely in the artisanal design and construction of infrastructure with a reliance on the use of local materials such as stone, and the onsite construction of reinforced concrete features.

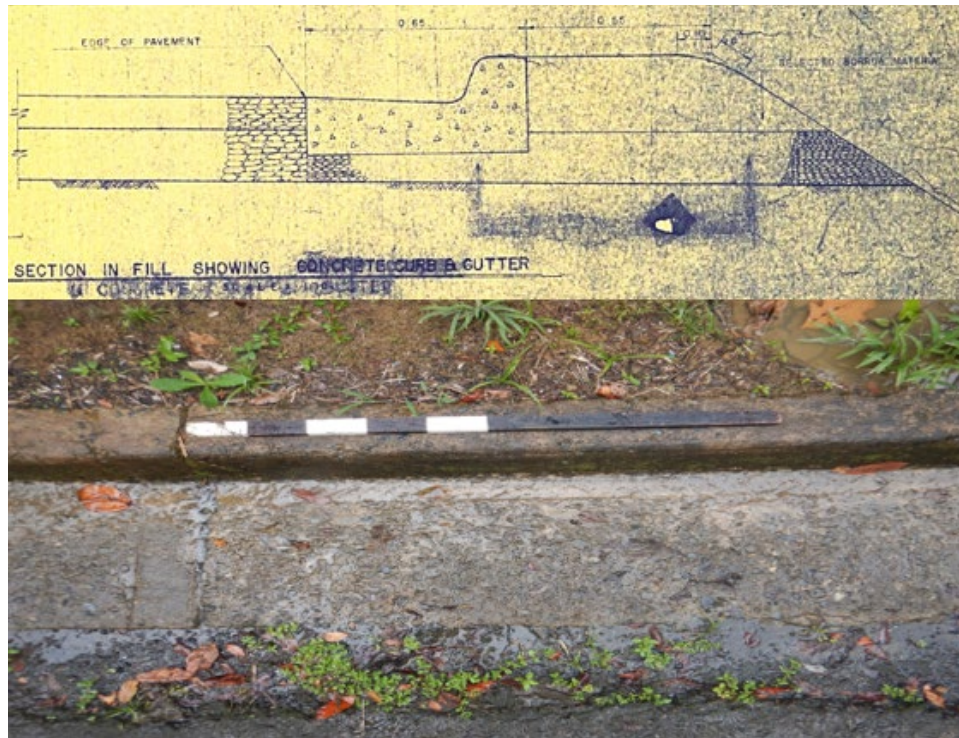
Figure 14. Curbs & gutters details on 1966 plans; curbs & gutters section in PR9966.
