U.S. Department
of Transportation
**Federal Highway
Administration**

In Reply Refer To:
HSST-1/CC-178

Name of system: Next Generation Terminal (NGT)
Type of system: Terminal
Test Level: Test Level 3
Testing conducted by: Applus IDIADA KARCO Engineering, LLC
Date of request: February 14, 2023

Request for Federal Aid Reimbursement Eligibility of Highway Safety Hardware

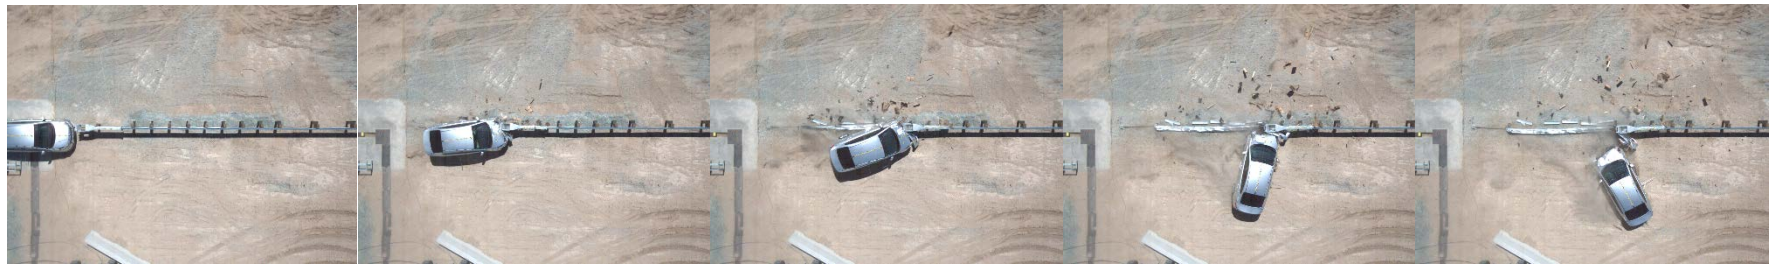
Figure 2 Summary of Test 3-30

MASH 2016 Test 3-30 Summary

0.000 seconds

0.180 seconds

0.360 seconds

0.630 seconds

0.810 seconds

Name / Model..... Next Generation Terminal (NGT™)
 Type..... Terminal
 Installation Length..... 187.5 ft. (57.2 m)
 Terminal Length..... 37.5 ft. (11.4 m)
 Road Surface..... Smooth Concrete to Fine Silty Soil

Impact Velocity..... 66.48 mph (106.99 km/h)
 Impact Angle..... 1.0°
 Location / Orientation..... 18.3 in. (465 mm) From Vehicle Centerline to Driver Side
 Kinetic Energy..... 360.6 kip-feet (488.9 Kilojoules)
 Minimum KE Required..... 288.0 kip-feet (390.0 Kilojoules)

Exit Velocity..... 12.86 mph (20.70 km/h)
 Exit Angle..... -76.8°
 Final Vehicle Position..... 50.4 ft. (15.4 m) Downstream
 18.6 ft. (5.7 m) Toward the Impact Side
 Vehicle Snagging..... Satisfactory
 Vehicle Pocketing..... Satisfactory
 Vehicle Stability..... Satisfactory
 Maximum Roll Angle..... -14.6°
 Maximum Pitch Angle..... 7.9°
 Maximum Yaw Angle..... -170.9°

Longitudinal OIV..... 24.9 ft/s (7.6 m/s)
 Lateral OIV..... -2.3 ft/s (-0.7 m/s)
 Longitudinal RA..... -10.8 g
 Lateral RA..... -3.4 g
 THIV..... 24.9 ft/s (7.6 m/s)
 PHD..... 10.8 g
 ASI..... 0.76

Required Test Number	Narrative Description	Evaluation Results
3-30 (1100C)	<p>Applus IDIADA KARCO Test No. P42215-01. Test Date September 16, 2022. Crash Test Report No. TR-P42215-01-NC for MASH 2016 Test 3-30 Crash Test of Sicking Safety Systems, LLC Next Generation Terminal (NGT™).</p> <p>The terminal was impacted by a 2016 Kia Rio small sedan at a velocity of 66.48 mph (106.99 km/h) and a CIA of 1.0°. Upon impact the impact head captured the test vehicle and they began retracting downstream along the first panel. NGT posts 1 through 5 sheared at the plug welds, as intended. The test vehicle released from the impact head and began yawing in a counterclockwise direction as it proceeded to its final resting position. MASH deformation limits were not exceeded and there was no penetration into the vehicle's occupant compartment. The vehicle experienced a maximum occupant impact velocity (OIV) of 24.9 ft/s (7.6 m/s) and a maximum ridedown acceleration (RA) of -10.8 g.</p>	PASS

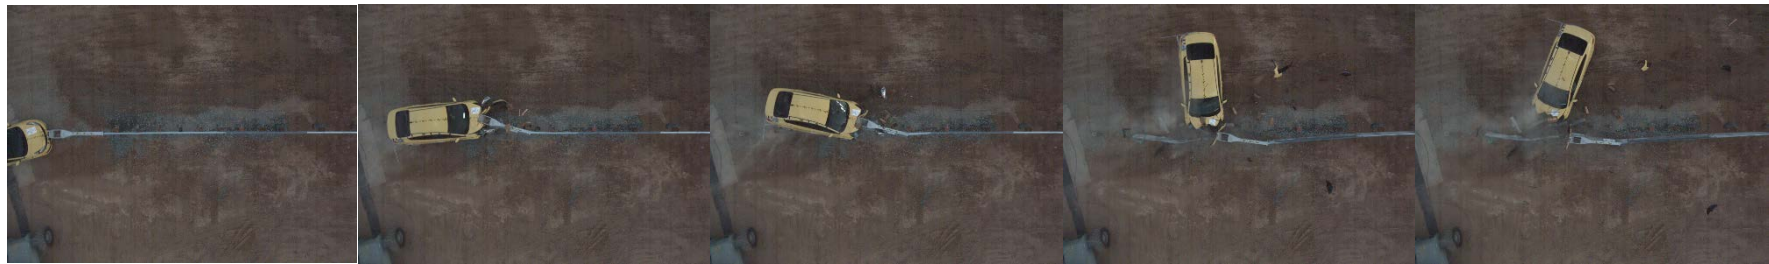
Figure 2 Summary of Test 3-32

MASH 2016 Test 3-32 Summary

0.000 seconds

0.200 seconds

0.300 seconds

0.600 seconds

0.700 seconds

Name / Model..... Next Generation Terminal (NGT™)
 Type..... Terminal
 Installation Length..... 187.5 ft. (57.2 m)
 Terminal Length..... 37.5 ft. (11.4 m)
 Road Surface..... Smooth Concrete to Fine Silty Soil

Impact Velocity..... 61.82 mph (99.49 km/h)
 Impact Angle..... 14.9°
 Location / Orientation..... 1.0 in. (25 mm) From Vehicle
 Centerline on Passenger Side
 Kinetic Energy..... 315.2 kip-feet (427.3 Kilojoules)
 Minimum KE Required..... 288.0 kip-feet (390.0 Kilojoules)

Exit Velocity..... 5.90 mph (9.50 km/h)
 Exit Angle..... 81.3°
 Final Vehicle Position..... 27.5 ft. (8.4 m) Downstream
 18.4 ft. (5.6 m) Field Side
 Vehicle Snagging..... Satisfactory
 Vehicle Pocketing..... Satisfactory
 Vehicle Stability..... Satisfactory
 Maximum Roll Angle..... -18.1°
 Maximum Pitch Angle..... -17.8°
 Maximum Yaw Angle..... 231.4°

Longitudinal OIV..... 30.8 ft/s (9.4 m/s)
 Lateral OIV..... -3.9 ft/s (-1.2 m/s)
 Longitudinal RA..... -9.7 g
 Lateral RA..... 4.1 g
 THIV..... 31.5 ft/s (9.6 m/s)
 PHD..... 9.8 g
 ASI..... 0.86

Static..... 1.4 ft. (0.4 m)
 Dynamic..... 2.1 ft. (0.6 m)
 Working Width..... 2.4 ft. (0.7 m)
 Debris Field..... 90.2 ft. (27.5 m) Longitudinally
 6.3 ft. (1.9 m) Laterally

Required Test Number	Narrative Description	Evaluation Results
3-32 (1100C)	<p>Applus IDIADA KARCO Test No. P42191-01. Test Date September 02, 2022. Crash Test Report No. TR-P42191-01-NC for MASH 2016 Test 3-32 Crash Test of Sicking Safety Systems, LLC Next Generation Terminal (NGT™).</p> <p>The terminal was impacted by a 2016 Kia Rio small sedan at a velocity of 61.82 mph (99.49 km/h) and a CIA of 14.9°. Upon impact the impact head captured the test vehicle and began retracting downstream. NGT plug welded posts 1 through 4 yielded flat to grade. As the retracting continued the test vehicle began to yaw in a clockwise direction. The vehicle lost contact with the impact head and continued yawing until reaching its final resting position downstream. MASH deformation limits were not exceeded and there was no penetration into the vehicle's occupant compartment. The vehicle experienced a maximum occupant impact velocity (OIV) of 30.8 ft/s (9.4 m/s) and a maximum ridedown acceleration (RA) of -9.7 g.</p>	PASS
