Name of system: NOVUS 100 Crash Cushion

Type of system: Crash Cushion

Test Level: TL-3

Request for Federal Aid Reimbursement Eligibility of Highway Safety Hardware

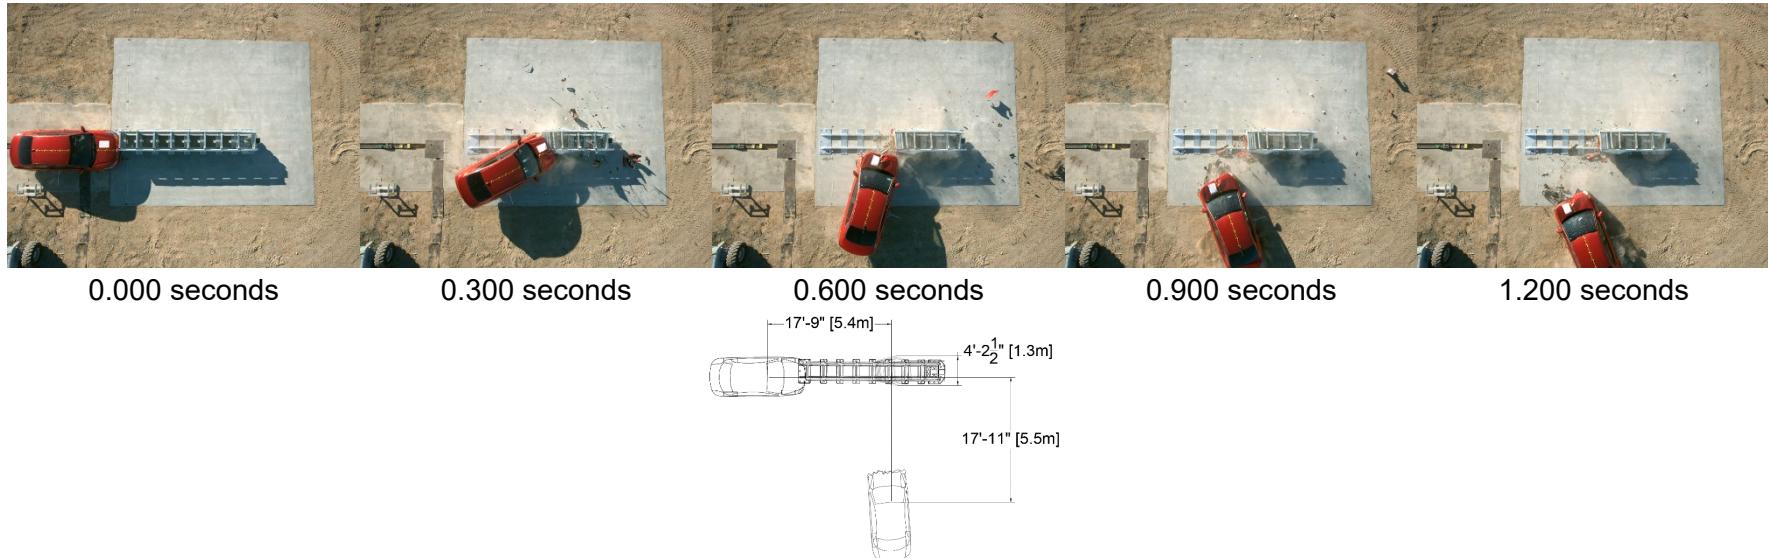
Figure 2 Summary of Test 3-30

GENERAL INFORMATION		Impact Conditions	Occupant Risk
Test Agency.....	Applus IDIADA KARCO	Impact Velocity (Target)..... 62.14 mph (100.00 km/h)	Longitudinal OIV..... 39.0 ft/s (11.9 m/s)
Test Number.....	P44008-01	Impact Velocity (Actual)..... 64.24 mph (103.38 km/h)	Lateral OIV..... -2.3 ft/s (-0.7 m/s)
Test Designation.....	3-30	Impact Angle (Target)..... 0.0° relative to the centerline of the system	Longitudinal RA..... -15.1 g
Test Date.....	1/18/24	Impact Angle (Actual)..... 0.4° relative to the centerline of the system	Lateral RA..... 5.3 g
TEST ARTICLE		Location / Orientation (Target)..... 1/4 vehicle width (16.9 in. [429 mm]) from the center of resistance	THIV..... 39.0 ft/s (11.9 m/s)
Name / Model.....	NOVUS™ 100	Location / Orientation (Actual)..... 16.7 in. (424 mm) from the center of resistance	PHD..... 15.6 g
Type.....	Crash Cushion	Kinetic Energy..... 335.7 kip-ft (455.2 kJ)	ASI..... 1.49

Crash Cushion Length.....	21.0 ft. (6.4 m)	Minimum KE Required..... 288.0 kip-ft (390.0 kJ)	
Road Surface.....	Smooth, clean concrete		
TEST VEHICLE		Exit Conditions	Test Article Deflections
Type / Designation.....	1100C	Exit Velocity..... N/A	Static..... 0.4 ft. (0.1 m)
Year, Make, and Model....	2018 Kia Rio	Exit Angle..... N/A	Dynamic..... 0.5 ft. (0.2 m)
Curb Mass.....	2,517.7 lbs (1,142.0 kg)	Final Vehicle Position..... 17.7 ft. (5.4 m) downstream	Working Width..... 4.3 ft. (1.3 m)
Test Inertial Mass.....	2,433.8 lbs (1,104.0 kg)	18.0 ft. (5.5 m) Left	Debris Field..... N/A
Gross Static Mass.....	2,599.2 lbs (1,179.0 kg)	Vehicle Snagging..... Satisfactory	
		Vehicle Pocketing..... Satisfactory	
		Vehicle Stability..... Satisfactory	
		Maximum Roll Angle..... 8.4 °	
		Maximum Pitch Angle..... -12.6 °	
		Maximum Yaw Angle..... -112.3 °	
Vehicle Damage			
		Vehicle Damage Scale..... 12-FD-7	
		CDC..... 12FDEW2

Maximum Deformation.... (0.0 in.) 0.0 mm

Required Test Number	Narrative Description	Evaluation Results
3-30 (1100C)	<p>Applus IDIADA KARCO Test No. P44008-01. Test Date January 18, 2024. Crash Test Report No. TR-P44008-01-A. MASH Test 3-30 of the VALTIR NOVUS™ 100 crash cushion.</p> <p>The crash cushion was impacted by a 2018 Kia Rio at a velocity of 64.24 mph (103.38 km/h) and a CIA of 0.4° relative to the centerline of the system, with the vehicle offset a 1/4 of its width so that the 1/4 width point aligns with the center of resistance of the crash cushion at the front placard.</p> <p>Upon impact the vehicle forced the crash cushion downstream until coming to a controlled stop 17.7 ft (5.4 m) downstream of the initial point of contact with the system. MASH deformation limits were not exceeded and there was no penetration into the vehicle's occupant compartment. The vehicle experienced a maximum occupant impact velocity (OIV) of 39.0 ft/s (11.9 m/s) and a maximum ridedown acceleration (RA) of -15.1 g.</p> <p>The NOVUS™ 100 crash cushion met all the requirements for MASH 2016 Test 3-30.</p>	PASS

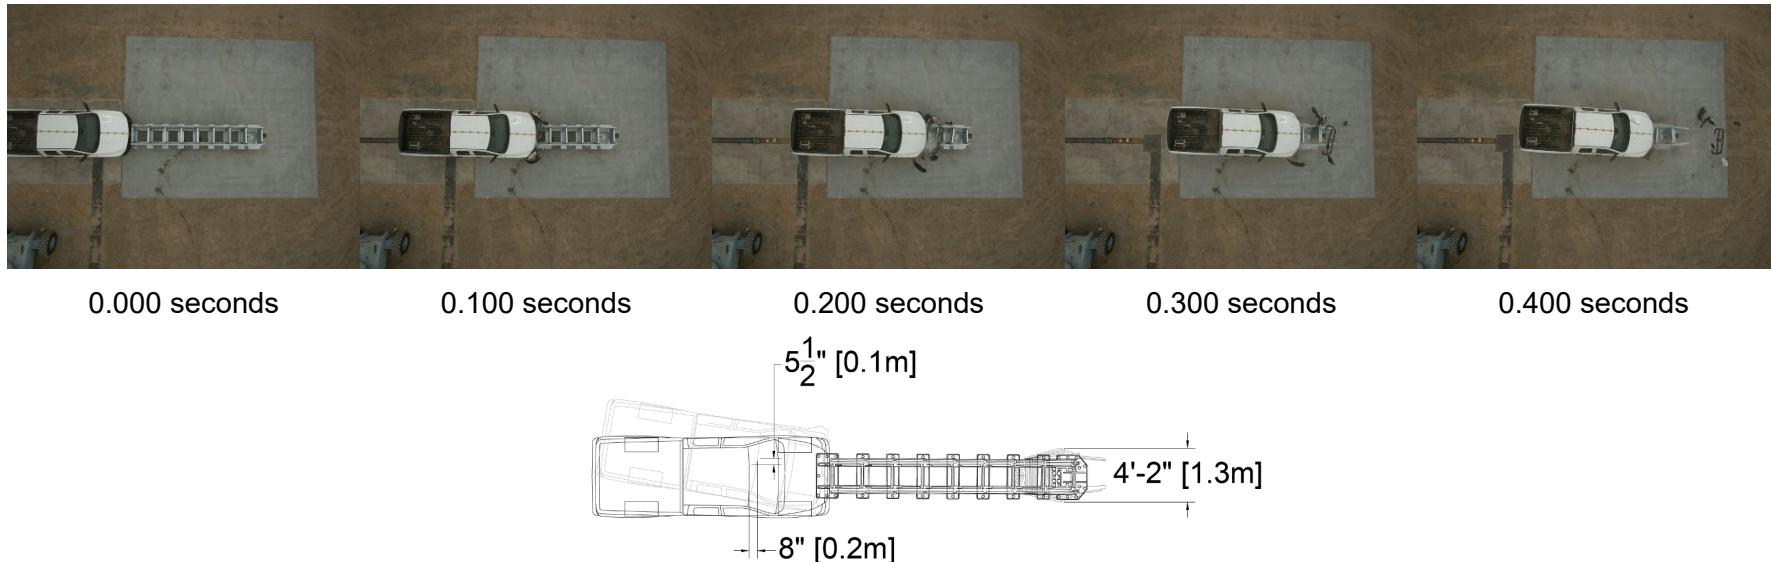
Figure 2 Summary of Test 3-31

GENERAL INFORMATION		Impact Conditions		Occupant Risk	
Test Agency.....	Applus IDIADA KARCO	Impact Velocity (Target).....	62.14 mph (100.00 km/h)	Longitudinal OIV.....	31.2 ft/s (9.5 m/s)
Test Number.....	P44009-01	Impact Velocity (Actual).....	61.16 mph (98.42 km/h)	Lateral OIV.....	3.3 ft/s (1.0 m/s)
Test Designation.....	3-31	Impact Angle (Target).....	0.0° relative to the centerline of the system	Longitudinal RA.....	-20.1 g
Test Date.....	1/19/24	Impact Angle (Actual).....	0.8° relative to the centerline of the system	Lateral RA.....	2.2 g
TEST ARTICLE		Location / Orientation (Target).....	Center of resistance	THIV.....	31.5 ft/s (9.6 m/s)
Name / Model.....	NOVUS™ 100	Location / Orientation (Actual).....	2.3 in. (58 mm) from the center of resistance	PHD.....	20.1 g
Type.....	Crash Cushion	Kinetic Energy.....	626.2 kip-ft (849.1 kJ)	ASI.....	1.31
Crash Cushion Length.....	21.0 ft. (6.4 m)	Minimum KE Required.....	594.0 kip-ft (806.0 kJ)	Test Article Deflections

Road Surface.....	Smooth, clean concrete	Exit Conditions		Static.....	0.7 ft. (0.2 m)
		Exit Velocity.....	N/A	Dynamic.....	0.7 ft. (0.2 m)
		Exit Angle.....	N/A	Working Width.....	4.3 ft. (1.3 m)
		Final Vehicle Position.....	0.7 ft. (0.2 m) Upstream 0.5 ft. (0.1 m) Left	Debris Field.....	N/A
TEST VEHICLE		Vehicle Snagging.....	Satisfactory	Vehicle Damage	
Type / Designation.....	2270P	Vehicle Pocketing.....	Satisfactory	Vehicle Damage Scale.....	12-FD-3
Year, Make, and Model....	2018 Ram 1500	Vehicle Stability.....	Satisfactory	CDC.....	12FDEW5
Curb Mass.....	5,070.5 lbs (2,300.0 kg)	Maximum Roll Angle.....	1.6 °	Maximum Deformation....	(0.0 in.) 0.0 mm
Test Inertial Mass.....	5,008.8 lbs (2,272.0 kg)	Maximum Pitch Angle.....	-7.0 °		
Gross Static Mass.....	5,008.8 lbs (2,272.0 kg)	Maximum Yaw Angle.....	5.8 °

3-31 (2270P)	<p>Applus IDIADA KARCO Test No. P44009-01. Test Date January 19, 2024. Crash Test Report No. TR-P44009-01-A. MASH Test 3-31 of the VALTIR NOVUS™ 100 crash cushion.</p> <p>The crash cushion was impacted by a 2018 RAM 1500 at a velocity of 61.16 mph (98.42 km/h) and a CIA of 0.8° relative to the centerline of the system, with the centerline of the vehicle impacting the centerline of resistance of the crash cushion at the front placard. Upon impact the vehicle forced the crash cushion until coming to a controlled stop 0.7 ft (0.2 m) from initial point of contact with the system. MASH deformation limits were not exceeded and there was no penetration into the vehicle's occupant compartment. The vehicle experienced a maximum occupant impact velocity (OIV) of 31.2 ft/s (9.5 m/s) and a maximum ridedown acceleration (RA) of -20.1 g.</p> <p>The NOVUS™ 100 crash cushion met all the requirements for MASH 2016 Test 3-31.</p>	PASS

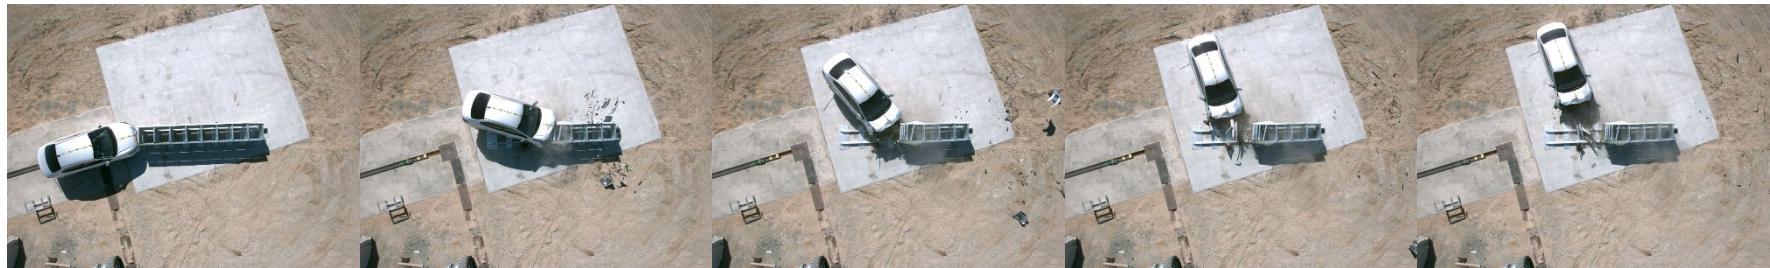
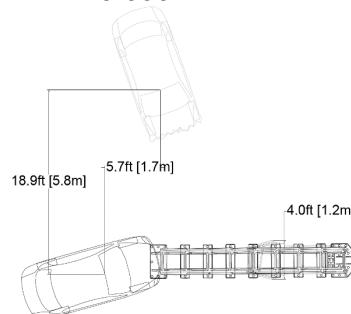
Figure 2 Summary of Test 3-32

Test Agency.....	Applus IDIADA KARCO
Test Number.....	P44010-01
Test Designation.....	3-32
Test Date.....	1/30/24

Name / Model.....	NOVUS™ 100
Type.....	Crash Cushion
Crash Cushion Length.....	21.0 ft. (6.4 m)
Road Surface.....	Smooth, clean concrete

Type / Designation.....	1100C
Year, Make, and Model....	2020 Kia Rio
Curb Mass.....	2,507.8 lbs (1,137.5 kg)
Test Inertial Mass.....	2,418.5 lbs (1,097.0 kg)
Gross Static Mass.....	2,583.8 lbs (1,172.0 kg)

Impact Velocity (Target).....	62.14 mph (100.00 km/h)
Impact Velocity (Actual).....	59.71 mph (96.10 km/h)
Impact Angle (Target).....	15.0° relative to the centerline of the system
Impact Angle (Actual).....	15.4° relative to the centerline of the system
Location / Orientation (Target)	Center of resistance
Location / Orientation (Actual).....	4.2 in. (107 mm) from the center of resistance
Kinetic Energy.....	288.3 kip-ft (390.9 kJ)
Minimum KE Required.....	288.0 kip-ft (390.0 kJ)

Exit Velocity.....	N/A
Exit Angle.....	N/A
Final Vehicle Position.....	5.7 ft. (1.7 m) Downstream 18.9 ft. (5.8 m) Left
Vehicle Snagging.....	Satisfactory
Vehicle Pocketing.....	Satisfactory
Vehicle Stability.....	Satisfactory
Maximum Roll Angle.....	-7.2 °
Maximum Pitch Angle.....	-9.6 °
Maximum Yaw Angle.....	86.1 °

Longitudinal OIV.....	38.4 ft/s (11.7 m/s)
Lateral OIV.....	-2.3 ft/s (-0.7 m/s)
Longitudinal RA.....	-17.9 g
Lateral RA.....	-7.5 g
THIV.....	39.0 ft/s (11.9 m/s)
PHD.....	18.0 g
ASI.....	1.35

Static.....	0.5 ft. (0.1 m)
Dynamic.....	0.5 ft. (0.1 m)
Working Width.....	4.0 ft. (1.2 m)
Debris Field.....	N/A

Vehicle Damage Scale.....	12-FD-7
CDC.....	1.2FDEW8
Maximum Deformation....	(0.0 in.) 0.0 mm

Required Test Number	Narrative Description	Evaluation Results
3-32 (1100C)	<p>Applus IDIADA KARCO Test No. P44010-01. Test Date January 30, 2024. Crash Test Report No. TR-P44010-01-A. MASH Test 3-32 of the VALTIR NOVUS™ 100 crash cushion.</p> <p>The crash cushion was impacted by a 2020 Kia Rio at a velocity of 59.71 mph (96.10 km/h) and a CIA of 15.4° relative to the centerline of the system, with the centerline of the vehicle directed at the center of the nose of the system. Upon impact the vehicle forced the crash cushion downstream until coming to a controlled stop 5.7 ft (1.7 m) downstream of the initial point of contact with the system. MASH deformation limits were not exceeded and there was no penetration into the vehicle's occupant compartment. The vehicle experienced a maximum occupant impact velocity (OIV) of 38.4 ft/s (11.7 m/s) and a maximum ridetop acceleration (RA) of -17.9 g.</p> <p>The NOVUS™ 100 crash cushion met all the requirements for MASH 2016 Test 3-32.</p>	PASS

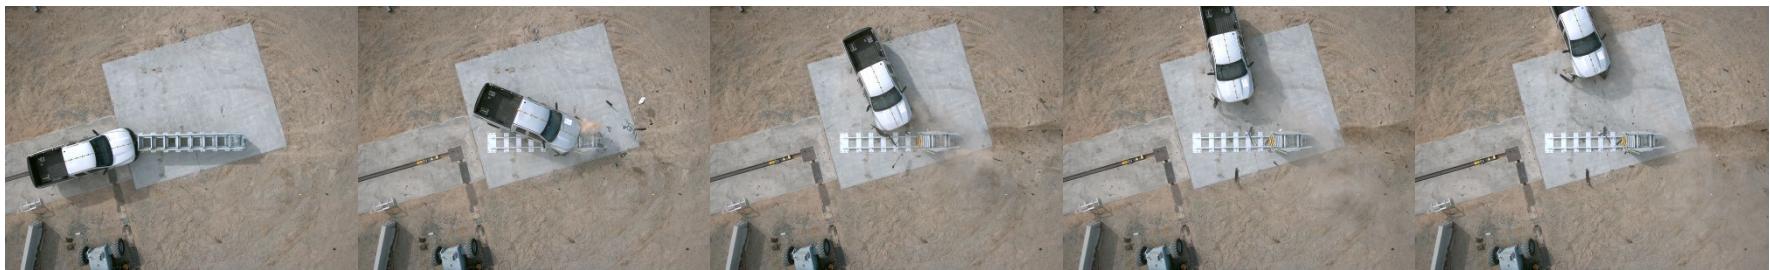
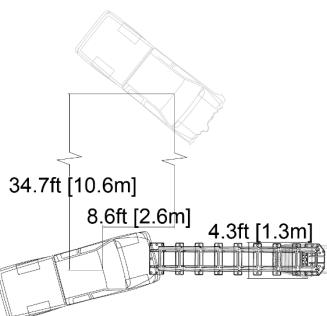
Figure 2 Summary of Test 3-33

Test Agency..... Applus IDIADA KARCO
 Test Number..... P44011-01
 Test Designation..... 3-33
 Test Date..... 1/31/24

Name / Model..... NOVUS™ 100
 Type..... Crash Cushion
 Crash Cushion Length..... 21.0 ft. (6.4 m)
 Road Surface..... Smooth, clean concrete

Type / Designation..... 2270P
 Year, Make, and Model.... 2018 RAM 1500
 Curb Mass..... 5,050.7 lbs (2,291.0 kg)
 Test Inertial Mass..... 5,011.0 lbs (2,273.0 kg)
 Gross Static Mass..... 5,011.0 lbs (2,273.0 kg)

Impact Velocity (Target)..... 62.14 mph (100.00 km/h)
 Impact Velocity (Actual)..... 61.60 mph (99.13 km/h)
 Impact Angle (Target)..... 15.0° relative to the centerline of the system
 Impact Angle (Actual)..... 15.3° relative to the centerline of the system
 Location / Orientation (Target)..... Center of resistance
 Location / Orientation (Actual)..... 4.1 in. (104 mm) from the center of resistance
 Kinetic Energy..... 635.6 kip-ft (861.7 kJ)
 Minimum KE Required..... 594.0 kip-ft (806.0 kJ)

Exit Velocity..... N/A
 Exit Angle..... N/A
 Final Vehicle Position..... 8.6 ft. (2.6 m) Downstream
 34.7 ft. (10.6 m) Left
 Vehicle Snagging..... Satisfactory
 Vehicle Pocketing..... Satisfactory
 Vehicle Stability..... Satisfactory
 Maximum Roll Angle..... -10.7 °
 Maximum Pitch Angle..... -4.7 °
 Maximum Yaw Angle..... 90.8 °

Longitudinal OIV..... 31.5 ft/s (9.6 m/s)
 Lateral OIV..... -3.3 ft/s (-1.0 m/s)
 Longitudinal RA..... -16.1 g
 Lateral RA..... 3.2 g
 THIV..... 32.2 ft/s (9.8 m/s)
 PHD..... 16.2 g
 ASI..... 1.10

Static..... 0.9 ft. (0.3 m)
 Dynamic..... 1.1 ft. (0.3 m)
 Working Width..... 4.3 ft. (1.3 m)
 Debris Field..... N/A

Vehicle Damage Scale..... 12-FD-3
 CDC..... 12FDEW9
 Maximum Deformation.... (0.0 in.) 0.0 mm

3-33 (2270P)	<p>Applus IDIADA KARCO Test No. P44011-01. Test Date January 31, 2024. Crash Test Report No. TR-P44011-01-A. MASH Test 3-33 of the VALTIR NOVUS™ 100 crash cushion.</p> <p>The crash cushion was impacted by a 2018 Ram 1500 at a velocity of 61.60 mph (99.13 km/h) and a CIA of 15.3° relative to the centerline of the system, with the centerline of the vehicle directed at the center of the nose of the system. Upon impact the vehicle forced the crash cushion downstream until coming to a stop 34.7 ft (10.6 m) towards the driver side from the initial point of contact with the system. MASH deformation limits were not exceeded and there was no penetration into the vehicle's occupant compartment. The vehicle experienced a maximum occupant impact velocity (OIV) of 31.5 ft/s (9.6 m/s) and a maximum ridetop acceleration (RA) of -16.1 g.</p> <p>The NOVUS™ 100 crash cushion met all the requirements for MASH 2016 Test 3-33.</p>	PASS

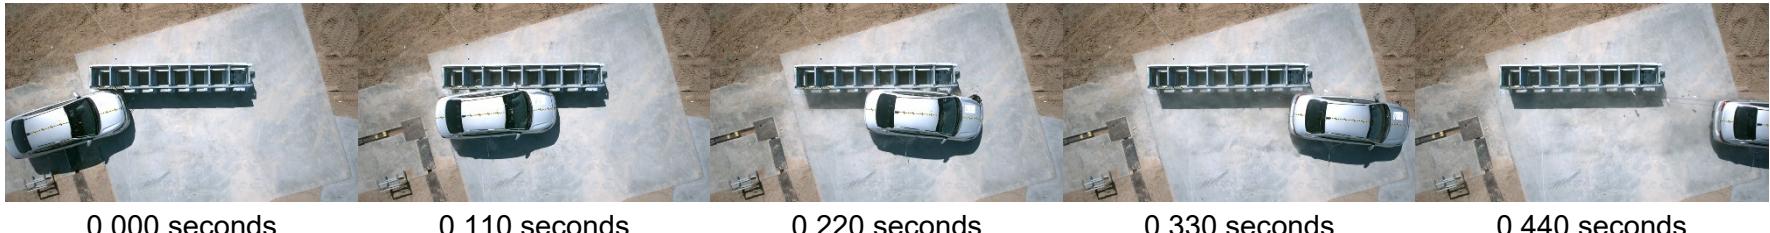
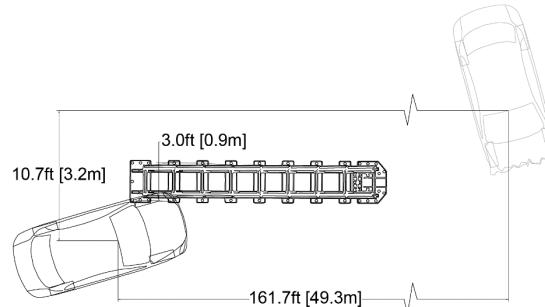
Figure 2 Summary of Test 3-34

Test Agency..... Applus IDIADA KARCO
 Test Number..... P44012-01
 Test Designation..... 3-34
 Test Date..... 2/27/24

Name / Model..... NOVUS™ 100
 Type..... Crash Cushion
 Crash Cushion Length..... 21.0 ft. (6.4 m)
 Road Surface..... Smooth, clean concrete

Type / Designation..... 1100C
 Year, Make, and Model.... 2018 Kia Rio
 Curb Mass..... 2,544.1 lbs (1,154.0 kg)
 Test Inertial Mass..... 2,396.4 lbs (1,087.0 kg)
 Gross Static Mass..... 2,561.8 lbs (1,162.0 kg)

Impact Velocity (Target)..... 62.14 mph (100.00 km/h)
 Impact Velocity (Actual)..... 61.61 mph (99.15 km/h)
 Impact Angle (Target)..... 15.0° relative to the centerline of the system
 Impact Angle (Actual)..... 15.7° relative to the centerline of the system
 Location / Orientation (Target)..... Centerline of diaphragm 2
 Location / Orientation (Actual)..... 5.0 in. (127 mm) upstream from the centerline of diaphragm 2
 Impact Severity..... 22.3 kip-ft (30.2 kJ)
 Minimum IS Required.... 19.0 kip-ft (26.0 kJ)

Exit Velocity..... 54.52 mph (85.79 km/h)
 Exit Angle..... 6.5°
 Final Vehicle Position..... 161.7 ft. (49.3 m) downstream
 Vehicle Snagging..... Satisfactory
 Vehicle Pocketing..... Satisfactory
 Vehicle Stability..... Satisfactory
 Maximum Roll Angle..... 1.9 °
 Maximum Pitch Angle..... -1.6 °
 Maximum Yaw Angle..... 22.2 °

Longitudinal OIV..... 9.5 ft/s (2.9 m/s)
 Lateral OIV..... -23.0 ft/s (-7.0 m/s)
 Longitudinal RA..... -2.5 g
 Lateral RA..... 10.9 g
 THIV..... 25.3 ft/s (7.7 m/s)
 PHD..... 11.0 g
 ASI..... 1.69

Static..... 0.0 ft. (0.0 m)
 Dynamic..... 0.1 ft. (0.0 m)
 Working Width..... 3.0 ft. (0.9 m)
 Debris Field..... N/A

Vehicle Damage Scale..... 11-FL-2
 CDC..... 11FLEN2
 Maximum Deformation.... (0.0 in.) 0.0 mm

3-34 (1100C)	<p>Applus IDIADA KARCO Test No. P44012-01. Test Date February 27, 2024. Crash Test Report No. TR-P44012-01-A. MASH Test 3-34 of the VALTIR NOVUS™ 100 crash cushion.</p> <p>The crash cushion was impacted by a 2018 Kia Rio at a velocity of 61.61 mph (99.15 km/h) and a CIA of 15.7° relative to the centerline of the system, with the vehicle impacting the CIP located at 5.0 in. (127mm) upstream from the centerline of diaphragm 2. Upon impact the vehicle was redirected before coming to a controlled stop 161.7 ft (49.3 m) downstream of the initial point of contact with the system. MASH deformation limits were not exceeded and there was no penetration into the vehicle's occupant compartment. The vehicle experienced a maximum occupant impact velocity (OIV) of -23.0 ft/s (-7.0 m/s) and a maximum ridedown acceleration (RA) of 10.9 g.</p> <p>The NOVUS™ 100 crash cushion met all the requirements for MASH 2016 Test 3-34.</p>	PASS

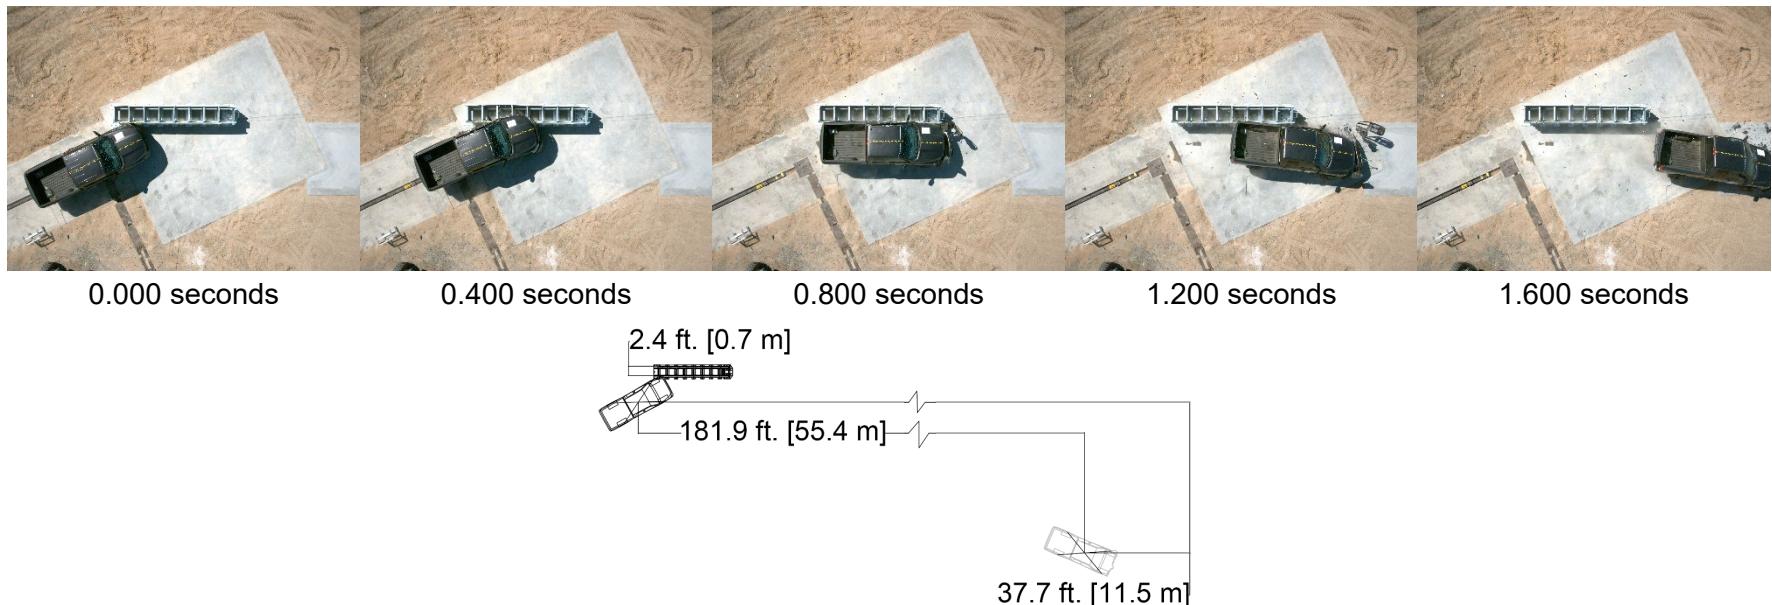
Figure 2 Summary of Test 3-35

GENERAL INFORMATION		Impact Conditions	Occupant Risk
Test Agency.....	Applus IDIADA KARCO	Impact Velocity (Target)..... 62.14 mph (100.00 km/h)	Longitudinal OIV..... 18.0 ft/s (5.5 m/s)
Test Number.....	P44013-01	Impact Velocity (Actual)..... 61.46 mph (98.91 km/h)	Lateral OIV..... -29.5 ft/s (-9.0 m/s)
Test Designation.....	3-35	Impact Angle (Target)..... 25.0° relative to the centerline of the system	Longitudinal RA..... -6.4 g
Test Date.....	2/29/24	Impact Angle (Actual)..... 25.6° relative to the centerline of the system	Lateral RA..... 10.1 g
TEST ARTICLE		Location / Orientation (Target)..... Centerline of diaphragm 2	THIV..... 35.4 ft/s (10.8 m/s)
Name / Model.....	NOVUS™ 100	Location / Orientation (Actual)..... 4.2 in. (107 mm) downstream from the centerline of diaphragm 2	PHD..... 10.2 g
Type.....	Crash Cushion	Impact Severity..... 118.2 kip-ft (160.2 kJ)	ASI..... 2.02
Crash Cushion Length.....	21.0 ft. (6.4 m)	Minimum IS Required..... 106.0 kip-ft (144.0 kJ)

Road Surface.....	Smooth, clean concrete		
TEST VEHICLE		Exit Conditions	Test Article Deflections
Type / Designation.....	2270P	Exit Velocity..... 49.91 mph (80.32 km/h)	Static..... 0.1 ft. (0.0 m)
Year, Make, and Model....	2018 RAM 1500	Exit Angle..... 7.6°	Dynamic..... 0.3 ft. (0.1 m)
Curb Mass.....	5,050.7 lbs (2,291.0 kg)	Final Vehicle Position..... 181.9 ft. (55.4 m) downstream	Working Width..... 2.4 ft. (0.7 m)
Test Inertial Mass.....	5,013.3 lbs (2,274.0 kg)	37.7 ft. (11.5 m) Passenger	Debris Field..... N/A
Gross Static Mass.....	5,013.3 lbs (2,274.0 kg)	Vehicle Snagging..... Satisfactory	
		Vehicle Pocketing..... Satisfactory	
		Vehicle Stability..... Satisfactory	
		Maximum Roll Angle..... -19.5 °	
		Maximum Pitch Angle..... 7.8 °	
		Maximum Yaw Angle..... 45.6 °	
Vehicle Damage			
		Vehicle Damage Scale..... 11-FL-5	
		CDC..... 11FDEW3	
		Maximum Deformation.... 2.1 in. (53 mm) driver toepan

3-35 (2270P)	<p>Applus IDIADA KARCO Test No. P44013-01. Test Date February 29, 2024. Crash Test Report No. TR-P44013-01-A. MASH Test 3-35 of the VALTIR NOVUS™ 100 crash cushion.</p> <p>The crash cushion was impacted by a 2018 Ram 1500 at a velocity of 61.46 mph (98.91 km/h) and a CIA of 25.6° relative to the centerline of the system, with the vehicle impacting the CIP located at 4.2 in. (107mm) downstream from the centerline of diaphragm 2. Upon impact the vehicle was redirected before coming to a controlled stop 181.9 ft (55.4 m) downstream of the initial point of contact with the system. MASH deformation limits were not exceeded and there was no penetration into the vehicle's occupant compartment. The vehicle experienced a maximum occupant impact velocity (OIV) of -29.5 ft/s (-9.0 m/s) and a maximum ridedown acceleration (RA) of 10.1 g.</p> <p>The NOVUS™ 100 crash cushion met all the requirements for MASH 2016 Test 3-35.</p>	PASS

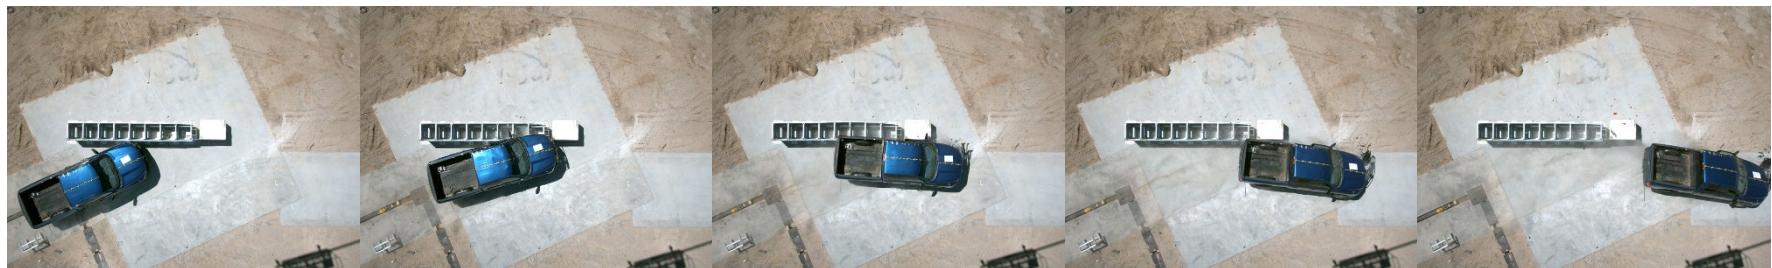
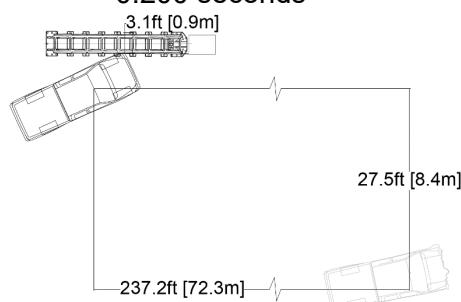
Figure 2 Summary of Test 3-36

Test Agency..... Applus IDIADA KARCO
 Test Number..... P44014-01
 Test Designation..... 3-36
 Test Date..... 4/3/24

Name / Model..... NOVUS™ 100
 Type..... Crash Cushion
 Crash Cushion Length..... 21.0 ft. (6.4 m)
 Road Surface..... Smooth, clean concrete

Type / Designation..... 2270P
 Year, Make, and Model.... 2018 RAM 1500
 Curb Mass..... 5,127.9 lbs (2,326.0 kg)
 Test Inertial Mass..... 5,001.1 lbs (2,268.5 kg)
 Gross Static Mass..... 5,001.1 lbs (2,268.5 kg)

Impact Velocity (Target)..... 62.14 mph (100.00 km/h)
 Impact Velocity (Actual)..... 63.93 mph (102.88 km/h)
 Impact Angle (Target)..... 25.0° relative to the centerline of the system
 Impact Angle (Actual)..... 24.6° relative to the centerline of the system
 Location / Orientation (Target)..... Centerline of diaphragm 5
 Location / Orientation (Actual)..... 6.6 in. (168 mm) downstream from the centerline of diaphragm 5
 Impact Severity..... 118.4 kip-ft (160.5 kJ)
 Minimum IS Required.... 106.0 kip-ft (144.0 kJ)

Exit Velocity..... 54.86 mph (88.29 km/h)
 Exit Angle..... 6.2°
 Final Vehicle Position..... 237.2 ft. (72.3 m) Downstream
 27.5 ft. (8.4 m) Right
 Vehicle Snagging..... Satisfactory
 Vehicle Pocketing..... Satisfactory
 Vehicle Stability..... Satisfactory
 Maximum Roll Angle..... -18.7 °
 Maximum Pitch Angle..... -4.8 °
 Maximum Yaw Angle..... 44.5 °

Longitudinal OIV..... 16.4 ft/s (5.0 m/s)
 Lateral OIV..... -29.9 ft/s (-9.1 m/s)
 Longitudinal RA..... -4.4 g
 Lateral RA..... 10.6 g
 THIV..... 34.4 ft/s (10.5 m/s)
 PHD..... 10.7 g
 ASI..... 2.11

Static..... 0.0 ft. (0.0 m)
 Dynamic..... 0.2 ft. (0.1 m)
 Working Width..... 3.1 ft. (0.9 m)
 Debris Field..... N/A

Vehicle Damage Scale..... 11-FL-4
 CDC..... 11FDEW2
 Maximum Deformation.... 2.6 in. (65 mm) At toepan

3-36 (2270P)	<p>Applus IDIADA KARCO Test No. P44014-01. Test Date April 3, 2024. Crash Test Report No. TR-P44014-01-A. MASH Test 3-36 of the VALTIR NOVUS™ 100 crash cushion.</p> <p>The crash cushion was impacted by a 2018 Ram 1500 at a velocity of 63.93 mph (102.88 km/h) and a CIA of 24.6° relative to the centerline of the system, with the centerline of the vehicle aligned to the center of the backup structure. Upon impact the vehicle was redirected before coming to a controlled stop 237.2 ft (72.3 m) downstream of the initial point of contact with the system. MASH deformation limits were not exceeded and there was no penetration into the vehicle's occupant compartment. The vehicle experienced a maximum occupant impact velocity (OIV) of -29.9 ft/s (-9.1 m/s) and a maximum ridedown acceleration (RA) of 10.6 g.</p> <p>The NOVUS™ 100 crash cushion met all the requirements for MASH 2016 Test 3-36.</p>	PASS

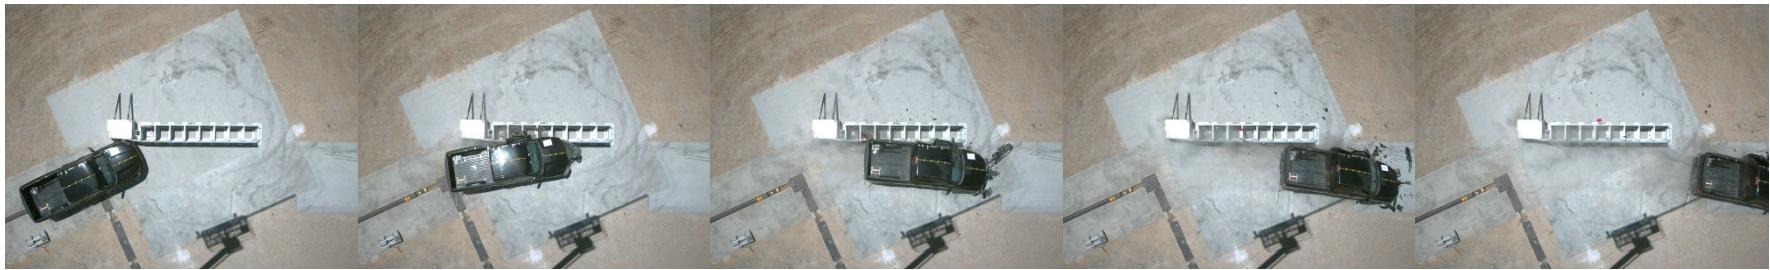
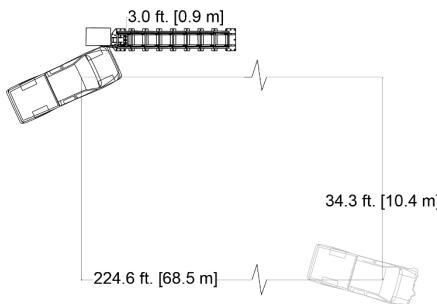
Figure 2 Summary of Test 3-37a

Test Agency..... Applus IDIADA KARCO
 Test Number..... P44015-01
 Test Designation..... 3-37a
 Test Date..... 4/30/24

Name / Model..... NOVUS™ 100
 Type..... Crash Cushion
 Crash Cushion Length..... 21.0 ft. (6.4 m)
 Road Surface..... Smooth, clean concrete

Type / Designation..... 2270P
 Year, Make, and Model.... 2019 RAM 1500
 Curb Mass..... 5,105.8 lbs (2,316.0 kg)
 Test Inertial Mass..... 5,081.6 lbs (2,305.0 kg)
 Gross Static Mass..... 5,081.6 lbs (2,305.0 kg)

Impact Velocity (Target)..... 62.14 mph (100.00 km/h)
 Impact Velocity (Actual)..... 60.73 mph (97.74 km/h)
 Impact Angle (Target)..... 25.0° relative to the centerline of the system
 Impact Angle (Actual)..... 24.7° relative to the centerline of the system
 Location / Orientation (Target)..... Beginning of the transition panel
 Location / Orientation (Actual)..... 5.5 in. (140 mm) upstream from the beginning of the transition panel
 Impact Severity..... 109.4 kip-ft (148.3 kJ)
 Minimum IS Required..... 106.0 kip-ft (144.0 kJ)

Exit Velocity..... 48.00 mph (77.25 km/h)
 Exit Angle..... 6.7°
 Final Vehicle Position..... 224.6 ft. (68.5 m) Downstream
 34.3 ft. (10.4 m) Right
 Vehicle Snagging..... Satisfactory
 Vehicle Pocketing..... Satisfactory
 Vehicle Stability..... Satisfactory
 Maximum Roll Angle..... -20.5 °
 Maximum Pitch Angle..... -8.6 °
 Maximum Yaw Angle..... 35.8 °

Longitudinal OIV..... 8.9 ft/s (2.7 m/s)
 Lateral OIV..... -10.2 ft/s (-3.1 m/s)
 Longitudinal RA..... 1.6 g
 Lateral RA..... -2.8 g
 THIV..... 13.8 ft/s (4.2 m/s)
 PHD..... 3.4 g
 ASI..... 0.71

Static..... 0.0 ft. (0.0 m)
 Dynamic..... 0.1 ft. (0.0 m)
 Working Width..... 3.0 ft. (0.9 m)
 Debris Field..... N/A

Vehicle Damage Scale..... 11-FL-7
 CDC..... 11FDEW1
 Maximum Deformation.... 6.0 in. (153 mm) At toepan

3-37a (2270P)	<p>Applus IDIADA KARCO Test No. P44015-01. Test Date April 30, 2024. Crash Test Report No. TR-P44015-01-A. MASH Test 3-37a of the VALTIR NOVUS™ 100 crash cushion.</p> <p>The crash cushion was impacted by a 2019 Ram 1500 at a velocity of 60.73 mph (97.74 km/h) and a CIA of 24.7° relative to the centerline of the system, with the centerline of the vehicle impacting the CIP located at the beginning of the transition panel. Upon impact the vehicle was redirected before coming to a controlled stop 224.6 ft (68.5 m) downstream of the initial point of contact with the transition. MASH deformation limits were not exceeded and there was no penetration into the vehicle's occupant compartment. The vehicle experienced a maximum occupant impact velocity (OIV) of -10.2 ft/s (-3.1 m/s) and a maximum ridedown acceleration (RA) of -2.8 g.</p> <p>The NOVUS™ 100 crash cushion met all the requirements for MASH 2016 Test 3-37a.</p>	PASS

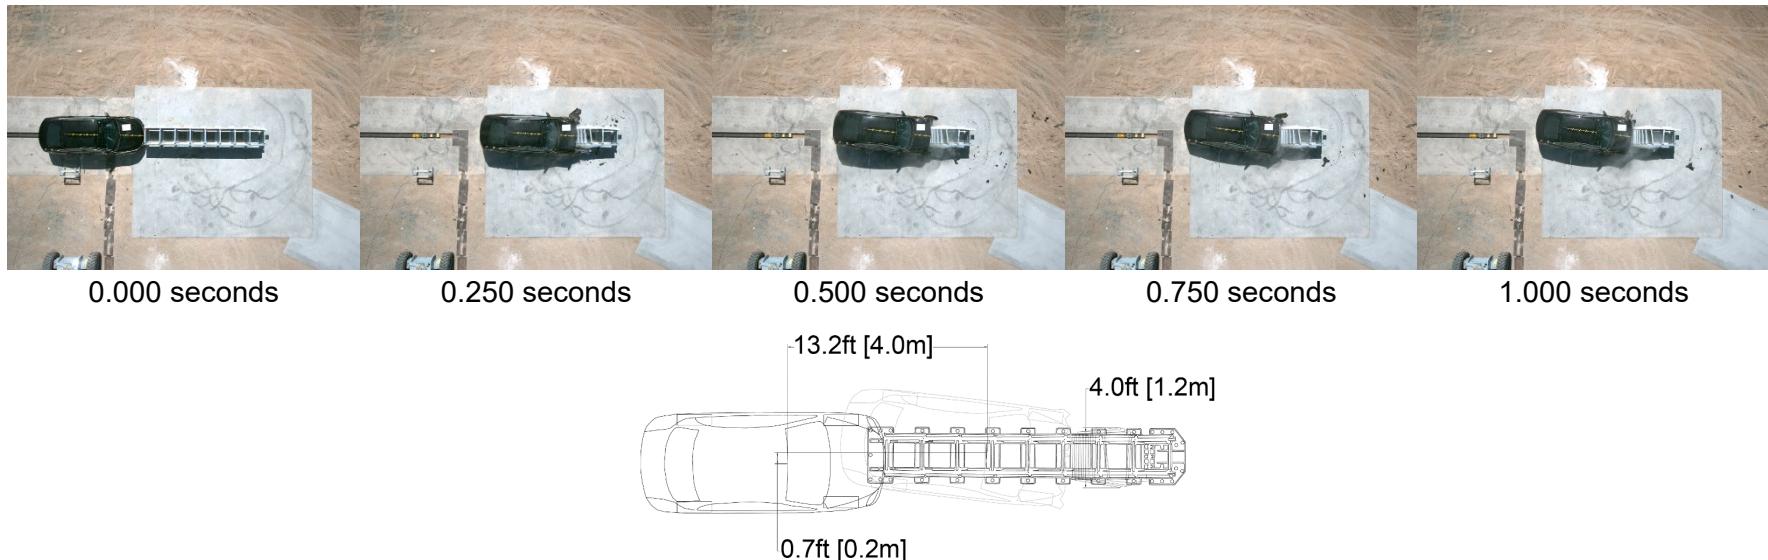
Figure 2 Summary of Test 3-38

GENERAL INFORMATION		Impact Conditions	Occupant Risk
Test Agency.....	Applus IDIADA KARCO	Impact Velocity (Target)..... 62.14 mph (100.00 km/h)	Longitudinal OIV..... 35.1 ft/s (10.7 m/s)
Test Number.....	P44033-01	Impact Velocity (Actual)..... 64.21 mph (103.34 km/h)	Lateral OIV..... 1.0 ft/s (-0.3 m/s)
Test Designation.....	3-38	Impact Angle (Target)..... 0.0° relative to the centerline of the system	Longitudinal RA..... -14.4 g
Test Date.....	3/12/24	Impact Angle (Actual)..... 0.5° relative to the centerline of the system	Lateral RA..... -2.6 g
TEST ARTICLE		Location / Orientation (Target)..... Centerline of the system	THIV..... 35.1 ft/s (10.7 m/s)
Name / Model.....	NOVUS™ 100	Location / Orientation (Actual)..... 0.7 in. (18 mm) from the centerline of the system	PHD..... 14.5 g
Type.....	Crash Cushion	Kinetic Energy..... 452.5 kip-ft (613.5 kJ)	ASI..... 1.01
Crash Cushion Length.....	21.0 ft. (6.4 m)	Minimum KE Required..... 392.0 kip-ft (532.0 kJ)

Road Surface.....	Smooth, clean concrete		
TEST VEHICLE		Exit Conditions	Test Article Deflections
Type / Designation.....	1500A	Exit Velocity..... N/A	Static..... 0.4 ft. (0.1 m)
Year, Make, and Model....	2018 Chevrolet Malibu	Exit Angle..... N/A	Dynamic..... 0.4 ft. (0.1 m)
Curb Mass.....	3,070.9 lbs (1,393.0 kg)	Final Vehicle Position..... 13.2 ft. (4.0 m) Downstream	Working Width..... 4.0 ft. (1.2 m)
Test Inertial Mass.....	3,282.7 lbs (1,489.0 kg)	0.7 ft. (0.2 m) Left	Debris Field..... N/A
Gross Static Mass.....	3,282.7 lbs (1,489.0 kg)	Vehicle Snagging..... Satisfactory	
		Vehicle Pocketing..... Satisfactory	
		Vehicle Stability..... Satisfactory	
		Maximum Roll Angle..... 3.3 °	
		Maximum Pitch Angle..... -7.1 °	
		Maximum Yaw Angle..... 9.3 °	
Vehicle Damage			
		Vehicle Damage Scale..... 12-FD-6	
		CDC..... 12FDEW5	
		Maximum Deformation.... (0.0 in.) 0.0 mm

Applus IDIADA KARCO Test No. P44033-01. Test Date March 12, 2024. Crash Test Report No. TR-P44033-01-A. MASH Test 3-38 of the VALTIR NOVUS™ 100 crash cushion.	
3-38 (1500A)	<p>The crash cushion was impacted by a 2018 Chevrolet Malibu at a velocity of 64.21 mph (103.34 km/h) and a CIA of 0.5° relative to the centerline of the system, with the centerline of the vehicle impacting the centerline of the crash cushion. Upon impact the vehicle forced the crash cushion downstream until coming to a controlled stop 13.2 ft (4.0 m) downstream of the initial point of contact with the system. MASH deformation limits were not exceeded and there was no penetration into the vehicle's occupant compartment. The vehicle experienced a maximum occupant impact velocity (OIV) of 35.1 ft/s (10.7 m/s) and a maximum ridethrough acceleration (RA) of -14.4 g.</p> <p>The NOVUS™ 100 crash cushion met all the requirements for MASH 2016 Test 3-38.</p>	PASS

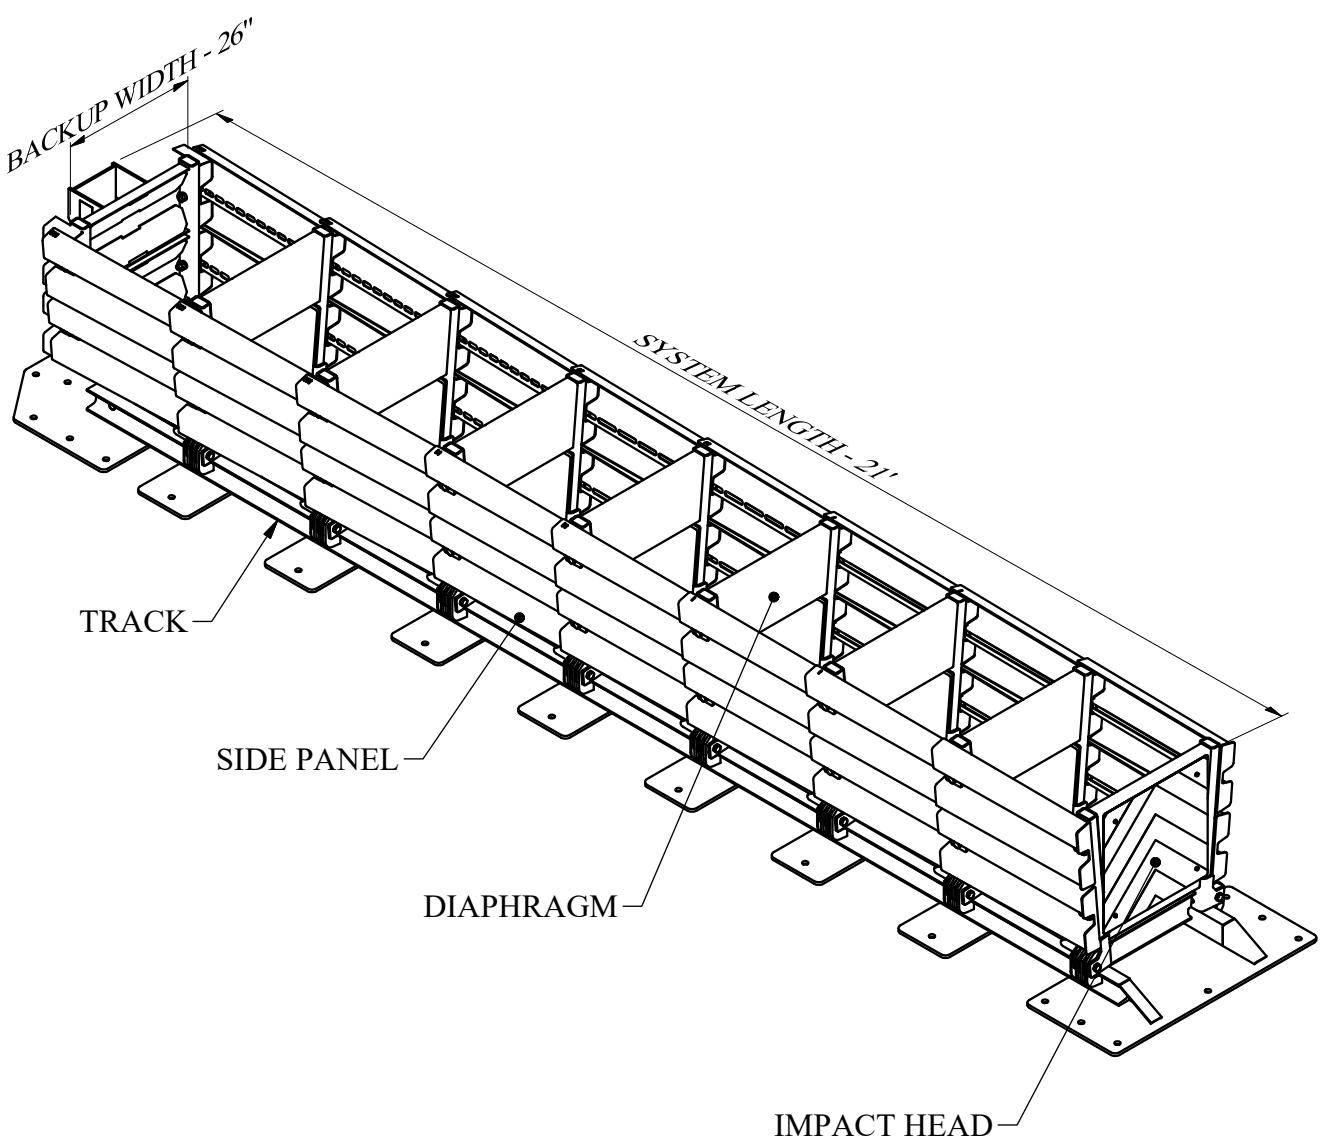
NOVUS™ 100 CRASH CUSHION

The NOVUS 100 MASH TL3 Crash Cushion consists of an engineered steel impact head and diaphragms, energy absorbing side panels. The system is MASH (Manual for Assessing Safety Hardware) Test Level 3 compliant as a re-directive, non-gating crash cushion.

The NOVUS 100 Crash Cushion consists of the Test Level 3 platform and framework and can be used to shield fixed objects of 26" [660 mm] wide.

Galvanized all-steel construction designed for durability.
Uses only 33 anchors.
Self contained backup.
Basetrack guide stabilizers.
Anchorage in concrete and asphalt.
High strength steel panels.

System Length: 21' [6.4 m]
System Width: 26" [660 mm]
System Height: 34 3/4" [883 mm]
System Weight: 3,800 lb [1723.6 kg] (approx)
