Appendix A

Agency Correspondence

Subject: National Historic Preservation Act, Section 106 and Hawaii Revised Statutes,
Chapter 6e Consultation for the Project to Replace Temporary Wainiha Bridges

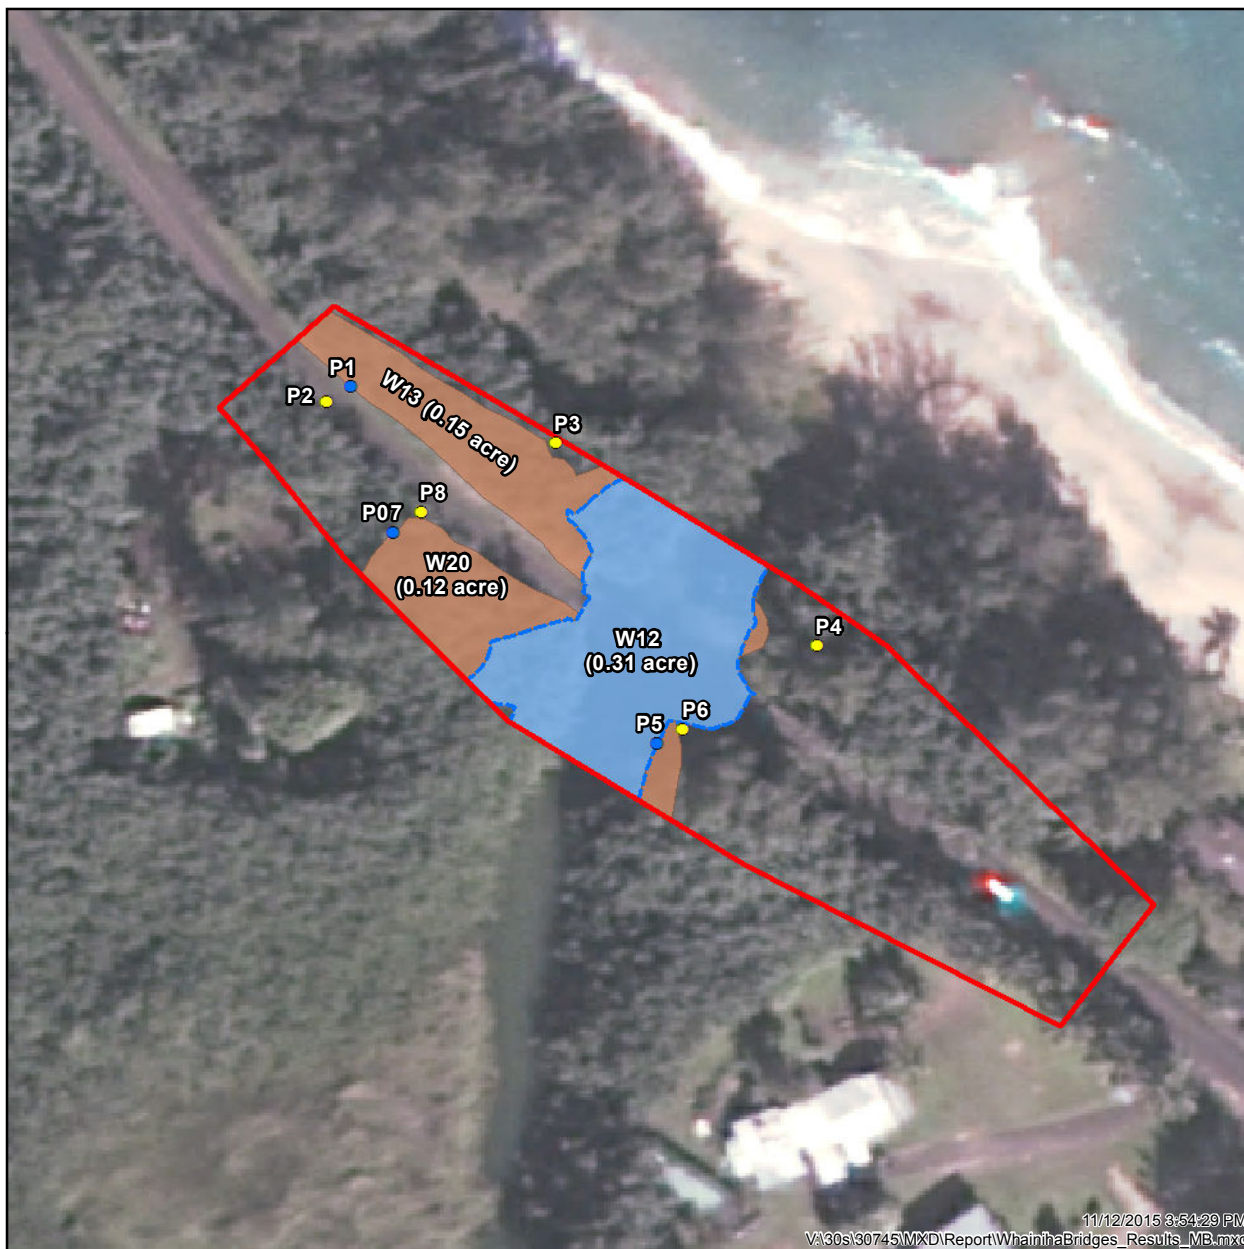
Waioli Stream Bridge

Data Points **Wetlands/WOUS** **--- High Tide Line** **Survey Area**

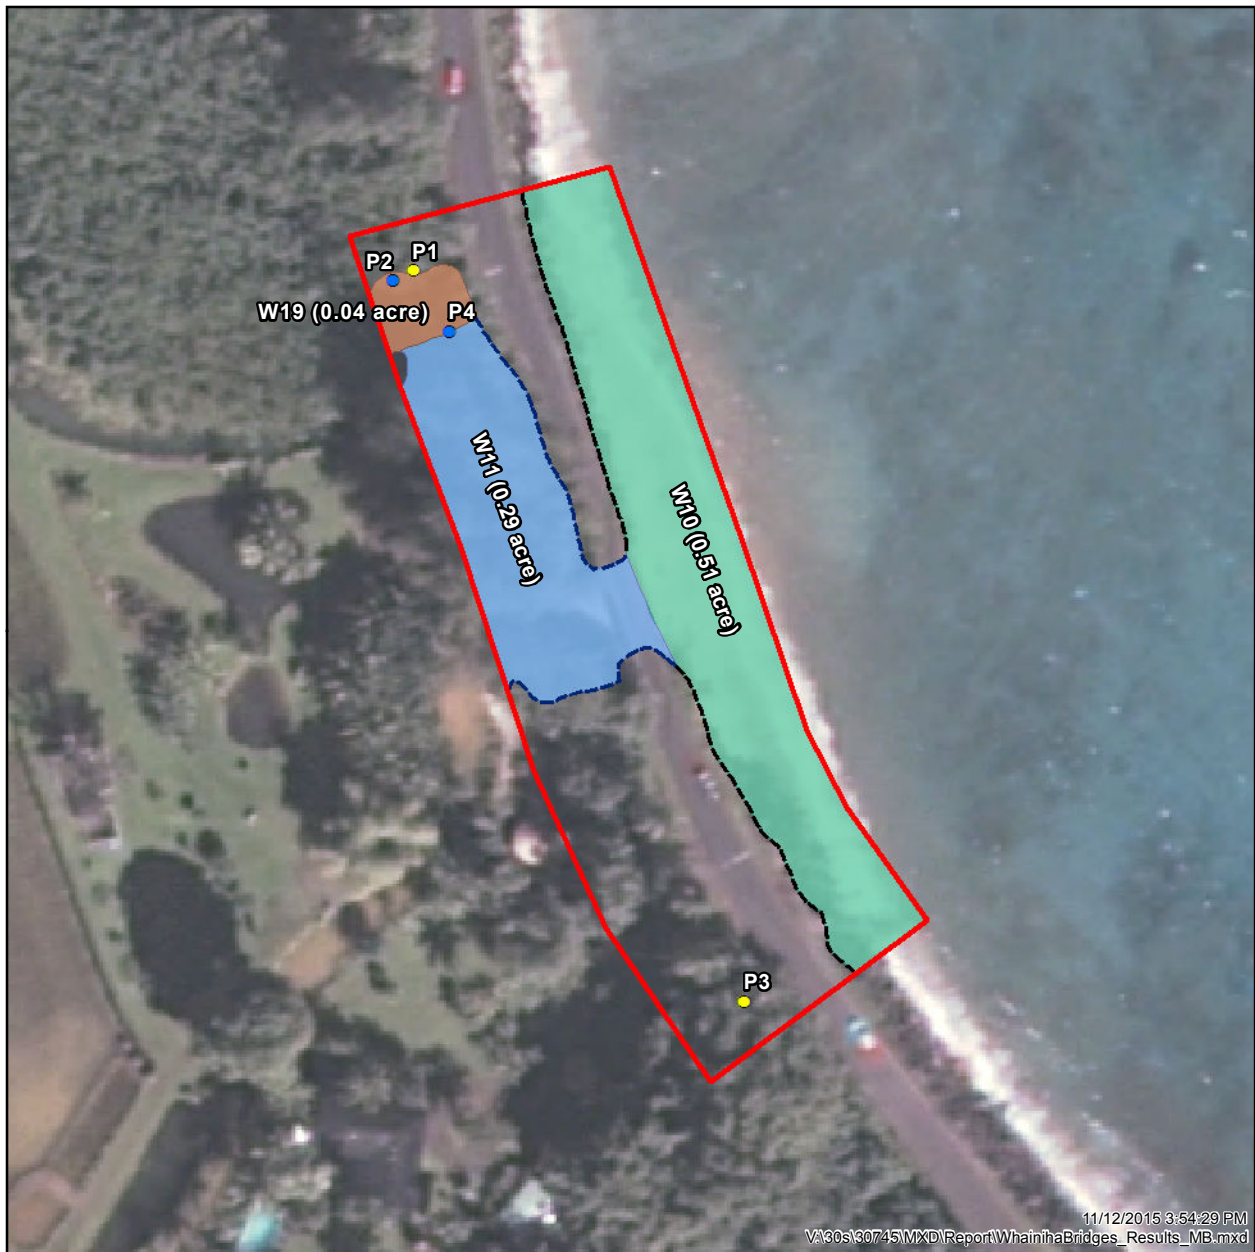
Waipa Stream Bridge

Data Points **Wetlands/WOUS** --- MHW Survey Area

● Upland M2USP - - - OHW

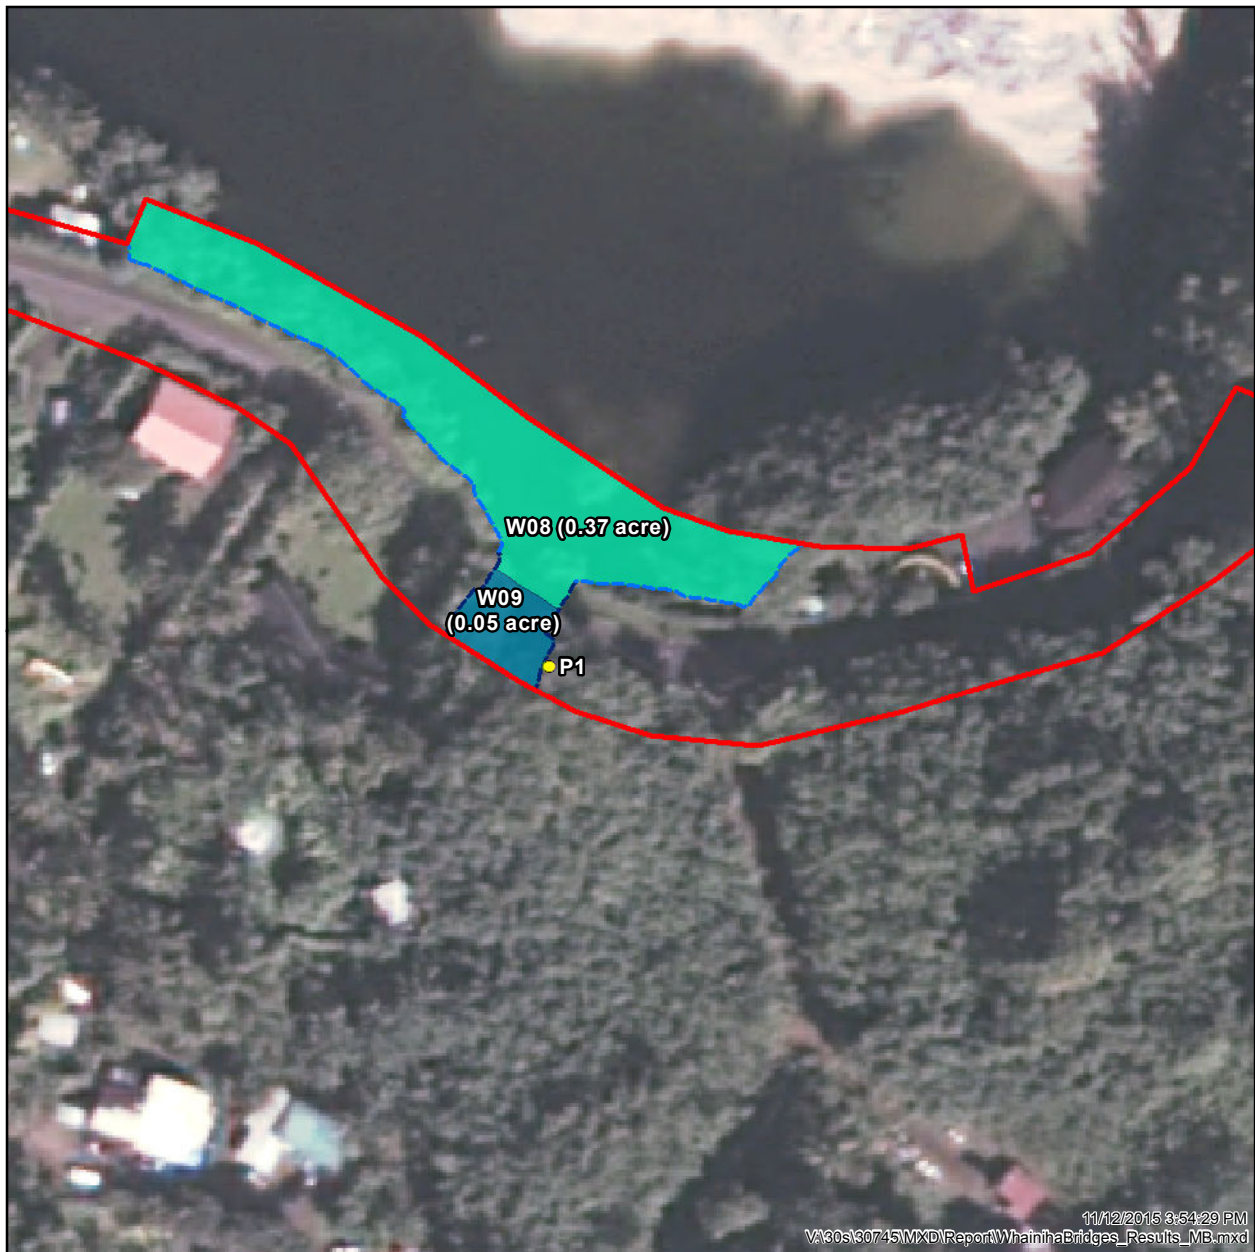
Waikoko Steam Bridge

Data Points **Wetlands/WOUS** **High Tide Line** **Survey Area**
 ● Upland ■ E1UBL --- OHWM
 ● Wetland ■ R2RB

Approximately 0.80 acre (0.32 ha) of tidal, non-wetland WoUS (R1 and M2) and 0.04 acre (0.02 ha) of wetlands (PFO) were delineated in the Waikoko survey area (Figure 4). The types and acreage of WoUS delineated by SWCA are summarized in Table 17.

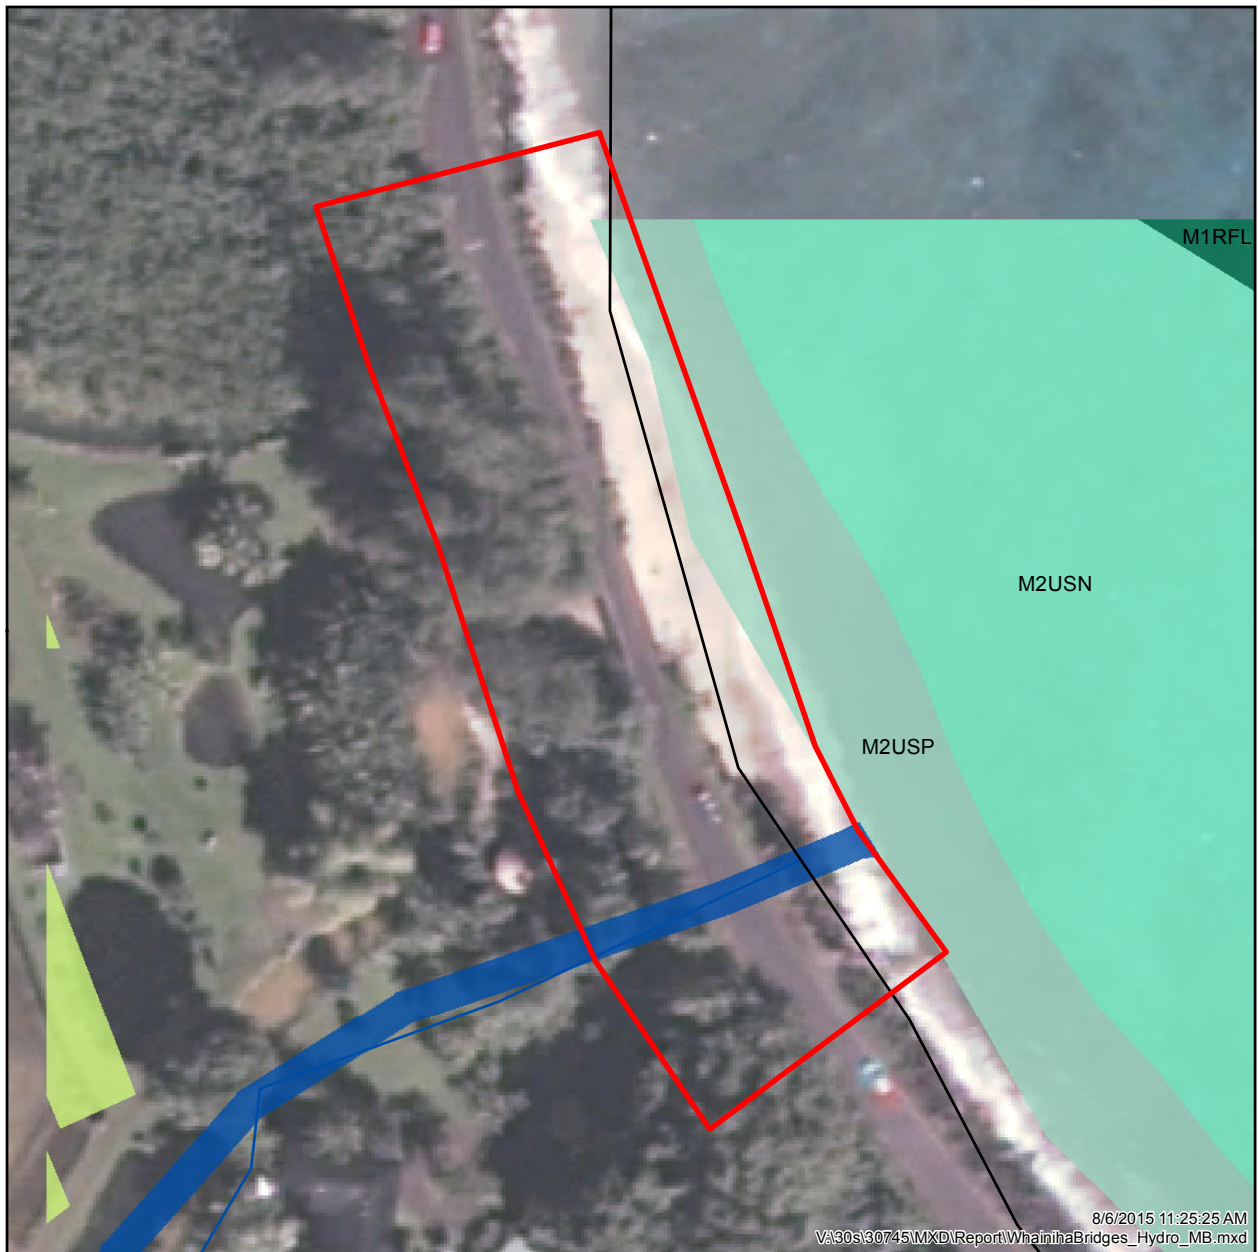
Bridges 2 & 3 Survey

Survey Area

National Hydrography Dataset

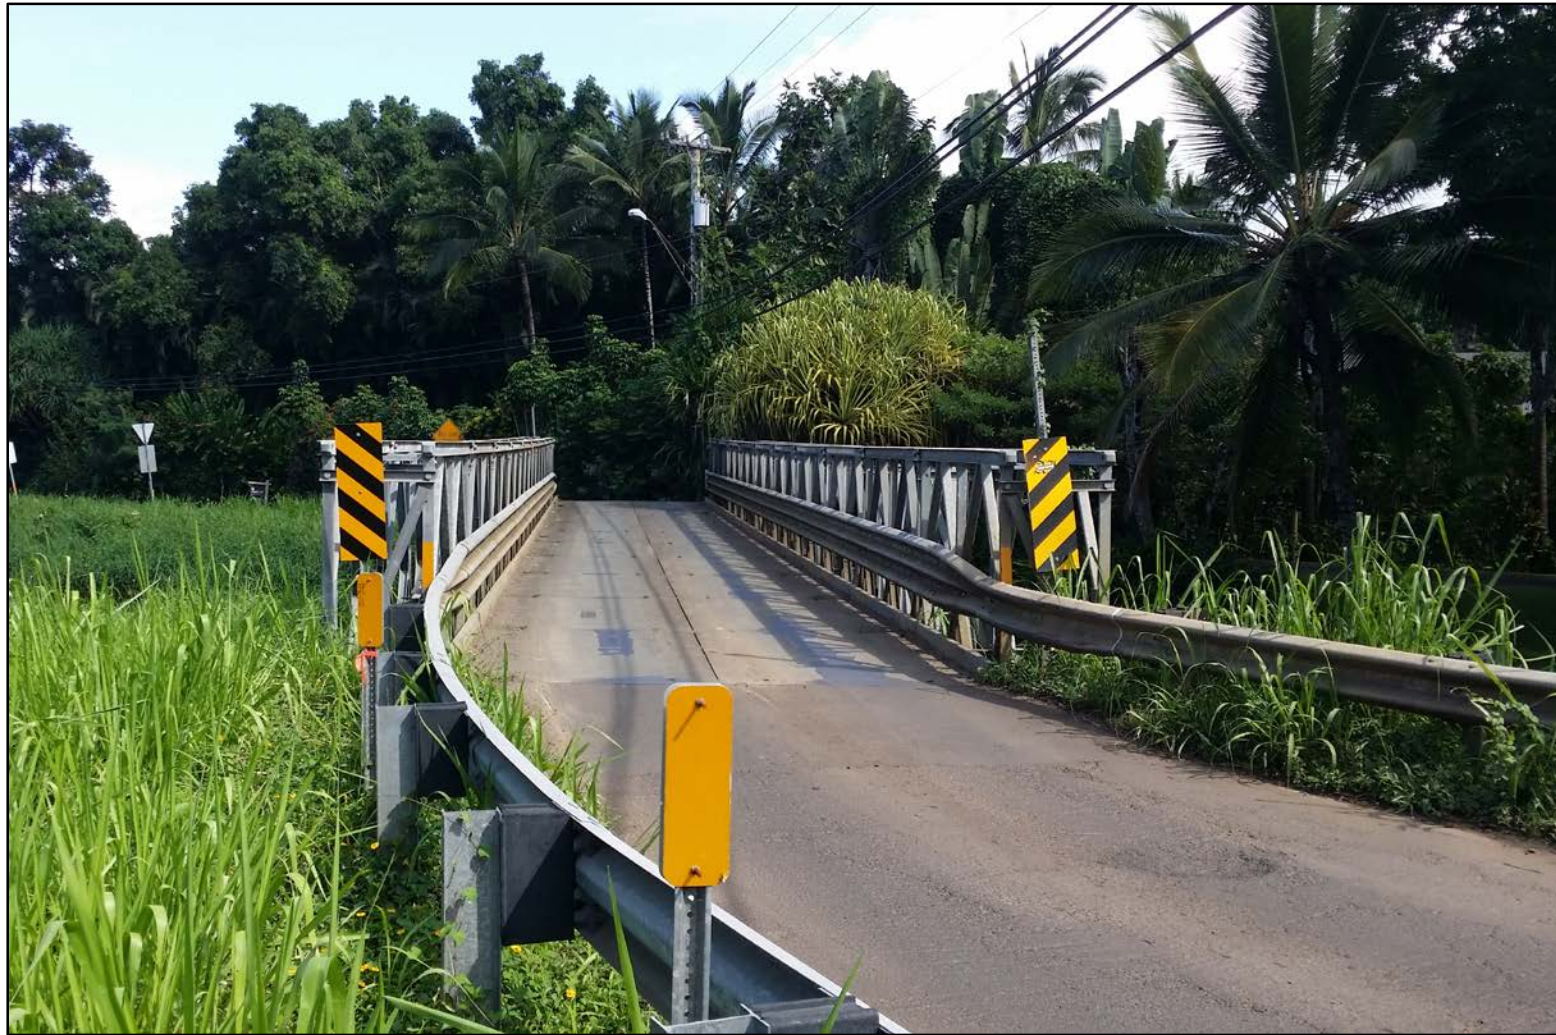
Figure 38. Portion of Kūhiō Highway, Wainiha Stream Bridge 1, a non-contributing structure within the historic bridges district, view to east

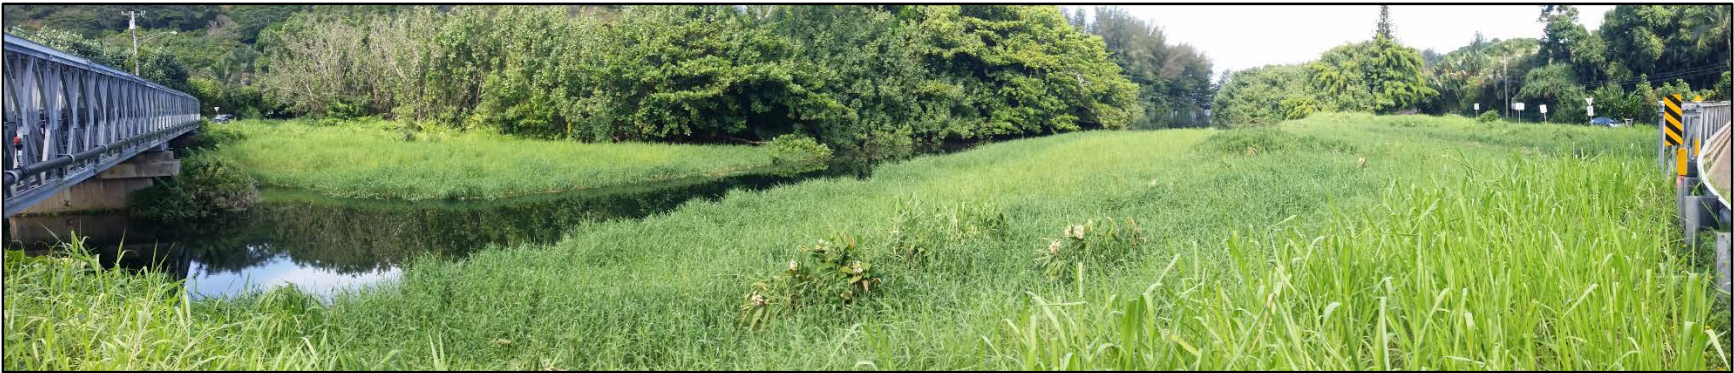
Figure 39. Portions of the Wainiha River downstream from Kūhiō Highway between Wainiha Bridges 2 and 3, non-contributing structures within the historic bridges district, panoramic view toward the Wainiha River mouth, to north

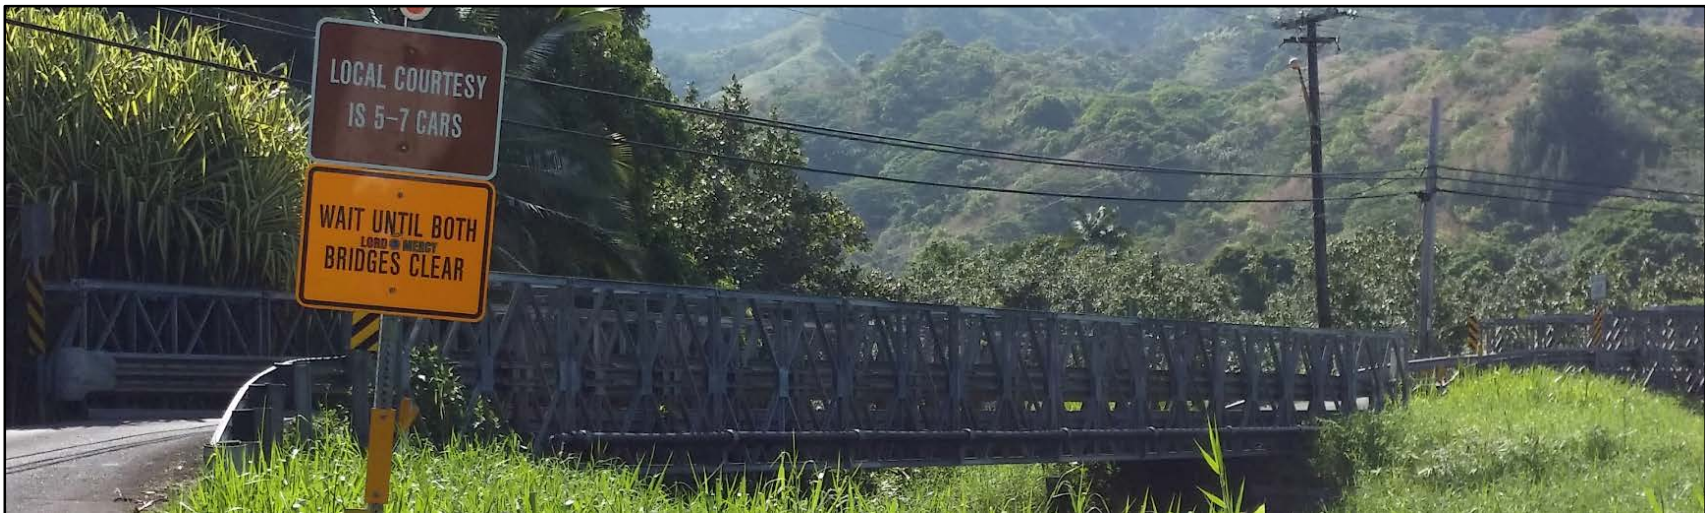
Figure 40. Portion of the Kūhiō Highway, view to south of Wainiha Bridge 2; note sign indicating the local custom of taking turns to cross the bridge, allowing 5-7 cars across at a time

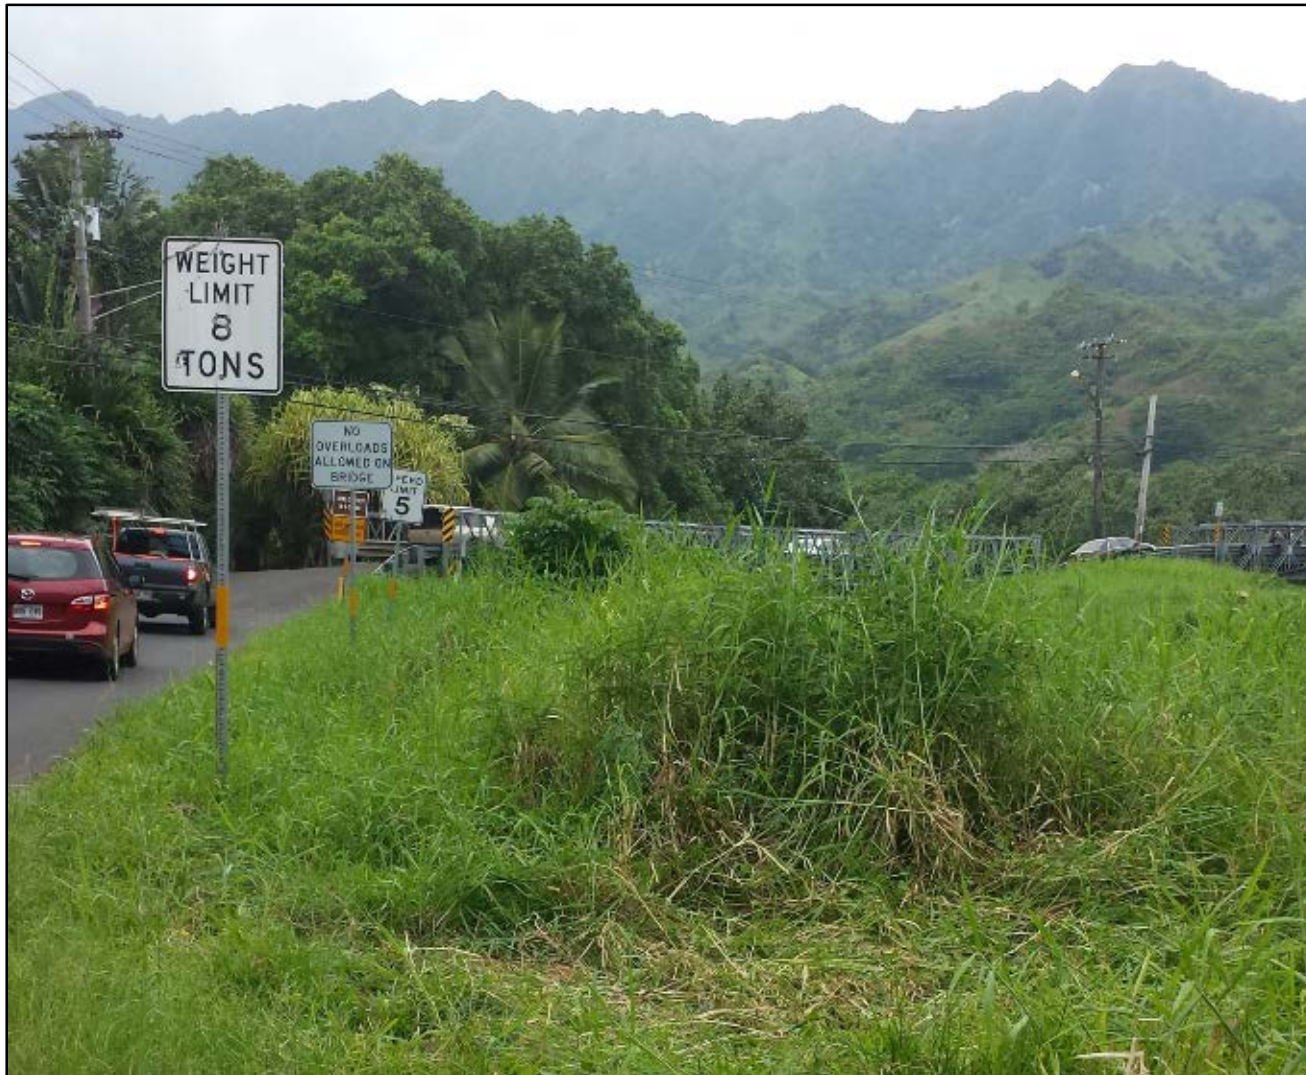
Figure 41. A portion of the Kūhiō Highway, view to south from the east side of the Wainiha Bridge 2, a non-contributing structure within the historic bridges district, general location of ST-3 in the foreground

All vestiges of these earlier bridges at Wainiha were most likely removed or have been totally obscured by flooding and replacement in 2004. The bridges have all been recently replaced by steel frame and panel bridges (see Figure 38 through Figure 43). "This bridge is a non-contributing feature of the Kauai Belt Road (North Shore section) district due to the complete replacement of the original 1931 bridge in 2004. It was replaced with a temporary modular prefabricated steel truss bridge" (Fung Associates 2013:3-76). No portions of the historic Wainiha Stream bridge features were observed by CSH archaeologists.

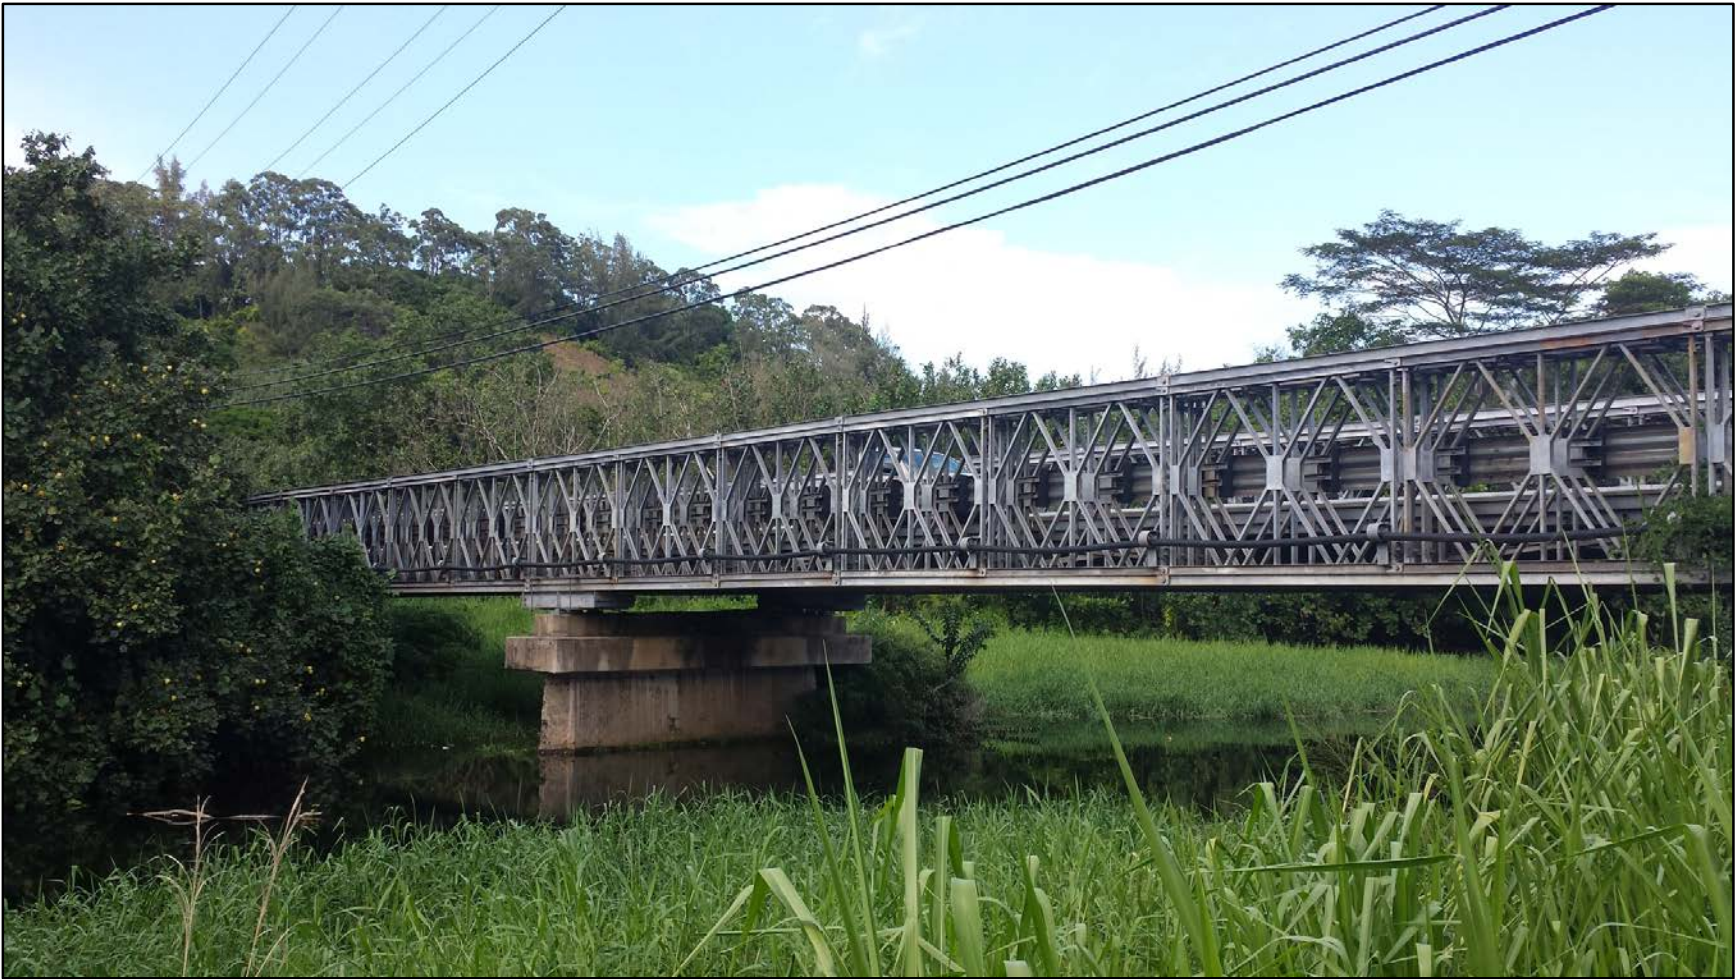
Figure 42. A portion of the Kūhiō Highway at the Wainiha Bridge 3, a non-contributing structure within the historic bridges district, general view to north

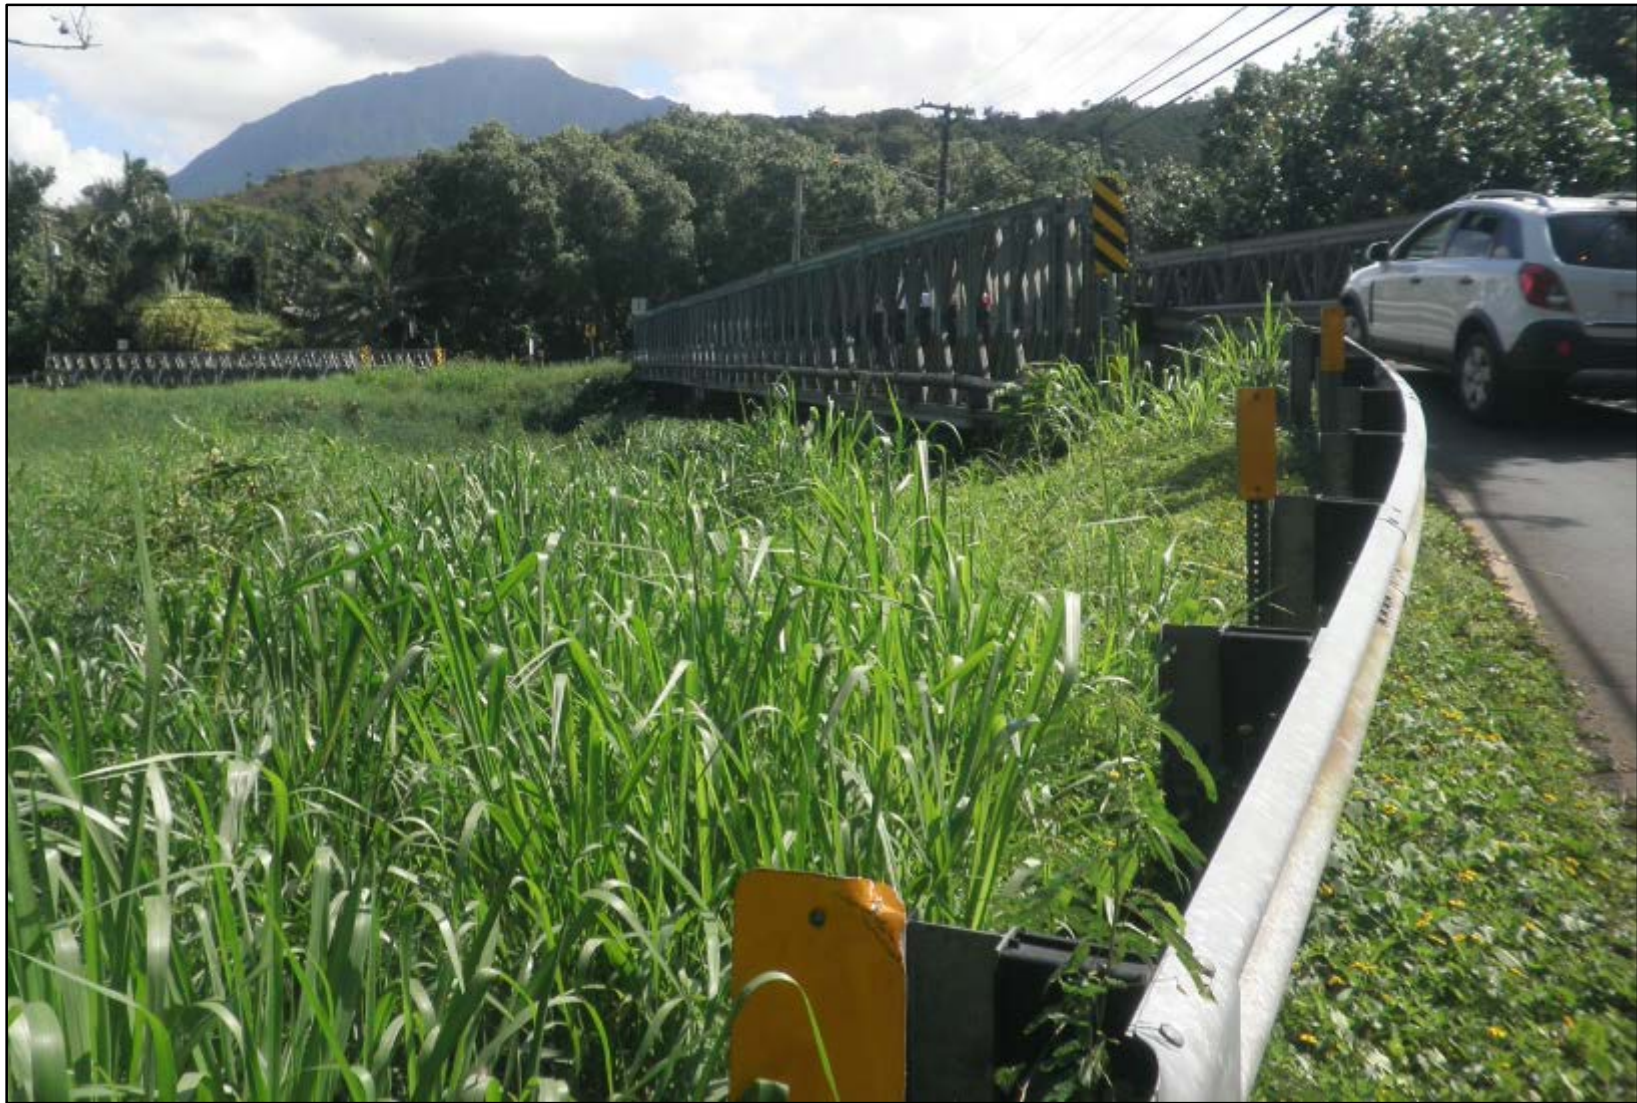
Figure 43. A portion of the Kūhiō Highway, Wainiha Bridges 3 and 2 respectively, non-contributing structures within the historic bridges district, general view to southeast with Pu‘uuaia in the background

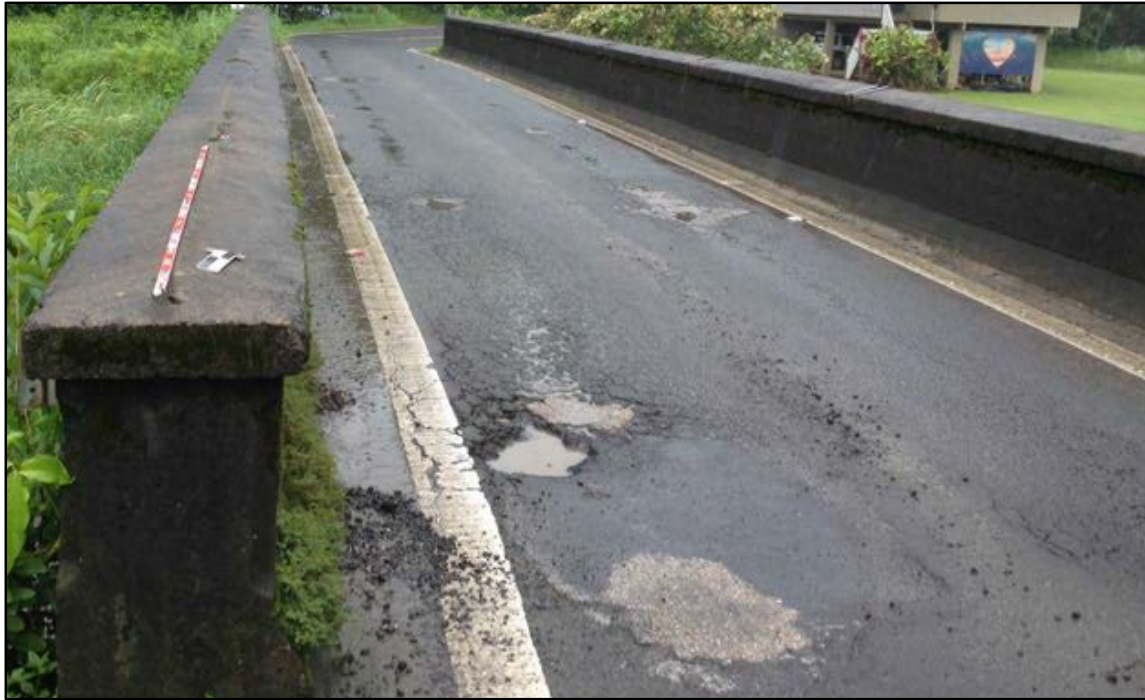
Figure 47. SIHP # 50-30-03-2296, the Wai'ole Stream Bridge, profile view to north

SIHP # 50-30-03-2296, the Wai'ole Stream Bridge, Hawai'i State Bridge Number 007005600500343, located on the western boundary of Hanalei Town, 0.21 km (0.13 miles) west of Anae Road, is the oldest concrete girder bridge in Hawai'i (Fung Associates 2013:8-10) (Figure 44 through Figure 48). Designed by Joseph Hughes Moragne and built by George W. Mahikoa, the Wai'oli Stream Bridge was built in 1912 and was determined eligible to the National Register in 1978 with high preservation value eligibility status. The bridge is a contributing structure to the Kaua'i Belt Road (North Shore section) archaeological district (Fung Associates 2013:3-83).

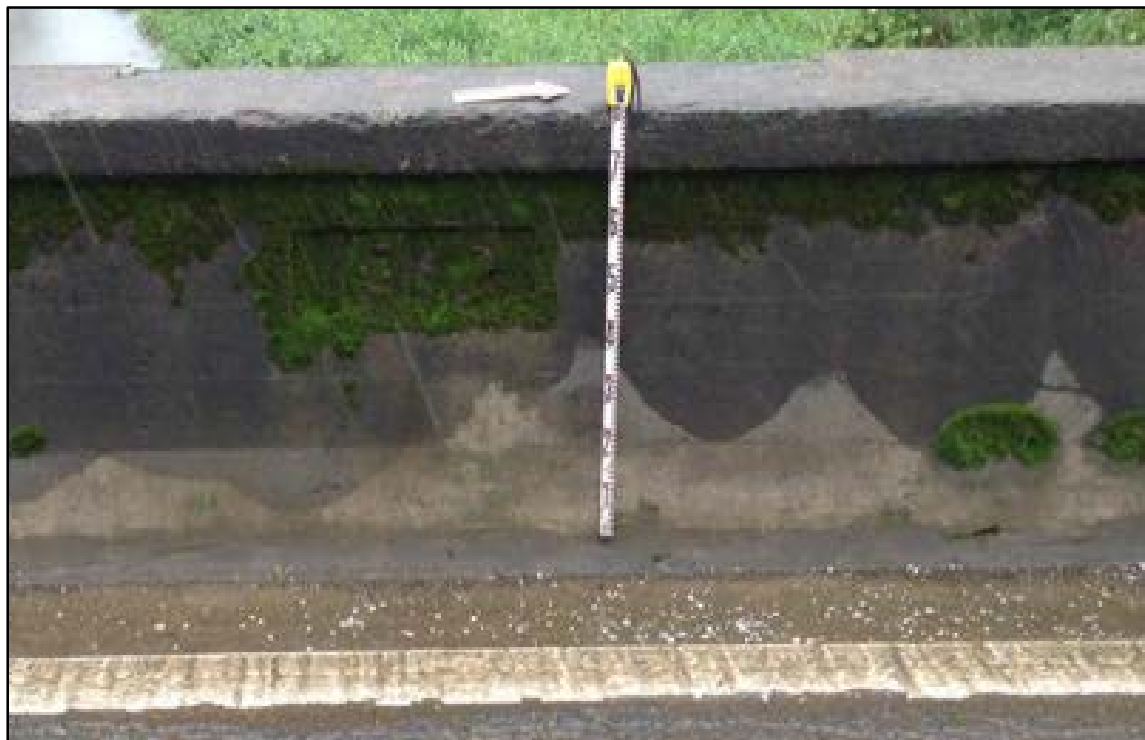
Figure 48. SIHP # 50-30-03-2296, the Wai'ole Stream Bridge, profile view to west, showing concrete stamped "1912"

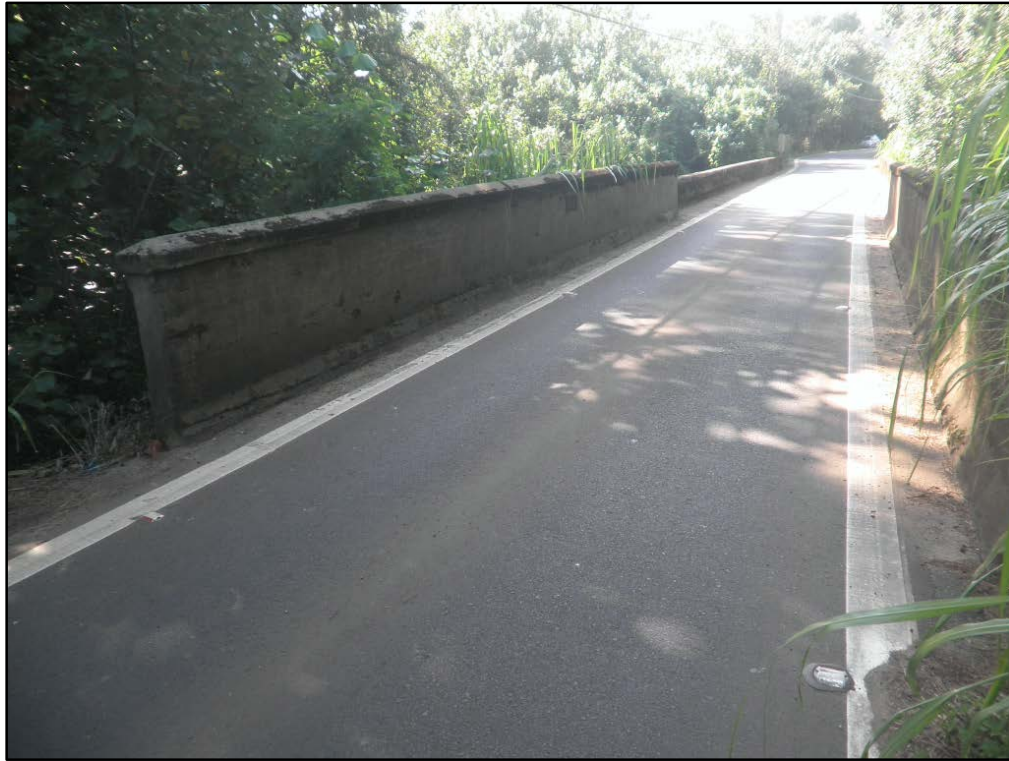
Figure 51. SIHP # 50-30-03-2297, the Waipā Stream Bridge, general view to northwest; note the 1912 bridge portion in the foreground

The Waipā Stream Bridge, Hawai'i State Bridge Number 007005600500396, was designed by Joseph Hughes Moragne (Figure 49 through Figure 56). Originally built in 1904 as a timber bridge by the Department of Public Works, the Waipā Stream Bridge, 0.79 km (0.49 miles) west of Kumu Road, was rebuilt in 1912 as a reinforced concrete T-beam bridge and extended in 1925. The Waipā Stream Bridge built by George R. Ewart, Jr. in 1912 features a concrete flat slab, a concrete T-beam superstructure, a concrete abutment and concrete wall pier with solid concrete parapets/railing with a concrete cap, including three spans with a total length of 13.7 m (45 ft) and width of 4.7 m (15.4 ft). The date of the bridge's construction, 1912, is incised in the bridge concrete on the interior of the southern parapet. An extension was added to the Waipā Stream Bridge in 1925, designed by Ralph L. Garlinghouse, a five-span, cast-in-place feature, adding 27.4 m (90 ft) to the previous length with a width of 4.9 m (16 ft). The total length of the Waipā Stream Bridge is currently 41 m (134.5 ft). Both portions of the bridge's parapets are concrete with rail caps, however, the bridges are of slightly different widths and the parapets are slightly different heights:

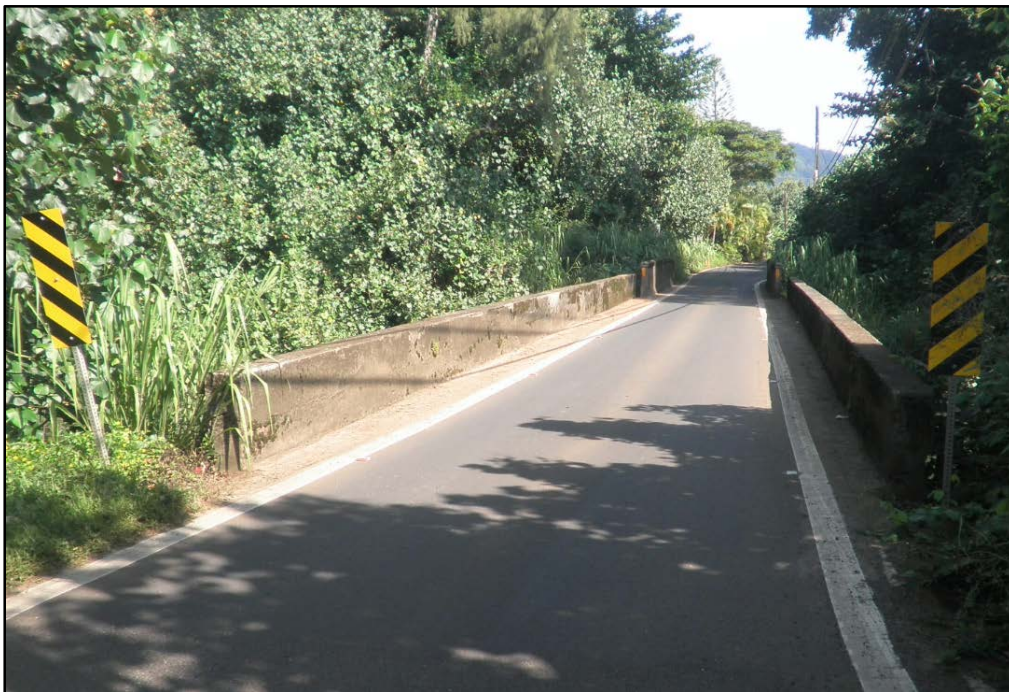
Figure 52. SIHP # 50-30-03-2297, the Waipā Stream Bridge, view to southeast; note the 1925-built concrete bridge extension in the foreground

According to Territorial Highway Department reports, the Waipa Bridge was modified and assumed its unusual design of two different bridges in 1925. The original design plans for the Waipa Bridge indicated there was an existing 'old' timber bridge over the river in 1912. In addition . . . the 1912 concrete bridge served as an extension of the timber bridge and was probably built to span a widened river channel . . . one of the timber bridge spans had collapsed, so the second concrete bridge at Waipa apparently became a replacement for the timber bridge. The Waipa Bridge collapsed in 1919 and a temporary trestle of 'light construction' was built to span the washout. No plans were found for the new concrete bridge extension, although County Engineer R.L. Garlinghouse drew a similar concrete-slab bridge design for another structure in 1925. The Waipa extension bridge had five spans for a total length of 90'. It was an unusual structure as it did not match the original bridge's width, wall design, or wall height. [Fung Associates 2013:21]

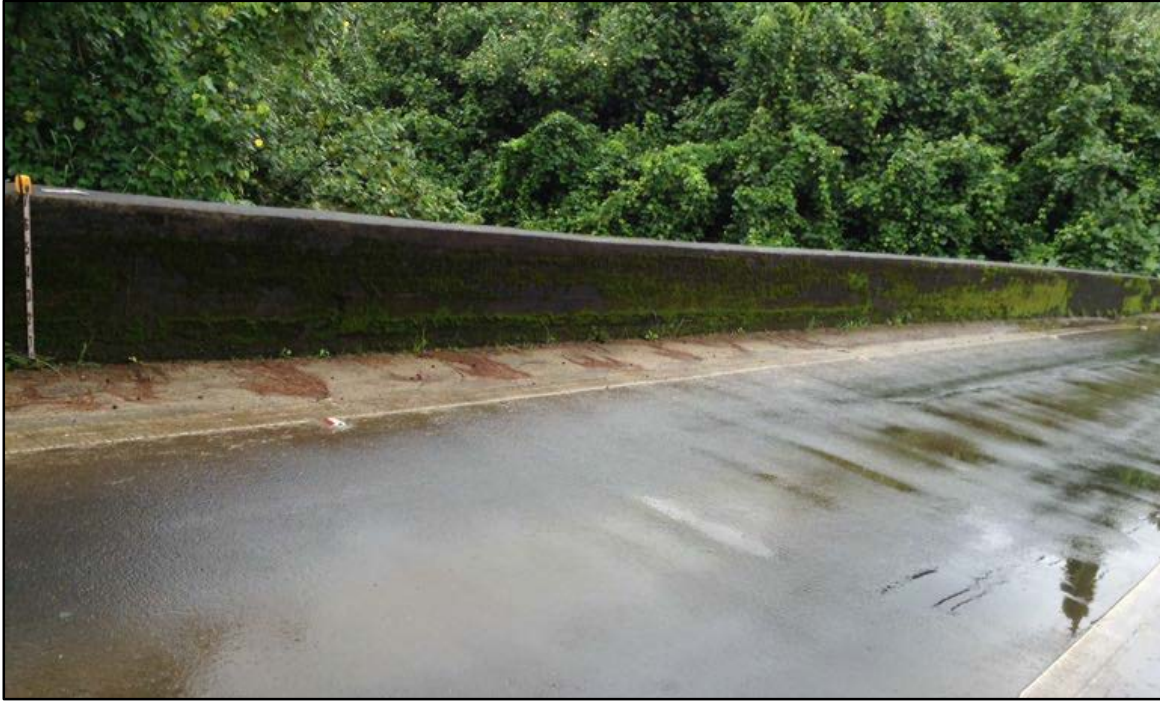
Figure 53. SIHP # 50-30-03-2297, the Waipā Stream Bridge, portion of the 1925 extension, profile view to west

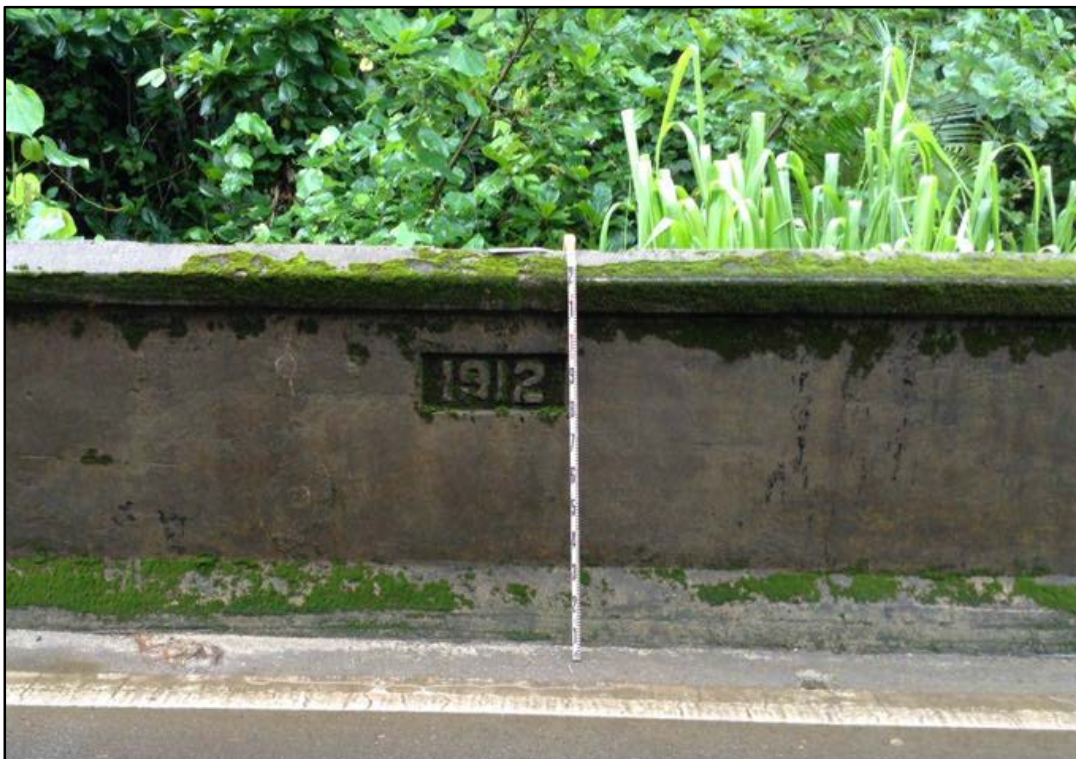
Figure 56. SIHP # 50-30-03-2297, the Waipā Stream Bridge, showing concrete stamped “1912,” view to west

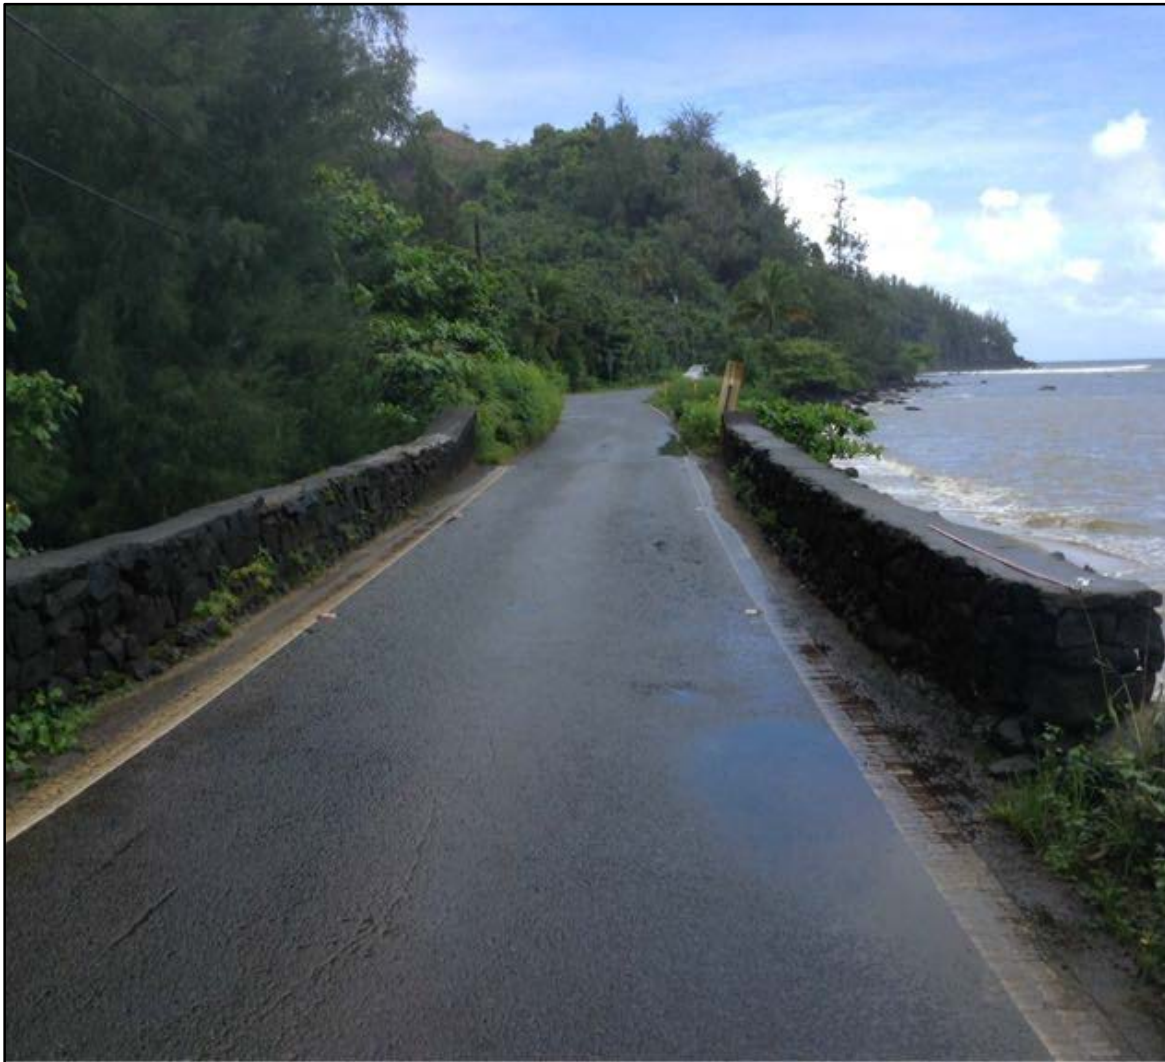
Figure 57. SIHP # 50-30-03-2298, the Waikoko Stream Bridge, general view to north

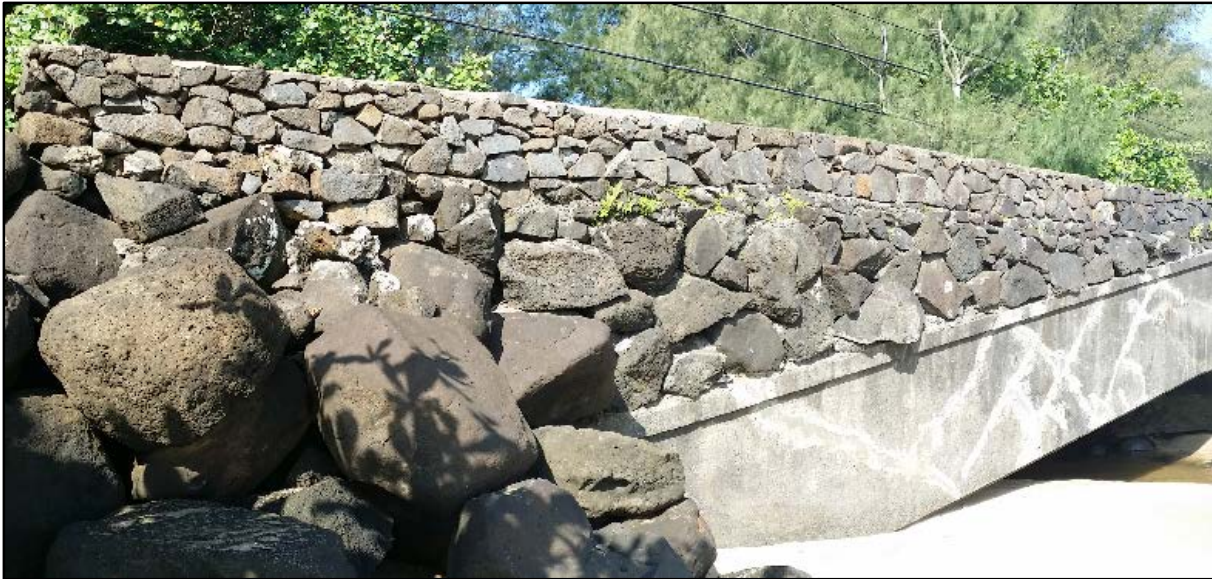
Figure 60. SIHP # 50-30-03-2298, the Waikoko Stream Bridge, general view to west of the bridge's *makai* face; note approximately eight courses of basalt boulders mortared on top of the concrete portion of the bridge damaged in the 1946 tsunami
