Appendix A

Agency Correspondence

Subject: National Historic Preservation Act, Section 106 and Hawaii Revised Statutes,
Chapter 6e Consultation for the Project to Replace Temporary Wainiha Bridges

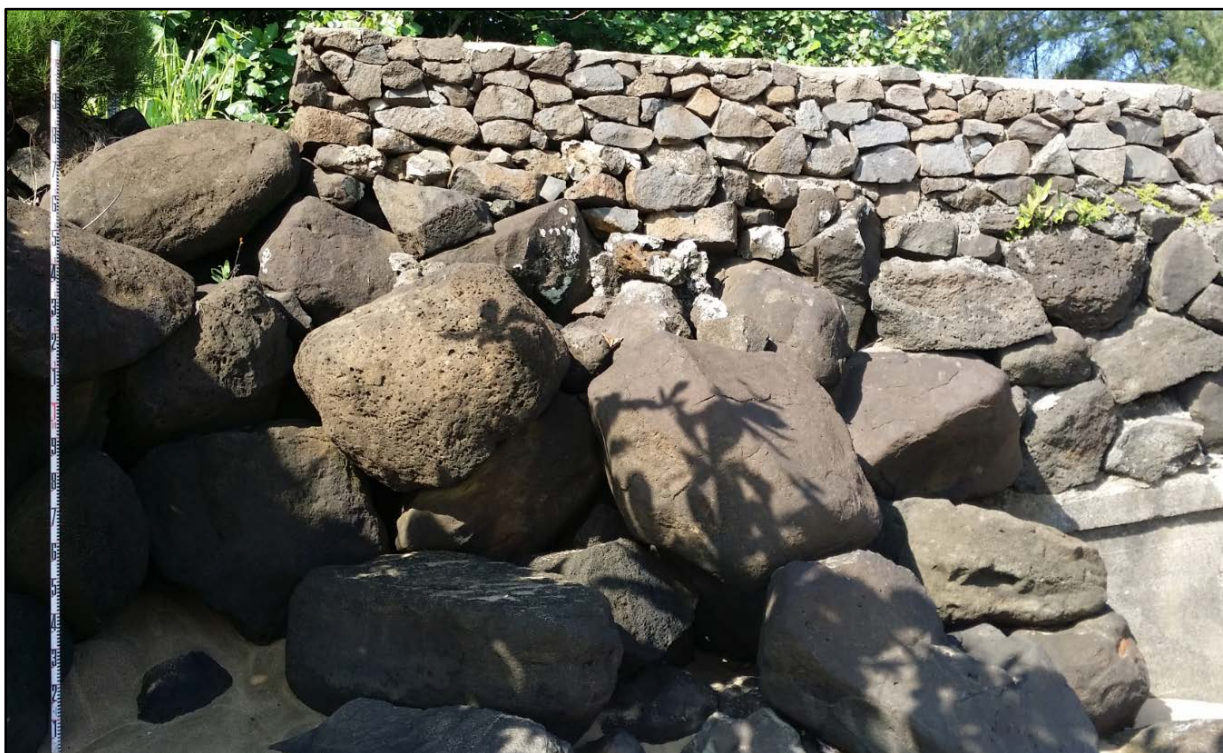
Figure 61. SIHP # 50-30-03-2298, the Waikoko Stream Bridge, profile view to west of the southern terminus of the bridge's *makai* face; note the successive courses of stacked and mortared basalt (one through eight)

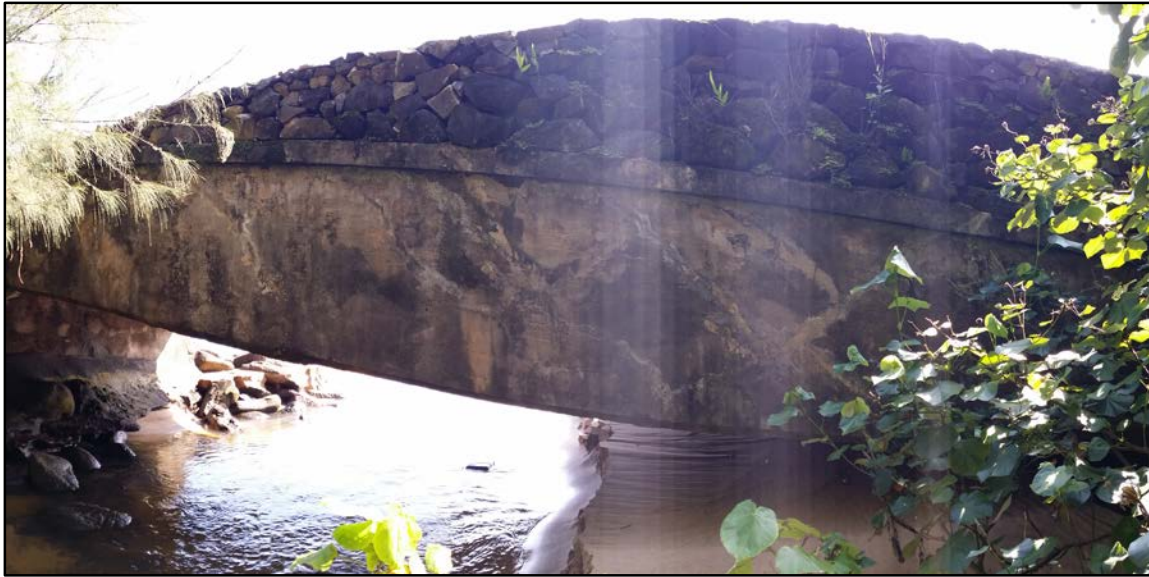
Figure 62. SIHP # 50-30-03-2298, the Waikoko Stream Bridge, general view to northeast of the bridge's *mauka* face; note approximately five courses of basalt boulders mortared on top of the concrete portion of the bridge damaged in the 1946 tsunami

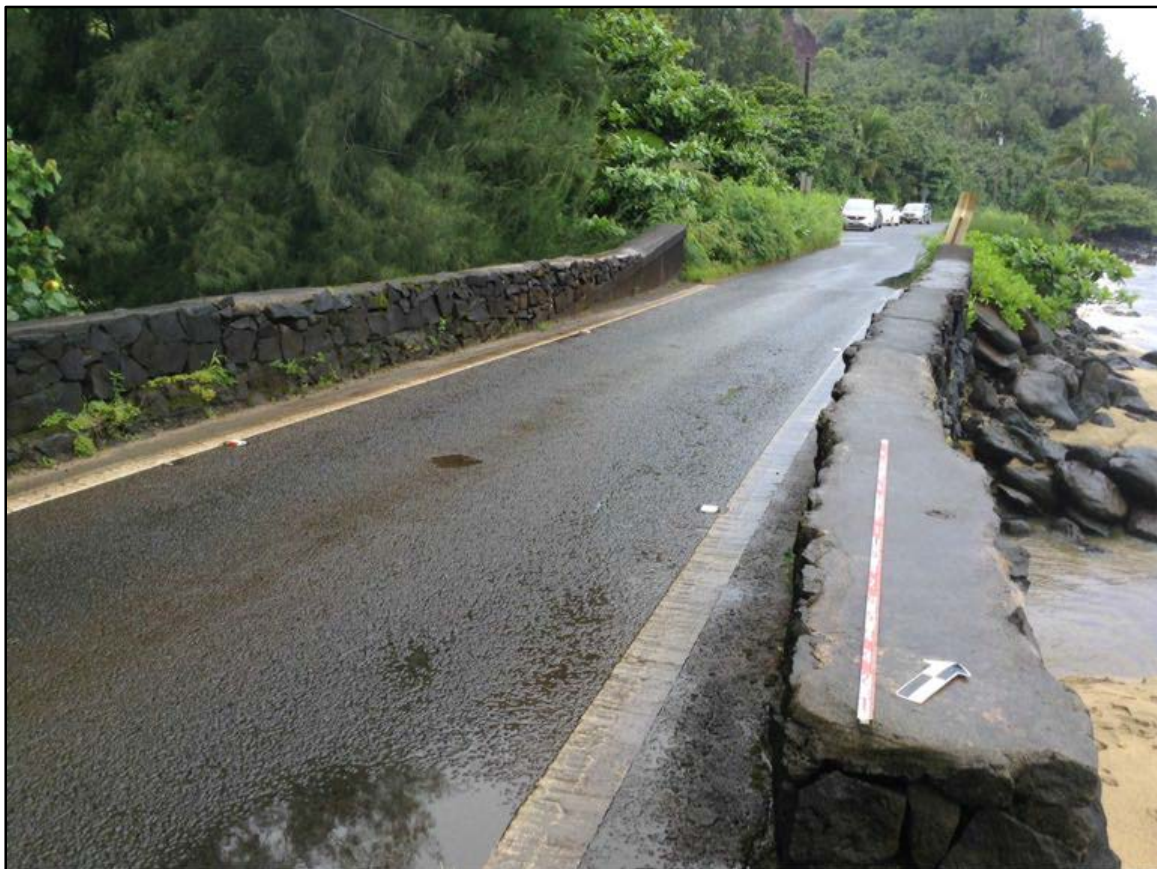
Figure 63. SIHP # 50-30-03-2298, the Waikoko Stream Bridge, general view to northwest

The Waikoko Bridge, Hawai'i State Bridge Number 007005600500427, originally built in 1904 as a timber bridge, was replaced 1912-1913 as a concrete flat slab, one-span bridge, with a concrete through girder superstructure, a concrete abutment wall substructure and masonry/rock parapets/railings, with a total length of 13.7 m (45 ft) and a width of 4.7 m (15.4 ft) (Fung Associates 2013:13) (Figure 57 through Figure 68). Located 1.3 km (0.8 miles) west of Kumu Road, the Waikoko Bridge was designed by Joseph Hughes Moragne and built by George Mahikoa.

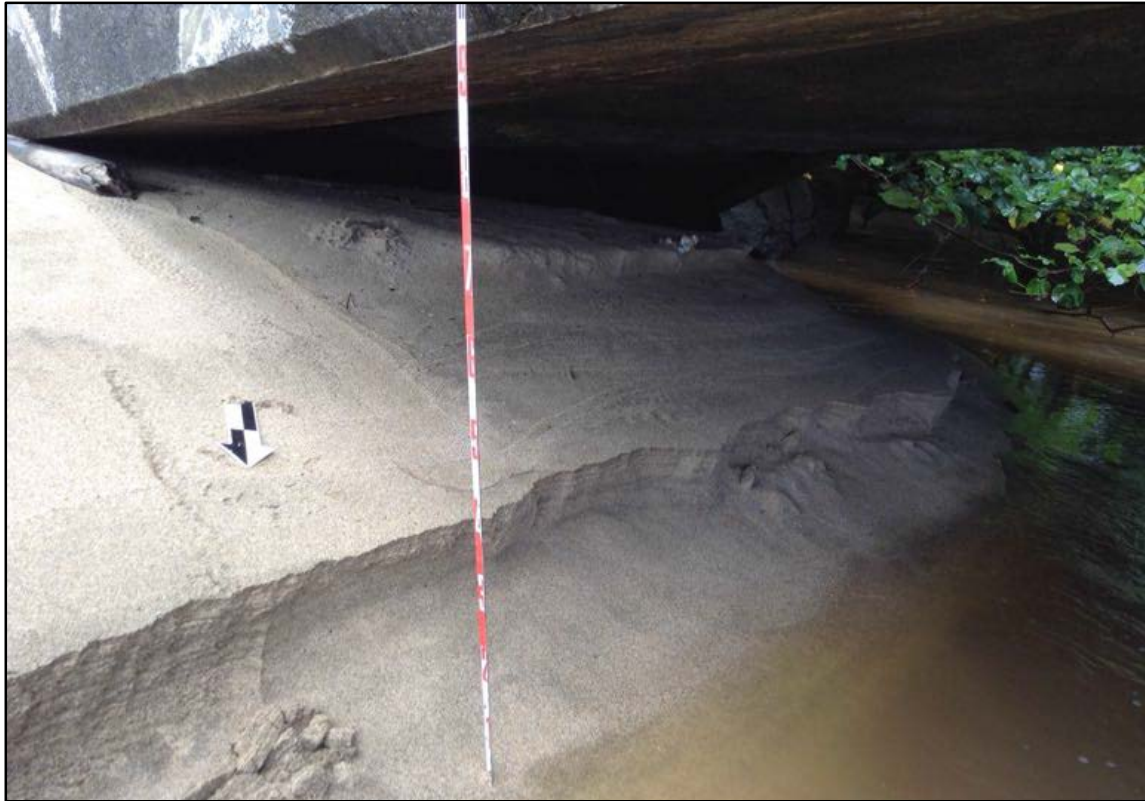
Figure 64. SIHP # 50-30-03-2298, the Waikoko Stream Bridge, underneath profile view to south of the 1912 portion of the bridge undermined by the 1946 tsunami

Currently the Waikoko Bridge abuts the shoreline, with large basalt boulders piled, as a base course, approximately 2 m high to create the road bed approaching both sides of the bridge. After the southeast end of the 1912 concrete bridge collapsed in the 1946 tsunami event, it was repaired with approximately eight courses of mortared basalt boulders on the *makai* face and approximately five courses of stacked stones atop the original concrete bridge on the *mauka* bridge face, both sides utilizing a smoothed concrete cap. A portion of the original concrete bridge now supports the road and the stacked and mortared basalt boulder repair at an approximately 30 degree angle to the ground and stream surface below, extending into the beach sands on the southeastern portion of the bridge.

the tidal wave undermined its eastern abutment, which caused the bridge to sink on one side. The bridge settled to rest at an angle of nearly 30 degrees. Several days after the tidal wave, the County Board of Supervisors instructed the county engineer to make plans to rebuild the Wainiha and Waikoko bridges . . . Waikoko Bridge was repaired by filling the collapsed end of the bridge to a level grade and laying a new roadbed on the bridge. The original bridge still rests on an angle . . . [Fung Associates 2013:22]

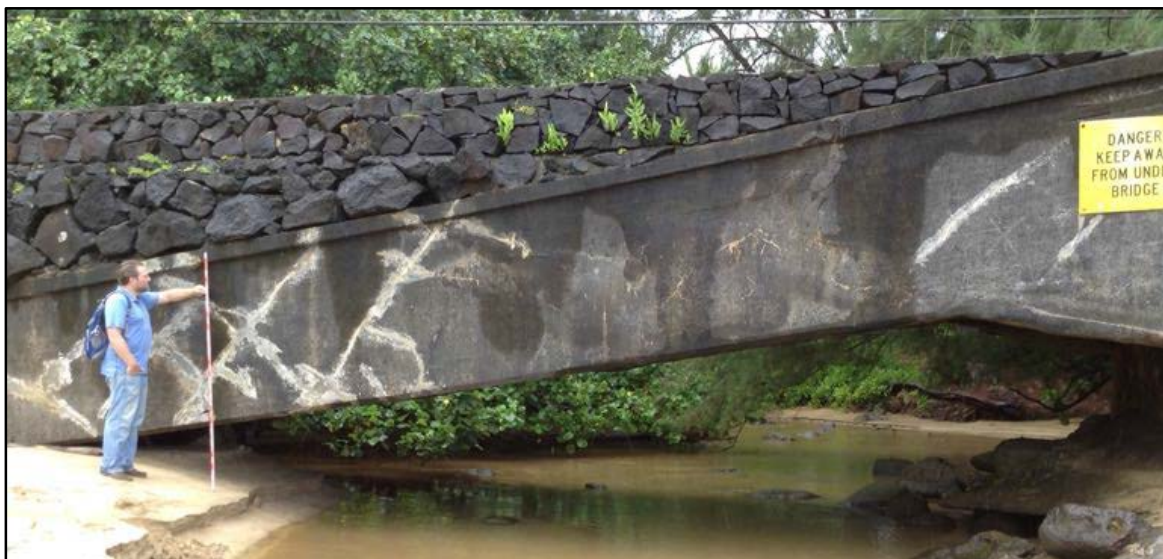
Figure 65. SIHP # 50-30-03-2298, the Waikoko Stream Bridge, profile view to southwest; note the 1912 portion of the bridge undermined by the 1946 tsunami, with portions of the overlying basalt boulder and mortar repair

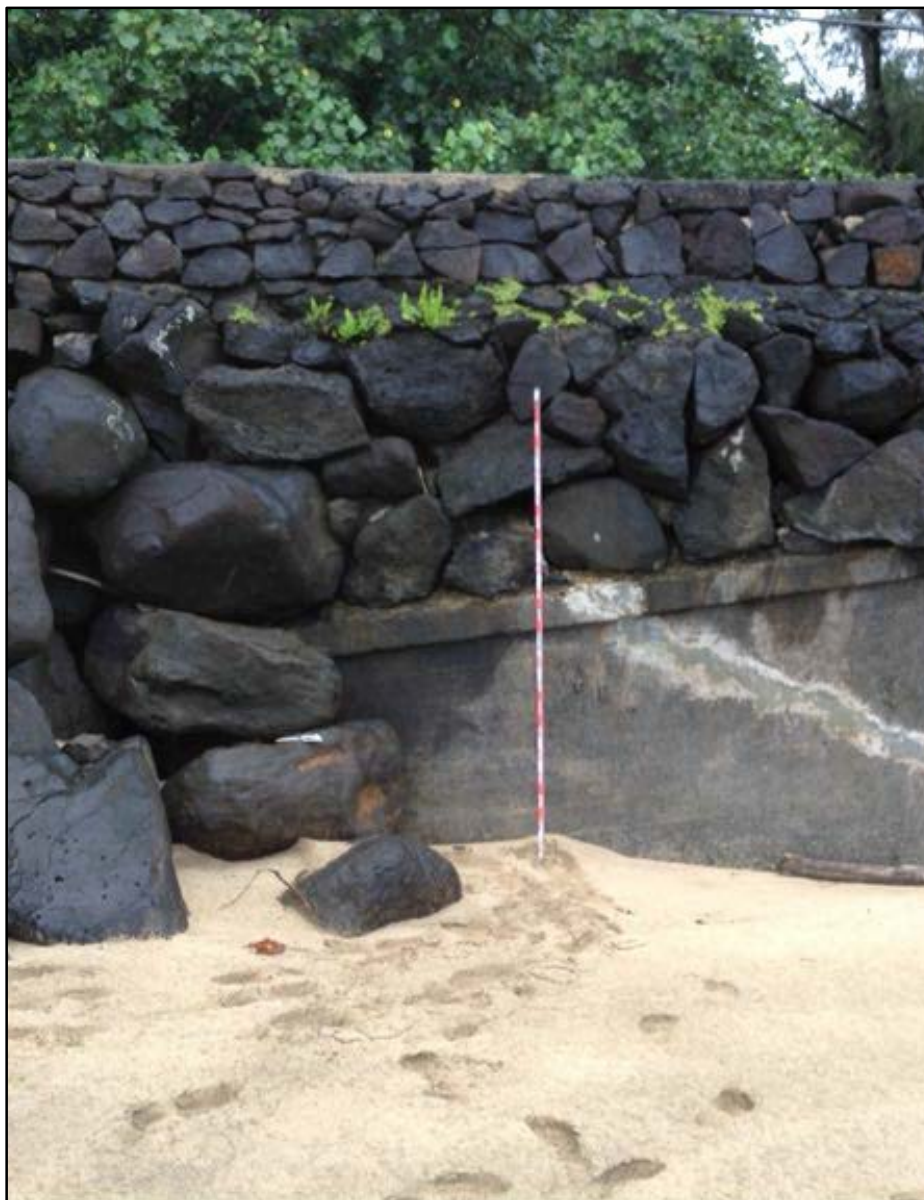
Figure 66. SIHP # 50-30-03-2298, the Waikoko Stream Bridge, profile view to southwest; note the 1912 portion of the bridge undermined by the 1946 tsunami, with portions of the basalt base coarse and overlying basalt boulder and mortar repair

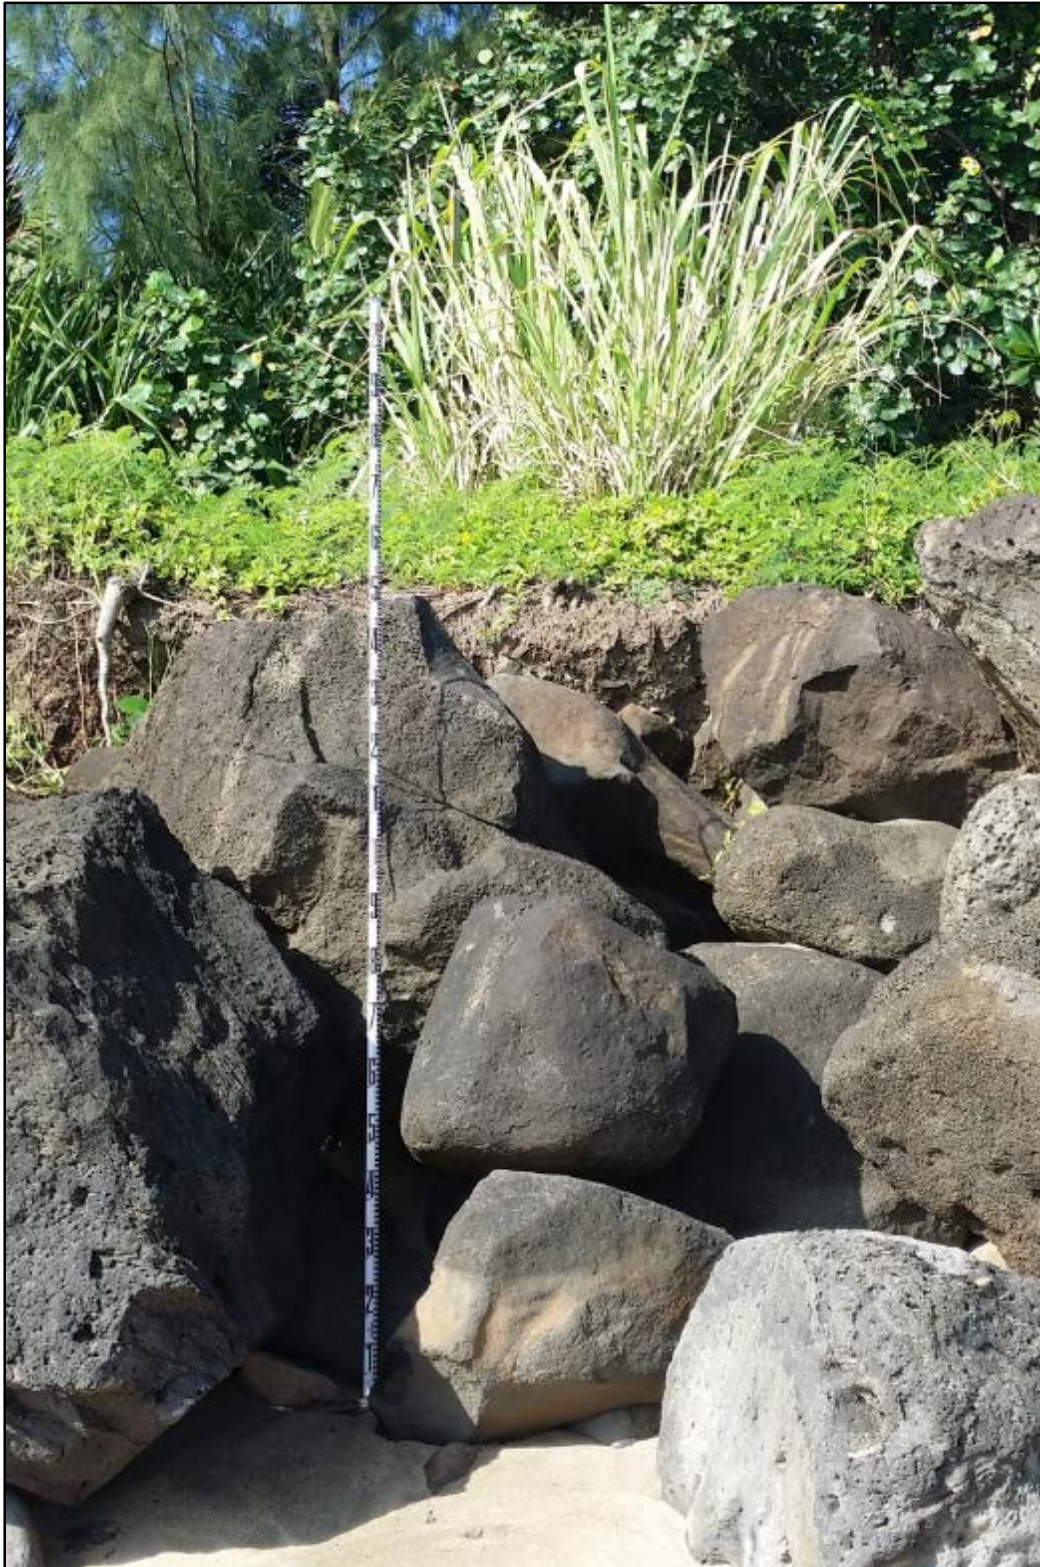
Figure 67. Southern portion of SIHP # 50-30-03-2298, basalt boulder base course of the Waikoko Stream Bridge, view to north

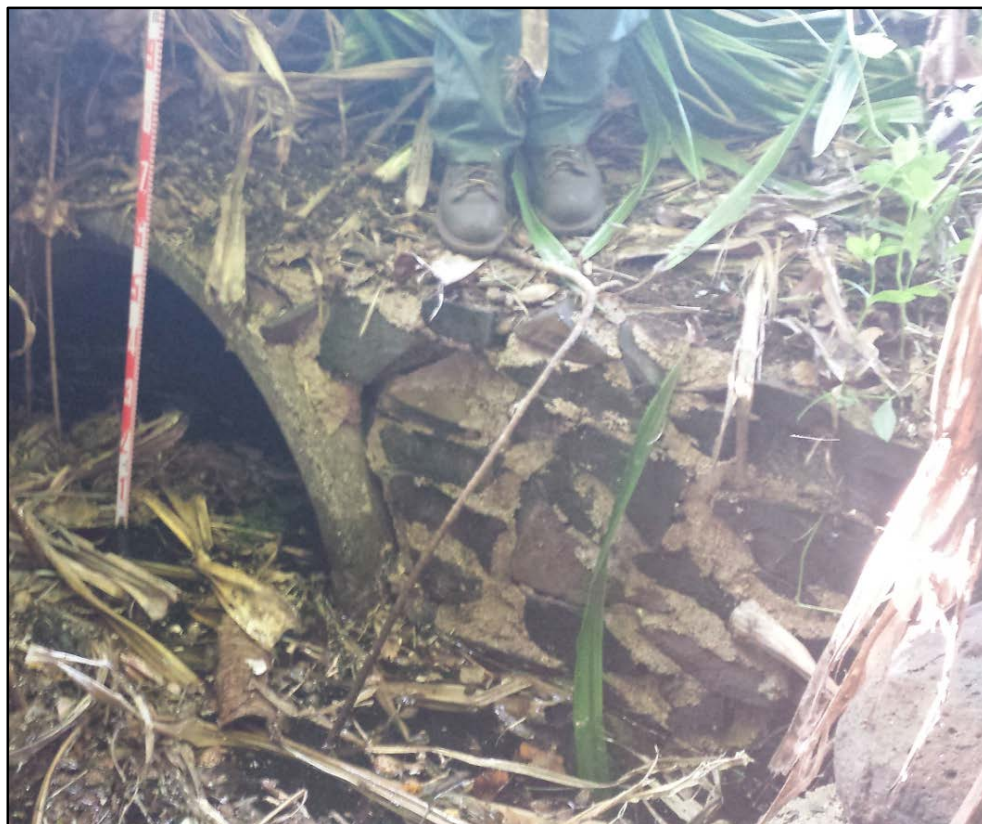
Figure 73. SIHP # 50-30-02-2299, intake portion of the road culvert and buttressing northeast of Wainiha Bridge 2, on the east side of Kūhiō Highway, view to southwest

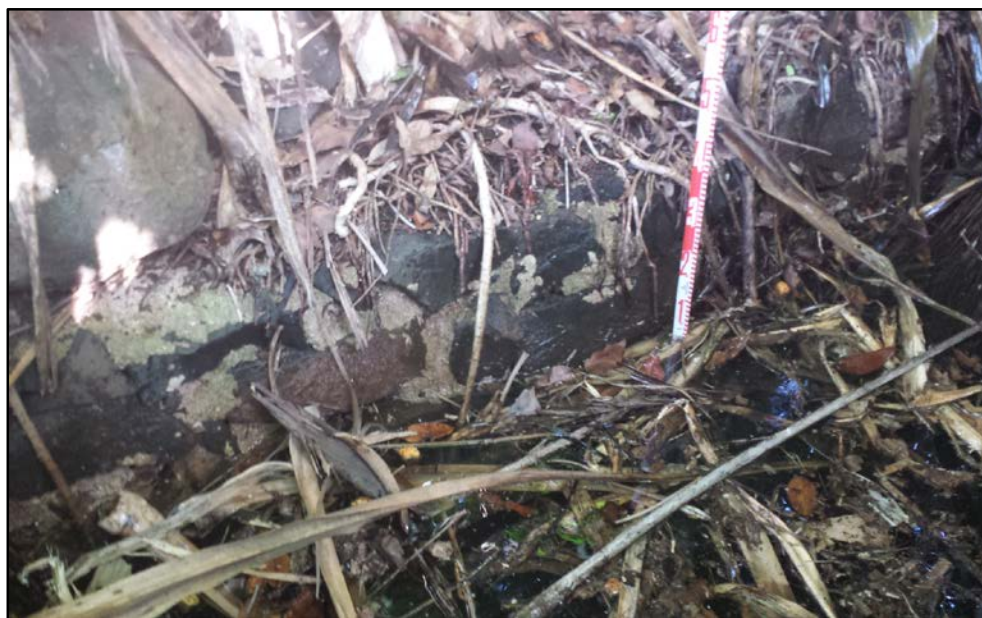
Figure 74. SIHP # 50-30-02-2299, road culvert northeast of Wainiha Bridge 2, portion of the intake revetment on the east side of Kūhiō Highway, view to southeast

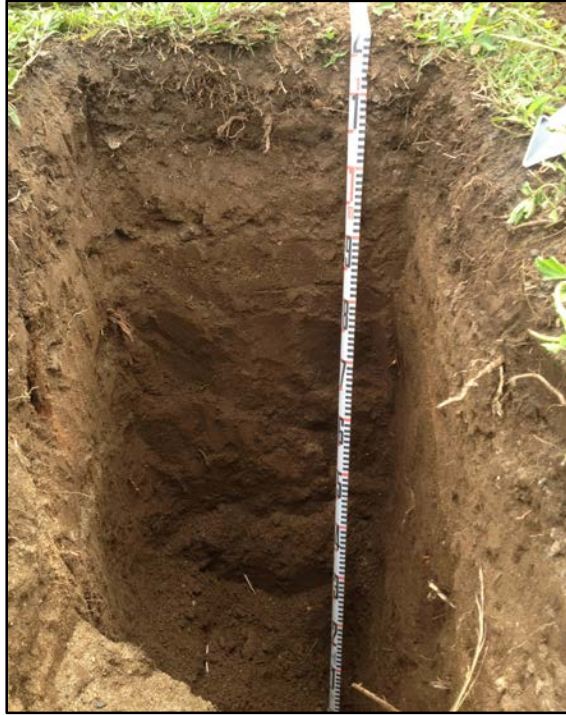
Figure 86. ST-2, profile view of the east wall, view to southeast

ST-2 is located on the south section of road segment between Wainiha Bridges 2 and 3 (see Figure 77). ST-2 measures 1.2 m deep by 0.5 m in diameter. The stratigraphic profile of ST-2 consists of dark brown loamy sand (Stratum Ia, 0–4 cmbs), dark brown loamy sand (Stratum Ib, 4–15 cmbs), dark yellowish brown sandy loam (Stratum II, 15–55 cmbs), and grayish brown sandy loam (Stratum III, 55–120 cmbs). The water table was not observed in ST-2. Zero artifacts were recovered from ST-2. Figure 85 through Figure 88 depict the ST-2 situation and stratigraphic profile and Table 17 provides a stratigraphic summary.

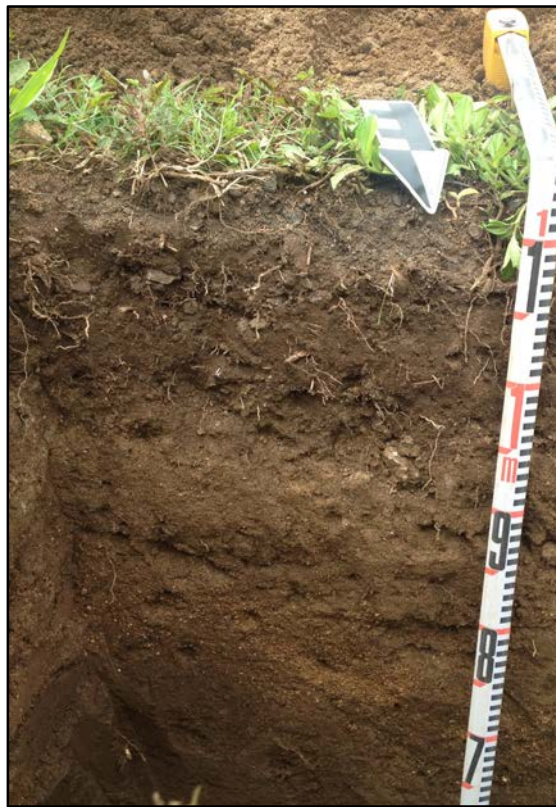
Figure 87. ST-2, profile view of the south wall, view to south

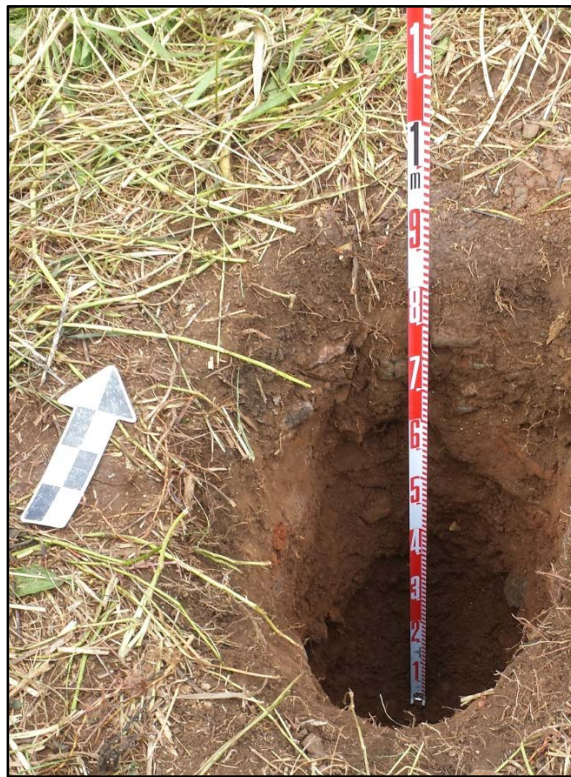
Figure 91. ST-3 surface to the base of excavations, profile view to north

ST-3 is located on the *makai* side of the highway in the approach to Wainiha Bridge 2 northbound (see Figure 77). ST-3 measures 0.85 m deep by 0.5 m in diameter. The stratigraphic profile of ST-3 consists of dark brown gravelly silt loam, A horizon formed on fill (Stratum Ia, 0–25 cmbs) and dark reddish silt loam fill (Stratum Ib, 25–85 cmbs). The water table was not observed in ST-3. Zero artifacts were recovered from ST-3. Figure 89 through Figure 92 depict the ST-3 situation and stratigraphic profile and Table 18 provides a stratigraphic summary.

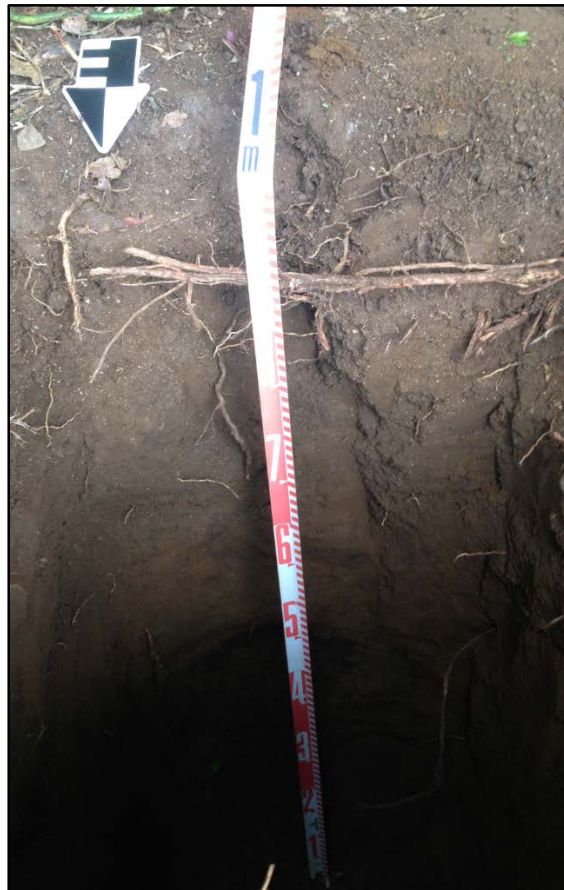
Figure 95. ST-4, profile of the south wall; view to south

ST-4 is located on the *mauka* side of the highway, on the eastern side of Wainiha Bridge 1 (see Figure 78). ST-4 measures 0.93 m deep by 0.5 m in diameter. The stratigraphic profile of ST-4 consists of grayish brown sandy clay loam (Stratum I, 0–19 cmbs), grayish brown sandy clay loam (Stratum II, 19–37 cmbs), dark brown sandy loam (Stratum III, 37–60 cmbs) and a dark yellowish brown loamy sand (Stratum III, 60–93 cmbs). The water table was not observed in ST-4. Zero artifacts were recovered from ST-4. Figure 93 through Figure 97 depict the ST-4 situation and stratigraphic profile and Table 19 provides a stratigraphic summary. Strata II and III in ST-4 are the deepest terrestrial sand deposits found during subsurface testing. Although no artifacts were observed, Strata II and III in ST-4 also display characteristics of soil development suggesting significantly less disturbance, greater antiquity, and thus greater probability of encountering historic properties within these deposits.

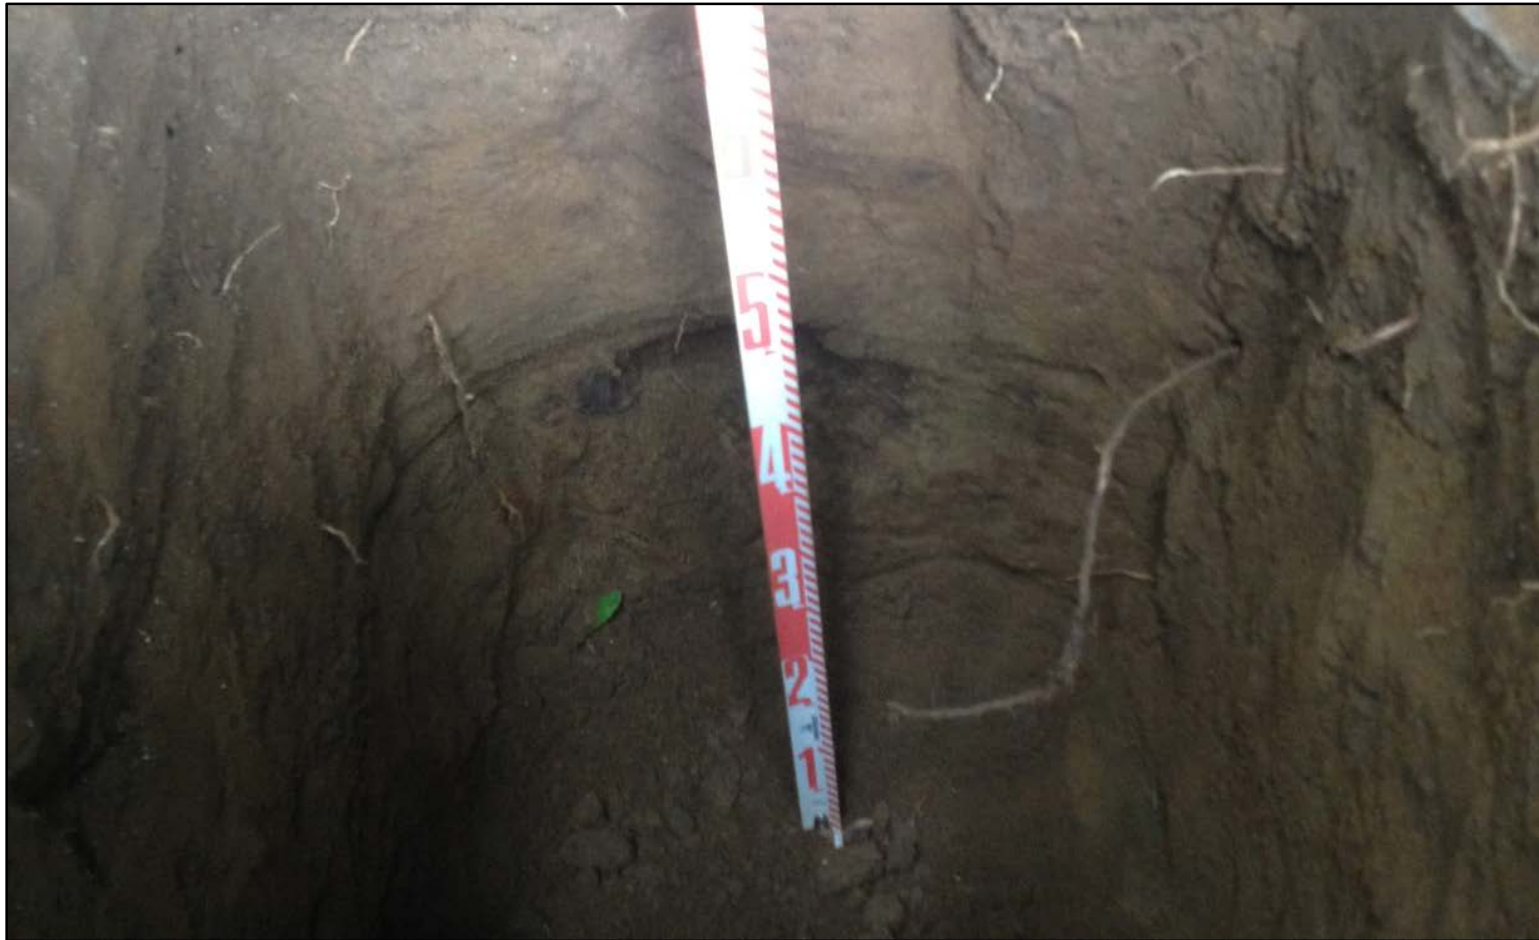
Figure 96. ST-4, profile of the south wall, view to the south; note base of excavation at 90 cmbs

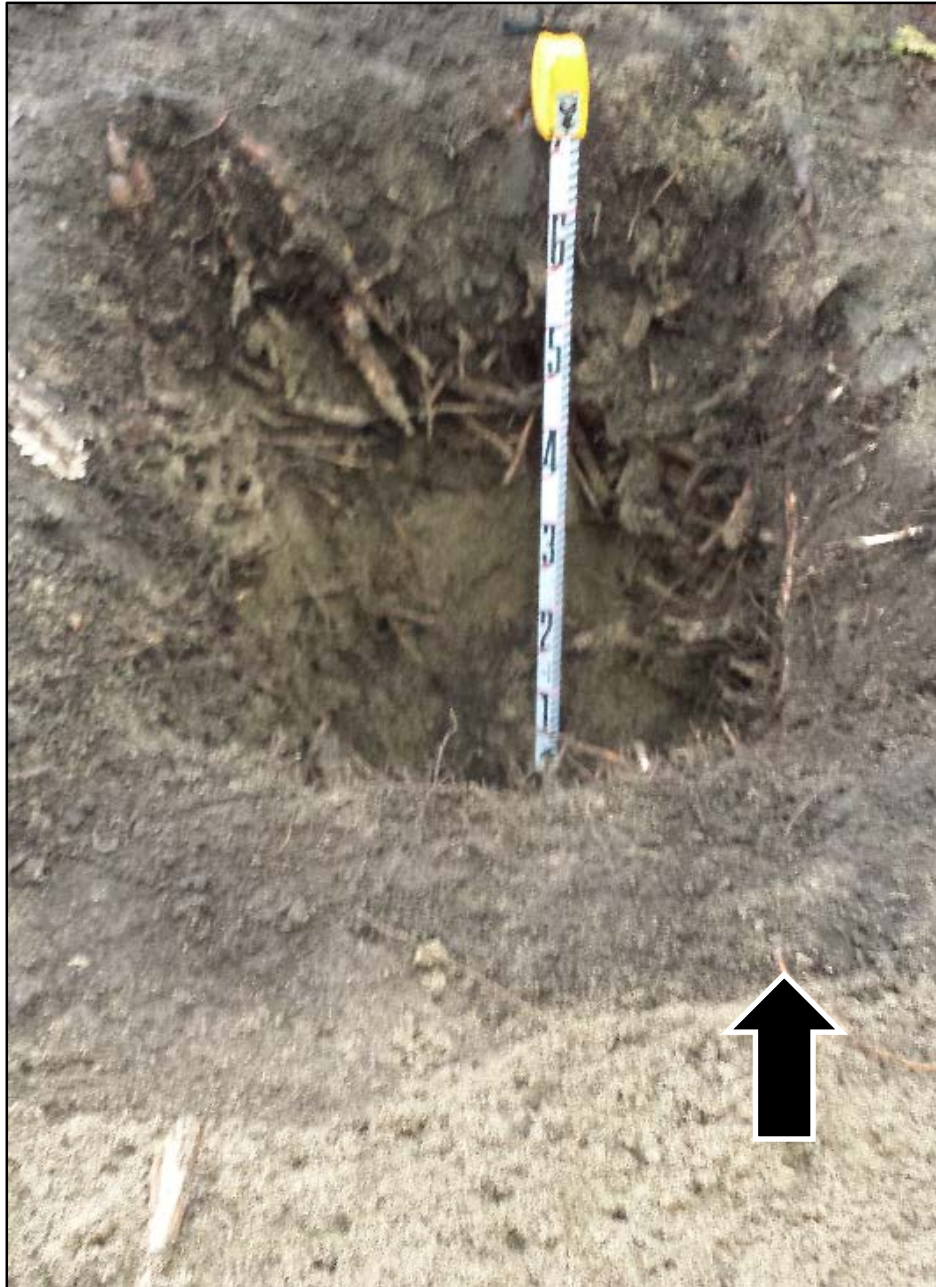
Figure 99. ST-5 at 60 cmbs, profile view to north

ST-5 is located on the *mauka* side of the highway in a gravel bar of the west flood terrace of Wai'oli Stream Bridge (see Figure 79). ST-5 measures 0.95 m deep by 0.5 m in diameter. The stratigraphic profile of ST-5 consists of very dark brown sandy loam (Stratum I, 0–25 cmbs) and dark yellowish brown sand (Stratum II, 25–95 cmbs), dark brown sandy loam (Stratum III, 37–60 cmbs) and a dark yellowish brown loamy sand (Stratum III, 60–93 cmbs). The water table was not observed in ST-5. Zero artifacts were recovered from ST-5. Figure 98 through Figure 100 depict the ST-5 situation and stratigraphic profile and Table 20 provides a stratigraphic summary. The marine sand sediments in ST-5 have been reworked by the stream and mixed with alluvium and are a significant distance for the modern shoreline, suggesting these sediments have been here for a long time. This could increase the potential for historic properties to be encountered in any disturbance to existing vegetation and sediments in the vicinity of ST-5.

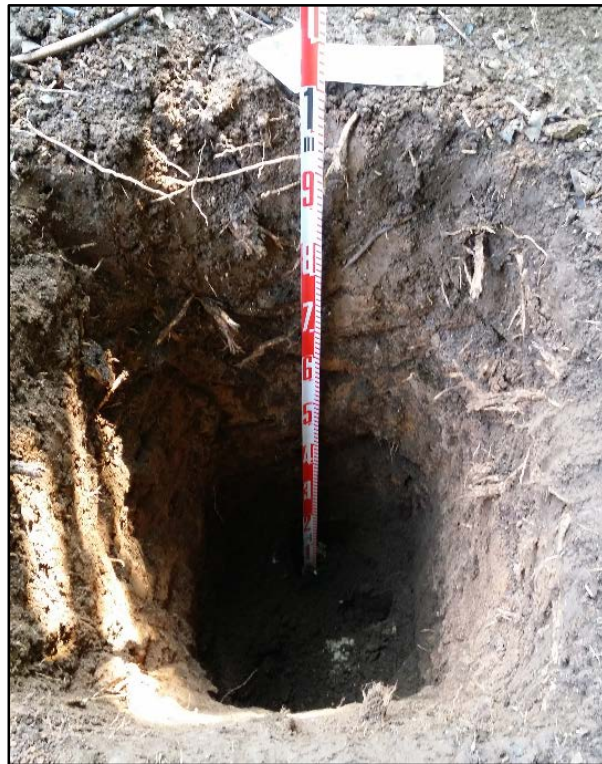
Figure 103. ST-6, profile view to east at the BOE, 95cmbs

ST-6 is located on the *mauka* side of the highway on the west side of Waipā Stream Bridge 2 (see Figure 80). ST-6 measures 0.95 m deep by 0.5 m in diameter. The stratigraphic profile of ST-5 consists of very dark brown sandy loam fill (Stratum I, 0–27 cmbs), dark reddish brown sandy loam fill (Stratum II, 27–60 cmbs) and a very dark brown; natural sandy loam (Stratum III, 60–95 cmbs). The water table was not observed in ST-6. Zero artifacts were recovered from ST-6. Figure 101 through Figure 104 depict the ST-6 situation and stratigraphic profile and Table 21 provides a stratigraphic summary.
