Demonstration Projects  
Program

DP-68  
PERMANENT GROUND ANCHORS  
Volume 2  
Field Demonstration Project Summaries

FHWA-DP-90-068-003  
April 1990

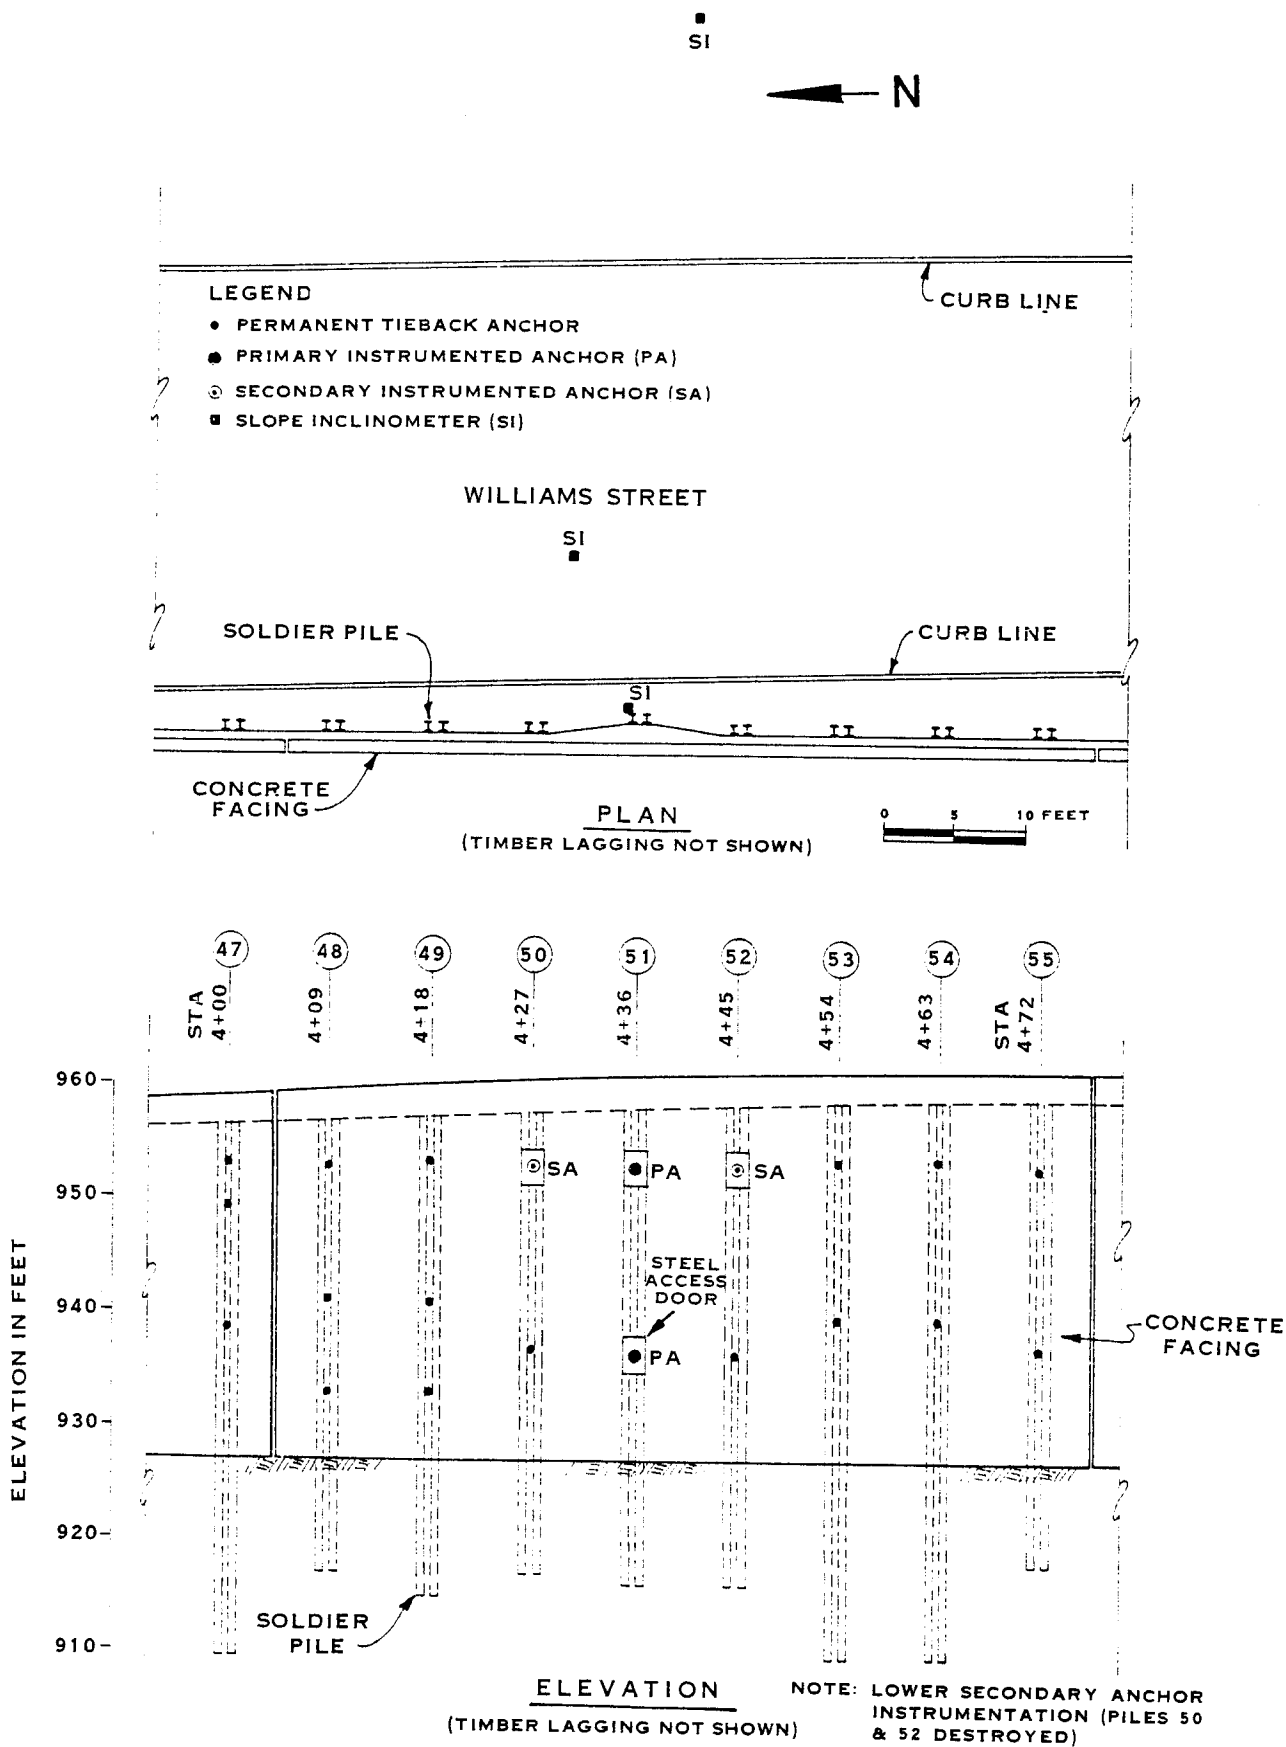
FIGURE 1 - PLAN AND PROFILE OF PERMANENT TIEBACK WALL

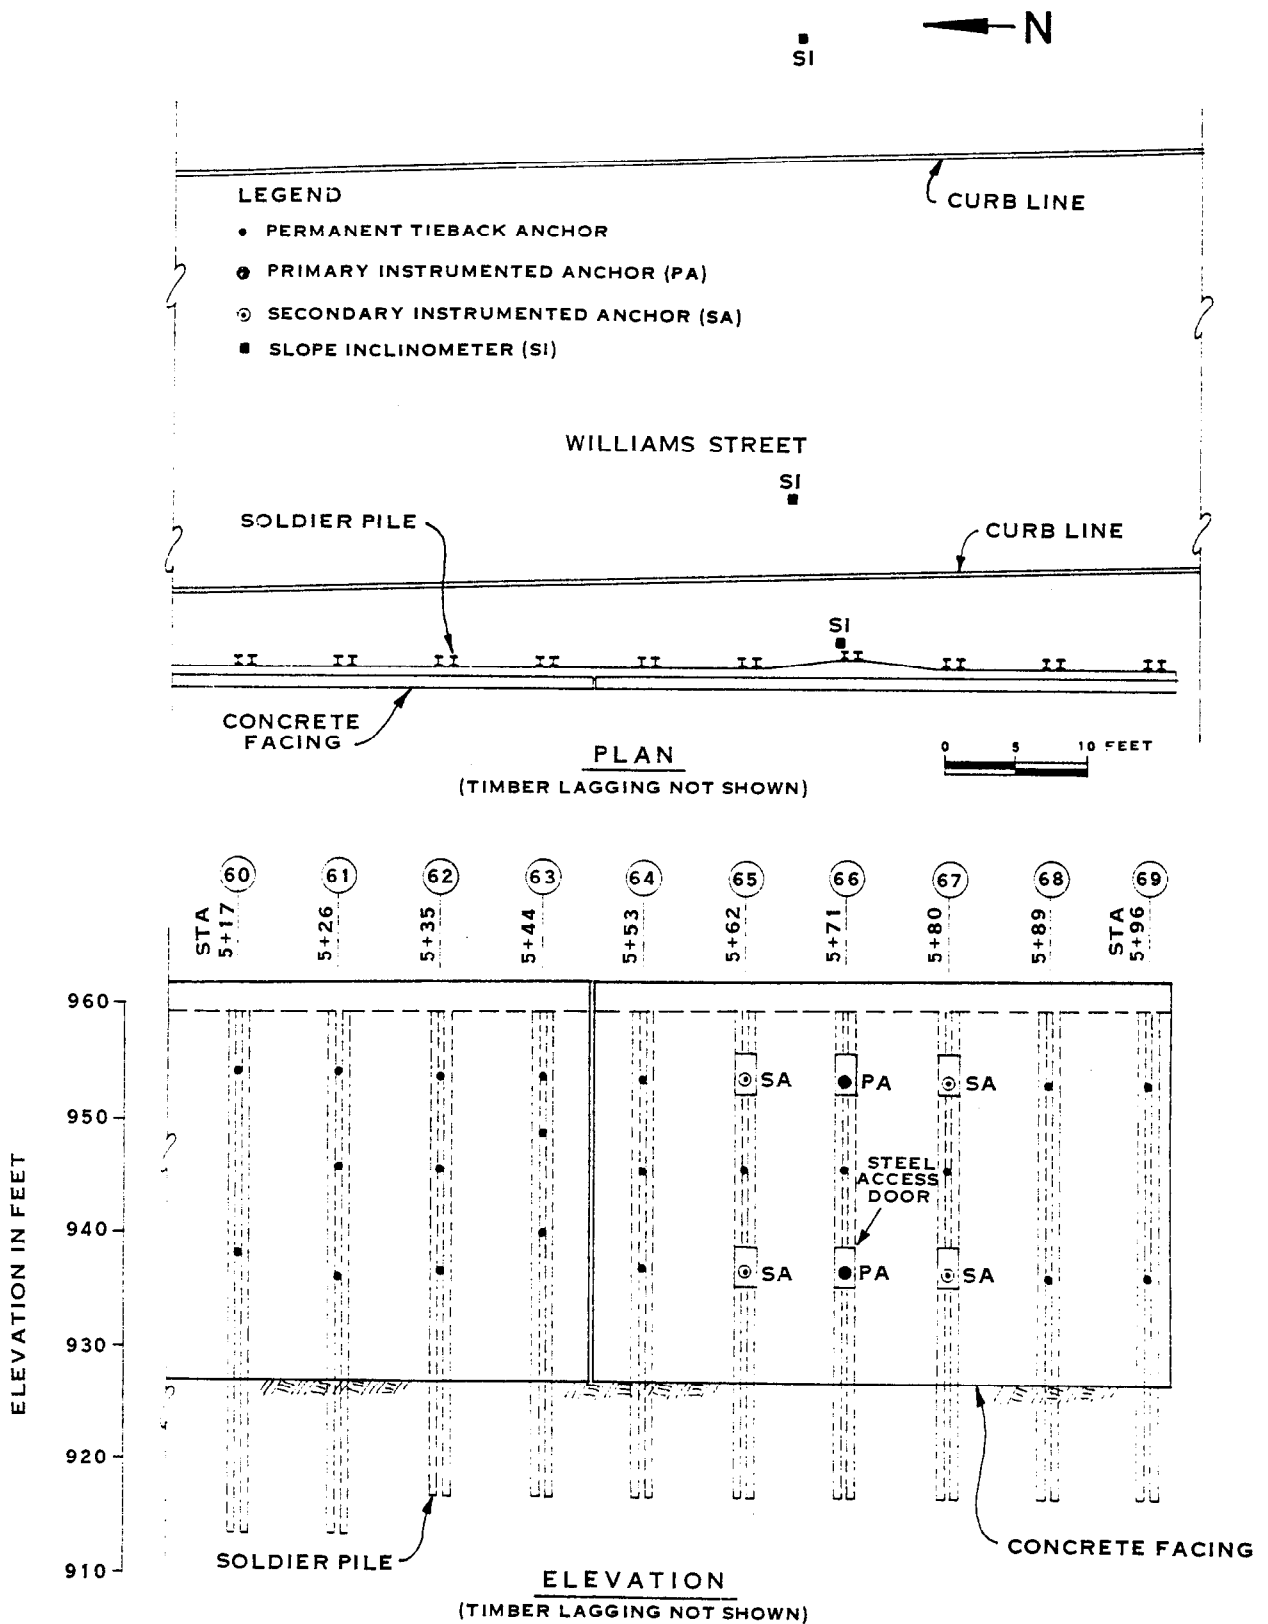
FIGURE 2 - PERMANENT TIEBACK WALL INSTRUMENTATION

The instrumentation of the permanent tieback wall consists of several monitoring devices. The instrumentation plan was recommended by Mr. John Dunncliff and is appended to this report. Table I briefly presents all monitoring devices, including type and source of instruments and their primary purpose within the program. A discussion of the instrument plan is contained in the following paragraphs.

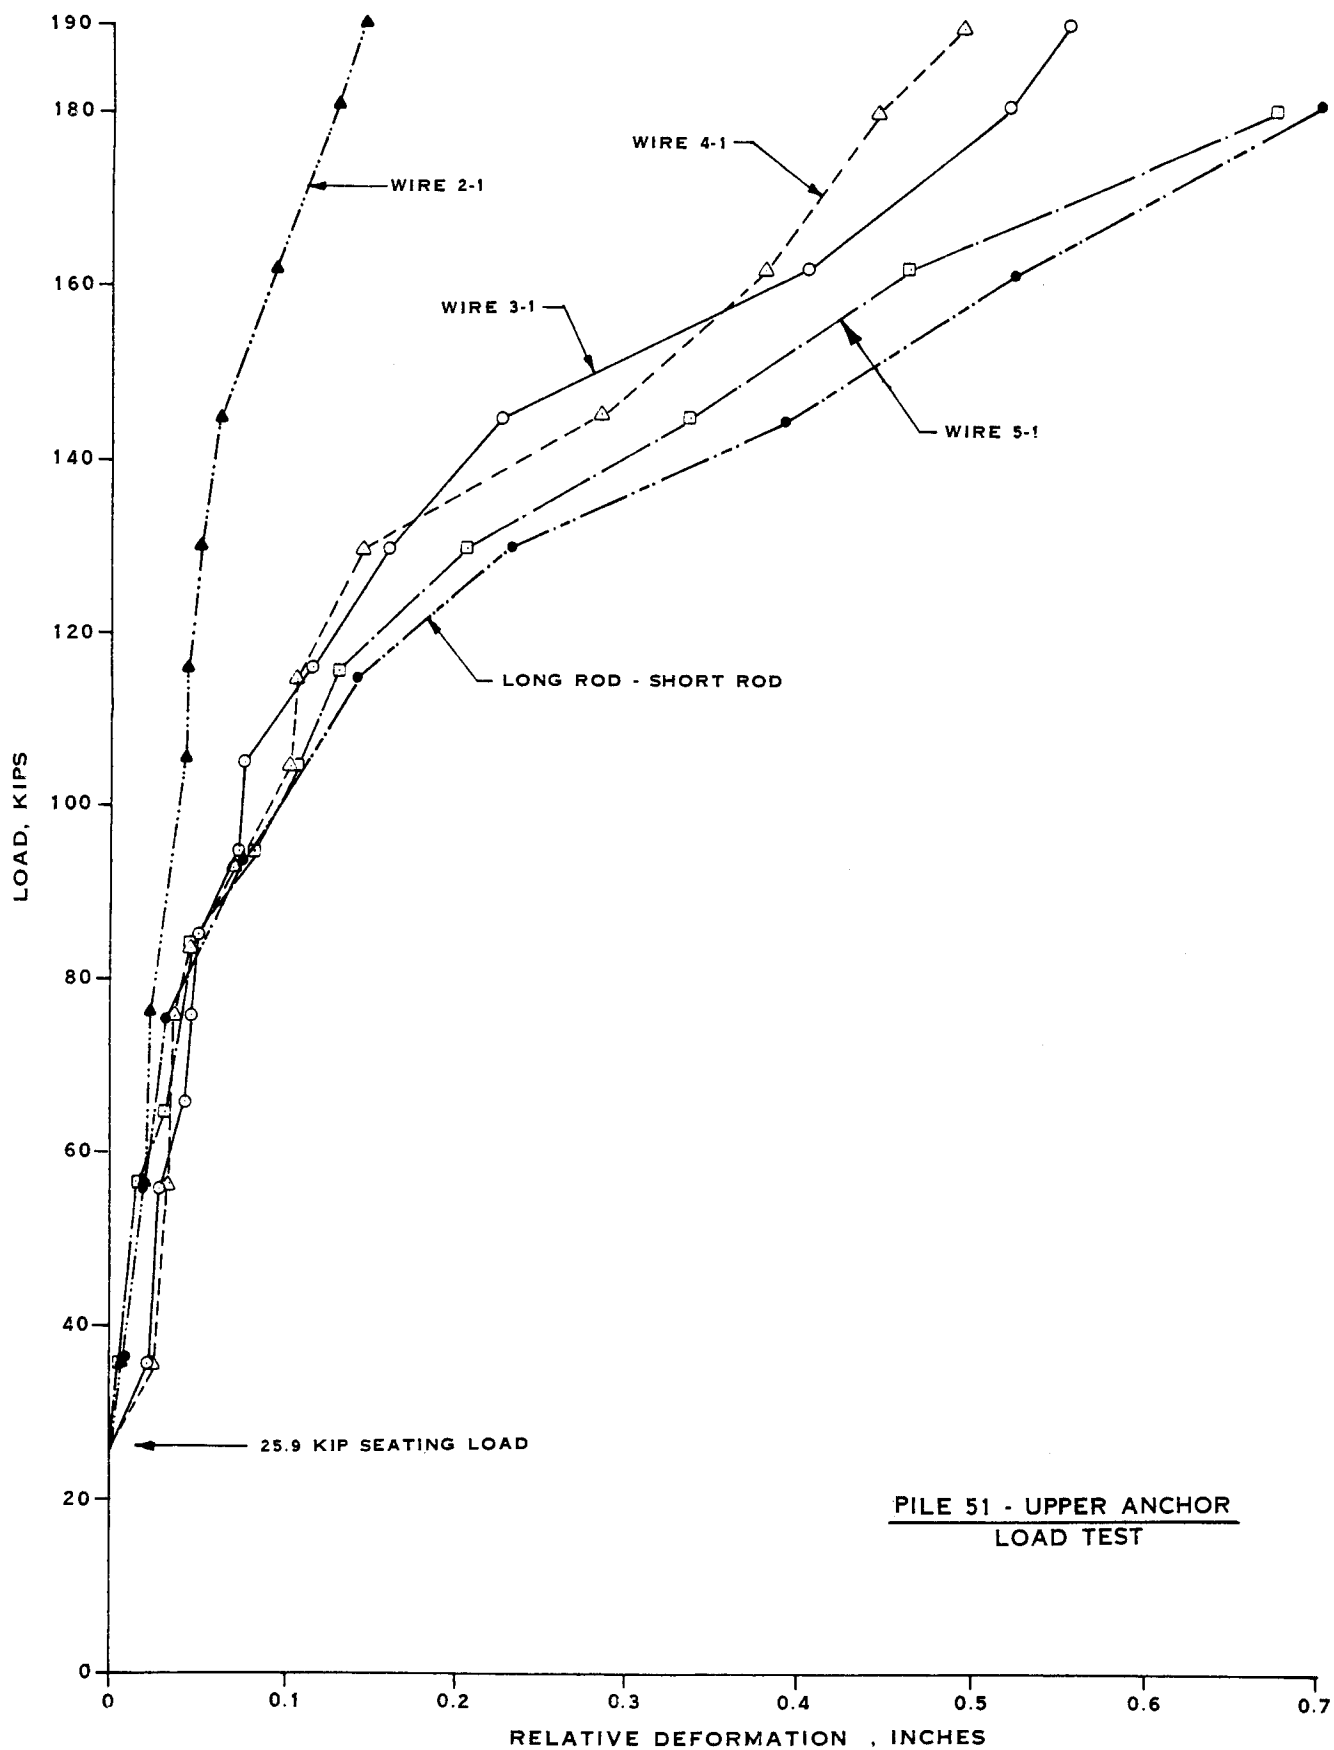
FIGURE 18-COMPARISON OF WIRE TELLTALE VERSUS ROD TELLTALE DURING LOAD TEST

The amount of possible slippage of the wire #1 and short rod telltale anchors can be estimated by making the assumption that telltale anchor slippage is the only cause of difference between the apparently underestimated modulus values determined during the load test and the manufacturer's modulus. Thus, the difference between the elongation compatible with the manufacturer's modulus and the elongation measured by wire #1 (or the short rod) could approximately equal the amount of slippage. The amount of estimated slippage increases with increasing load and is approximately 0.3 inches at maximum loads. If the wire #1 and short rod readings are corrected for the estimated slippage, all the wire differences (2-1, 3-1, 4-1, 5-1, and the long rod-short rod) plotted on Figures 19 through 22 would be moved to the right with respect to the ordinate.

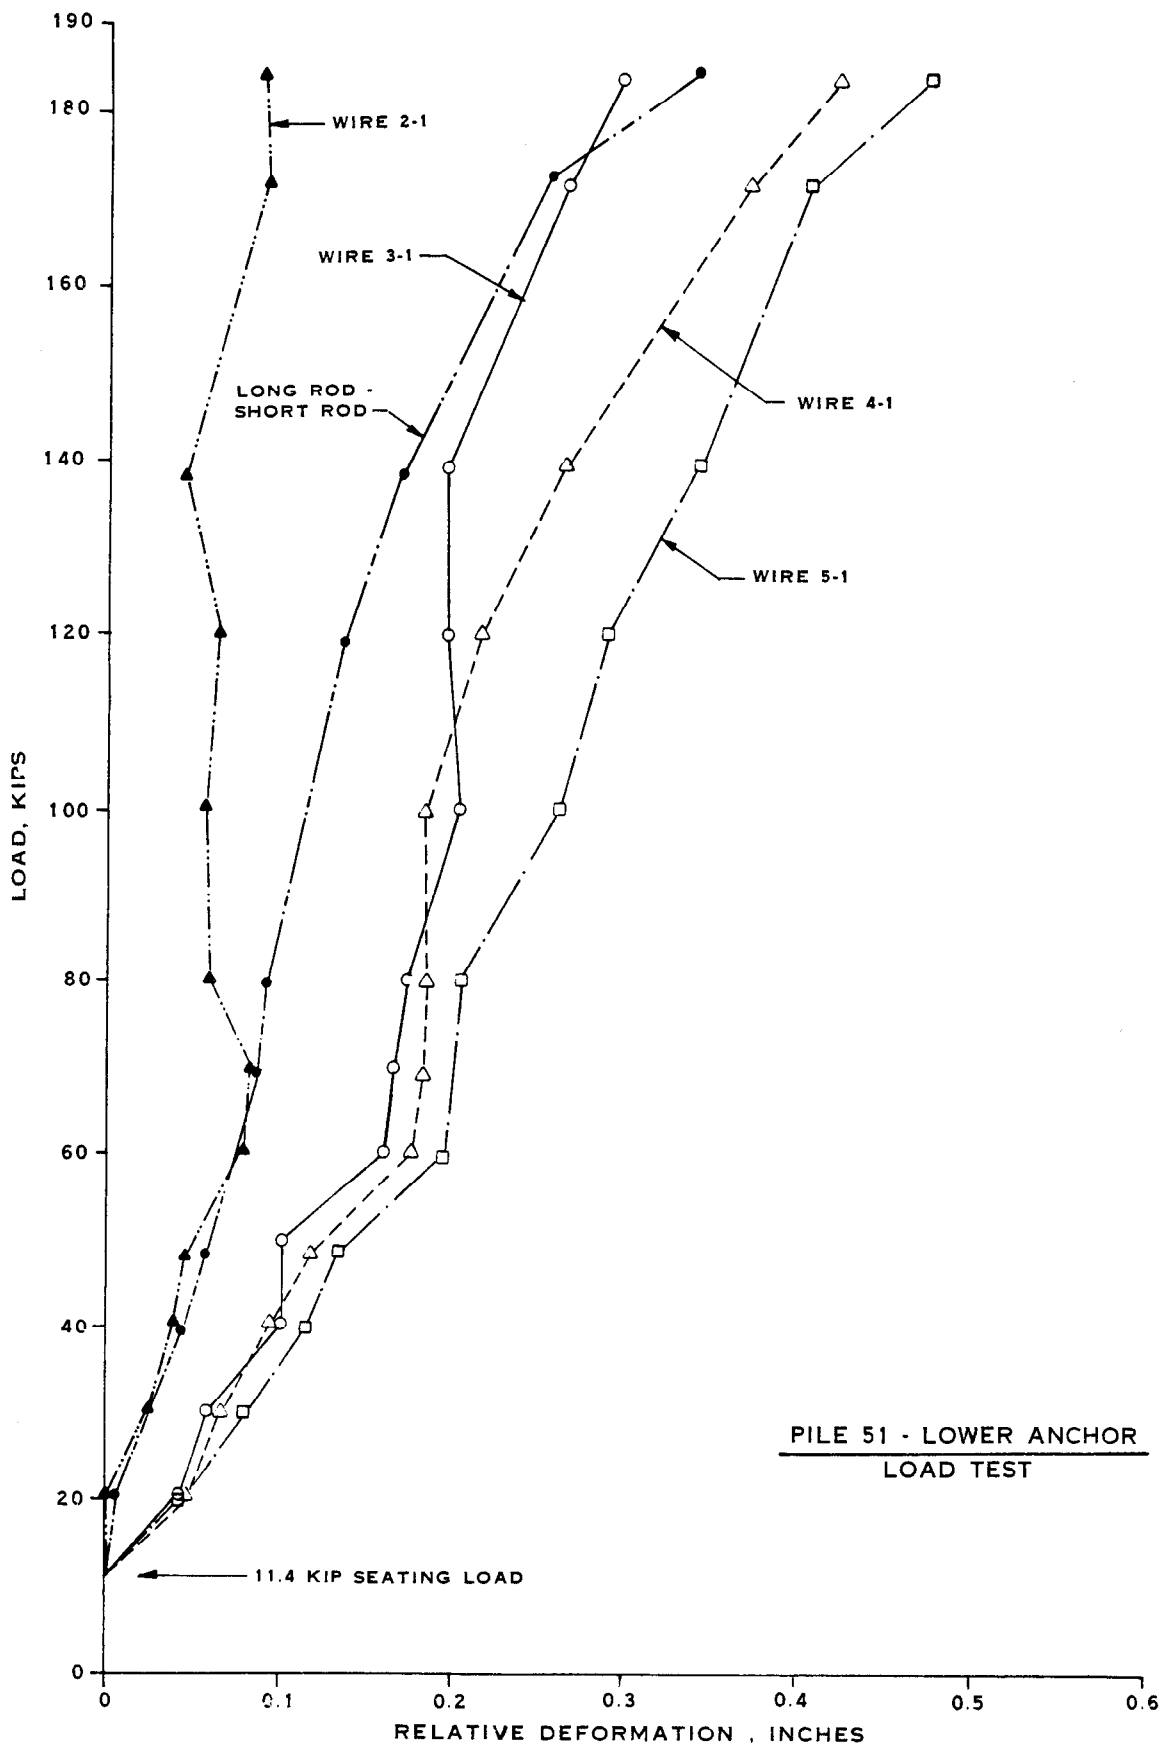
FIGURE 19 - RELATIVE DEFORMATION IN BOND ZONE - LOAD TEST

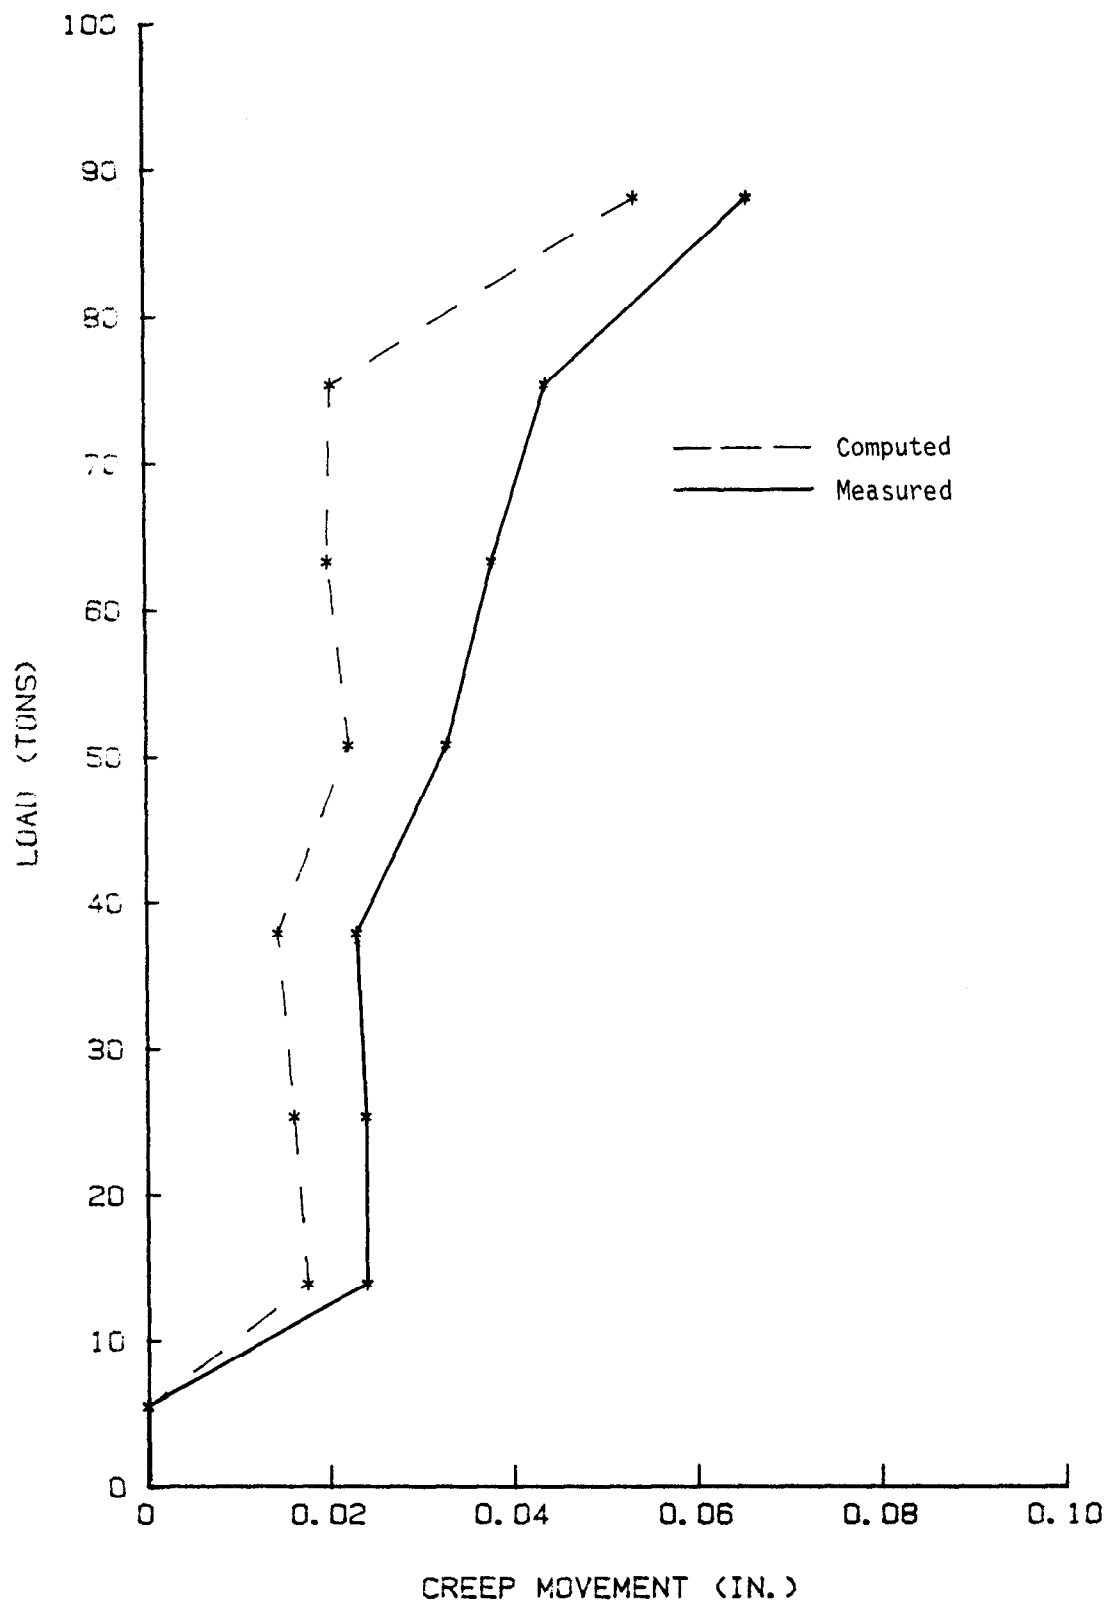
Figure 31. Measured Versus Computed Creep Movement of Tieback 18-2

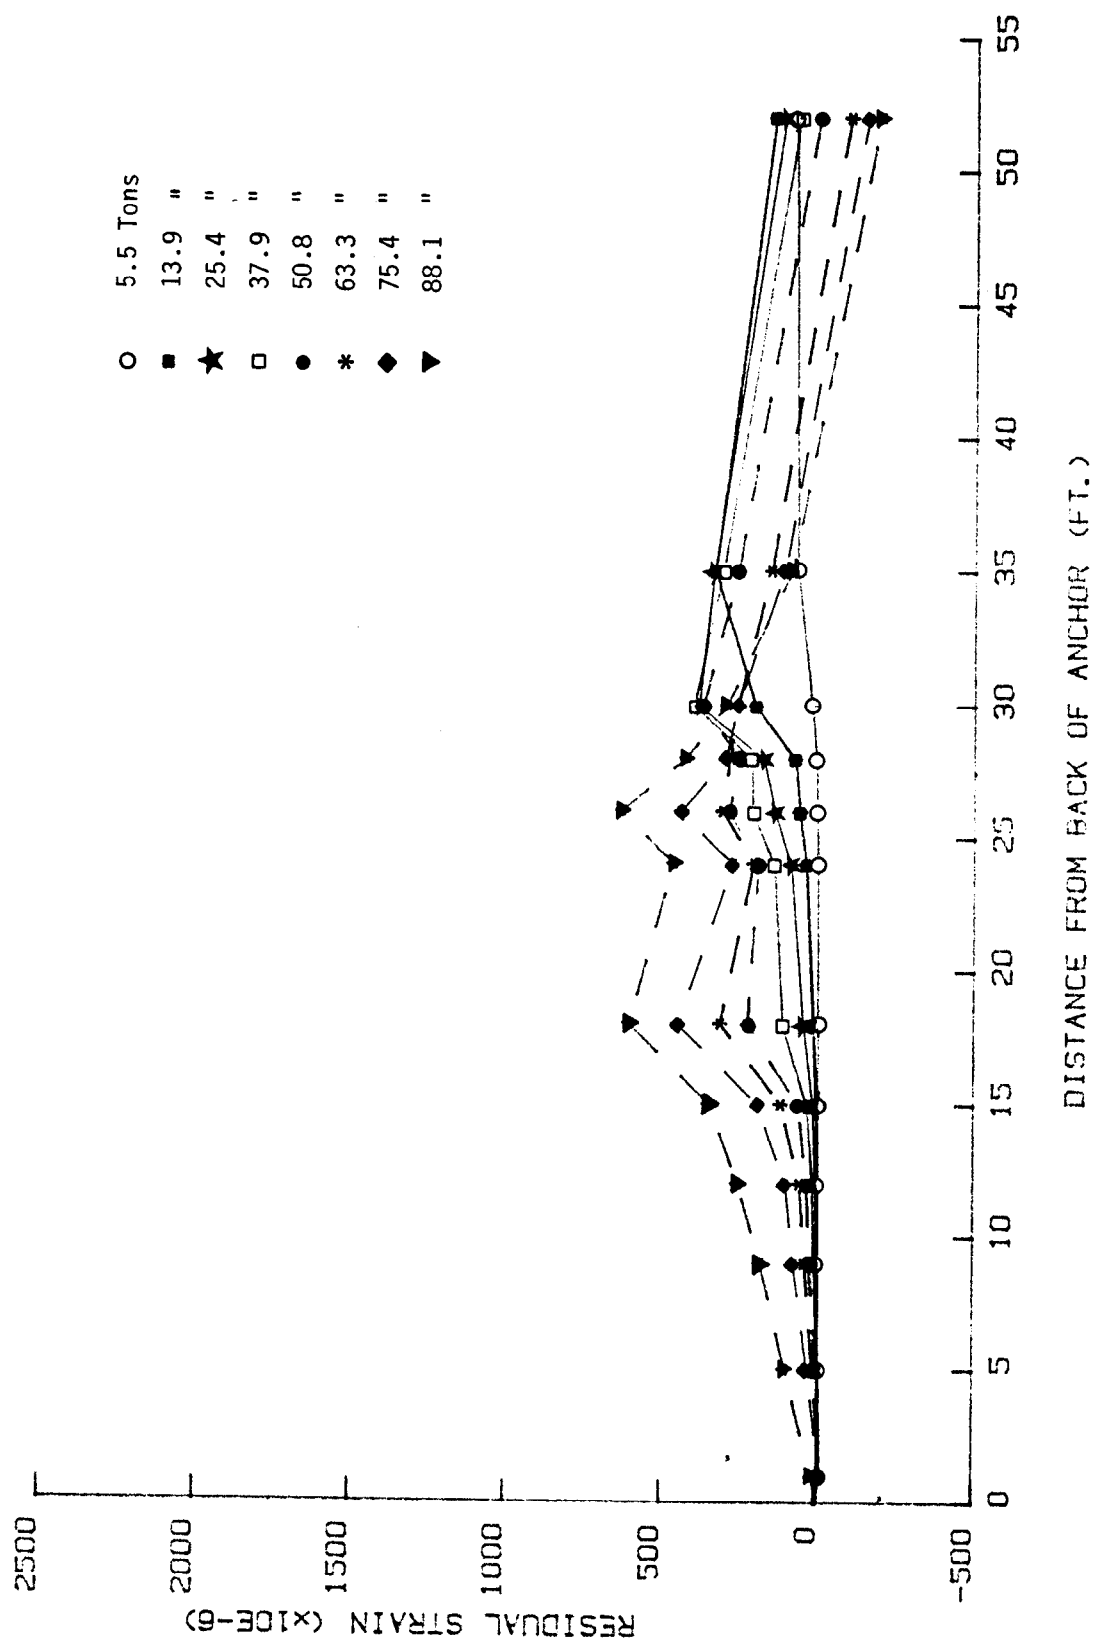
Figure 27. Distribution of Residual Strain in the Tendon of Tieback 18-2

Residual-strain distribution in the tendon is presented in Figure 27. In the unbonded length, residual strain decreased with increasing load, as was the case for tieback 15-8. The residual-strain distribution in the anchor length conformed to expected behavior. As the load increased, the residual strain in the tendon increased. The transition zone between the unbonded length and the anchor length was well-defined and occurred 28 to 30 feet from the back of the anchor. This indicates that the minimum unbonded length was provided.

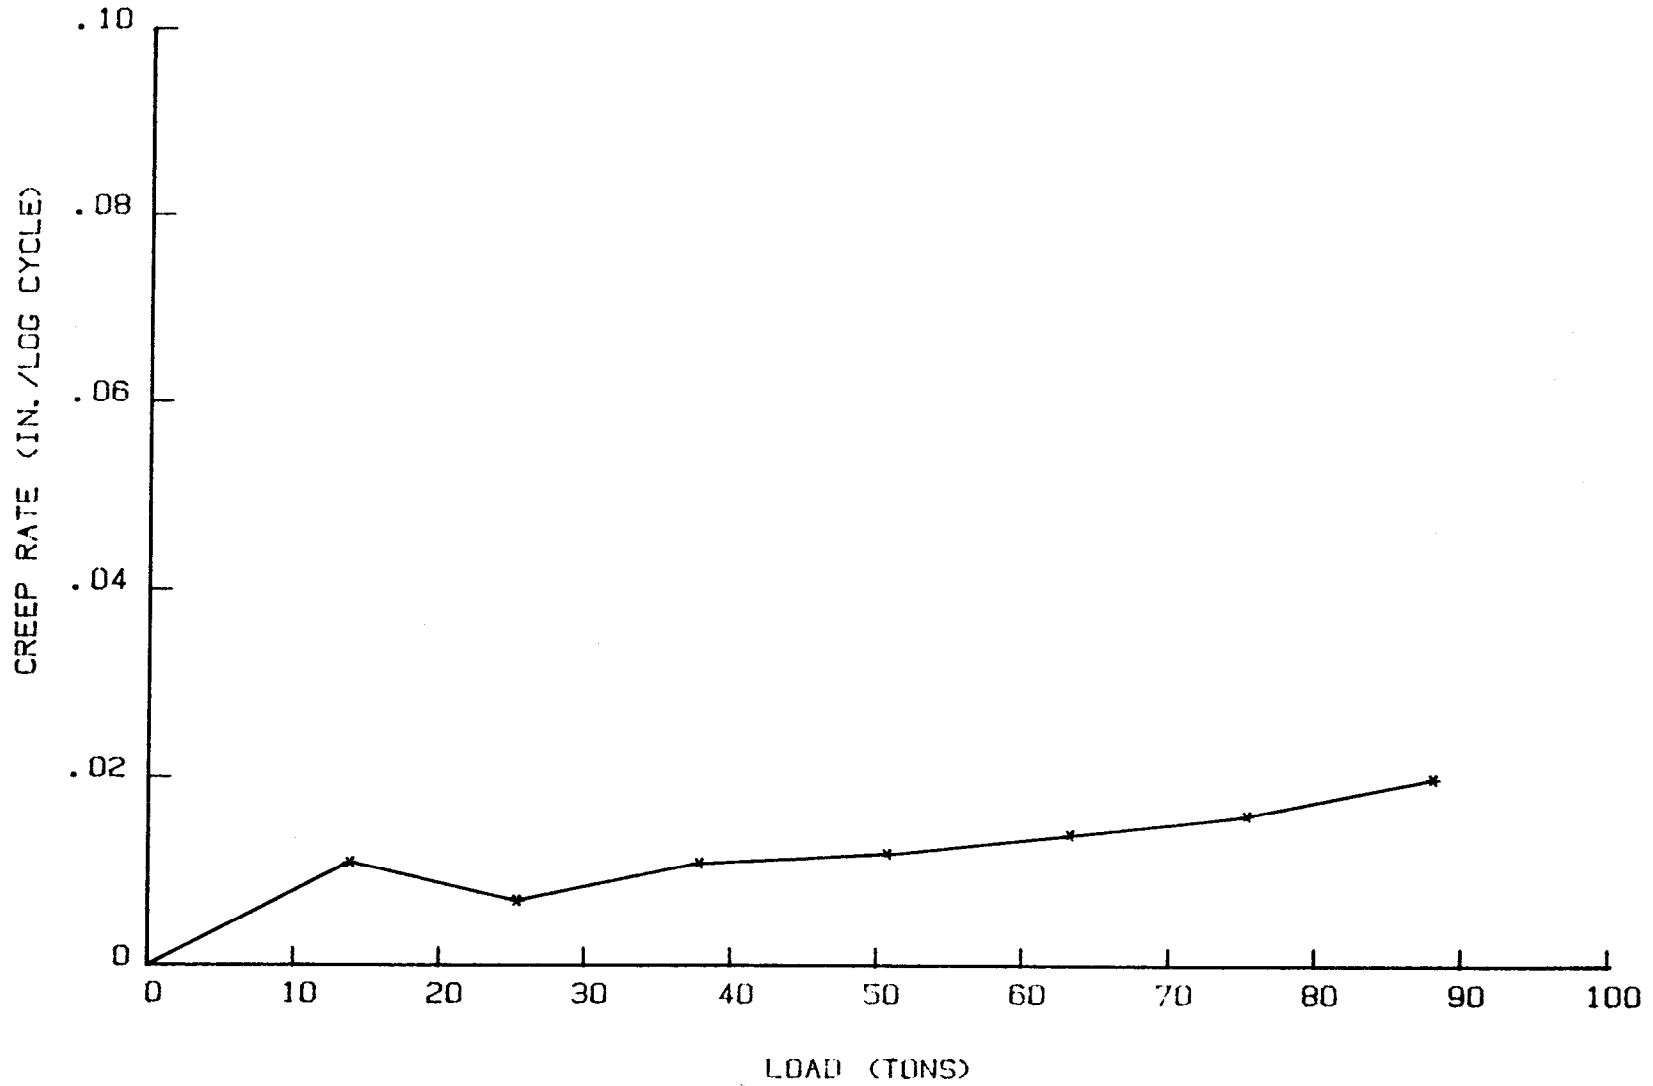
Figure 25. Creep Rate Versus Load for Tieback 18-2

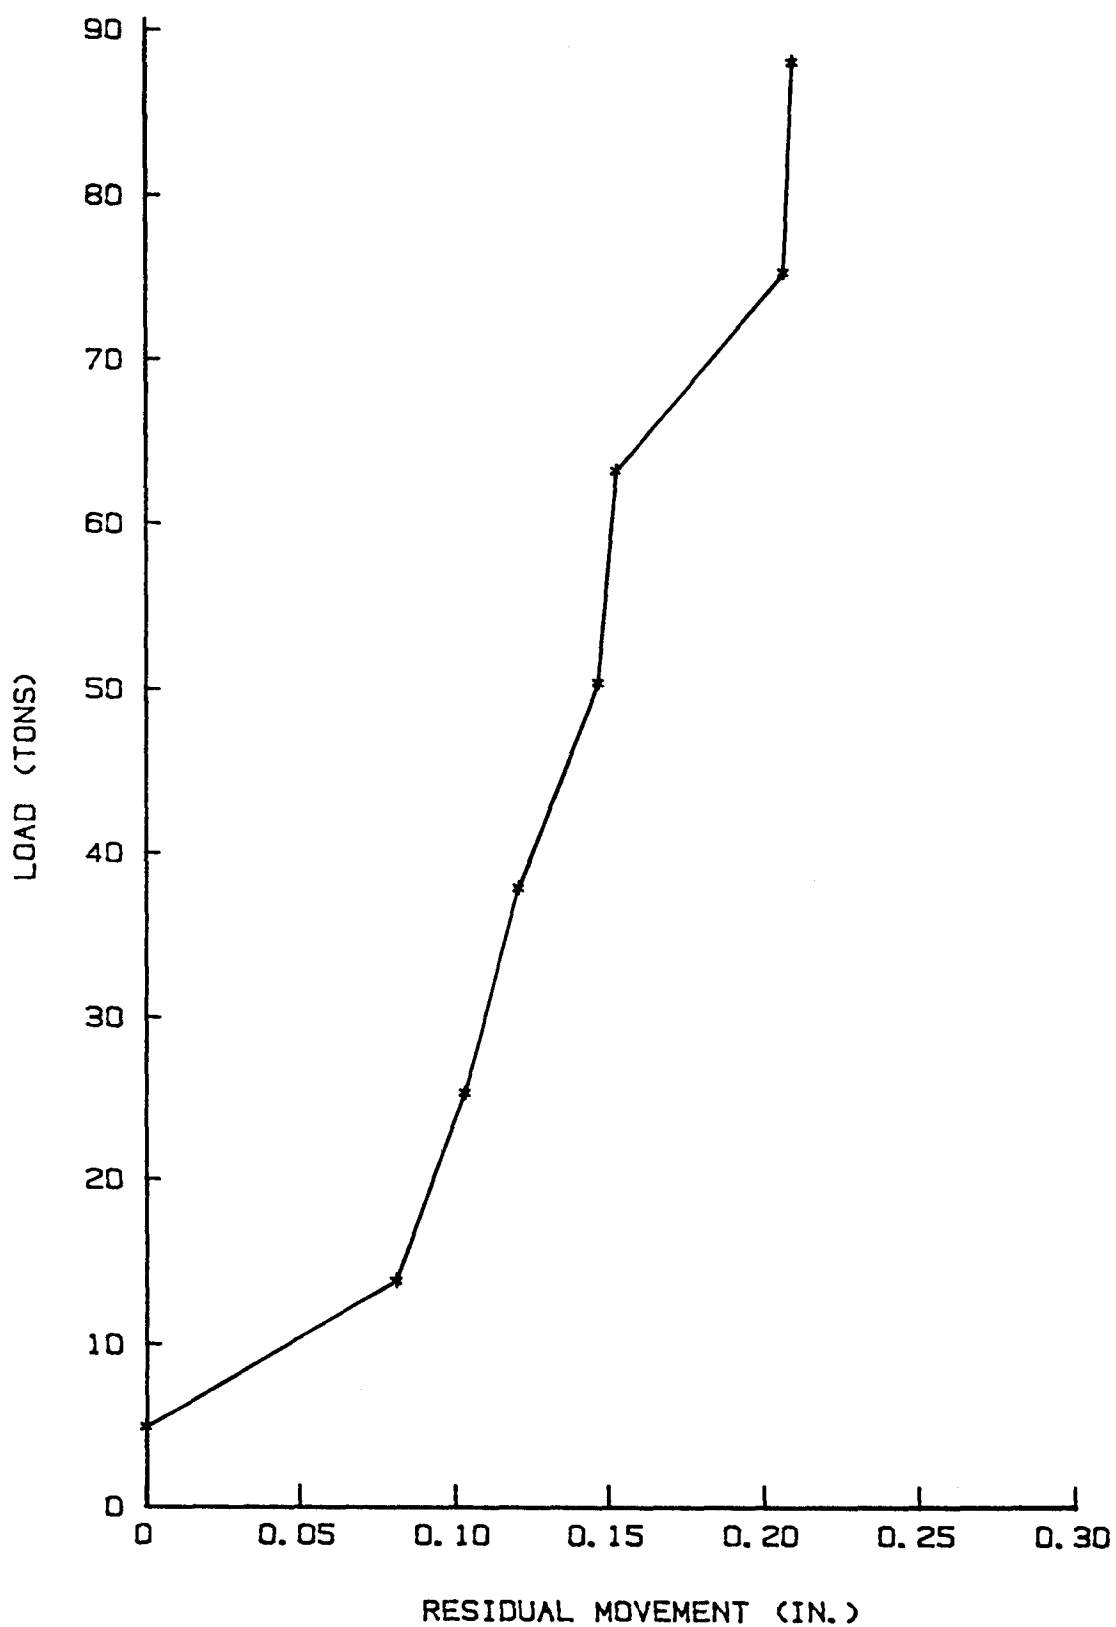
Figure 23. Residual Anchor Movement of Tieback 18-2

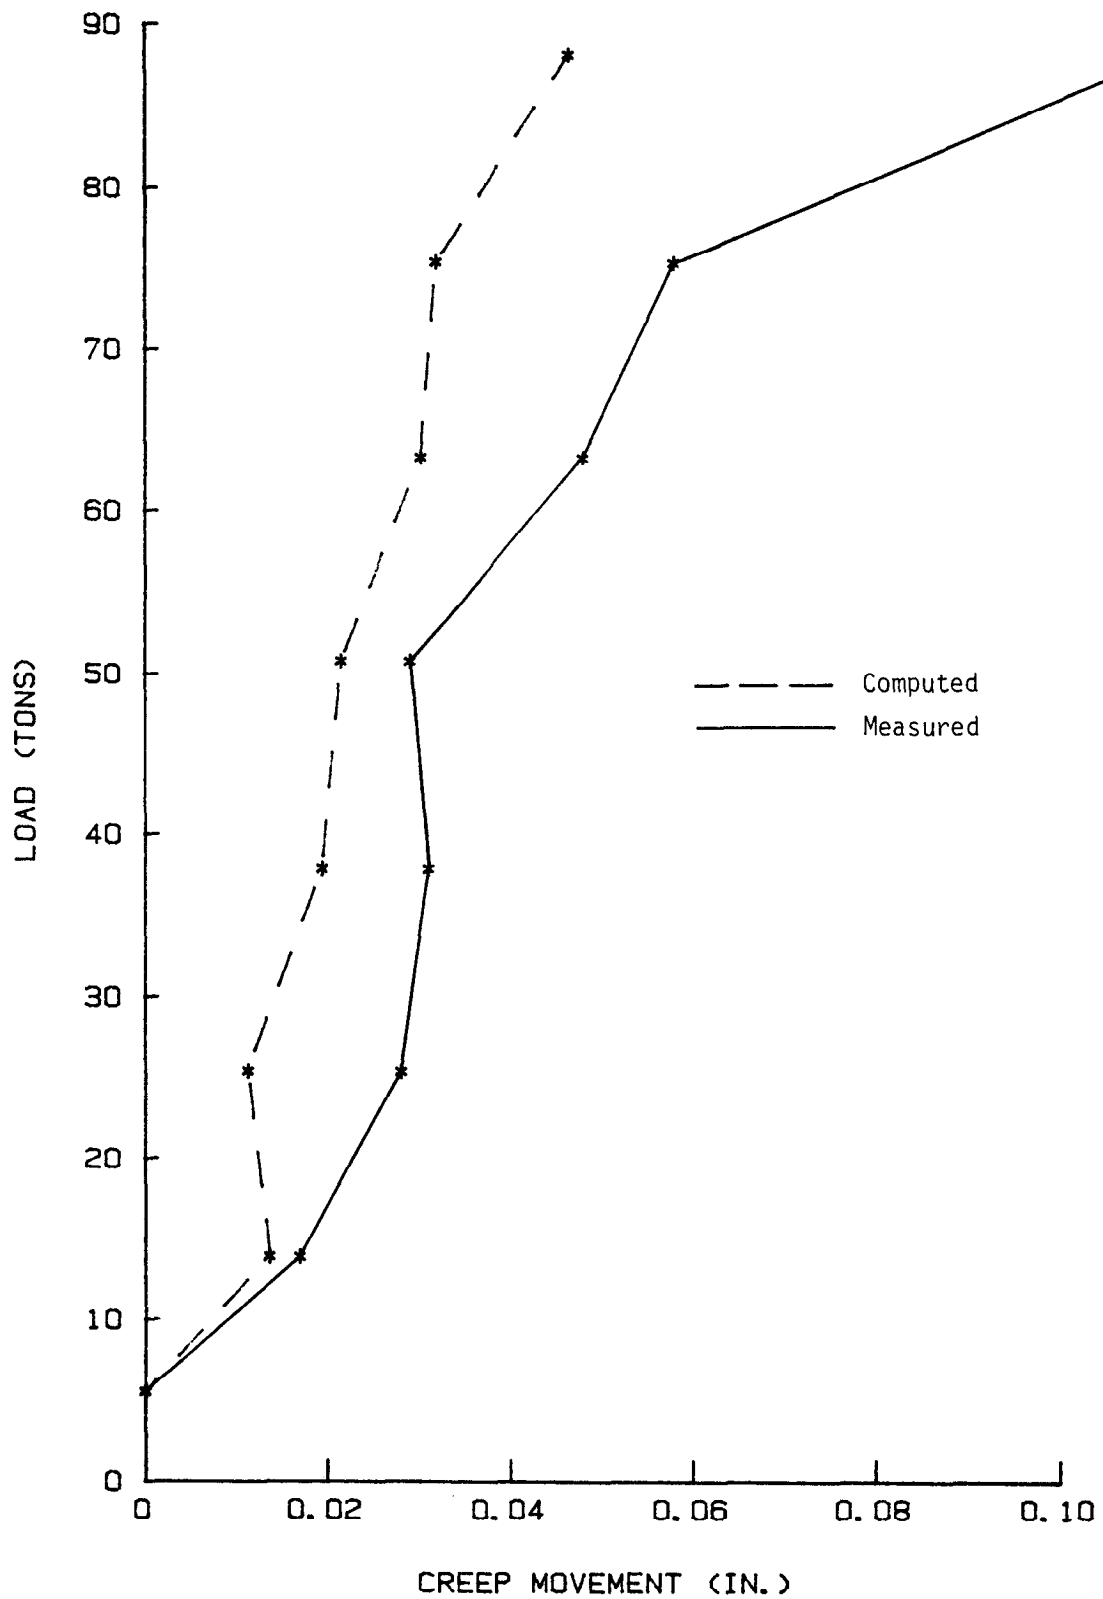
Figure 21. Measured Versus Computed Creep Movement of Tieback 15-8

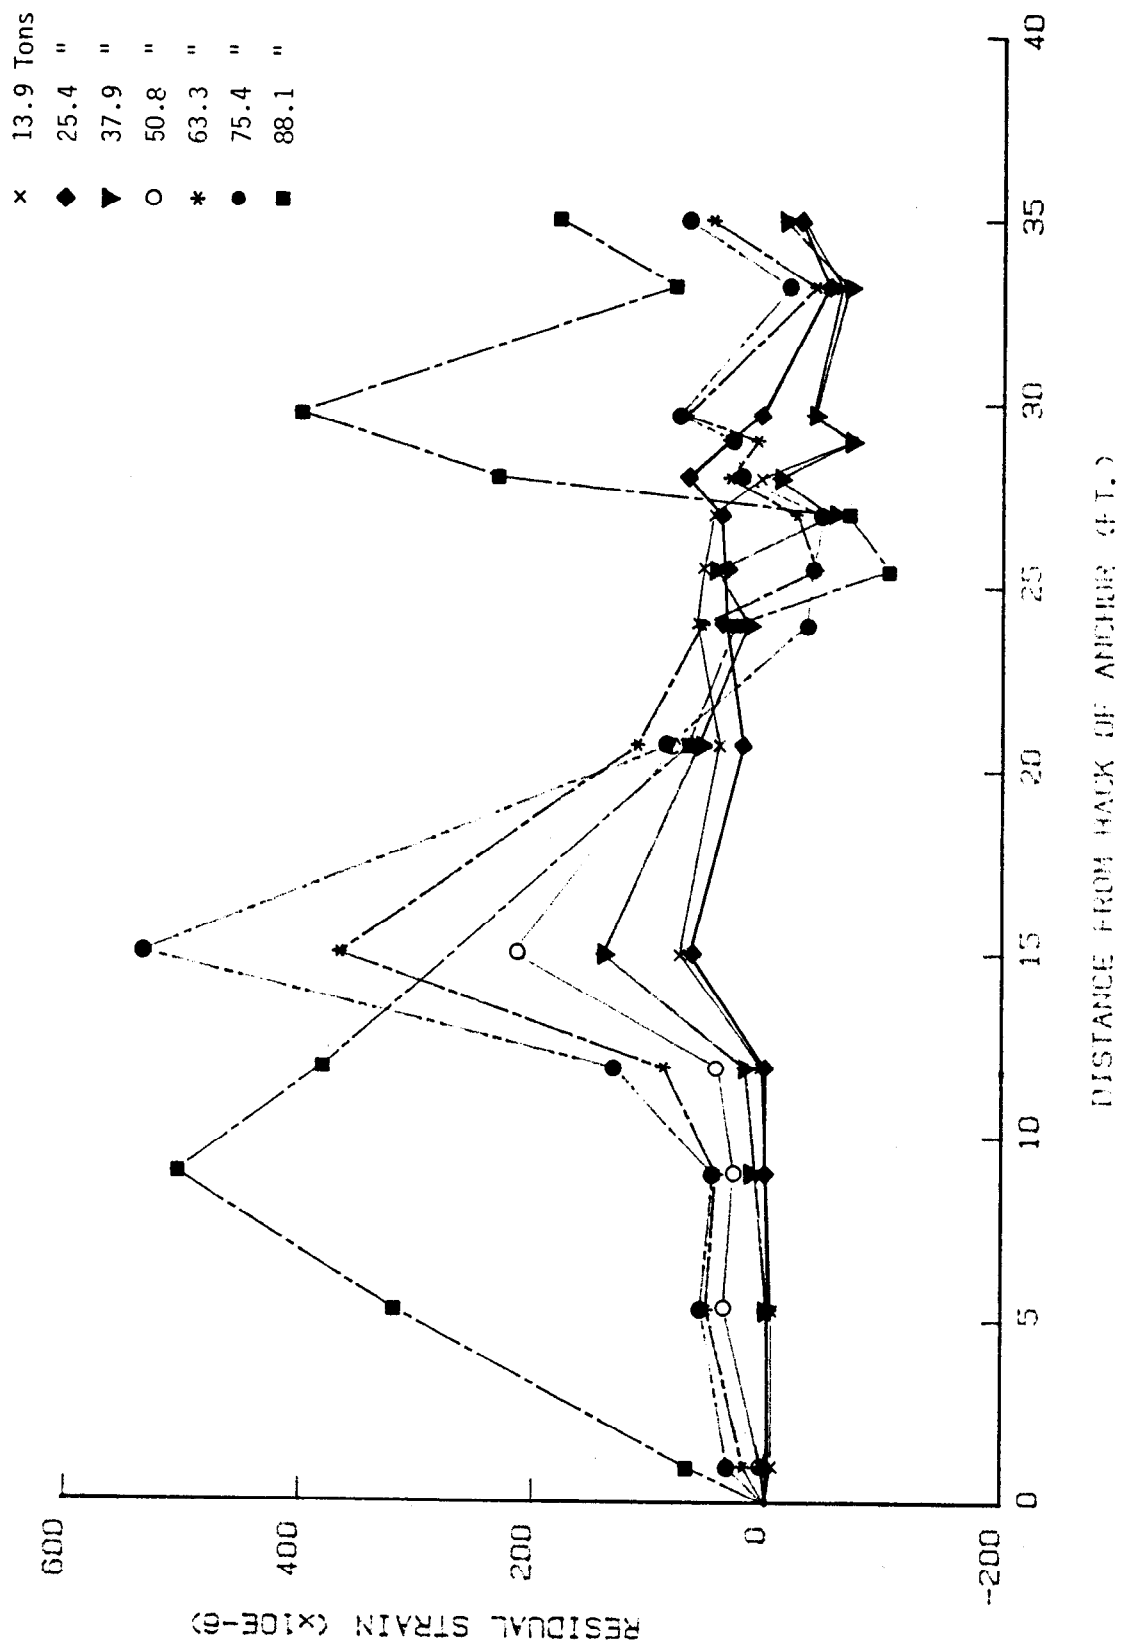
Figure 19. Distribution of Residual Strain in the Deformed Metal Tube of Tieback 15-8

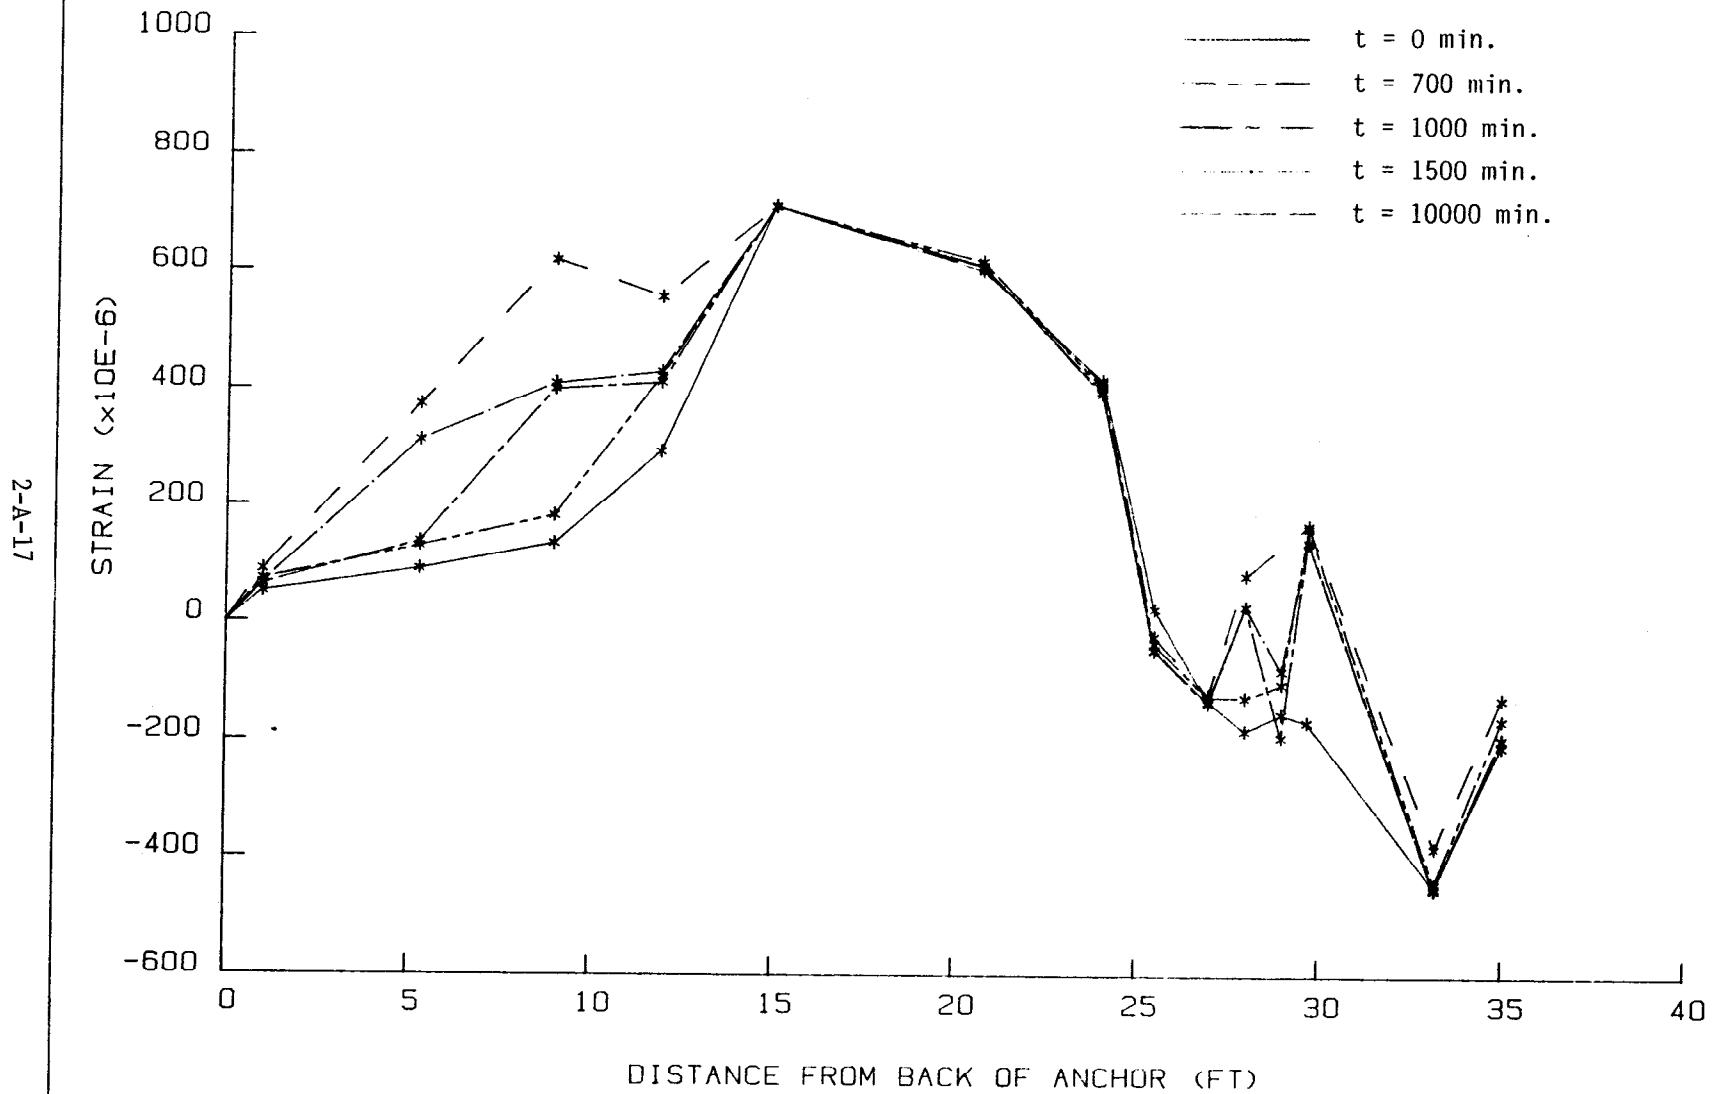
Figure 17. Time-dependent Redistribution of Strain in the Deformed Metal Tube of Tieback 15-8 at 88.1 Tons
