Demonstration Projects  
Program

DP-68  
PERMANENT GROUND ANCHORS  
Volume 2  
Field Demonstration Project Summaries

FHWA-DP-90-068-003  
April 1990

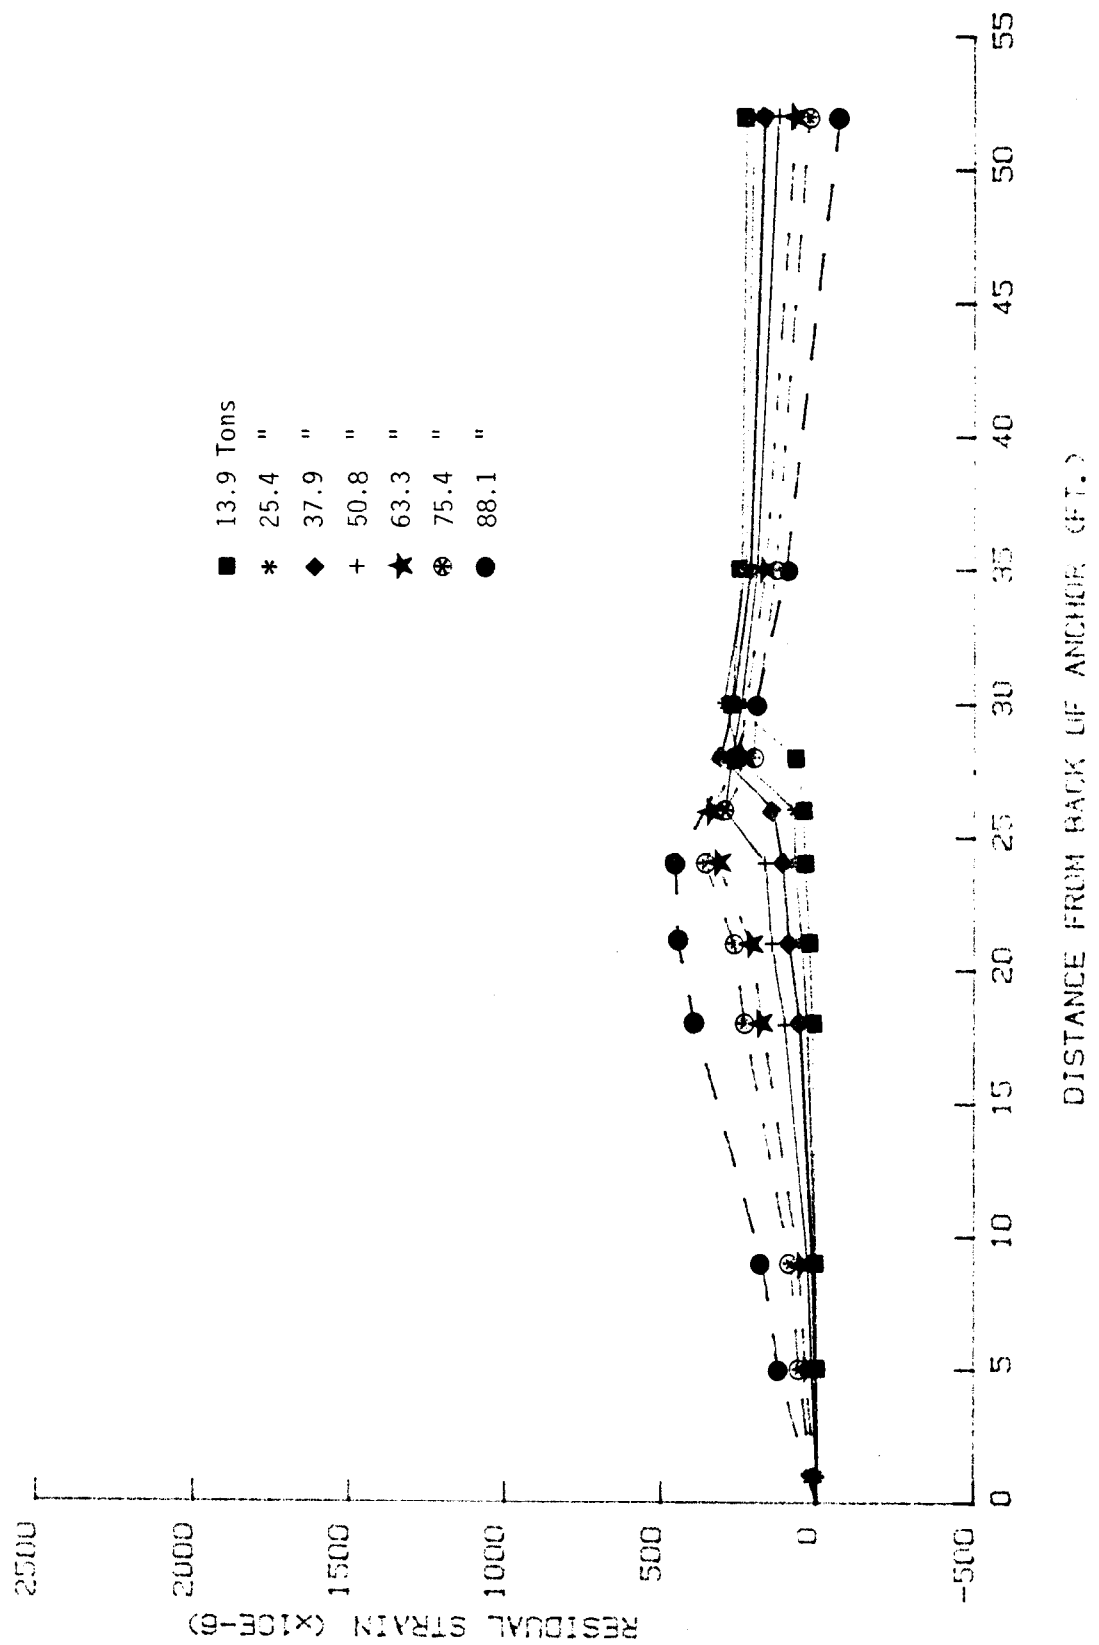
Figure 15. Distribution of Residual Strain in the Tendon of Tieback 15-8

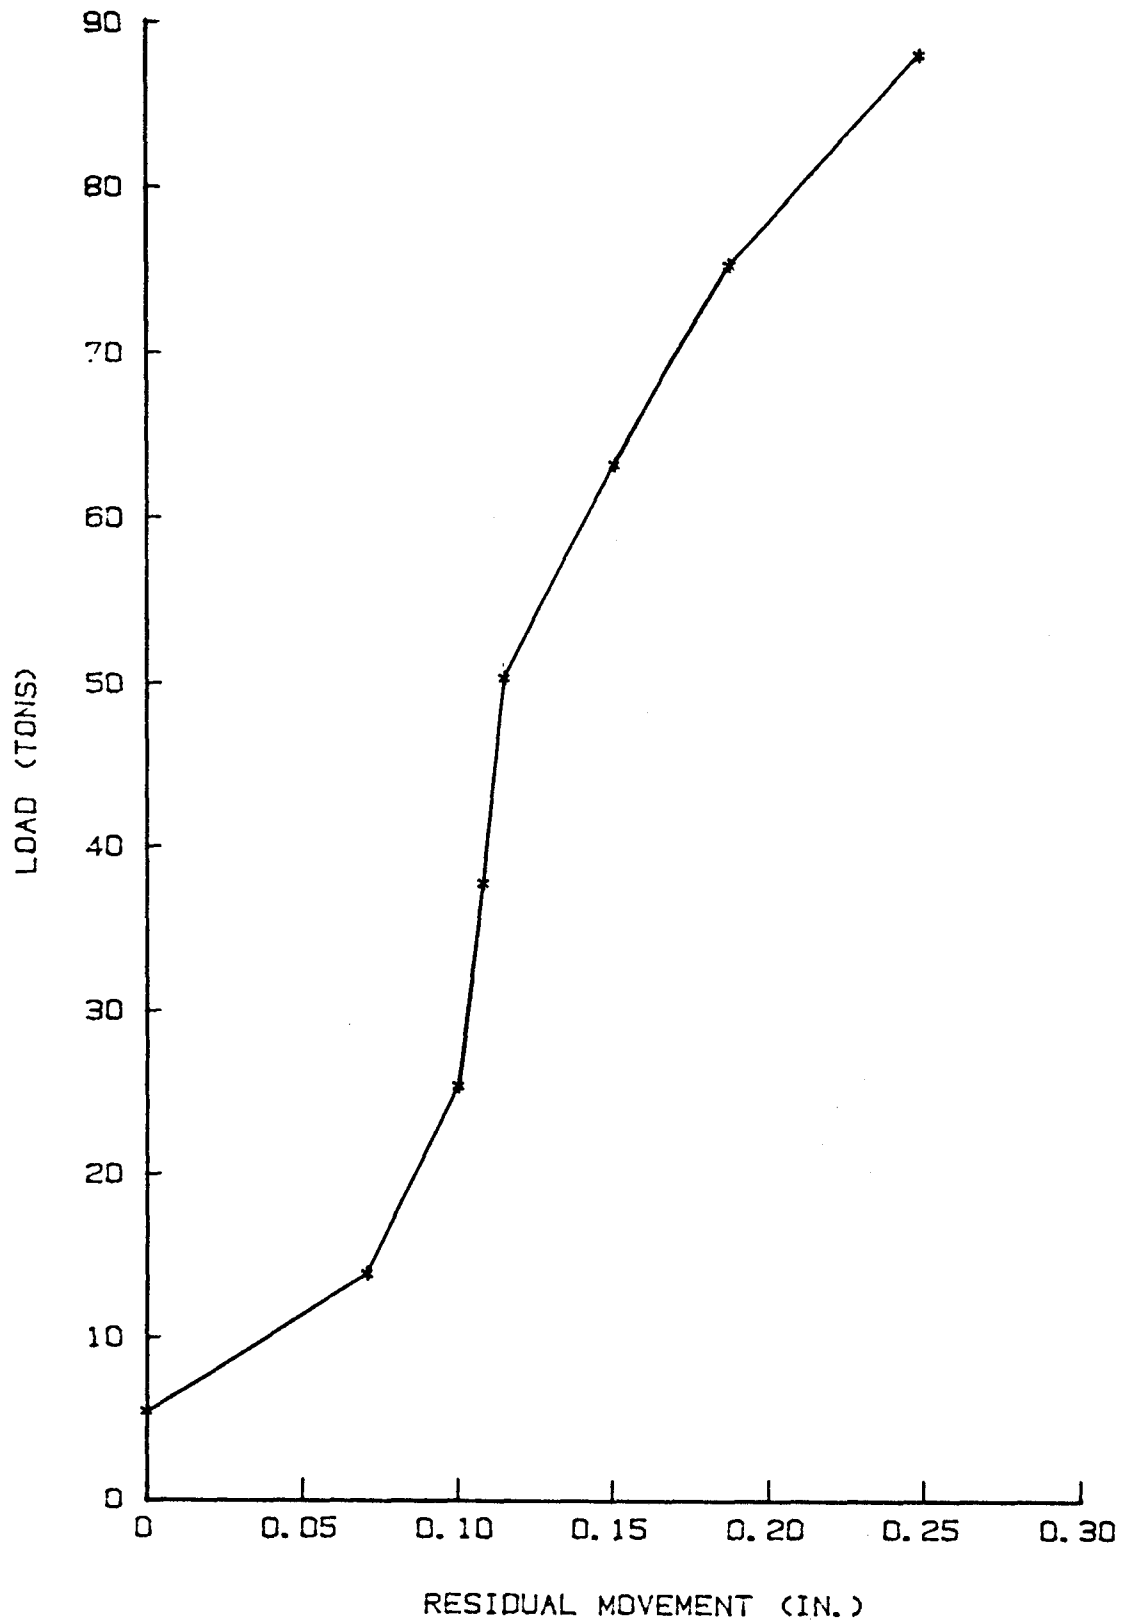
Figure 11. Residual Anchor Movement of Tieback 15-8

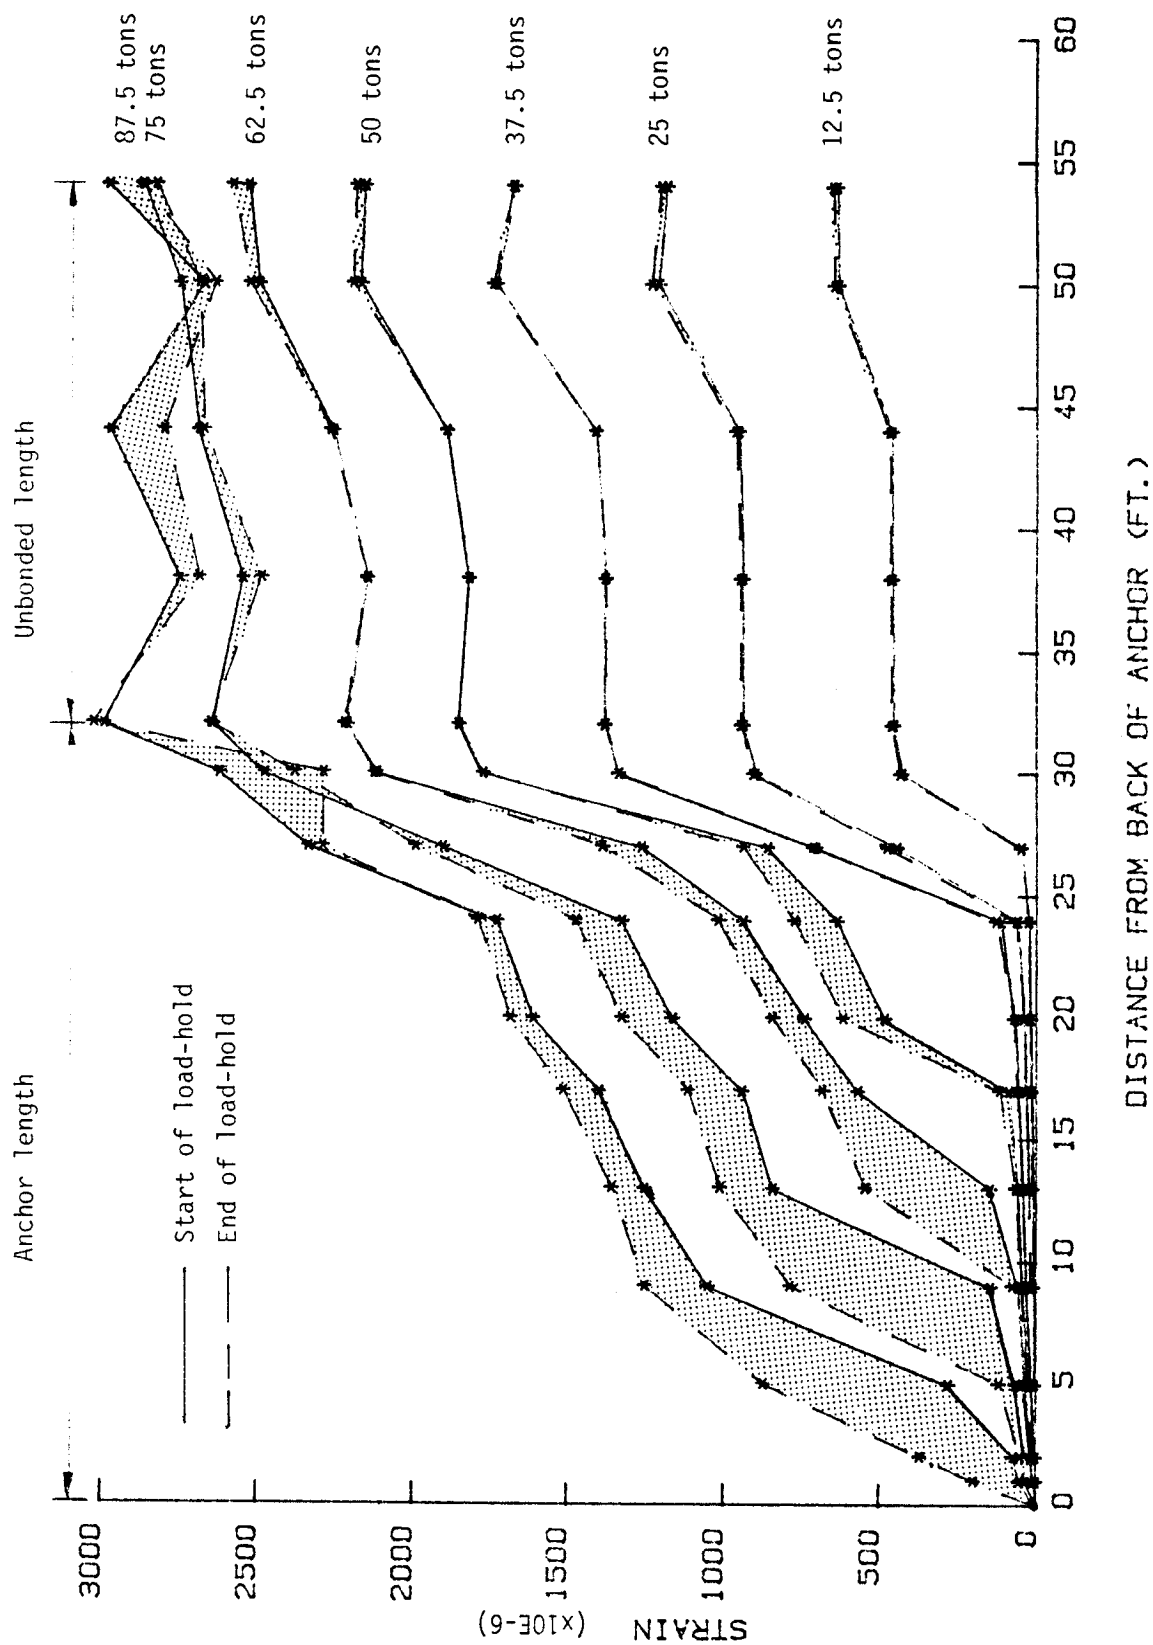
Figure 9. Distribution of Strain in the Tendon of a Straight-shafted Tieback Anchored in a Cohesive Soil

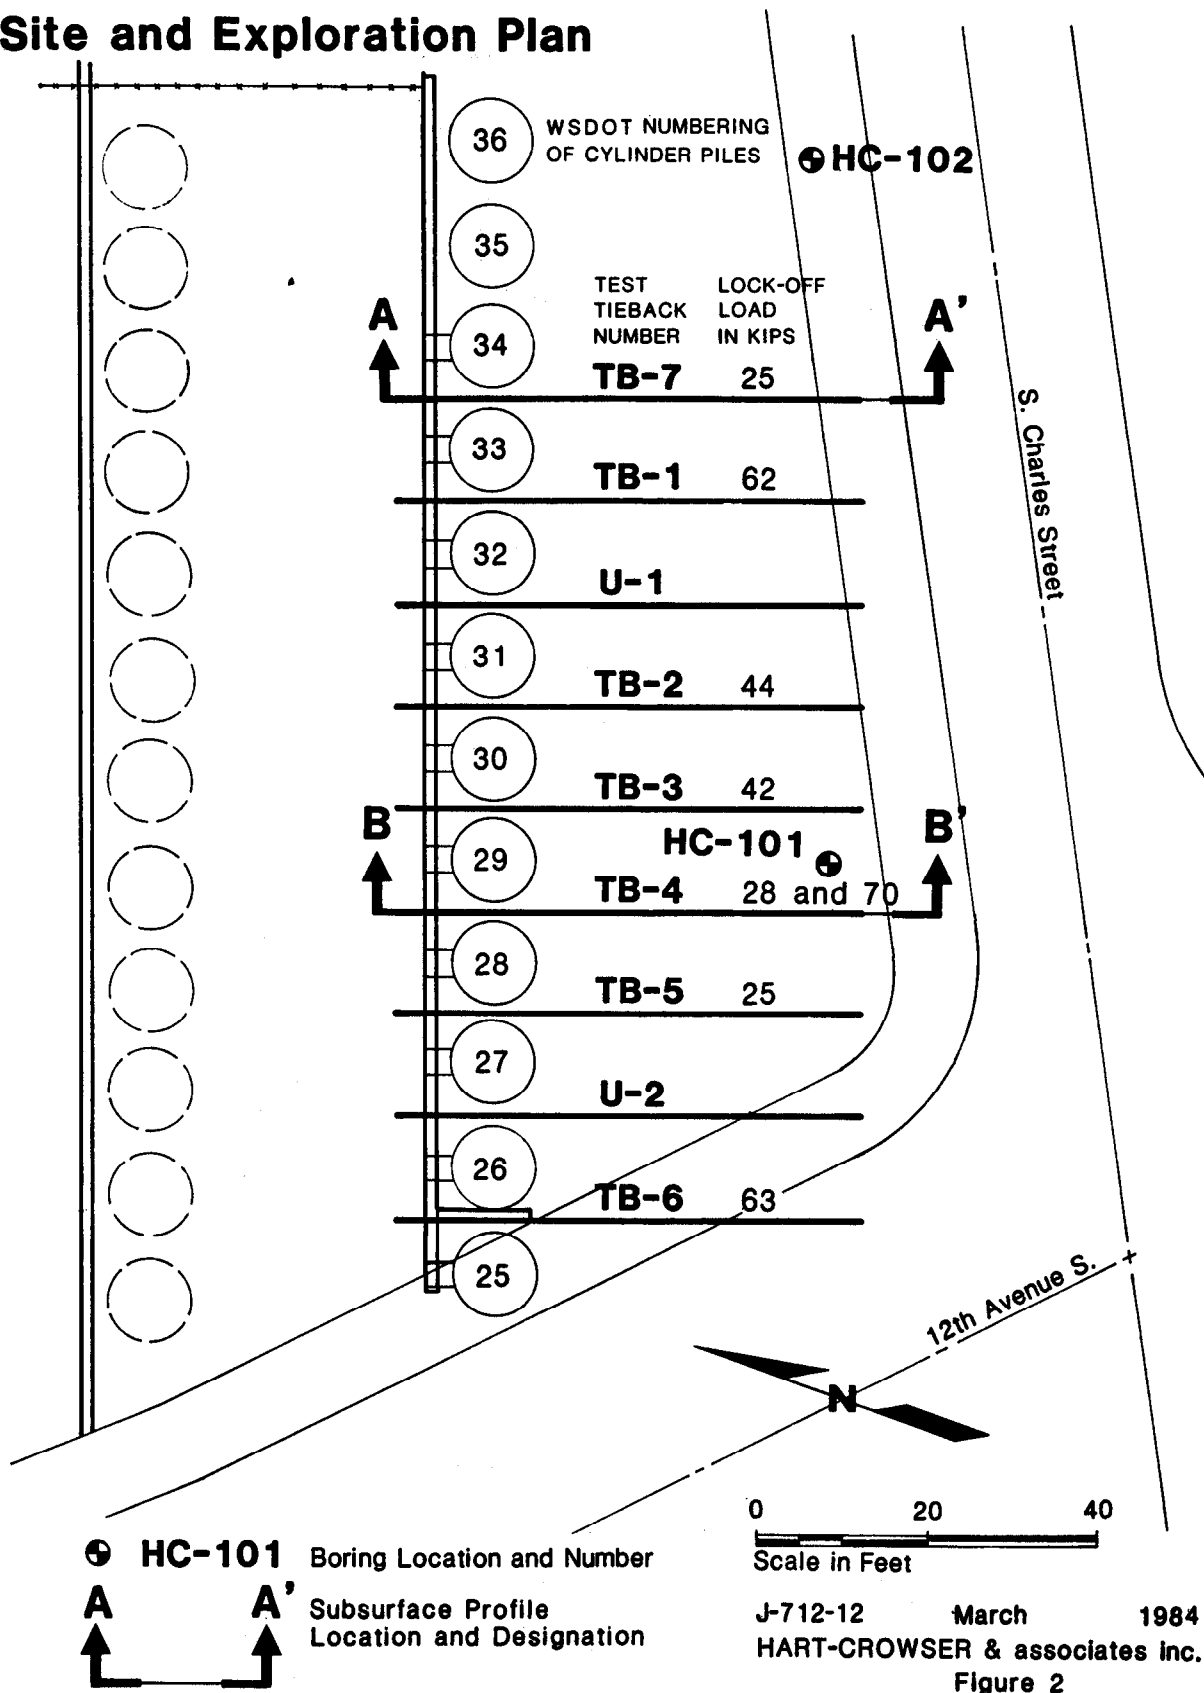
# Site and Exploration Plan

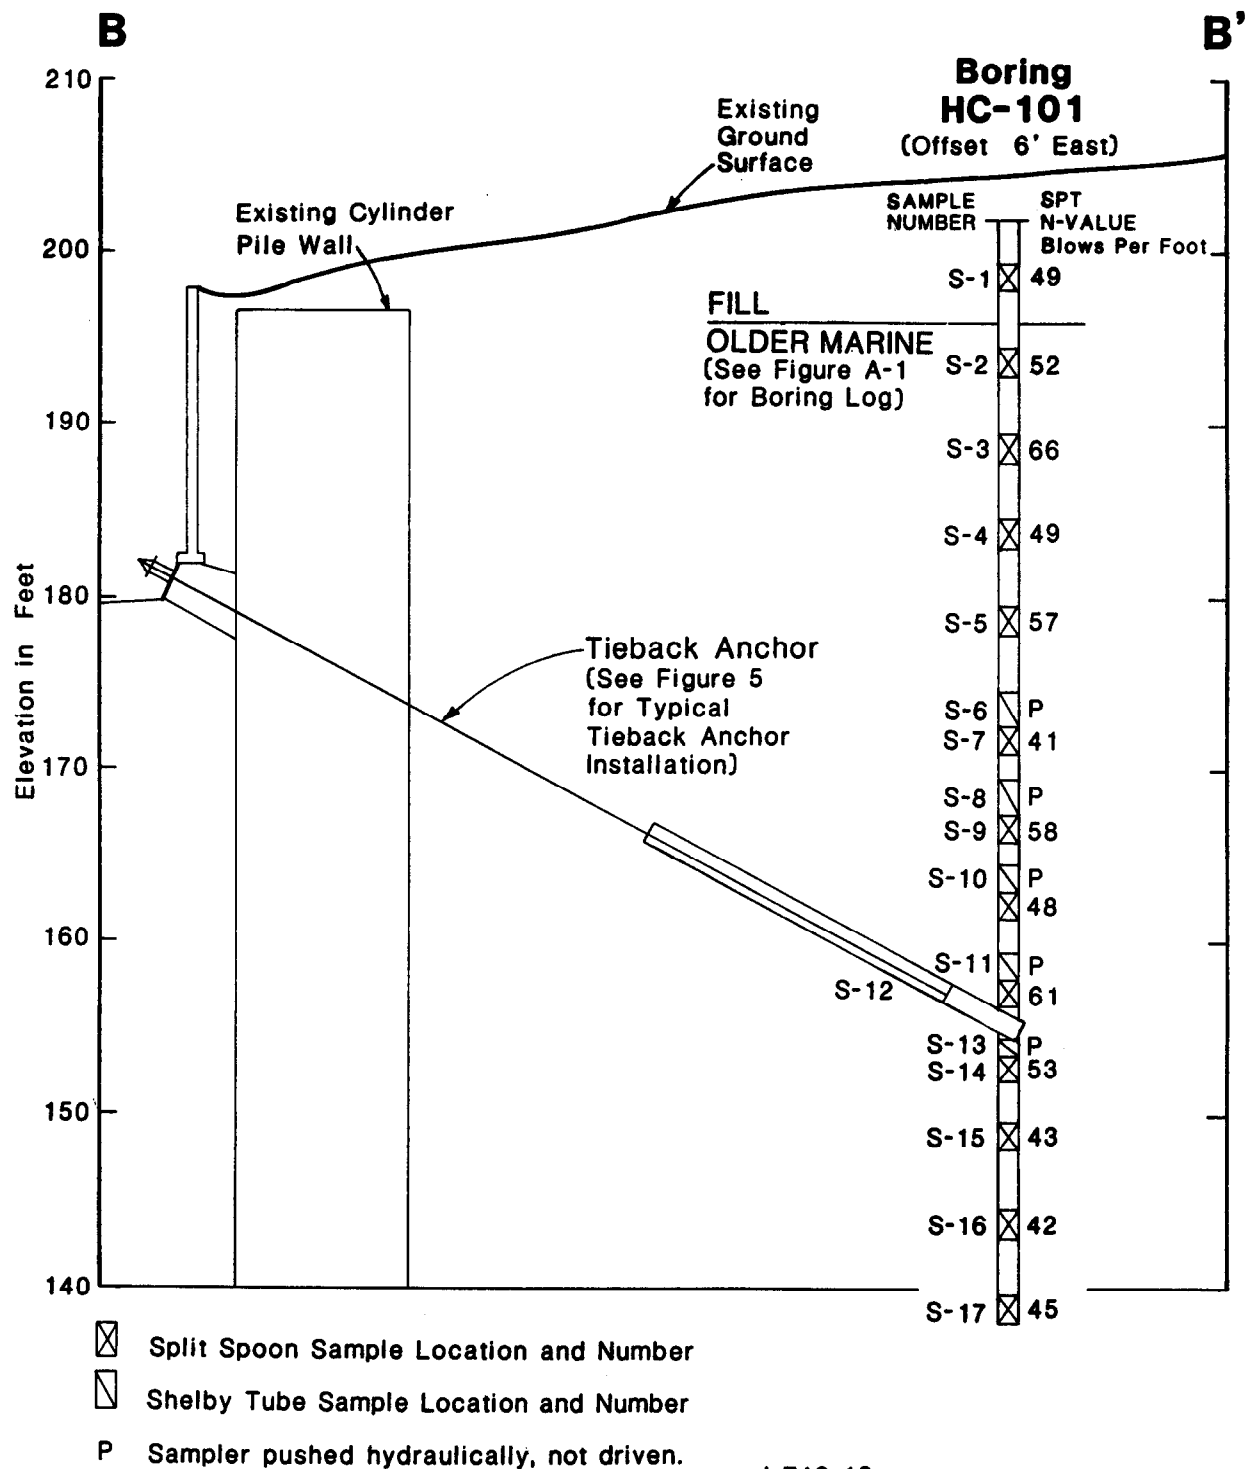
# Generalized Subsurface Profile B-B'

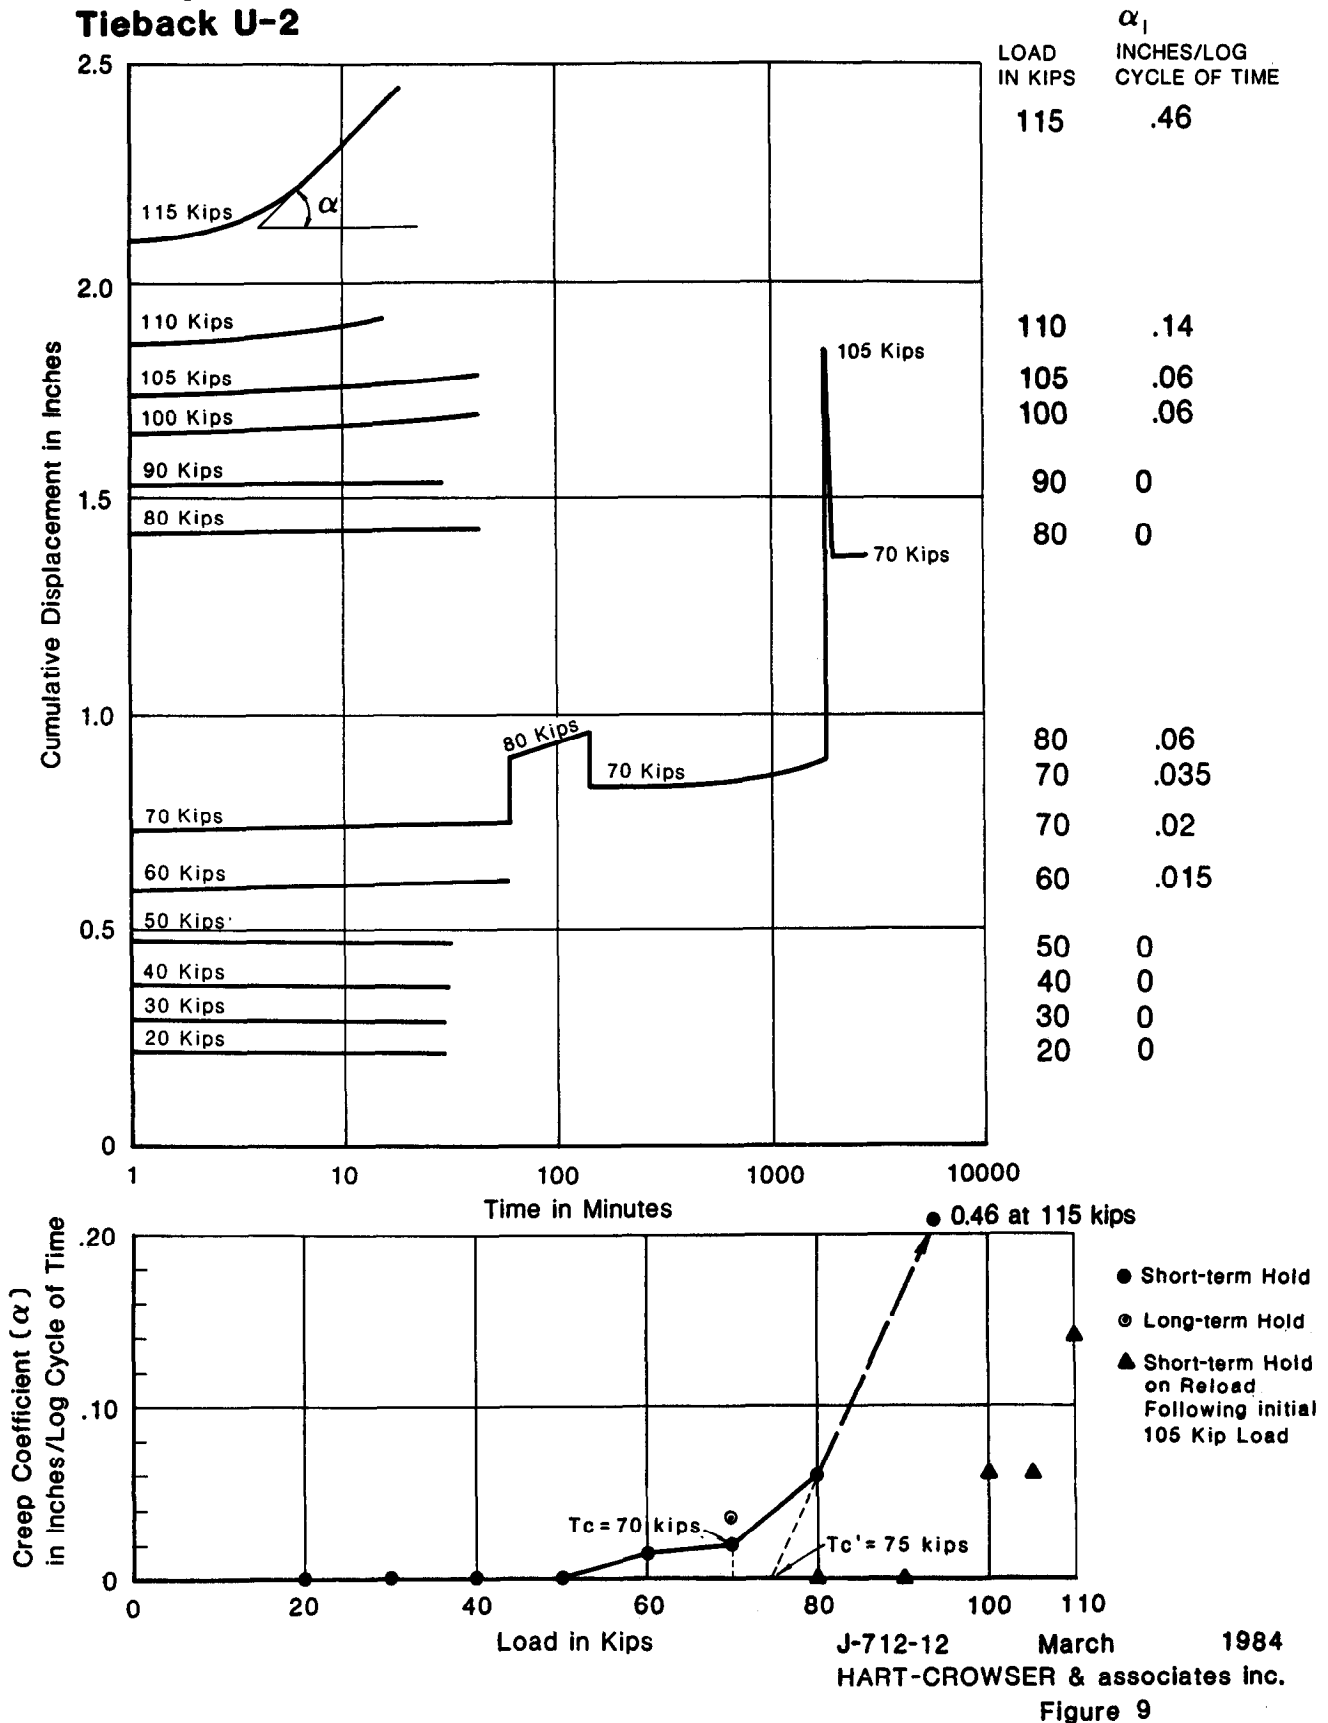
# Creep Curves and Creep Coefficient Plot Tieback U-2

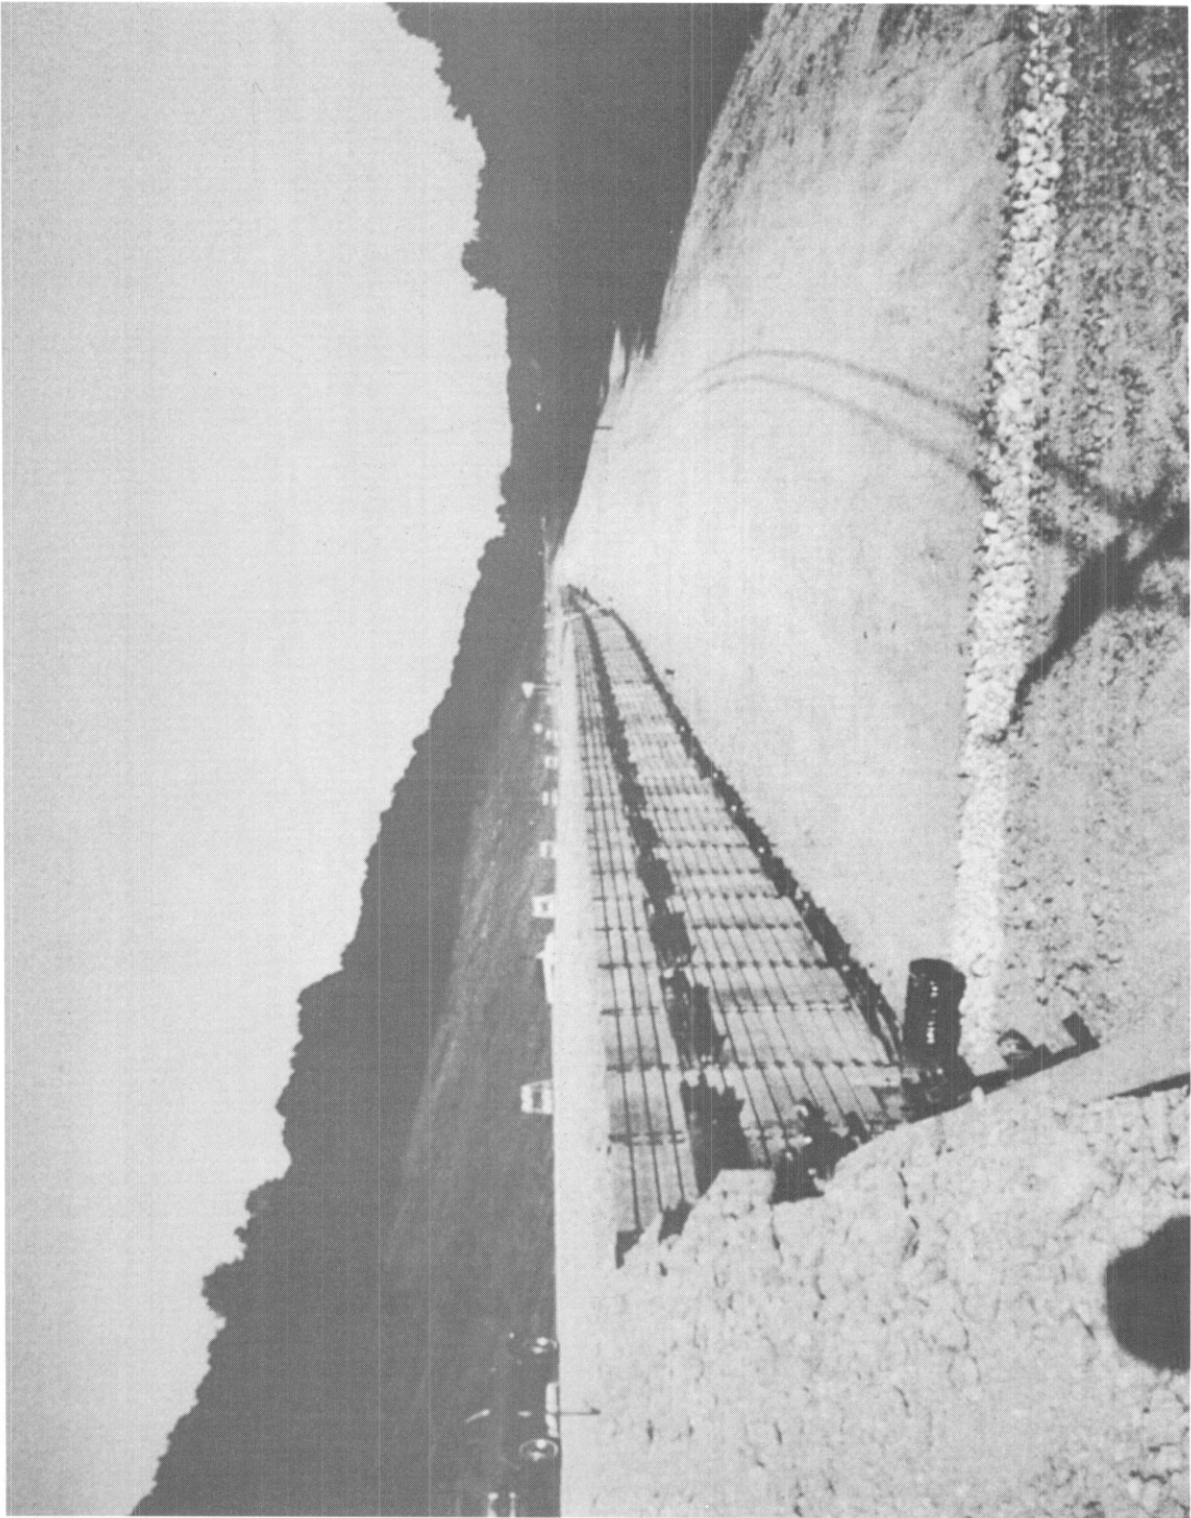
Figure 1A. Ky. 227 Slide Site When Tieback Wall is Nearly Complete.

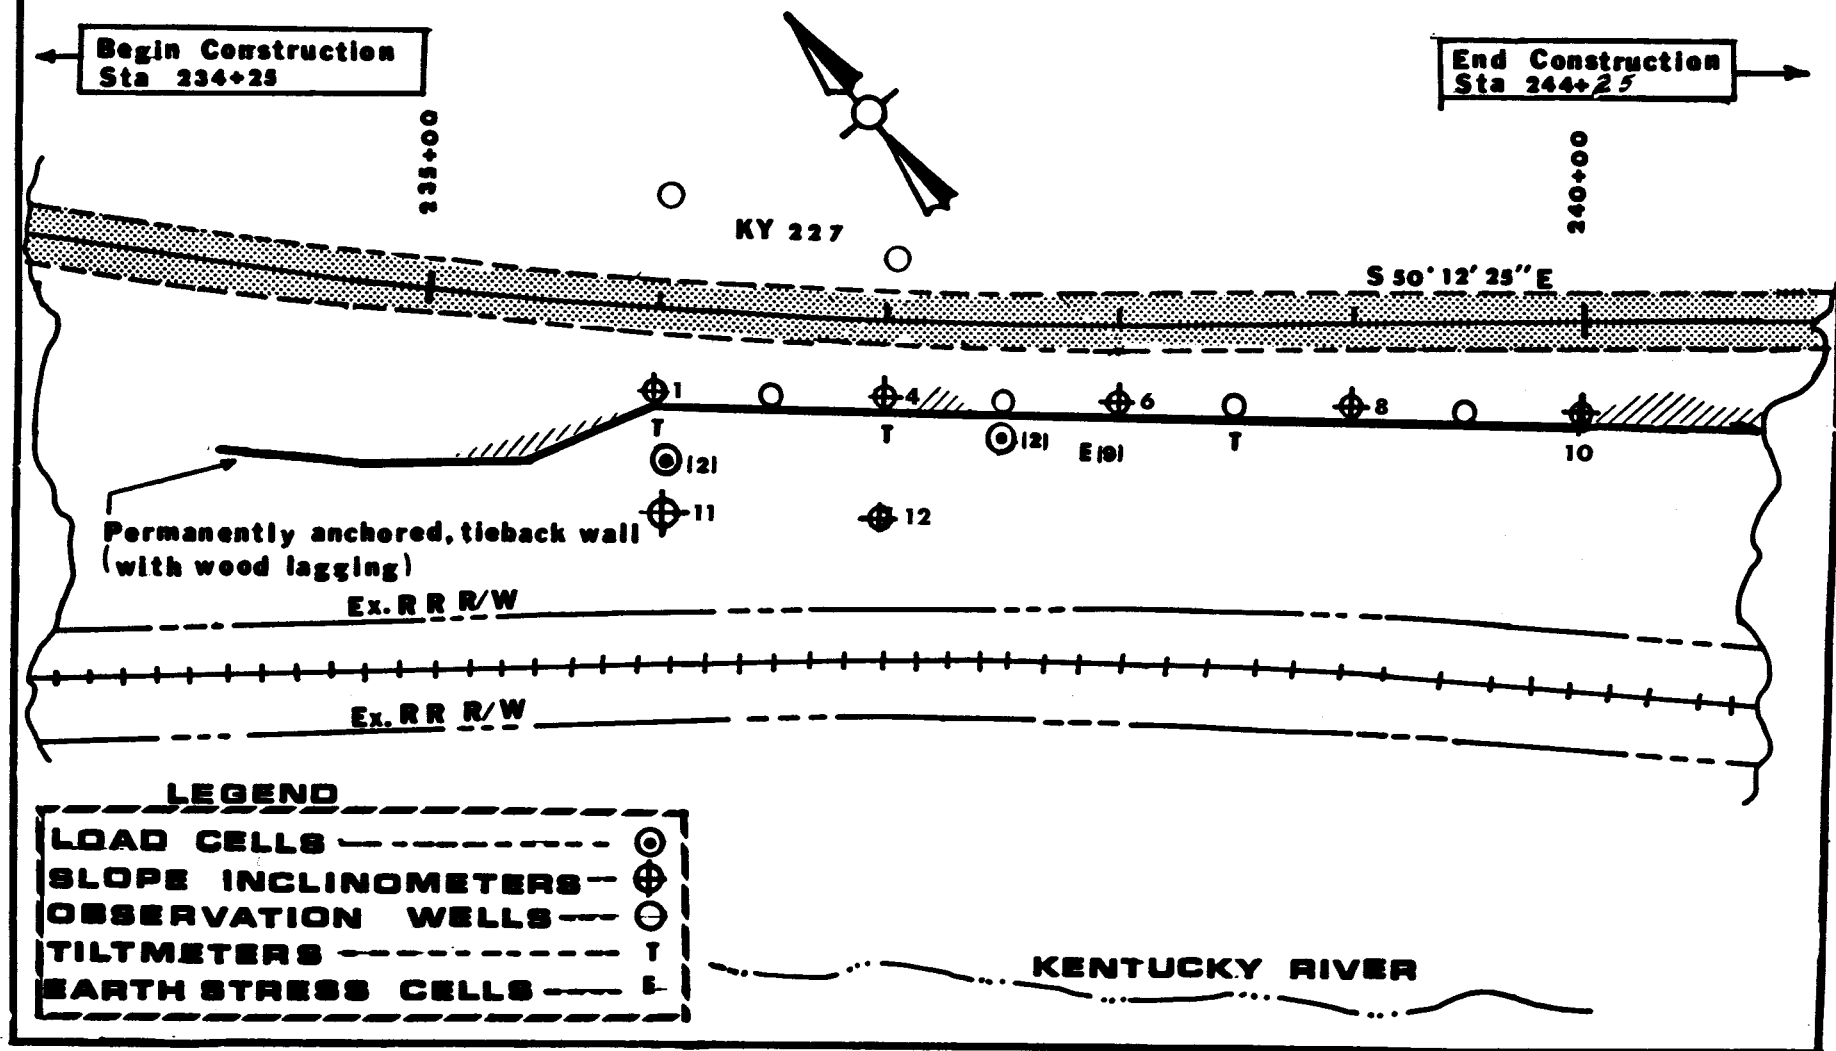
Figure 14. Plan View of Site with Instrumentation Locations.

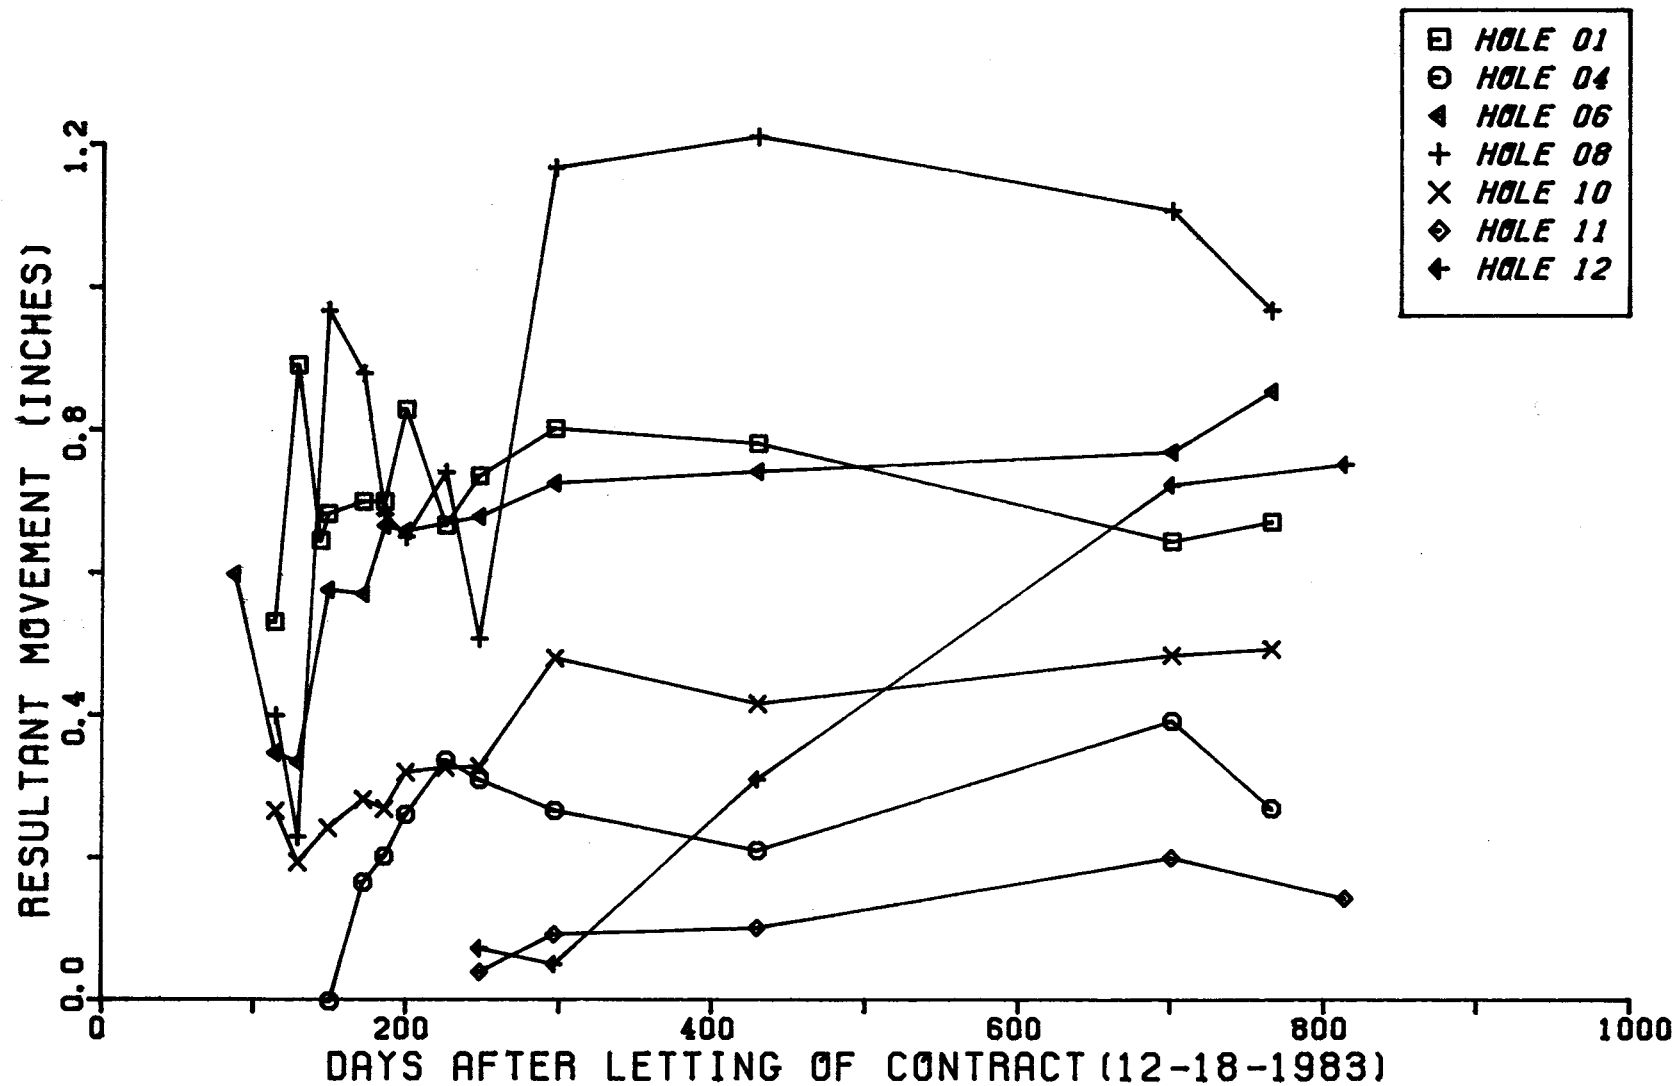
FIGURE 20. SLOPE INCLINOMETER 10 - LATERAL MOVEMENT AT STATION 240 + 00, 30 FEET RIGHT.

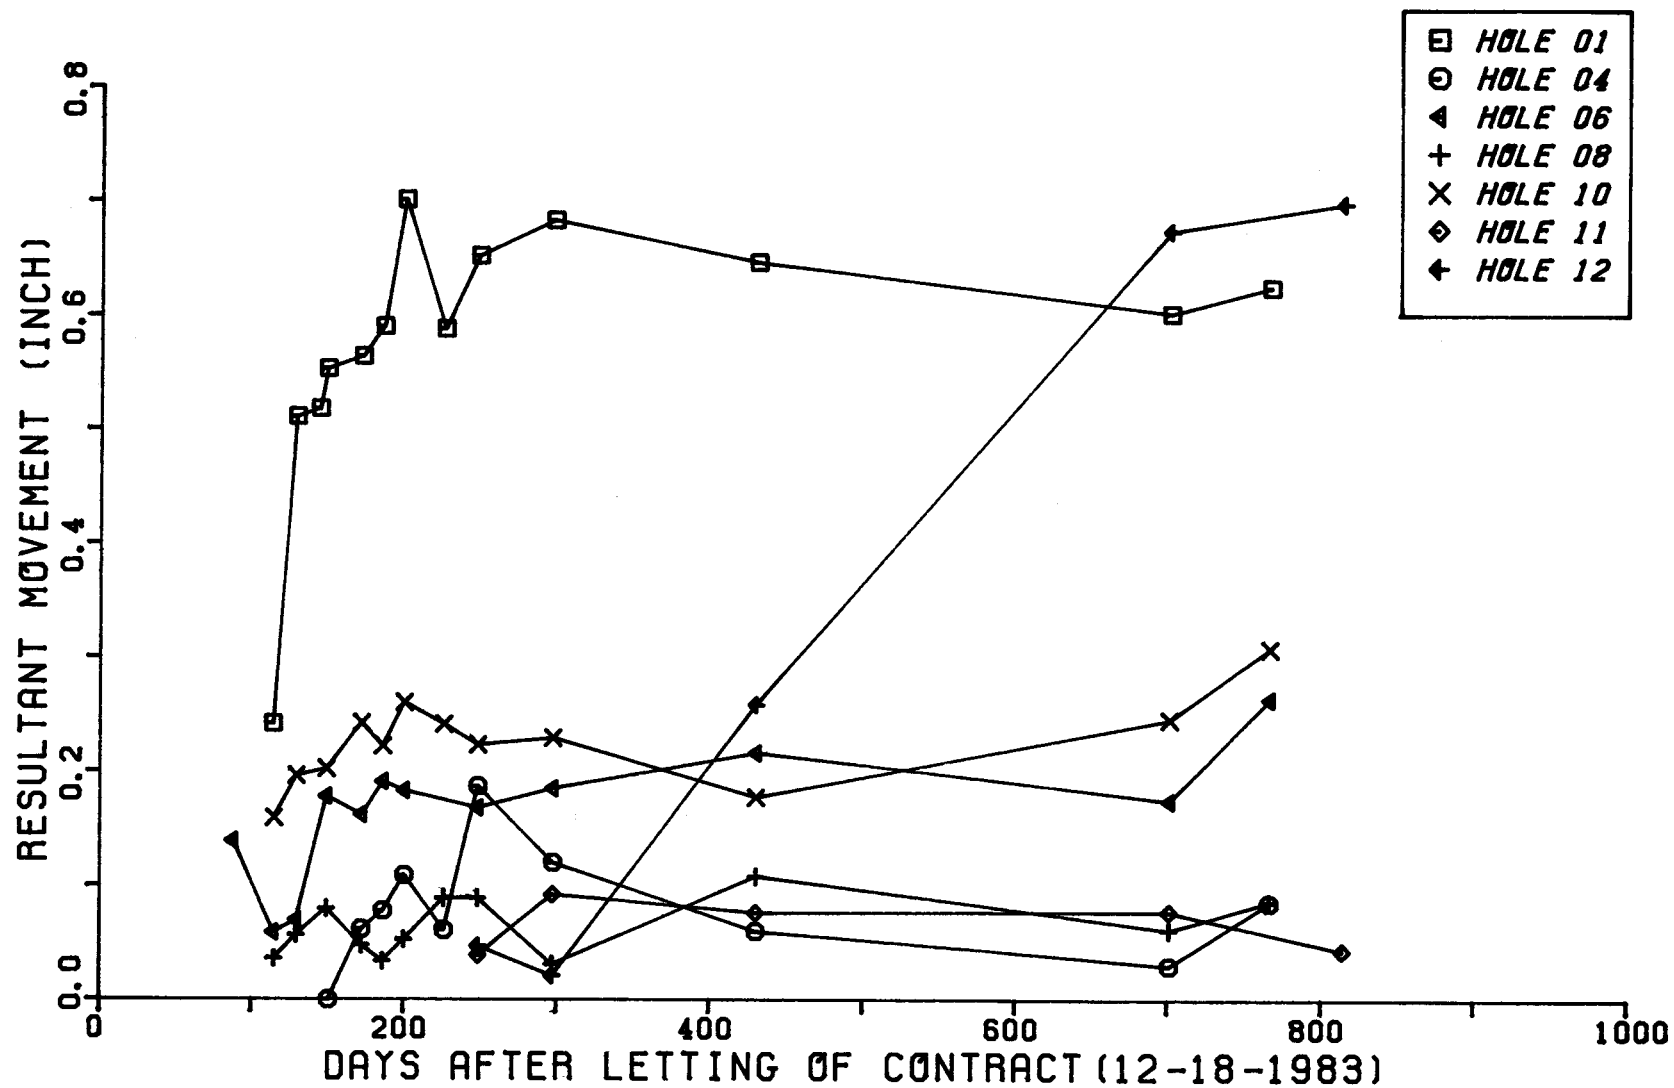
FIGURE 21. MOVEMENT OF TIEBACK WALL SLOPE INCLINOMETERS AT A DEPTH OF 1-2 FEET.

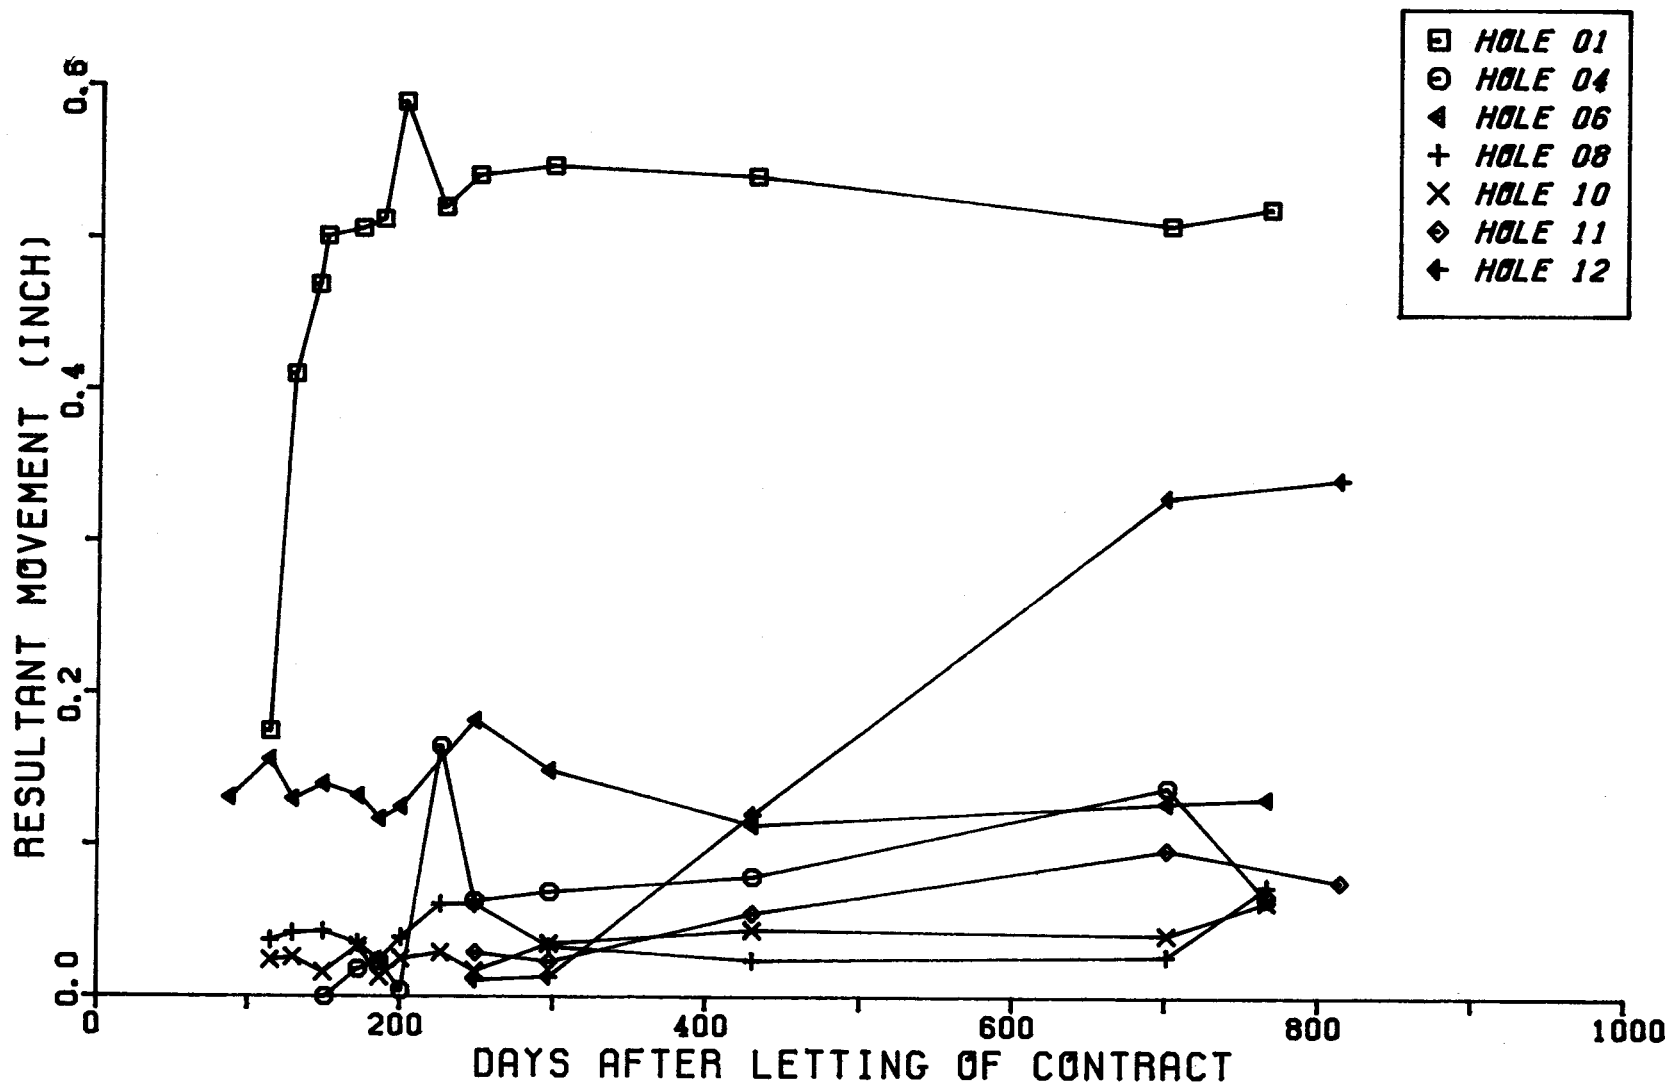
FIGURE 22. MOVEMENT OF TIEBACK WALL SLOPE INCLINOMETERS AT A DEPTH OF 7-8 FEET.

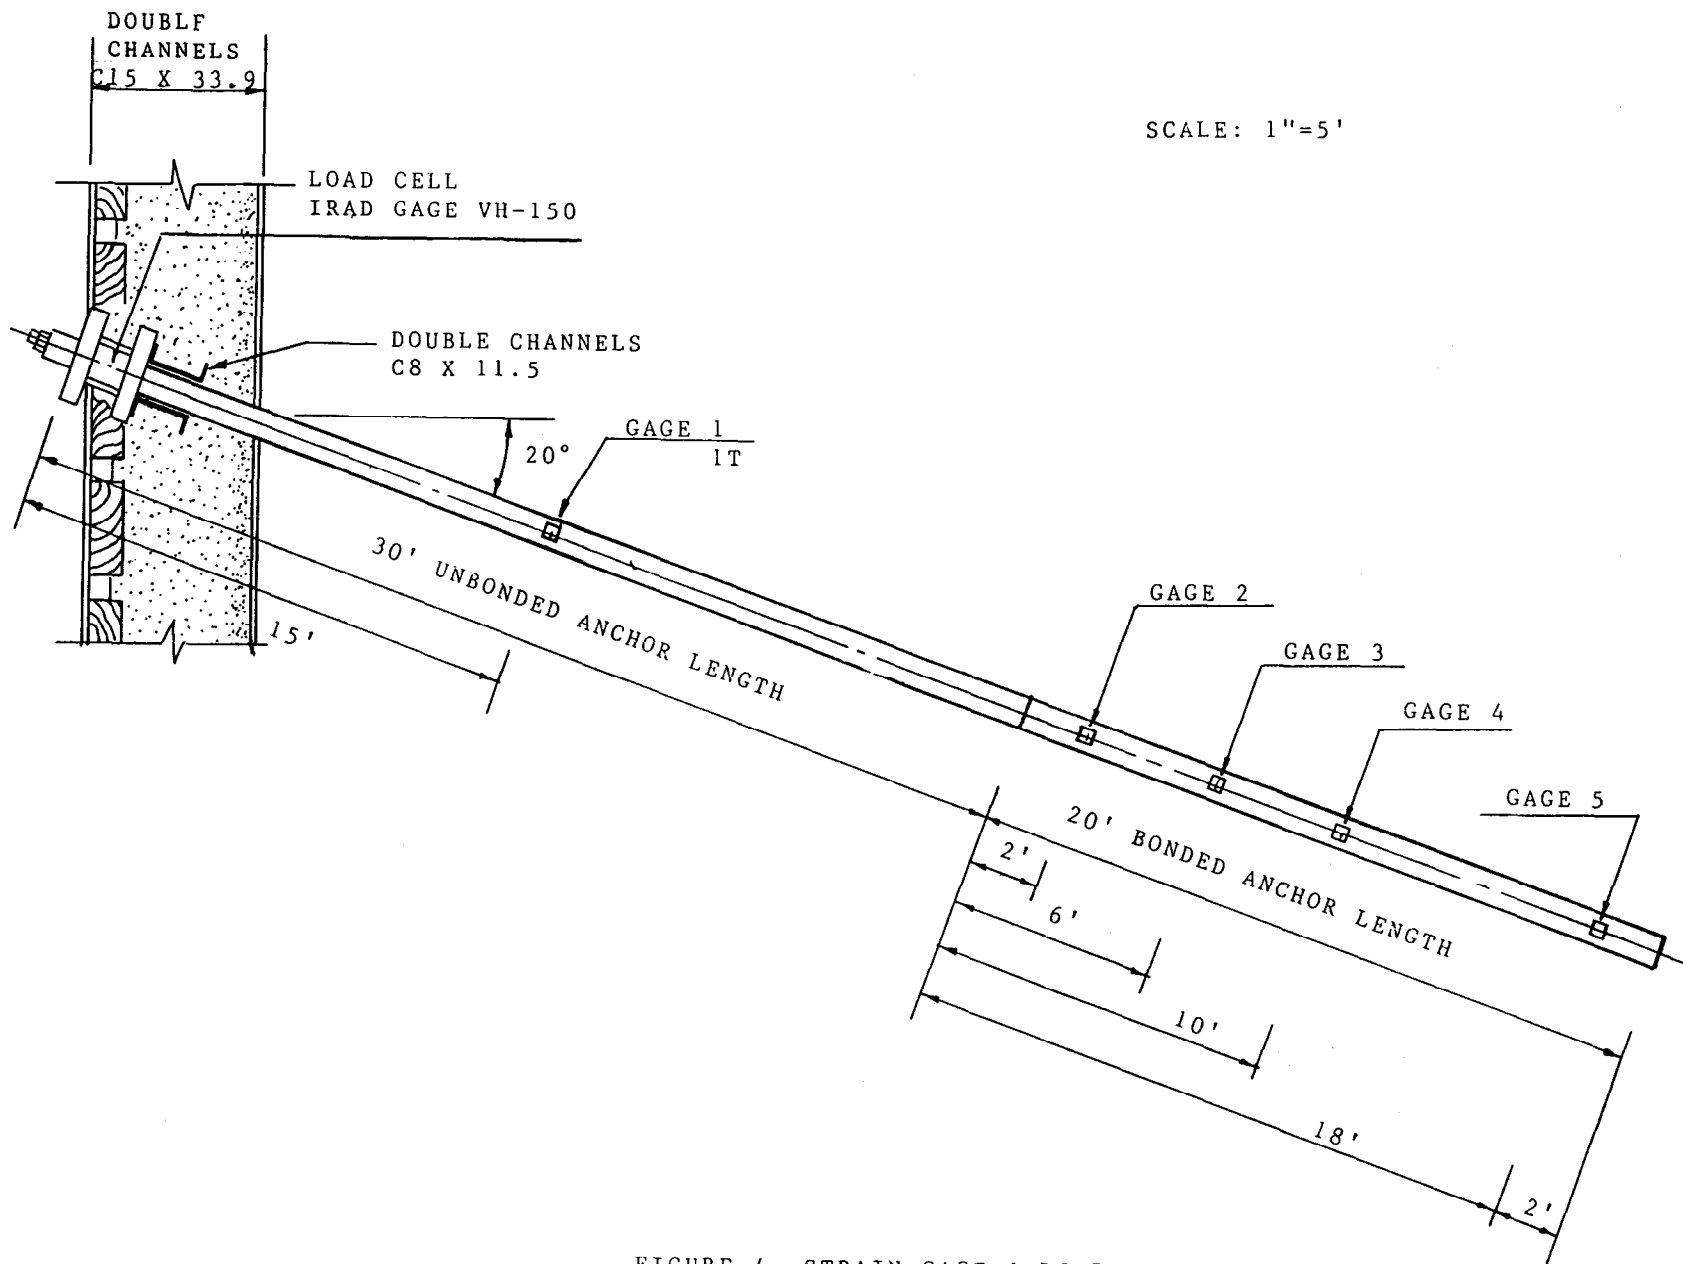
FIGURE 3B. STRAIN GAGE LOCATIONS  
SOLDIER BEAM #93
