Demonstration Projects  
Program

DP-68  
PERMANENT GROUND ANCHORS  
Volume 2  
Field Demonstration Project Summaries

FHWA-DP-90-068-003  
April 1990

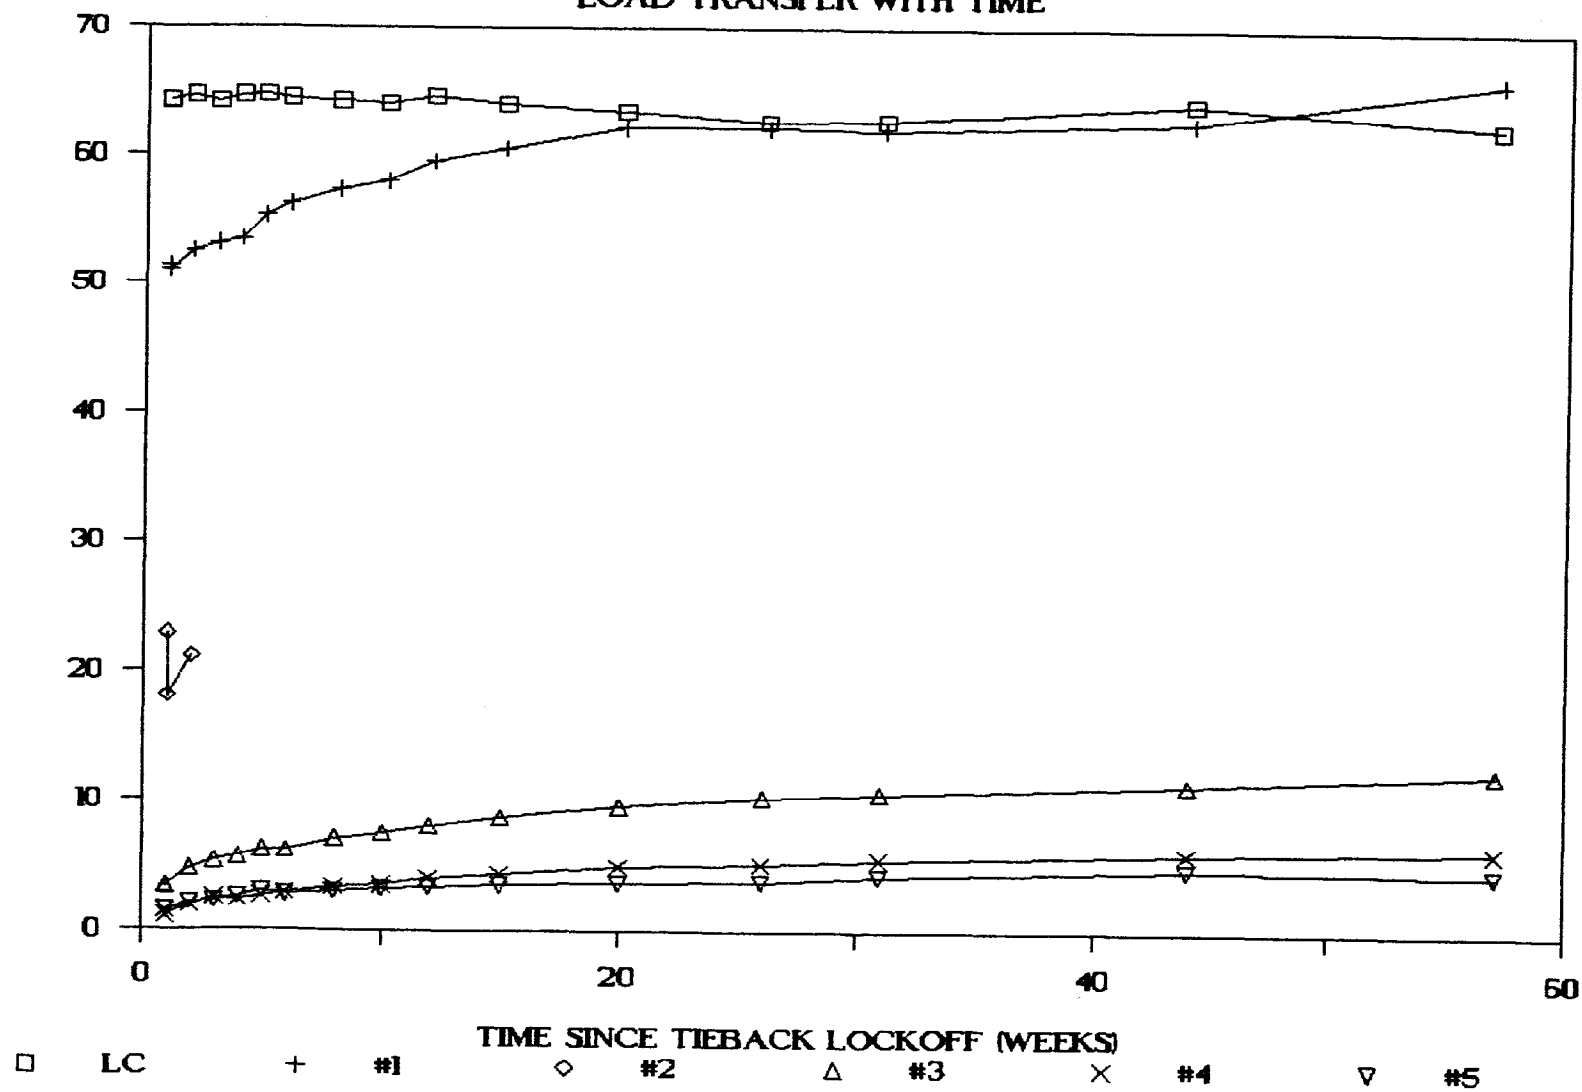
GRAPH 1

LOAD TRANSFER WITH TIME

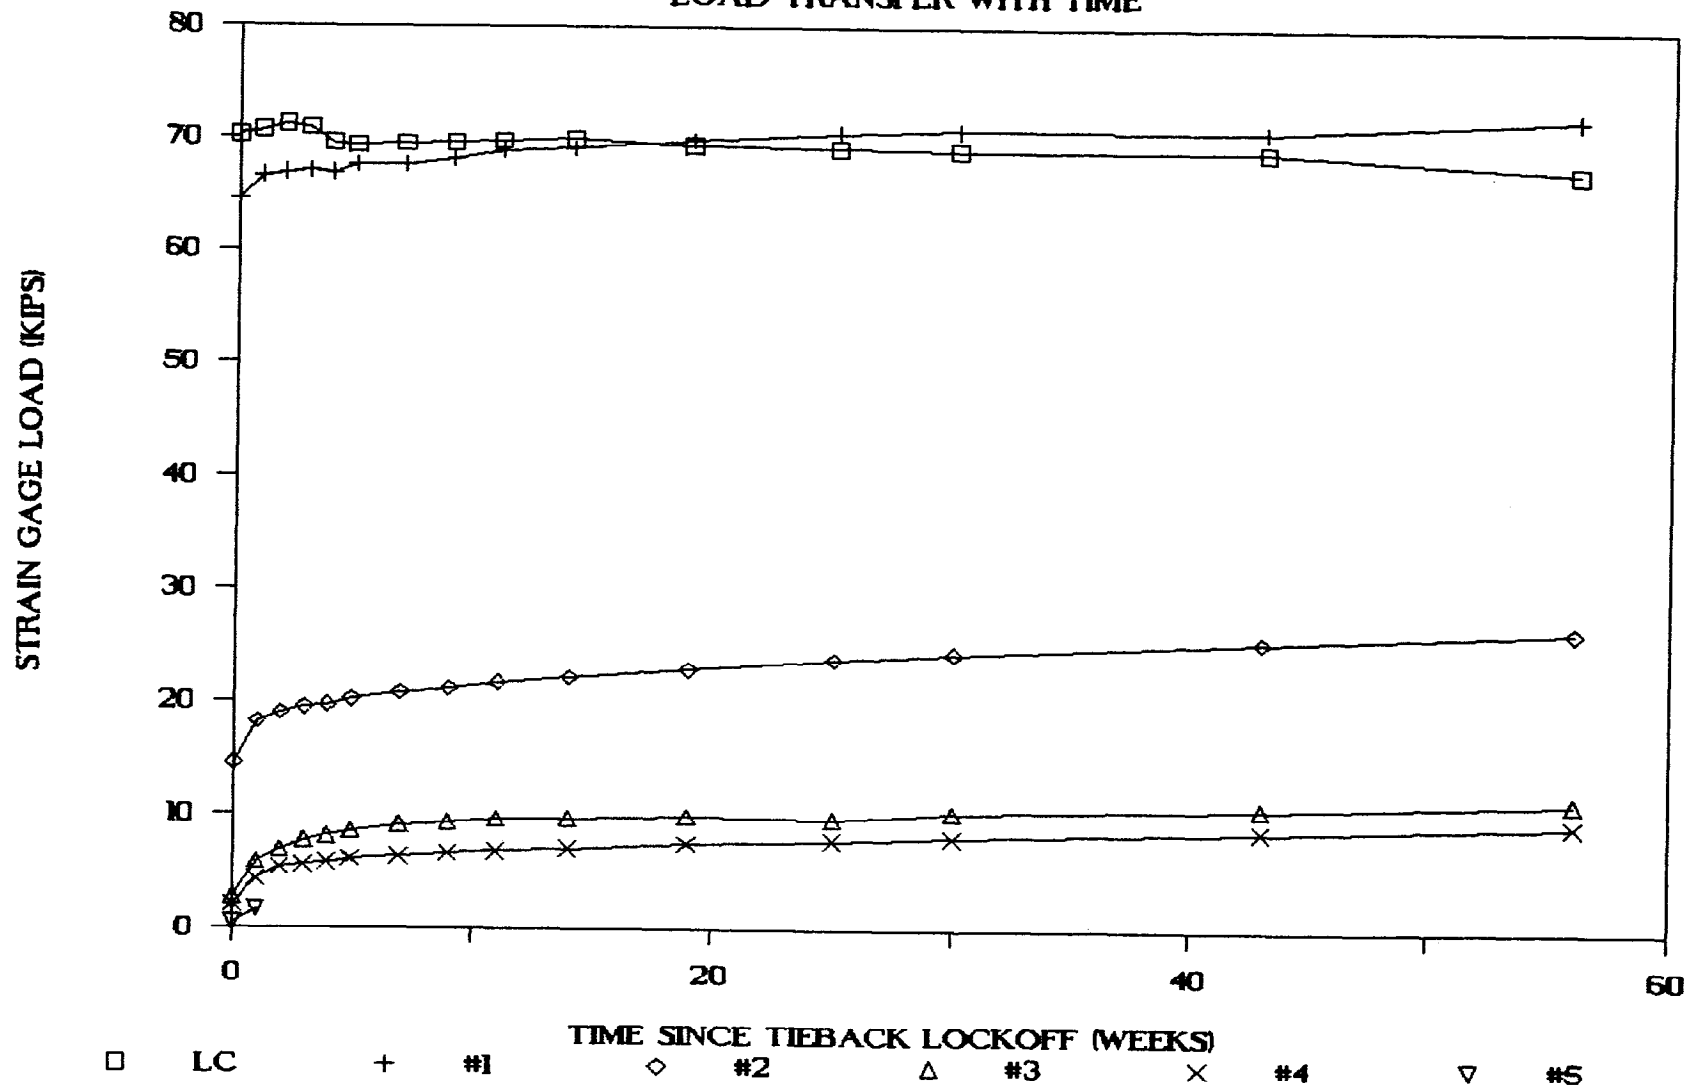
GRAPH 2

LOAD TRANSFER WITH TIME
