100-Year Coating Study

PUBLICATION NO. FHWA-HRT-12-044

NOVEMBER 2012

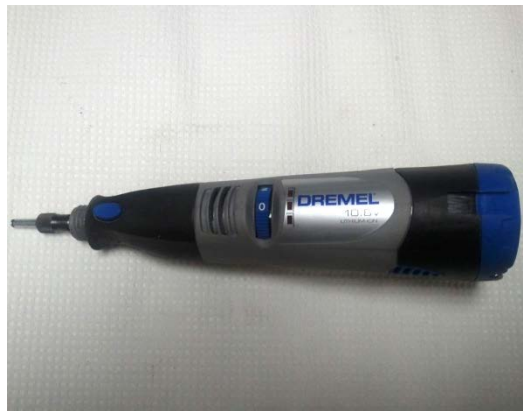
Figure 4. Photo. Dremel[®] scribing tool.

All test areas of type II test panels were scribed. A mechanical scribing tool used for type I panels was not suited for the large-size test panels. As a result, the test areas were scribed manually using a high-speed Dremel[®] tool with a scribing bit, as shown in figure 4. C-clamps were used to support a metallic guide along which the scribing was done.

Initial trial scribes were made on dummy test panels to optimize the speed of rotation of the Dremel[®] bit and applied pressure. The pattern (depth and width) of the scribe made on the dummy test panels was examined using a handheld optical microscope. From this trial, operational parameters were finalized to obtain the ASTM D1654-08 specified width and depth of the scribe, and actual scribes were made on all of the type II panels.⁽¹¹⁾

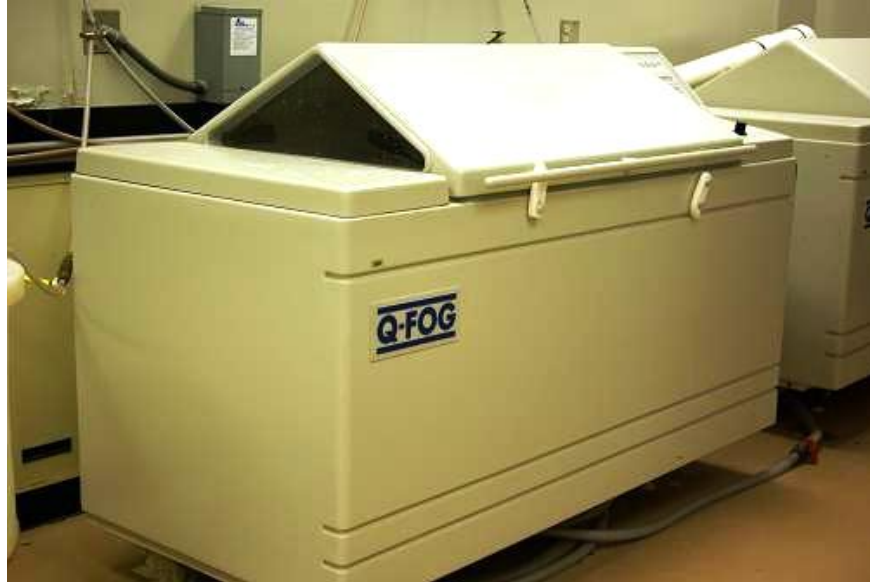
Figure 5. Photo. Salt-fog chamber.

Figure 5 and figure 6 show a salt fog chamber and a weathering tester, respectively. A 16-h salt-fog accumulation test was conducted before each cyclic salt-fog test to check the atomizing and fog quantity as well as the pH of the collected solution. Typical collection volume of the accumulation test was 0.034–0.068 oz/h, with uniform accumulation in all collection vessels placed at the four corners of the salt-fog chamber and at the center a few feet away from the spray nozzle. Pump speed, throw pressure, and flow rate were adjusted to optimize the collection volume.

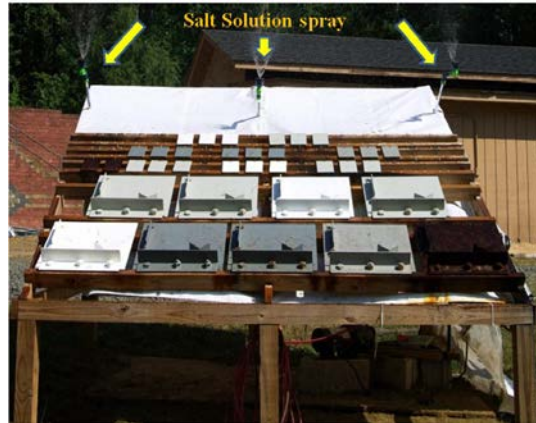
Figure 7. Photo. NWS rack at TFHRC.

Type I and II test panels were deployed on two wooden racks inclined at 30 degrees facing south in the backyard at TFHRC in McLean, VA, as shown in figure 7 and figure 8.

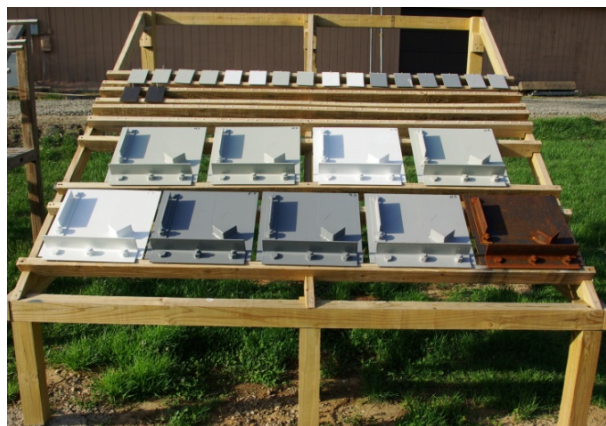
Figure 8. Photo. NW rack at TFHRC.

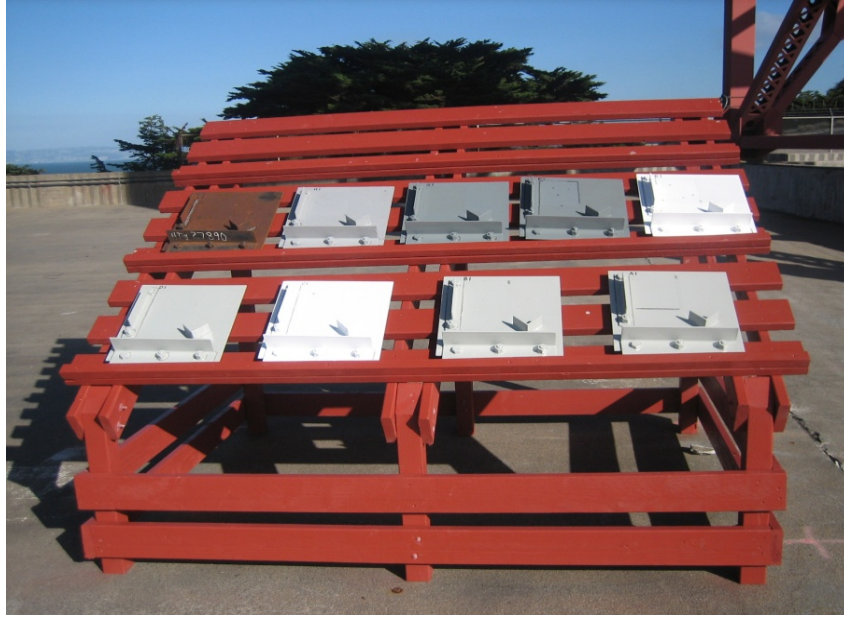
Figure 10. Photo. Type II panels deployed at GGB.

The outdoor exposure condition at GGB was considered extremely harsh due to severe fog conditions containing airborne chlorides. Figure 10 shows type II panels deployed on top of the south anchorage house near the south abutment. Test panels were scheduled to be evaluated every 6 months for coating performance.

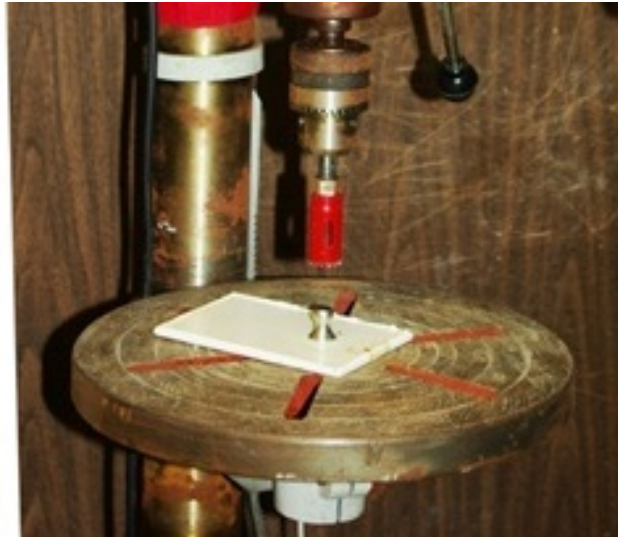
Figure 12. Photo. Drill press to score a test area around a dolly.

The surface of coated test panels and the base of the dollies were cleaned with detergent water and were lightly roughened with an abrasive pad. The dollies were glued on the test panel surface using a high-strength epoxy adhesive. The cut through the coating around the edge of the dolly was made using a drill press after the complete curing of the adhesive, as seen in figure 12. The initial and final adhesion strengths of coating systems were measured by hydraulic method. Figure 13 shows the hydraulic adhesion tester used in this study. For each coating system, three pull-off adhesion tests were performed on two unscribed virgin type I panels and on each of the tested type I panels. No adhesion strength tests were performed on type II panels.

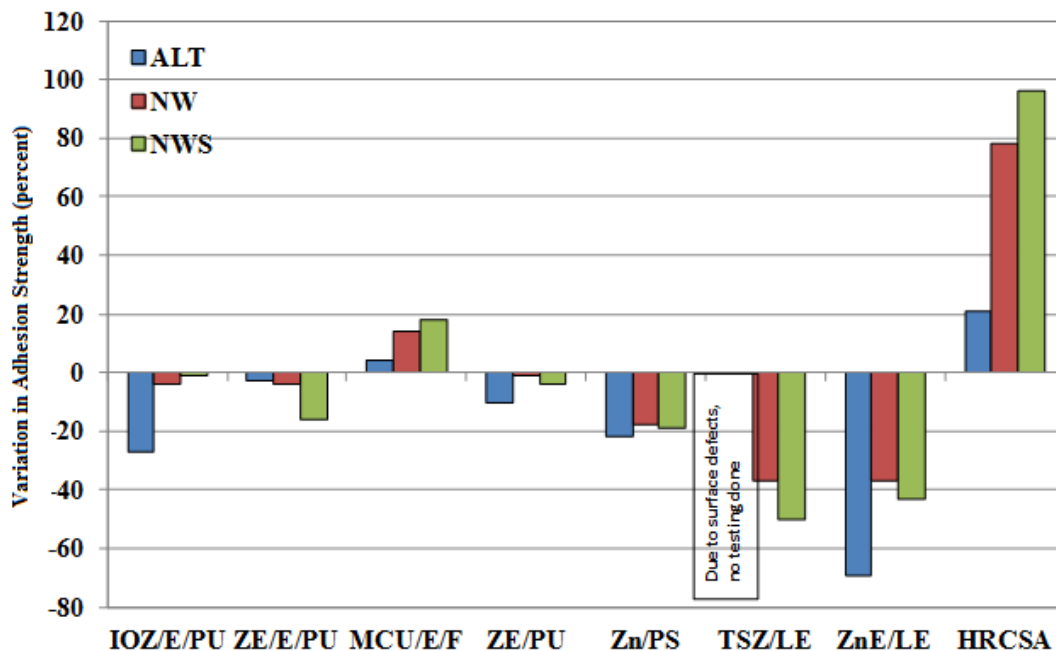
Figure 19. Graph. Mean adhesion strength changes of type I panels.

Adhesion strength changes in type I panels after exposure in ALT, NW, and NWS are summarized in table 10, and the corresponding bar graph is shown in figure 19. All coating systems, except HRCSA and MCU/E/F, showed varying degrees of adhesion strength reduction at the end of testing in every test condition. No clear trend was observed between reduction of adhesion strength and test conditions. It is unclear at this time why HRCSA, which exhibited the weakest initial adhesion strength, had the largest strength gain during testing. However, it may be reasoned that because HRCSA had the weakest coating before and after testing, relatively small increases in post-test absolute adhesion strength resulted in significant increases in terms of percentage. Such a trend was more pronounced for NW and NWS panels than ALT panels. Adhesion strength data for TSZ/LE could not be obtained at the termination of ALT because the coating surface was so blistered that the adhesion dollies did not stick to the surface of the panels. Because ZnE/LE panels had peeling top coats at the end of testing, dollies were carefully placed in areas with intact top coats. ZnE/LE panels had the largest adhesion strength reduction. The two worst performing two-coat systems (TSZ/LE and ZnE/LE) in gloss and color also

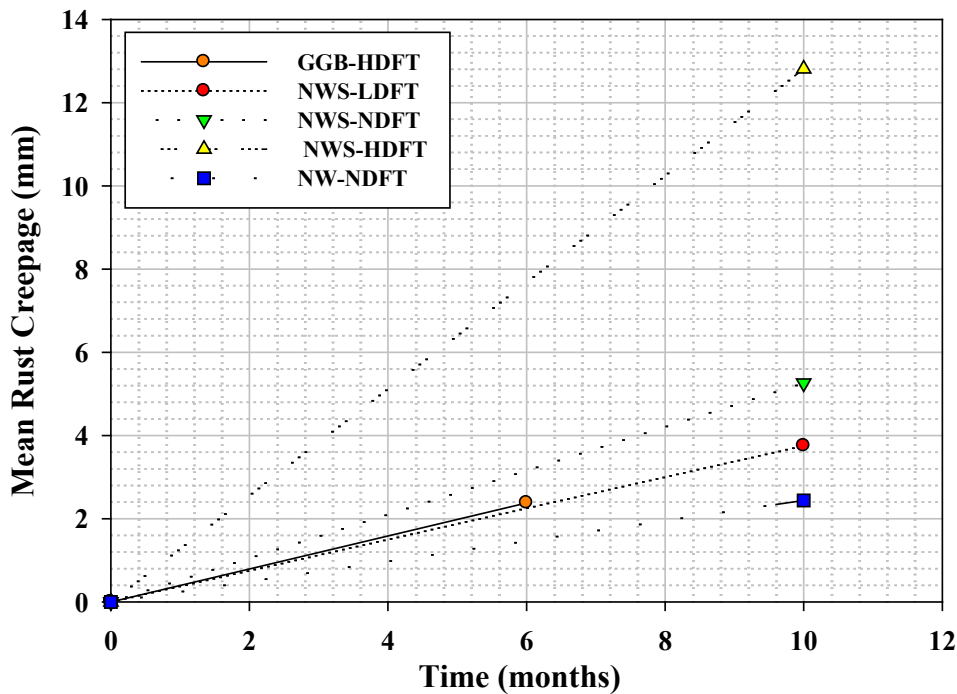
Figure 22. Graph. Rust creepage growth of ZnE/LE (type II panels).

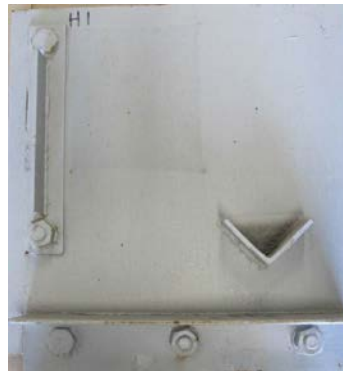
Figure 40. Photo. Progressive changes of HRCSA—type II in NW, NWS, and GGB.

Figure 33 through figure 40 show digital photographs of all coating systems on type II panels before exposure and at 6 months of outdoor exposure testing at GGB. These figures also show conditions of panels before and after exposure in NW and NWS for 10 months. Although each type II panel consisted of low, high, and nominal DFT areas, rust was observed predominantly at hard-to-reach areas where coating was non-uniformly applied and/or where there were coating defects (bare areas). These areas included nuts, bolts, underside of the T-attachment, and the wide-angle attachment. TSZ/LE showed formation of white zinc oxide within the scribe on all DFT areas as well as along the edges of nuts and bolts and underneath the attachments (see figure 38). The ZnE/LE panel exhibited excessive rusting on all DFT areas and along the edges of nuts and bolts and underneath the attachments in NWS (see figure 39). The same panel also showed rust buildup within the V-notch section where salt water could be collected. This form of deterioration reveals that ZnE/LE was particularly venerable to prolonged exposure to salt water. The low DFT area of this coating system developed cracks all over the surface, which was similar to what was observed toward the end of ALT (see figure 32). The two controls did not show any signs of rusting within the three DFT areas (see figure 33 and figure 34). As observed in ALT, the next best performing coating system in comparison to the two three-coat controls was HRCSA, as indicated by negligible rusting and rust creepage (see figure 40).
