Long-Term Pavement Performance Data Analysis Program: Effect of Dowel Misalignment on Concrete Pavement Performance

PUBLICATION NO. FHWA-HRT-20-070

NOVEMBER 2020

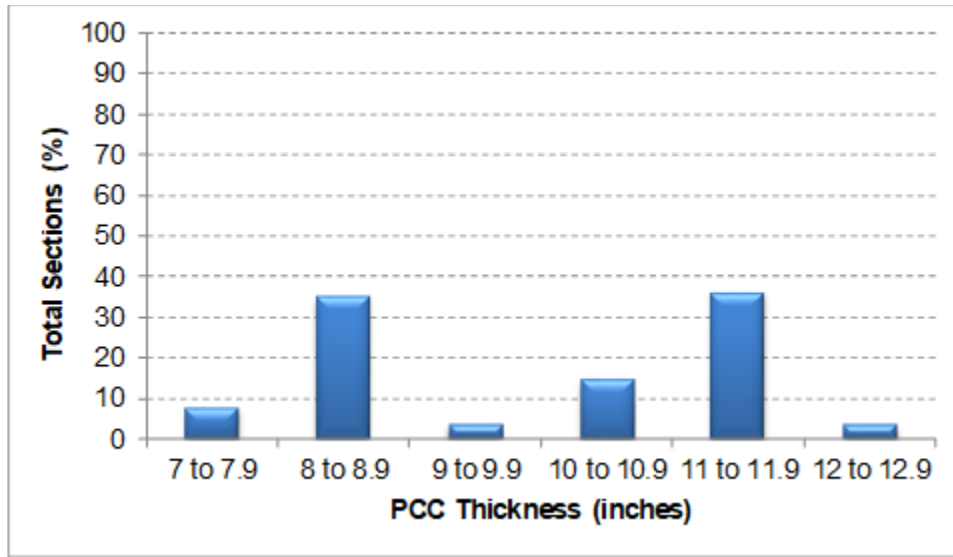
Figure 2. Chart. Percentage of analysis pavement test sections with respect to PCC thickness.

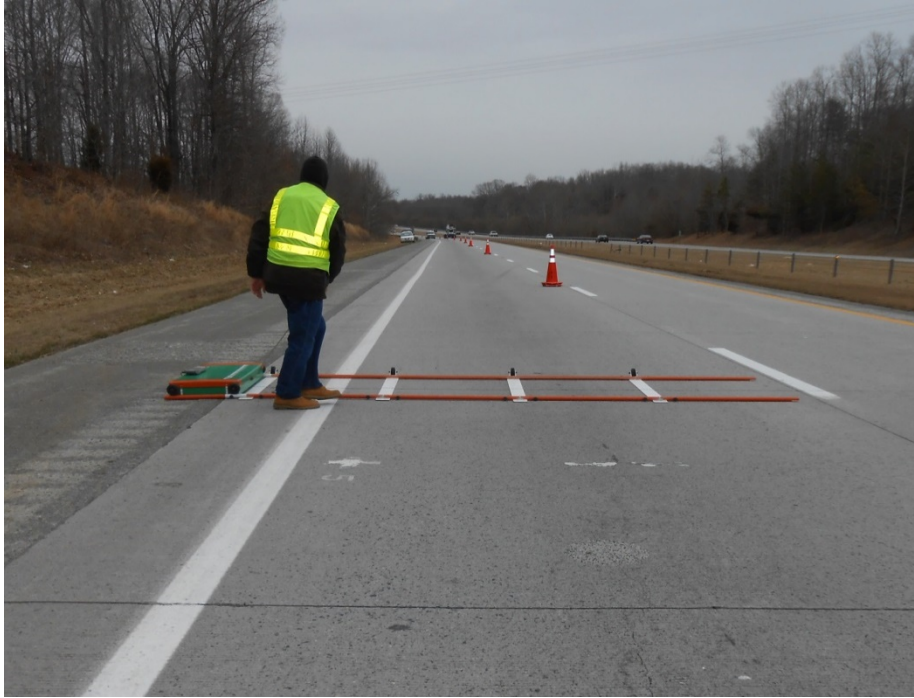
Figure 5. Photo. MIT scanning of North Carolina LTPP test section 37_0207.

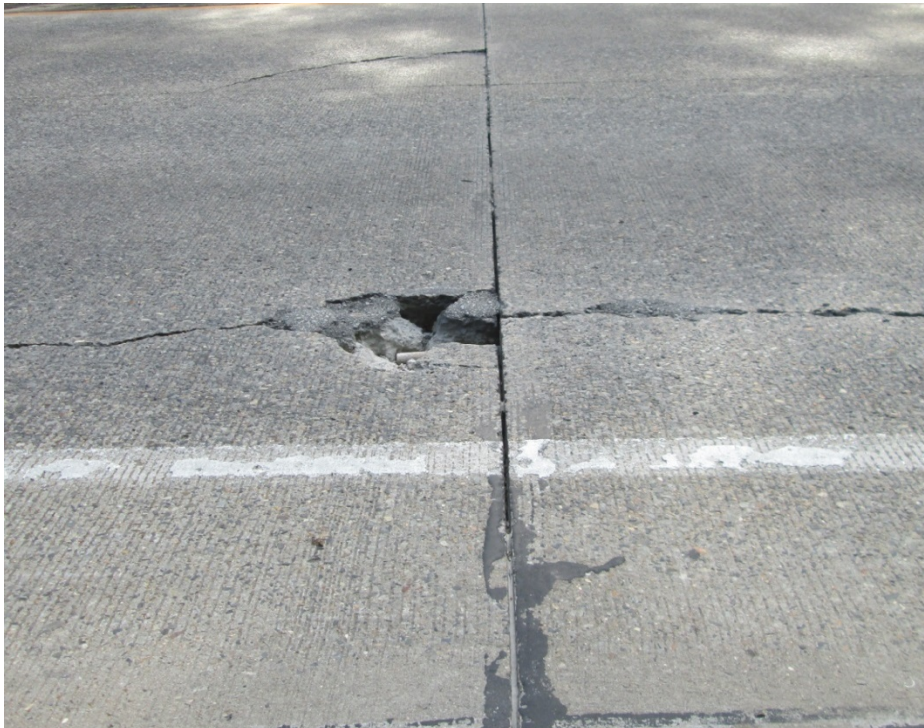
Figure 6. Photo. Cracking and spalling on Arkansas LTPP test section 05_0217.

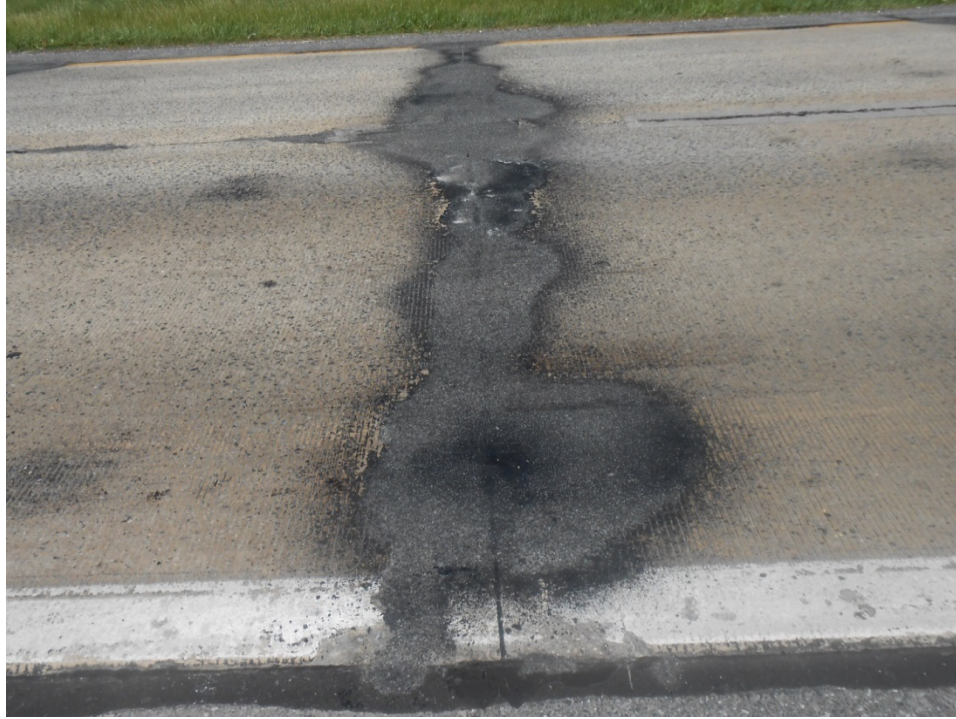
Figure 7. Photo. Full-width spray patching on Delaware LTPP test section 10_0208.

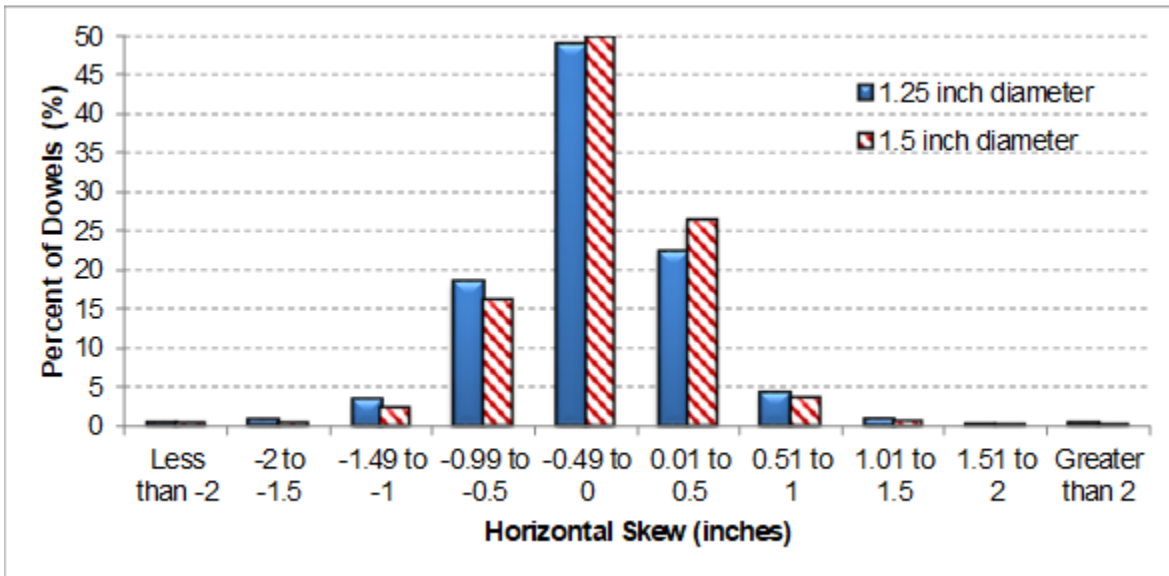
Figure 9. Chart. Horizontal skew distribution of dowels (23,300 1.5-inch-diameter dowels from 1,997 transverse joints and 21,240 1.25-inch-diameter dowels from 1,824 transverse joints).

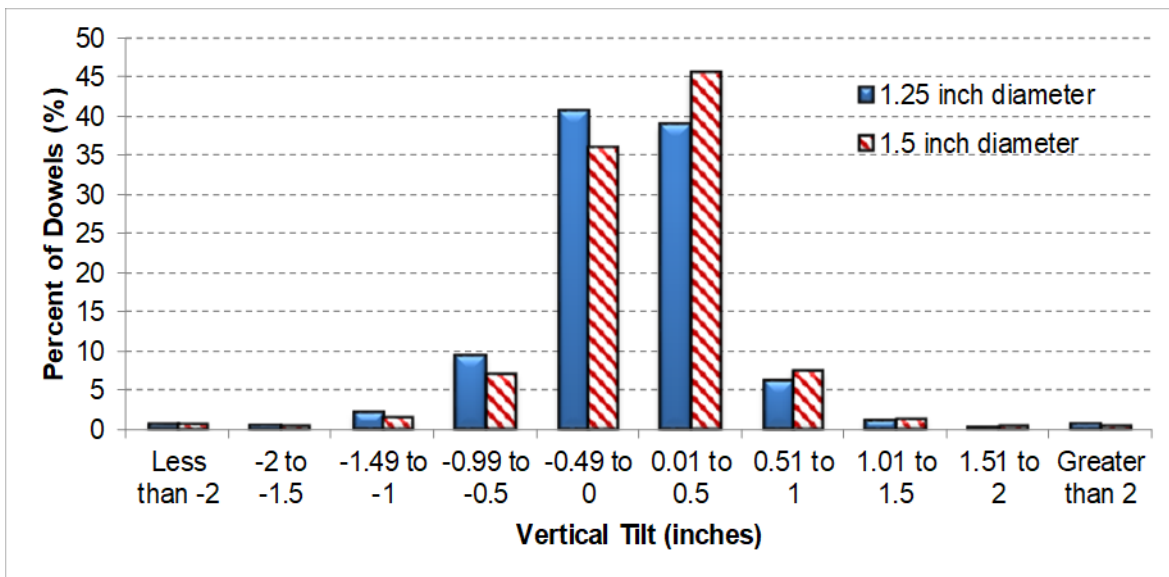
Figure 10. Chart. Vertical tilt distribution of dowels (23,300 1.5-inch-diameter dowels from 1,997 transverse joints and 21,240 1.25-inch-diameter dowels from 1,824 transverse joints).

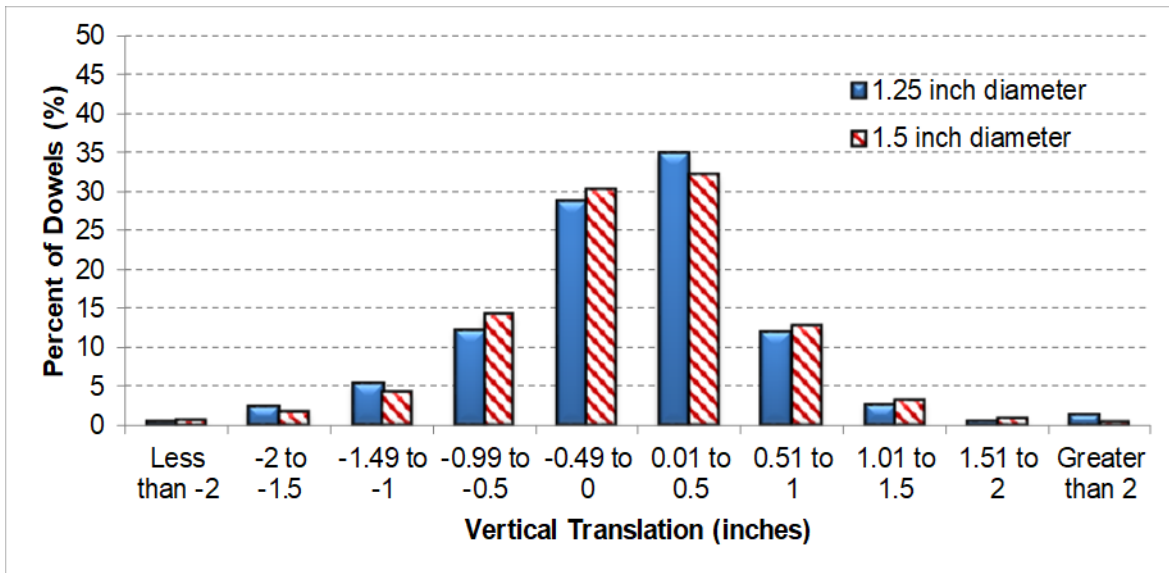
Figure 12. Chart. Vertical translation distribution of dowels (23,300 1.5-inch-diameter dowels from 1,997 transverse joints and 21,240 1.25-inch-diameter dowels from 1,824 transverse joints).

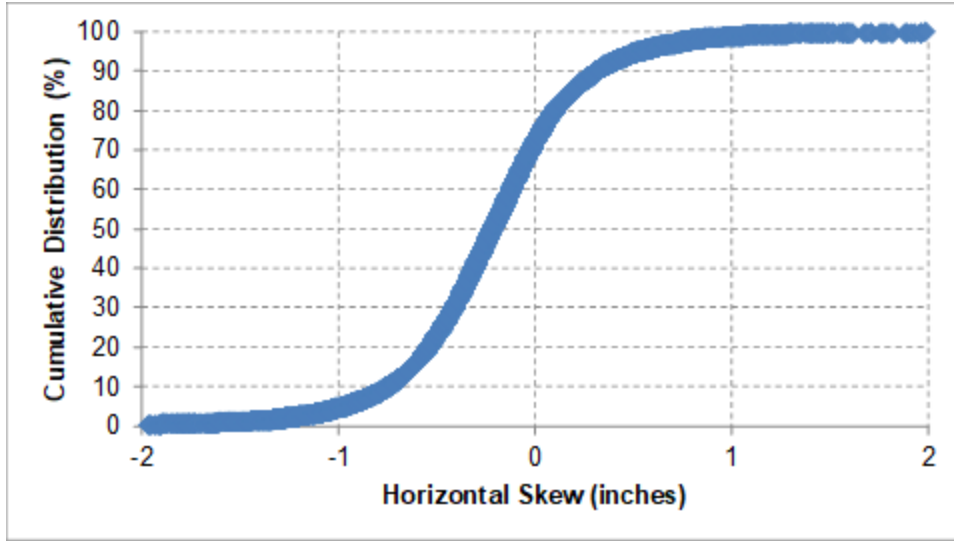
Figure 13. Chart. Cumulative horizontal skew distribution of 21,240 1.25-inch-diameter dowels from 1,824 transverse joints.

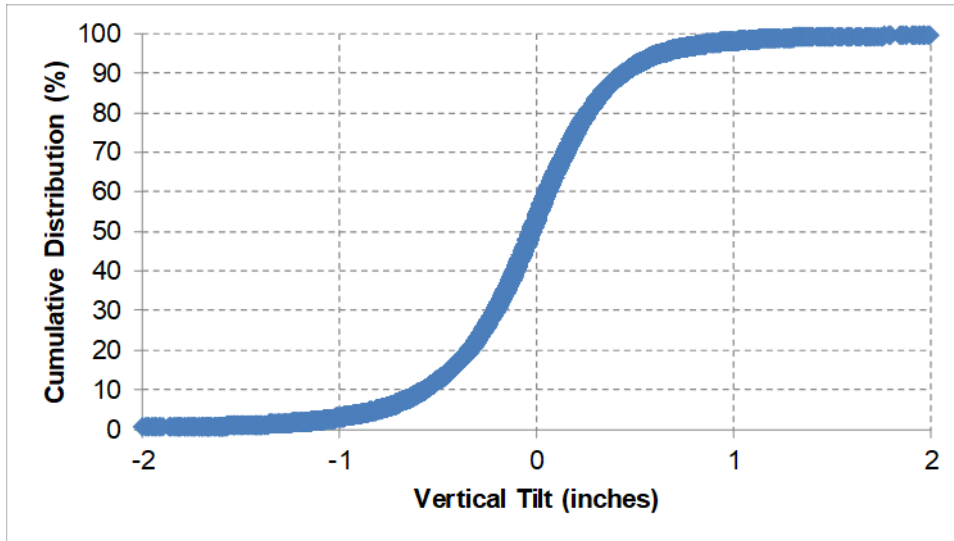
Figure 14. Chart. Cumulative vertical tilt distribution of 21,240 1.25-inch-diameter dowels from 1,824 transverse joints.

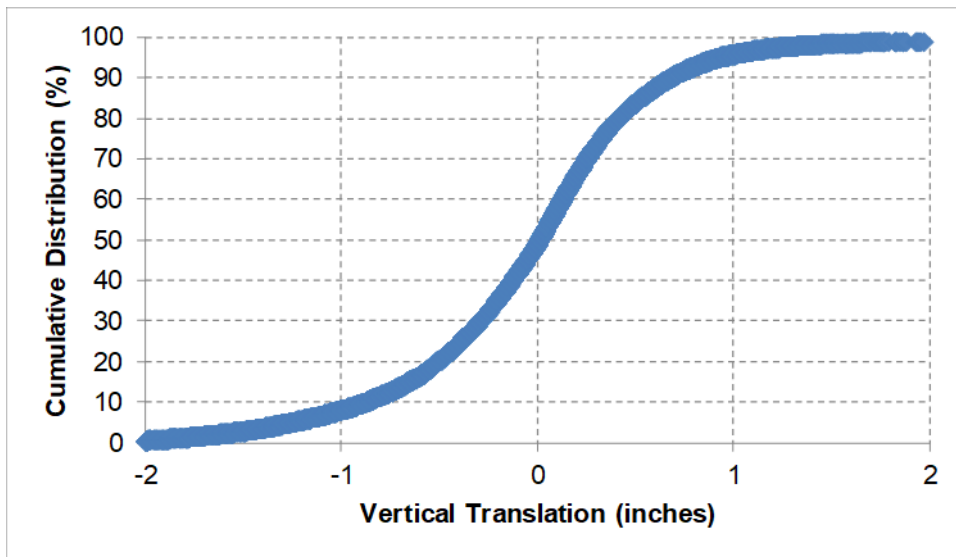
Figure 16. Chart. Cumulative vertical translation distribution of 21,240 1.25-inch-diameter dowels from 1,824 transverse joints.

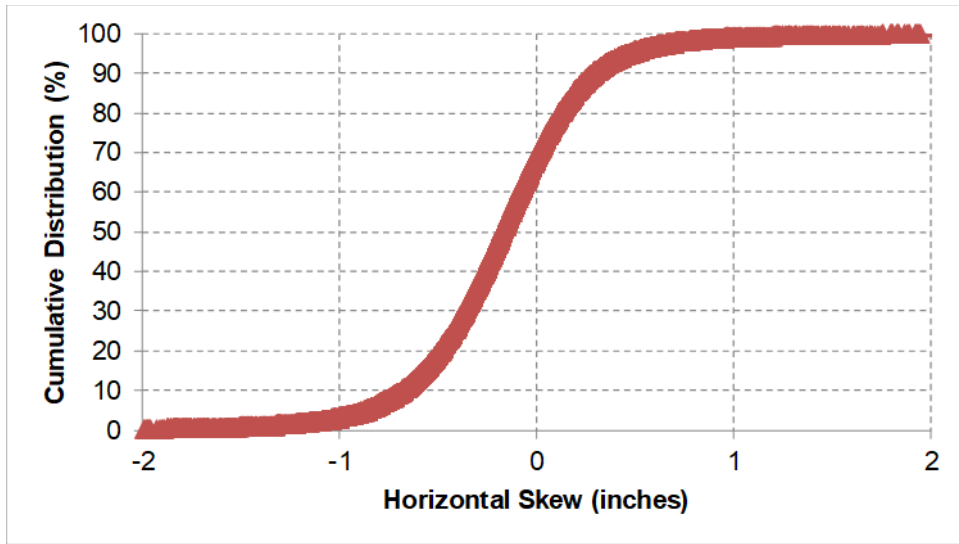
Figure 17. Chart. Cumulative horizontal skew distribution of 23,300 1.5-inch-diameter dowels from 1,997 transverse joints.

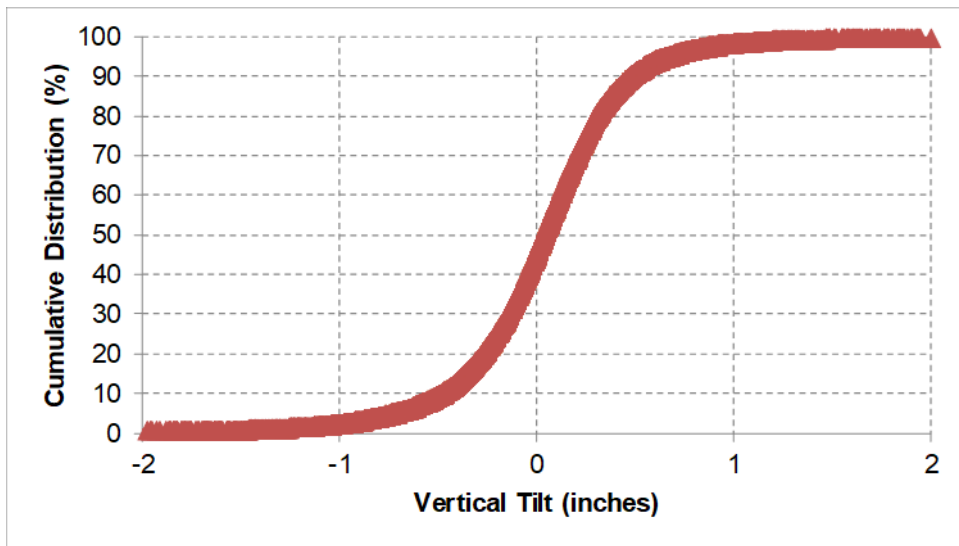
Figure 18. Chart. Cumulative vertical tilt distribution of 23,300 1.5-inch-diameter dowels from 1,997 transverse joints.

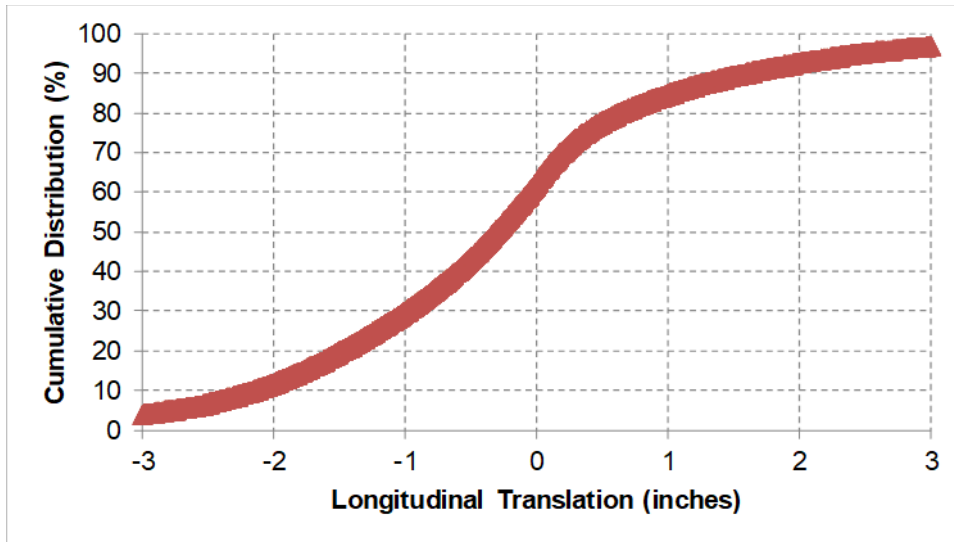
Figure 19. Chart. Cumulative longitudinal translation distribution of 23,300 1.5-inch-diameter dowels from 1,997 transverse joints.

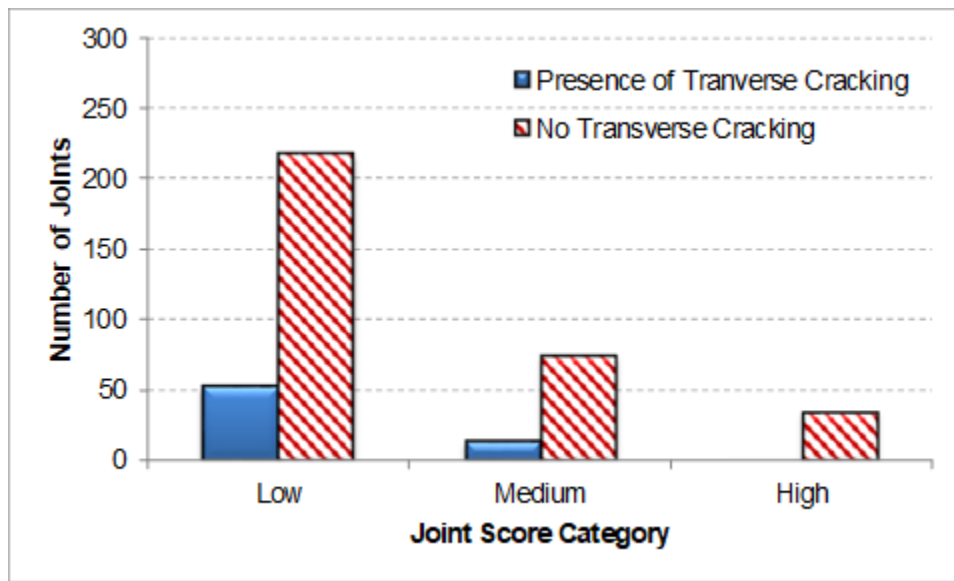
Figure 88. Chart. Joint score and presence of cracking for LTPP test sections in Arizona.

Summary results of the LTPP test sections analyzed shown in table 40 indicate no definitive relationship between the joint score and transverse cracking or spalling of PCC slabs, except for three instances. Arizona and Arkansas have a p -value of less than 0.05, indicating a relationship between the joint score and slab cracking. Similarly, Iowa has a p -value of less than 0.05, indicating a relationship between the joint score and spalling. These results suggest other factors have a stronger effect on transverse cracking and spalling, but there may be some project-specific situations where dowel alignment (as measured using the joint score) has some influence on transverse cracking and spalling. Thus, dowel alignment may be a contributing factor, but not necessarily the primary factor, for these distresses. More detailed analyses of the data may be required to identify other contributing factors. LTPP test sections in North Carolina,

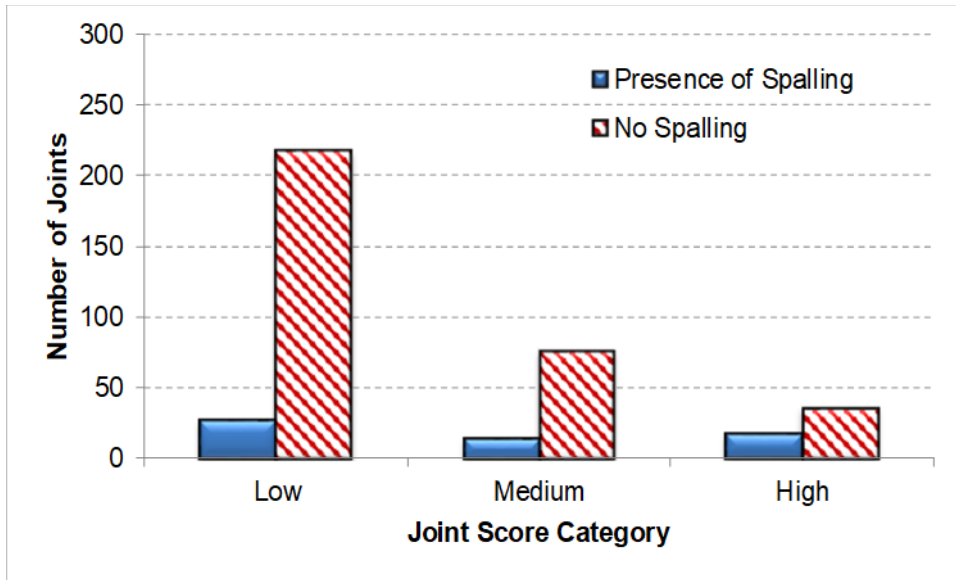
Figure 99. Chart. Joint score and presence of spalling for LTPP test sections in Iowa.

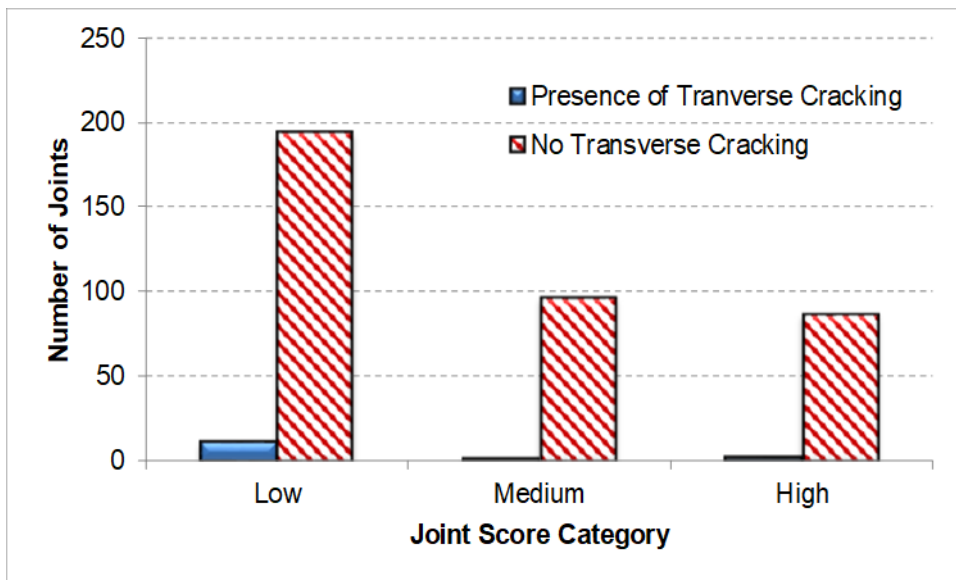
Figure 100. Chart. Joint score and presence of cracking for LTPP test sections in Kansas.

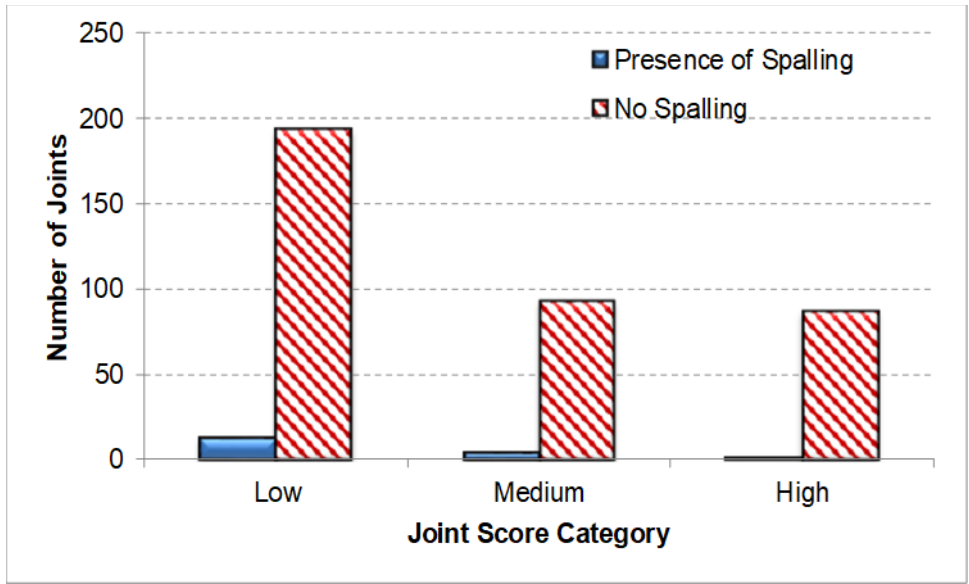
Figure 101. Chart. Joint score and presence of spalling for LTPP test sections in Kansas.

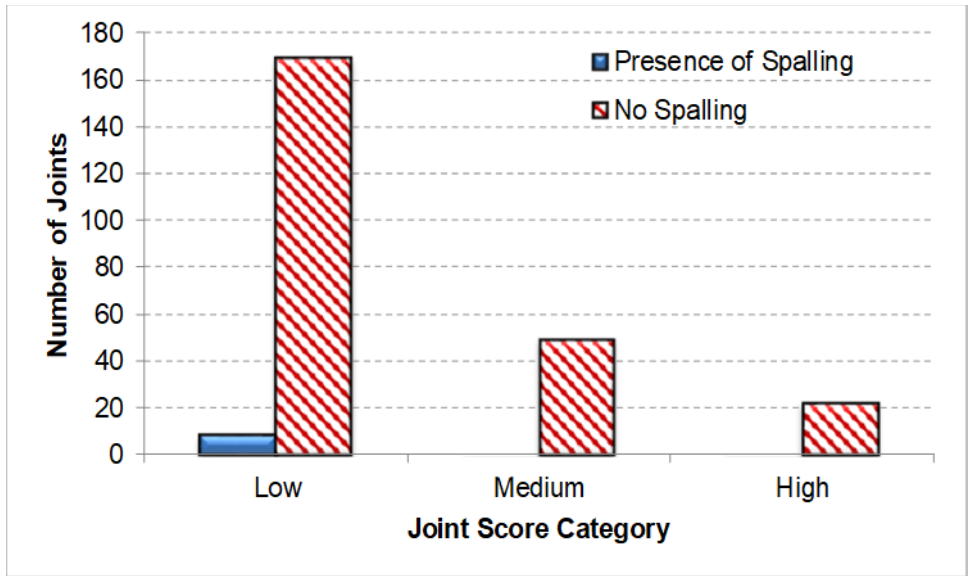
Figure 103. Chart. Joint score and presence of spalling for LTPP test sections in North Carolina.

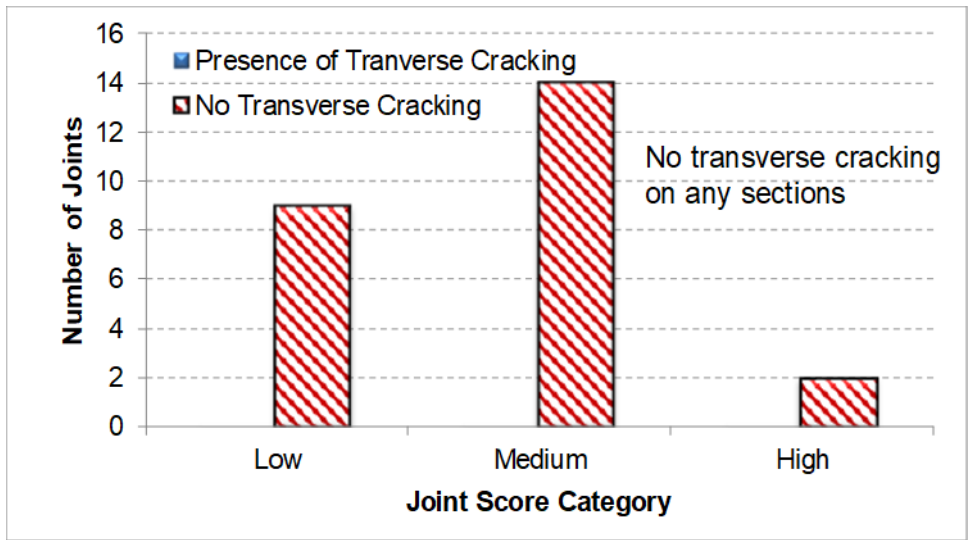
Figure 106. Chart. Joint score and presence of cracking for the LTPP test section in South Dakota.

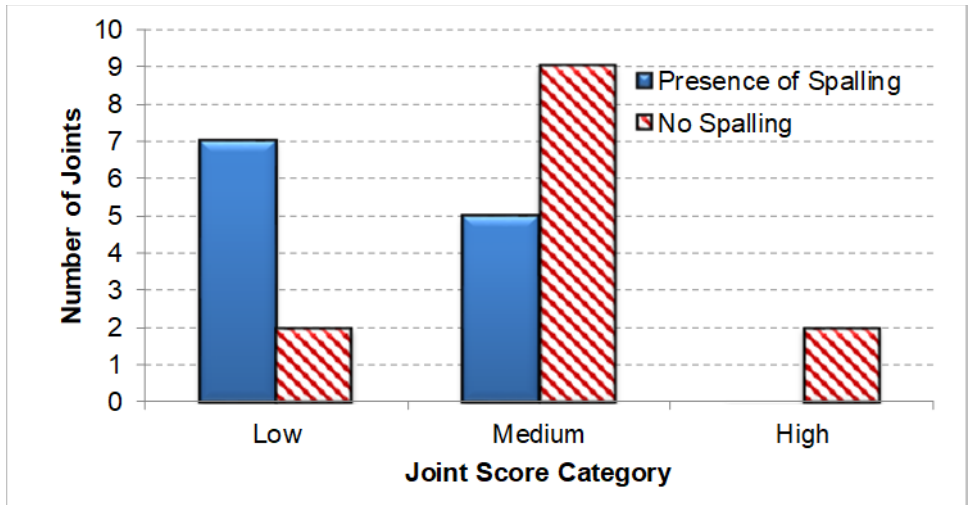
Figure 107. Chart. Joint score and presence of spalling for the LTPP test section in South Dakota.

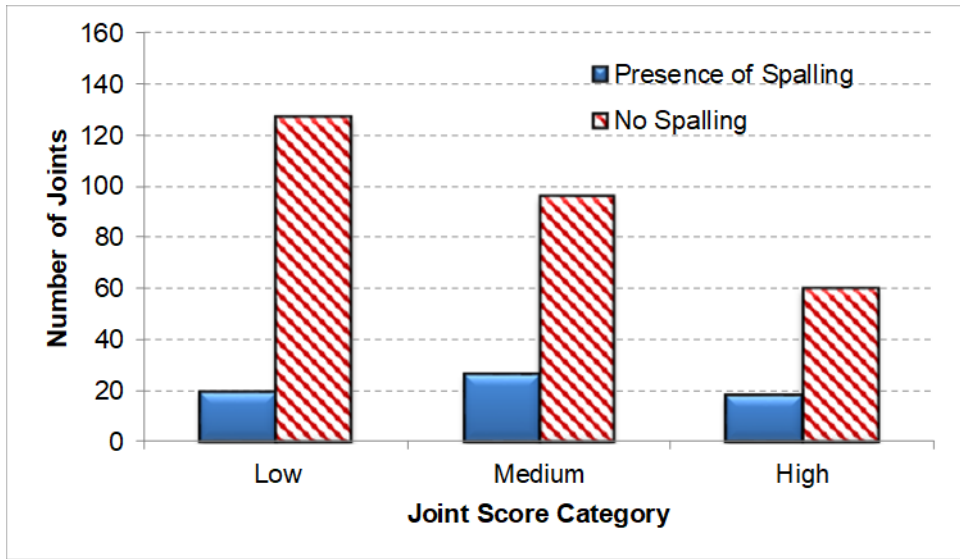
Figure 109. Chart. Joint score and presence of spalling for LTPP test sections in Wisconsin.
