Magnetic Flux-Based Nondestructive Evaluation Technologies for Assessing Corrosion Damage in External and Internal Post-Tensioned Tendons: Development Efforts and Evaluation Results

PUBLICATION NO. FHWA-HRT-23-005

DECEMBER 2022

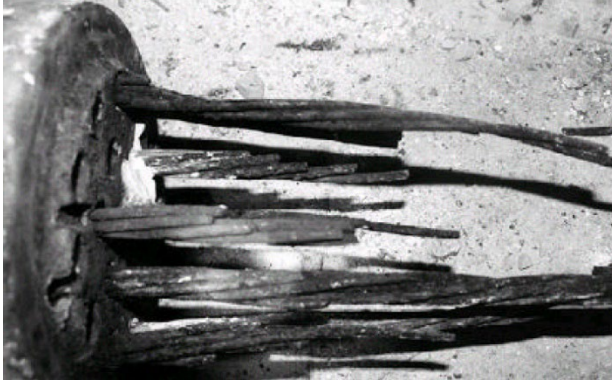
Figure 1. Photos. Examples of corrosion-induced tendon failures.

Figure 1-A shows a corroded anchor head recovered from the Niles Channel Bridge in Florida in 1999. It failed after 13-yr of service. Figure 1-B shows a failed tendon section on the Varina-Enon Bridge in Virginia in 2007. The tendon in question failed prematurely after 17-yr of service due to severe corrosion of 19 0.6-inch seven-wire strands. As a result, the Virginia Department of Transportation (VDOT) replaced the fractured tendon and another one exhibiting severe corrosion. Figure 1-C shows the first failed tendon in the Ringling Causeway Bridge in Florida in January 2011 after fewer than 8-yr of service. Another tendon also failed in the same year (July 2011). Figure 1-D shows the Roosevelt Bridge in Florida, which was temporarily braced during the emergency repair of the corroded internal tendons in 2020. Similar PT corrosion problems have been observed in other countries, including the United Kingdom, France, Italy, South Korea, and Hong Kong. Two recent synthesis reports compiled many more corrosion problems, including the cases cited in this paragraph.^(3,6)

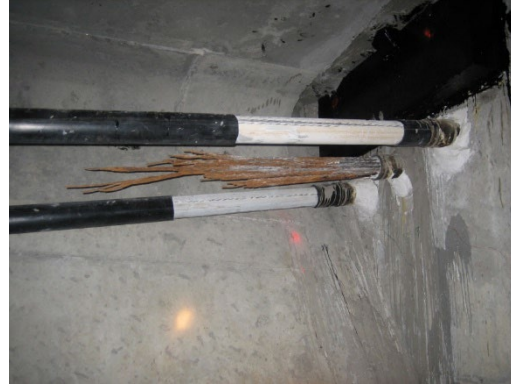
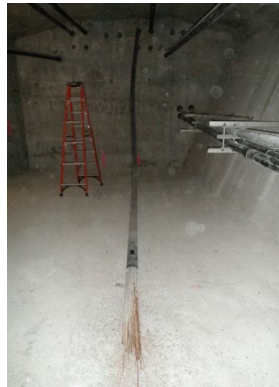
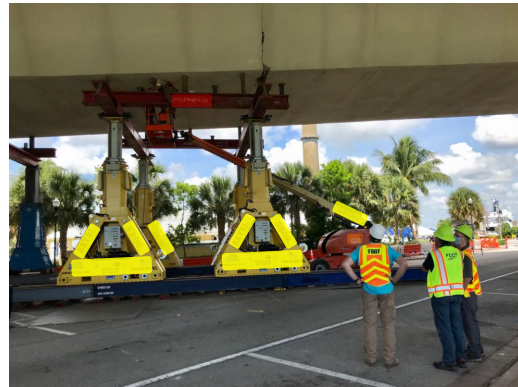
A. Niles Channel Bridge.⁽²⁾

B. Varina-Enon Bridge.⁽³⁾

C. Ringling Bridge.⁽⁴⁾

D. Roosevelt Bridge.⁽⁵⁾

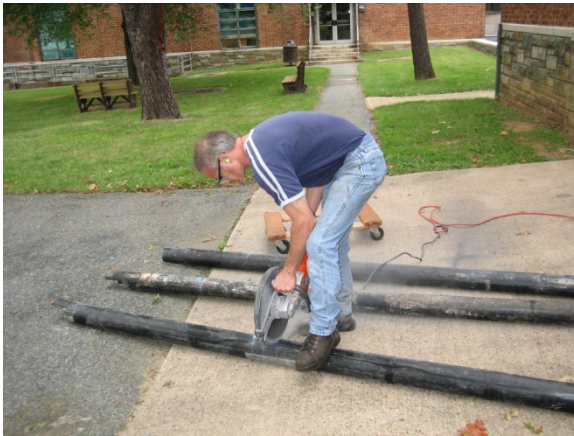
Figure 2. Photos. Introduction of artificial damage into field tendon specimens.

For the first in-house study, VDOT donated seven grouted external PT tendon segments retrieved from the Varina-Enon Bridge. They were 4.0 inches in diameter and 7–10-ft in length. Each tendon segment contained 19 0.6-inch, 270-ksi seven-wire strands. Among them, three segments were selected for laboratory testing and labeled as tendons A, B, and C. Different levels of artificial damage were introduced to them at Turner-Fairbank Highway Research Center (TFHRC) of FHWA. A saw equipped with a diamond blade (and an impressed current method (figure 2-A) and an impressed current method (figure 2-B) were employed to make the predetermined damage in the tendon specimens.

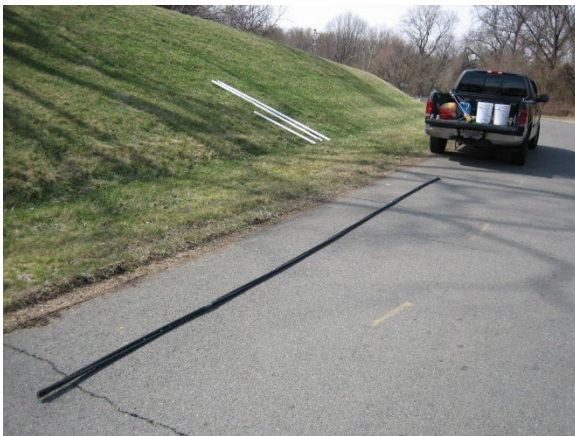
The second type was a bundle of three 25-ft-long, 0.6-inch, seven-wire strands containing various levels of artificial damage along the strand length. After the strands were bundled on the ground (figure 4-A), the strands were inserted into a 2-inch polyvinyl chloride (PVC) pipe. As the final step, the pipe was filled with a commercially available prepackaged grout (figure 4-B).

A. A bundle of seven-wire strands.

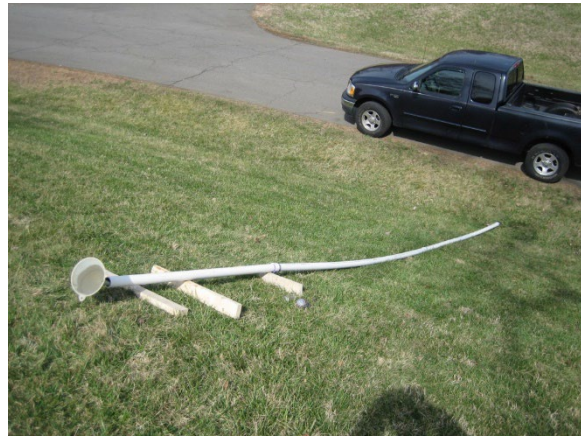
Figure 4. Photos. Preparation of a 25-ft long mockup tendon.

B. Grout filling in the mockup tendon.

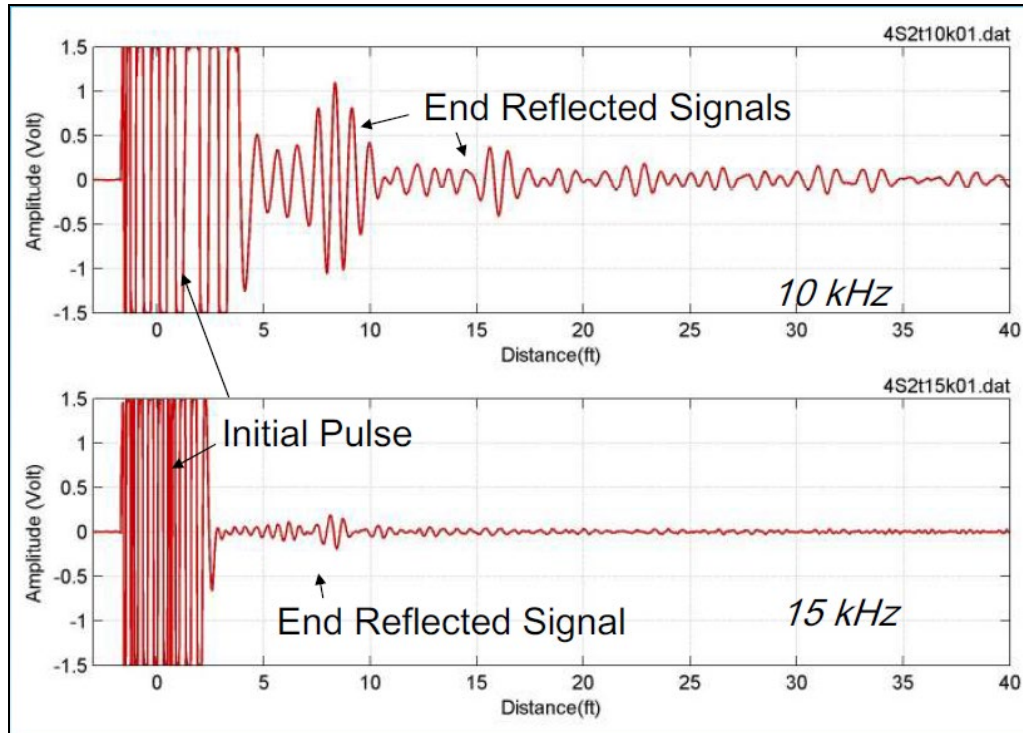
Figure 8. Graph. MsS data from the 25-ft mockup.

The MsS could not identify the locations of the artificial damage in the specimens. It was concluded that cementitious grout and no tension in the specimens contributed to very high wave attenuation. Consequently, no further testing was performed.

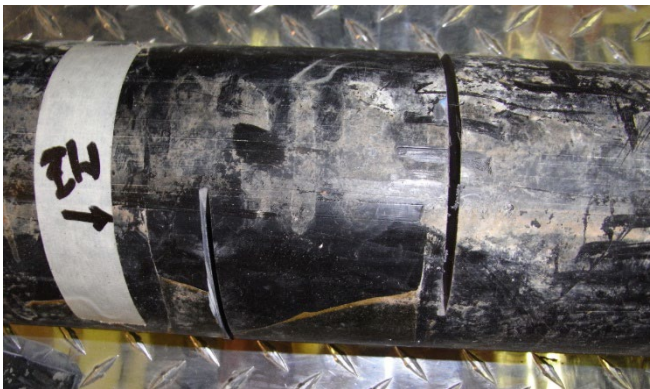
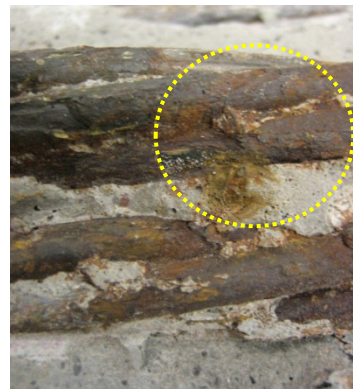
Figure 25. Photos. Examples of artificial damage.

Figure 25 shows examples of damage from three saw cuts (figure 25-A) and minor impressed current damage of approximately 0.2-percent section loss (figure 25-B).

A. Damage from three saw cuts.

B. Impressed current corrosion damage.

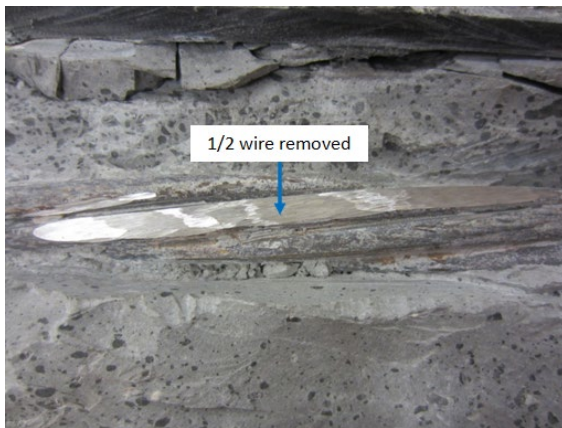
In order to evaluate the accuracy of the permanent magnet-type MMFM system, a blind test was performed using a tendon D specimen from the Varina-Enon Bridge. Figure 26 shows two artificial section losses of 0.4-percent (figure 26-A) and 1.4-percent (figure 26-B).

A. Damage number 1
(0.4-percent section loss).

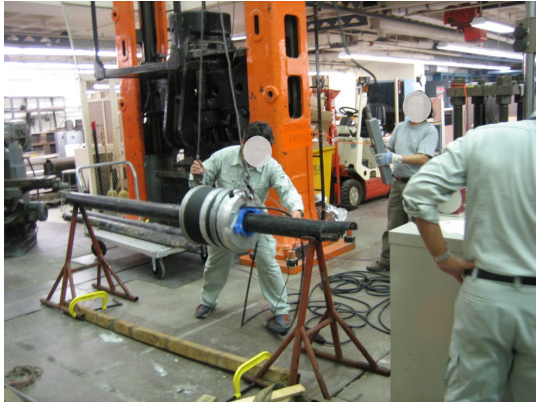
Figure 27. Photos. Solenoid-type magnetizers.

During the study's early stage, researchers designed and fabricated two solenoid-type magnetizers, labeled the first generation and the second generation.

Figure 27 shows the first-generation solenoid-type testing at Columbia University's Carleton Laboratory (figure 27-A) and the second-generation solenoid-type testing at TFHRC (figure 27-B).

A. First-generation magnetizer.

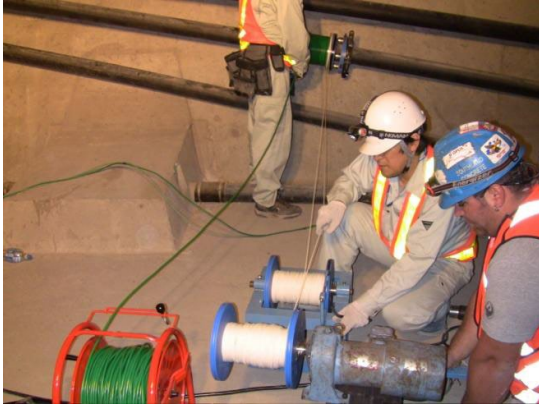
Figure 29 shows the magnetizer being installed on a test tendon using a motorized wire-wrapping system (figure 29-A) and an operator pulling the magnetizer with a rope during a scan measurement (figure 29-B).

A. Motorized wire-wrapping system.

The second-generation solenoid type was powered by an industrial-grade generator providing three-phase AC at 240-V/30 A.

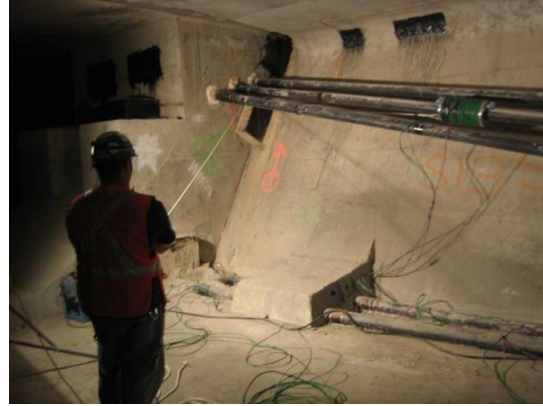
Figure 29. Photos. First MMFM testing in the Varina-Enon Bridge.

B. Scan measurement.

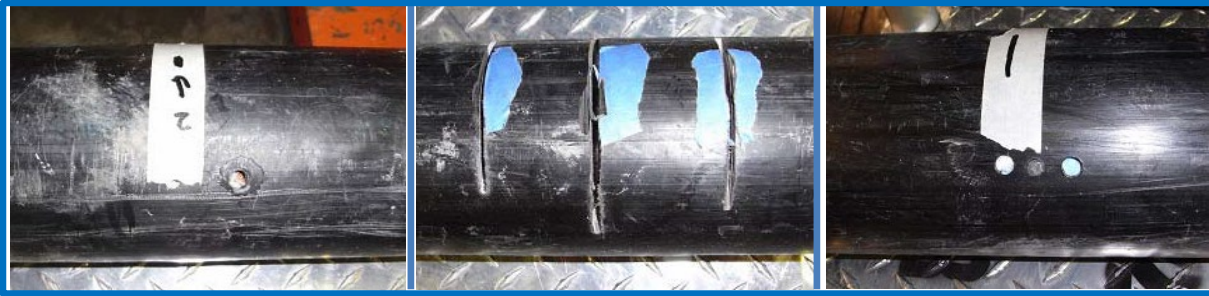
Figure 31. Photos. Artificial damage conditions of tendon A specimen.

Figure 31 shows photographs of artificial damage introduced into the tendon A specimen, and figure 32 shows a matching graph of magnetic flux versus scan distance data.

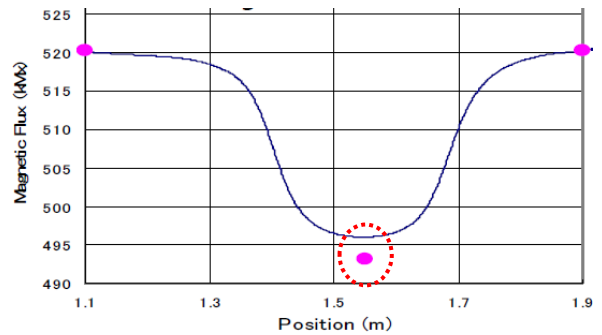
Figure 33 shows two examples of the scan measurement data and point measurement data superimposed at three locations for a 0.4-inch cut (figure 33-A) and a 7.9-inch cut (figure 33-B). The middle points correspond to the cut locations and the left and right points for intact areas.

A. Magnetic flux chart for defect length of 0.4 inches.

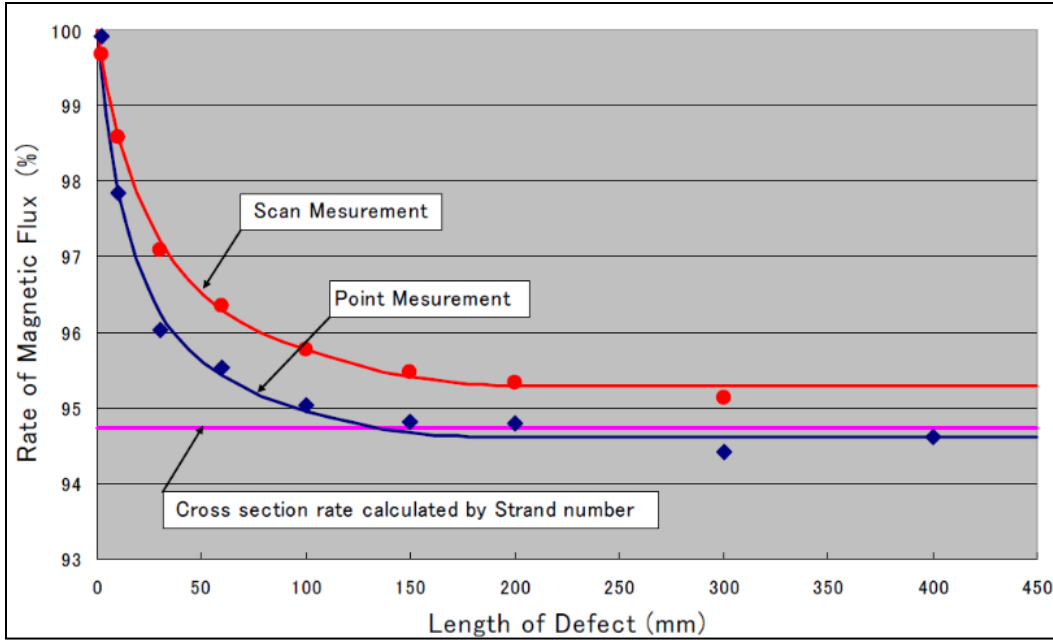
Figure 34 summarizes the relationships between the cut length and the reduction of magnetic flux in terms of the magnetic flux rate obtained by the scan and point measurement methods.

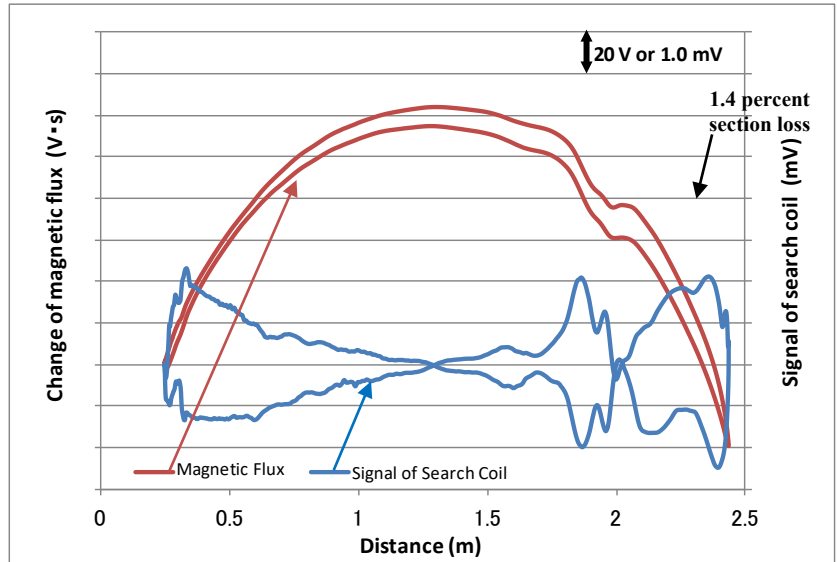
Figure 35 presents the change of magnetic flux and the search coil signal of the permanent magnet-type magnetizer versus scan distance data from the tendon D specimen. The other two datasets, that is, the radial and H_{Gx} signals, are omitted here.

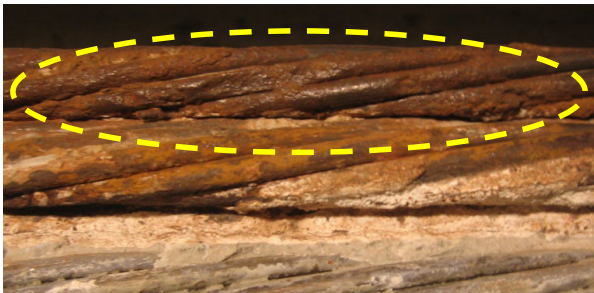
The MMFM data exhibited reduced magnetic flux over the exposed bare strand section, indicated by the solid red ellipse. The recognizable corrosion damages were also visually confirmed in the section. Figure 40 shows two closeup photographs of the observed corrosion damages.

A. Corroded strands.

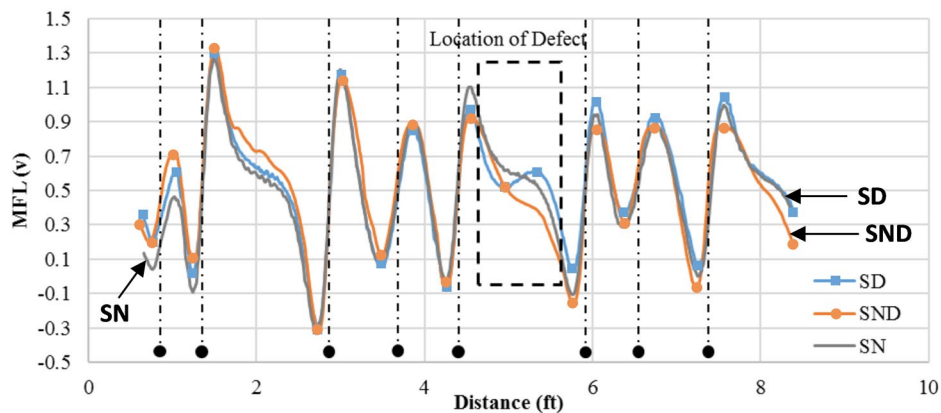
Galvanized 3-inch-diameter metal ducts were buried in the cantilever section of the top slab beneath approximately 3.5 to 4 inches of concrete cover and number 3 transverse rebars. The existing strands in the ducts were removed and replaced with seven new 0.6-inch strands for the MFL testing. Three cases of no damage (designated as SND), 100-percent section loss (SD), and no strands (SN) were tested with the active magnetic field method. The test strands prepared for the SD case were completely cut for 4 inches in the midlength to simulate complete metal loss. Figure 48 shows three MFL datasets and the transverse rebar locations.

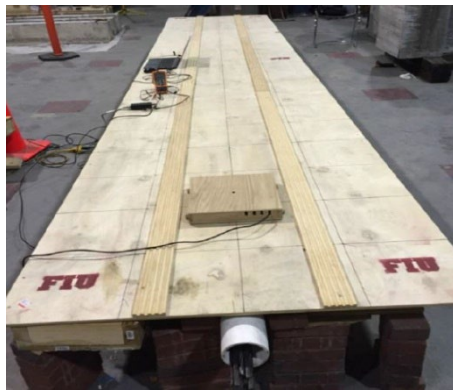
Another laboratory study was conducted with another mockup to determine the effectiveness of an electromagnetic-based inductance method. The laboratory setup consisted of a 20-ft-long tendon mockup made with multiple strands encased in a 4-inch PVC pipe. The strands had three section losses along the length: a 100-percent cut at 2.5-ft, a 50-percent cut at 10-ft, and a 14-percent cut at 16-ft. Since the penetration depth of the magnetic field around the inductor coil increased with the diameter of the coil, multiple inductor coil configurations were tested to find the best combination of penetration depth and resolution. A sheet of plywood was placed 3 inches above the mockup tendon to support the testing equipment. Inductance measurements were made at uniform intervals along the strand length, as shown in figure 49.

A. Overview.

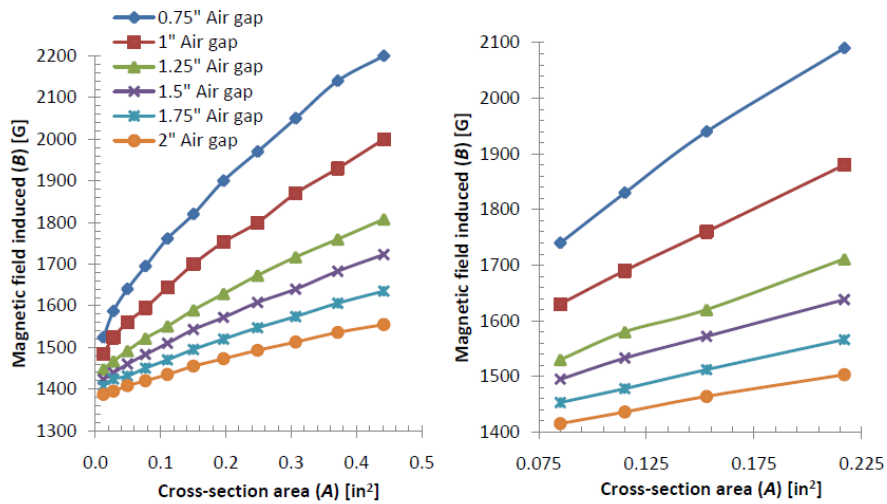
For the laboratory study, the researchers used the AISI 1018 steel rods that had 11 cross-sectional areas (diameter 1/16–3/4 inches; length 18–24 inches), new seven-wire strands that had four cross-sectional areas (diameters 1/16~3/4 inches) and corroded seven-wire strands that were obtained from a demolished bridge (original diameter was 0.5 inches). Tests were conducted to study the magnetic reluctance of concrete by using different airgaps and concrete thicknesses for all the specimens. Hollow wooden blocks and concrete blocks were used to create physical separations of different sizes between the pole face and the steel specimens. Figure 54 shows the IMFD data from AISI 1018 steel rods and new seven-wire strand steel with different cross-sectional areas as a function of airgap from 0.75 to 2.0 inches.

The induced magnetic field was proportional to the cross-sectional areas of both types of specimens. Also, the new seven-wire steel strands exhibited a higher degree of magnetization than the AISI 1018 steel rods. The researchers attributed this to the higher carbon content in the seven-wire steel strands and suggested that the metallurgy affected the amount of magnetic field induced in the steel specimens. Similar data obtained from five different thicknesses of concrete blocks are plotted in figure 55.

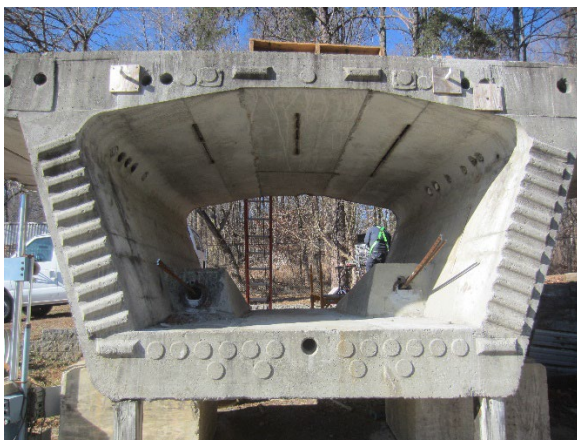
After the first round of experiments was completed in the FHWA NDE laboratory, the prototypes were taken to a full-size precast box girder segment stored in the TFHRC’s backyard. Initially, all internal tendons were empty. In preparation for the RFM testing, four 3.5-inch internal metal ducts were chosen. The clear concrete cover was 6.0 inches. Each duct was inserted with three to six 0.6-inch seven-wire strands. Each strand bundle received one of four damage levels: no damage (0-percent), minor damage (1-percent section loss), moderate damage (10-percent section loss), and severe damage (30-percent section loss). Figure 68 shows a front view of the box girder specimen (figure 68-A) and damage information (figure 68-B).

A. Front view.

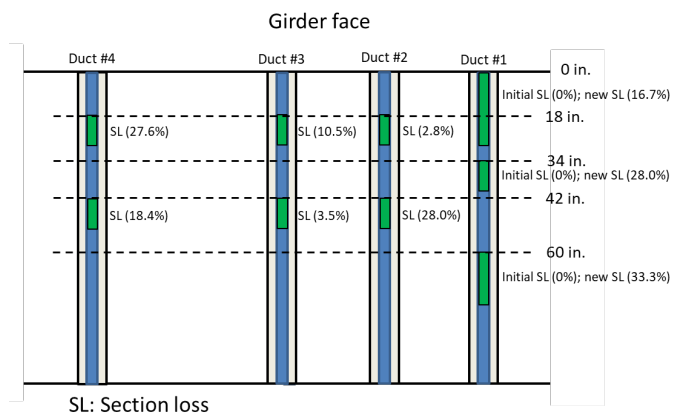
B. Damage information.

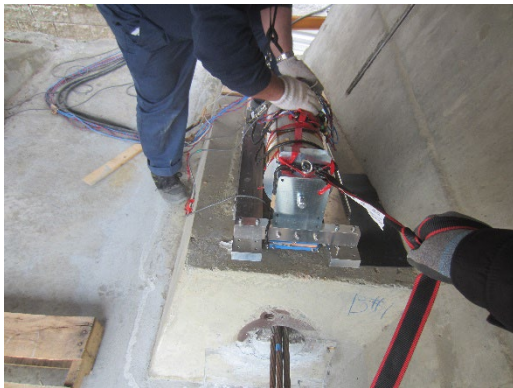
Figure 71 shows a scan measurement over blister number 1 (figure 71-A) inside the box girder and another scan measurement over an internal duct embedded in the box girder's deck section (figure 71-B).

A. Scanning over blister number 1.

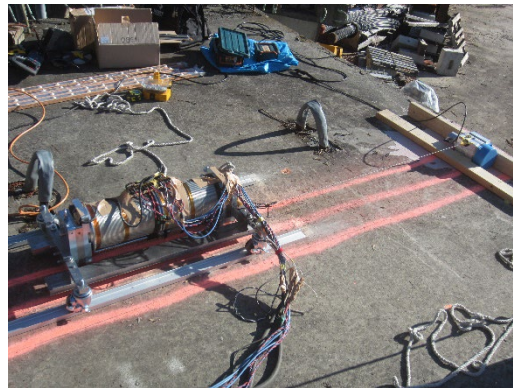
Figure 71. Photos. RFM testing on the box girder specimen.

B. Scanning over an internal tendon.

To scan the ducts smoothly, detachable fittings, such as crossbars and casters, were added to the magnetizer, as shown in figure 71-B. These added fittings increased the magnetizer's weight to 250 lb. The clearance between the bottom of the yokes and the concrete surface was 0.35 inches, including the rail thickness of 0.08 inches.
