# Nondestructive Evaluation of T1 Steel in the Sherman Minton Bridge

PUBLICATION NO. FHWA-HRT-23-045

MARCH 2024

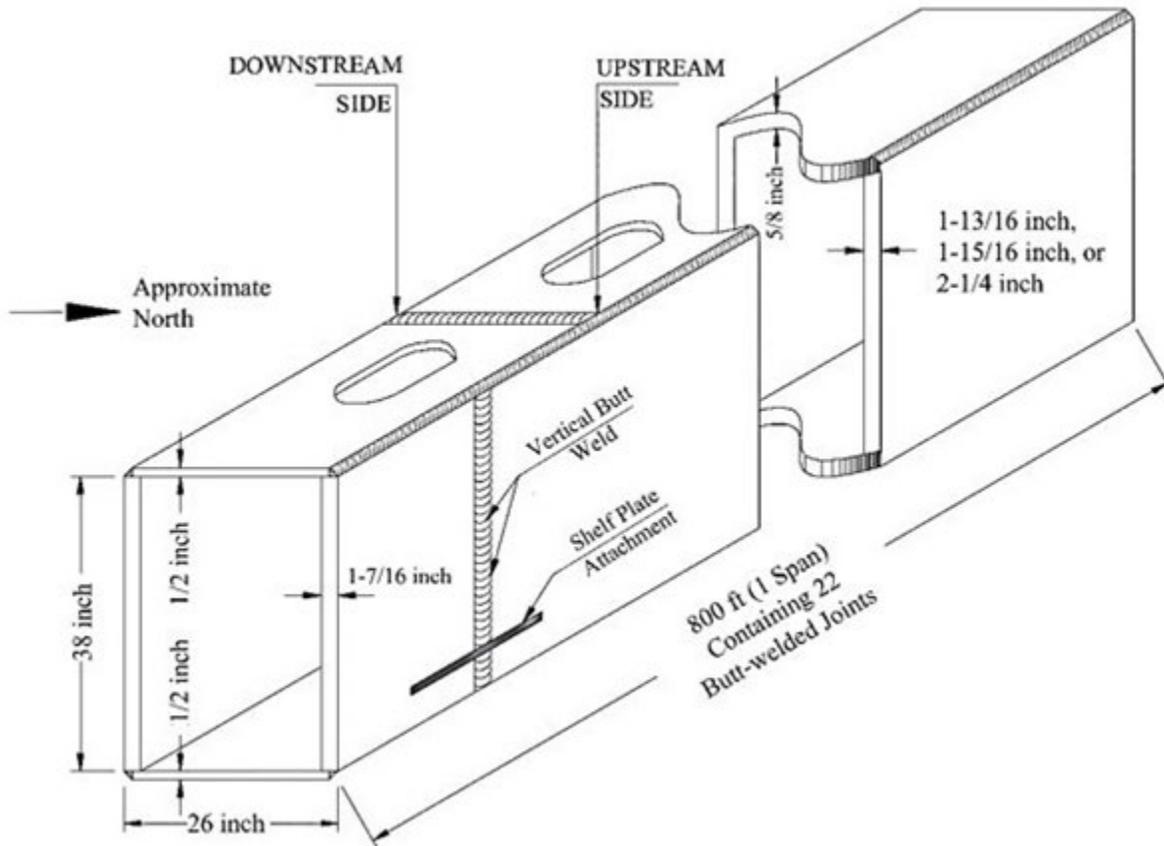
**Figure 2. Schematic. Typical vertical butt weld at the transition of plate thickness.**

Regular inspections conducted during the service life of the bridge prior to 2011 found surface-breaking cracks on several different details on the bridge. The indepth inspection that led to the bridge closure found a significant number of additional cracks and other weld flaws. The following sections describe cracking in each different type of detail. The most significant cracking in terms of the safety of the bridge were cracks along the vertical butt welds used to join plates of varying thicknesses at the joints (figure 2).

Figure 2 shows cracks observed in the tie girder at the butt welds, which are vertical welds that join plates of different thicknesses. Figure 3-A and figure 3-B show cracks that were oriented both parallel and perpendicular to the primary stress. Figure 3-A shows two lateral cracks in the weld (parallel to the axial stress), with closeup views of the MT indication for the crack. Figure 3-B shows a vertical crack (perpendicular to the axial stress) is approximately 3 inches in length with stop holes drilled at the top and bottom ends of the crack to arrest crack growth.

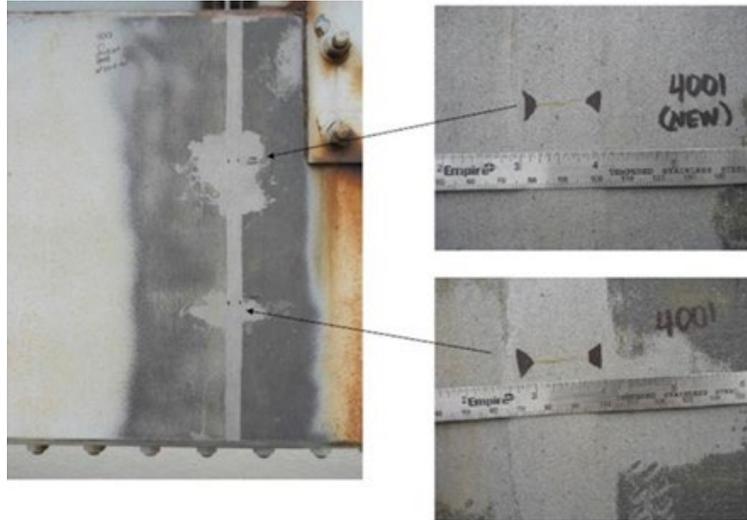
**Figure 3. Photos. Typical transverse and longitudinal cracks.**

A. Typical transverse cracks in CJP butt weld in tie girder.

B. Typical longitudinal crack in CJP butt weld in tie girder.

Based on the results of metallographic studies, the cracking observed on the S-M Bridge was due to hydrogen cracking. Since hydrogen cracking typically forms within 24 to 48 h after completion of the welding process, the cracks observed in the bridge may have been present since the bridge was fabricated. The quality control (QC) processes that the engineers used during the fabrication did not detect the cracking, which was ubiquitous among welds in the S-M Bridge.

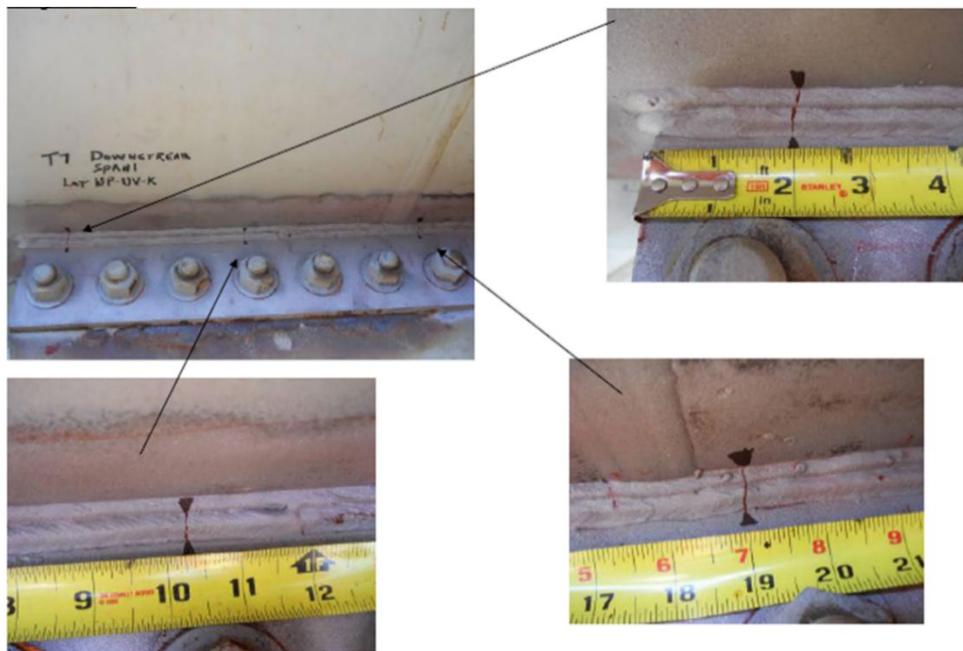
**Figure 4. Photo. Typical cracking in fillet welds that attached longitudinal gusset plate to tie girder.**

Inspectors found transverse cracks (perpendicular to axial stress) in the shelf plates used to attach gusset plates connecting the diagonal lateral braces. These plates were also made from T-1 steel and were attached with single bevel groove CJP welds. The shelf plates were welded to the tie girder splice plates and transverse to the vertical butt welds in the tie, also made of T-1 steel.

Cracks ran along the length and ends of these welds, as shown in figure 4, which shows an overall view of a shelf plate with three crack indications. Closeup views of each of the three cracks are shown with arrows to the crack location on the shelf plate. All cracks along the attachment in the weld were immediately adjacent to the base metal. Those at the ends were at the weld toes; hence, they extended into the base metal of the tie girder.

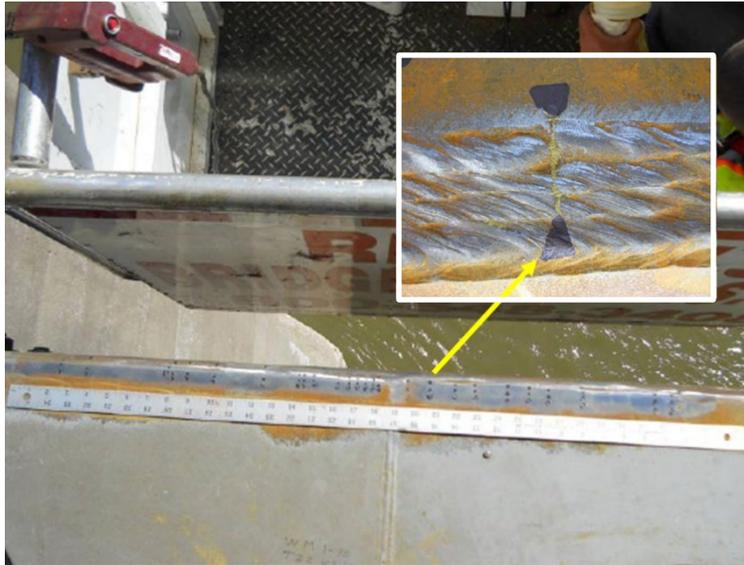
**Figure 5. Photo. Cracks in fillet welds at the corner of a tie girder.**

The engineers used longitudinal fillet welds to join the four plates making up the rectangular tie girder box cross section. Cracks were reported at some locations in these welds, as shown in figure 5. In terms of volume, these fillet welds comprised most welding on the bridge. In total, about 2.4 mi of corner fillet welds are on the structure.

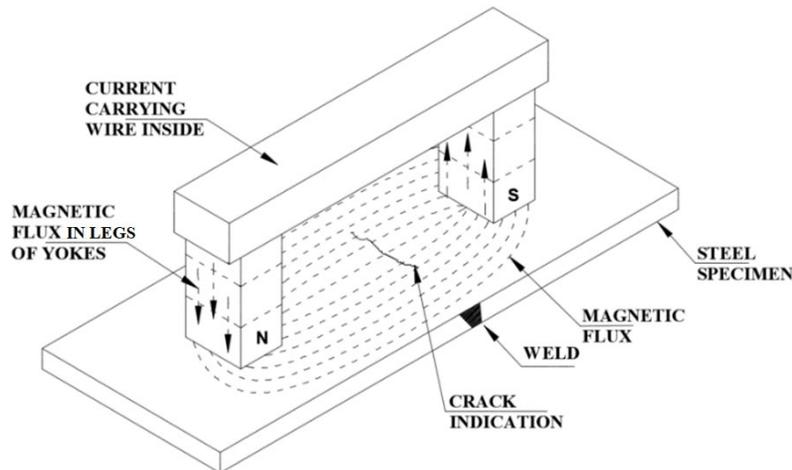
**Figure 6. Schematic. MT for crack detection.**

MT consists of inducing a magnetic field in the surface of the steel and assessing leakage of that field that may occur if a crack is present within the induced field. The MT process begins by applying finely divided iron particles to the surface. The iron particles, which are attracted to the leaking field, collect at a surface-breaking crack or surface defect and create a visual “indication.” The iron particles include a dye to make the particles red, yellow, or gray to create a color contrast with the material being tested.

Field inspections with MT typically employ MT yokes that have a wire coil in the handle and two steel legs that couple the magnetic field into the steel member under inspection, as shown in figure 6. A crack in the steel material disrupts the flow of the magnetic field, resulting in flux leakage into the air. Cracks positioned orthogonally to the magnetic flux create the largest disturbance. When cracks are parallel to the direction of the magnetic field, the field disturbance is minimal, and the sensitivity reduced. For inspection, most MT procedures require orienting the yoke in two orthogonal positions for each area to be inspected.

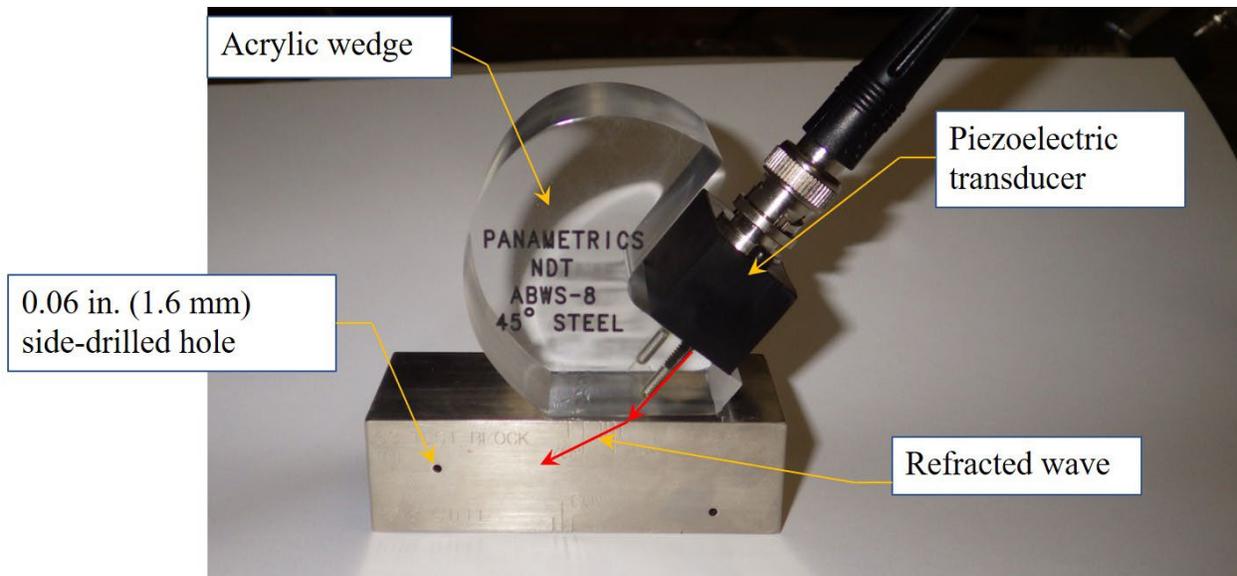
**Figure 7. Photo. Ultrasonic transducer used to detect indications in welds.**

To determine the depth of the indication in the weld using geometry and the known wave velocity in the steel, inspectors used the refracted angle of the beam. The refracted angles commonly used for inspection are specified angles with efficient mode conversion to introduce acoustic energy (waves) into the steel. Variations from the specified angles reduce the amount of energy introduced and, hence, may affect the amplitude of signals reflected from indications in the weld. Variation in the velocity of shear wave in the steel affects the refracted angle (figure 7), and, therefore, the amplitude of signal reflected from indication in the weld.

An indication is assessed to determine if it constitutes a “rejectable indication” by comparing the amplitude of a wave reflected from a 0.06-inch-(1.5 mm)-side-drilled hole (SDH), which provides a consistent edge reflection regardless of the incident angle. The amplitude of an indication in the weld is adjusted to account for the attenuation of the wave as it propagates through the steel. In the current AASHTO/AWS D1.5M/D1.5 *Bridge Welding Code*, the amplitude adjustment is  $2 \text{ dB} \times (\text{path length} - 1 \text{ inch})$ .<sup>(9)</sup> The amplitude rating of a certain indication is the difference between the adjusted amplitude of the indication signal and the amplitude of the SDH. As a result, the decibel rating typically provided in a standard UT form represents the gain needed to make the indication amplitude the same as the SDH amplitude. If the adjusted indication signal is smaller than the SDH signal, then the gain needs to be added to the adjusted indication signal to match the SDH. If the adjusted indication signal is larger than that produced by the SDH, the gain needs to be subtracted from the indication signal to match the SDH signal. The amplitude of reflections reported from UT are large when the amplitude values are small, e.g., a  $-2 \text{ dB}$  indication is larger in amplitude than with a  $+2 \text{ dB}$  indication.

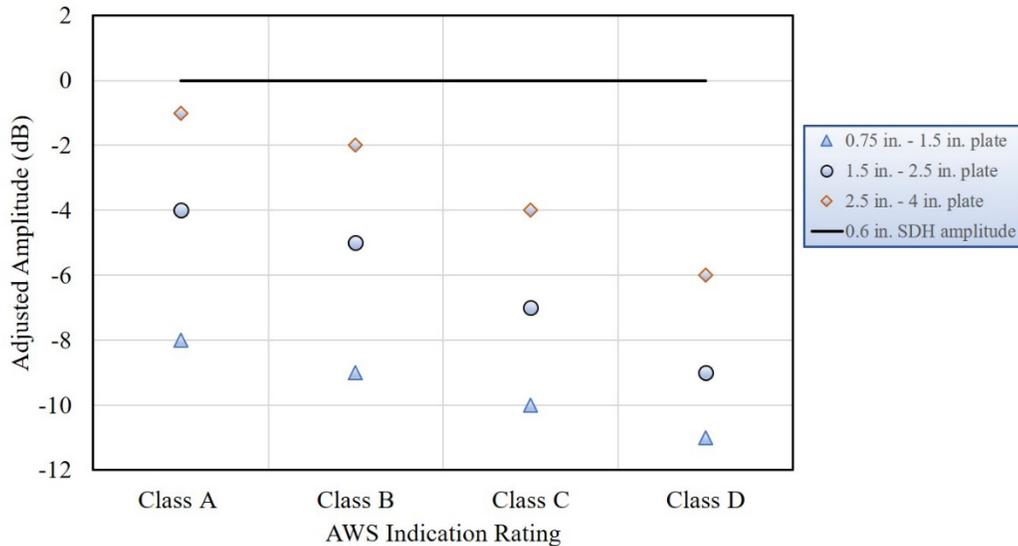
**Figure 8. Graph. AASHTO/AWS D1.5M/D1.5 indication rating requirement for 70-degree shear waves for plates ranging in thickness from 0.75 inch to 4 inches.<sup>(9)</sup>**

Of note is that the difference in amplitude between a class A indication and a class D indication for plates 1.5–2.5 inches thick is only 5 dB. The difference between a class A, which is always rejectable, and a class B indication, which may be acceptable depending on the measured length of the indication, is only 1 dB. As a result, the amplitude of the signal reflected from a flaw in a

bridge weld is critical in terms of determining if the given indication is acceptable or rejectable. Therefore, the influence of the wave velocity and the attenuation in the steel are critical to the appropriate disposition of indications found in welds. Steps to mitigate these effects include installing reference blocks formed from material that is acoustically like the material being tested in terms of velocity and attenuation.

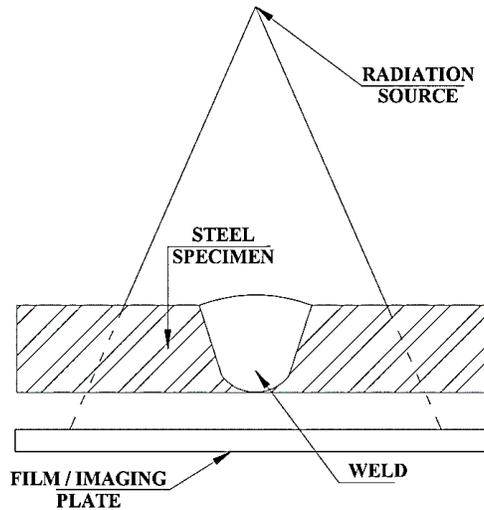
**Figure 9. Schematic. RT testing of welds.**

The photons that penetrate the material can come from different sources. Decaying isotopes such as cobalt-60 or iridium-192 produce gamma rays. X-ray machines or linear accelerators also can produce photons. The general test arrangement for RT consists of placing the photon source on one side of the specimen and placing the film or detector on the other side of the specimen, as shown in figure 9. The film captures the legacy of the photons that penetrate the material. As photons propagate the material, they attenuate because of scattering from interactions with ion cores and absorption in the material. Low-density materials scatter and absorb photon energy less frequently than high-density materials. Materials with high atomic numbers (larger cores) result in more scattering losses than materials with low atomic numbers. For example, using lead as a shield is effective because of its high density and large atomic number.

Visual inspection of the resulting film depiction of the density of the materials is used to identify indications in RT. The detection of flaws, such as porosity or a lack of fusion, occurs because the material has a lower density where the porosity has formed. Because the attenuation of photons relies on scattering from ion cores in the material, vertical cracks aligned with the direction of

the photons penetrating through the material may not appear as detectable indications. Generally, RT is expected to be most sensitive to volumetric weld flaws, such as slag inclusions, porosity, and a lack of fusion in the weld. Many inspectors consider RT less effective for detecting cracks than UT, particularly if the crack is aligned parallel to the direction of the photon path from the source to the detector.

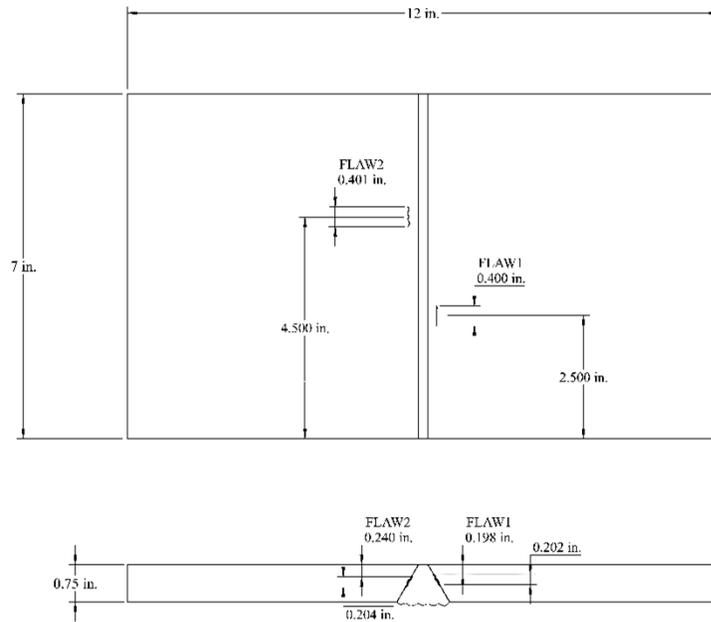
**Figure 10. Schematic. Typical test plate used for performance testing showing the plan for implanted flaws.**

Researchers at FHWA's NDE Laboratory provided the test plates used in the performance testing on the S-M Bridge. Figure 10 shows a drawing of a typical test plate with two implanted flaws. The test plate shown in figure 10 contains two crack-like flaws that lie along the fusion line of the weld. The steel test plates typically contained implanted flaws of varying length and depth within a groove weld placed along the centerline of the plate. The performance test plates had both subsurface flaws and surface-breaking flaws. The MT analysis used only specimens with surface-breaking flaws because this technology detects only surface-breaking cracks or very near-surface cracks. The thickness of the test plates used was smaller than the welded plates in

the S-M Bridge. Although obtaining plates of similar geometry to the S-M Bridge members would have been preferable, time constraints precluded obtaining new specimens that matched the S-M Bridge plate geometry.

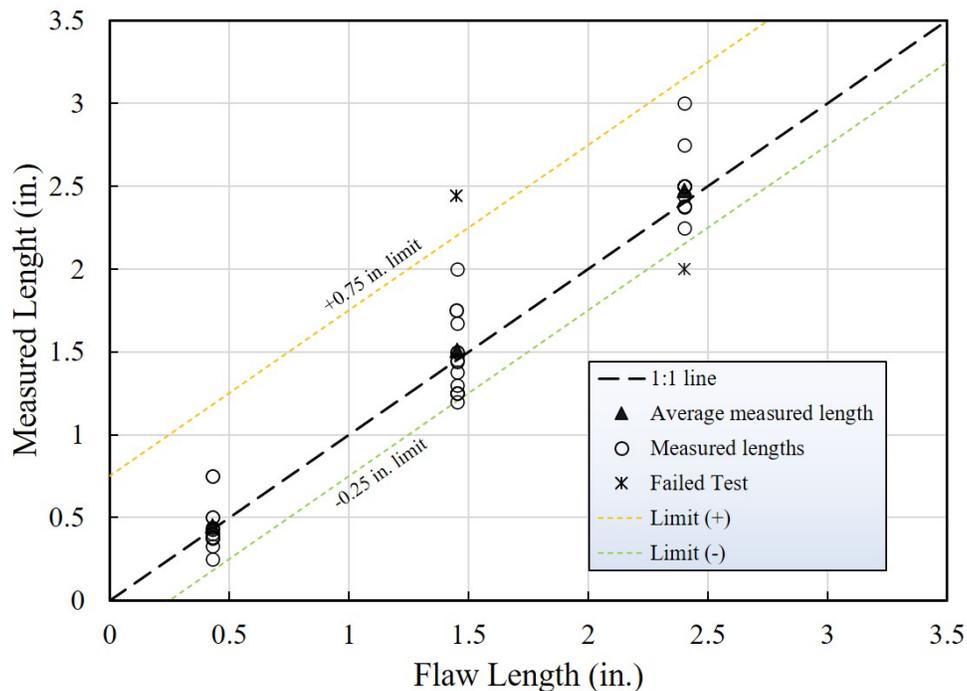
**Figure 11. Graph. Measured flaw lengths versus actual flaw length for MT performance test.**

Figure 7 shows the length measurements provided by the inspectors during the performance tests. The horizontal axis in the figure is the actual length of the flaw, and the vertical axis shows the measured values reported by the inspectors. A solid triangle represents the average length measurements, and an open circle indicates each individual measurement. A 1:1 line drawn on the figure shows the exact correlation of measured and actual flaw length for illustration purposes. As shown in the figure, the reported results both overestimated and underestimated the length of the flaw as compared to its actual length.

The team analyzed these data to quantify the accuracy of the MT technique as applied by the inspectors successfully completing the performance tests. These data provide insight regarding how accurate a typical MT inspection would be in the field based on the sample of 15 inspectors' testing assessed on the S-M Bridge. Table 4 shows the results from the successful performance tests. The data in the table include the average error, which is the average of the difference between the actual length of the implanted flaw and the reported length from each inspector. As shown in figure 11, reported flaw lengths are sometimes less than and sometimes greater than the actual length.

The maximum standard deviation of length measurement error was 0.23 inch. In other words, for the inspectors successful in completing the performance test, the maximum standard deviation of length measurement error was less than 0.25 inch. The table also shows the coefficient of variation (COV), which is the standard deviation divided by the mean value. The COV illustrates the dispersion of the results from the mean value, which decreases as the crack length increases, as shown in table 4.

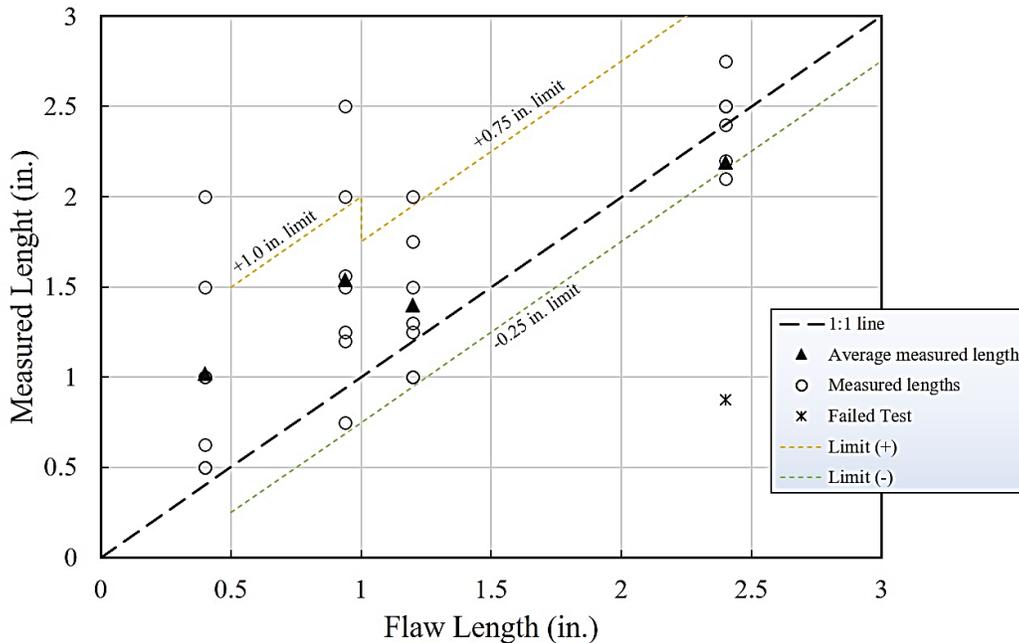
**Figure 12. Graph. Flaw length measurement data from the UT performance tests.**

The team conducted an analysis of the results of the performance tests to assess the capability of the inspectors to accurately determine the length of a flaw. Figure 12 presents the results of reported flaw lengths from the performance testing. A 1:1 line illustrates where measured data exactly matched the known length of the flaw. The solid triangle shows the average length measurements, and open circles show the individual measurements from inspectors. As these data illustrate, measured length exceeds the actual length in all cases for the smallest flaw. Most of the reported crack lengths for the longer flaws were also longer than the actual length of the flaw. Significant flaw scatter occurred in the results from different inspectors for the same flaw, as illustrated in the figure.

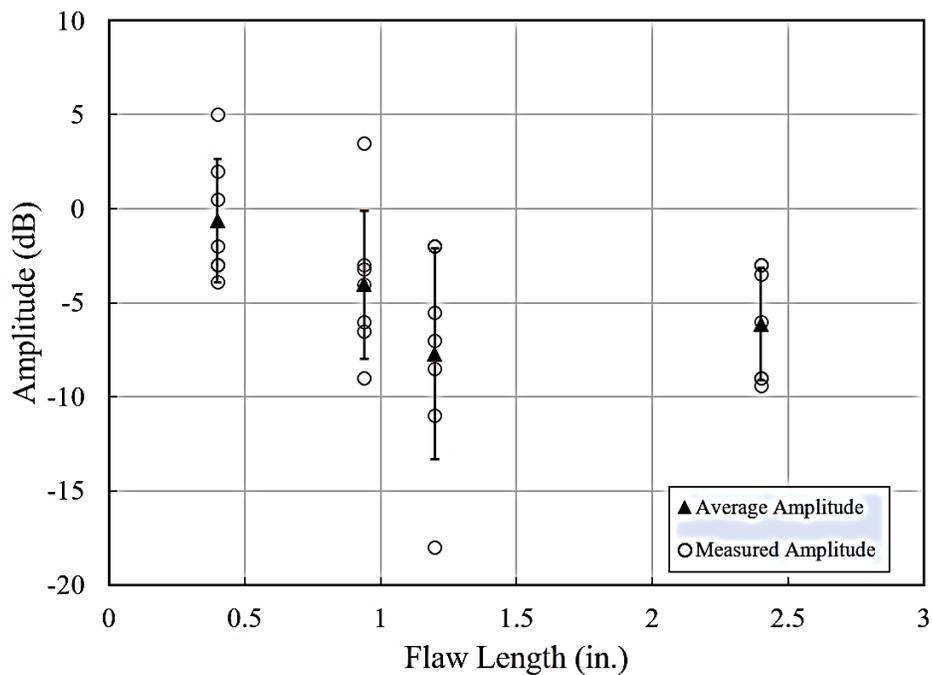
**Figure 13. Graph. Reported amplitudes for flaws in test plates.**

The amplitude of indications detected using UT is the key criteria used to determine if the indication is rejectable or not. Consequently, variations in amplitude between different inspectors leads to different interpretations or resolution of an indication. Although the specific reported amplitude of an indication was not part of the criteria for the performance test, the team used the amplitudes reported on the UT inspection reports to characterize the variation between different inspectors examining the same flaw. Figure 13 shows the individual measurements reported by inspectors during the performance test for the four different flaws ranging in size from 0.40 inch to 2.4 inches. The figure also shows the average of the reported amplitudes and the standard deviation. As the figure shows, large scatter was in the reported amplitude measurements used to classify the flaw and determine if it is rejectable. It should be noted that the amplitude data are plotted as a function of flaw length for convenience but are not necessarily dependent on the flaw length.

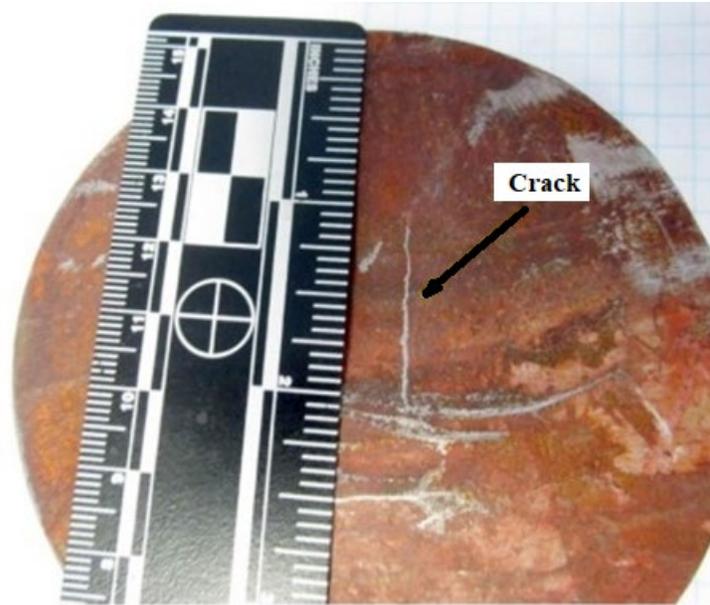
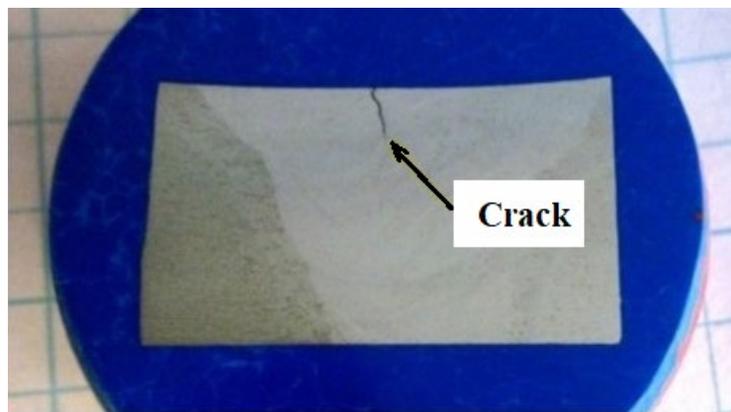
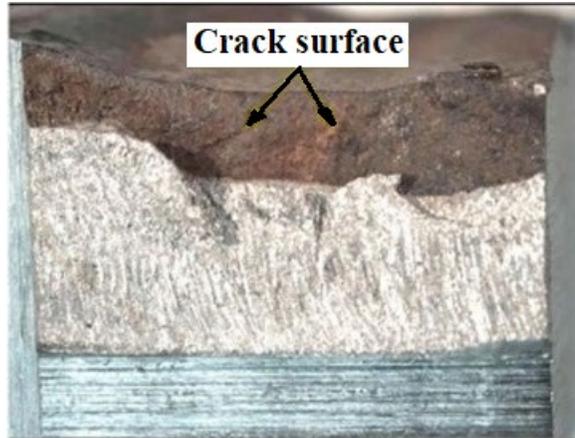
**Figure 14. Photos. Core no. 4.**

Exemplar results for surface-breaking flaws can be used to illustrate NDT performance for detecting in situ surface-breaking flaws. For example, locations of cores no. 4 and no. 11 were largely above the shelf plate and appeared to have surface-breaking flaws that extended into the vertical butt weld. For core no. 4, a surface-breaking crack was present as shown in figure 14-A, figure 14-B, and 14-C. Figure 14-A shows a photograph of a 1-inch MT indication on the surface

of the core. The crack extends to some depth into the core as shown in figure 14-B. Corrosion on the crack surface (figure 14-C) indicates the crack had existed for some period before the core's removal from the bridge. Only RT detected the flaw in core no. 4; neither UT nor MT detected this flaw in situ on the bridge.

A. MT indication on the surface.

B. Polished and etched crack extending into core no. 4.

C. Crack surface after core was broken open at the crack.

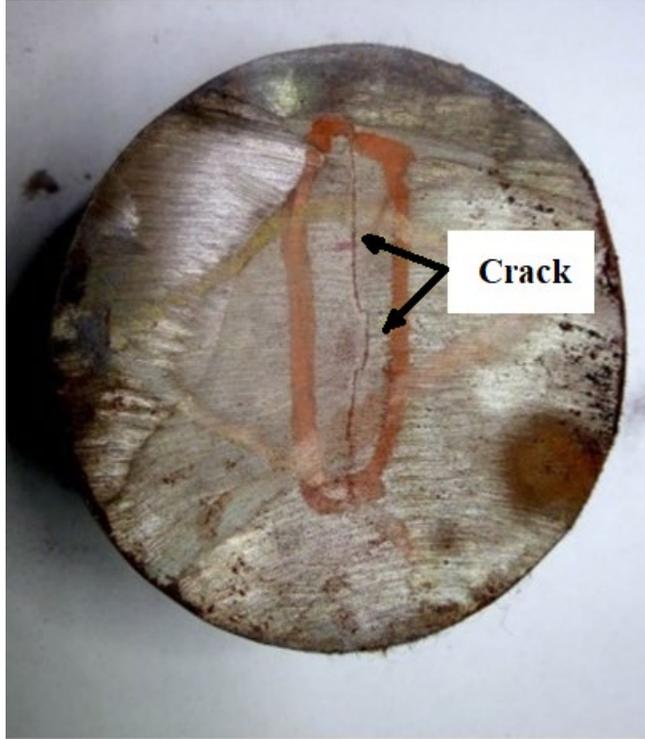
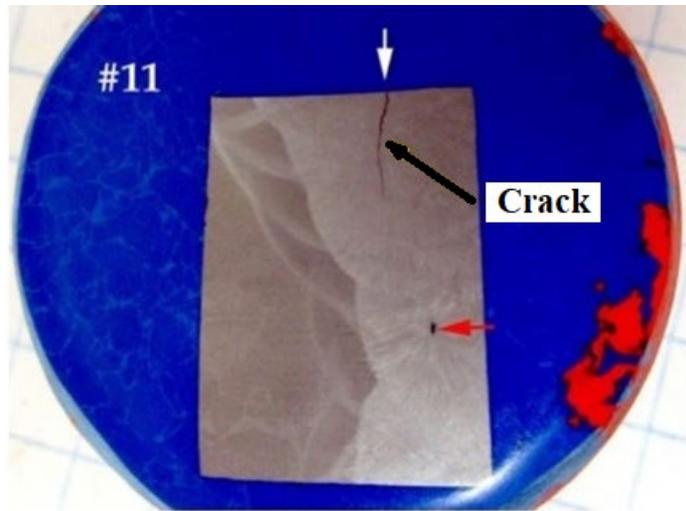
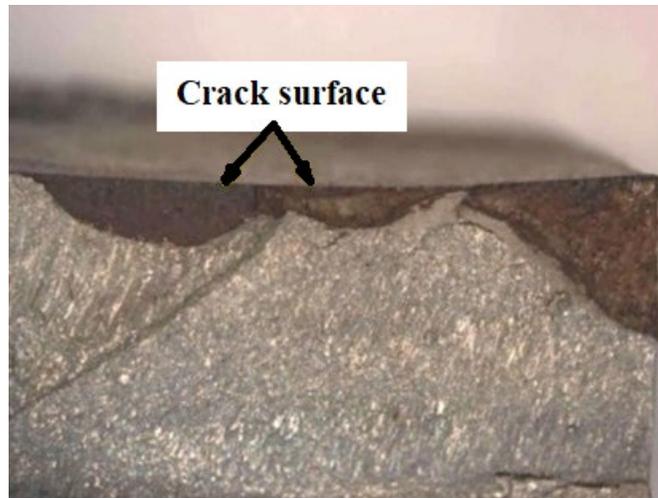
In contrast, figure 15 shows a crack in core no. 11 that is about 1.44 inches long and was detected by both UT and MT. When in situ, this crack initiated in the shelf plate weld and extended into the vertical butt weld. The shelf plate weld, located transverse to the vertical butt weld, was removed prior to the core being removed from the bridge. The MT report documented a transverse crack in the shelf plate weld that extended into the vertical butt weld. The UT report showed a 2.5-inch indication in that area. The same inspector completed the MT and UT inspections on the same day. However, the RT report for that portion of the vertical butt weld did not state indications near the core. As shown in table 7, the RT report showed a small indication near the core, but the location of the indication was several inches below the location of the core so no overlap occurred between this indication and the actual crack. Consequently, because no overlap existed, the project team assumed is that RT did not detect this flaw in the field.

A. MT indication on the surface.

B. Polished and etched crack extending into core no. 11.

C. Crack surface after core was broken open at the crack.

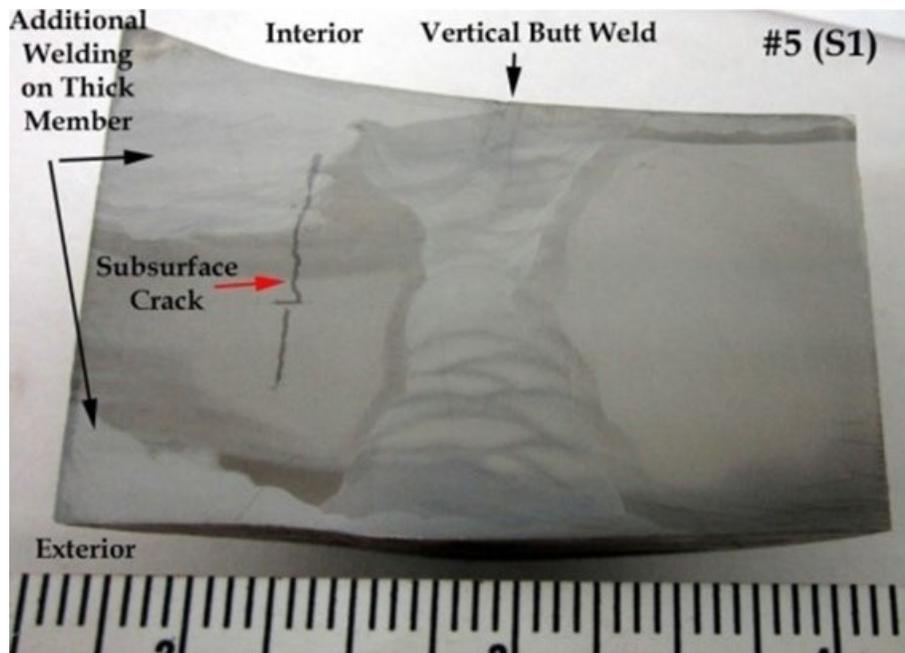
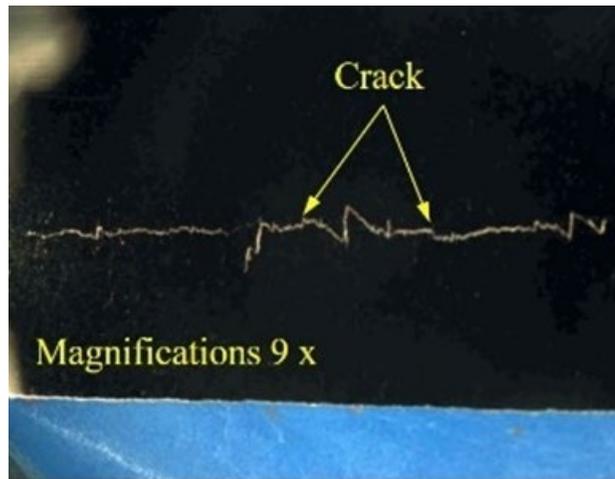
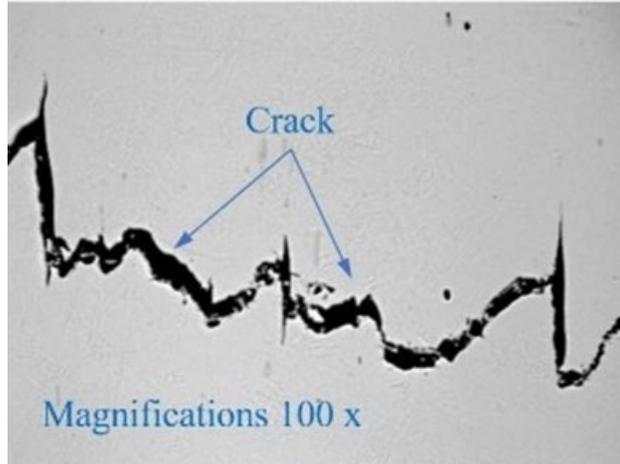
**Figure 16. Photos. Core no. 5.**

The metallurgical analysis revealed that the crack in core no. 5 was about 1.2 inches long, although the engineers determined that the crack extended outside the core. Both RT and UT reported flaws at this location. RT reported a 1-inch flaw, and UT reported a 2.5-inch crack at the location of the flaw. The results presented in the final field inspection report indicated that UT had missed a major crack in core no. 5. However, the inspectors discovered that UT did detect this flaw, but the labeling of the original UT inspection form was incomplete.<sup>(17)</sup>

The subsurface flaw shows an irregular cracking pattern as compared with a fatigue-type crack, which commonly is a crack with a smooth surface. The inspectors found a crack in core no. 5, which they assessed to be a hydrogen-assisted crack with a very irregular surface, as shown in figure 15-B, which shows the crack at a magnification of 9x, and in figure 15-C at a magnification of 100x.

A. Polished and etched crack at magnification of 1x.

B. Crack extending at magnification of 9x.

C. Crack at 100x magnification.

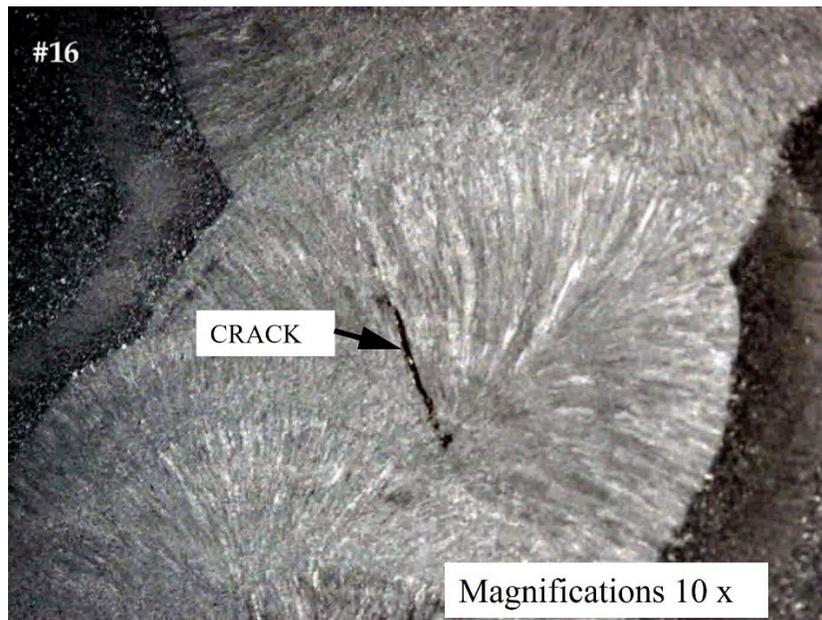
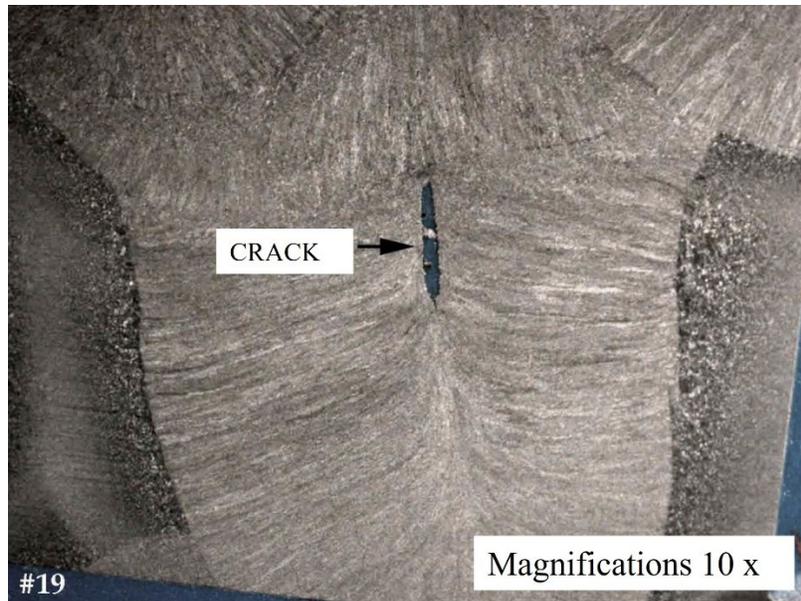
Figure 17 shows subsurface flaws in core no. 16 (figure 17-A) and core no. 19 (figure 17-B). Testing showed a flaw in core no. 16 as 0.1 inch in length from the metallurgical report.<sup>(18)</sup> No UT indication associated with the flaw in core no. 16 was reported, whereas the RT report indicated an incomplete fusion flaw at this location. In contrast, testing and a metallurgical analysis showed that core no. 19 had a flaw length as 0.08 inch. UT reported the length as 1.25 inches, while the RT reported no flaw at this location. For both cores no. 16 and no. 19, the metallurgical report assessed that these were “minor welding discontinuities confined to individual weld passes and not indicative of active cracking mechanisms.”<sup>(18)</sup>

A. Core no. 6.

B. Core no. 19.

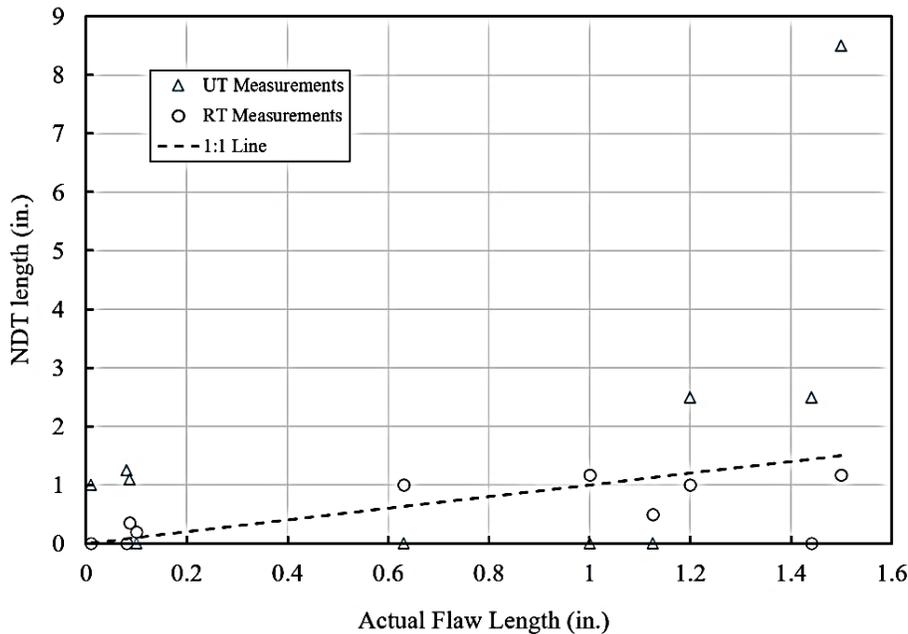
**Figure 18. Graph. Length measurements reported by RT and UT as compared with actual flaw lengths.**

Figure 18 shows the results from the analysis. This figure plots the results of indications reported by UT and RT. If UT or RT did not report an indication near a flaw, the symbol appears on the horizontal axis. The dashed line in the figure indicates the actual crack lengths according to the metallurgical analysis. This figure graphically illustrates that UT results overestimate the length of the flaw in all cases, whereas the RT results are mixed. Generally, RT reported indication sizes larger than the actual size when flaws were small and less than the actual size when flaws were large.
