Substructure Condition Evaluation of the Willow Valley Creek Bridge Using Geophysical Logging Methods

PUBLICATION NO. FHWA-HRT-23-080

OCTOBER 2023

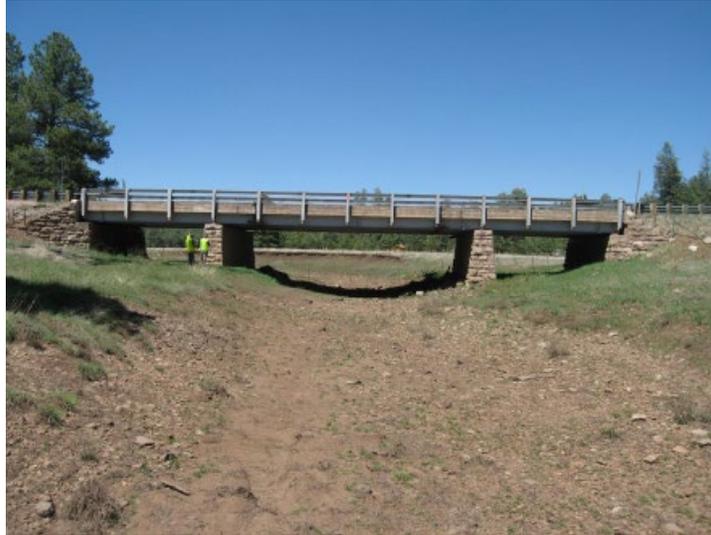
Figure 1. Photo. Elevation view of Willow Valley Creek Bridge.

The Willow Valley Creek Bridge is a 104-ft (31.7-m)-long, three-span structure that was originally constructed in 1934 and widened in 1968. Figure 1 shows an elevation view of the bridge. The existing bridge consists of two traffic lanes with a clear opening of 31 ft 6 1/4 inch (9.61 m) curb-to-curb and a 34 ft 1 3/4 inch (10.4 m) out-to-out width. The original bridge plans and the original widening project and as-built plans of the widening project are available for this bridge. Figure 2 shows drawings of the plan and an elevation view of the bridge. Figure 3 shows a plan with cross-sectional details of piers. Three spans of the bridge are 27 ft (8.3 m), 50 ft (15.2 m), and 27 ft (8.3 m) long with a 35-ft (10.7-m)-long suspended span in the middle of span 2. The superstructure is composed of seven steel rolled beams, with a cast-in-place concrete deck. The superstructure is continuous along the bridge length, except for interruptions at the suspended span, which is attached by pin and hanger type connections at the girders and expansion joints through the concrete slab.

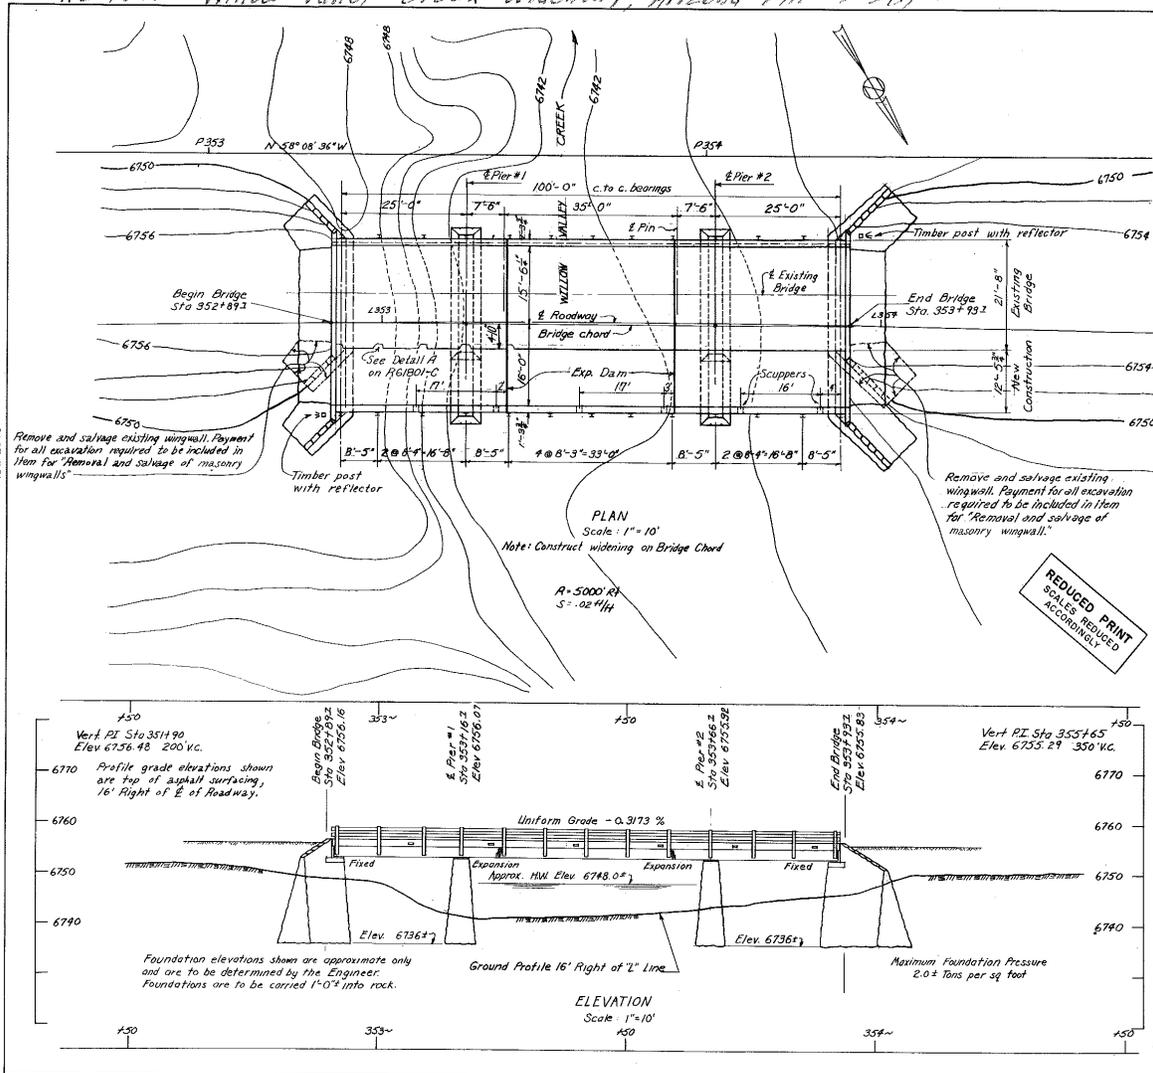
Figure 2. Drawing. Plan and profile for Willow Valley Creek Bridge (FHWA 2015).

The widening project in 1968 extended the pier and abutment widths with similar construction using mortared rubble masonry. However, as-built drawings (figure 2) show that concrete bases were constructed at the bottom of the walls below the rubble masonry sections. This construction method resulted in all four piers and abutments having very distinct “old” and “new” sections, with visible differences in the condition of the masonry in the two sections. A very distinct vertical joint line also separates the two sections on each pier and abutment, with (typically) a clear vertical crack or partial discontinuity at this joint line. Concrete-bearing seats are inset within the top of the abutment and pier masonry walls.

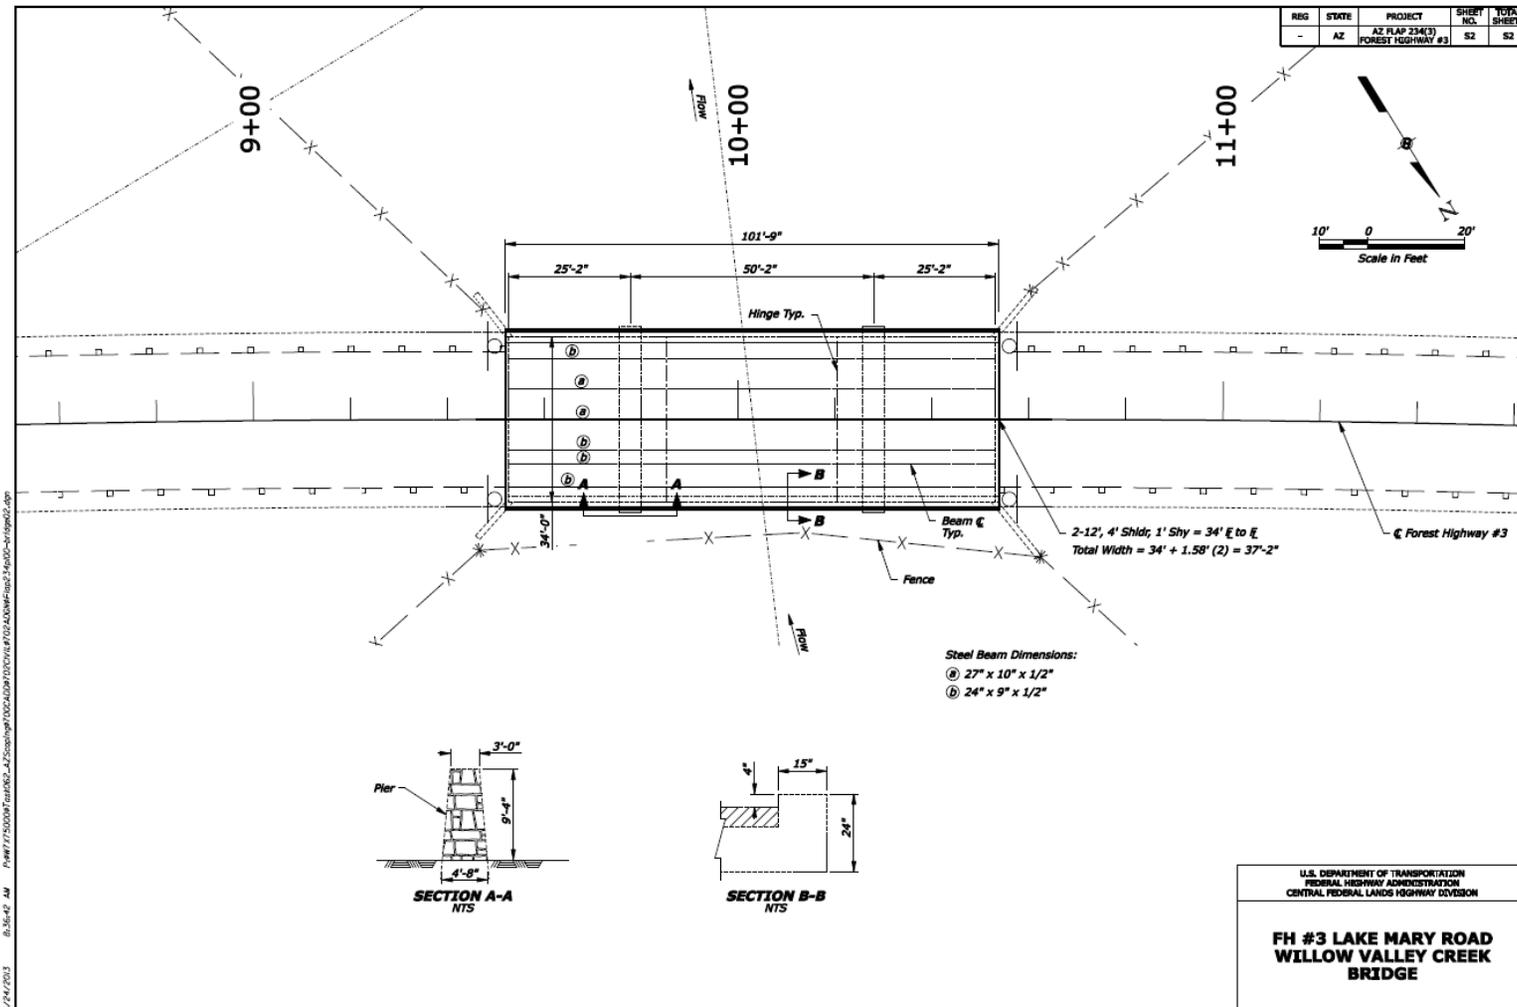
Figure 3. Drawing. Plan view of the bridge with pier and abutment details.

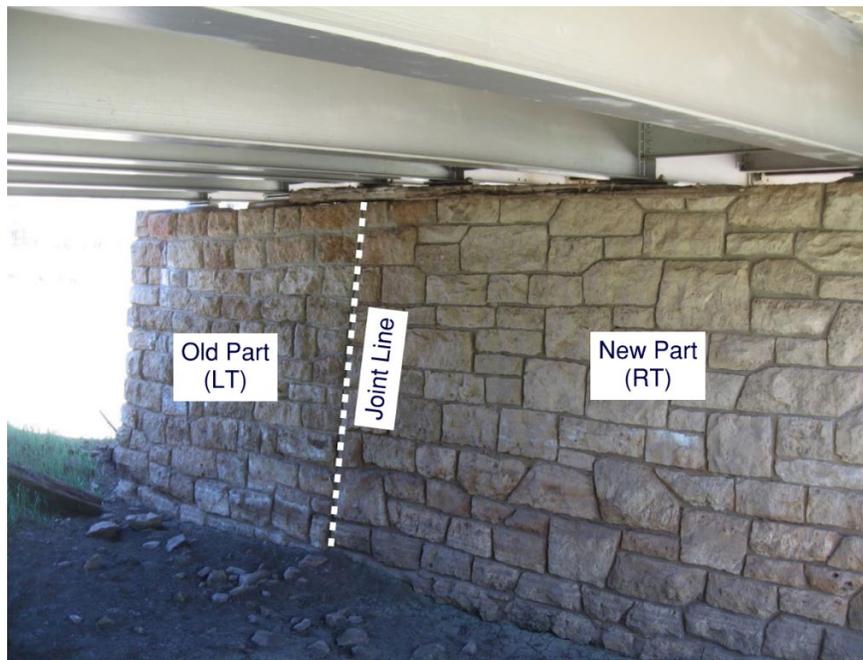
Figure 4. Photo. The general condition of pier 1 of the Willow Valley Creek Bridge.

The 2014 bridge inspection reports noted that the bridge deck condition rating was in fair condition, with hairline transverse cracking and spalls with exposed rebar at the suspended slab joint locations. The overall girder was rated as poor, with isolated corrosion. The abutment and pier were rated overall to be in satisfactory condition, with isolated cracks noted in mortar joints. Figure 4 shows the general condition of pier 1. The inspection reports also indicated that water had reached the steel girders. A detailed hydraulic analysis of the bridge indicated that the bridge abutment and pier were socketed at a 1 ft (0.3 m) minimum into the bedrock, and the bridge was not scour critical.

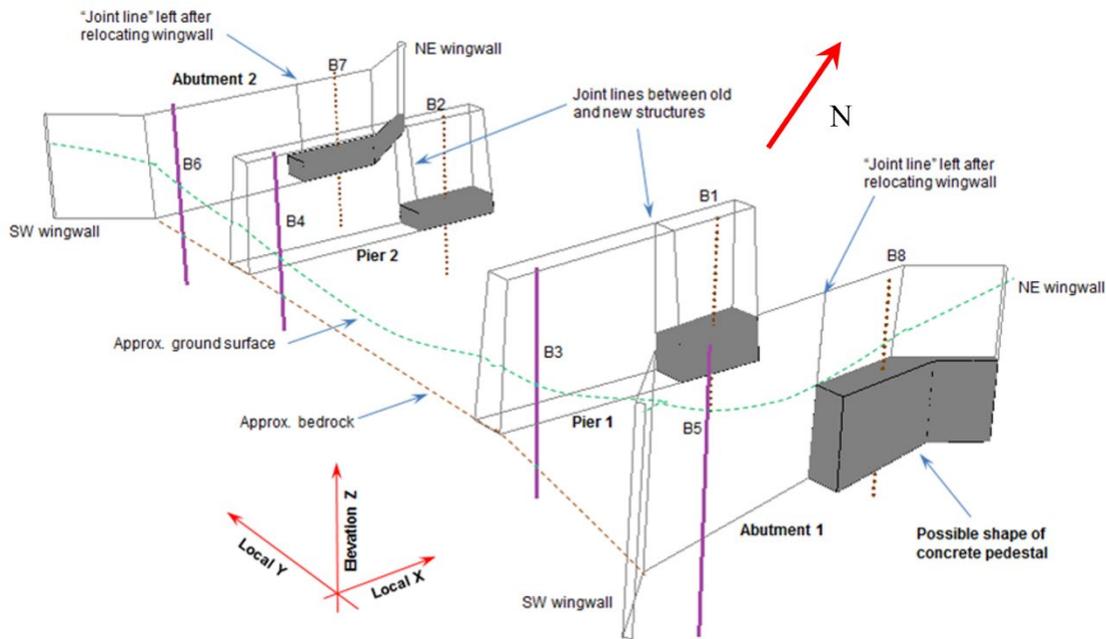
Figure 5. Illustration. Coreholes in the Willow Valley Creek Bridge.

As shown in figure 5, the engineers drilled the coreholes to investigate the older (1934) foundations (borehole (B)5, B3, B4, and B6) on the left side of the bridge (looking north) and the newer (1968) foundations (B8, B1, B2, and B7) on the right side in the fall of 2014. For all figures in this report, the term left (LT) denotes the older foundation, and right (RT) denotes the newer foundation. A borehole geophysical logging consultant collected the geophysical logs in October 2014. Post field data collection, the consultant also provided data processing and interpreted the image features and elastic moduli.

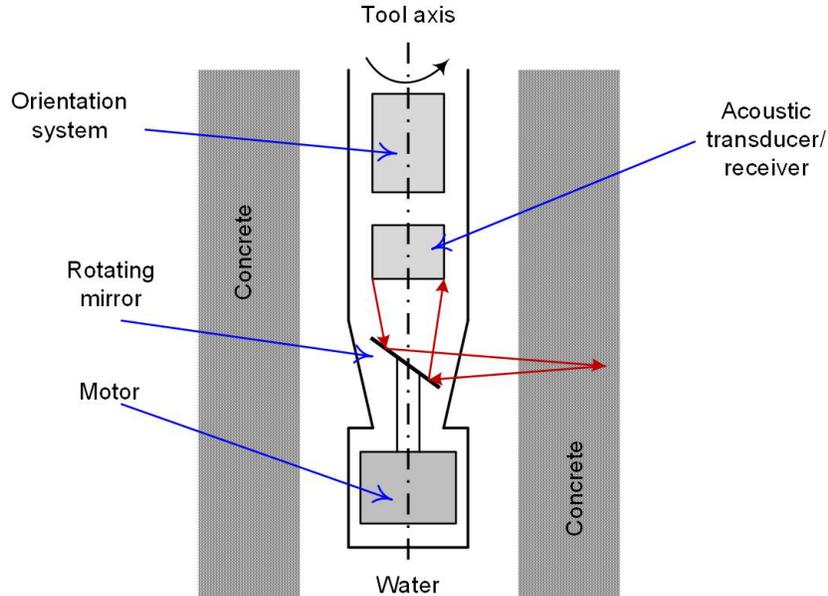
Figure 6. Illustration. Acoustic televiewer tool (ATV).

In this project, an ATV tool was used to collect an ultrasonic image of the inside of the corehole. The data were collected every 2.5 degrees around the borehole (144 samples/revolutions) and every 0.1 inches (0.23 cm) vertically. As shown in figure 6, in the ATV head, a mirror rotates, and the ultrasonic transducer is both the transmitter (Tx) and the Rx. The image is oriented with a three-axis magnetometer and three-axis accelerometer sensor package. Figure 6 shows the two-way travel time and amplitude of the reflected signal.

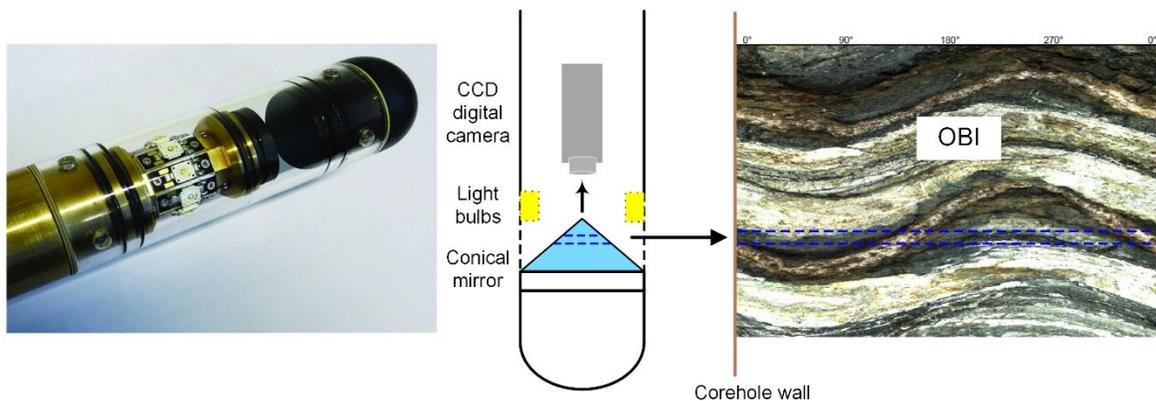
Figure 7. Illustration. Optical televiewer tool (OTV).

Figure 7 shows a composite OBI: a photograph of the OBI shown on the left, a schematic of the OBI tool shown in the middle, and an example of a sinusoidal “unwrapped” image shown on the right. For the Willow Valley Creek Bridge project, an OBI tool was used in the coreholes to create an image that was sampled vertically every 3 inches (0.3 cm) and horizontally for every 1 degree.

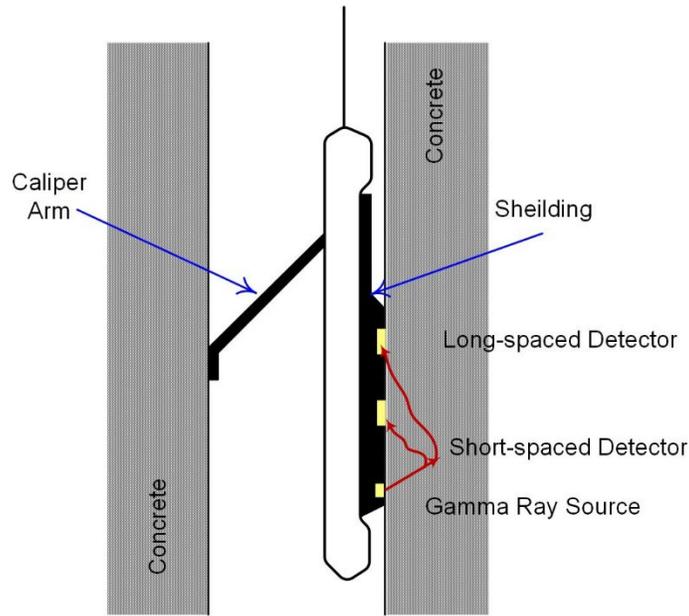
Figure 8. Illustration. Compensated dual-detector density tool.

As shown in figure 8, the tool uses a cesium radioactive source with two or more detectors, and it is decentralized with a one-arm caliper. The tool is shielded and focused to see a directional “pie-shaped” wedge on the low side of the drill hole. This measurement is calibrated and quantified, and it is typically one of the most accurate log measurements recorded. This log is used to determine the formation density, which is related to porosity lithology and is used in the rock modulus calculations.

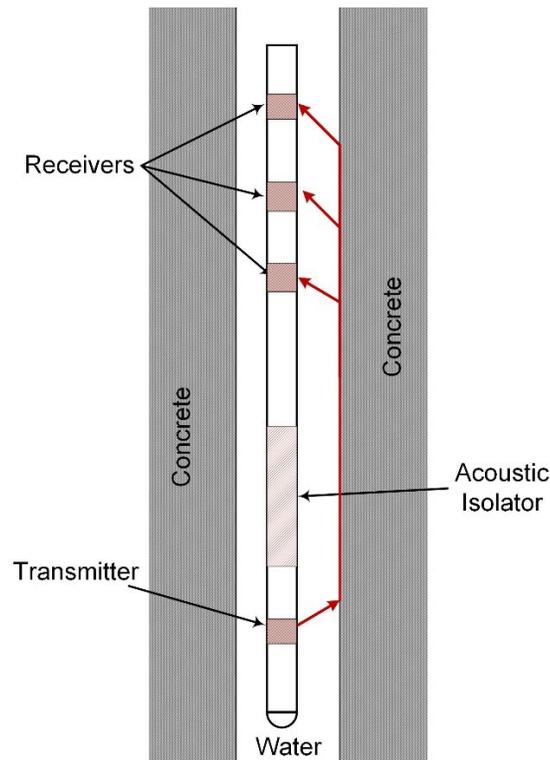
Figure 9. Illustration. Full waveform sonic (FWS) tool.

Figure 9 shows a schematic drawing of a four-Rx sonic tool. In this project, we collected FWS logs in the fluid-filled, downward-drilled holes with a digital FWS probe using a monopole Tx and three different Rxes at 23.6 inches (0.6 m), 31.5 inches (0.8 m), and 39.4 inches (1.0 m), respectively. We used a monopole Tx frequency of approximately 15 kHz to resolve both P and S waves and collected data at a 4 $\mu\text{s}/\text{pixel}$ sample rate as well as a second longer time window (16 μs) sample rate to resolve reflected tube waves or possibly from structural boundaries. The waveforms were collected every 3 inches (7.62 cm) vertically in coreholes B1, B2, B7, and B8, and every 0.6 inches (1.52 cm) in coreholes B3–B6, which had short fluid-filled intervals.

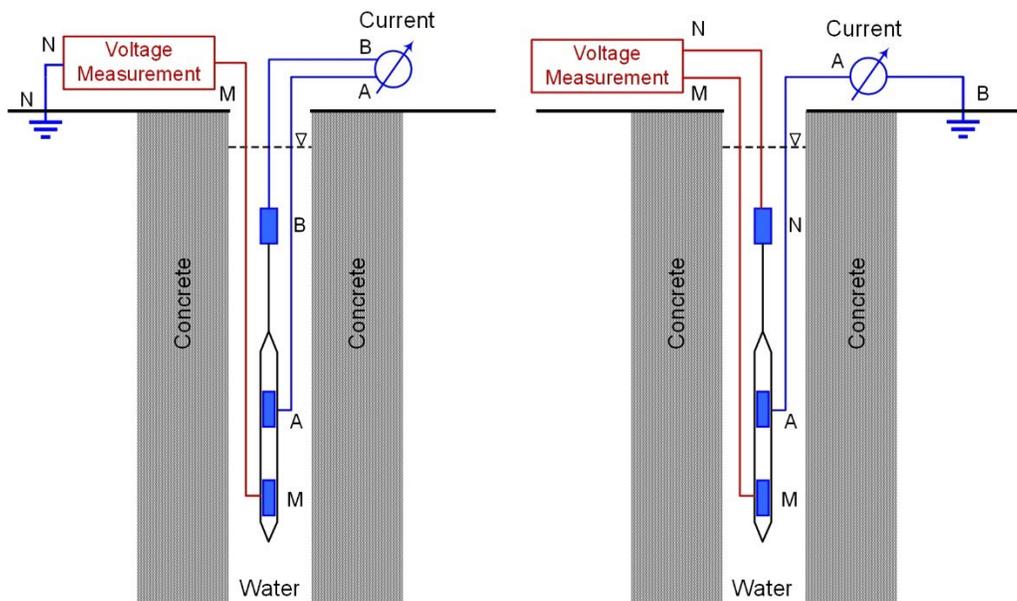
Figure 10. Illustration. Normal (left) and modified (right) resistivity array tools.

Resistivity is a quantitative physical property of the formation. Normal resistivity arrays are one method of measuring this physical property (figure 10). New tools working on single conductor logging cable utilize a 25-ft (7.62-m)-long insulated bridle with the surface electrode replaced with an electrode at the top of the bridle. They utilize four electrodes: two current electrodes (A and B) and two potential (M and N) electrodes. The AM spacing determines the depth of investigation. Long-normal (64N) resistivity looks deeper into the formation than the short-normal (16N) array. The resistivity is controlled by borehole and formation water quality, saturation, rock fabric (grain size, grain shape, etc.), porosity, and mineralization. High resistivity is anticipated in low porosity, cemented, partially to nonsaturated, and nonmineralized formations. Lower resistivity in soil or rock may indicate more conductive water quality, increased porosity, increased conductive mineralization, or clay content. Limestone is usually more resistive than shale. Concrete and mortar may be resistive, depending on saturation and additives. Electrical (Wenner array) resistivity measurements have been used in the past to characterize the corrosive environment in reinforced concrete structures (Wightman et al. 2004).

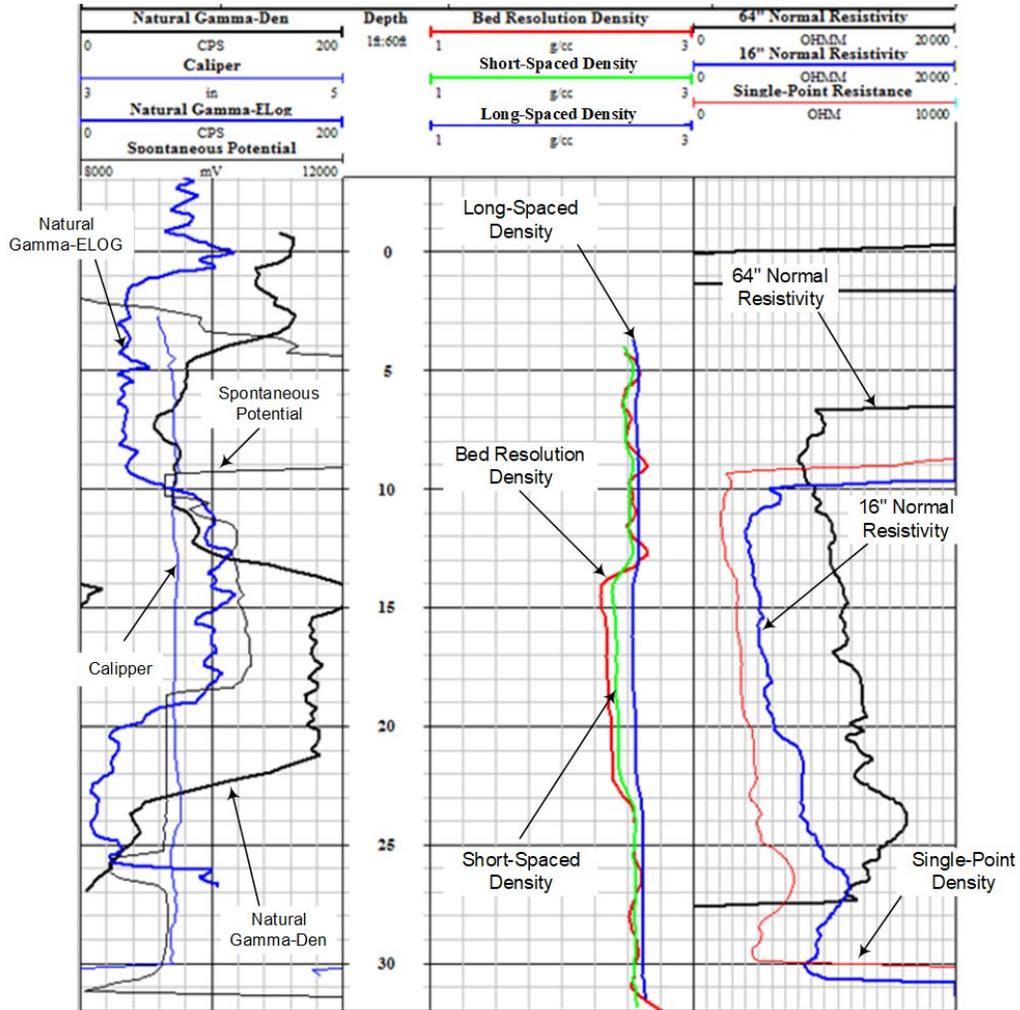
In figure 11, the individual tool files correctly depth correlate the different measurements on a given probe. However, when the two files are compared, the natural gamma log counts on the electric probe (blue curve, track 1) are higher than the natural gamma log on the density probe (black curve, track 1).

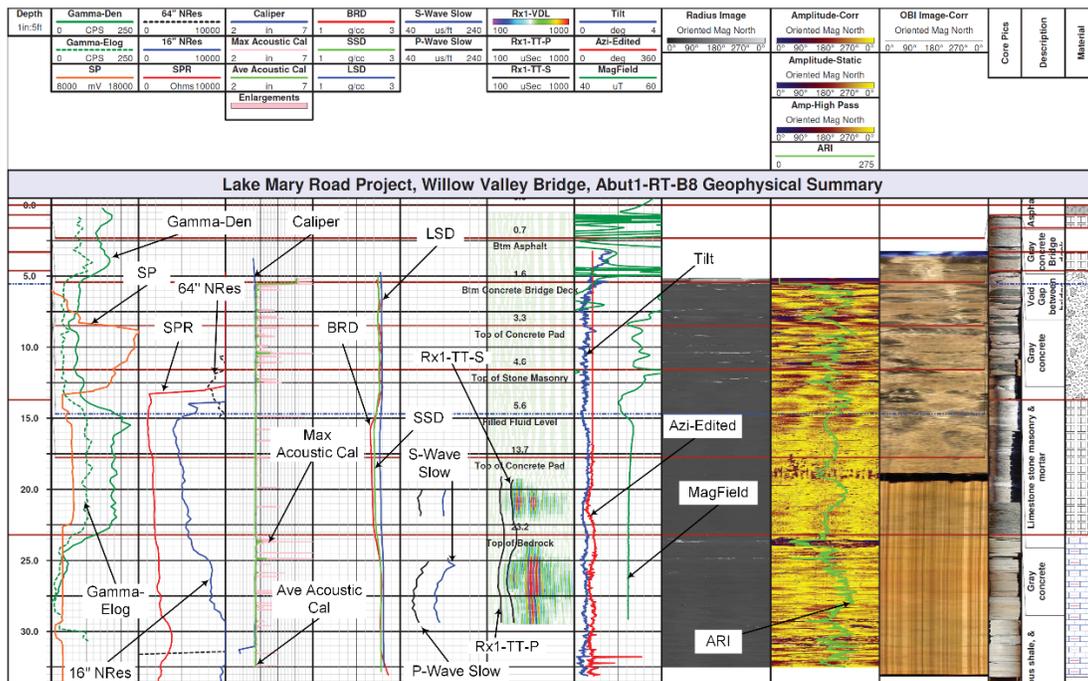
The two gamma logs are plotted in figure 12 at the same scale. However, the gamma collected with the ELOG probe has lower cps values because it has a smaller gamma detector than the gamma on the density probe. Frequently, gamma logs are normalized in API units instead of cps. One gamma API unit is 1/200 of the full-scale value of the gamma log in a specially constructed model in Texas. Additionally, the higher gamma cps values between 15 ft (4.57 m) and 23 ft (7 m) are associated with the concrete foundation. As expected, carbonate sediments have very low cps values. Elastic moduli were only calculated in Pier1-RT-B1 due to limited velocity information. They are calculated with the formulas described in the next section.

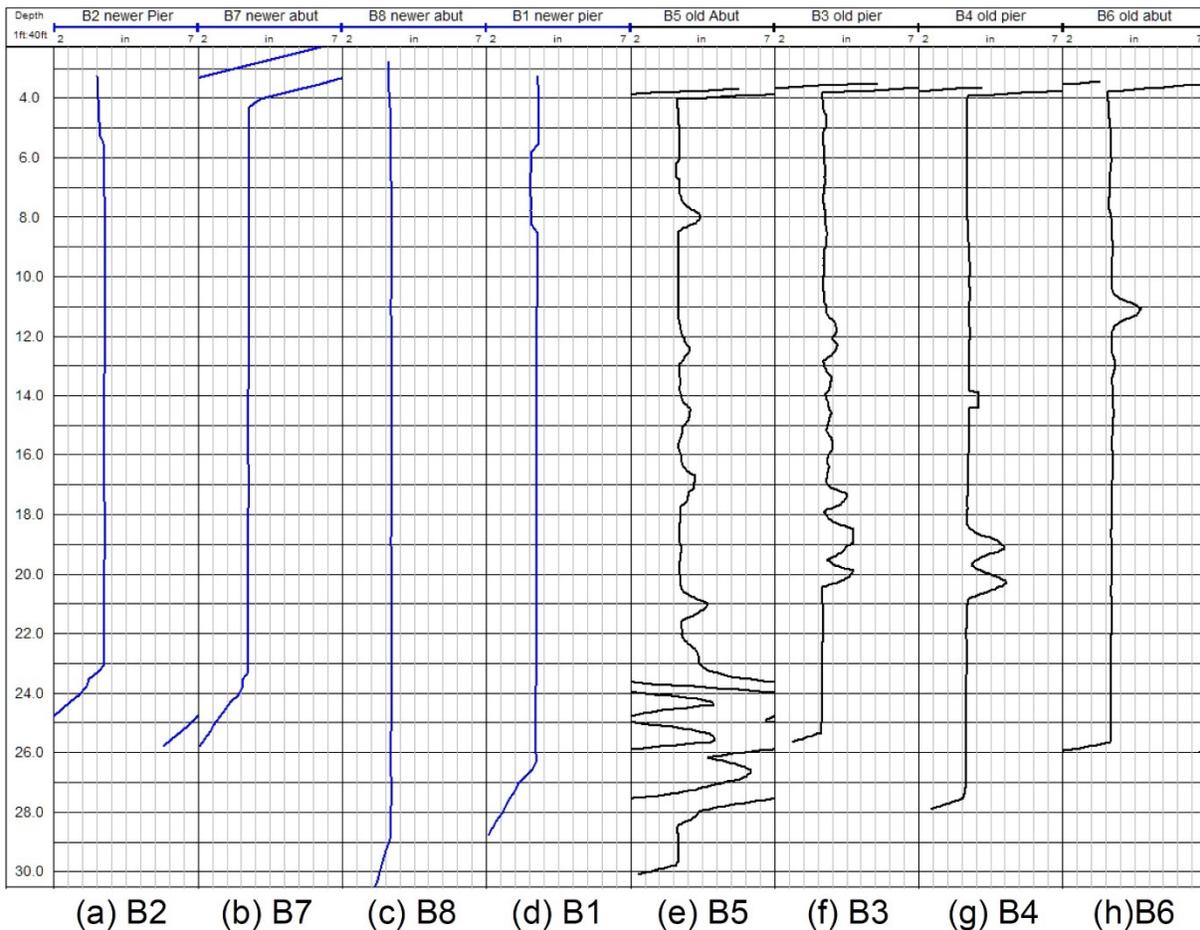
Figure 14. Illustration. Caliper logs from the newer foundation side (a to d) and from the older foundation side (e to h).

We used a one-arm mechanical caliper on the density combination probe. The caliper is used to decentralize the sidewall density measurement, but it also provides the hole diameter. The caliper thus provides a gross hole condition measurement; however, it uses a long arm and provides only one point of contact. Consequently, it is not as responsive as a multiarm caliper measurement. Figure 14 shows caliper logs for newer and older sides of the bridge foundation. The caliper response indicated that coreholes B1, B2, B7, and B8 were largely in drill gauge and good condition. Coreholes B3–B6 were enlarged in the stone masonry section of the holes.

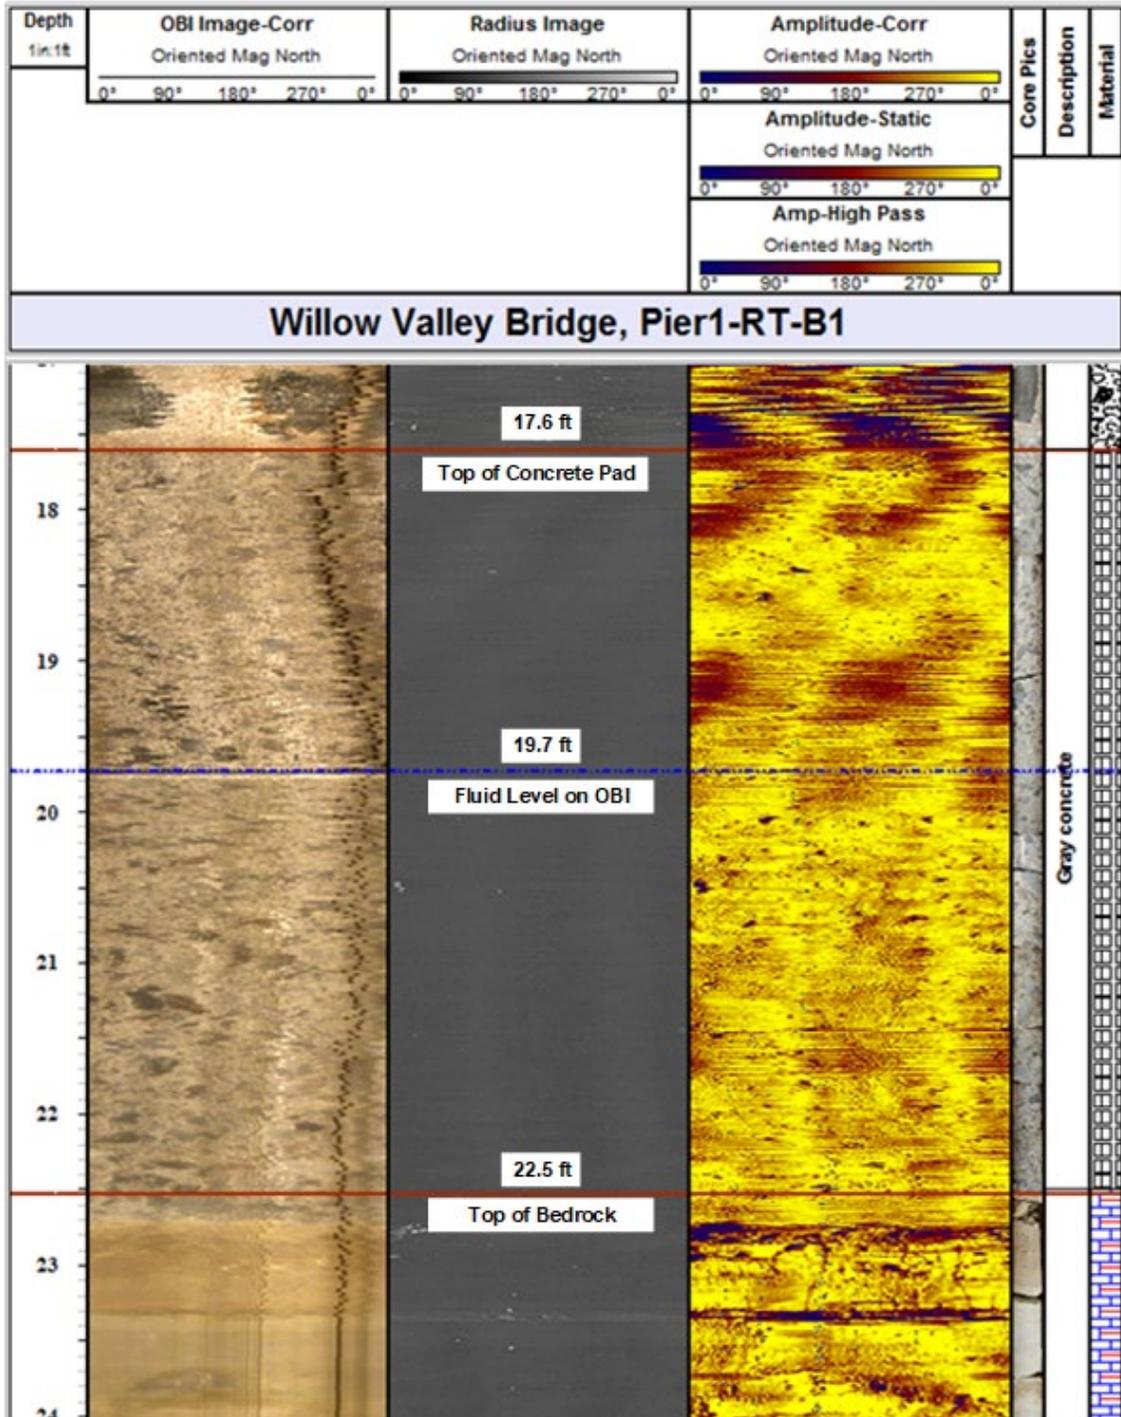
Figure 15. Illustration. Image logs across the concrete pad in Pier1-RT-B1 showing no apparent cracks or fractures.

Concrete pads are located under the stone masonry in the new foundations in holes B1, B2, B7, and B8 on the right side of the bridge. A thinner concrete pad is also located at the top of these piers; however, the image tools did not obtain very useable images in this pad. Image logs of the concrete pad at the base are shown in figure 15 to figure 17. In figure 15, turbid water was encountered at 19 ft (5.8 m) during the OBI log. The corehole wall was coated with apparent drill cuttings/mud on the OBI image, nearly masking the concrete texture. However, this coating and the turbid fluid are transparent to the acoustic image. In figure 16, the concrete pad is several inches thicker than indicated in the core. The fluid level is located at about the middle of the pad in figure 17.

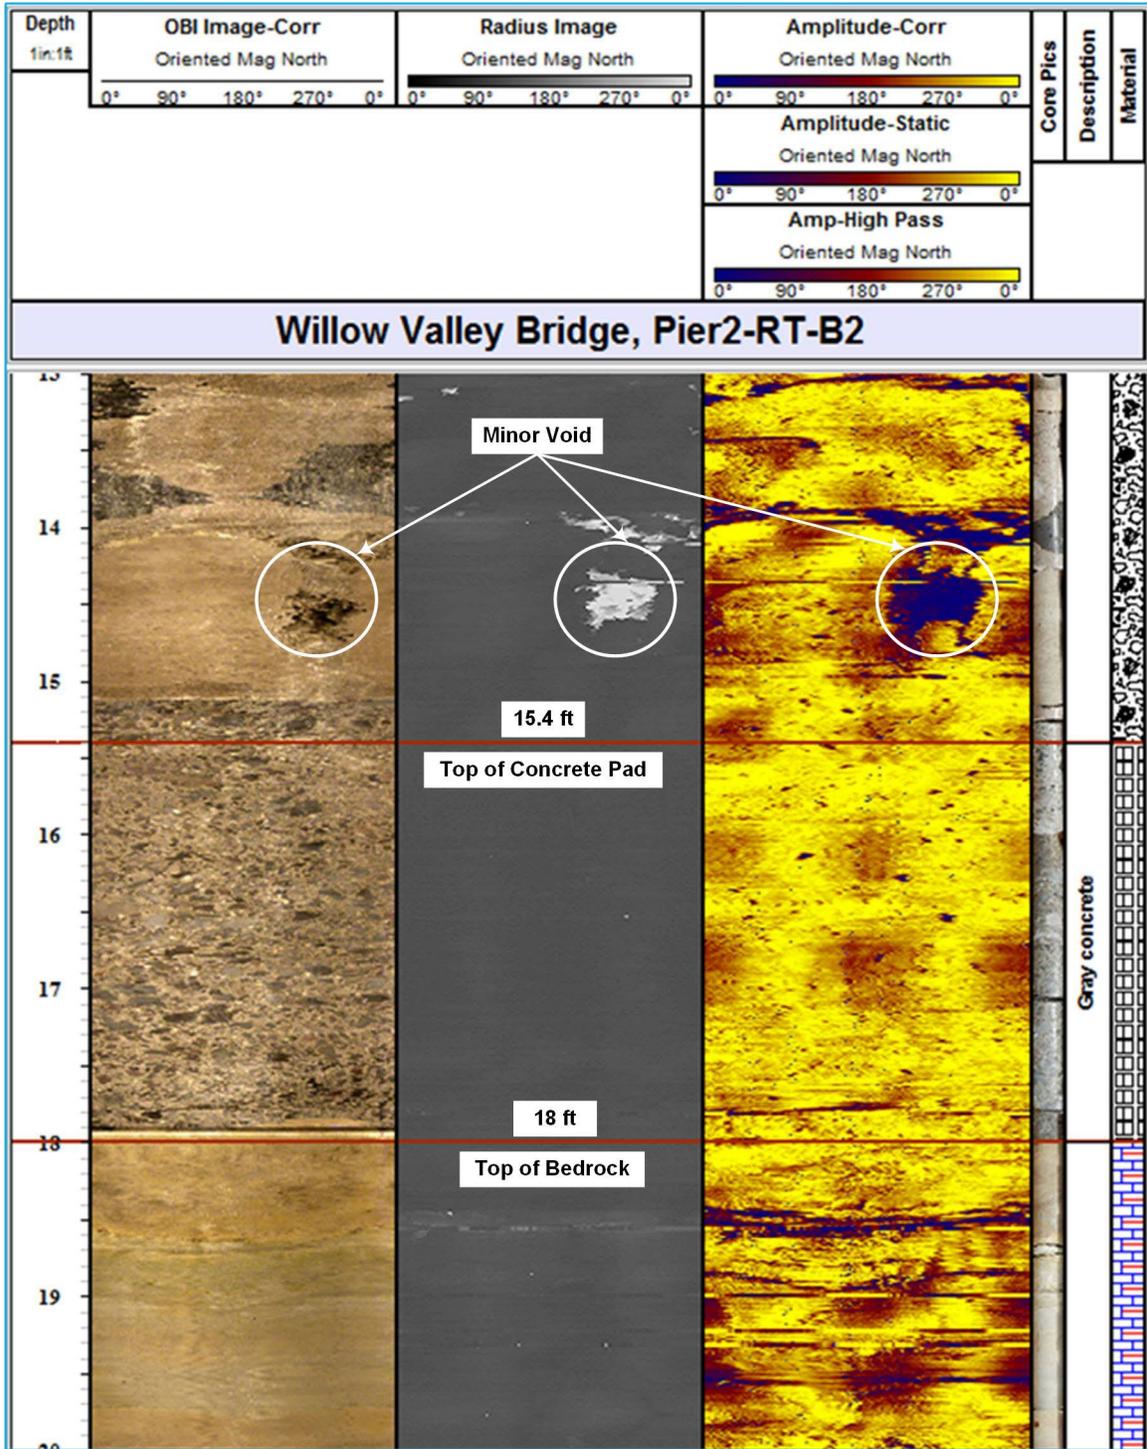
Figure 16. Illustration. Image logs across the concrete pad in Pier2-RT-B2 showing no apparent cracks or fractures.

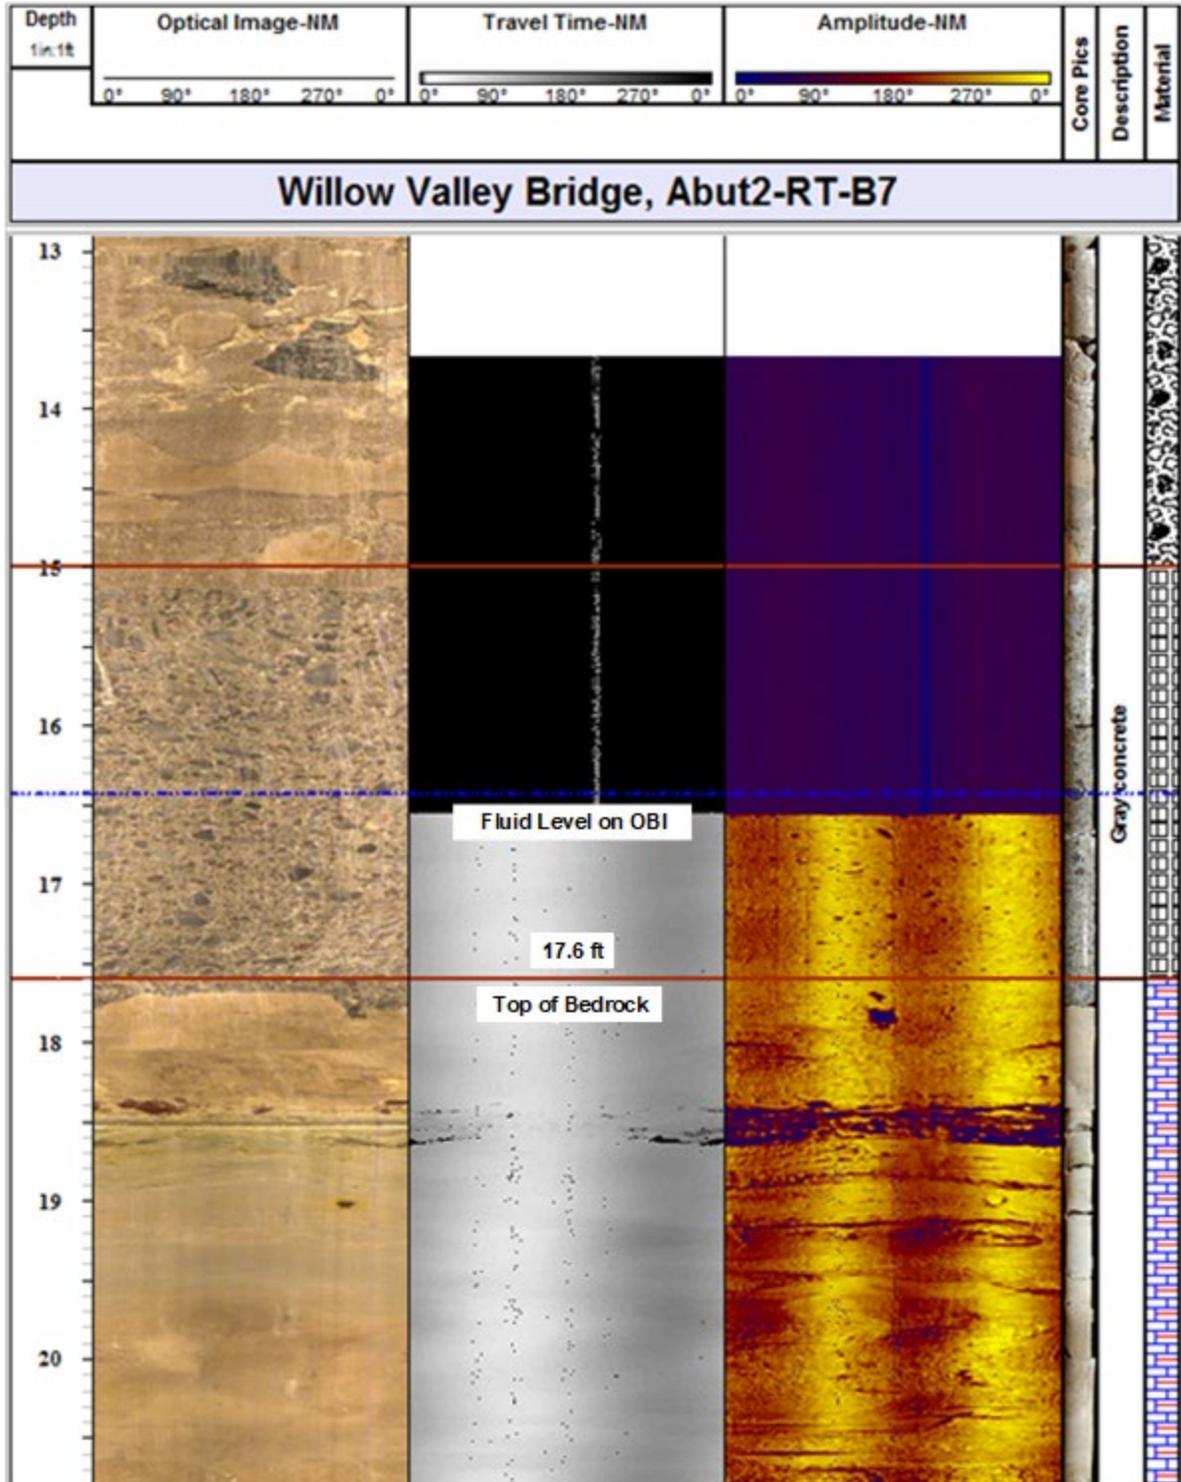
Figure 17. Illustration. Image logs across the concrete pad in Abut2-RT-B7 showing no apparent cracks or fractures.

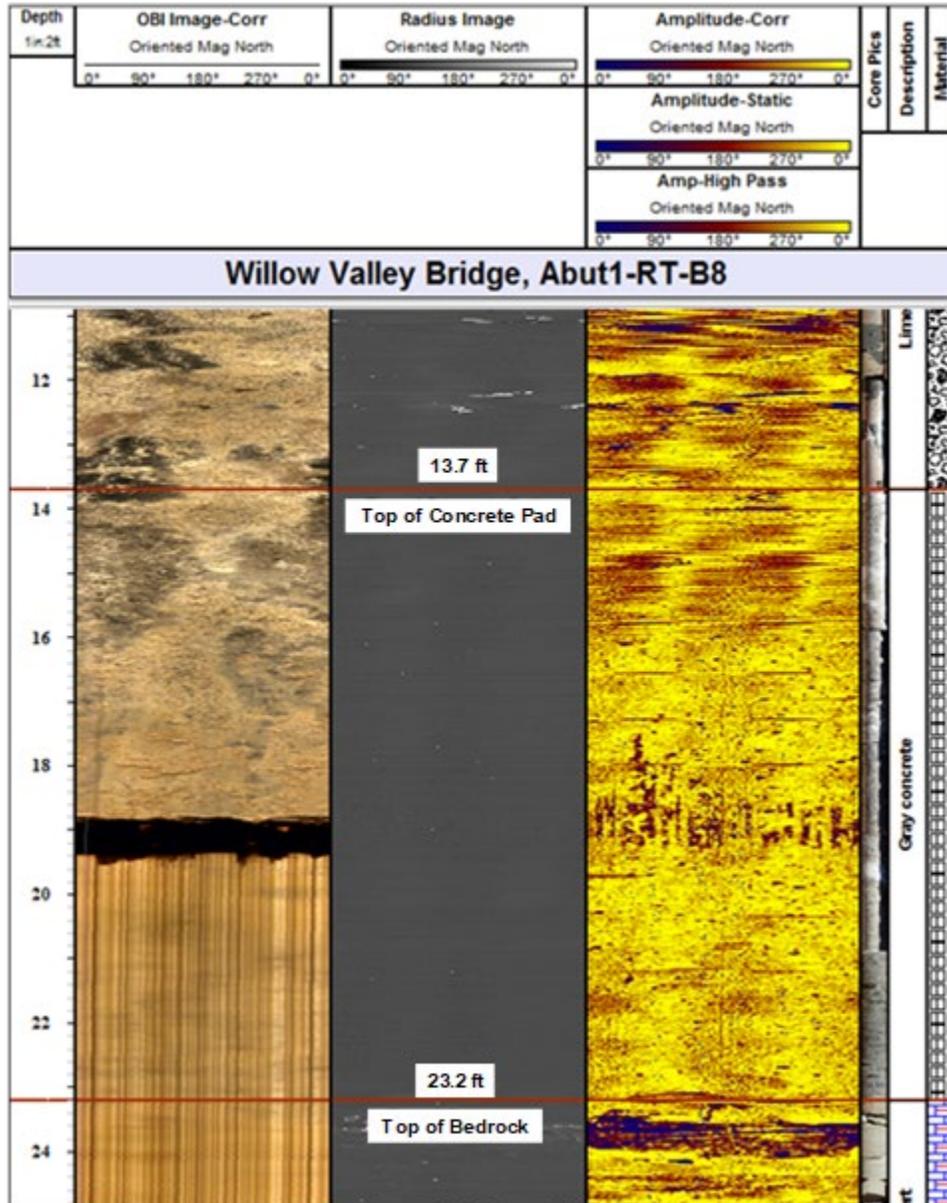
Figure 18. Illustration. Image logs across the concrete pad in Abut1-RT-B8 showing no apparent cracks or fractures.

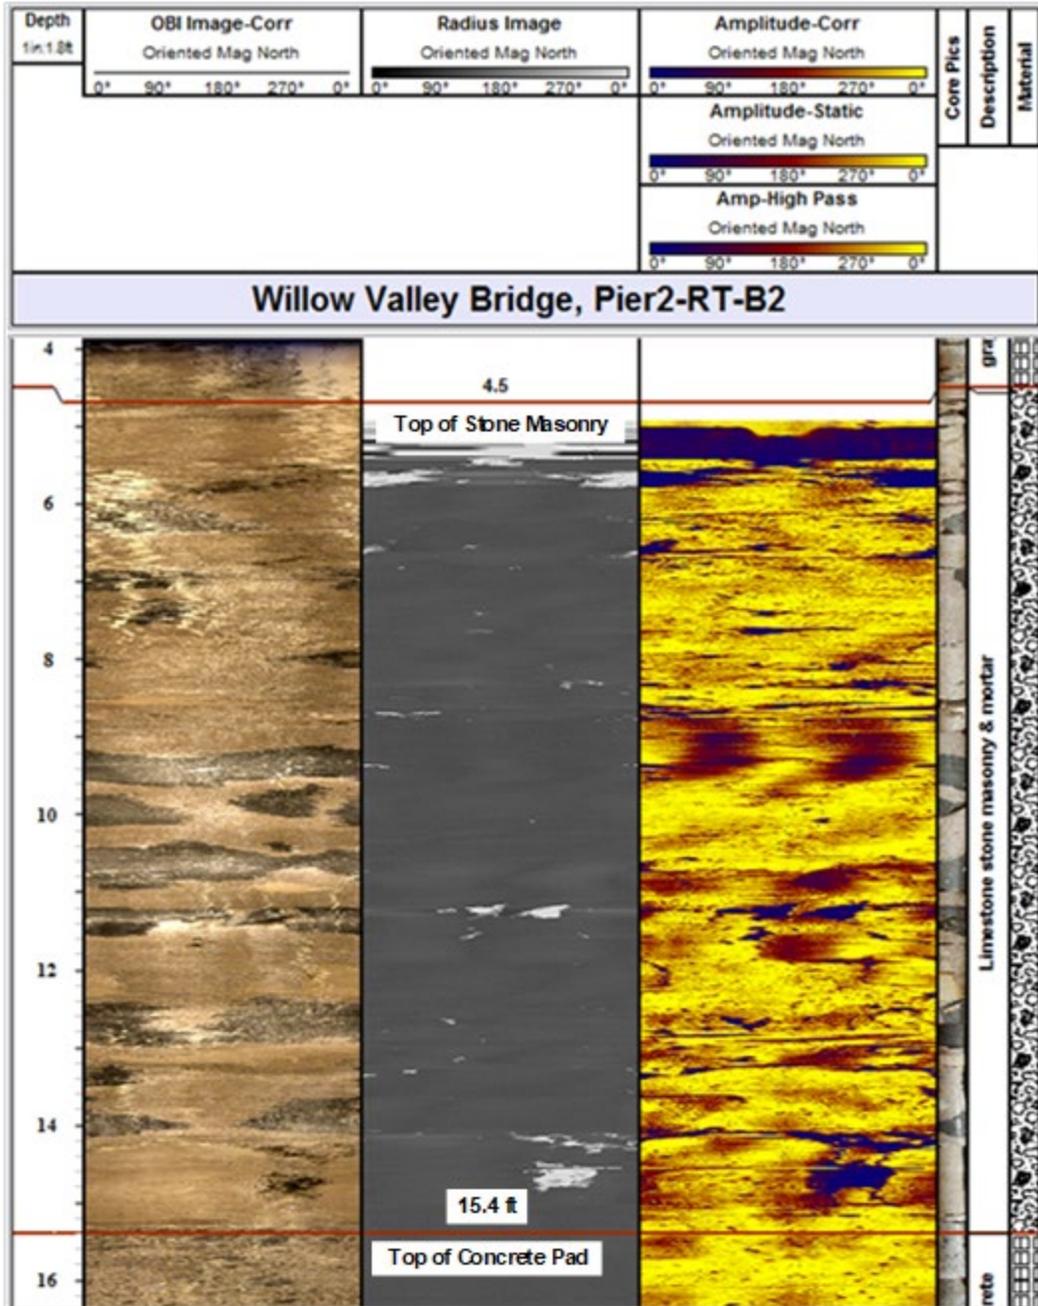
Figure 19. Illustration. Image logs across stone masonry in Pier2-RT-B2.

Figure 18 to figure 21 represent logs showing deterioration in stone masonry construction. The older portion of abutment 1 (where B-5 corehole is located) had the worst deterioration. In figure 19, a few minor enlargements at the edge of clasts are shown at 11 ft (3.4 m) and 14 ft–15ft (4.3 m–4.6 m) on the travel time image. However, it was possible to fill this hole to the top of the pier for the acoustic logs. In figure 20, B5 has the most deterioration. Also, two vugs are in the bedrock in B4. Fine mortar eroded around the harder rubble/clasts can also be seen in figure 21. Figure 22 shows a closeup OBI image in B4 above the bedrock.

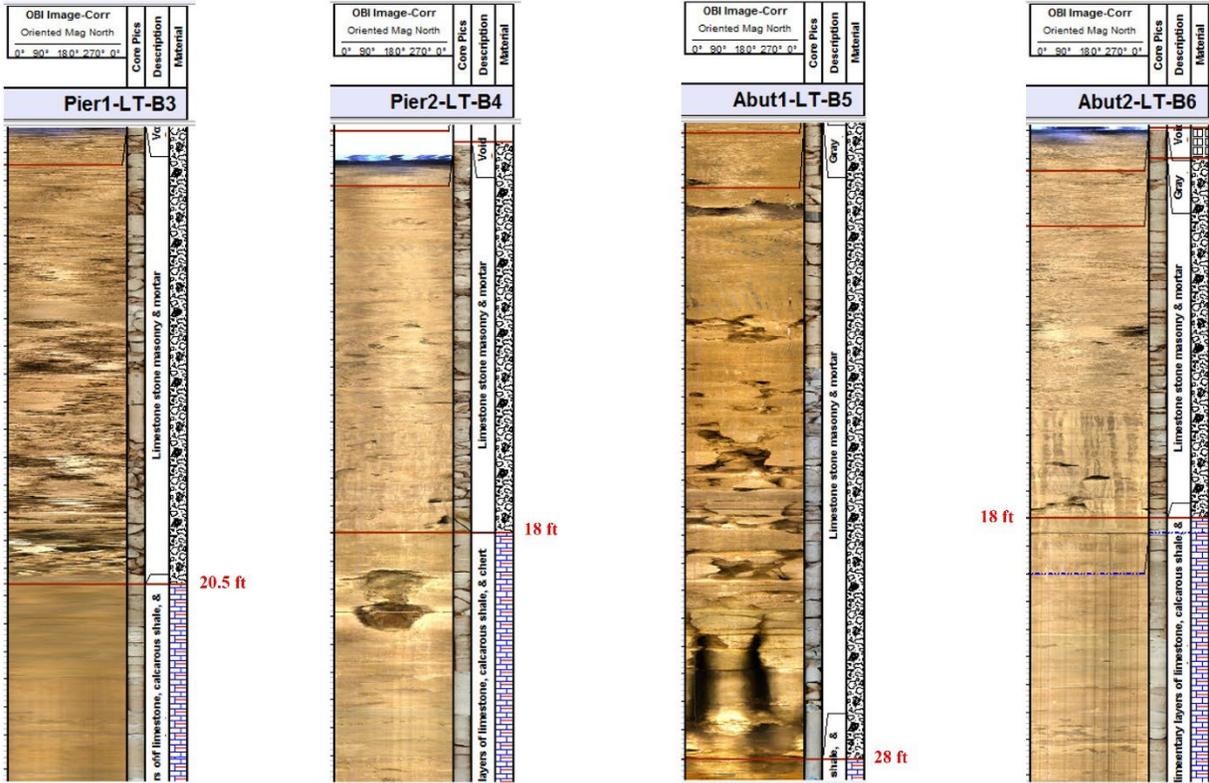
Figure 20. Illustration. OBI images of the stone masonry in the old foundation (B3–B6) showing the various amount of enlargement of the mortar around clasts.

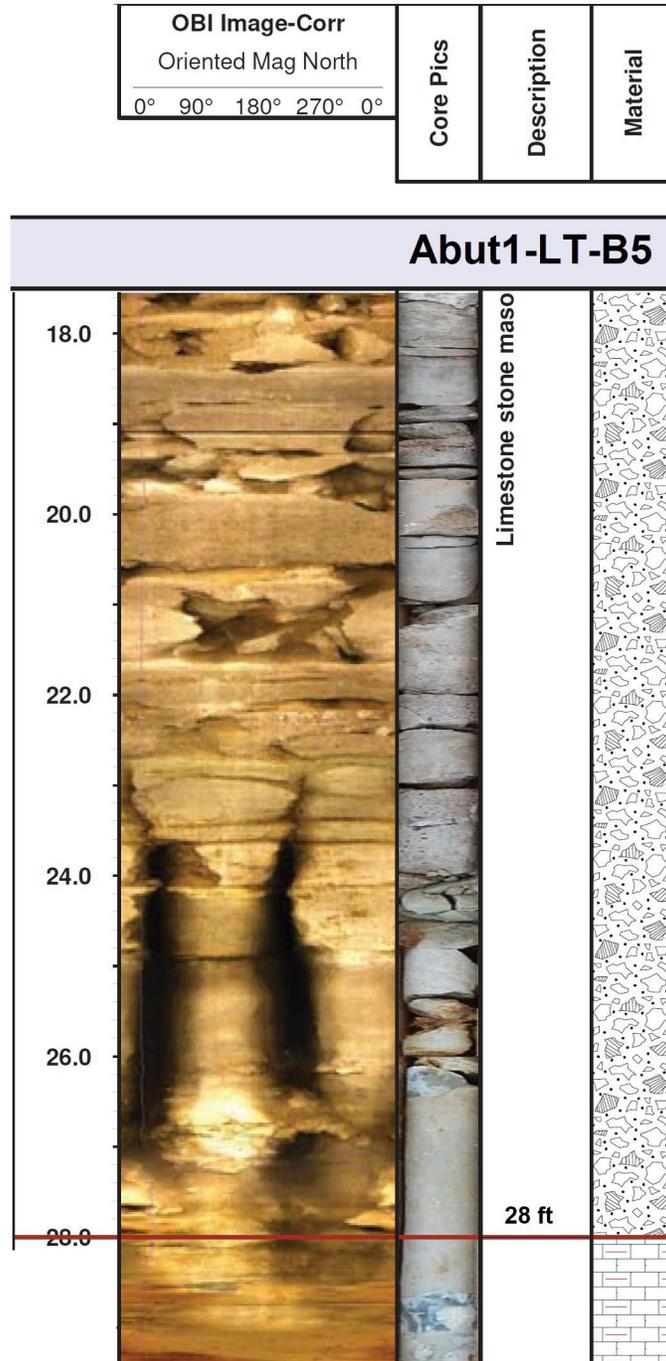
Figure 21. Illustration. Detailed OBI image in Abut1-LT-B5. The two near-vertical enlarged joints have a strike of N41E (MN).
