Substructure Condition Evaluation of the Willow Valley Creek Bridge Using Geophysical Logging Methods

PUBLICATION NO. FHWA-HRT-23-080

OCTOBER 2023

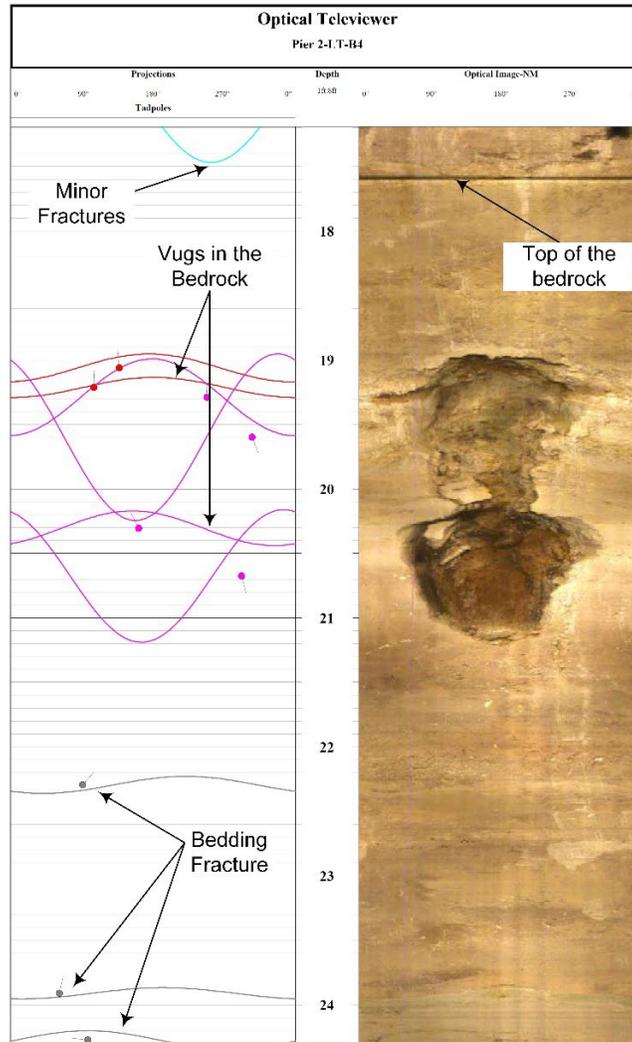
Figure 22. Illustration. Optical televiewer image (right) and stereographic projections and tadpole (left) of Pier2-LT-B4 over the bedrock interval.

Figure 18 to figure 21 represent logs showing deterioration in stone masonry construction. The older portion of abutment 1 (where B-5 corehole is located) had the worst deterioration. In figure 19, a few minor enlargements at the edge of clasts are shown at 11 ft (3.4 m) and 14 ft–15ft (4.3 m–4.6 m) on the travel time image. However, it was possible to fill this hole to the top of the pier for the acoustic logs. In figure 20, B5 has the most deterioration. Also, two vugs are in the bedrock in B4. Fine mortar eroded around the harder rubble/clasts can also be seen in figure 21. Figure 22 shows a closeup OBI image in B4 above the bedrock.

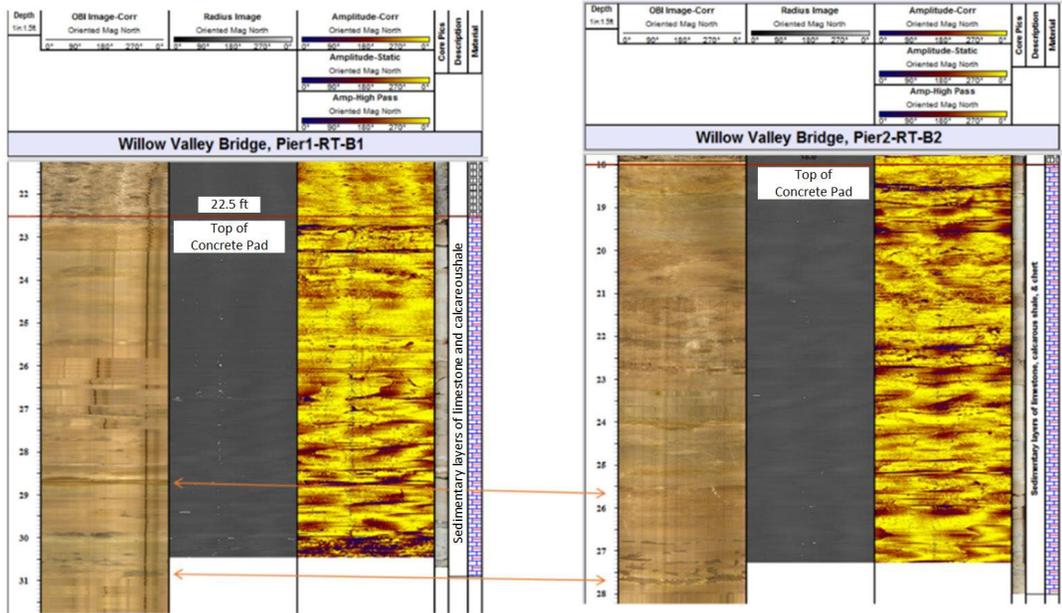
Figure 23. Illustration. Image logs for Pier1-RT-B1 and Pier2-RT-B2 in the bedrock.

Figure 23 to figure 29 show logs displaying the bedrock features. The survey data collected with the image logs shows the tilt of the coreholes is near vertical. Core breaks in the bedrock are near perpendicular to the core, which is consistent with the image log picks. In figure 23, the correlation of two features is shown with the arrows. Bedding features in B3, B4, and B6 can be correlated as shown by the arrows in figure 24. This feature is the same as seen at the bottom of B1 and B2 in figure 23. In figure 25, the poor image quality in B8 is due to turbid borehole fluid preventing any strong bedding correlation; however, the bedding features from 26 to 27 ft (7.9 to 2.1 m) in B7 appear to be the same beds correlated in figure 23 and figure 24. In figure 27, the column to the right shows all the feature picks combined in a single plot.

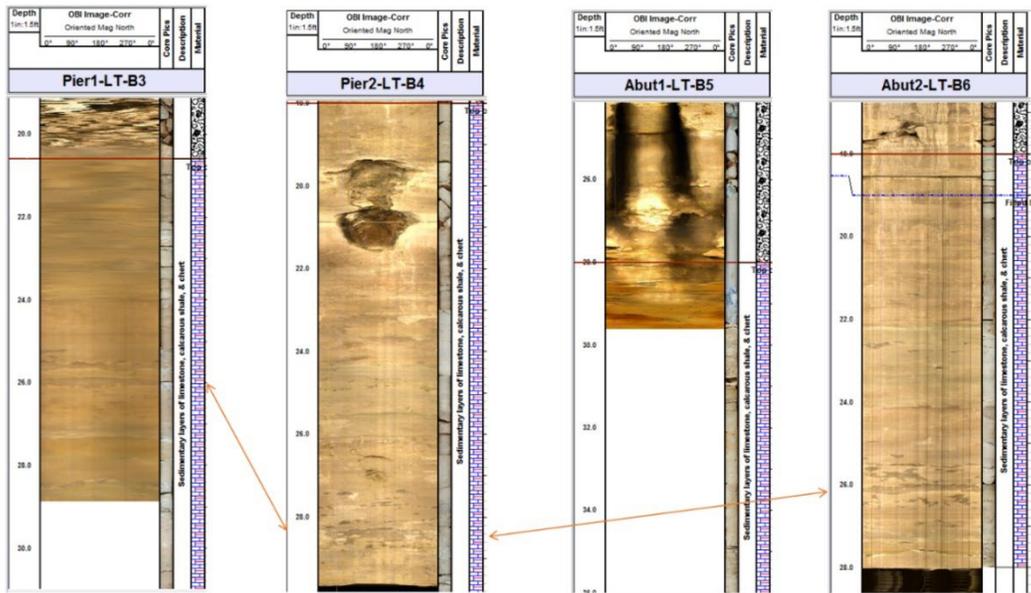
Figure 24. Illustration. OBI images in old foundation (B3-B6) over the bedrock interval.

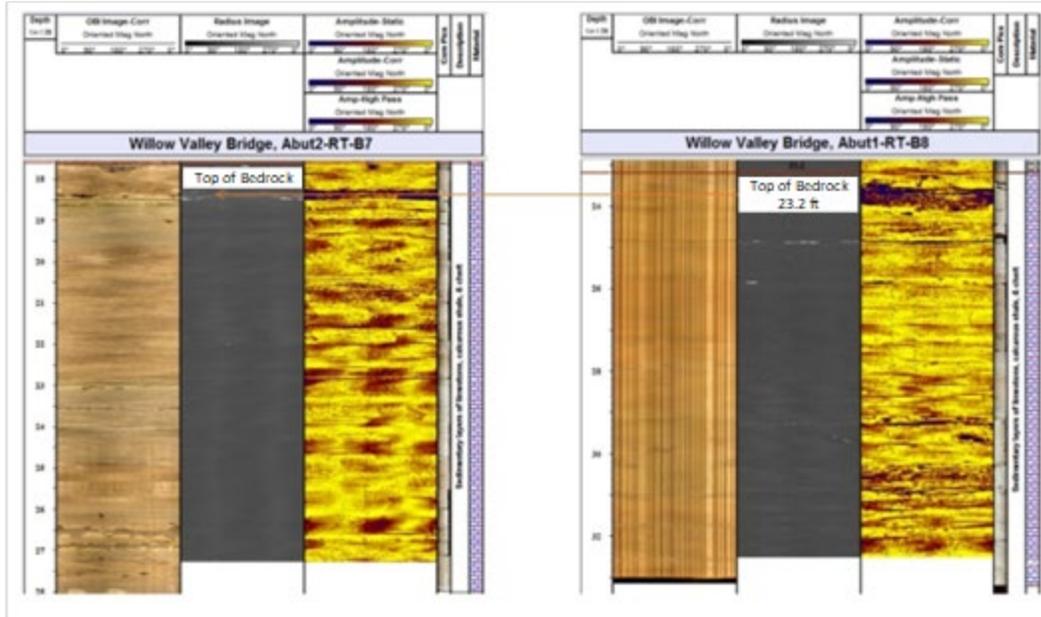
Figure 25. Illustration. Image logs for old foundation Abut2-RT-B7 and Abut1-RT-B8 in the bedrock.

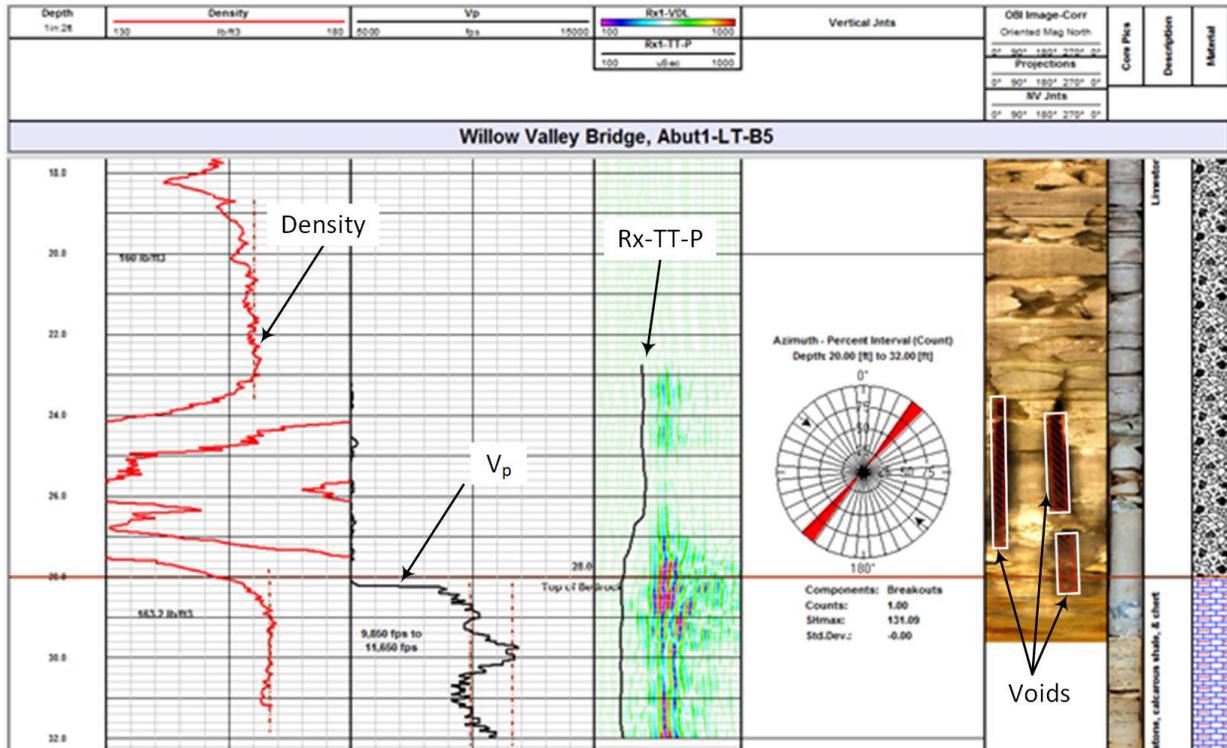
Figure 26. Illustration. The large near-vertical enlargements in Abut1-LT-B5 are striking N41E (MN).

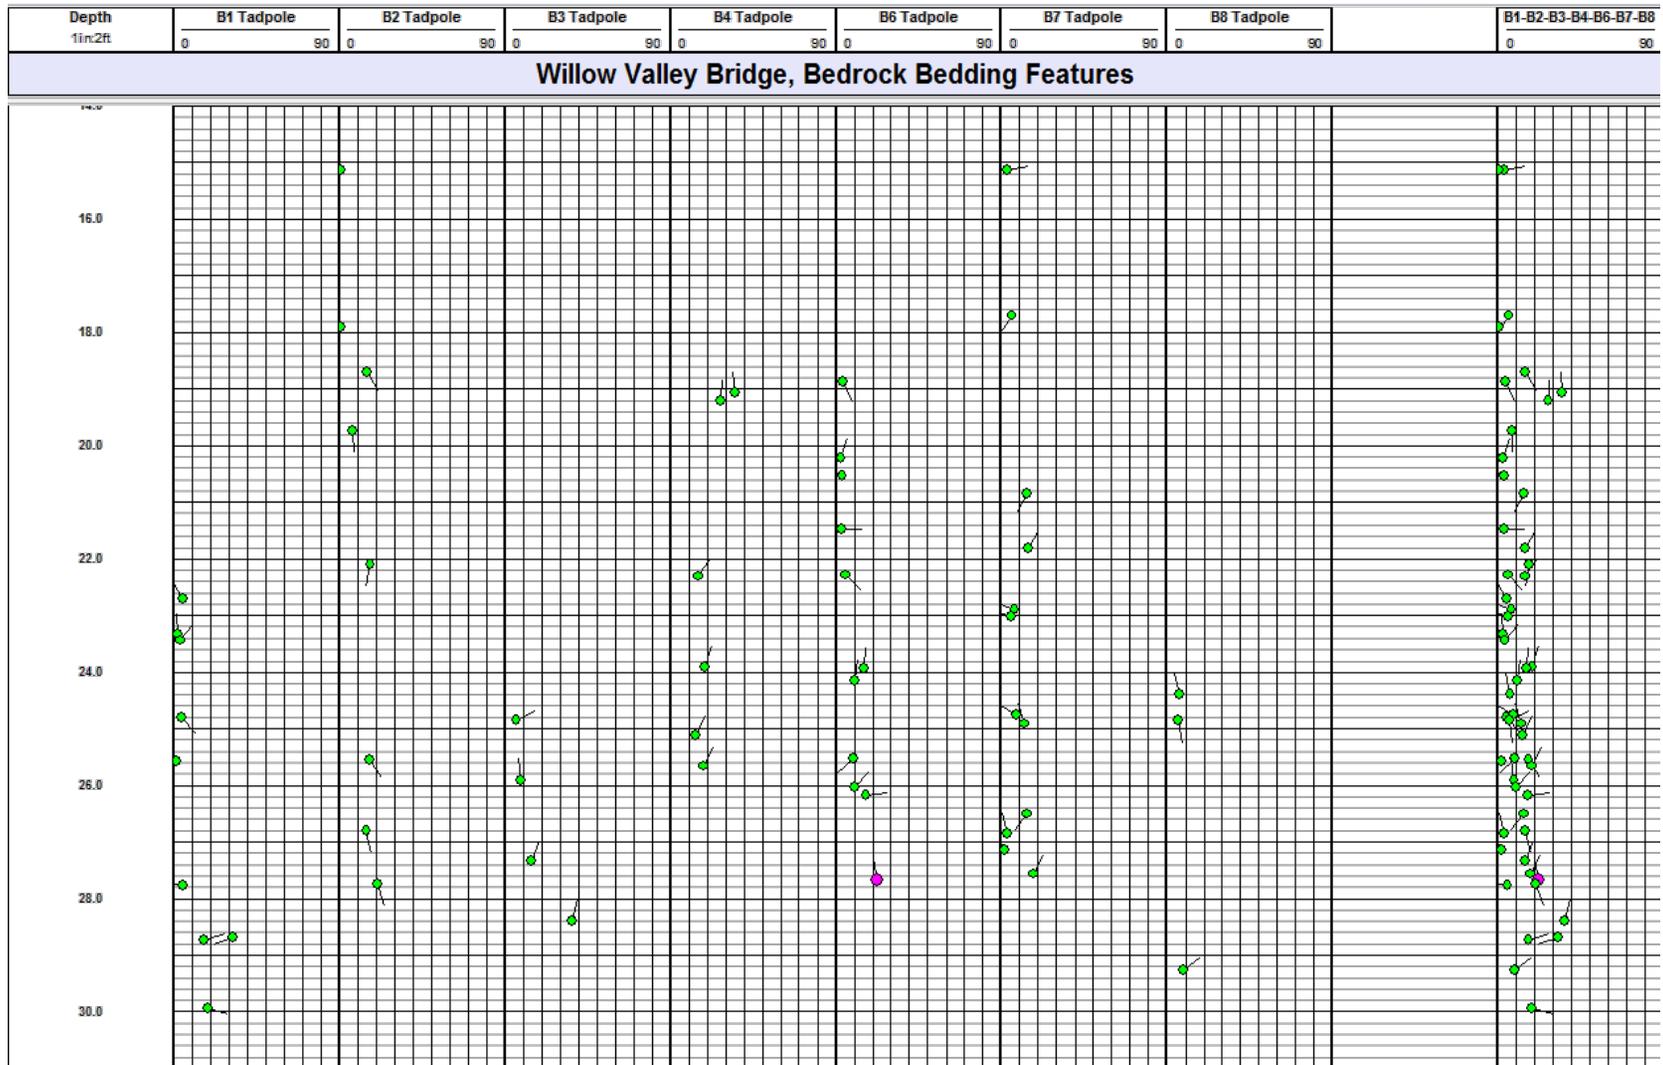
Figure 27. Illustration. Tadpole summary plot of the bedrock feature picks in B1–B4 and B6–B8.

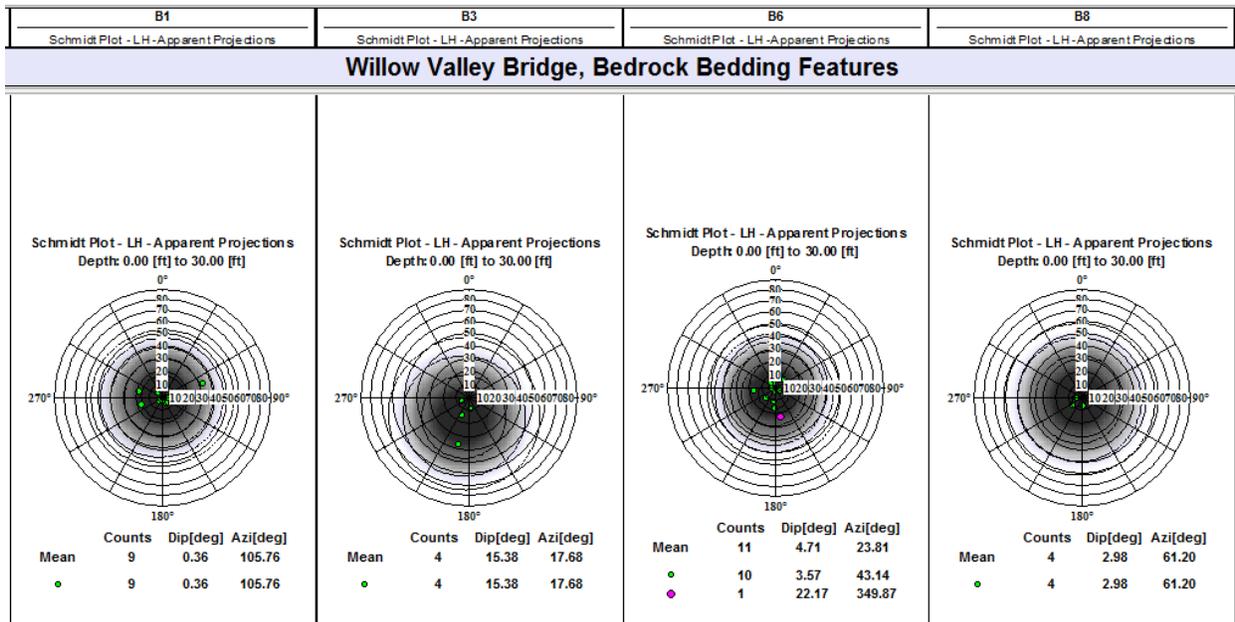
Figure 28. Illustration. Schmidt plots of the feature picks in the bedrock in B1, B3, B6, and B8.

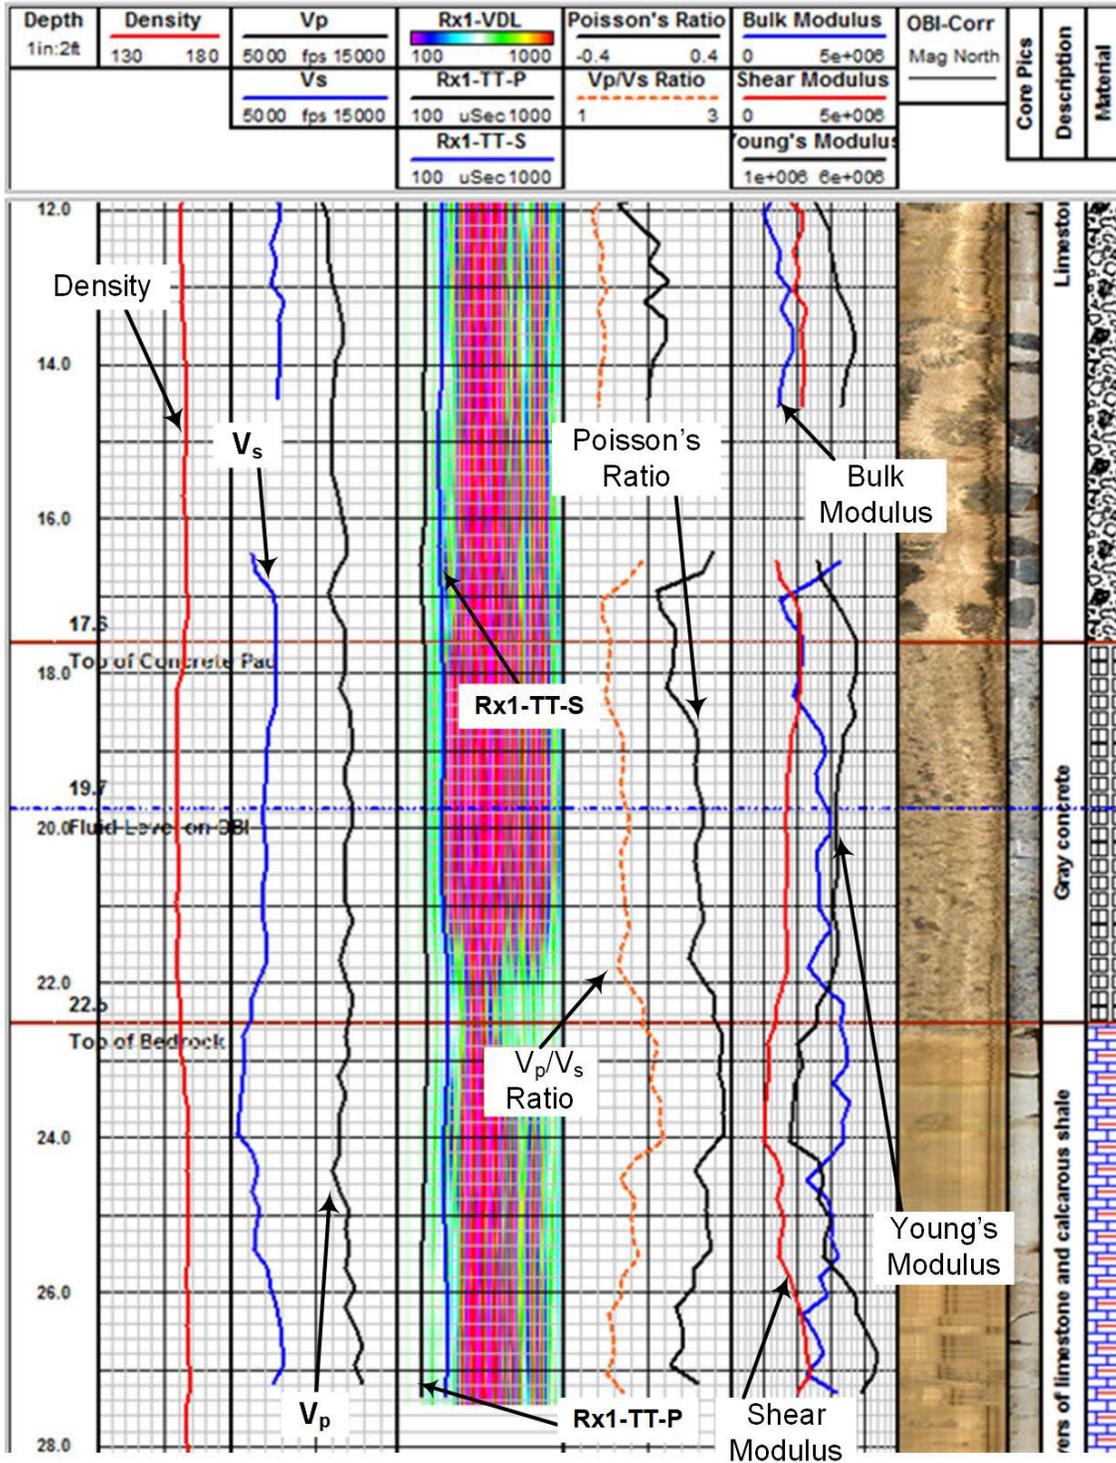
Figure 30b shows elastic moduli logs for corehole B1 in pier 1. The elastic moduli (shear, bulk, Young's moduli, and Poisson ratio) logs, shown on the right, are derived from the measured compressional and shear velocities and density logs shown on the left (refer to Figure 13 equations). Integrity assessment of the foundation element near the corehole region can be made by observing variations in elastic moduli in these logs. Very little variation in elastic moduli in figure 30b indicated the stone masonry was in good condition in the right portion of pier 1. The integrity of other parts of the stone masonry could be inferred from composite logs in figure 31 to figure 37.

Figure 30b. Illustration. Pier1-RT-B1 physical properties (elastic moduli) logs.

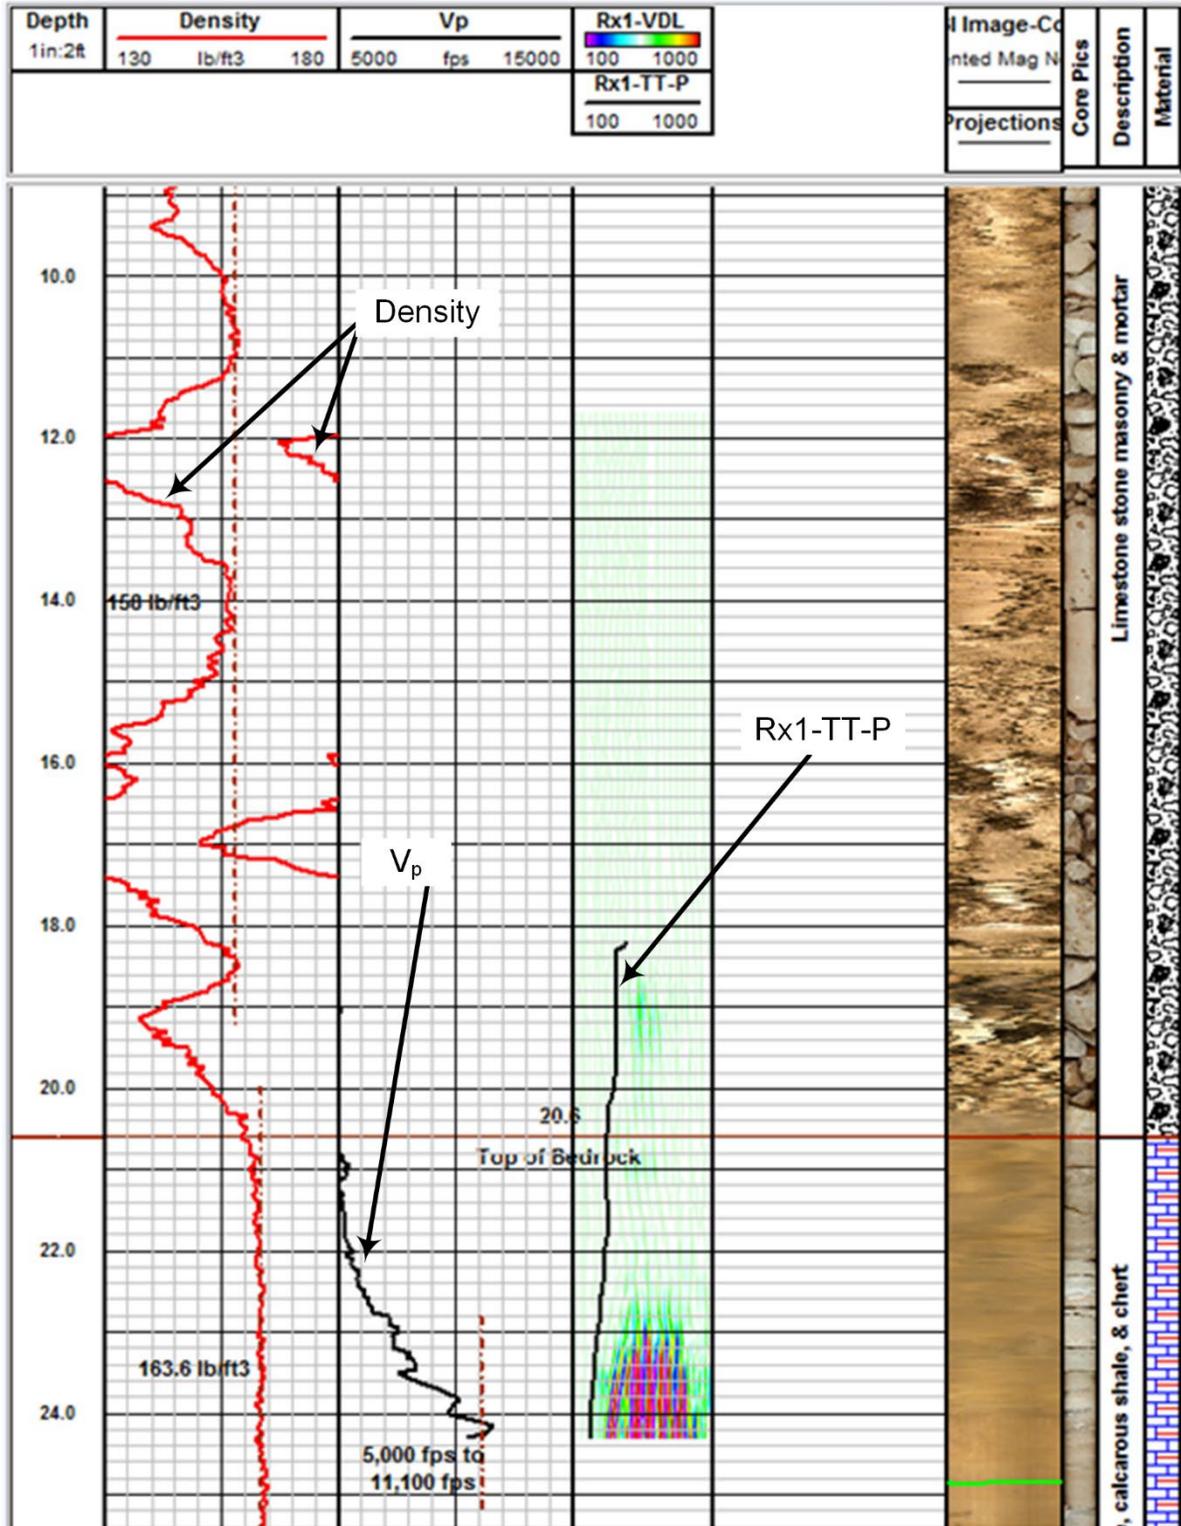
Figure 34. Illustration. Pier1-LT-B3 physical parameter summary.

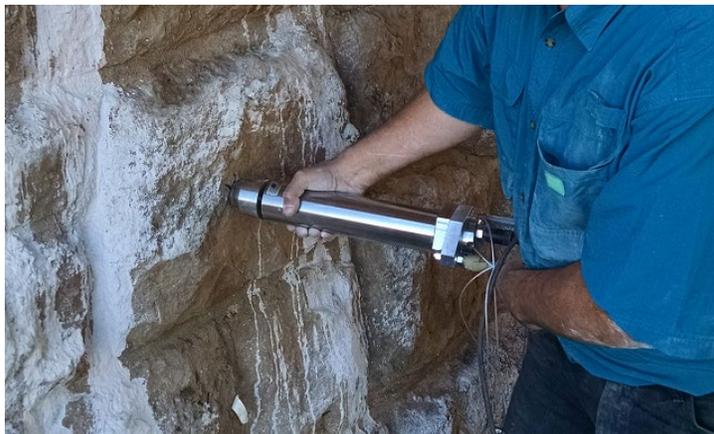
Figure 38. Photo. Source with the attached handle being applied at the rock surface.

Initially, we conducted downhole seismic testing using a magnetostrictive source applied at the surface of masonry foundation and a hydrophone string that was lowered down the coreholes. At each source point, the tip of the source was pressed manually against a sufficiently flat spot on the surface of a limestone block at a foundation masonry wall, and then the source was powered to send seismic waves into the foundation structure (figure 38).

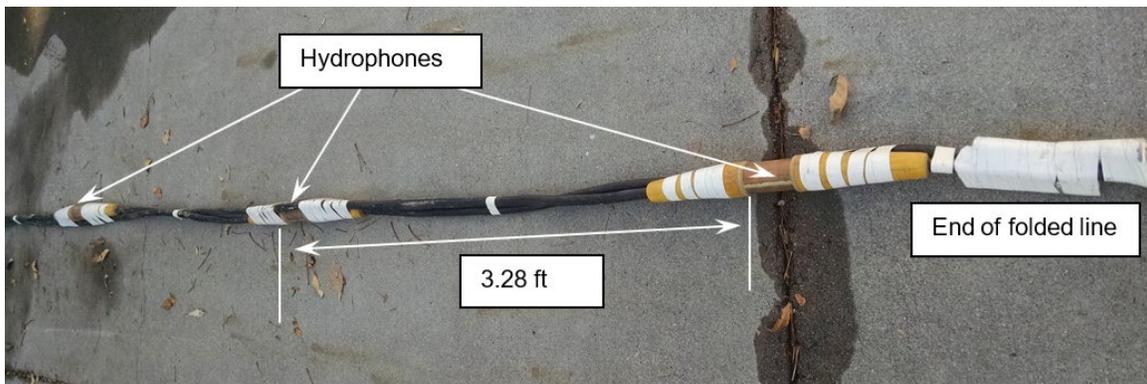
We folded a string of 12 hydrophones at 6.56 ft (2 m) center to center spacing (figure 40 and figure 41) to form a linear array of hydrophones at 3.28 ft (1 m) centers, enabling a simultaneous installation of up to 8 hydrophones in coreholes that were a maximum of 30 ft (9.1 m) deep. This setting required conducting four rounds of shots through all selected source points and moving hydrophones up by 0.82 ft (0.25 m) between consecutive rounds to get the desired distribution of hydrophone records in each corehole.

Figure 40. Photo. Twelve-hydrophone line in B-1, folded to shrink offset between hydrophones to 3.3 ft (1 m).

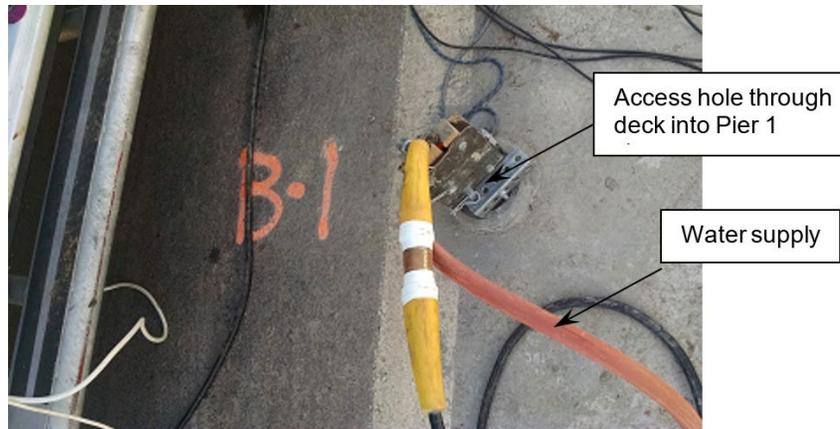
Figure 41. Photo. Folded hydrophone line suspended in corehole Pier1-LT-B1.

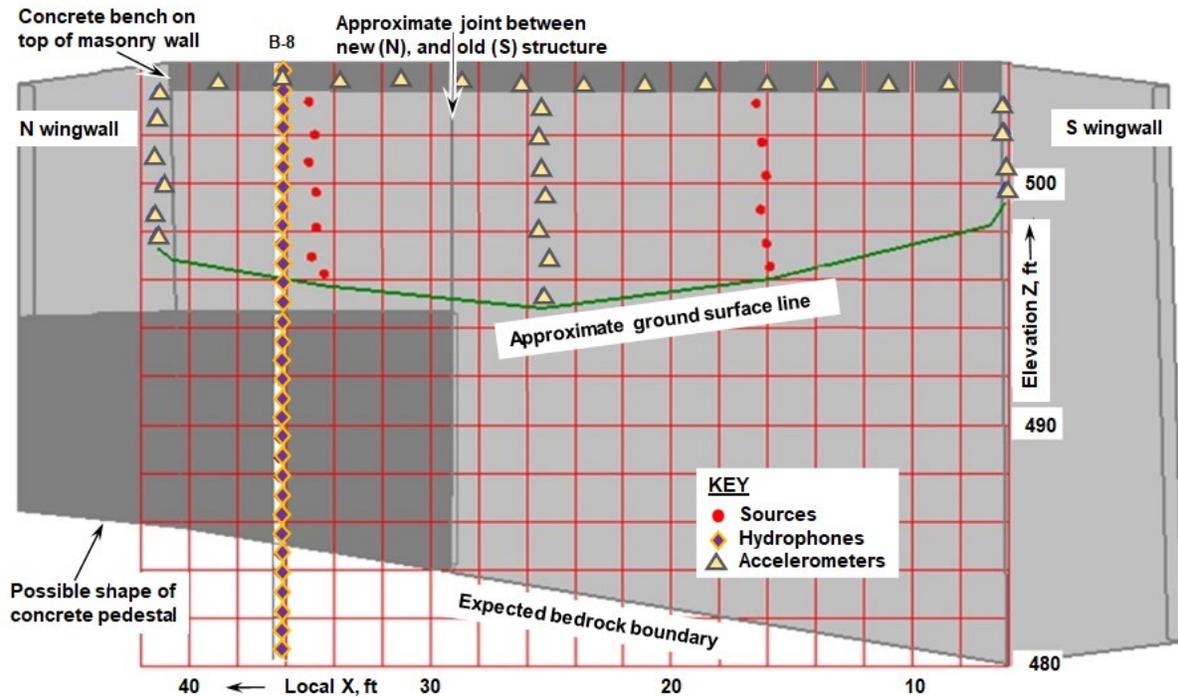
An example of the downhole seismic from abutment 1 is shown in figure 43. In general, 2 approximately vertical lines of source points (dots in figure 43) were selected on a sidewall of each foundation unit, and the accelerometers (triangles) were arranged in sets of 11 stations, plus 1 common station used as a reference for all records per each foundation unit. The line of eight hydrophones (diamonds in figure 43) was lowered into the coreholes drilled from the bridge deck into the surveyed foundation unit and down into the bedrock.

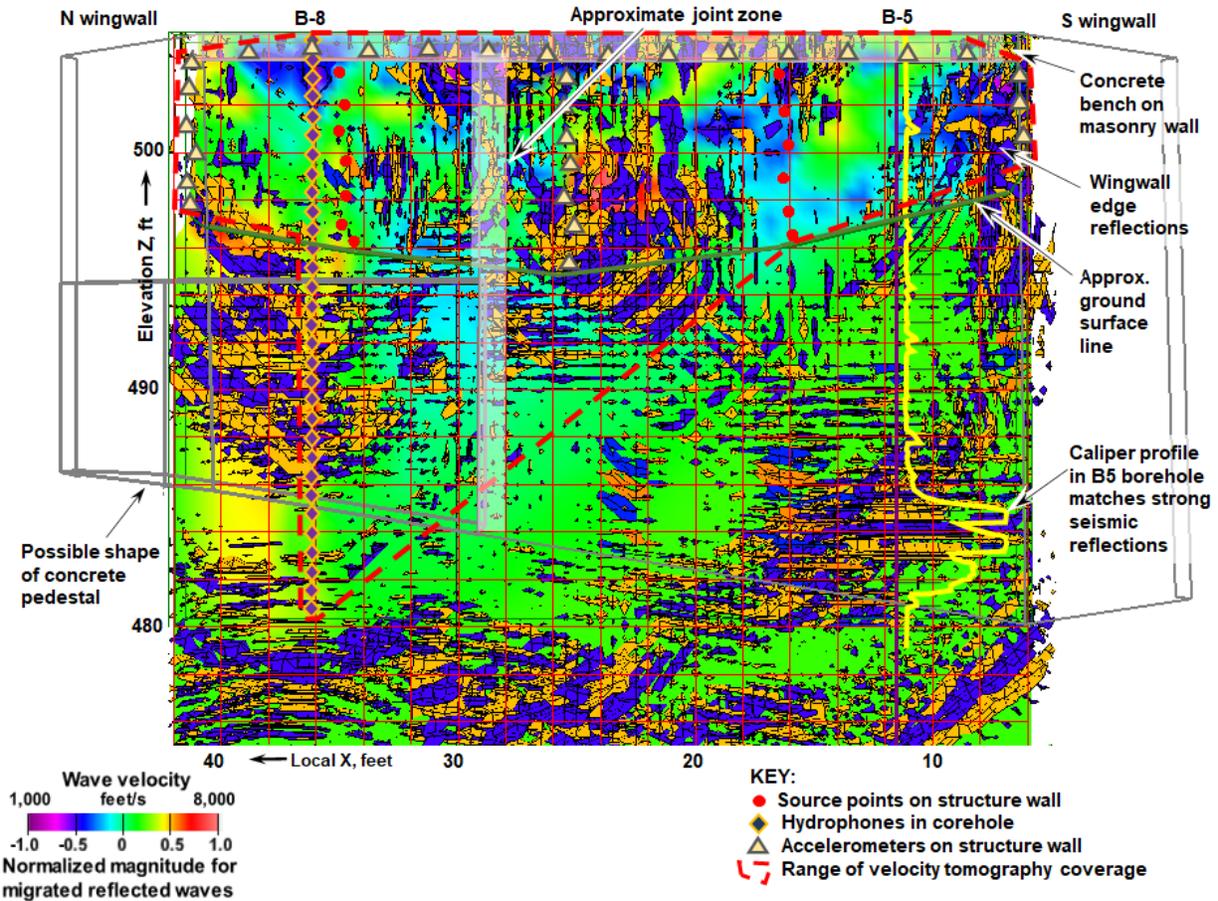
Figure 46 indicates “reflectogram” images constructed through migration of reflected seismic waveforms to their reflection points superimposed on the velocity model in Figure 45. Because it uses reflected arrivals, the reflectogram has full wall coverage. The migrated waveforms correlated well with the known abutment wall boundaries and with the interpreted location of voids in the wall foundation (indicated by the yellow caliper line). A strong reflective anomaly correlates with the elevated velocity related to the pedestal. Furthermore, an S-shaped dipping zone below the depth of 484 ft (147.5 m) appears parallel to a possible inclined bedrock boundary.
