NextScour Case Study: The I-6064/I-95 Bridge Replacements Over the Lumber River in Lumberton, NC

PUBLICATION NO. FHWA-HRT-24-038

FEBRUARY 2024

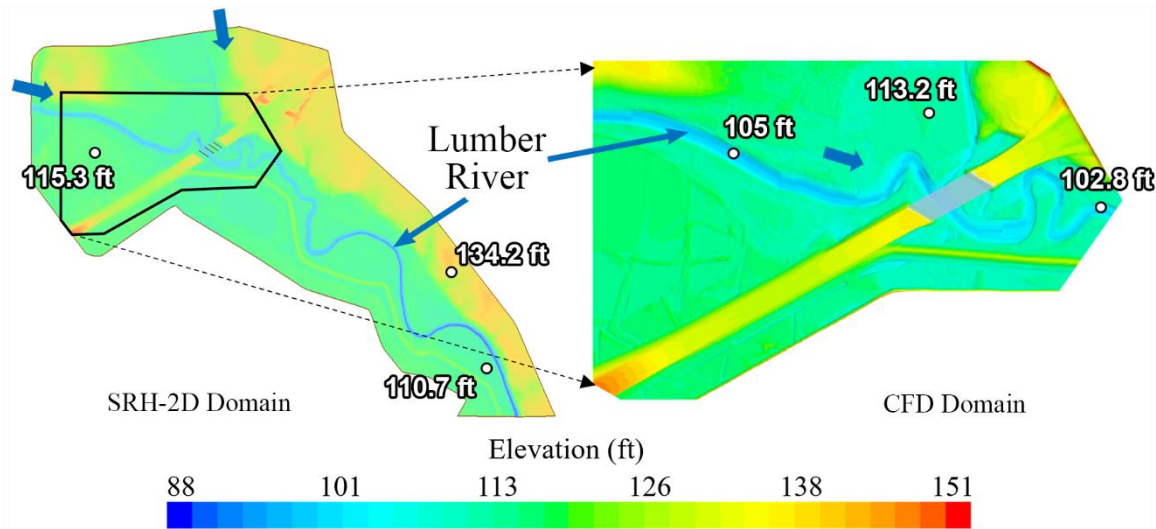
Figure 3. Images. Subwatershed elevation (SRH-2D) and computational domain elevation (CFD).

The full-scale simulation for NCDOT I-6064/I-95 Lumber River bridge was divided into three stages: preparation of the full-scale computational domain, preprocessing of the simulation, and postprocessing analysis of the results. In the first stage, the computational domain for the Lumber River bridge subwatershed was generated using point cloud data exported from the SRH-2D model, as shown in figure 3. NCDOT developed this digital elevation model (DEM) using light detection and ranging (LiDAR) data combined with cross-section survey data. Figure 3 shows the whole subwatershed domain used for SRH-2D modeling, and a polygonal box shows the boundary of the smaller CFD domain. Both the SRH-2D and CFD domains included the proposed design of the I-95 highway, bents, and spill-through abutments. The CFD domain in figure 3 is 3,772 ft long by 2,415 ft wide.

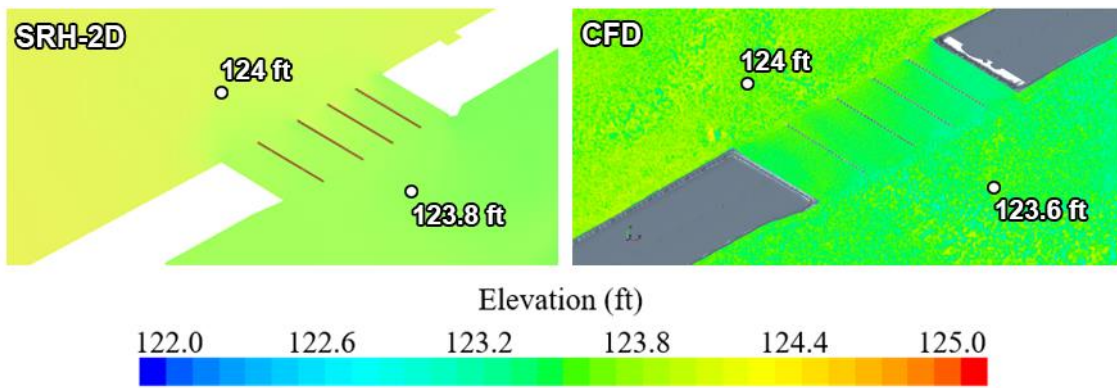
Figure 6. Images. Water surface elevation comparison between SRH-2D and CFD models for the Q_{100} flood event.

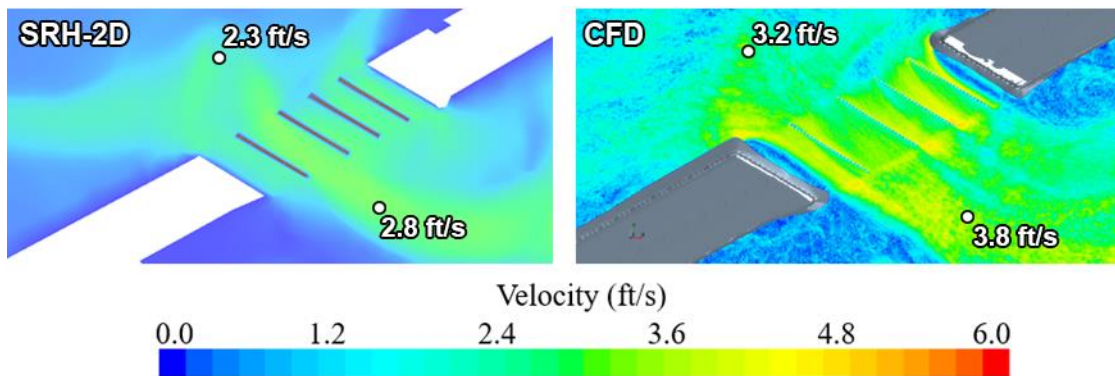
Figure 7. Images. Flow velocity comparison between SRH-2D and CFD models at 60 percent water depth for the Q_{100} flood event.

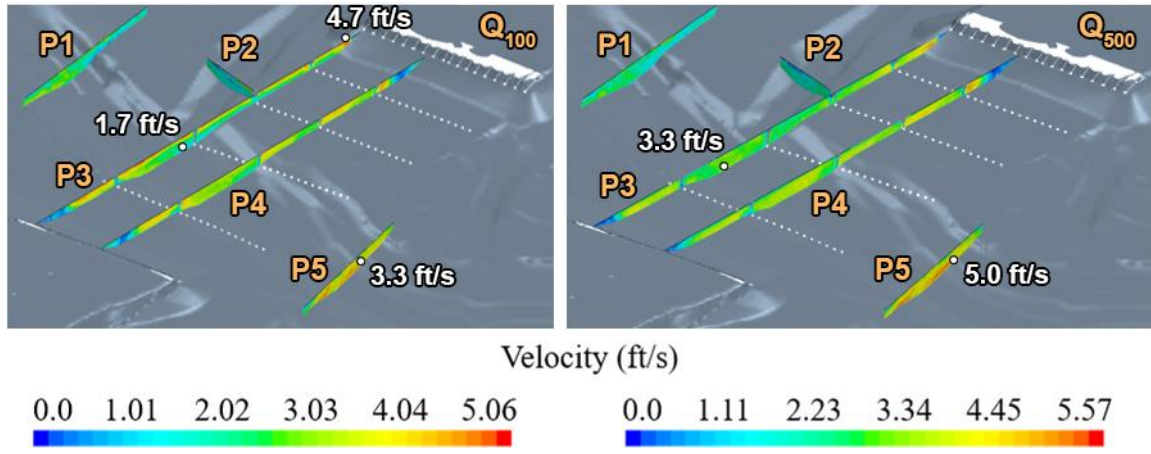
Figure 9. Images. Velocity distribution of each cross section.

Table 2 and table 3 show that the average velocity of 2.2 ft/s in the main channel of the Lumber River upstream of the bridge was higher than the average velocity in the main channel of Five Mile Branch for both flood events. Both of these velocities were smaller than at cross sections P3 and P4, where the flow discharges were combined. The highest velocity of 3.5 ft/s (Q_{100}) or 4 ft/s (Q_{500}) occurred at cross section P5, where the flow was accelerated along the main channel of the Lumber River. CFD's results of water surface elevation for each section were close to SRH-2D's, with an average difference of 0.5 ft. The difference in velocities ranged from 0.3 ft/s to 0.5 ft/s except at P5, which had a slightly larger difference of 0.9 ft/s because SRH-2D cannot fully model the 3D flow field.

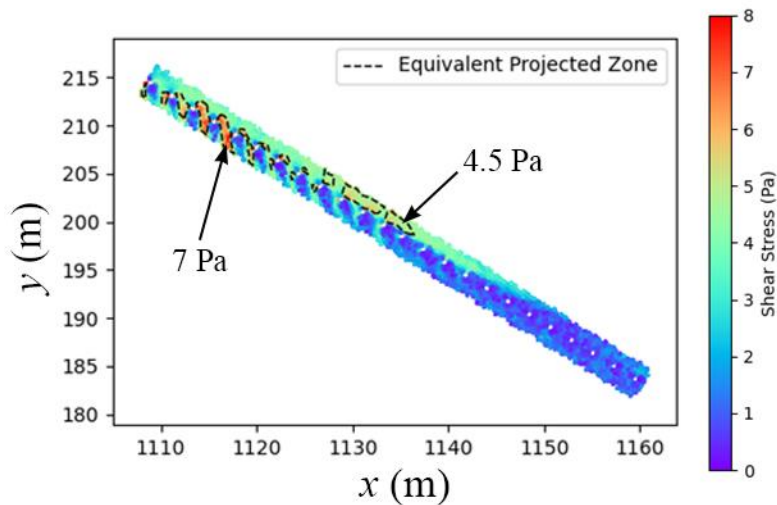
Figure 12. Graph. Cell area used to determine nominal shear stress for bent R4 for the Q_{500} discharge.

Based on the approach described previously, figure 12 shows the cells selected to compute the nominal shear stress at bent R4 for the Q_{500} discharge. The combined area enclosed within the dashed lines is equal to the projected area for bent R4, which was 32.8 m^2 (352.9 ft^2). The corresponding nominal shear stress value, shown in figure 13, was 5.6 Pa (0.118 pounds per square ft (psf)).

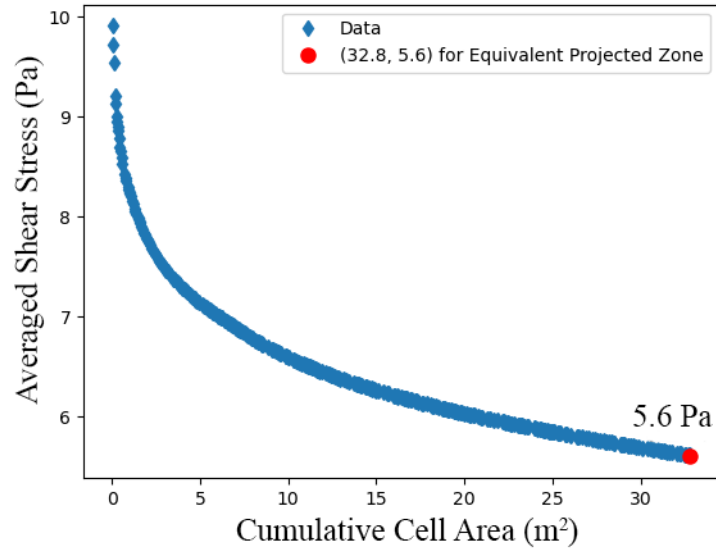
Figure 13. Graph. Averaged shear stress over cumulative cell area for bent R4 for the Q_{500} discharge.

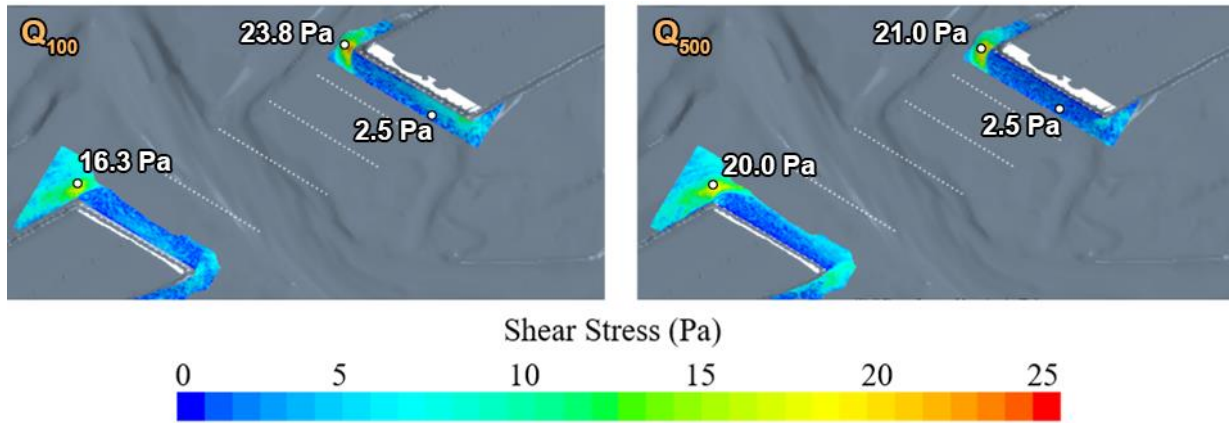
Figure 14. Images. Shear stress distribution around abutments for Q_{100} and Q_{500} discharge.

The same approach was adopted for the abutments, as shown in figure 14. The computational cells considered were located on the embankment slope from the water surface elevation down to the toe of the abutment. For abutments, the projected area was measured as the flow depth times the length of the abutment wall to the toe of the abutment slope plus an additional two times the flow depth. Figure 15 shows the cells selected to compute the nominal shear stress at the left abutment for the Q_{100} discharge. The averaged shear stress values for these cells are plotted in figure 16. The nominal shear stresses at the left and right abutments for the Q_{100} discharge was 17.8 Pa (0.374 psf) and 14.9 Pa (0.313 psf), respectively. Table 4 summarizes the values of nominal shear stresses and projected areas from the two floods. The maximum nominal shear stress value for pier scour is 5.6 Pa (0.118 psf) and occurs at bent R4 during the Q_{500} flood. The maximum nominal shear stress value for abutment scour is 17.8 Pa (0.374 psf) and occurs at the left abutment during the Q_{100} flood.

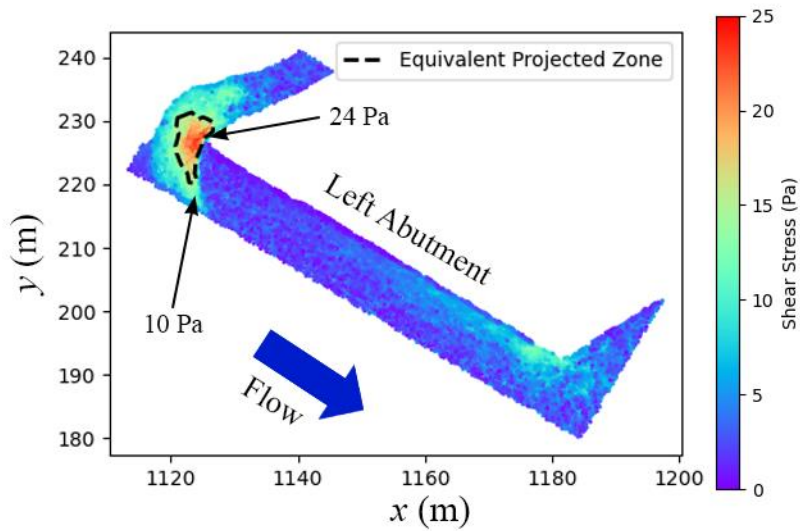
Figure 15. Graph. Cell area used to determine the nominal shear stress for the left abutment for the Q_{100} discharge.

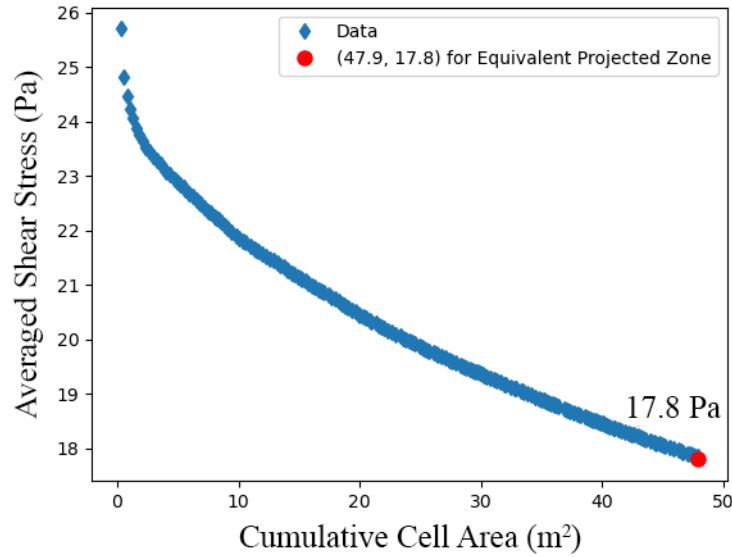
Figure 16. Graph. Averaged shear stress over cumulative cell area for the left abutment for the Q_{100} discharge.

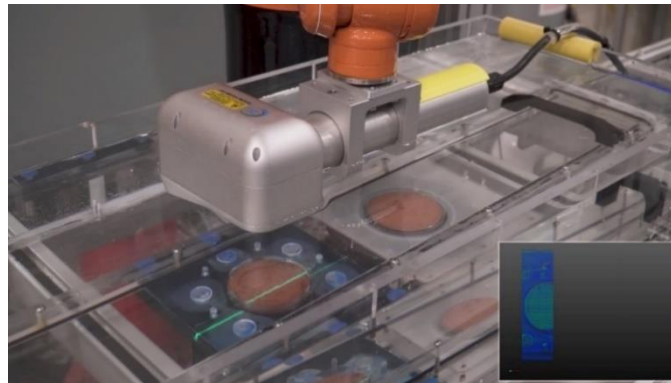
Figure 20. Photo. Laser scan of soil surface and digitized soil surface (inset).

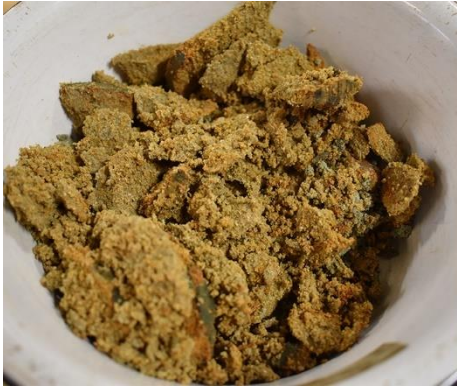
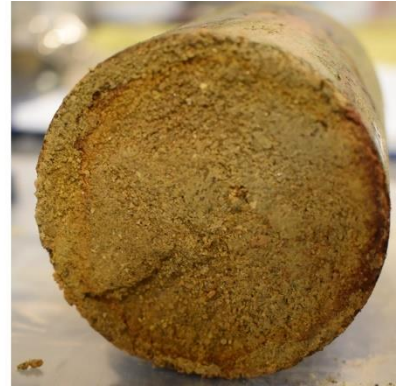
A. ST-11, B-172.

The Geotechnical Laboratory classified samples ST-11 from B-172 and ST-23 from B-174 as poorly graded sand with silt (SP-SM) per the USCS. Both soils were nonplastic. The boring logs suggested that the samples were collected from the Black Creek Formation, where ST-11 was designated as a clayey soil type and ST-23 was designated as a silty or clayey gravel and sand type. On the other hand, the CPT soundings (figure 18) suggested the soils at both locations were sand mixtures with layers of silt mixtures. Photos of samples ST-11 and ST-23 are shown in figure 24.

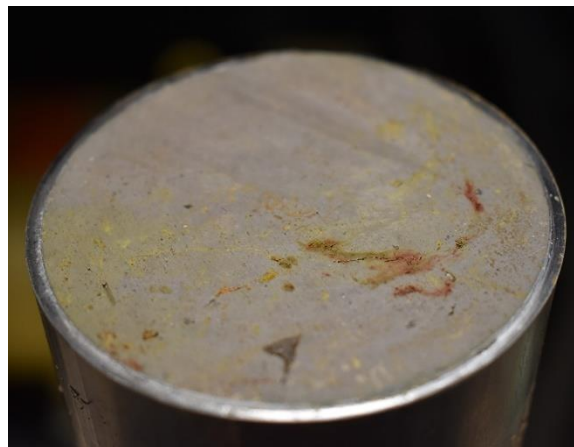
Figure 25. Photo. ST-3 B-157 specimen.

Sample ST-2 from B-157, however, came from a potential clay layer. No soil classifications were conducted directly on that sample, but the Geotechnical Laboratory did classify sample ST-3, which was directly beneath it. Sample ST-3 was classified as a highly plastic clay (CH) per the USCS. The B-157 boring log suggested that the layer, which contained both samples, was gray, highly plastic, fine sandy, and silty clay and was designated as a clayey soil type. On the other hand, the CPT soundings suggested that the layer was silt mixtures with layers of clay and sand mixtures (figure 18). Figure 25 shows a photo of sample ST-3.

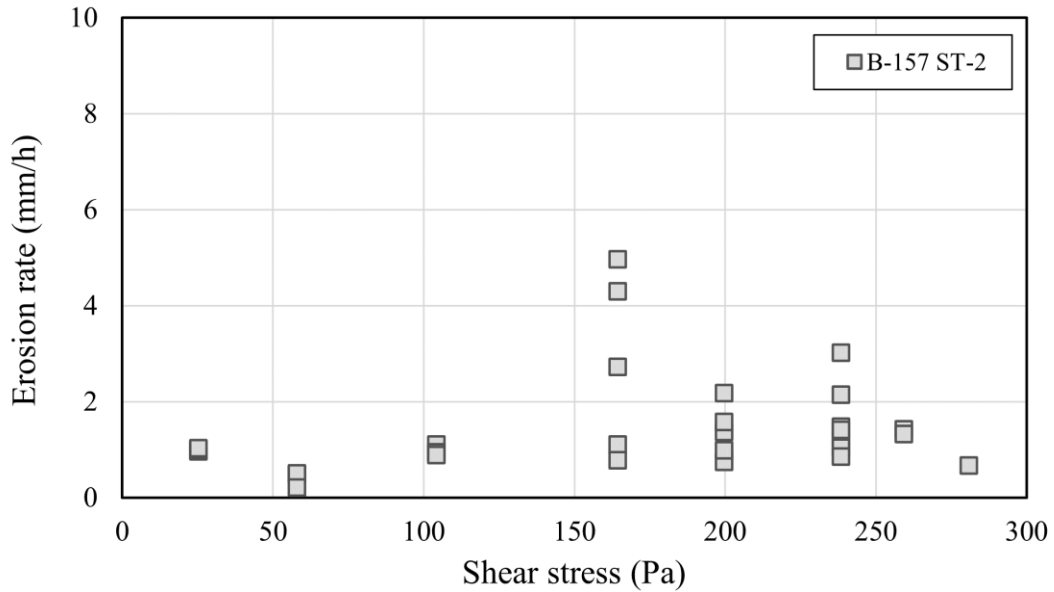
Figure 26. Graph. Erosion rates from ESTD testing of ST-2.

Based on the results of the soil classification of ST-3 and the CPT data from B-157, FHWA researchers were confident that the ST-2 sample tested in the ESTD was representative of the silt and clay layer found at elevations 80–85 ft. The erosion data from sample ST-2 testing in the ESTD is shown in figure 26. Figure 27 shows the ST-2 erosion data in log-log scale, along with the erosion categories proposed by Briaud et al. (2011). Because of the data scatter in figure 26 and figure 27, it was very difficult to fit the data with a single curve to calculate a critical shear stress value. Therefore, alternative methods were considered to derive a shear stress distribution for the entire clay layer instead of only finding a deterministic value of the critical shear stress.

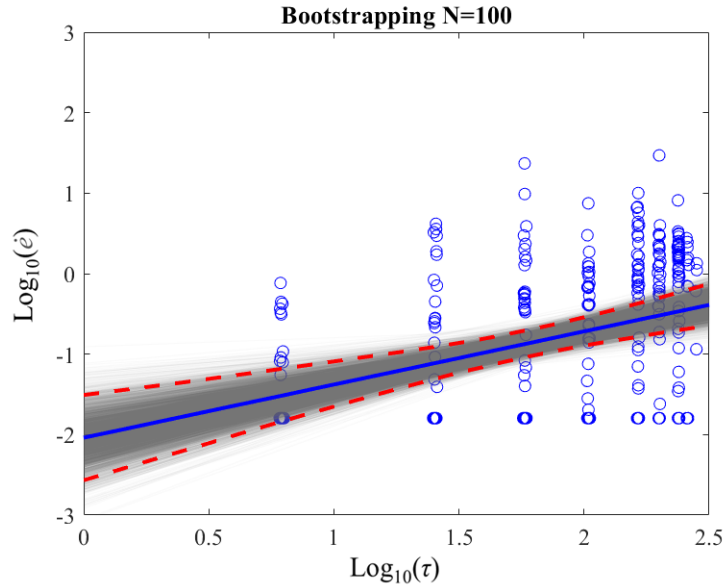
Figure 29. Graph. Bootstrapping technique showing 50,000 linear fittings.

The second step of the bootstrapping method was to randomly select a subset of data points from the total set and apply the logarithmic best fit equation. A script randomly selected 100 out of the 314 total data points and then applied the best fit function to calculate a corresponding critical shear stress. This process was then repeated 50,000 times to get a distribution of critical shear stresses (figure 29). The two dashed lines in figure 29 represent the 95-percent confidence limits on the linear fit of the mean critical shear stress. The solid line is the mean linear fit of the 50,000 iterations. Figure 30 plots a histogram of all 50,000 critical shear stresses. The mean value of the critical shear stresses was 38.7 Pa (0.813 psf), which was within a few percent of the value calculated previously for the entire 314-point dataset. The standard deviation was 12.9 Pa (0.271 psf), and the COV was 0.33. Both mean and COV were used as the critical shear stress distribution parameters. Since the erosion rates follow a lognormal distribution, the distribution of the critical shear stress was also assumed to be lognormal.

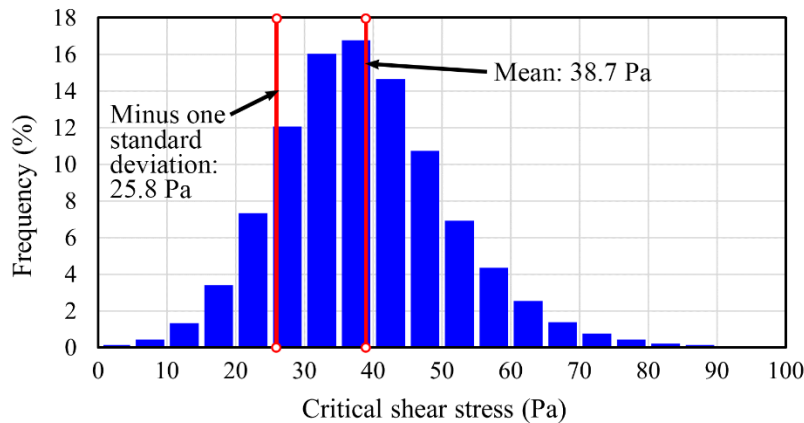
Figure 30. Graph. Histogram of the 50,000 critical shear stresses.

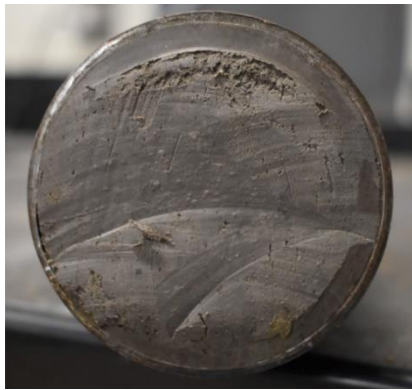
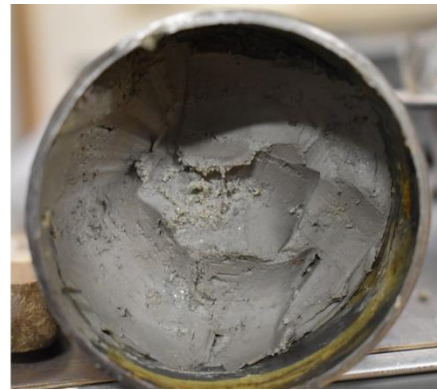
A. ST-15, B-172.

Sample ST-15 from B-172 was classified as a highly plastic clay (CH) per the USCS. The B-172 boring log suggested the sample was collected from the Black Creek Formation and was designated as a clayey soil type. On the other hand, the CPT sounding suggested the soil at the specimen location was predominantly silt mixtures and clays. Sample ST-29 from B-174 was classified as a low plasticity clay (CL) per the USCS. The B-174 boring log suggested that the sample was also collected from the Black Creek Formation and was designated as a clayey soil type. On the other hand, the CPT soundings suggested that the soil at the specimen location was predominantly silt mixtures and clays. Figure 31 shows photos of the surfaces of samples ST-15 and ST-29. Table 6 summarizes the geotechnical results from the five samples classified by the Geotechnical Laboratory.

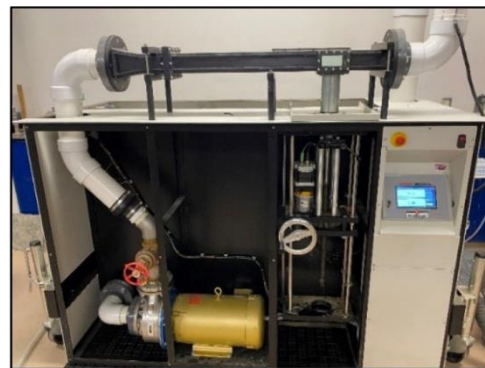
Note: Dimensions in mm. 1 mm = 0.039 inch.

Figure 32. Sketch. (a) EFA cross section based on Briaud (1999), and (b) laboratory device at TFHRC (Nicks et al, 2023).

The five samples were tested in the EFA, which is shown in figure 32. The soil in the Shelby tube was first extruded, trimmed, and then placed and tested in the EFA under a range of water velocities. The test was run until either 0.4-inches of the specimen had eroded or 60 min had elapsed, whichever occurred first. Then, the sample was removed from the device, and the surface roughness of the specimen was measured using a laser texture scanner. The hydraulic shear stress at the water-soil interface was calculated for each speed using the Moody chart (Moody 1944). The relationship between erosion rate and hydraulic shear stress/velocity for each specimen (i.e., the erosion function of the soil) was then determined (Figure 33 and figure 34, respectively). Table 7 shows each specimen's critical shear stress and velocity (i.e., the stress/velocity at which erosion initiates). Note that the ST-29 B-174 specimen did not erode under the maximum possible velocity of 19.0 ft/s in the EFA device, so its critical shear stress and velocity could not be determined.

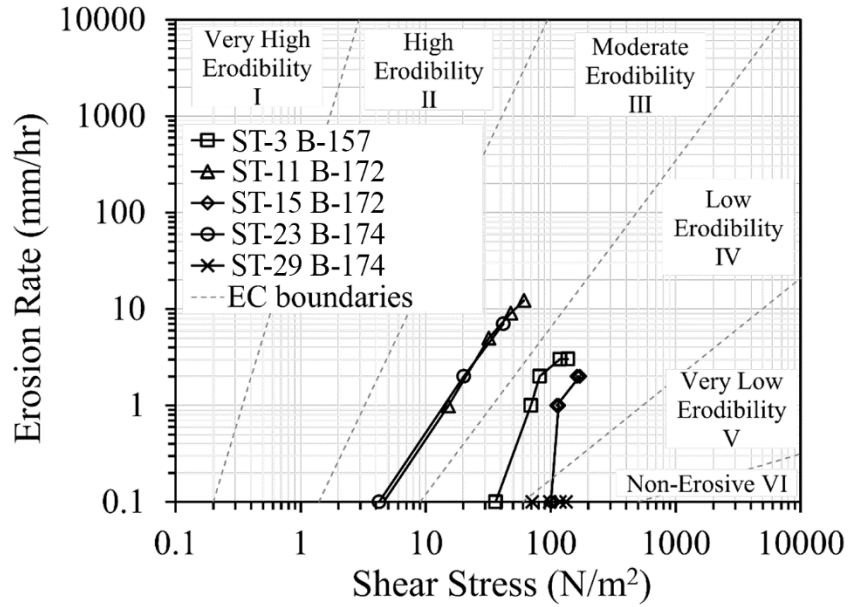
Figure 33. Graph. EFA erosion function results, shear stress.

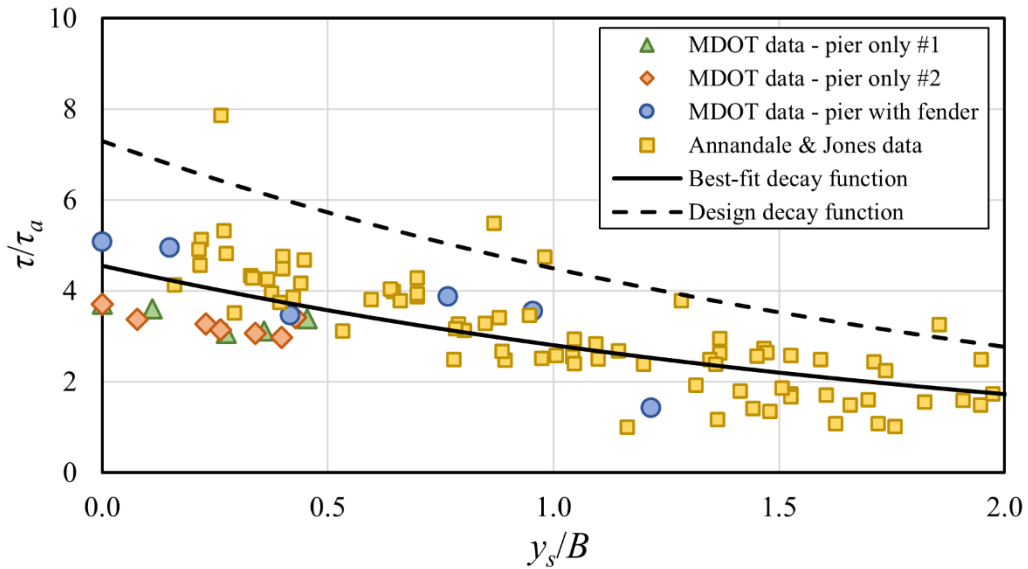
Figure 36. Graph. Decay function from FHWA’s flume test data and Annandale and Jones data (Annandale 2006).

The second method for developing a decay function involves analyzing the results of scour data from flume experiments. When the FHWA Hydraulics Laboratory conducted a similar TPF study for the Michigan DOT (MDOT), the hydraulics researchers performed physical modeling of several scaled bridge pier configurations in their flume (FHWA 2023). The MDOT project featured large bascule piers with sheet-pile coffer dams and a fender system. The scaled models included pier only, pier with sheet pile, and pier with the fender. Flume scour tests ran for 70 to 120 hours and were paused at regular intervals to scan the bathymetry and measure the incremental progress of the scour hole. These scans were then imported into CFD to calculate the bed shear stresses in the scour hole (FHWA 2023). These data, together with data from Annandale and Jones (Annandale 2006) were normalized and then plotted in figure 36.

Figure 36 indicates that data from the three MDOT scaled bridge models reasonably aligned with Annandale’s and Jones’ results. The best fit equation through the data, also referred to as the best fit decay function, is given by equation 8. Shan et al. (2016) used a reliability index (RI) to measure the reliability and accuracy of an equation. The same RI analysis was performed here to give the best fit decay function a reliability index of 2.0. Equation 8 was multiplied by a safety factor of 1.60 to get the more conservative design decay function, which is given in equation 9.

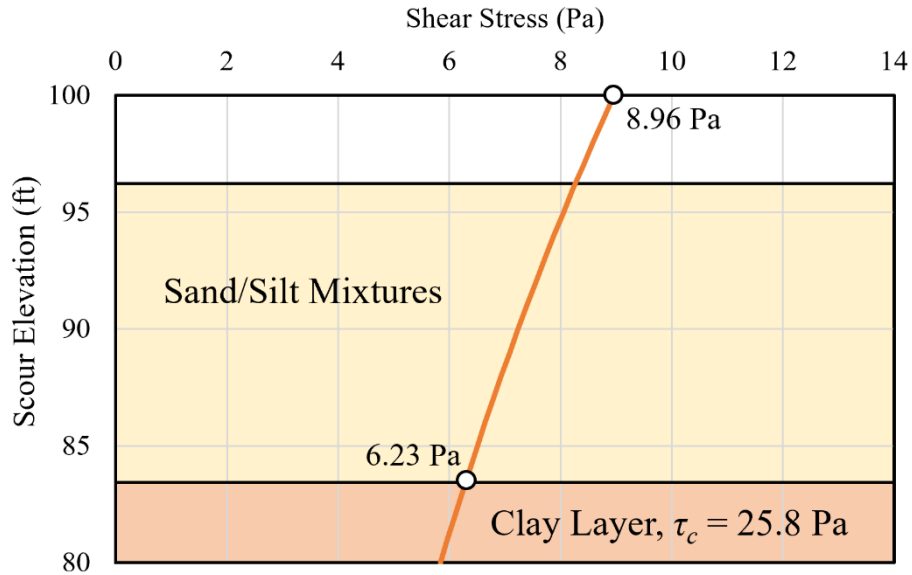
Figure 37. Graph. Deterministic pier scour analysis using decay function and clay resistance for Q_{500} .

critical shear stress value in the clay layer. Figure 37 reveals that at 83-ft elevation, the decayed shear stress was 6.23 Pa (0.131 psf) for Q_{500} , much less than the design clay erosion resistance of 25.8 Pa (0.542 psf), which was equal to the mean shear stress minus one standard deviation. Therefore, the total pier scour would stop at 83 ft under these conditions.

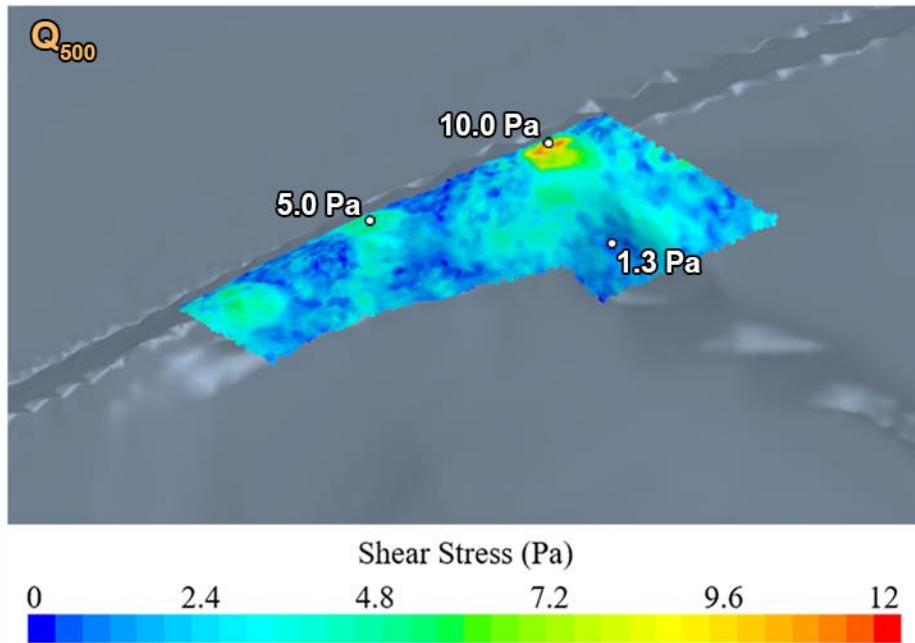
Figure 39. Image. Shear stress distribution in the Lumber River bend.

Downstream of the I-6064/I-95 bridge, a meander bend of the Lumber River is directly adjacent to the proposed highway, resulting in a potential scour hazard of the embankment. NCDOT prefers not to excavate the channel at the bend to install buried riprap countermeasures and instead plans to install a vertical sheet pile wall with lightweight fill and deadman tiebacks next to the highway. The CFD model developed for Task 1 also calculated bed shear stresses for the bend area, which were used to evaluate potential lateral and vertical scour. Figure 39 shows the shear stress distribution at the bend for the Q_{500} flood event. Table 9 lists the surface average and maximum shear stress values for four different design floods. The maximum value of 12.5 Pa (0.263 psf) was much smaller than the design critical shear stress of 25.8 Pa (0.542 psf) for the clay soil layer. However, FHWA did not test any samples from the bend in the ESTD or the EFA. If NCDOT is confident that the same clay layer exists at the bend, as illustrated in figure 40, it could potentially protect the base of the vertical wall from additional scour.
