Emerging in-situ scour testing device (ISTD) technology uses an innovative erosion head that more accurately measures soil erosion resistance, resulting in cost-effective foundation designs and increased reliability and resiliency in bridge performance.

Recommended citation: Federal Highway Administration, *In-Situ Scour Testing Device (ISTD), State Demonstrations of Field Soil Tests, Butte City, CA* (Washington, DC: 2024) <https://doi.org/10.21949/1521778>

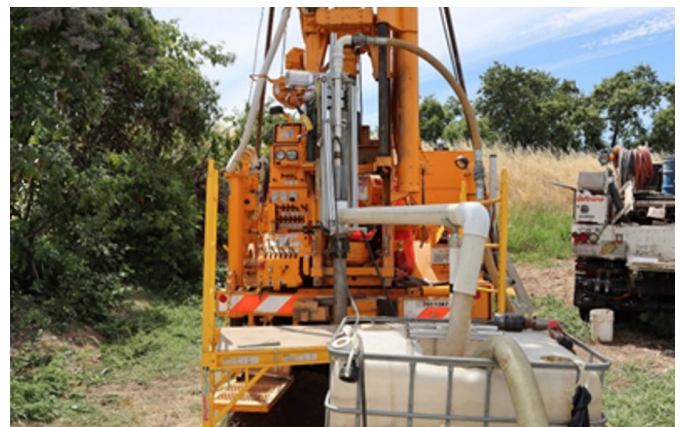
■ The ISTD equipment assembled in front of the drill rig.

The demonstration occurred on June 26, 2019, but the drill crew and the hydraulics team arrived a day earlier to conduct as much ISTD field testing as possible in the two-day span. After the CPT and SPT tests were completed, the drillers augered to 25 ft and the hydraulics team assembled the remaining equipment, including the water tank, pump, piping, hoses, linear drive, and laptop, to prepare for the first test.
