Field Evaluation of At-Grade Alternative Intersection Designs, Volume I—Operations Report

PUBLICATION NO. FHWA-HRT-24-126

JULY 2024

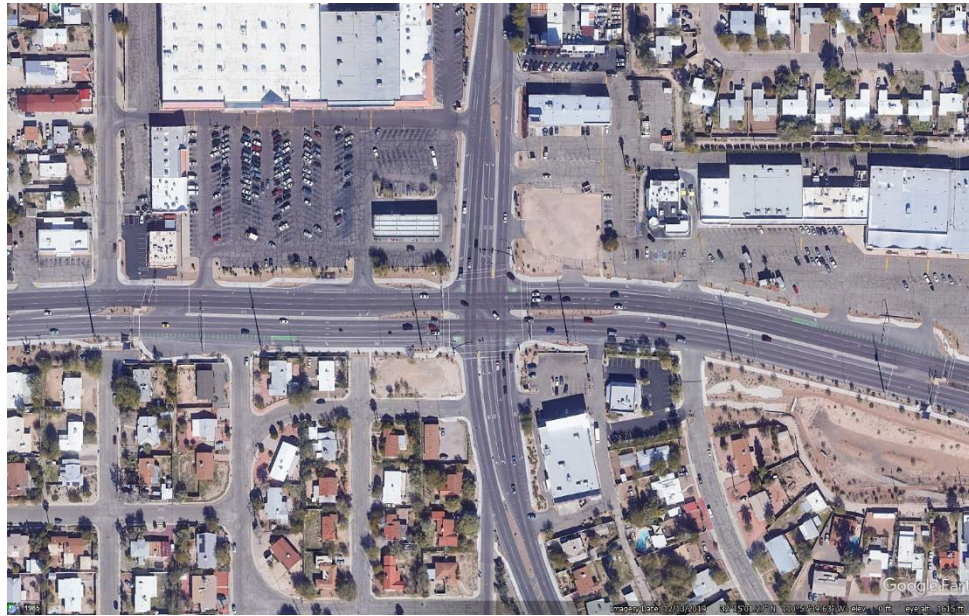
Figure 3. Photo. Grant Road at First Avenue intersection, overview of main intersection and U-turns, after condition in Tucson, AZ.⁽³²⁾

The research team acquired after data at the intersection of Grant Road at First Avenue in Tucson, AZ. The key design features of the Grant Road improvement plan included indirect left turns, eight bus pullouts with shelters and benches, a bike and pedestrian signal at 6th Avenue, 8-ft sidewalks, and 7-ft bike lanes. Figure 2 shows an aerial view of the intersection in the before condition. Figure 3 shows an overview of the main intersection and neighboring U-turns during the after period. Figure 4 shows a closeup of the main intersection in the after period.

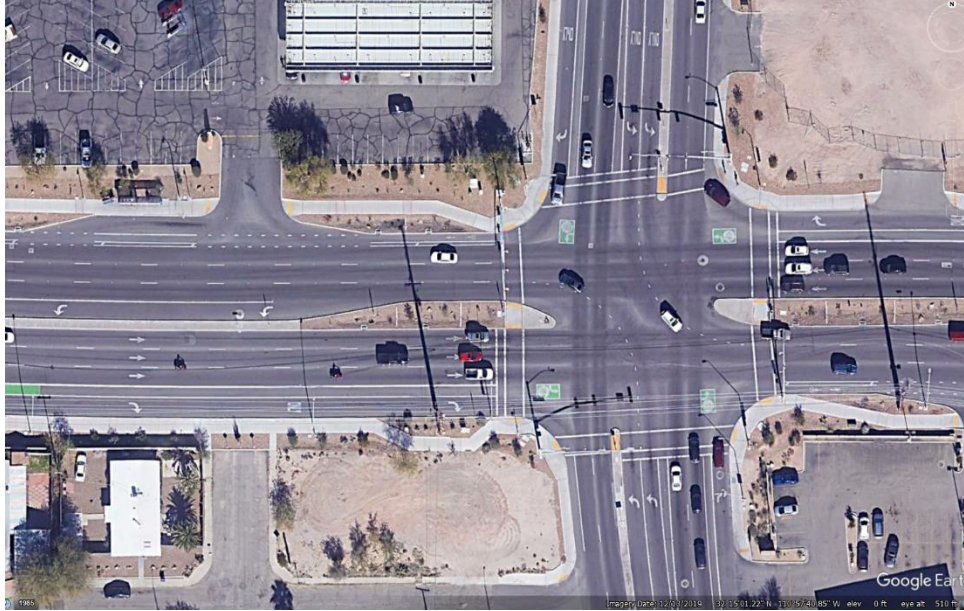
Figure 4. Photo. Grant Road at First Avenue intersection, closeup of main intersection, after condition in Tucson, AZ.⁽³²⁾

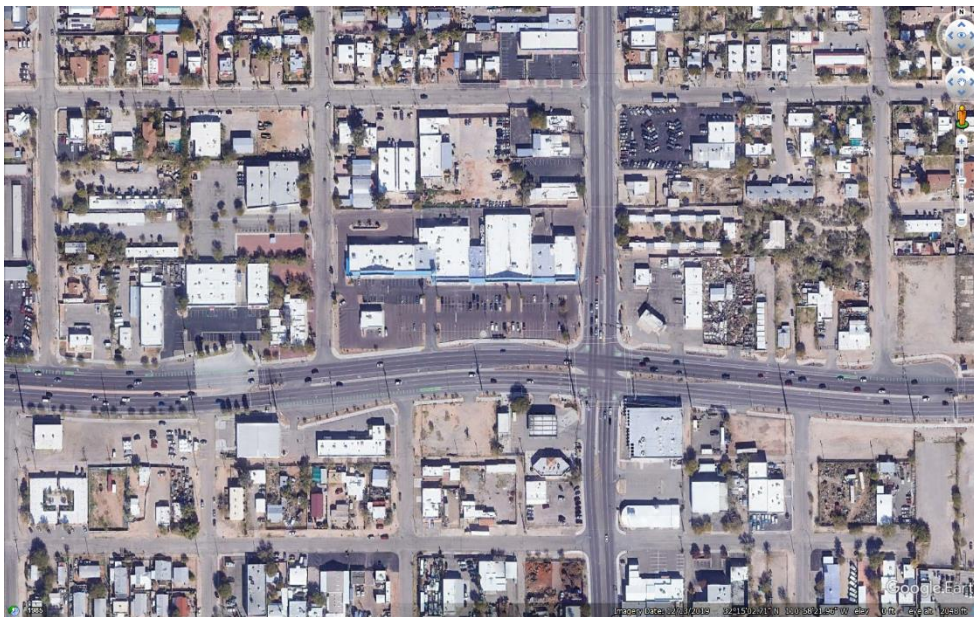
Figure 6. Photo. Grant Road at Stone Avenue intersection, overview of main intersection and U-turns, after condition in Tucson, AZ.⁽³²⁾

The research team acquired after data at the intersection of Grant Road at Stone Avenue in Tucson, AZ. This intersection was part of the second phase of the Grant Road improvement plan. The plan's main objective was improving regional mobility by introducing the indirect left turn. Figure 5 shows an aerial view of the intersection in the before condition. Figure 6 shows an overview of the main intersection and neighboring U-turns during the after period. Figure 7 shows a closeup of the main intersection in the after period.

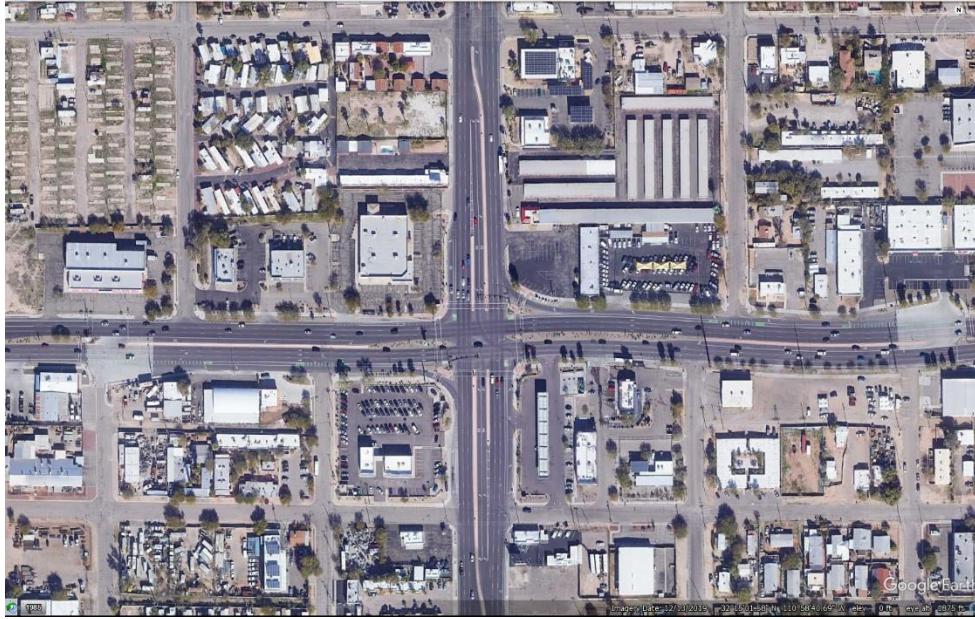
Figure 8. Photo. Grant Road at Oracle Road North intersection, overview of main intersection and U-turns (comparison site), after condition in Tucson, AZ.⁽³²⁾

The research team collected posttreatment data at the intersection of Grant Road at Oracle Road North in Tucson, AZ, and used this information for cross-sectional comparisons. Figure 8 shows an overview of the main intersection and neighboring U-turns during the after period and figure 9 shows a closeup of the main intersection in the after period. The key design features for the second phase of the Grant Road improvement plan included: indirect left turns, eight bus pullouts with shelters and benches, bicycle and pedestrian signals at 6th Avenue, 8-ft wide sidewalks, and 7-ft wide bicycle lanes. Similar pedestrian, bicycle, and transit treatments were included along the improvement area of the Grant Road corridor. This characteristic makes Oracle Road North a good option for comparing sites with the MUT configuration.

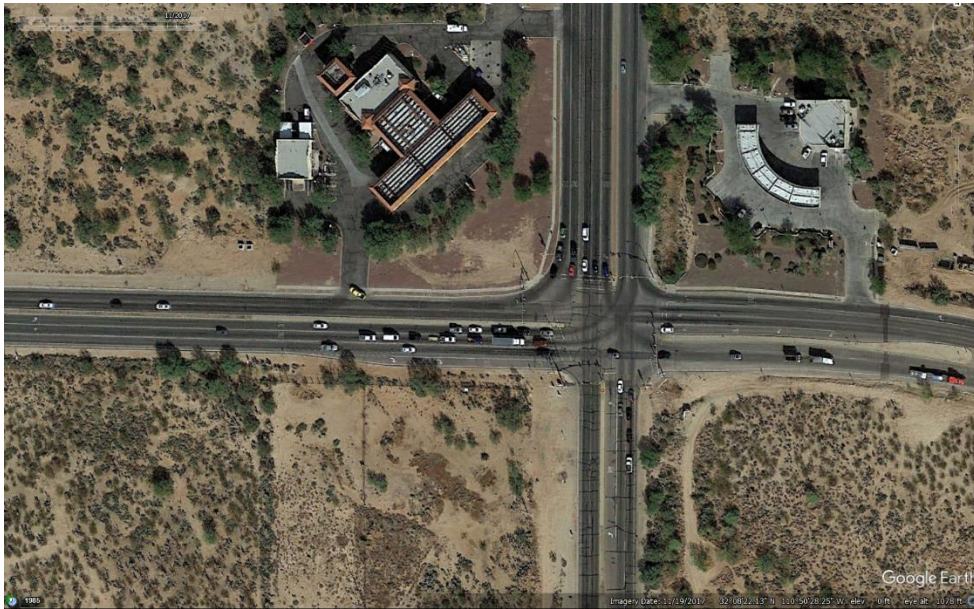
Figure 10. Photo. Valencia Road at Kolb Road intersection, overview of main intersection and U-turns, before condition in Tucson, AZ.⁽³²⁾

The intersection of East Valencia Road at Kolb Road is located within the city limits of Tucson, AZ; however, the Regional Transportation Authority administered the project for the city. Figure 10 shows an aerial view of the Kolb Road at Valencia Road intersection during the before condition. The before condition was a traditional intersection. The after configuration included significant access modifications. Figure 11 shows that the after condition added MUTs and an additional access road that functions like a quadrant. In addition, the lengths of the deceleration lanes were extended to accommodate expected queues and midblock U-turns were added. Figure 12 provides a closeup view of the main intersection.

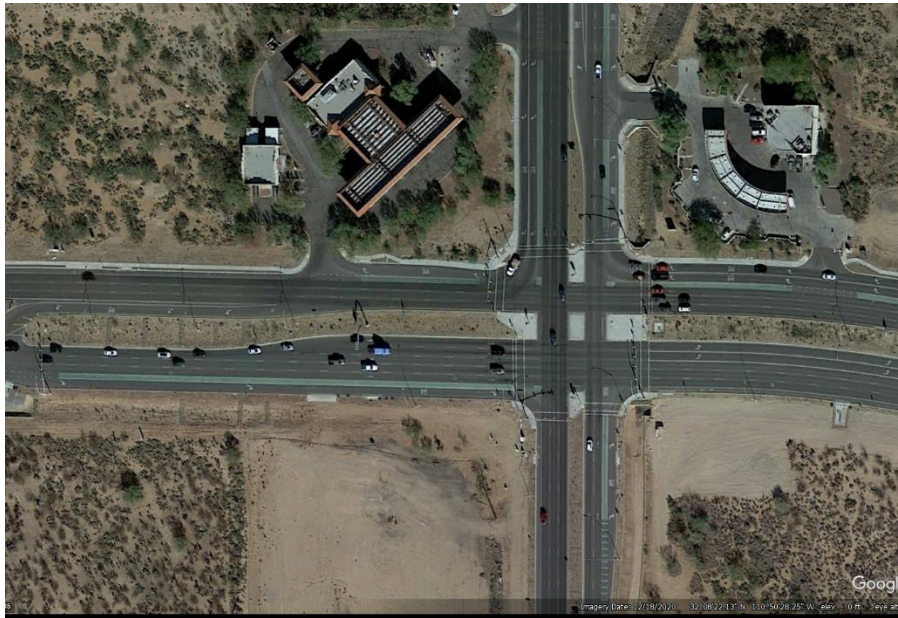
Figure 12. Photo. Valencia Road at Kolb Road intersection, closeup of main intersection and U-turn, after condition in Tucson, AZ.⁽³²⁾

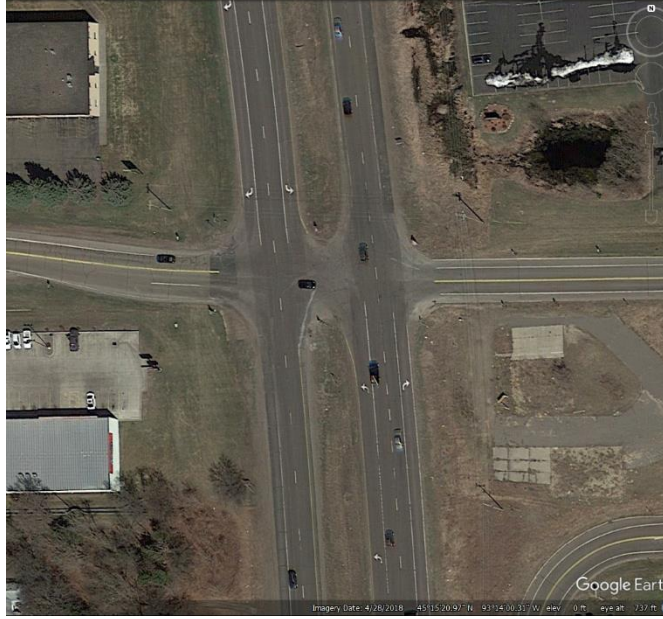
Note: MN-65 runs north-south and 157th Avenue NE runs east-west, north at top.

Figure 13. Photo. MN-65 at 157th Avenue intersection, before condition.⁽³²⁾

The location of the intersection with 157th Avenue NE is entirely within the city limits of Ham Lake, MN, but the construction project was administered by the Minnesota Department of Transportation (MnDOT). The project construction spanned 2018 to 2019. Figure 13 is an aerial view of the intersection before construction. Figure 14 is an aerial view following construction. Figure 15 provides a closeup view of the intersection.

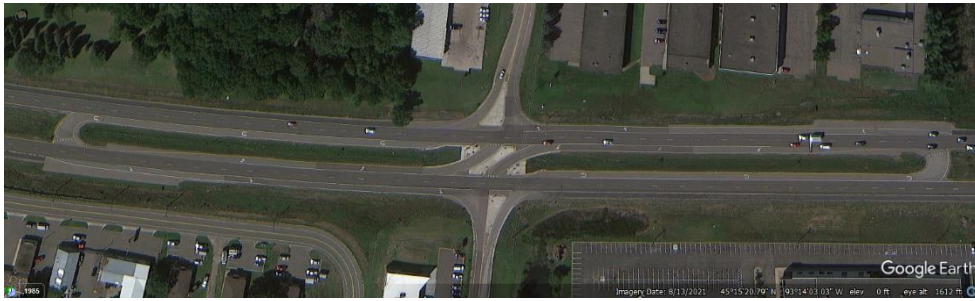
Note: MN-65 runs north-south and 157th Avenue NE runs east-west, north at right.

Figure 14. Photo. MN-65 at 157th Avenue intersection, after condition in Ham Lake, MN.⁽³²⁾

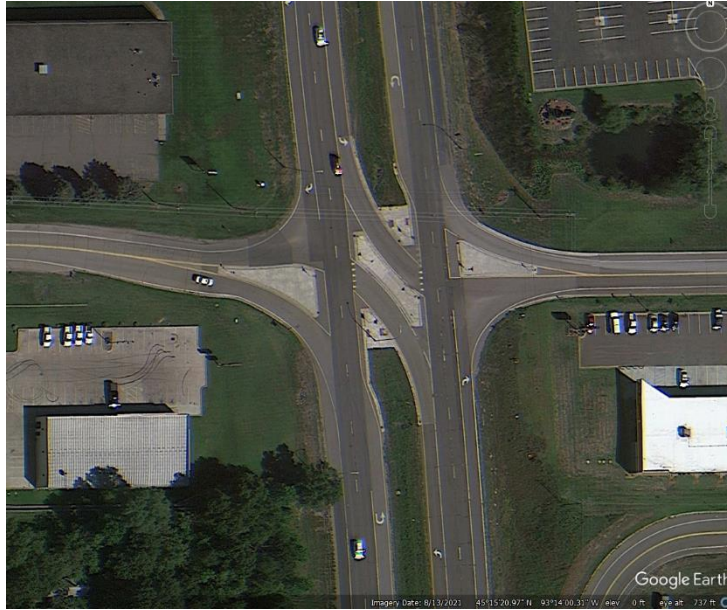
Note: MN-65 runs north-south and 157th Avenue NE runs east-west, north at top.

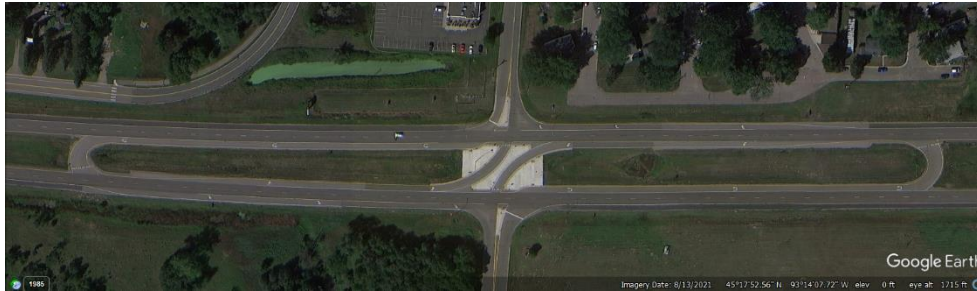
Figure 17. Photo. MN-65 at 181st Avenue intersection, overview of main intersection and U-turns, after condition in Ham Lake, MN.⁽³²⁾

The RCUT constructed at the intersection of MN-65 and 181st Avenue NE (also known as Baltimore Street NE) is located in Ham Lake, MN. Figure 16 shows an aerial view of the intersection in the before condition, figure 17 shows an overview of the RCUT in the after condition, and figure 18 provides a closeup of the main intersection. MnDOT designed the project, and construction occurred in 2019.

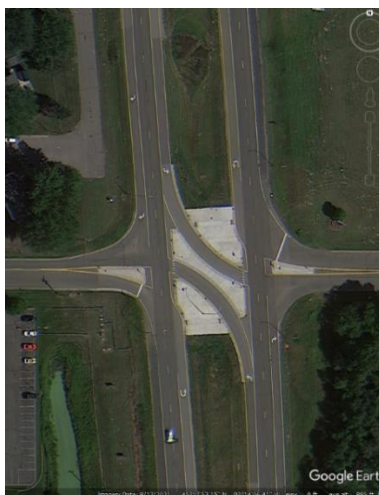
Figure 18. Photo. MN-65 at 181st Avenue intersection, closeup of main intersection, after condition.⁽³²⁾

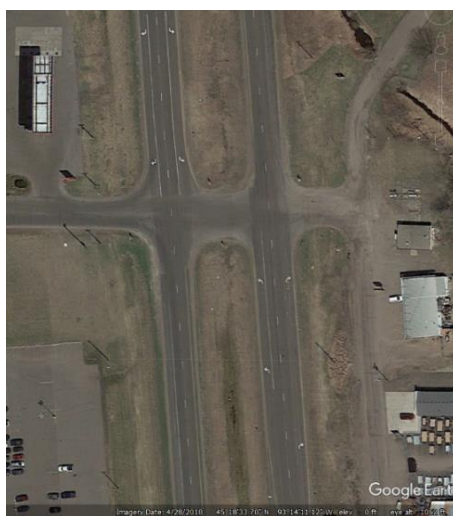
Figure 19. Photo. MN-65 at 187th Lane intersection, before condition in East Bethel, MN.⁽³²⁾

The intersection of MN-65 and 187th Lane NE is another intersection in a series of RCUTs located along MN-65 in Minnesota. The corridor traverses through the cities of Ham Lake, MN, and East Bethel, MN. Figure 19 is an aerial view of the intersection in the before condition, figure 20 is an overview of the RCUT in the after condition, and figure 21 provides a closeup of the main intersection.

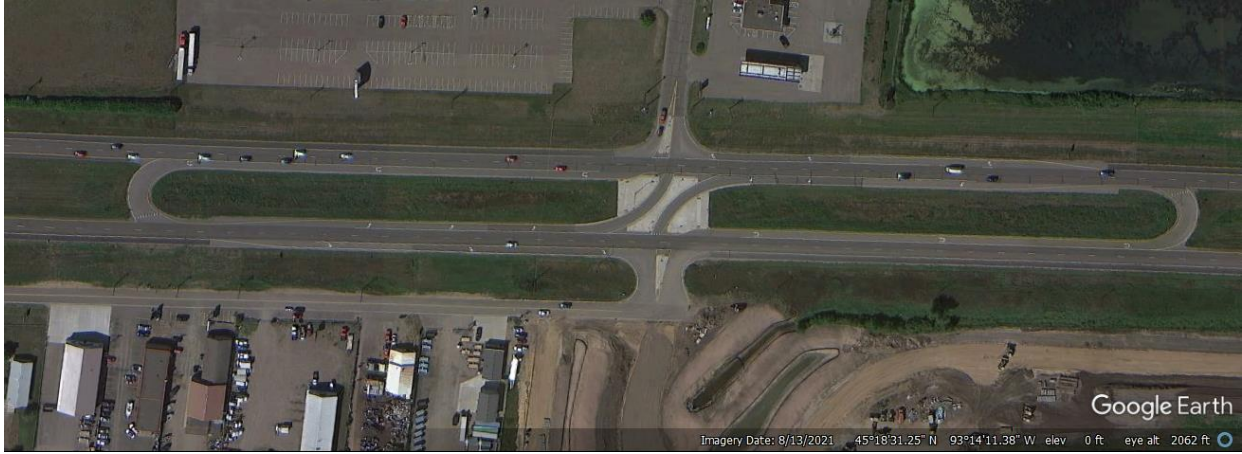
Figure 20. Photo. MN-65 at 187th Lane intersection, overview of main intersection and U-turns, after condition in East Bethel, MN.⁽³²⁾

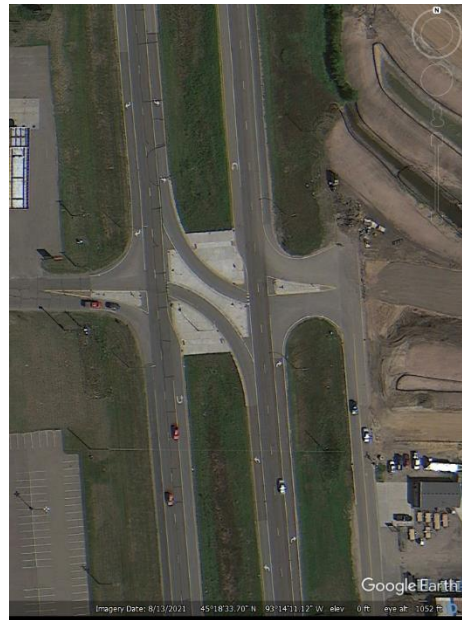
Figure 21. Photo. MN-65 at 187th Lane intersection, closeup of main intersection, after condition in East Bethel, MN.⁽³²⁾

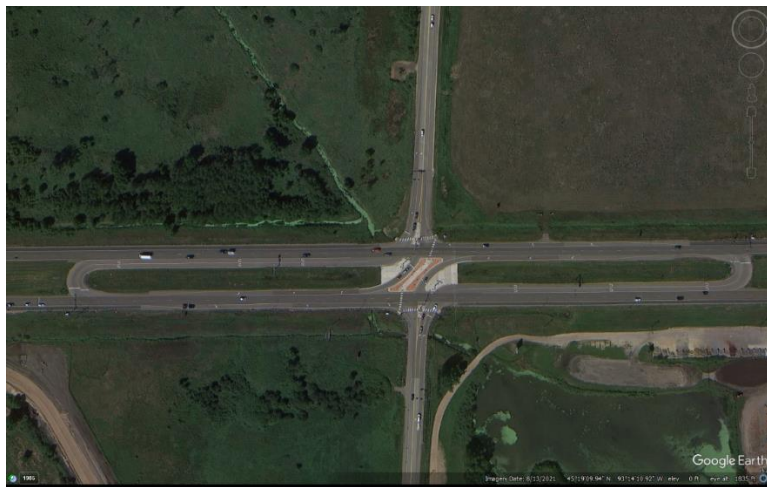
Note: MN-65 runs north-south and Viking Avenue NE runs east-west, north to right.

The intersection of MN-65 at Viking Boulevard NE is in East Bethel, MN. Figure 22 shows the before period, Figure 23 shows the after period, and figure 24 is a closeup of the main intersection for the after period. MnDOT administered the design, and construction occurred from 2018 to 2019. This intersection was the only signalized RCUT included in the study of the

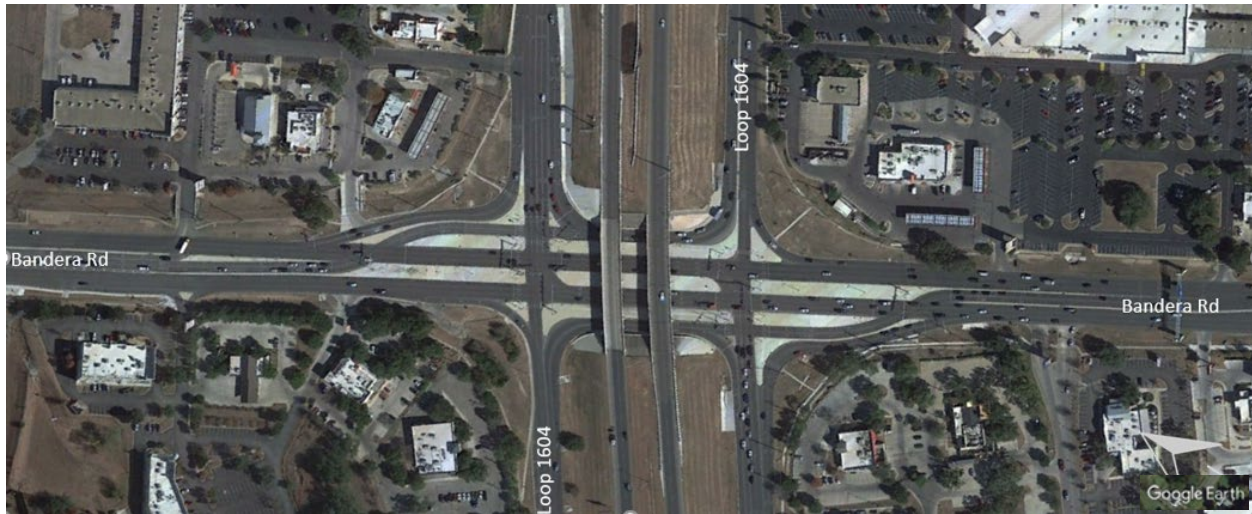
Figure 26. Aerial Photograph. SH-16 at Loop 1604 in San Antonio, TX, after condition.⁽³²⁾

The research team acquired data located at the interchange of Texas State Highway 16 (SH-16), also known as Bandera Road, and West Loop 1604 Access Road (also known as East Charles William Anderson Loop). This study site is in San Antonio, Bexar County, TX. Figure 26 shows an aerial view of the SH-16 (Bandera Road) at West Loop 1604 Access Road interchange. The at-grade intersections to be included in this study are the intersections between SH-16 (Bandera Road) and the West Loop 1604 Access Road intersections on each side of the interchange. West Loop 1604 Access Road is constructed on structures over SH-16 (Bandera Road), and SH-16 (Bandera Road) is constructed at grade. For this application, the Texas turnaround (also referred to as the Texas U-turn) space is converted to accommodate the displaced left traffic.

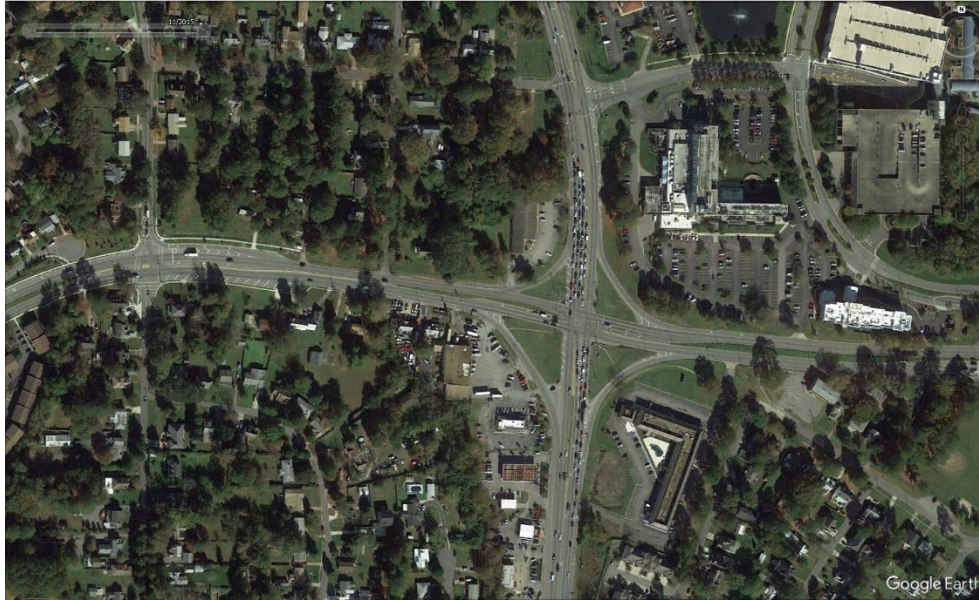
Figure 27. Photo. Military Highway at Northampton Boulevard intersection, before condition (photo date November 19, 2017) in Norfolk, VA.⁽³²⁾

The Norfolk, VA, intersection included DLTs on the north and south approaches. The research team acquired after data at the intersection of Military Highway at Northampton Boulevard (U.S. 13 at VA SR-165) in Norfolk, VA, following construction of a DLT on the north and south approaches. The east and west approaches retain a more traditional configuration; before data were collected in 2015. Figure 27 is an aerial view of the intersection in the before condition, figure 28 is an overview of the DLTs and MUTs in the after condition, and figure 29 provides a closeup of the main intersection. The project construction began in August 2016 and was completed in July 2018.

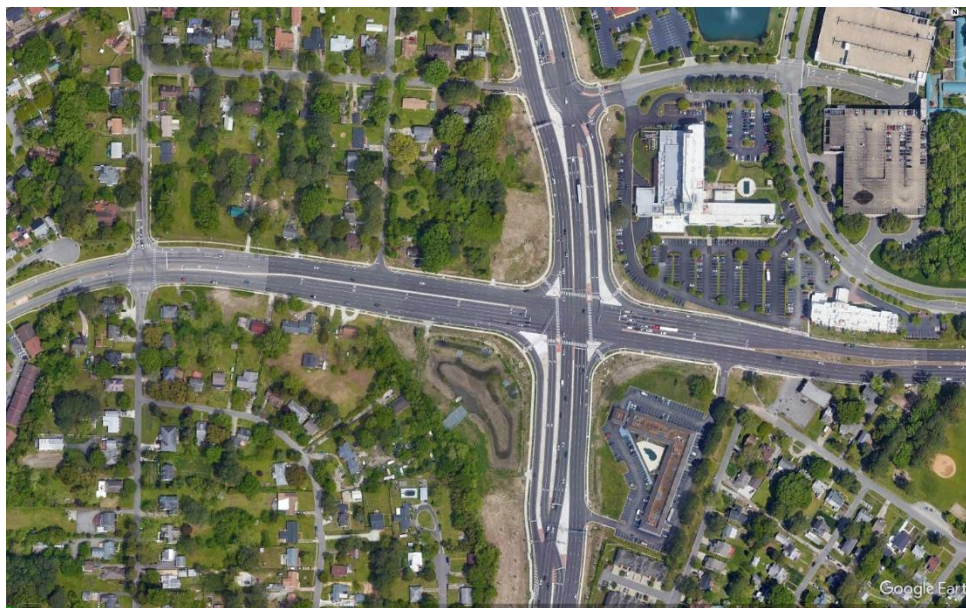
Figure 28. Photo. Military Highway at Northampton Boulevard intersection, overview of main intersection and U-turns, after condition in Norfolk, VA.⁽³²⁾

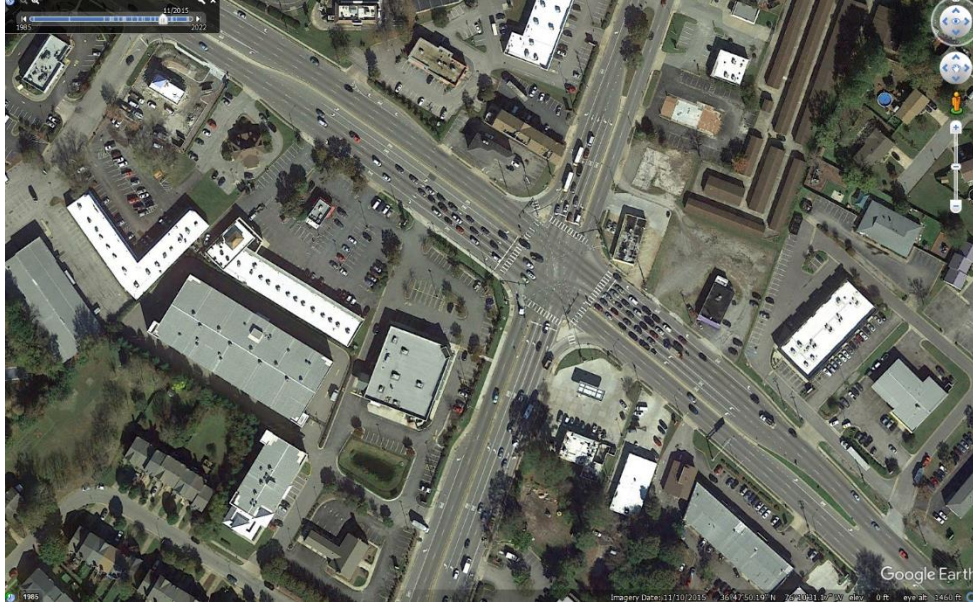
Figure 30. Photo. Indian River Road at Kempsville Road intersection, before condition (photo date November 10, 2015) in Virginia Beach, VA.⁽³²⁾

Figure 30 is an aerial view of the intersection in the before condition, figure 31 is an overview of the DLTs in the after condition, and figure 32 provides a closeup of the newly constructed Kempsville Road at Indian River Road intersection. The facility at this location is owned by the city of Virginia Beach, VA, and the Virginia DOT has worked closely with the city on this effort. The after design is a hybrid intersection with DLTs on the north and south approaches and MUTs on the east and west approaches.

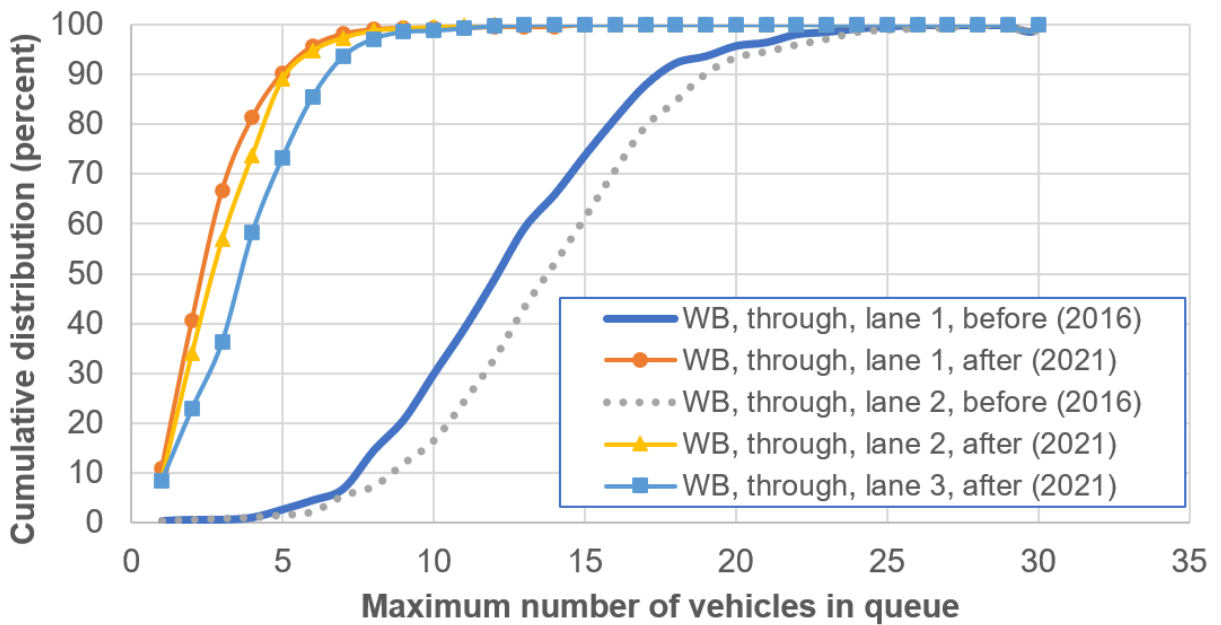
Note: Number of Vehicles is the number of vehicles representing the 85th percentile maximum queue (stated another way, 85 percent of the cycles had queues of this length or shorter, or 15 percent of the signal cycles had queues longer than this value).

Figure 41. Graph. Distribution of maximum queue length for Grant Road at First Avenue WB through by period and lane.

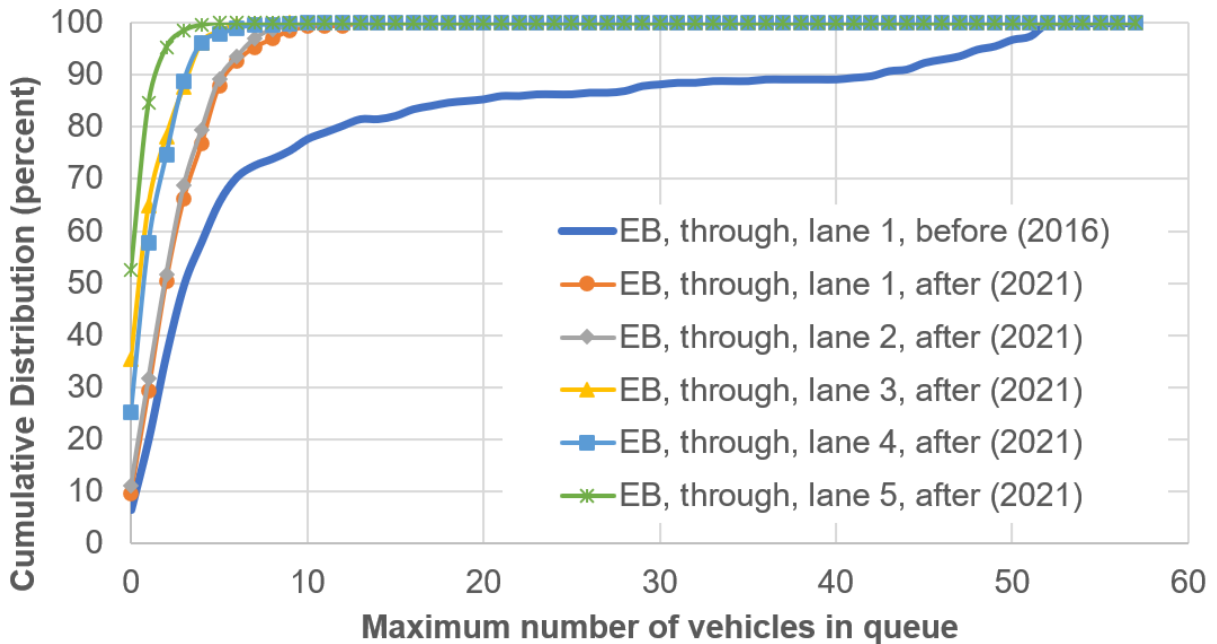
Figure 48. Graph. Distribution of maximum queue length for Valencia Road at Kolb Road EB through by period and lane.

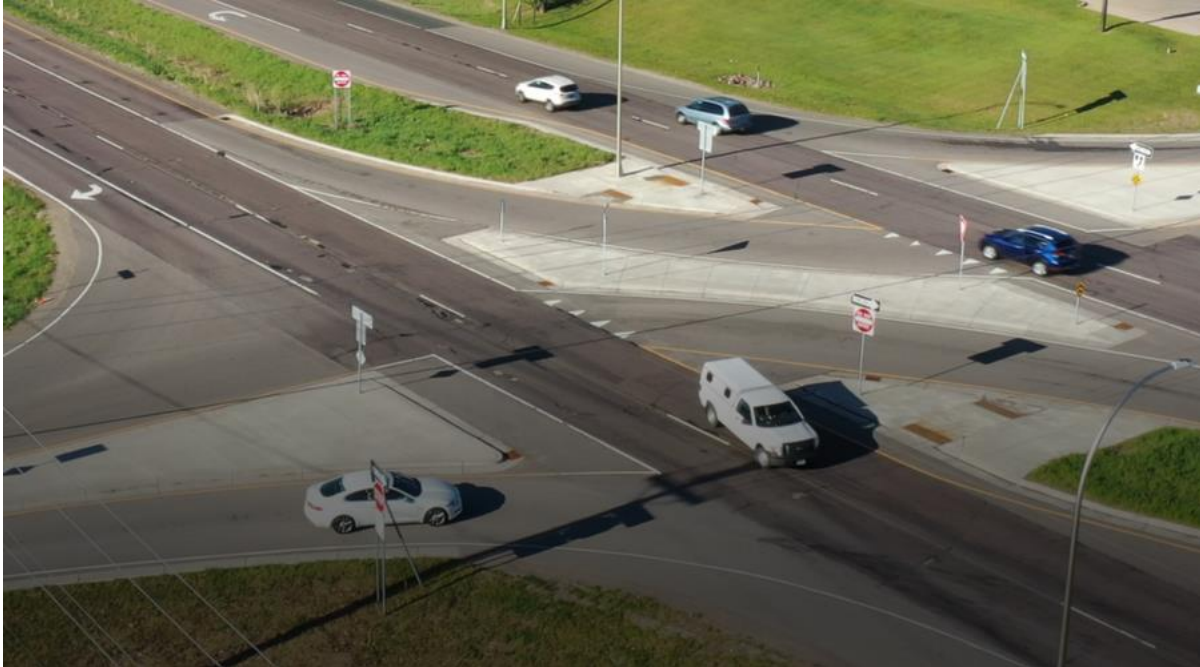
Figure 71. Photo. Van completes illegal U-turn instead of continuing onto minor road.

For maneuvers from a major leg to a minor leg, the RCUT provides a channelized direct left turn. To facilitate the minor-to-major right-turn maneuver, U-turns are typically restricted in the channelized direct left turn for the primary intersection location. Figure 69, figure 70, and figure 71 show an example from Minnesota 157th Avenue NE of how this no U-turn restriction at the primary intersection can be violated. This violation introduces potential conflicts with the minor road right turn.

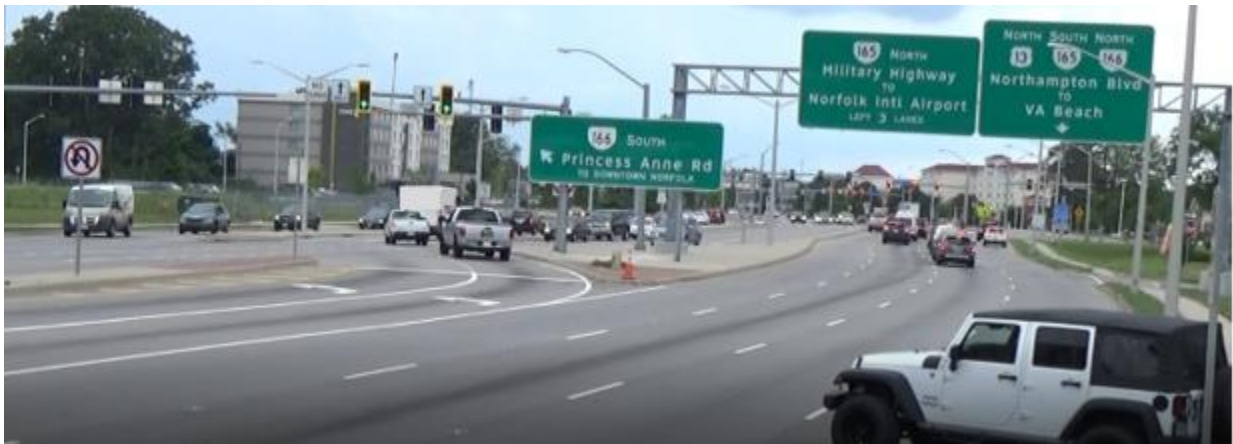
Figure 73. Photo. Vehicle entering road from driveway at an angle that is almost perpendicular to the road.

Renovation or rehabilitation of an existing road can introduce concerns for adjacent business owners. Often the loss or relocation of a driveway can be perceived as a potential future loss in business. Consequently, the removal of a driveway can be controversial. For alternative intersections, however, the retrofit design may mean that there is little flexibility in driveway placement. If the driveway location is positioned in a way that road users can compromise the alternative intersection effectiveness, then consideration should be given to removing the driveway. Figure 73, figure 74, and figure 75 demonstrate an access management challenge for one of the approaches at the Norfolk, VA, site.

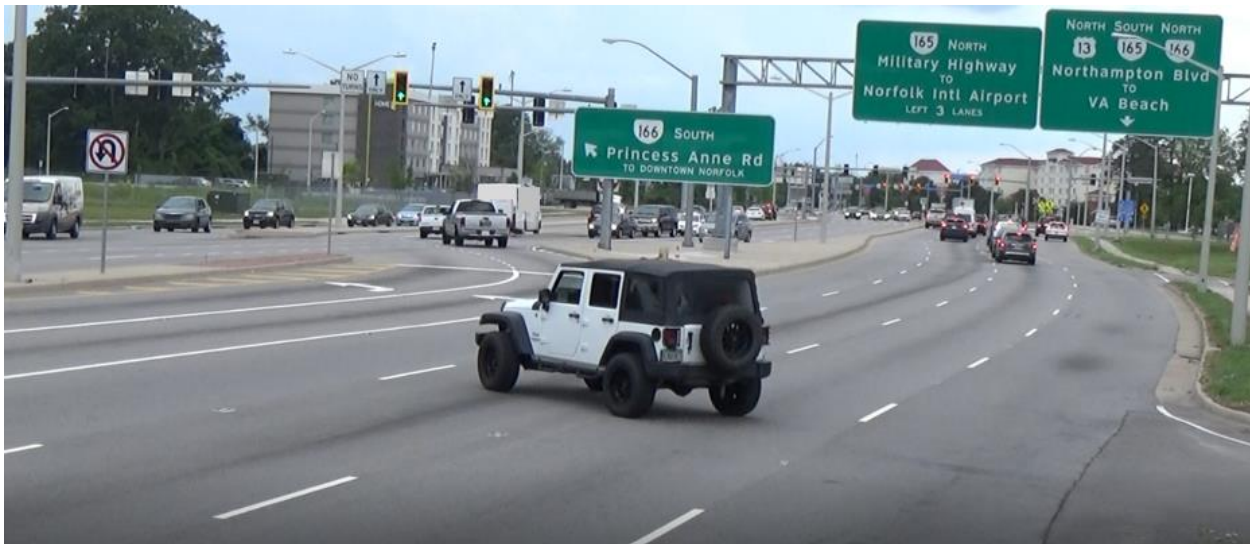
Figure 74. Photo. Vehicle crossing the road to access the crossover intersection.

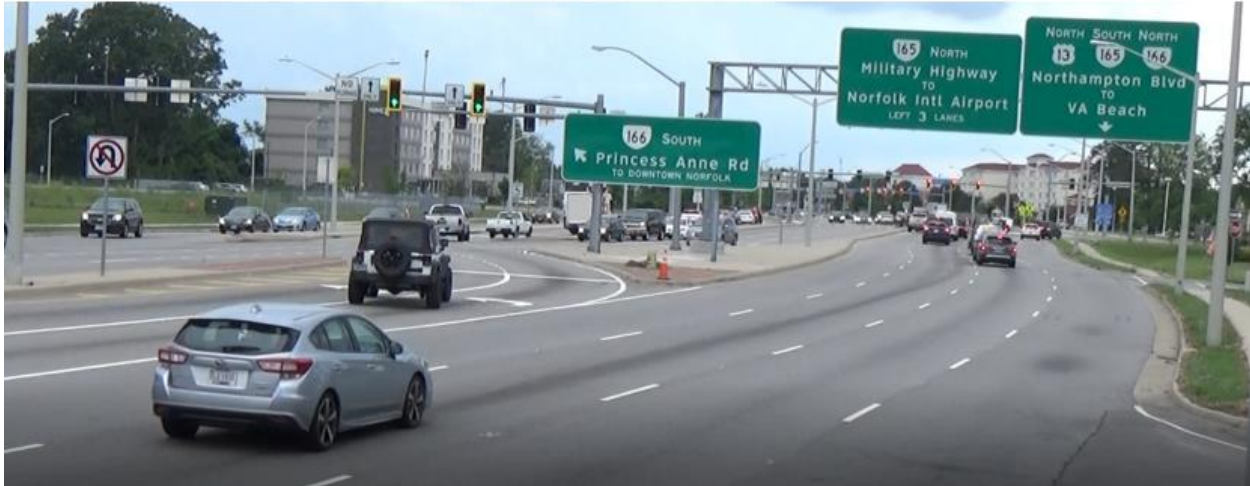
Figure 75. Photo. Vehicle successful (this time) in completing maneuver.

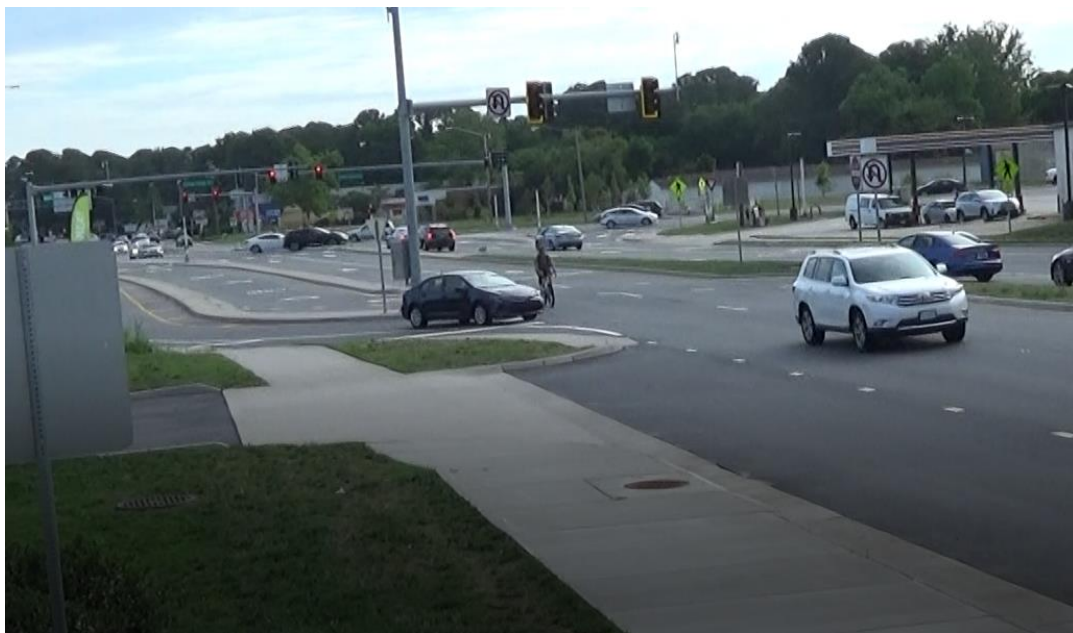
Figure 76. Photo. Conflict between bicycle and motor vehicle.

Many alternative intersections provide dedicated facilities for bicycles to travel through the corridor. In some instances, a location has historically been heavily congested during the peak hour, resulting in a corridor that is less desirable for bicycles. Both drivers and bicyclists need to be acutely aware of each other at these alternative intersection locations. Figure 76 depicts an example of one bicyclist traversing the Virginia Beach, VA, site. At this location, the motor vehicle was executing a right turn on yield as the vehicle exited the crossover intersection. At the same time, a bicyclist with right-of-way was traveling SB, but the automobile continued forward. Ultimately the bicyclist had to take evasive action.
