Federal Highway Administration (FHWA) Coatings and Corrosion Laboratory (CCL): Ongoing Research on Tendon Corrosion

Office of Infrastructure Research and Development
FHWA CCL
October 2023

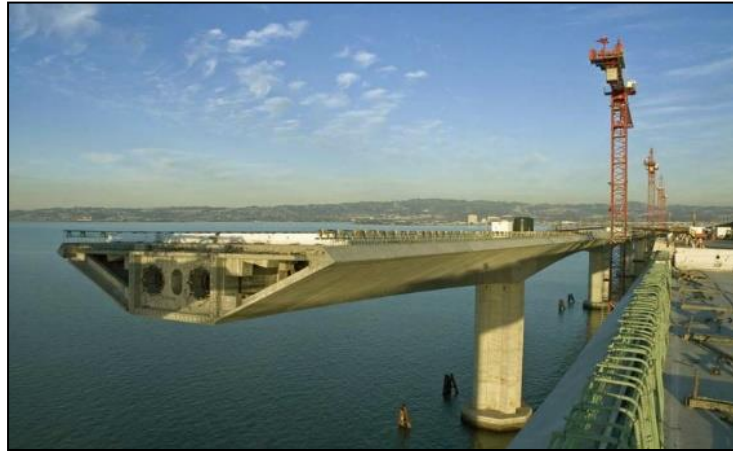
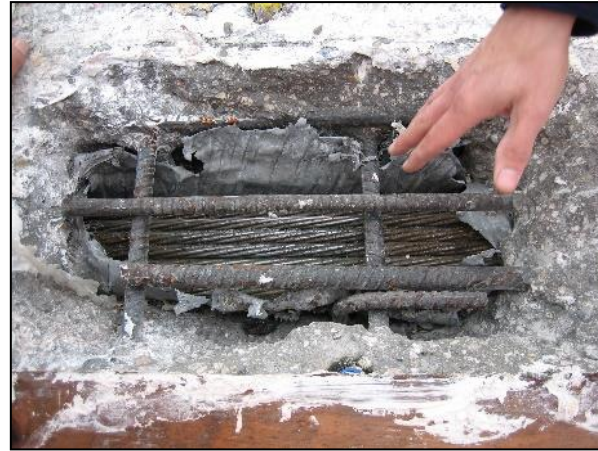
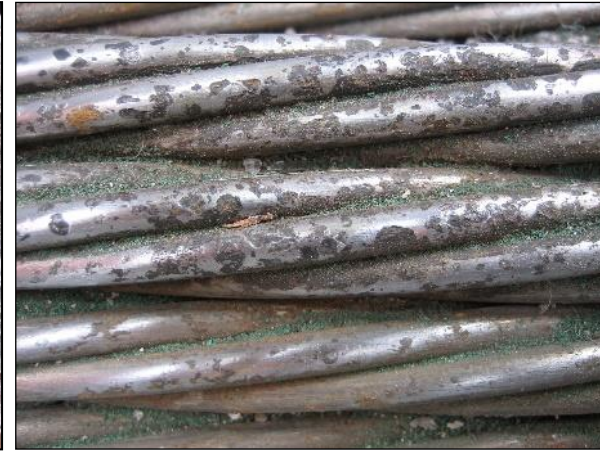
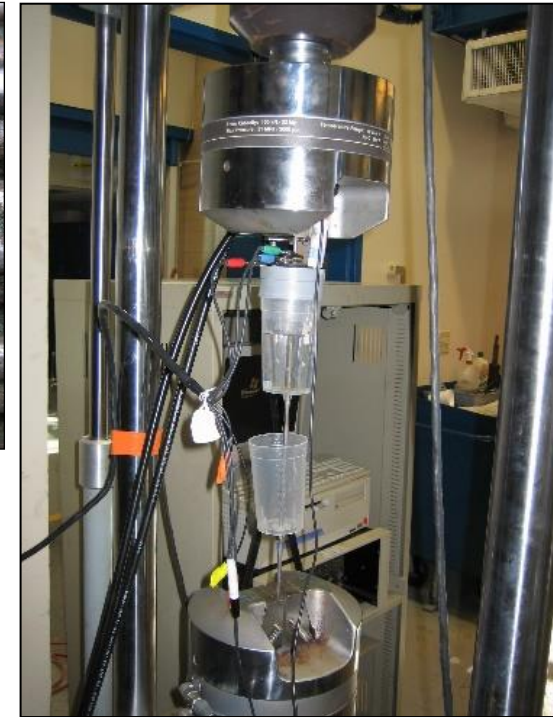
Technical Assistance: San Francisco-Oakland Bay Bridge (2006)

Background: Caltrans inspectors discovered many ungrouted internal tendons during the construction of the San Francisco-Oakland Bay Bridge Construction in 2006. At the request of the FHWA California division office, CCL participated in the corrosion investigative work.

Based on the analysis of water samples collected from the site and findings from the lab investigation, the study concluded that most seven-wire prestressing strands were not exposed to a very aggressive environment for pitting corrosion.

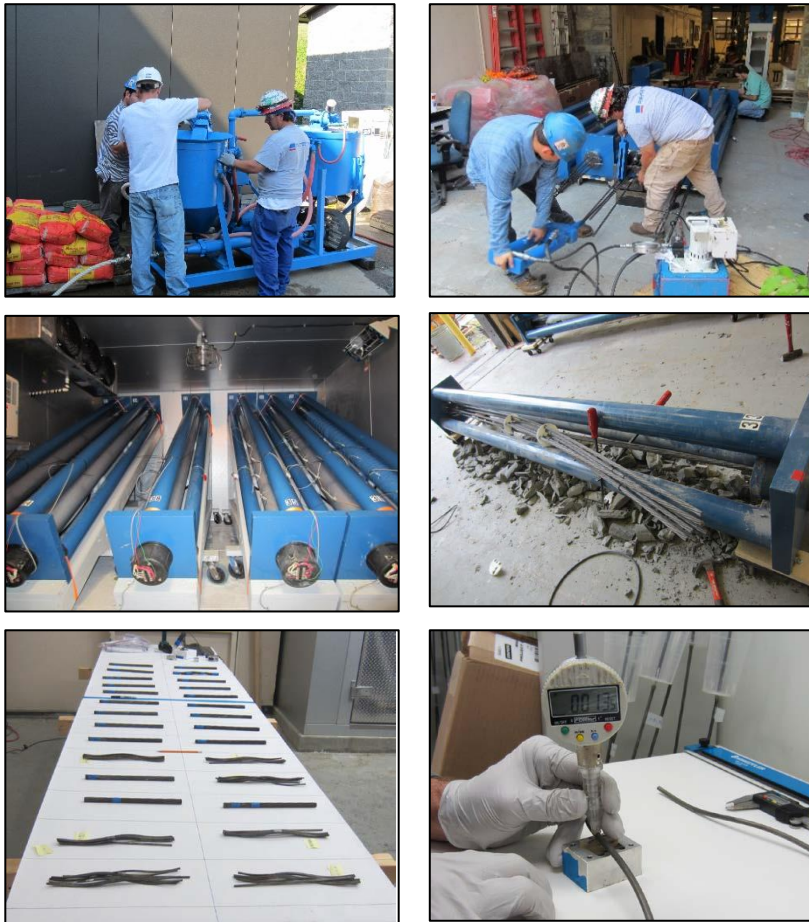
Determination of Chloride Thresholds for Tendon Corrosion (2012–2014) (3/5)

Number of Specimens

- Stressed Specimens @ 60% GUTS: 8 EA (Chloride concentrations: 0, 0.08, 0.2, 0.4, 0.6, 0.8, 1.0, and 2.0 % by weight of cement)

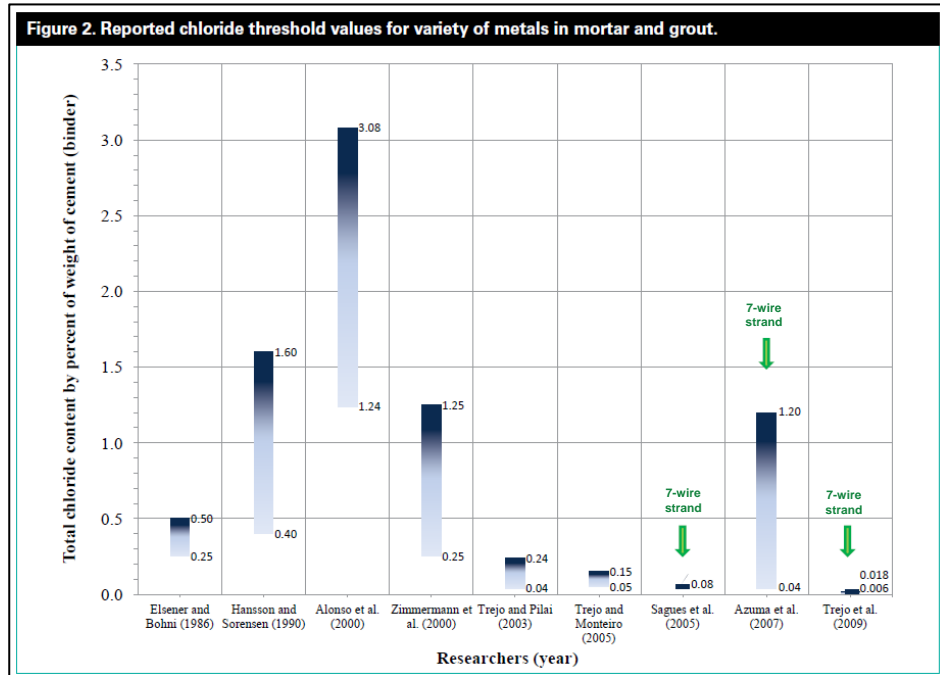
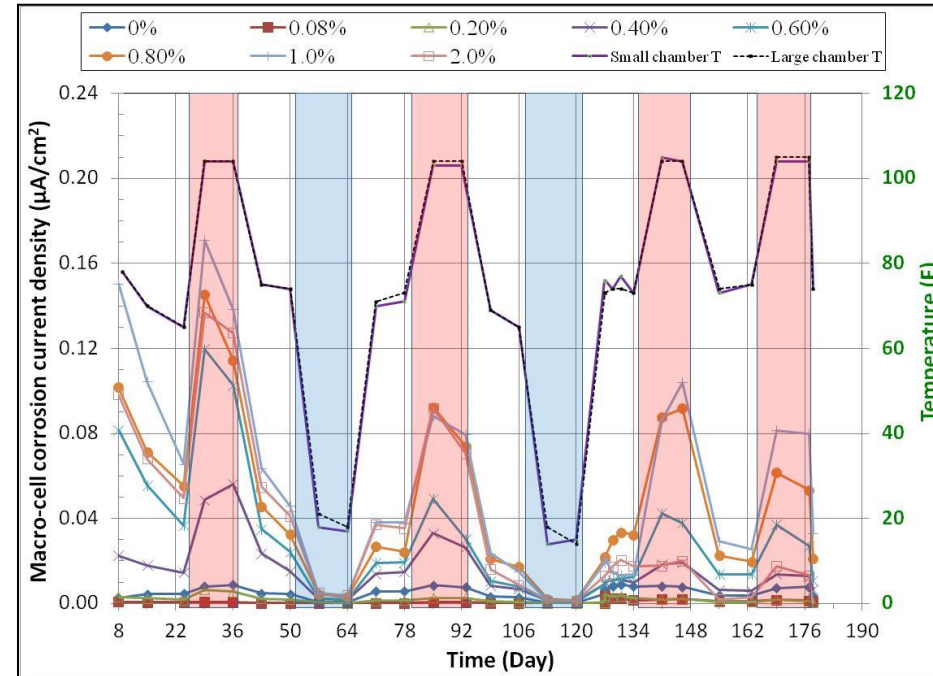
Determination of Chloride Thresholds for Tendon Corrosion (2012–2014) (4/5)

Major conclusions (Lee and Zielske 2014):

- Chloride threshold for corrosion initiation = 0.4 percent by weight of cement or 0.2 percent by weight of sample.
- Chloride threshold for corrosion propagation = 0.8 percent by weight of cement or 0.4 percent by weight of sample.
- These thresholds are for normally hardened grout. There are much lower thresholds for defective grout and other unfavorable conditions.

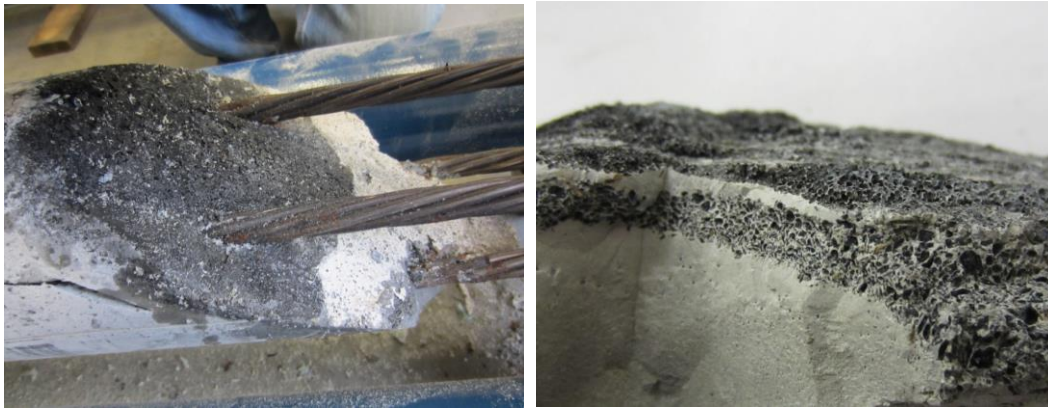
Free sulfate contractions ranged from 0 to 1.5 percent by weight of grout samples.

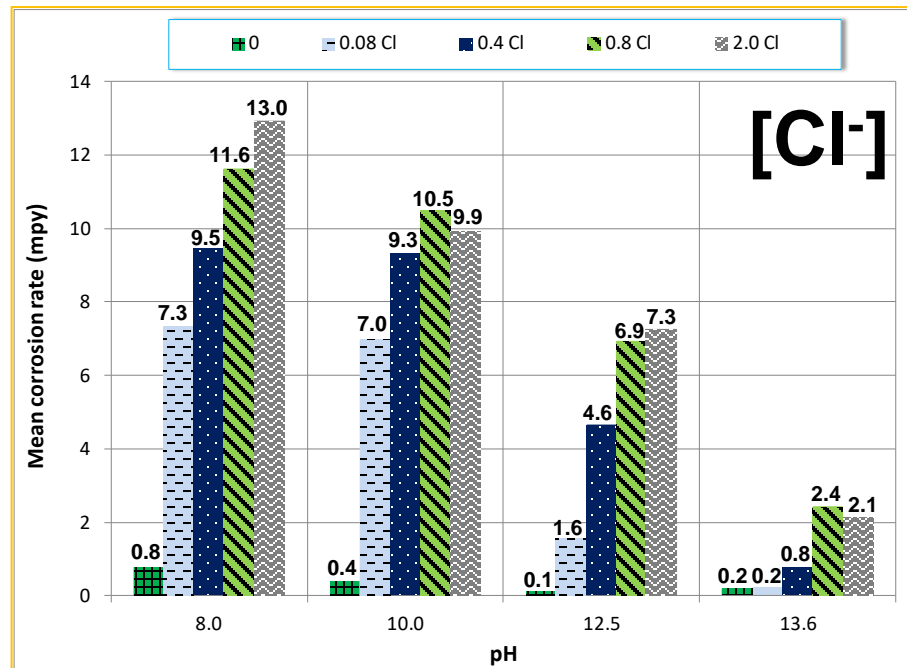
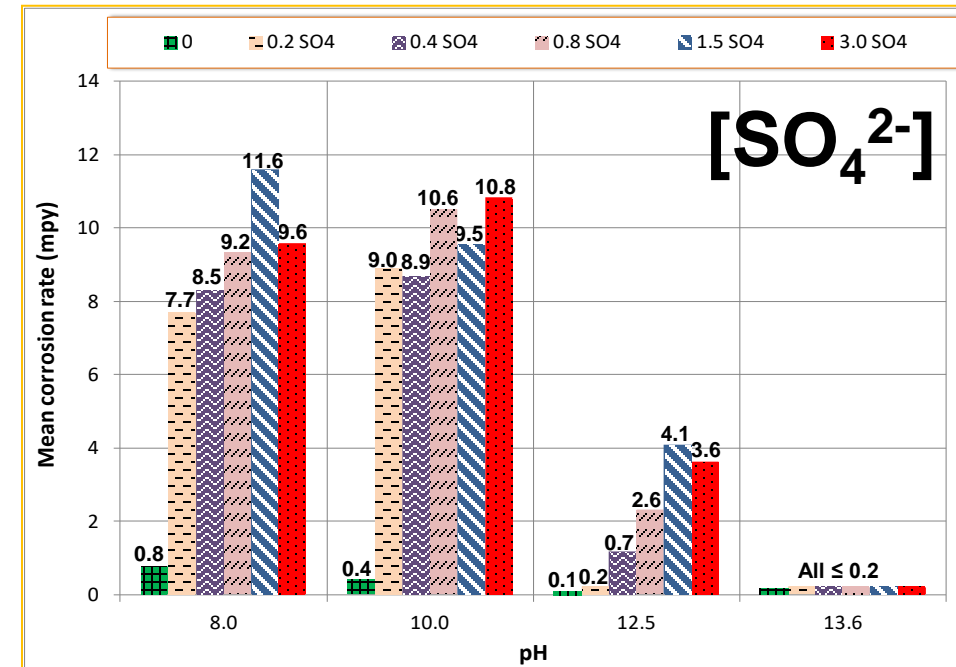
Grout Segregation and Sulfate Corrosivity Study (2014–2019) (7/8)

Major conclusions (Lee 2021):

- Chloride and sulfate ions exhibited similar mean corrosion rates in pH 8.0 and 10.0 aqueous solutions.
- Corrosion rate by sulfate ions decreased as pH increased to 12.5 and 13.6 → virtually zero in pH 13.6.
- Chloride ions exhibited higher corrosion rates than sulfate ions as pH increased to 12.5 and 13.6.

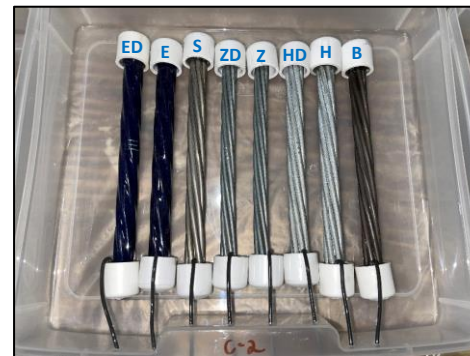
Testing in good-quality grout.

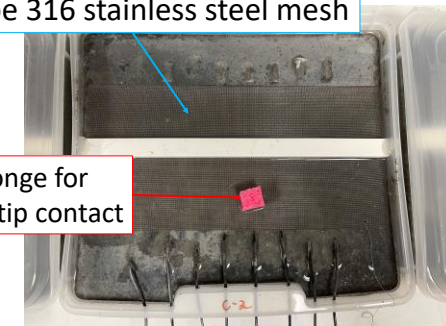
Type 316 stainless steel mesh

Sponge for RE tip contact

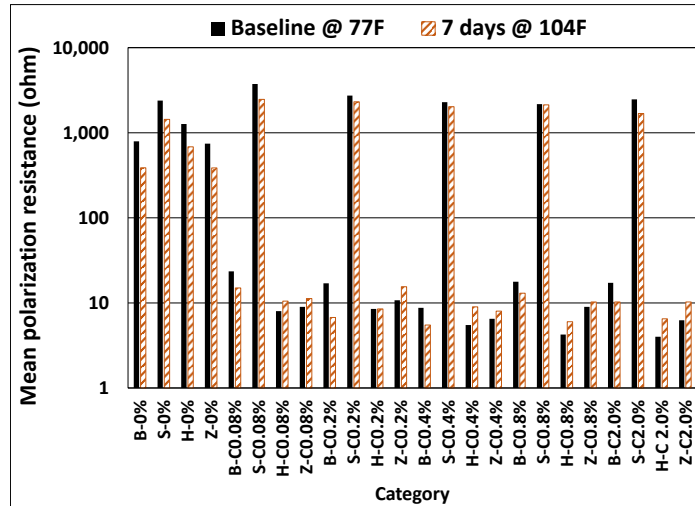
Mean polarization resistance data.

- The conventional bare strand (**B**) exhibited the lowest corrosion resistance.
- Duplex 2205 SS strand (**S**) performed very well with the most positive corrosion potential and the highest polarization resistance (PR), and the lowest macrocell corrosion current (I_{macro}).
- The hot-dip galvanized (**H**) and 95-percent zinc/5-percent aluminum coated strands (**Z**) were the most active materials with very negative corrosion potential, the lowest PR, and the largest I_{macro} .
- The flow-filled epoxy strand (**E**) showed encouraging performance due to its high-quality electrical insulation barrier; when artificial coating defects were introduced (**ED**), the mean coating resistance was reduced significantly.

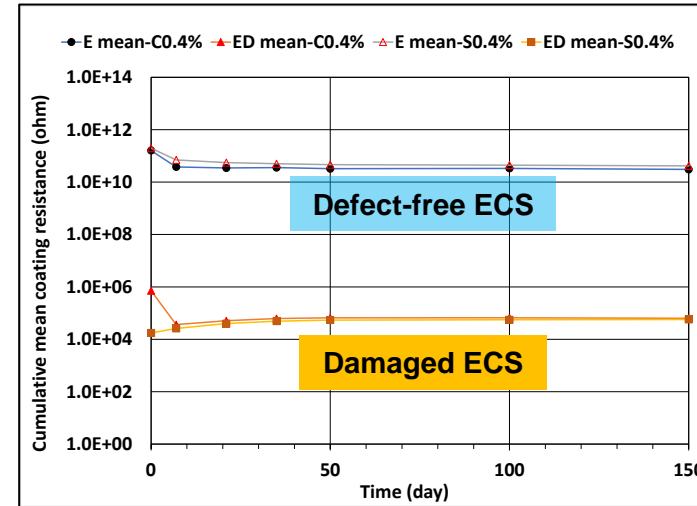
Cumulative mean coating resistance data.

ECS = epoxy-coated strand.

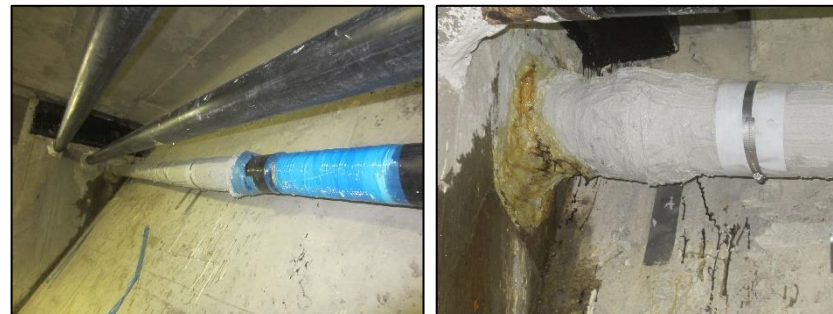
Field trial in Varina-Enon Bridge.

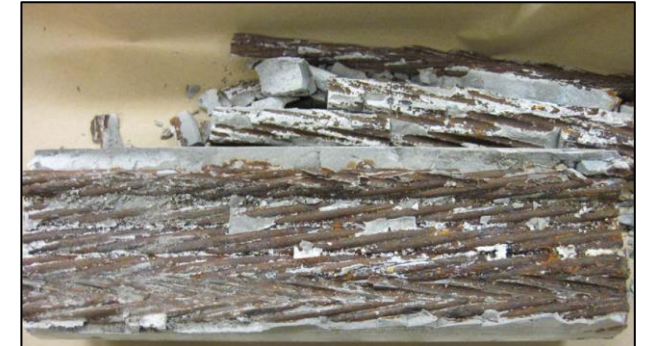
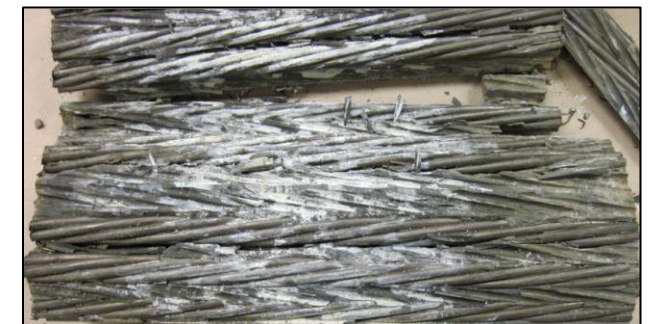
208 days in 5% NaCl fog chamber

Laboratory evaluation at the FDOT.
