**ENGINEERING DESIGN REPORT**

**KUHIO HIGHWAY,  
REHABILITATION OF WAINIHA BRIDGES**

**Wainiha, Hanalei, Island of Kauai**

**OCTOBER 2012**

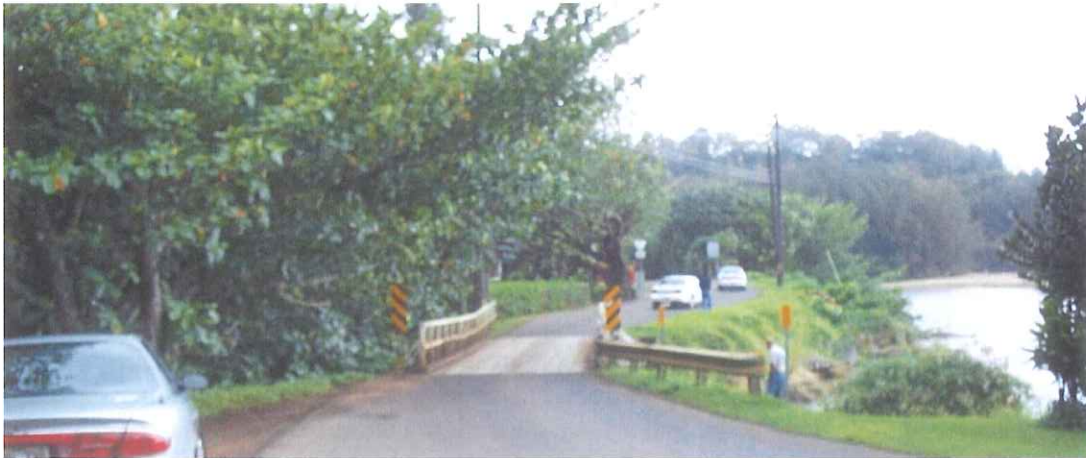
**Photo 1 : Previous Bridge #1 - Looking from Lihue toward Haena**

Bridge #1 was comprised of steel King Post trusses and was approximately 42-feet in length and 11-feet in width. The bridge deck was constructed with wooden timbers and was at elevation of approximately 10.10-feet (MSL). This bridge was equipped with wooden railings/guardrails. A 3-inch waterline is attached below the bridge on the upstream side of the bridge.

- Spalling of AC pavement at Haena approach adjacent to bridge deck,
- Corrosion of steel girders,
- Heavy corrosion and section loss in steel compression strut at midspan,
- Tension rods, including welded splices, are heavily corroded (scaling and pitted),
- Tension rods are loose (slack) under light vehicular loads on bridge,
- Spalling and scaling along base of Lihue abutment wall,
- Void at base of Lihue abutment wall,
- Embankment erosion behind Haena abutment wall,
- Concrete debris/drift in channel, and
- Structural Sufficiency Rating = 3.0, out of a possible 100.

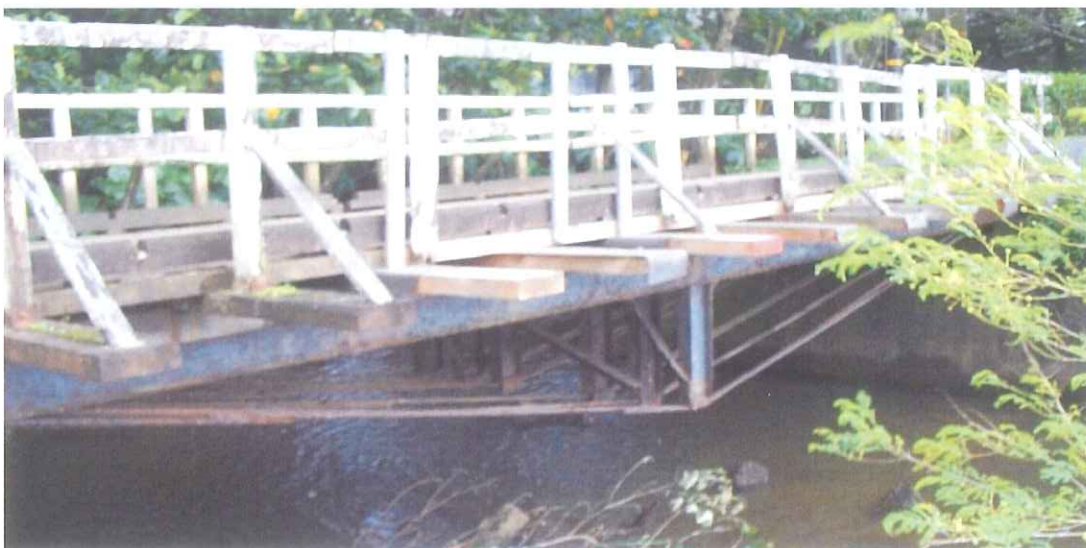
**Photo 2 : Previous Bridge #1 - Trusses (Looking from Makai Side)**

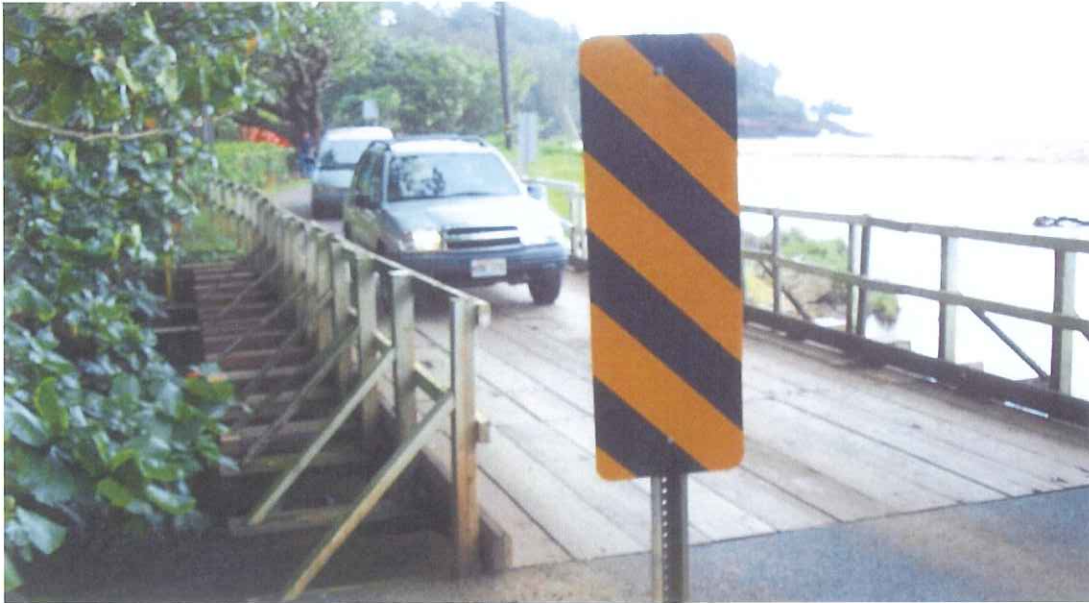
**Photo 3 : Previous Bridge #1 - Looking from Lihue Side**

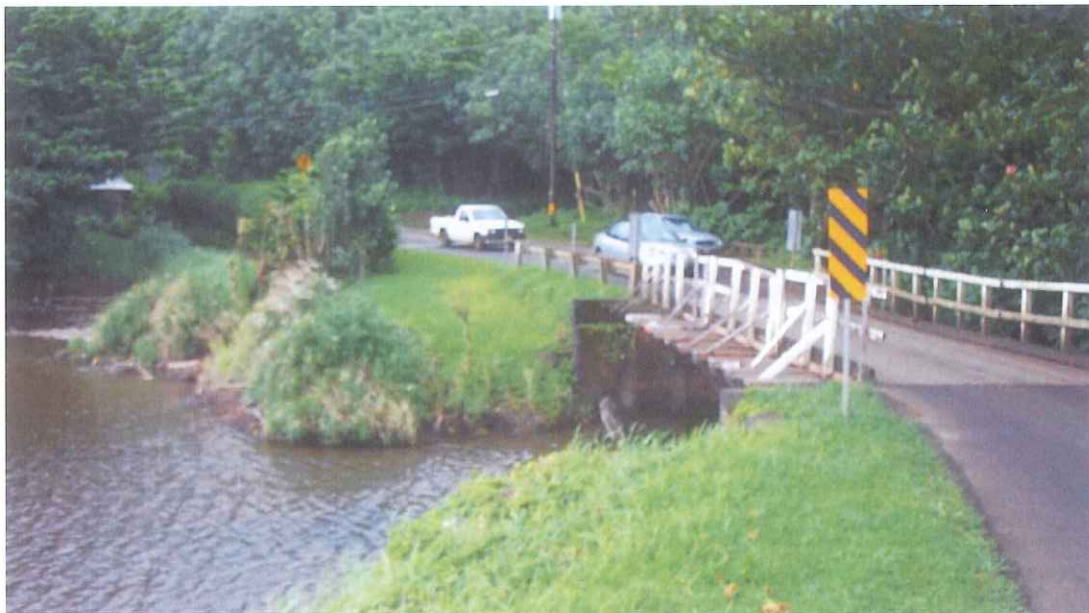
**Photo 4 : Previous Bridge #1 - Looking from Haena toward Lihue**

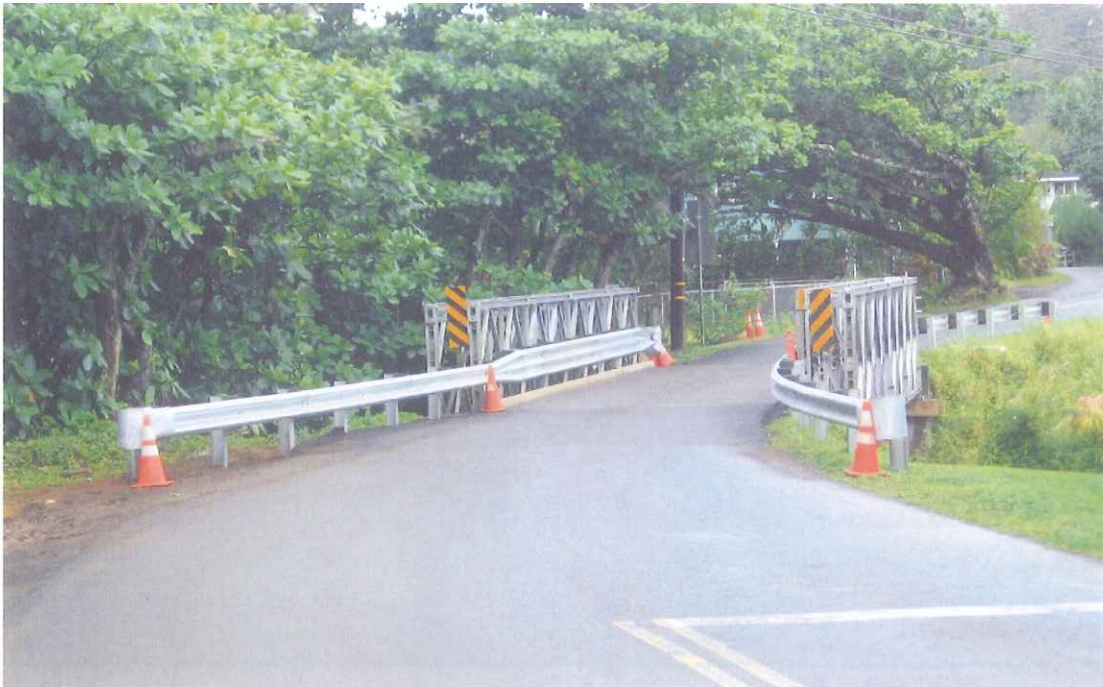
**Photo 5 : Current Bridge #1 - Looking from Lihue side**

Following the October 2007 Load Test, Bridge #1 was replaced with a temporary ACROW Panel Bridge. The following photographs illustrate the previous and current conditions of Bridge #1.

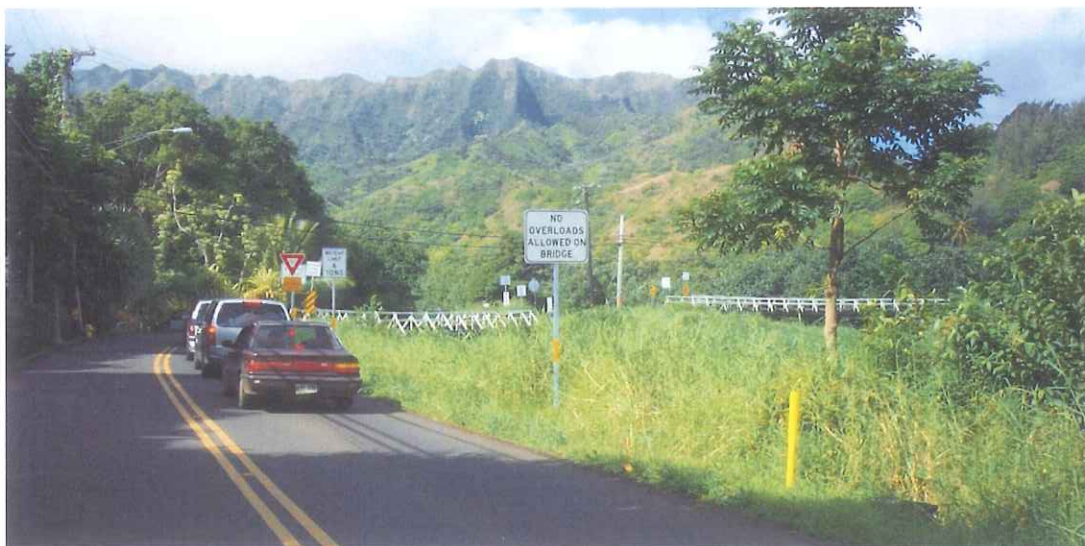
**Photo 7 : Previous Bridge #2 and #3 - Looking from Hanalei**

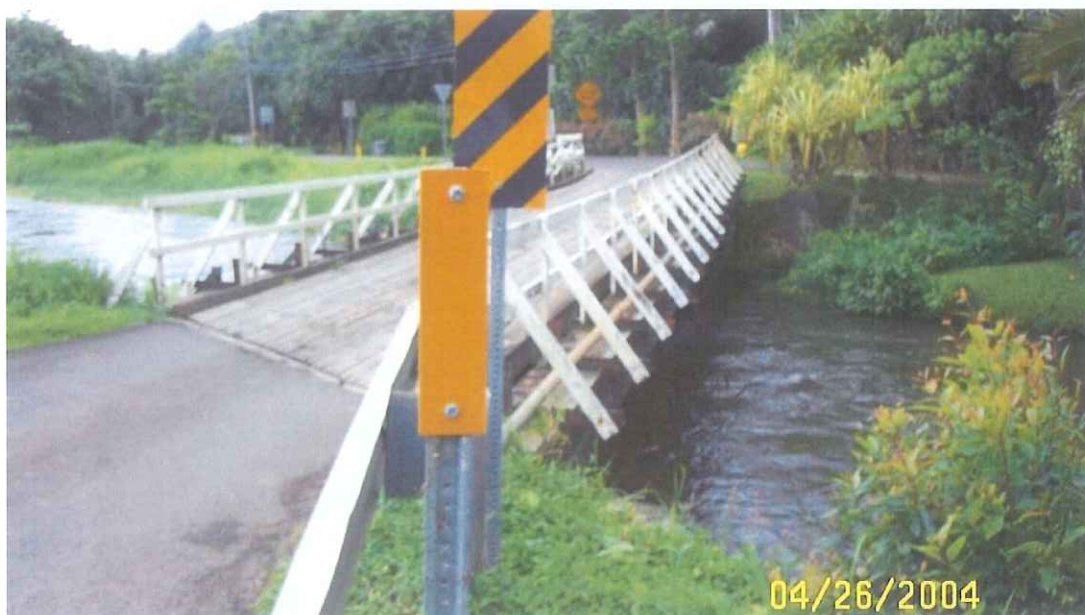
**Photo 8 : Previous Bridge #2 - Looking from Haena Side**

Subsequent to the 2001 biennial bridge inspection, Bridge #2 suffered permanent sag in the eastern *makai* corner. The sag was attributed to web crushing of the corroded girders. A temporary ACROW Panel Bridge was placed directly above the Queen Post truss bridge. The Queen Post truss system was eventually removed.

- Checks and cracks in timber decking,
- Corrosion of brackets for 8-inch ductile iron pipe,
- Heavy section loss in steel girders,
- Major corrosion of tension bars,
- Heavy corrosion of tension bar to compression strut connections,
- Heavy corrosion of diagonal bracing,
- Visible deflection of the superstructure,
- Significant vibration of bridge under loading,
- Spalls along the top edge of the Haena abutment,
- Vertical cracks in upstream wingwall of Lihue abutment,
- Heavy buildup of soil and vegetation on abutment seats.
- Deterioration of timber railing to post connection,
- Scaling of both abutments in tidal zone,
- Broken tension rods,
- Damaged and displaced timber curb along downstream end,
- Heavy corrosion of compression struts at midspan,
- Deterioration of timber headers at both abutments, and
- Structural Sufficiency Rating = 2.0, out of a possible 100.

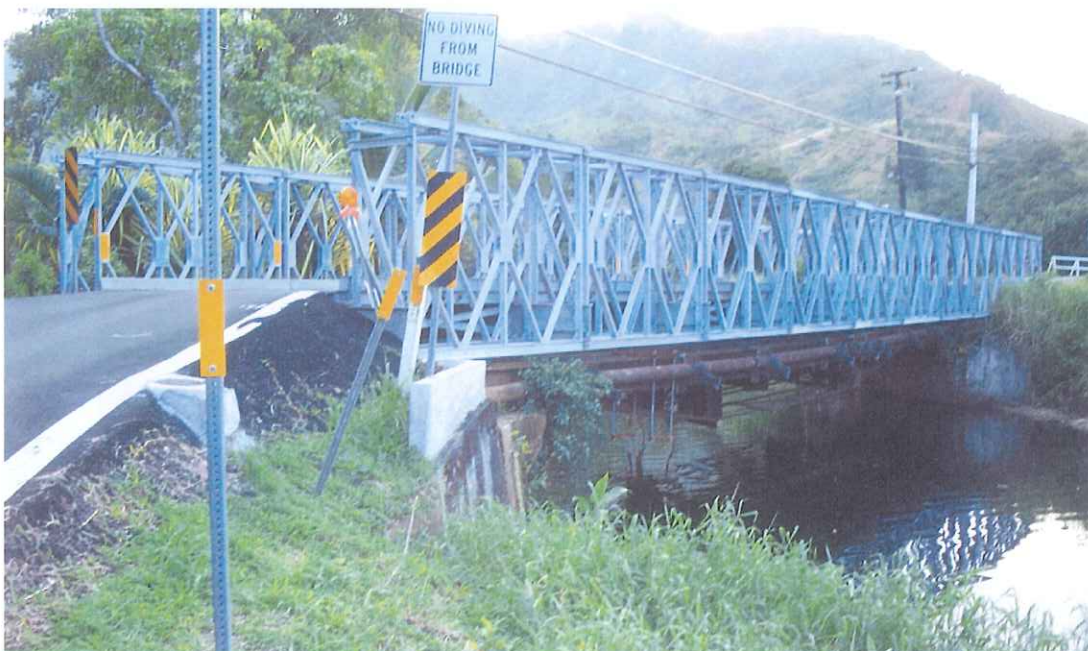
**Photo 10 : Current Bridge #2 - ACROW Panel Bridge over Queen Post Truss**

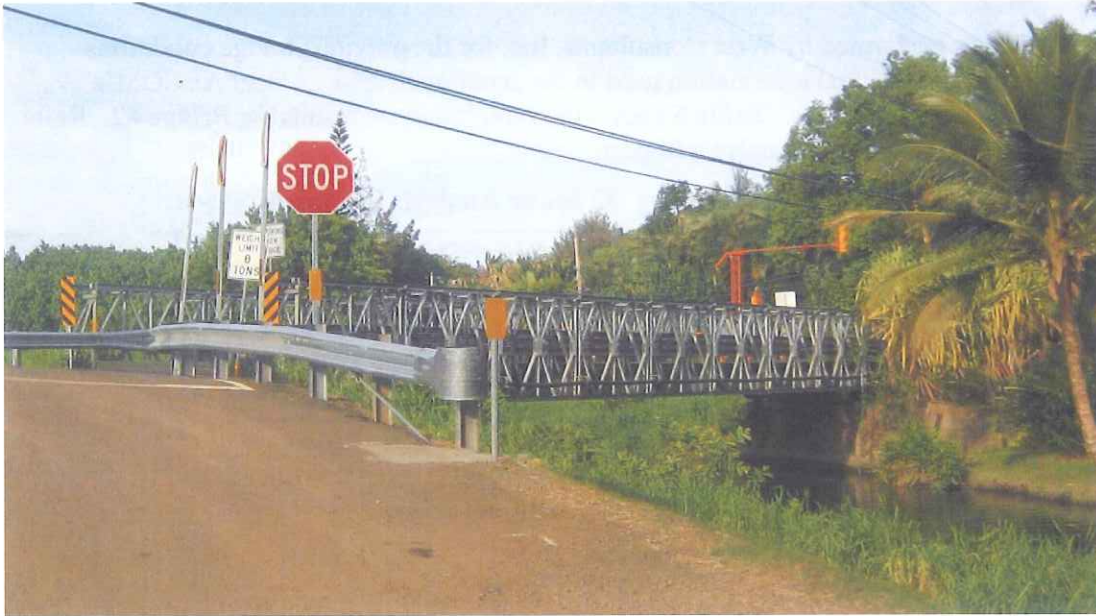
**Photo 11 : Current Bridge #2 - ACROW Panel Bridge (no Queen Post Truss)**

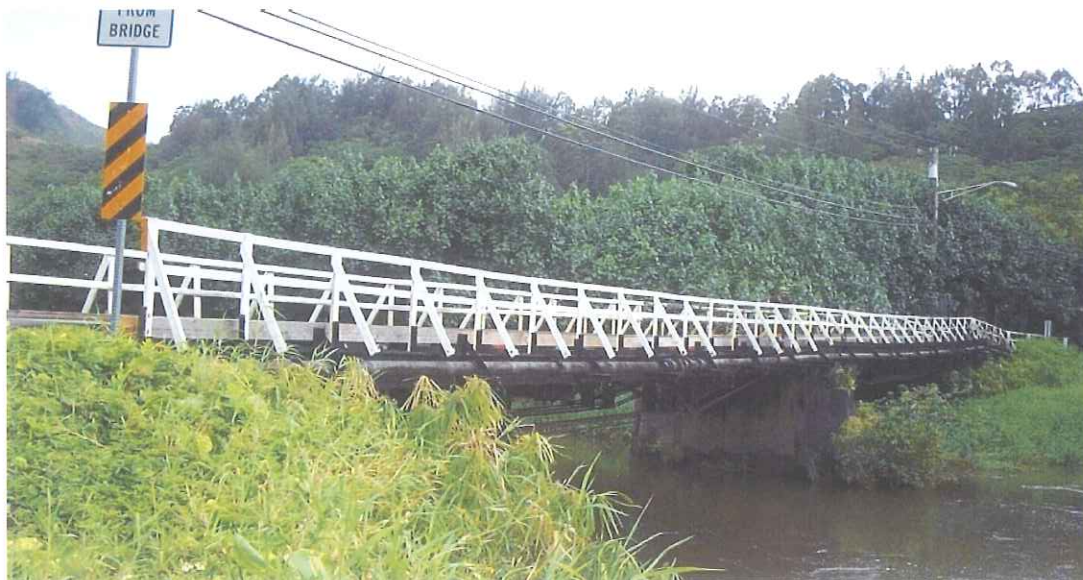
**Photo 12 : Previous Bridge #3 – Looking from Makai Side**

Bridge #3 was a three (3) span bridge. It was comprised of two (2) steel truss Queen Post spans totaling approximately 146-feet in length and 11-feet in width. The third span was much shorter and located on the Haena side of the bridge. It was approximately 24-feet in length and did not utilize tension rods like the other two (2) spans. This bridge had an approximate deck elevation of 14.35-feet (MSL). This bridge was also equipped with wooden railings. A 3-inch waterline is attached below the bridge deck on the upstream side of the bridge and a 6-inch waterline is attached below the deck on the downstream side. The following photographs illustrate the previous and current conditions of Bridge #3.

- Inadequate and rotted wood railing,
- Displacement of timber curb,
- Corroded steel girders,
- Corroded and broken tension rods,
- Spalling of Haena abutment,
- Scour around left pier,
- Soil build up on bridge seats,

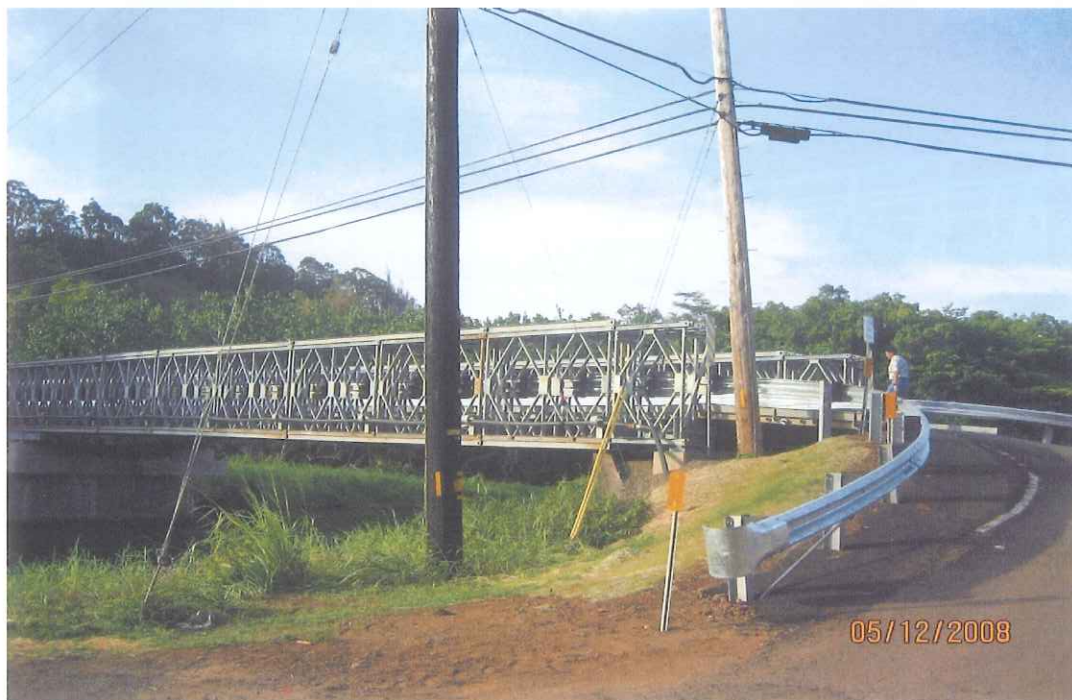
**Photo 14 : Current Bridge #3 – Looking from Ala 'Eke Road towards Haena**
