Glenn Highway Chickaloon Bridge

Matanuska Susitna, Alaska

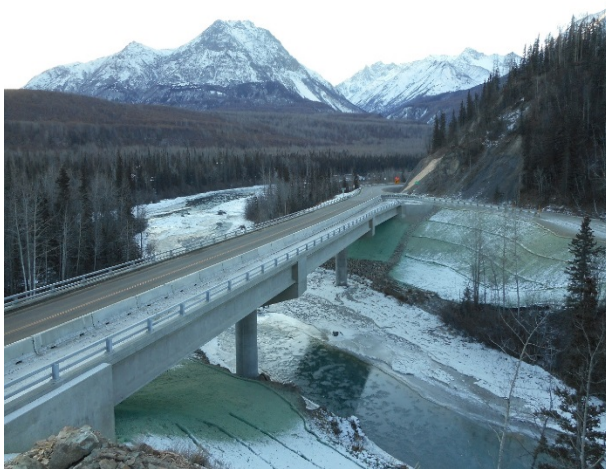
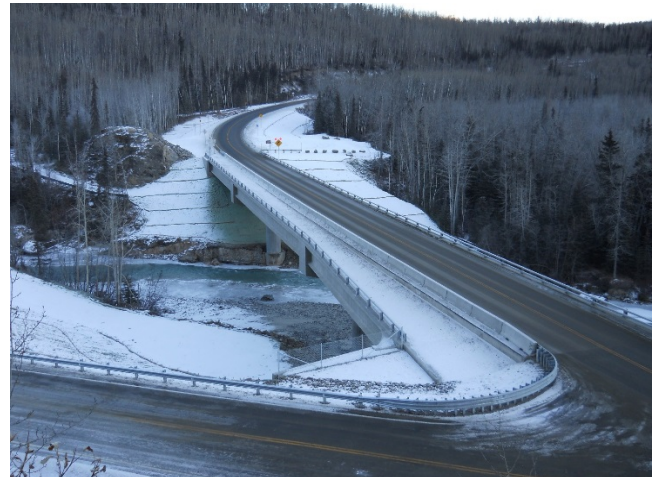
The bridge, which crosses the Chickaloon River, is a three-span, 45 foot by 350-foot-long precast bulb-tee girder bridge with cast-in-place decking. The two center piers were placed on 10-foot diameter drilled shafts approximately 55 feet deep, and the two abutments included five-foot diameter drilled shafts installed to roughly the same depth. The new bridge was constructed adjacent to the existing bridge to minimize the interruption of accessibility to the Alaska residents. The removal of the old bridge took place upon the completion of construction.

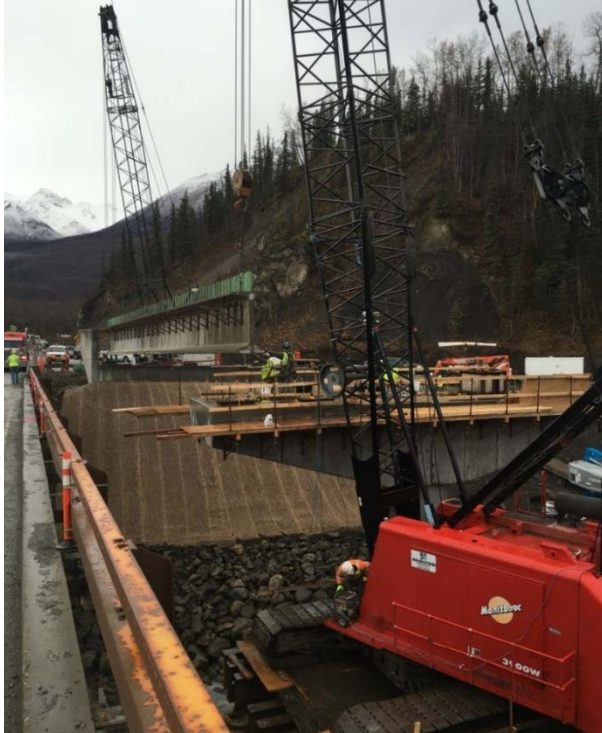
Initial construction required building a seven-span temporary work trestle over the Chickaloon River. Workers could move about freely with equipment and materials while constructing the new bridge and without interrupting the flow of traffic on the old bridge.

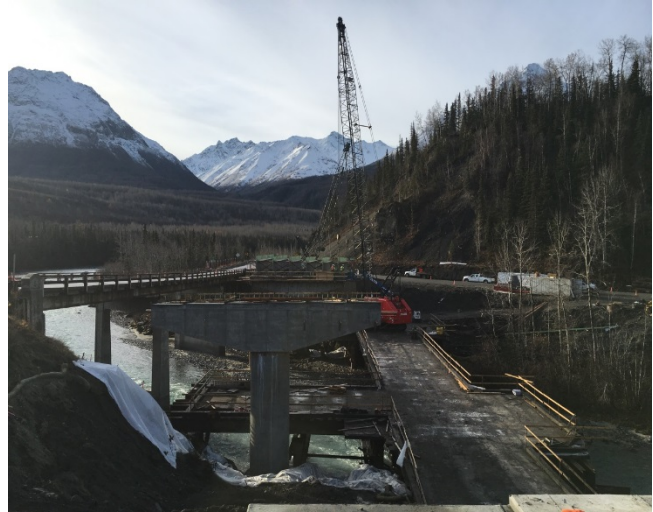
Girders for the new bridge were trucked in from Anchorage, after being barged up from Seattle, Washington. The size of the girders was such that two cranes were needed to set them in place, each crane picking up one end of the girder.

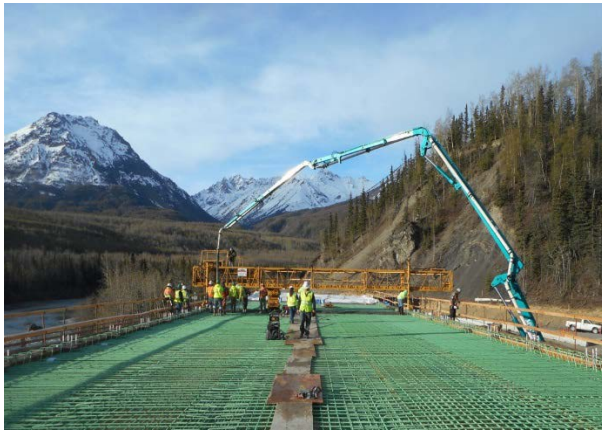
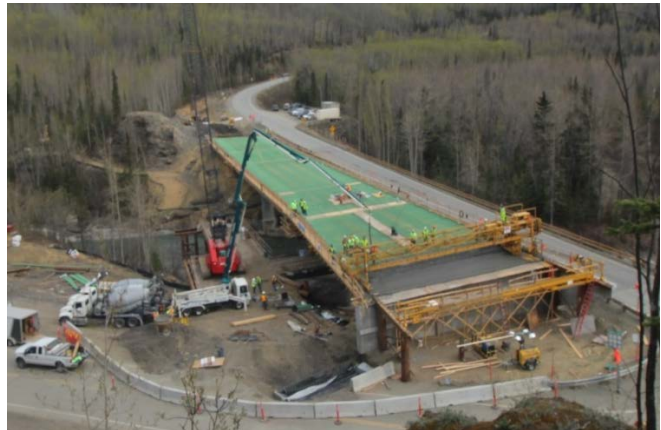
It took five separate deck pours to complete the bridge deck. The cast-in-place concrete deck serves to stabilize the structure.

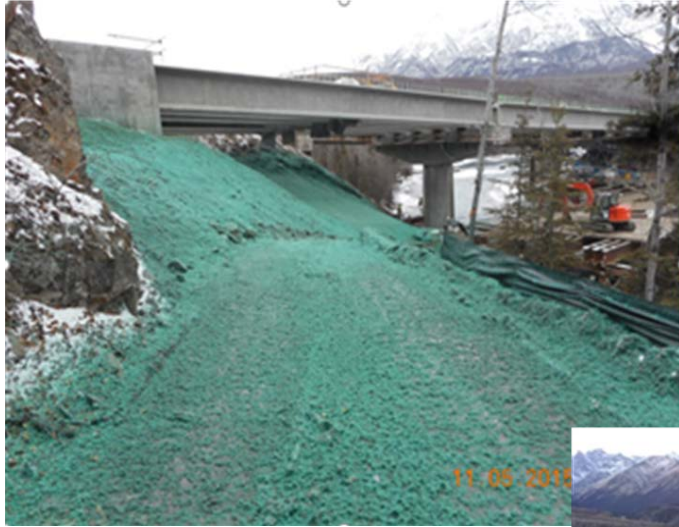
A final placement of a 3-ft layer of NFS (non-frost-susceptible) material below the pavement layer will aid in maintaining the integrity of the pavement through the extreme weather conditions in Alaska.

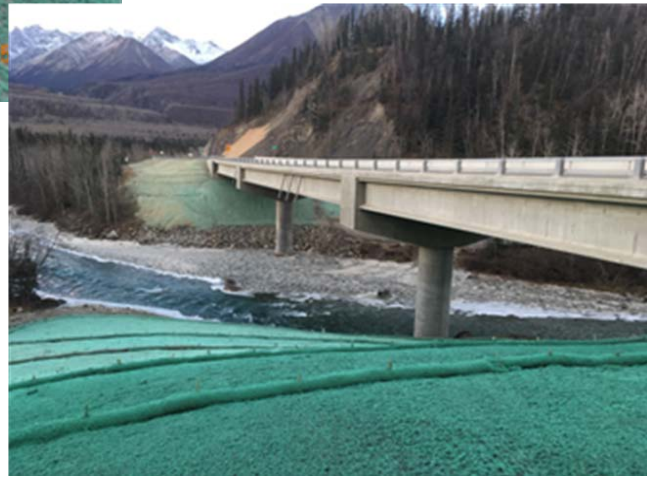
Hydroseed was blown around the surrounding area to ensure ground stabilization throughout the extreme winter weather conditions while the project construction was shut down.

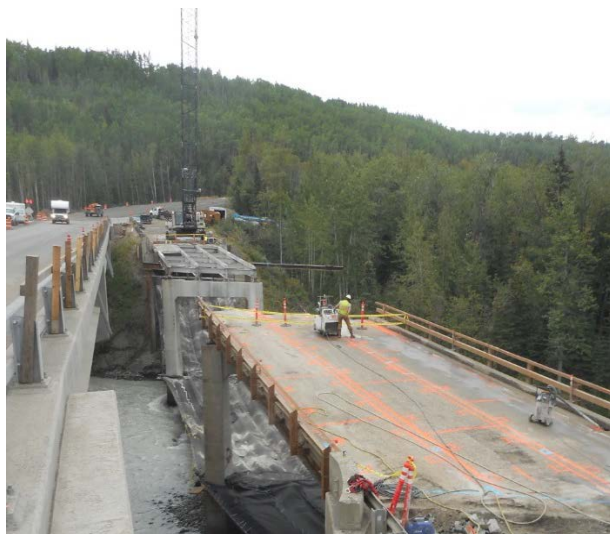
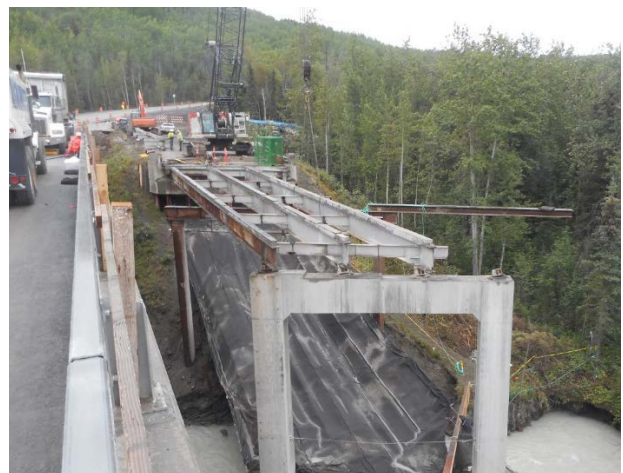
Upon completion of the new bridge, the crews made ready to demolish the existing bridge. A geogrid and geotextile fabric layer was placed under the existing bridge to contain the debris during removal. Then the deck, railing, and girders were cut and removed in sections.
