# PRELIMINARY ENGINEERING REPORT

*Roosevelt Drive Upgrade Study  
MT B Silver Bow 2016(9)  
IDIQ Contract No. DTFH7015D00007  
Task Order No. 69056719F000080*

**WESTERN FEDERAL LANDS HIGHWAY DIVISION**

Prepared by:  
**ROBERT PECCIA &  
ASSOCIATES**  
Helena, Montana

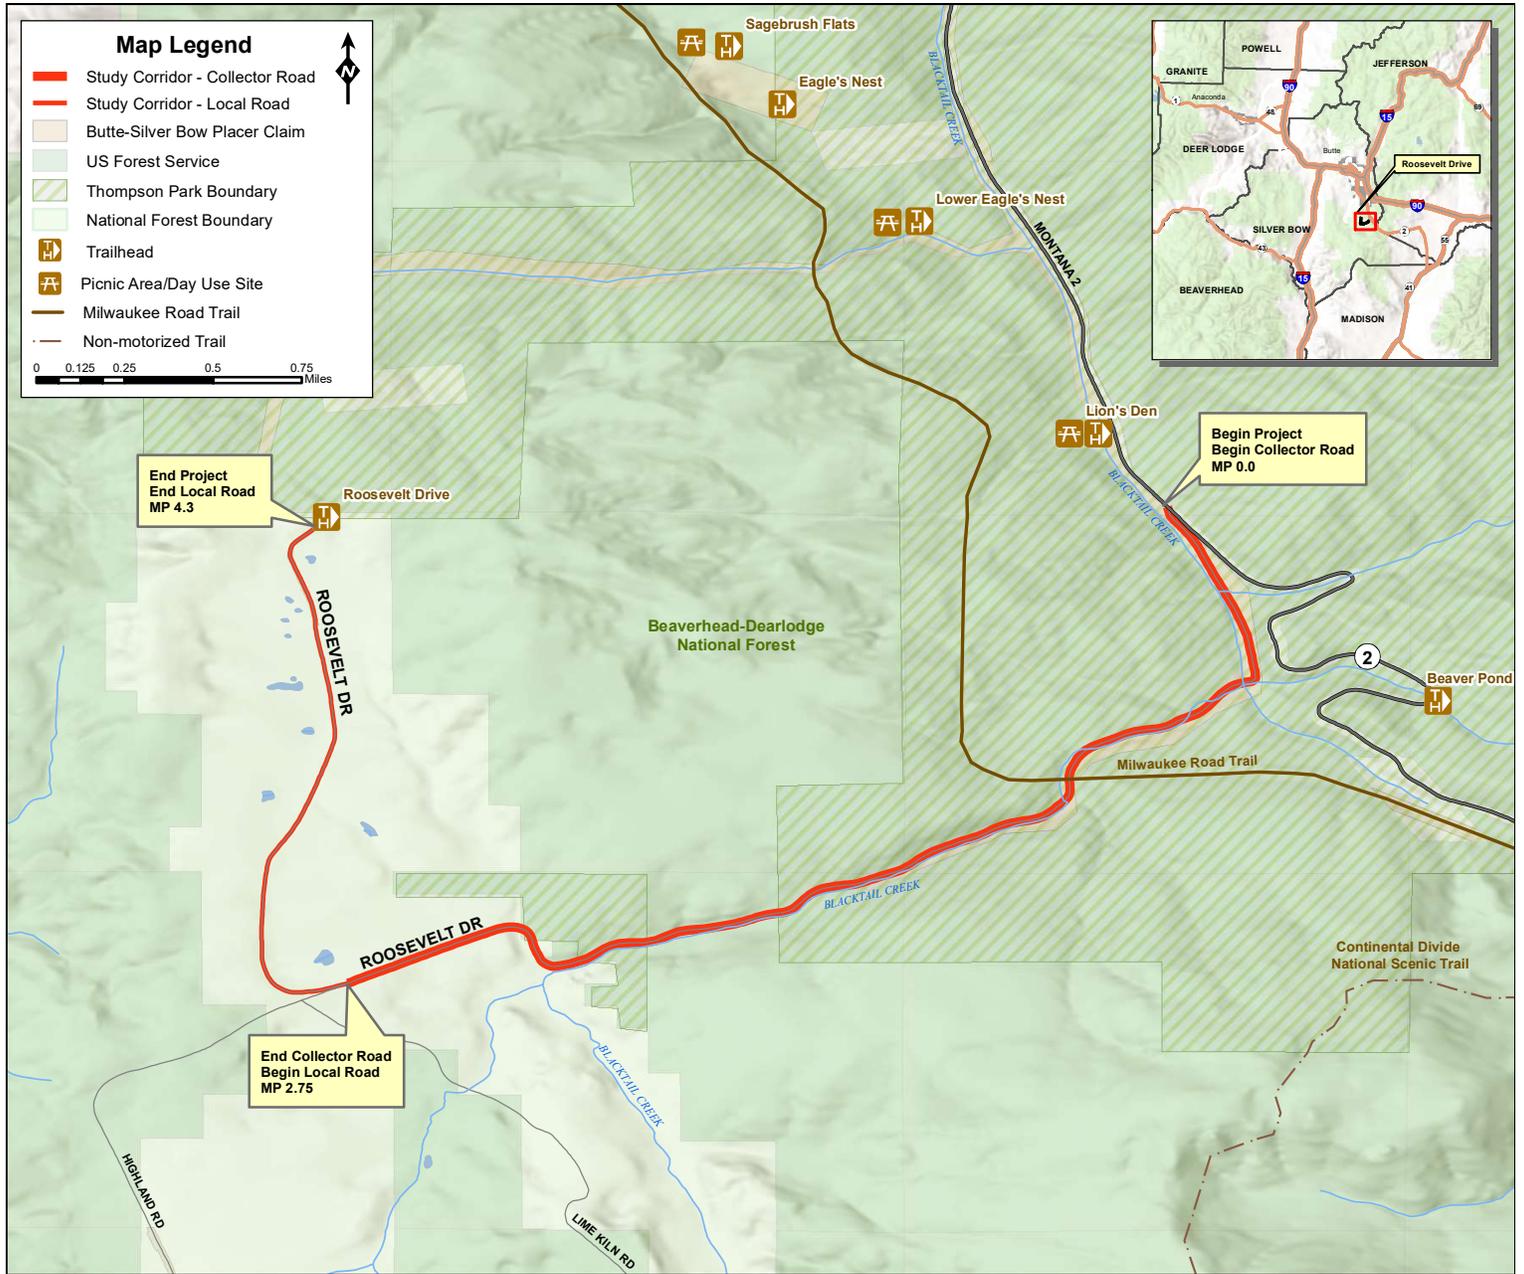
Figure 1.1: Study Area

Roosevelt Drive begins at Montana Highway 2/US Highway 10, approximately two and one-half miles south of Butte, Montana in Silver Bow County. The roadway extends for approximately 4.3 miles and ends at the Roosevelt Drive Trailhead at Thompson Park. The first 2.75 miles of the roadway is functionally classified as a minor collector with the remaining 1.55 miles classified as a local road. **Figure 1.1** presents the study corridor.

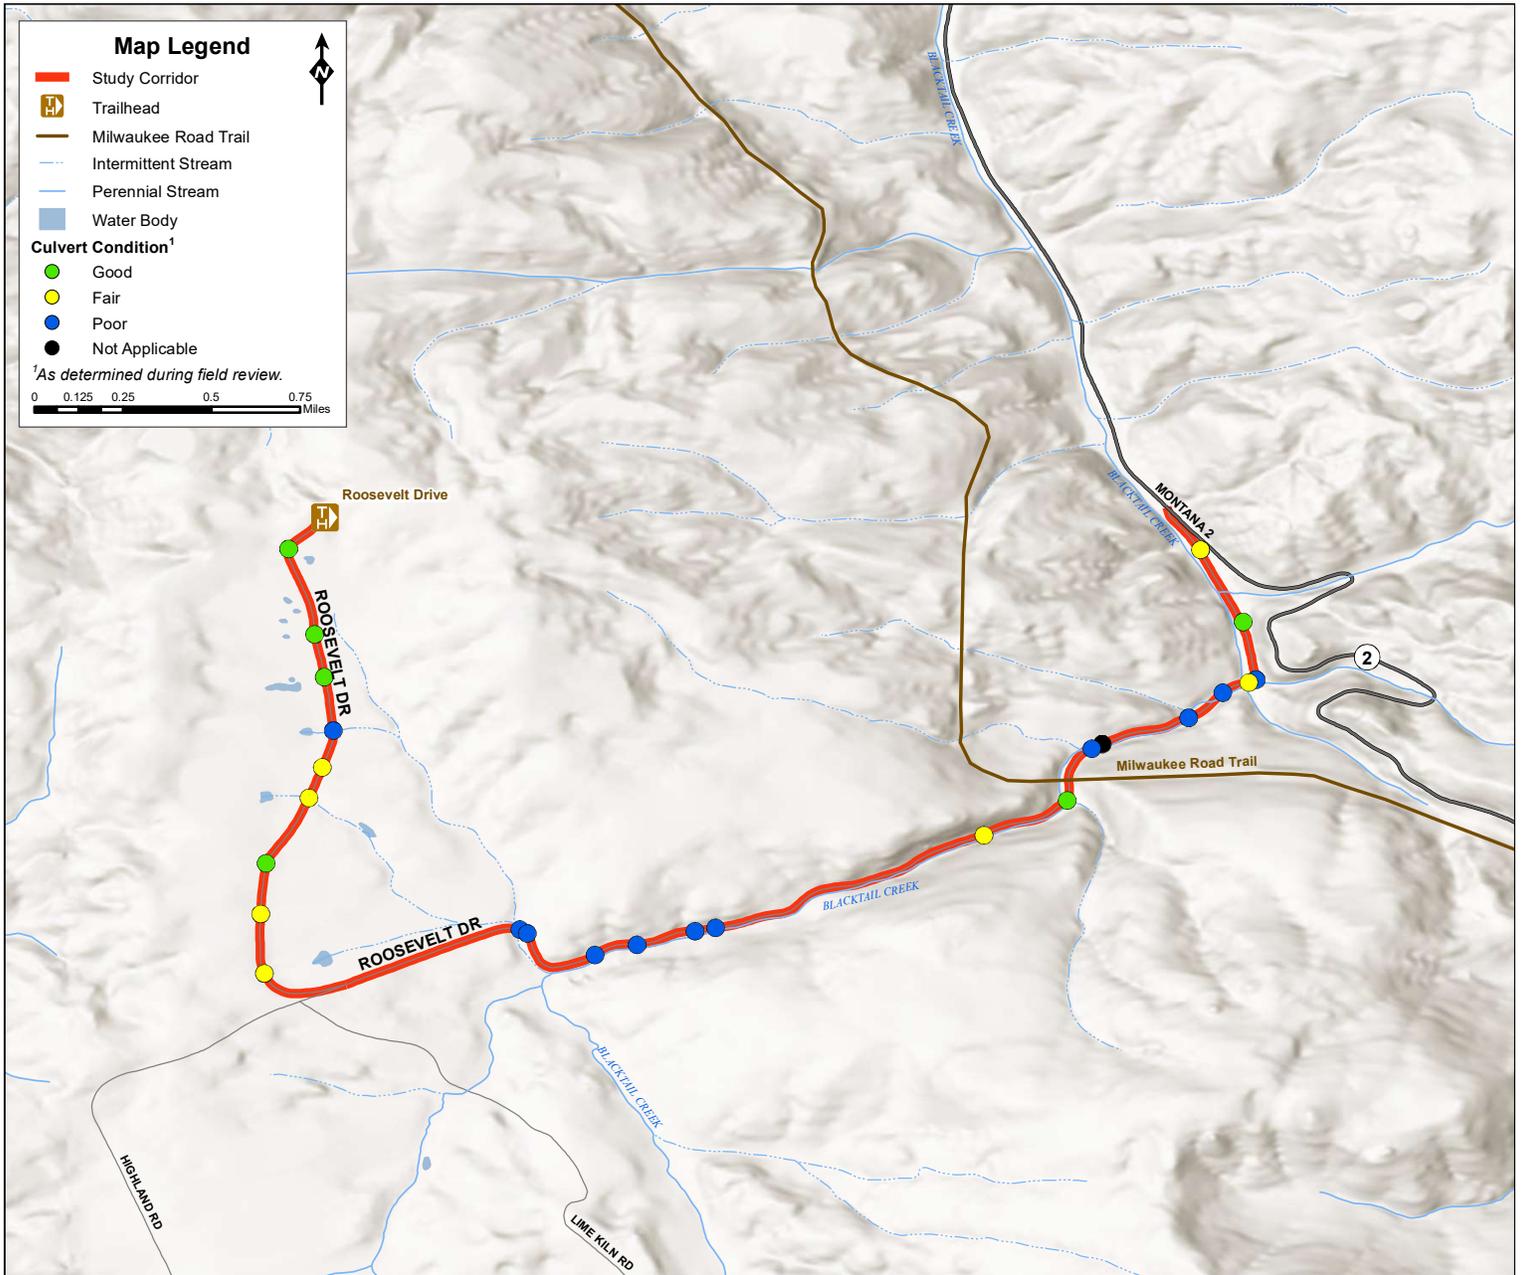
Figure 2.1: Surface Water Features

A total of 25 culverts were identified during the field review. Of those culverts, nine major culverts with a diameter of 30 inches or more were identified. Approximately 56 percent of the culverts were in fair or good conditions. Also noted during the field review was that many of the culverts appear to be undersized to accommodate flow from Blacktail Creek and its tributaries.

**Appendix A** contains an inventory of each structure and lists the specification and condition of each culvert. **Figure 2.1.** shows the locations of the culverts inventoried. All data contained in the appendices were

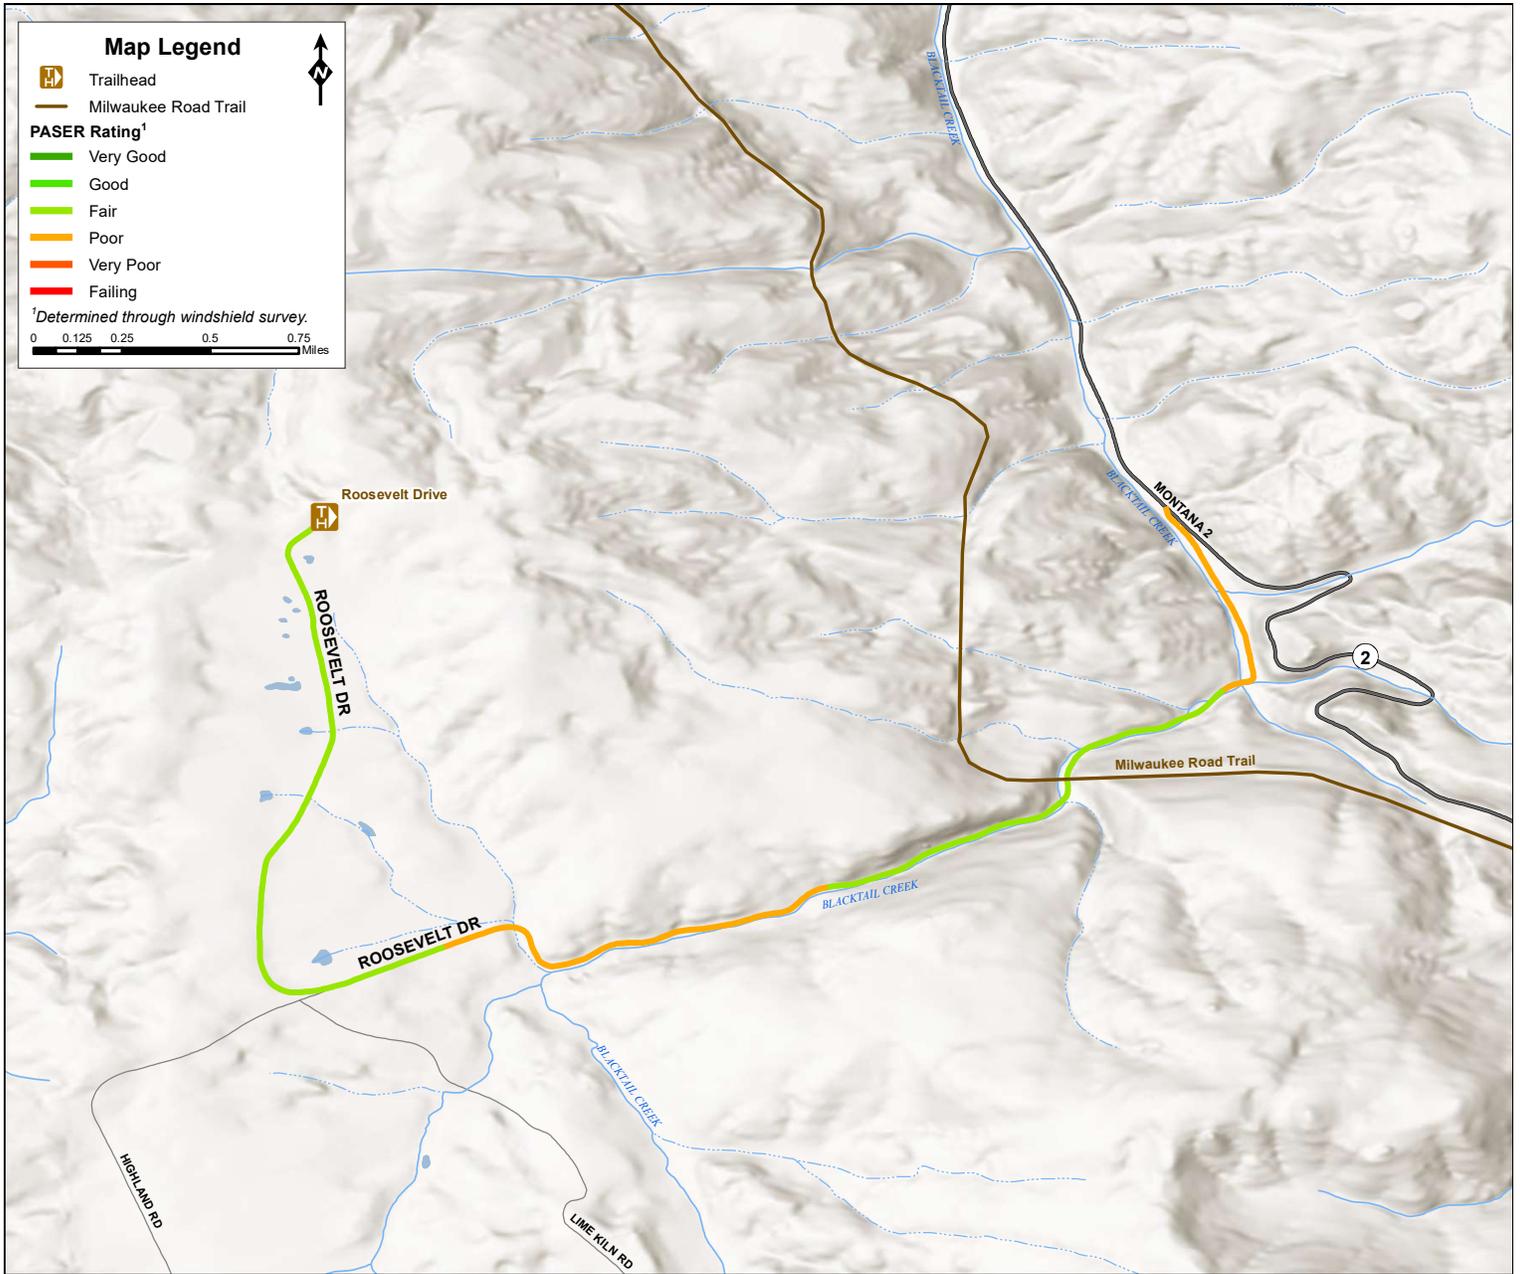
**Figure 2.2: Pavement Condition and Roadway Width**

Pavement condition was also assessed as part of the field review process. A windshield survey of the roadway was performed to assess the existing surfacing condition. The evaluation was completed using methods and standards defined in the Pavement Surface Evaluation and Rating (PASER) documents. Based on this assessment, the pavement is generally in fair to poor condition. Physical deficiencies observed during the evaluation include transverse and longitudinal cracking, alligator cracking, potholing, flushing, rutting, distortion, edge erosion, and failing patches. **Table 2.4** and **Figure 2.2** show the PASER ratings and roadway widths taken approximately every half-mile.

Begin (MP)	End (MP)	Length (mi)	Width (ft)	Surface Type	PASER Rating	
<b>Collector Road</b>						
0.0	0.6	0.6	23	Paved	3	Poor
0.6	1.1	0.5	25	Paved	5	Fair
1.1	1.6	0.5	22	Paved	4	Fair
1.6	2.0	0.4	24	Paved	3	Poor
2.0	2.5	0.5	22	Paved	3	Poor
<b>Local Road</b>						
2.5	2.9	0.4	22	Paved	4	Fair
2.9	3.2	0.3	22	Paved	4	Fair
3.2	3.7	0.5	20	Paved	4	Fair
3.7	4.2	0.5	18	Paved	4	Fair

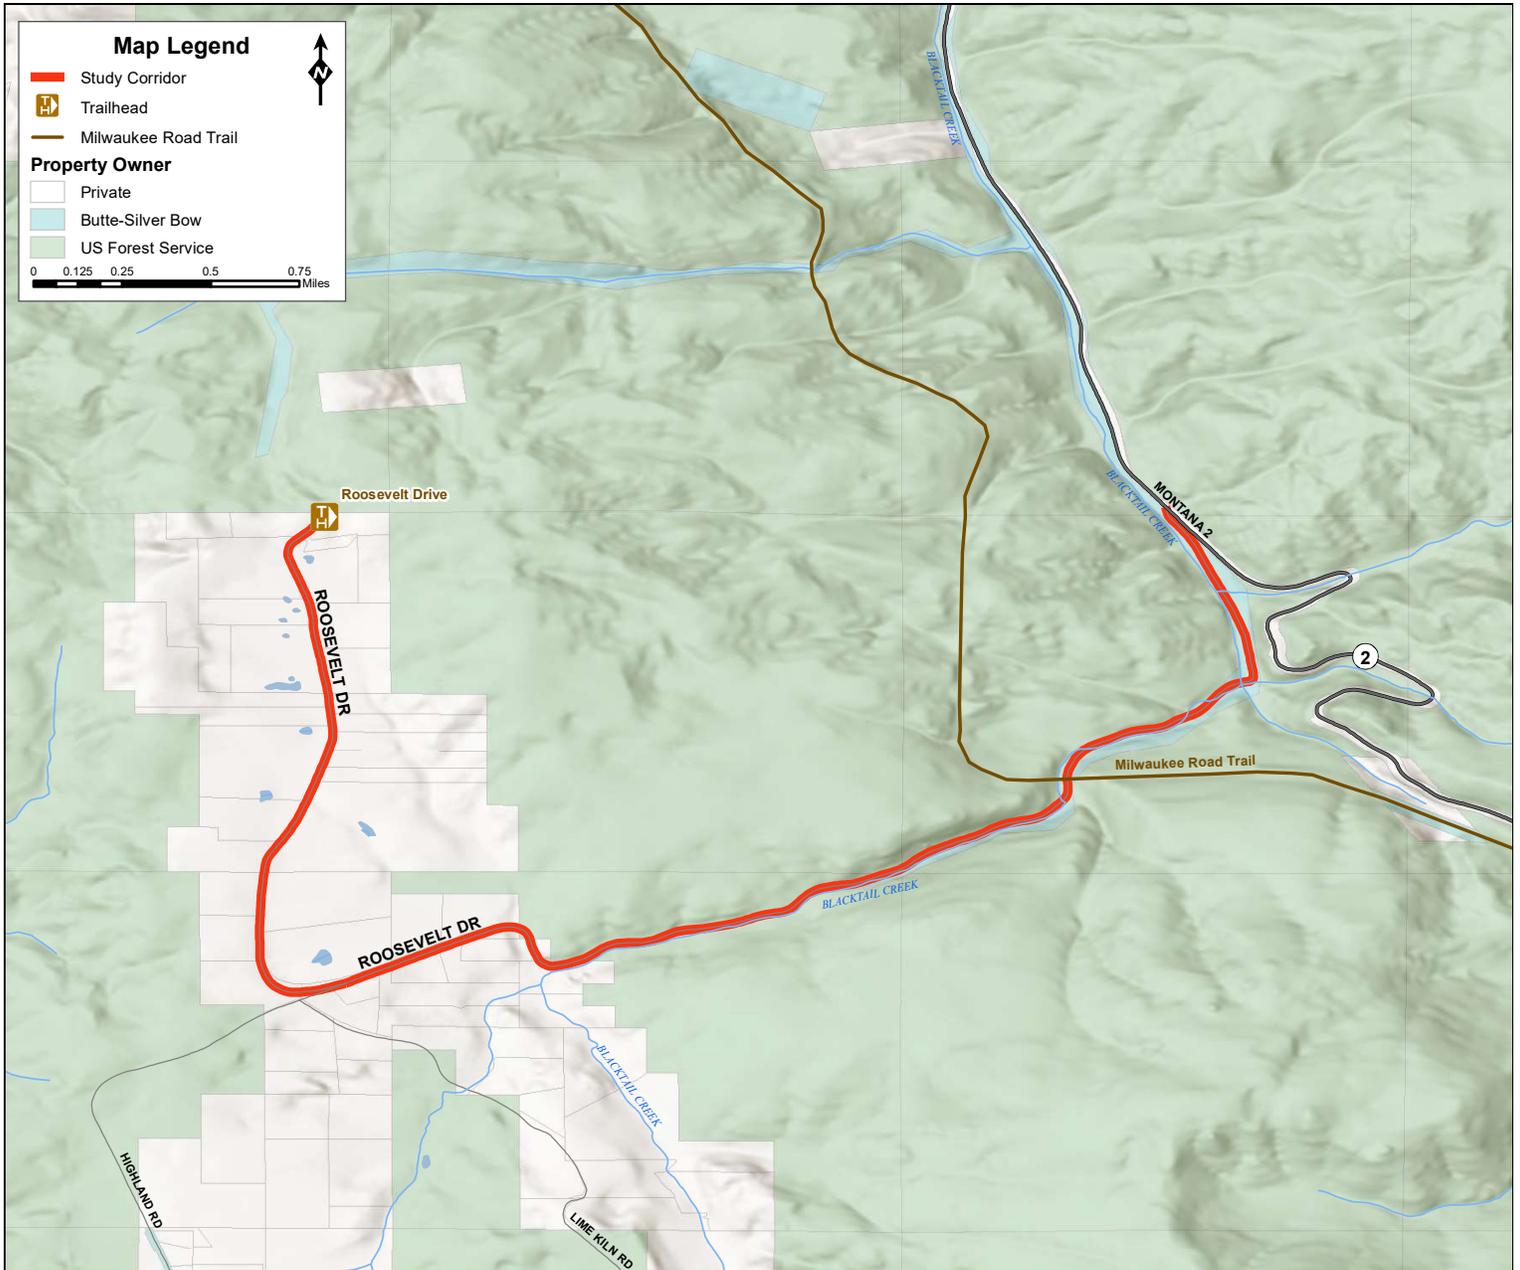
Figure 2.3: Property Ownership

Butte-Silver Bow Road Division Standard Drawings require 60 feet of right-of-way for both local and collector roads. Butte-Silver Bow appears to have title for Roosevelt Drive through the study area, however, roadway right-of-way is not well defined. Based on Montana cadastral data, much of the first two miles of Roosevelt Drive lies within Forest Service land boundaries with the road existing in easement. Between MP 2.2 and 3.9, the land adjoining the road is privately owned with Roosevelt Drive passing through several privately-held properties. It appears that Butte-Silver Bow has easements for the roadway on these properties. From about MP 3.9 to 4.3, Butte-Silver Bow owns an approximate 50-foot wide right-of-way. **Figure 2.3** shows the public and private land ownership within the study area based on cadastral data.

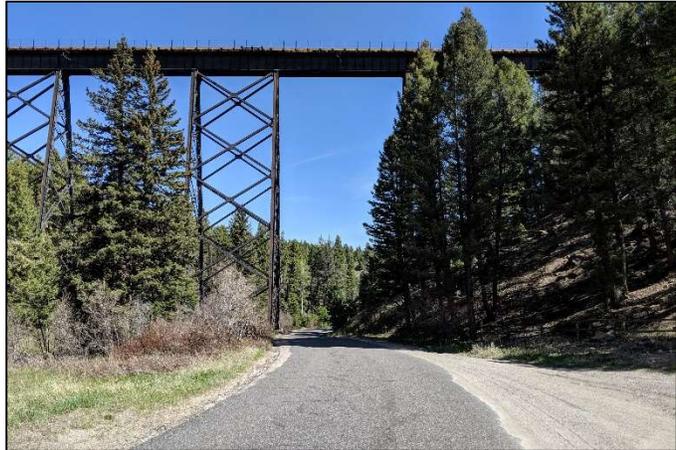
*The popular Milwaukee Road Rail-Trail crosses Roosevelt Drive via a trestle with piers located within the roadside clear zone.*

There are no bridges on Roosevelt Drive. However, the trestle for the Milwaukee Road Trail crosses above Roosevelt Drive at MP 1.0. One of the trestle piers is located within the clear zone on the right side of the roadway. This, along with the curvature of the roadway and limited sight distance attributable to the cut slope through this area, pose safety concerns at this location. Blacktail Creek has eroded the land surrounding the piers and has also caused concern for stability of the piers.

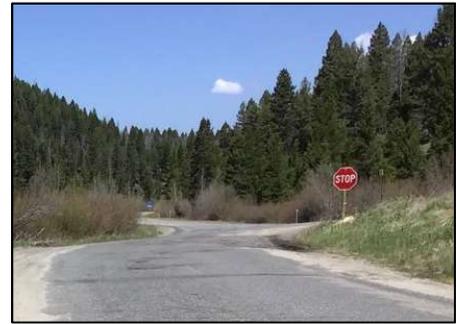
*The intersection of Highway 2 and Roosevelt Drive is a skewed intersection with non-standard geometrics and sight distance issues.*

Geometric design of intersections can impact roadway safety by shaping user expectations and defining how to safely move through the intersection where many conflicts exist. There are many design considerations associated with intersections including sight distance, alignment, profile, channelization, and turning movements. There are two primary intersections in the study area, both of which have non-standard geometrics. At the beginning of the corridor, Roosevelt Drive and Highway 2 intersect at an approximate 45-degree angle. The skew of this intersection presents concerns for sight distance, driver confusion, and difficult turning movements. Skewed intersections tend to have more frequent right-angle type crashes. AASHTO design standards recommend angles no more than 15 degrees from perpendicular (i.e. between 75 and 105 degrees). In addition to the sharp skew angle, Highway 2 begins a vertical climb immediately adjacent to the intersection, leading to further sight distance issues.

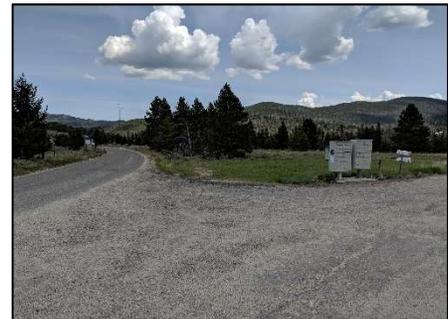
*The intersection of Roosevelt Drive/Lime Kiln Road/Highland Road essentially forms a triangle with three separate intersections. The intersection is used to access the community mailboxes.*

The second intersection, Roosevelt Drive/Lime Kiln Road/Highland Road, is located at MP 2.7. The intersection of these roadways essentially forms a triangle with three separate intersections. At the first point, Roosevelt Drive curves right while Highland Road (also named Moose Creek Road/Shiloh Lane) continues straight ahead. There is a yield sign on the Roosevelt Drive approach leg as it merges with Highland Road. Approximately 500 feet away, where Roosevelt Drive and Lime Kiln Road intersect, the intersection is skewed at a 45-degree angle with two private driveways branching off from the intersection. The community cluster mailbox is also located at this intersection. The third intersection in this “triangle” (Lime Kiln Road and Highland Road) is a typical uncontrolled four-leg intersection. While the intersection experiences typically low traffic volumes, the non-standard alignment and traffic control can result in driver confusion and overall safety concern for users.

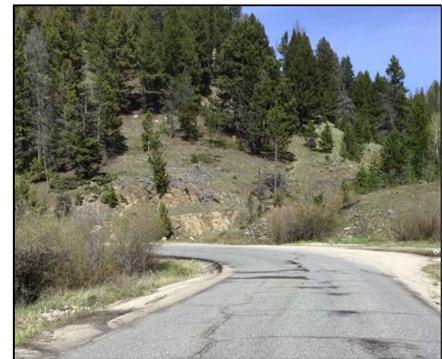
*At MP 0.5 there is a sharp 90-degree curve with vegetation obscuring drivers' sight lines. A cluster of 10 crashes were reported here.*

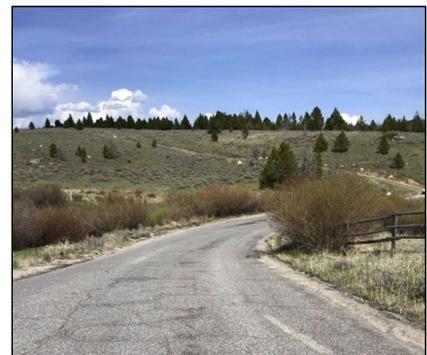
*Between MP 2.2 and 2.4 there is an s-curve with tight combination horizontal/vertical curves. The steep cut slope, vegetation, and parking along the road limits sight distance at this location.*

A cluster of 8 crashes occurred at the s-curve section (MP 2.2 to 2.4). The crashes that were reported in this section were roll over (4), fixed object (3), and sideswipe (1) crashes. The s-curves are tight horizontal curves with limited sight distance due to the steep cut slope

and vegetation. There is also a trail that branches from Roosevelt Drive which is used by hunters and other recreationists near this location. At times there are vehicles parked alongside the roadway at this location which reduces sight distances further and creates additional hazards.

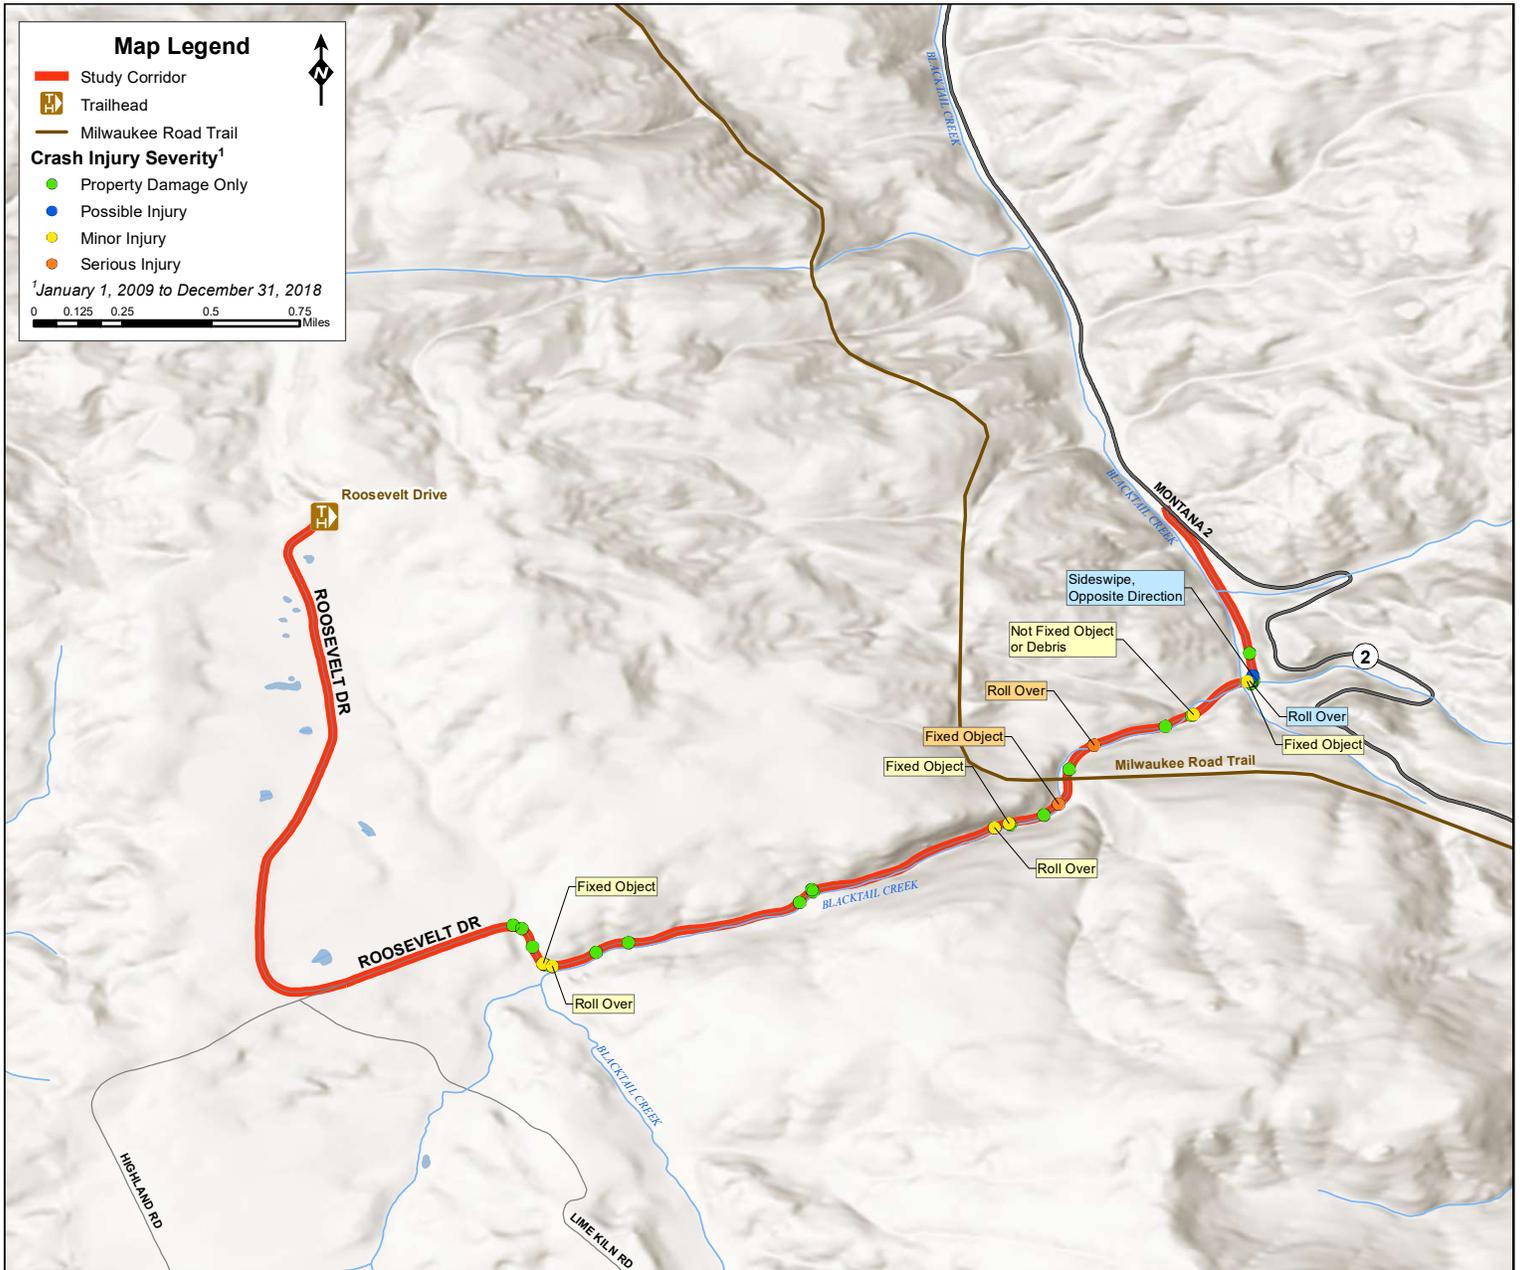
Figure 2.5: Crash Locations

All but two crashes involved a single vehicle. The main crash types were fixed object crashes (21) and rollover crashes (10). In the fixed object crashes the driver primarily collided with a ditch (13) or tree (5); one vehicle appears to have collided with the trestle pier for Milwaukee Road Trail. Road surface condition was listed as a contributing circumstance in 18 of the crashes. Six of the crashes (three fixed object, two rollover, and one not-fixed object) involved an impaired driver.

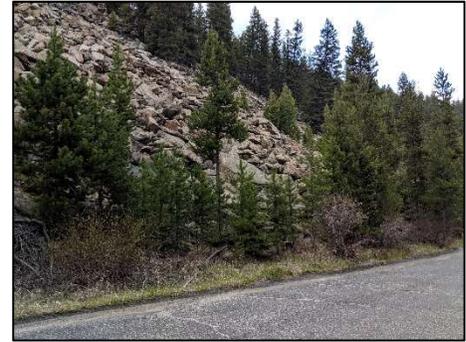
*Two landslides have occurred in the study area. The slides have been stabilized.*

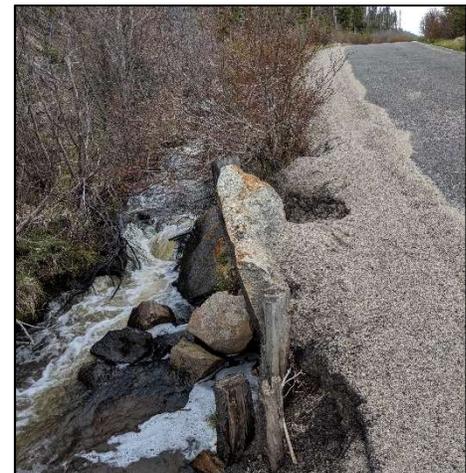
*Culverts help control drainage to reduce erosion. About 45 percent of culverts in the study area are in poor condition.*

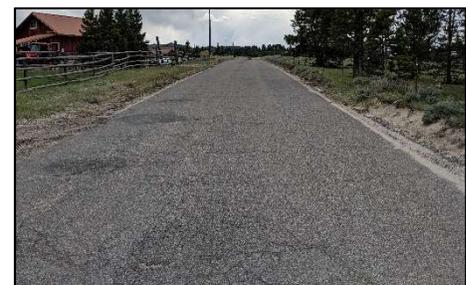
*There are several locations where the pavement experiences failures including cracking, potholing, flushing, rutting, distortion, edge erosion, and failing patches.*

As mentioned previously in **Section 2.1.5**, the pavement throughout the study area is generally in poor condition. There are several locations along the roadway where the pavement experiences failures including transverse and longitudinal cracking, alligator cracking, potholing, flushing, rutting, distortion, edge erosion, and failing patches. The cause of these failures is typically a weakened or deteriorating subgrade. This distress on the pavement can be caused by a variety of factors including poor drainage, erosion, frost heave, lack of compaction, or weak materials. In one location, near MP 0.65, an asphalt repair patch was noted as failing likely due to a weak or poorly compacted subgrade.

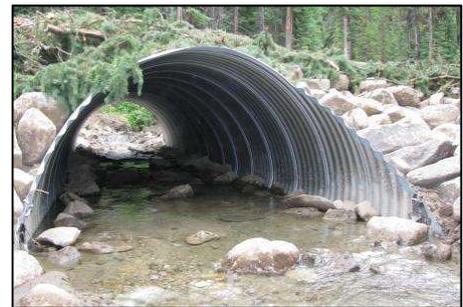
*New culverts would provide adequate passage for aquatic organisms.*

Many of the existing culverts on Roosevelt Drive are undersized or in poor condition. This option includes replacement of all of the culverts serving Blacktail Creek with the exception of the concrete box culvert at MP 0.34. Based on a preliminary evaluation, the new culverts for Blacktail Creek would likely be either round culverts nine feet in diameter, or box culverts with a nine-foot span and six-foot rise. All of the pipes would be countersunk and infilled with streambed material to provide adequate passage for aquatic organisms. Additionally, the minor culverts (those not serving Blacktail Creek) on the remainder of Roosevelt Drive would be reviewed and replaced if needed.

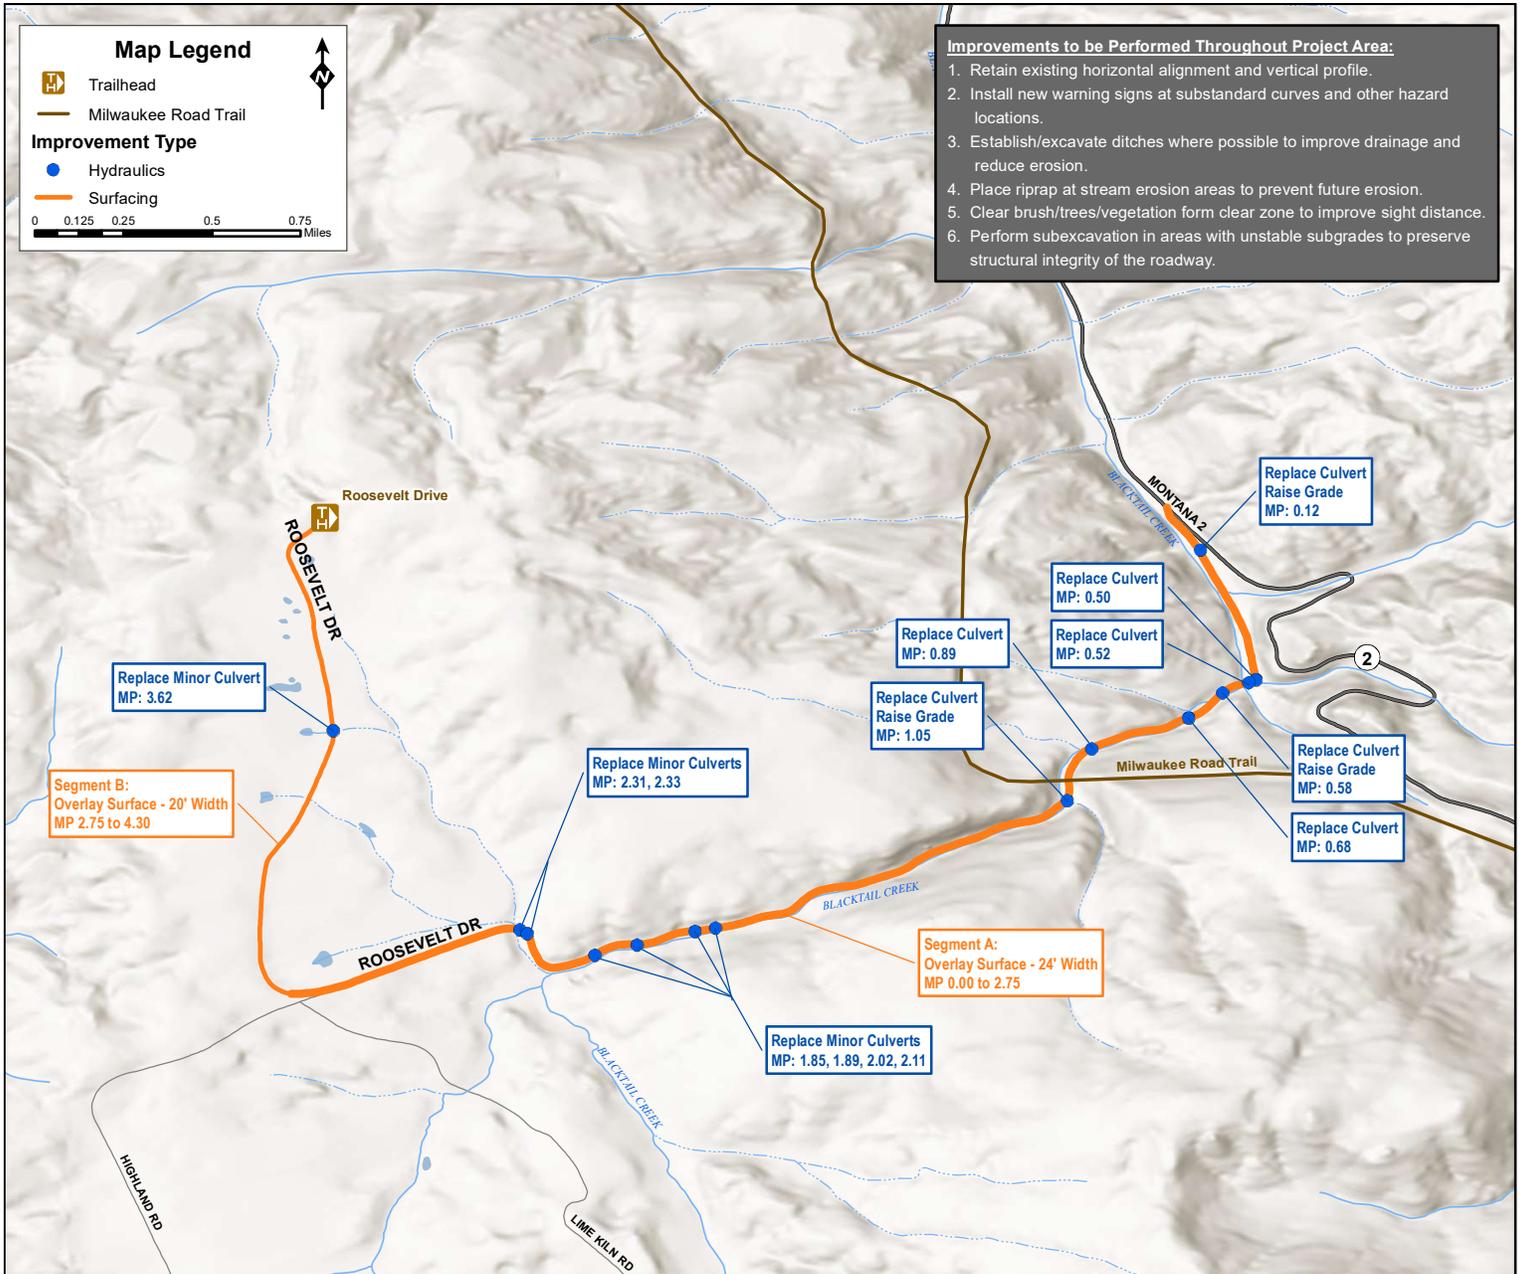
Figure 6.1: Option 1 – Rehabilitation on Existing Alignment

Throughout the study area, ditches would be established or excavated where possible. Road embankment armoring, or riprap, would also be placed in areas where the creek has eroded the roadway. These improvements would help improve drainage and prevent erosion thereby protecting Roosevelt Drive from further damage caused by Blacktail Creek.

The existing horizontal and vertical alignments would be retained with the exception of a few minor adjustments. At three locations (MP 0.12, MP 0.58, and MP 1.05) the roadway needs to raise slightly in order to facilitate installation of larger culverts for Blacktail Creek. This would result in a short raise in grade and new surfacing on Roosevelt Drive at these locations. Although the horizontal alignment would not be modified in this option, efforts to improve sight distance by clearing brush, trees, and other vegetation within the clear zone would be made as necessary throughout the project. This is especially true at the beginning of the project where Roosevelt Drive and Highway 2 meet. Vegetation at the intersection would be cleared to improve sight distance and warning signs installed on Highway 2 to warn drivers of the approaching intersection. Additional warning signs would be installed along Roosevelt Drive at the locations with substandard horizontal curves to alert drivers of the tight curves ahead. New signing may also be necessary at hazard locations warning for potential rockfall.

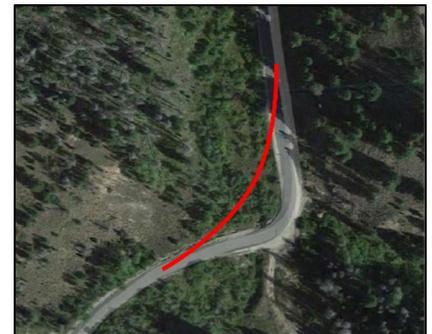
*The 90-degree curve at MP 0.5 would be flattened to achieve a 40-mph design speed.*

In addition to those improvements proposed in Option 1, modifications to the horizontal and vertical alignments are proposed. The sharp 90-degree curve at MP 0.50 would be improved by reconstructing the curve to meet current standards. To achieve a 40-mph design standard, the roadway would be shifted west approximately 100 feet at the center of the curve. Approximately 400 feet of new road would be constructed, and the Blacktail Creek culvert would be shifted approximately 200 feet downstream. Embankment material would be imported to construct road fill across the stream channel, but the resulting profile would closely match the existing profile. The existing road could be used to facilitate traffic during construction of the new curve.

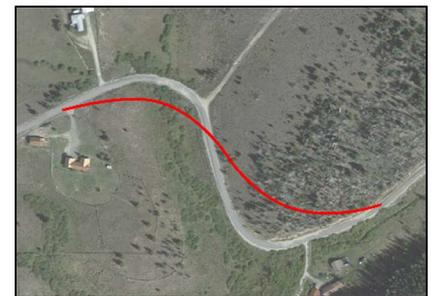
*The horizontal curves on the s-curve section between MP 2.2 and 2.4 would be flattened and a consistent, increasing grade would be established.*

In the s-curve section (MP 2.2 to 2.4), the curves would be reconstructed to meet existing standards. Extensive grading would be required to flatten the curves. To meet a 40-mph design speed, the southern curve would be shifted northeast about 150 feet at the center of the curve while the northern curve would be shifted about 100 feet southwest at the center of the curve. A consistent, increasing grade would be set through this reconstructed section, effectively eliminating the two abrupt vertical curves. Material from the grading efforts would be available for any embankment needs at this location. Ultimately, approximately 1,300 feet of new road would be constructed.

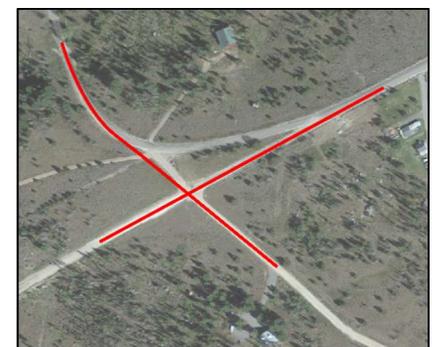
*The intersection at MP 2.7 would be modified to create a standard, uncontrolled four-way intersection.*

The Roosevelt Drive/Lime Kiln Road/Highland Road intersection (MP 2.7) would be improved by creating a standard four-way intersection. To achieve this, the Roosevelt Drive curve between Highland Road and Lime Kiln Road would be obliterated. The leg of Lime Kiln Road which passes by the cluster mailboxes would be improved to match the overlay on Roosevelt Drive. The intersection would have stop control along the minor approaches with advance warning signs.

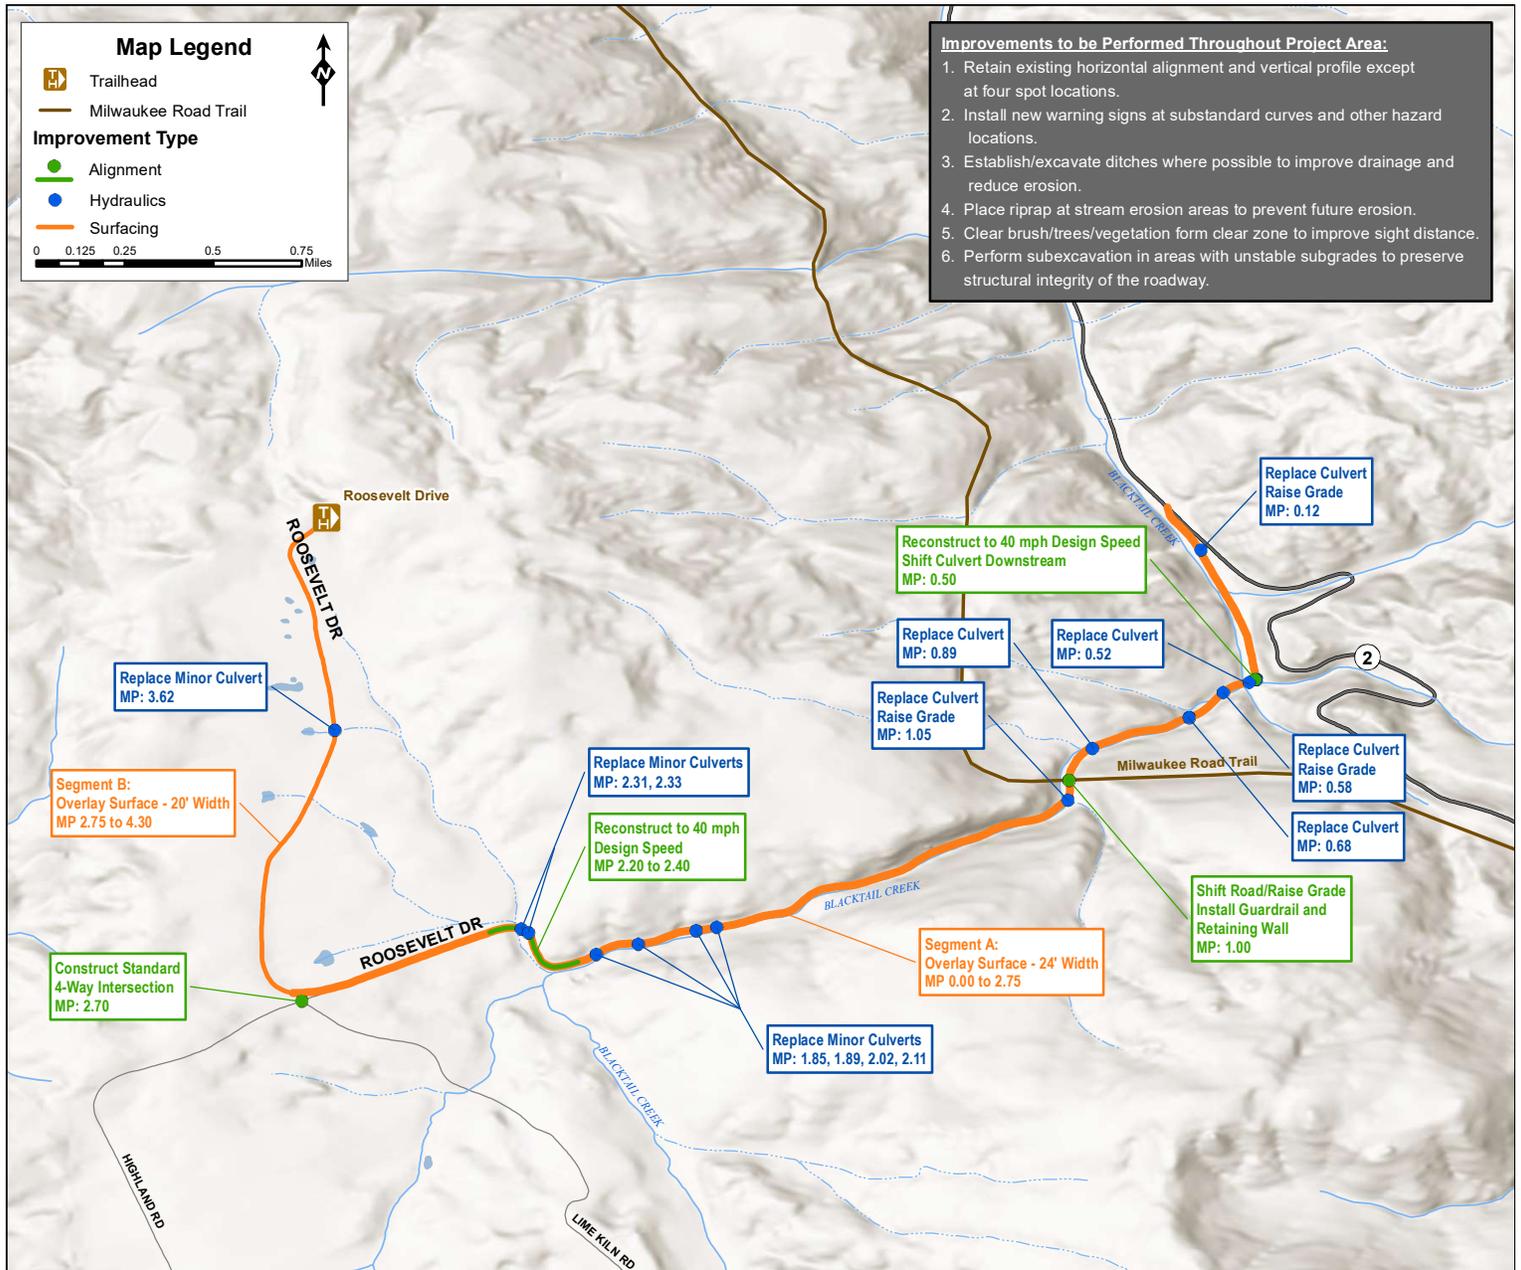
Figure 6.2: Option 2: Rehabilitation with Improved Geometrics

This option includes reconstruction of the corridor with minor modifications to the horizontal and vertical alignments. As in Option 1, all of the culverts serving Blacktail Creek would be replaced, with the exception of the concrete box culvert at MP 0.34. Other culverts would be evaluated and replaced/upgraded as needed. A 3-inch overlay of consistent width (24 feet on Segment A and 20 feet on Segment B) would be placed with subexcavation in areas with unstable subgrades. Additionally, ditches would be established or excavated where possible and riprap would be placed in areas where the creek has eroded the roadway as discussed in Option 1.

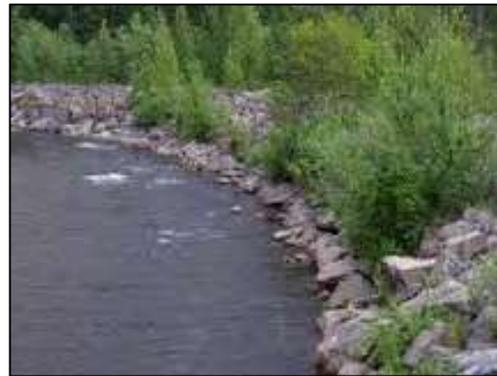
*Riprap would be placed along streambanks to control the flow of Blacktail Creek, stabilize the banks, and prevent further erosion on Roosevelt Drive.*

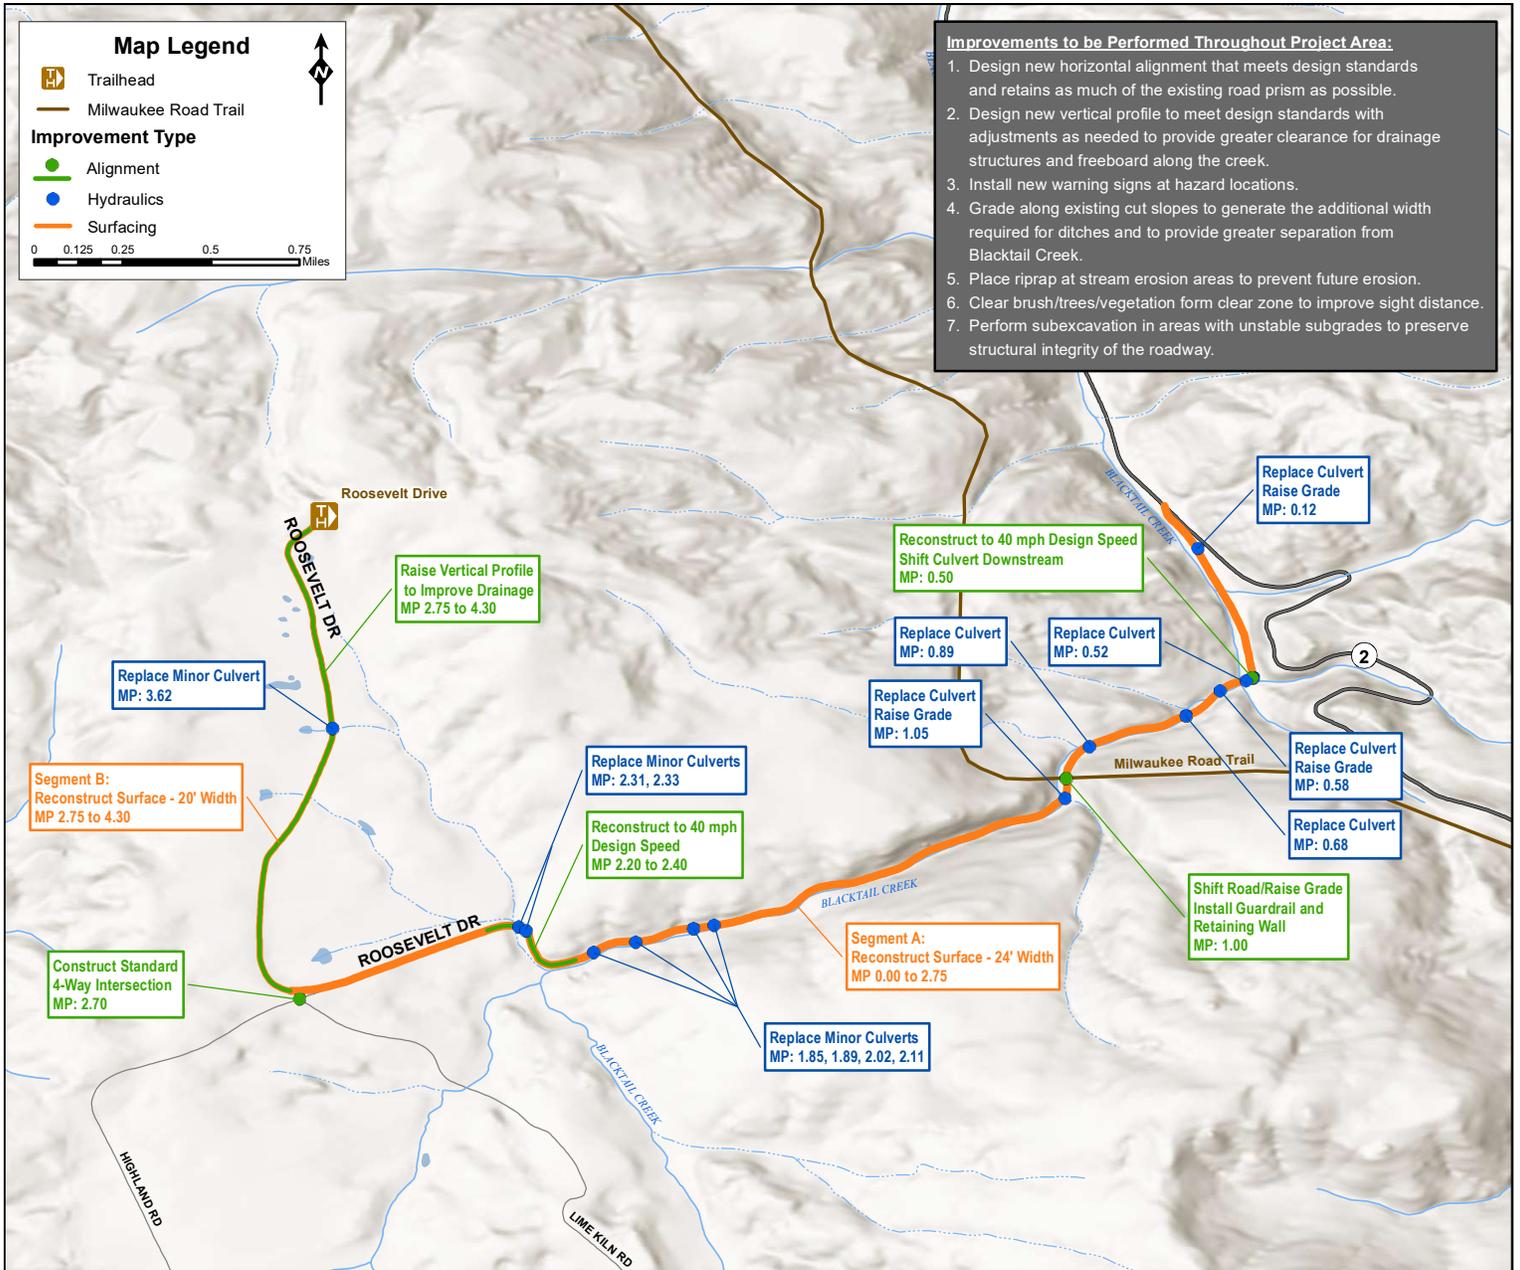
Figure 6.3: Option 3: Reconstruction with New Alignment

This option is the most impactful option and would result in reconstruction of the entire roadway. A new alignment for the entire project length would be designed to meet existing standards. The new alignment would be designed to retain as much of the existing road prism as possible. The proposed improvements at the 90-degree curve (MP 0.5), trestle (MP 1.0), s-curve section (MP 2.2 to 2.4), and Roosevelt Drive/Lime Kiln Road/Highland Road intersection (MP 2.7), as discussed in Option 2 would be included in Option 3. The new vertical profile would also be designed to meet applicable design standards with adjustments as needed to provide greater clearance for drainage structures and to provide adequate space between the surface of the water and the roadway to prevent flooding. In the local road section, the vertical profile would be raised to improve drainage and keep ditch flow off the road.

As in both Options 1 and 2, all of the culverts serving Blacktail Creek would be replaced, with the exception of the concrete box culvert at MP 0.34. Other culverts would be evaluated and replaced/upgraded as needed. To further stabilize and control the flow of Blacktail Creek, riprap would be placed in areas where the creek has eroded the roadway. Extensive grading would also occur along the existing cut slopes to generate the additional width required to create ditches and to provide greater separation between Roosevelt Drive and Blacktail Creek. Note that this may not be possible between MP 1.1 and 1.4 where a landslide occurred in the past. When reconstruction occurs, isolated subexcavation in areas with unstable subgrades may also be necessary. The new roadway new surfacing on Roosevelt Drive would be designed to a consistent width of 24 feet on Segment A (MP 0.0 to 2.75) and 20 feet on Segment B (MP 2.75 to 4.30).
