# PRELIMINARY ENGINEERING REPORT

*Roosevelt Drive Upgrade Study  
MT B Silver Bow 2016(9)  
IDIQ Contract No. DTFH7015D00007  
Task Order No. 69056719F000080*

**WESTERN FEDERAL LANDS HIGHWAY DIVISION**

Prepared by:  
**ROBERT PECCIA &  
ASSOCIATES**  
Helena, Montana

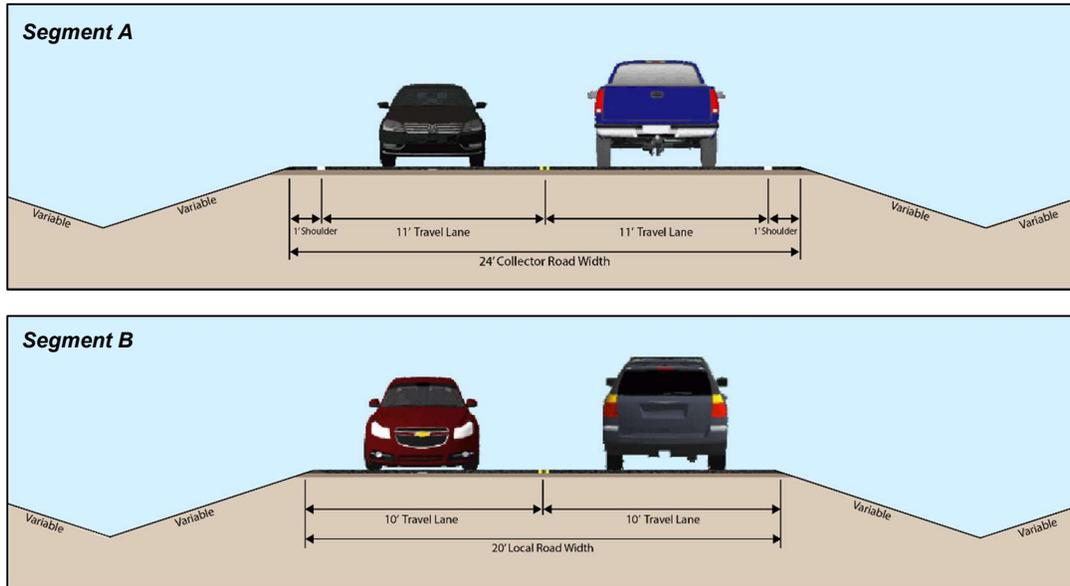
*To preserve the existing character of the roadway, it is recommended that the new surfacing on Roosevelt Drive be 24' on the collector portion of the roadway (Segment A) and 20' on the local portion (Segment B).*

To preserve the existing character of the roadway, while maintaining safe travel speeds and appropriate use, it is recommended that the new surfacing on Roosevelt Drive be 24 feet in width on Segment A and 20 feet in width on Segment B. This would discourage speeding and parking along the roadside while also providing adequate room to accommodate all roadway users and their needs. These widths would be the most easily achieved while also limiting impacts to adjacent lands. If a wider typical section is desired by implementation partners, full roadway reconstruction would be needed and re-evaluation of costs would be necessary.

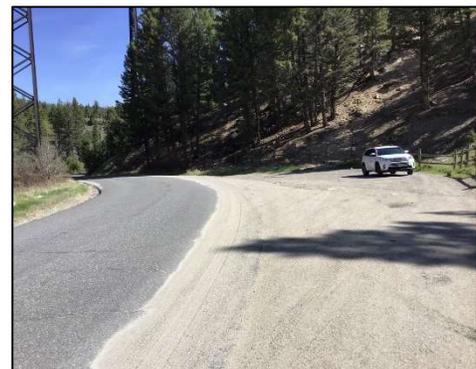
*Some pullouts on Roosevelt Drive may cause safety concerns rather than alleviate them. The pullout areas should either be improved to adequately accommodate users or removed to discourage undesirable use.*

Ten pullouts (mostly informal) were documented on Roosevelt Drive during the field review. All ten pullouts are located within the first 2.75 miles of the roadway. Some of these pullouts are located on tight corners while others are creating undesirable recreational use. In these instances, the pullouts may cause safety concerns rather than alleviate them. Pullout areas of particular concern on Roosevelt Drive are the one at the trestle crossing (MP 1.0) and the one on the s-curve section (MP 2.3). An established, wide pullout area exists at the trestle crossing but despite the fencing along the hillside, it is reportedly used as an access point to the Milwaukee Road Trail, which is discouraged by the Forest Service. On the s-curve there is a closed trail access with a small pullout that is used by recreationists, especially during hunting season. Parked cars at this location create roadside hazards and limit sight distance. The pullout areas should either be improved to adequately accommodate users or removed to discourage undesirable use. There are other small pullout areas where discouraged activity has been noted such as hiking and access to undesignated areas.
