LOCAL ROAD SAFETY PLAN

Project Decision Tree Example

PALM BEACH COUNTY LOCAL ROAD SAFETY PLAN DEVELOPMENT

Palm Beach County Route 717 (Muck City Road)

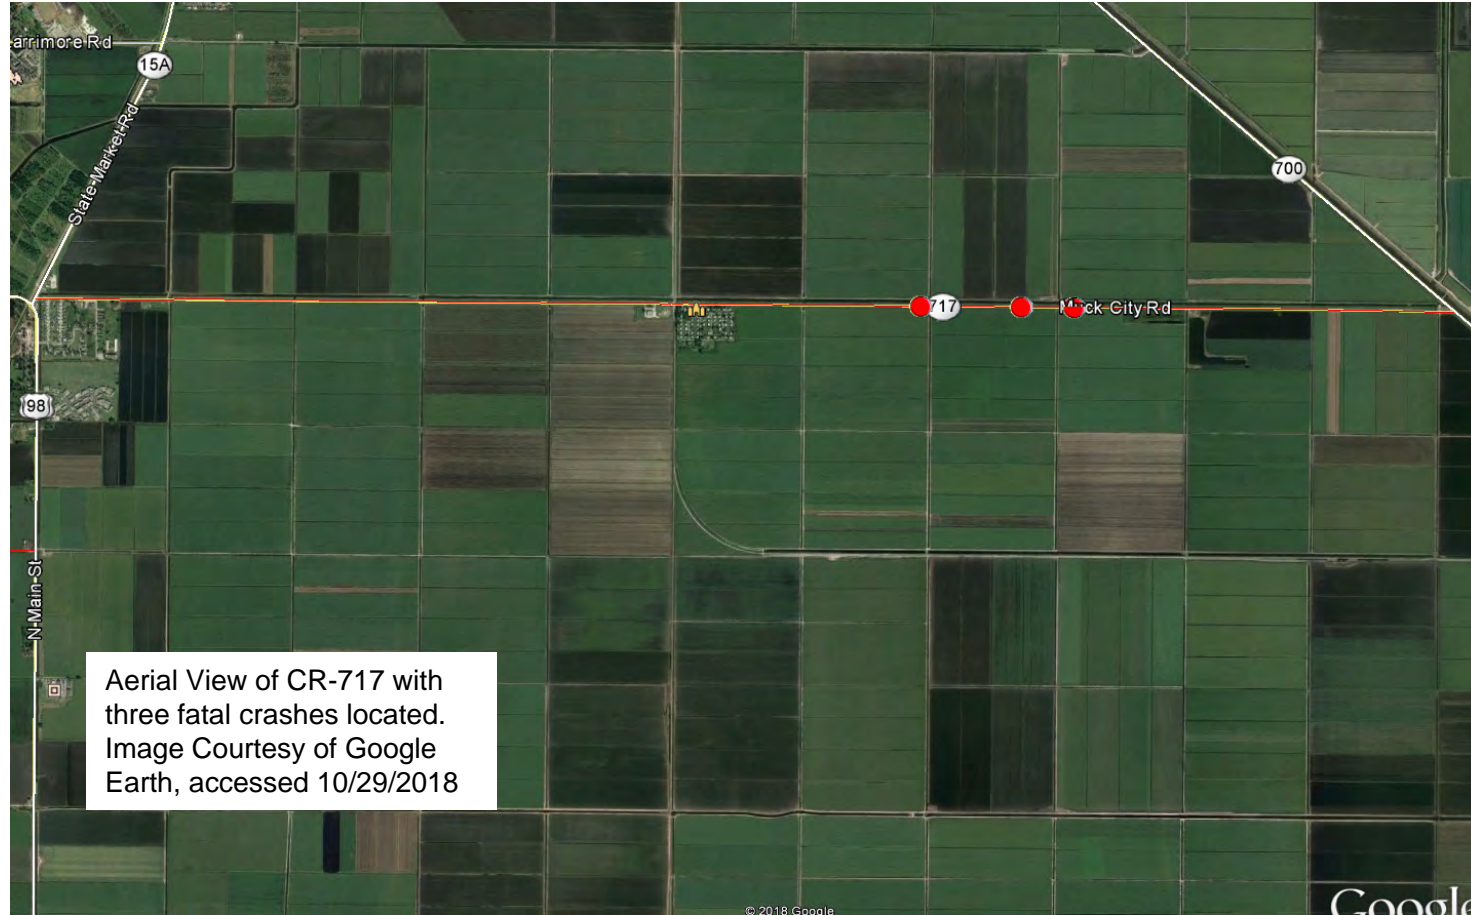
Site Overview

- 3 Fatal Crashes (2011-2014)
 - All single vehicle, roadway departure
 - No other severe crashes along corridor
- No grade or curvature present
- AADT 3,172 ([Palm Beach County, 2016](#))
- Site is 2 lanes with no shoulders
- Approximately 5.6 miles long

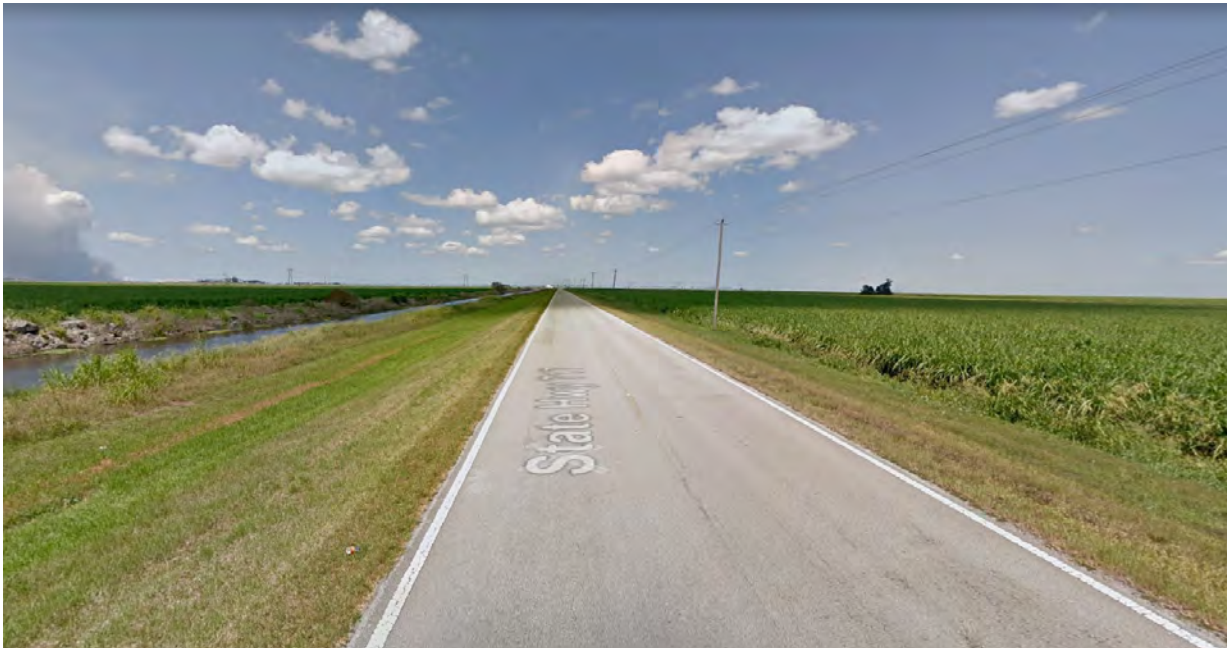
- Shoulders have gentle slope
- Fixed objects, like telephone poles, are set back from the roadway ~25'
- No barriers or equipment in clear zone
- Clear zone, roadside hardware, and roadside design improvements are NOT recommended at this site**

Typical view of CR-717. Image Courtesy of Google Street View, accessed 10/29/2018

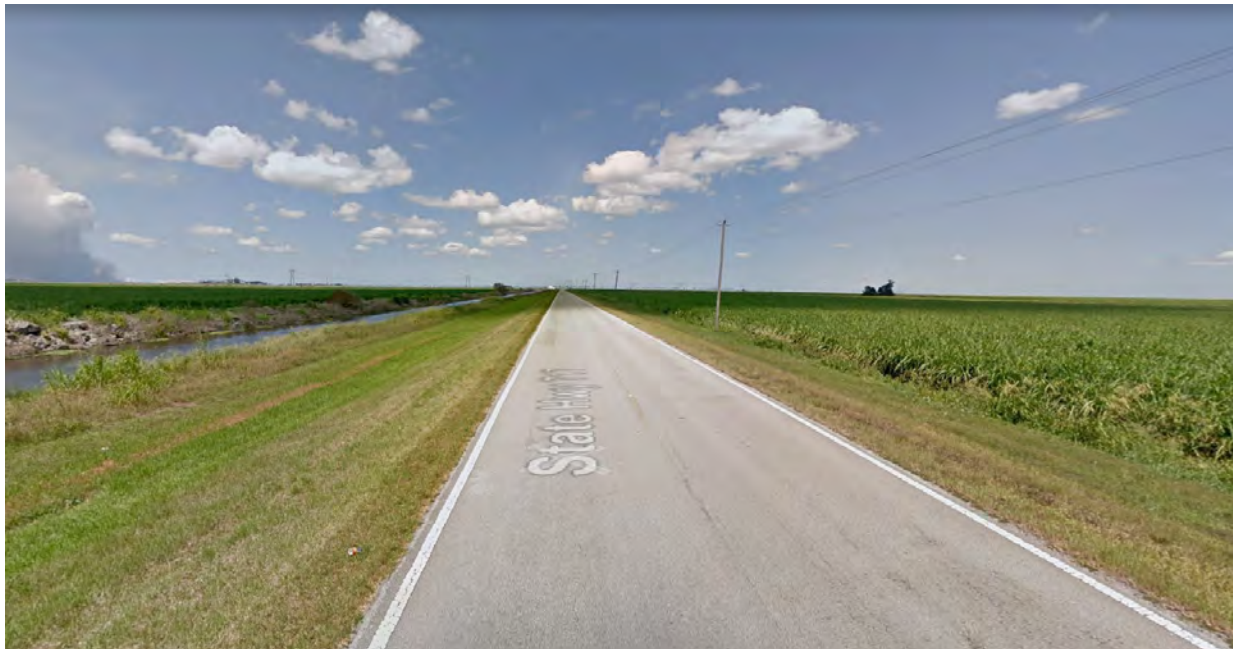
Typical view of CR-717. Image Courtesy of Google Street View, accessed 10/29/2018

- There is no shoulder along the corridor.
- Recommend to install paved 2-foot shoulder with edge/ shoulder rumble strips.**
- Recommend to install centerline rumble strips**
 - **Requires repainting of centerline to acceptable standards**

- ❑ The final recommendation is the installation of a 2-foot paved shoulder on both sides of the roadway with shoulder and centerline rumble strips.
- ❑ Approximate project cost = \$330,400
 - Shoulder rumble strips \$6,000 per mile x 5.6 miles = \$33,600
 - Centerline rumble strips (with restriping) \$4,000 per mile x 5.6 miles = \$22,400
 - 2 foot paved shoulder (both sides) \$49,000 per mile x 5.6 miles = \$274,400
