## **Appendix B – Wetlands Technical Reports**

**WETLAND AND STREAM DELINEATION FOR THE  
TANANA RIVER RECREATION ACCESS IMPROVEMENTS PROJECT,  
FAIRBANKS, ALASKA, 2020: AK FNSB TANANA(1)**

**ABR, Inc.—Environmental Research & Services**  
P.O. Box 240268  
Anchorage, AK 99518

October 2020

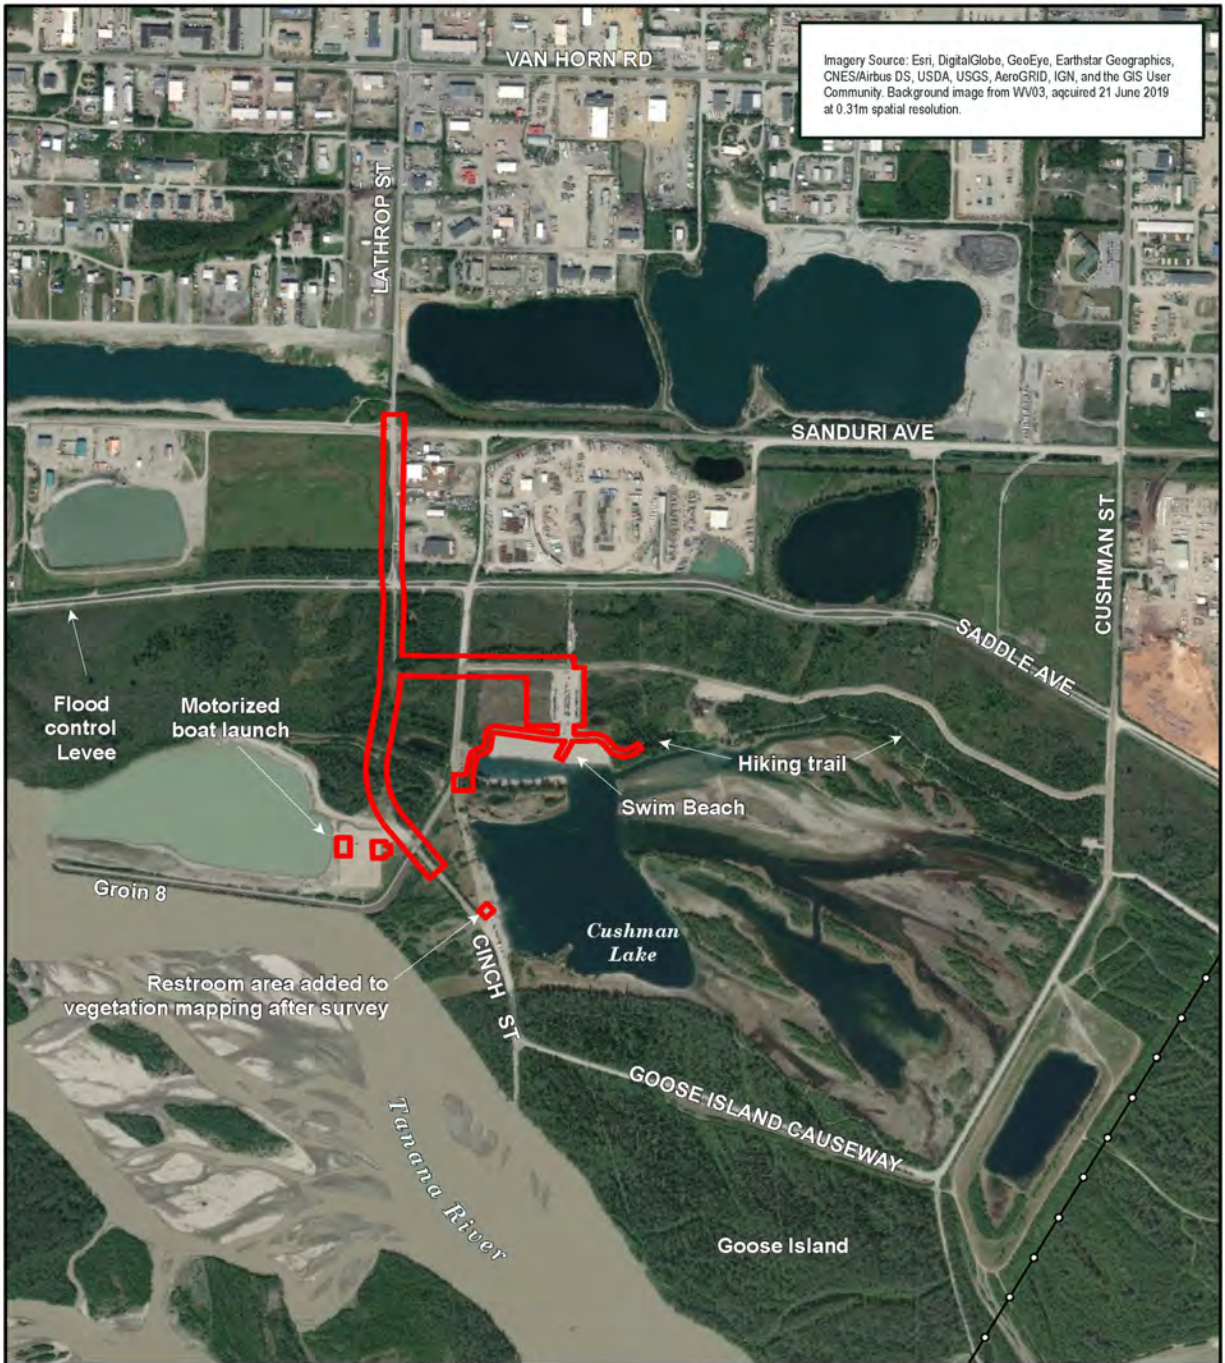
Figure 1. Wetland mapping study area for the proposed improvements, Tanana River Recreation Access Improvements Project, Alaska, 2020..... 2

Imagery Source: Esri, DigitalGlobe, GeoEye, Earthstar Geographics, CNES/Airbus DS, USDA, USGS, AeroGRID, IGN, and the GIS User Community. Background image from WV03, acquired 21 June 2019 at 0.31m spatial resolution.

## STUDY AREA

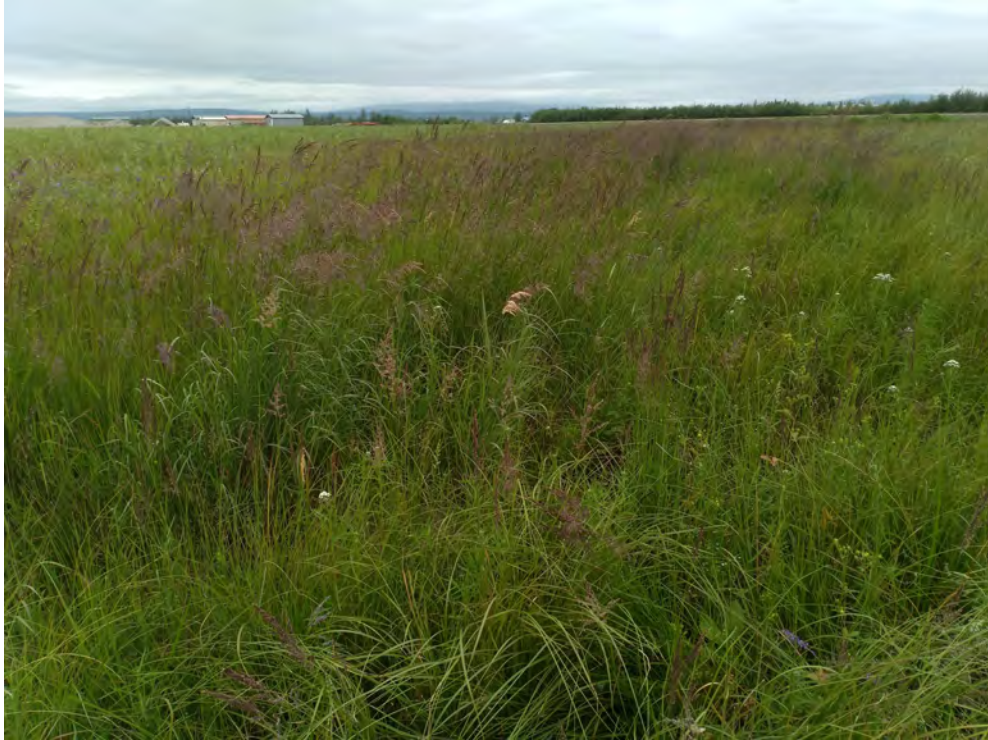
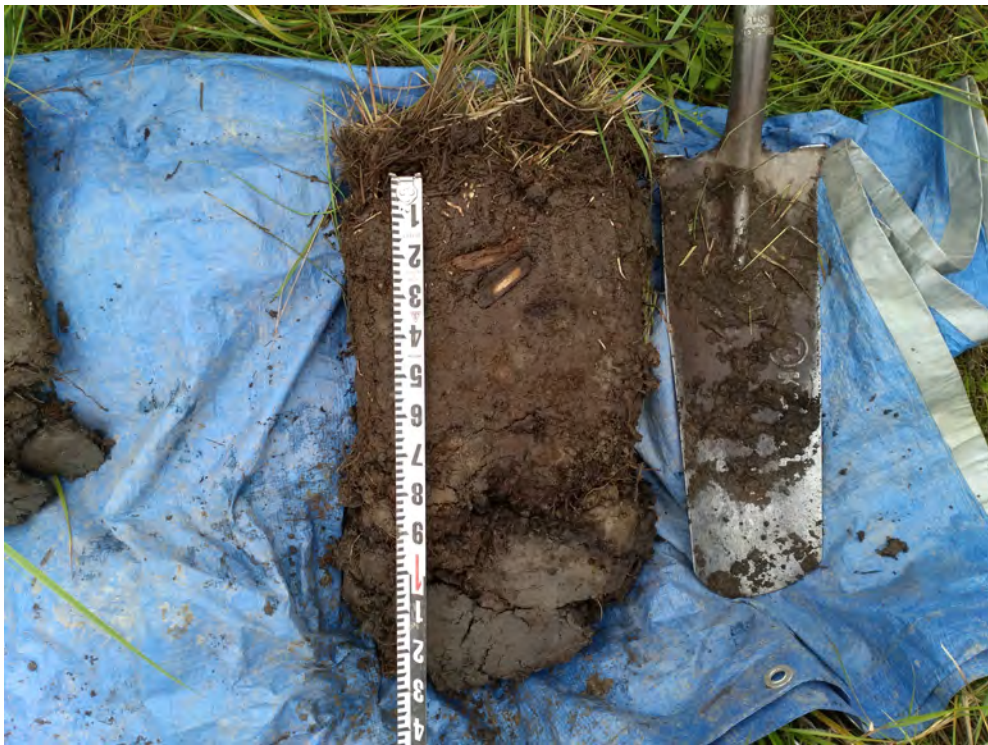
**Sampling Point:** W2-SP1  
**NWI classification:** PEM1B

**Hydric Soil Indicators:** Alaska Redox (A14)  
**Wetland Hydrology Indicators:** Geomorphic Position (D2), Drainage Patterns (B10)

Palustrine Seasonally Saturated Persistent Emergent (PEM1B) wetlands in the study area (0.16 acre; Table 2) consisted of small drainage features in a fallow field along the west side of South Lathrop Avenue (see plot W2-SP1 in Appendix A). The presence of non-native plant species and vehicle tracks, as well as altered drainage due to the road, indicates that vegetation, soils, and hydrology are significantly disturbed. The vegetation is dominated by *Calamagrostis canadensis* and *E. arvense*. Non-native species recorded included *Sonchus arvensis* (sow thistle), *Hordeum jubatum* (foxtail barley), *Trifolium hybridum* (Alsike clover), and *Plantago major* (broadleaf plantain). The site has a thick organic layer underlain by a silt loam mineral layer with Alaska Redox hydric soil characteristics. At the time of sampling, the soil pit lacked primary hydrology indicators but met wetland criteria with secondary characteristics.

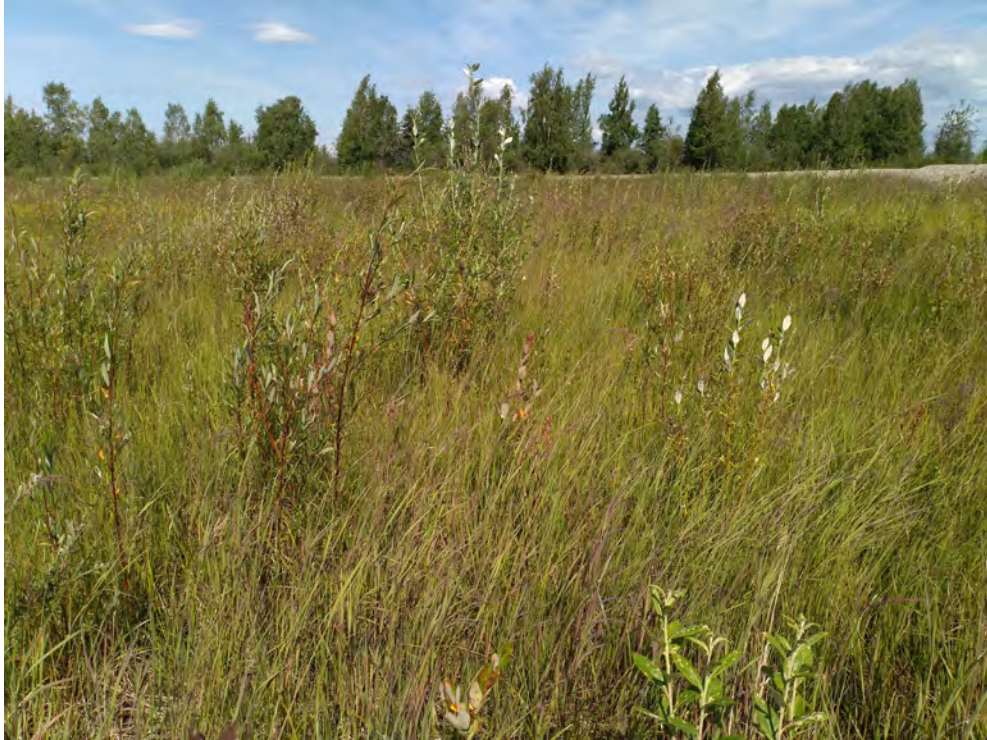
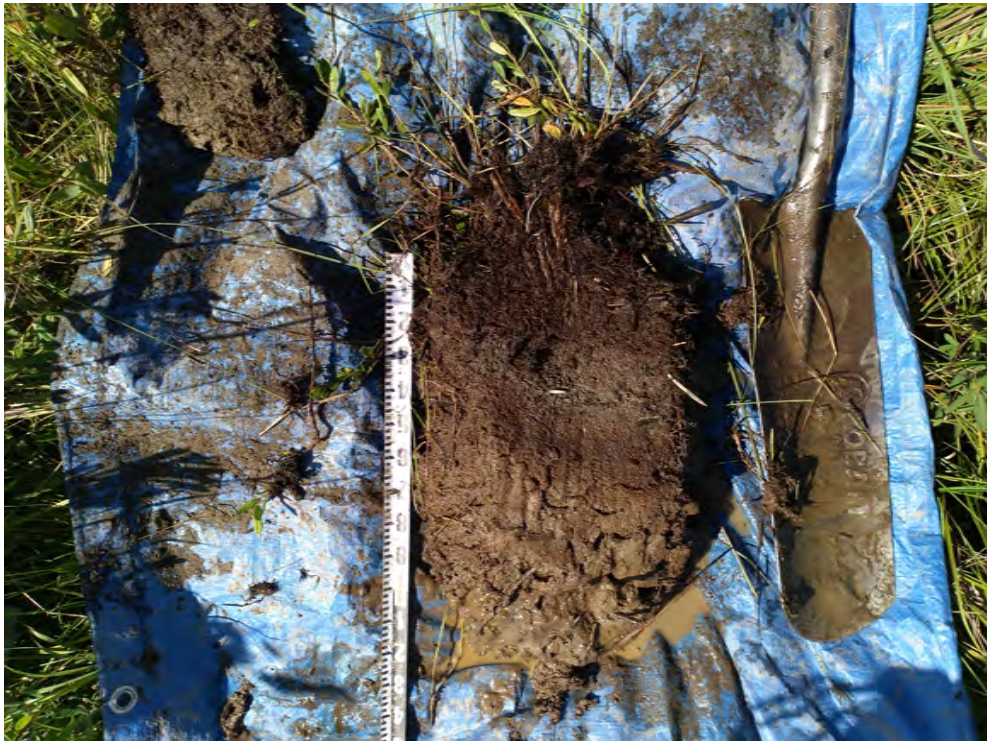
**Sampling Point:** W5-SP1  
**NWI classification:** PSS1/EM1B

Remarks: Hydrology may be disturbed by surrounding roadways but vegetation and soils clearly indicate wetland conditions predating disturbance.

**Hydric Soil Indicators:** Histic Epipedon (A2)  
**Wetland Hydrology Indicators:** High Water Table (A2), FAC-Neutral Test (D5), Saturation (A3)

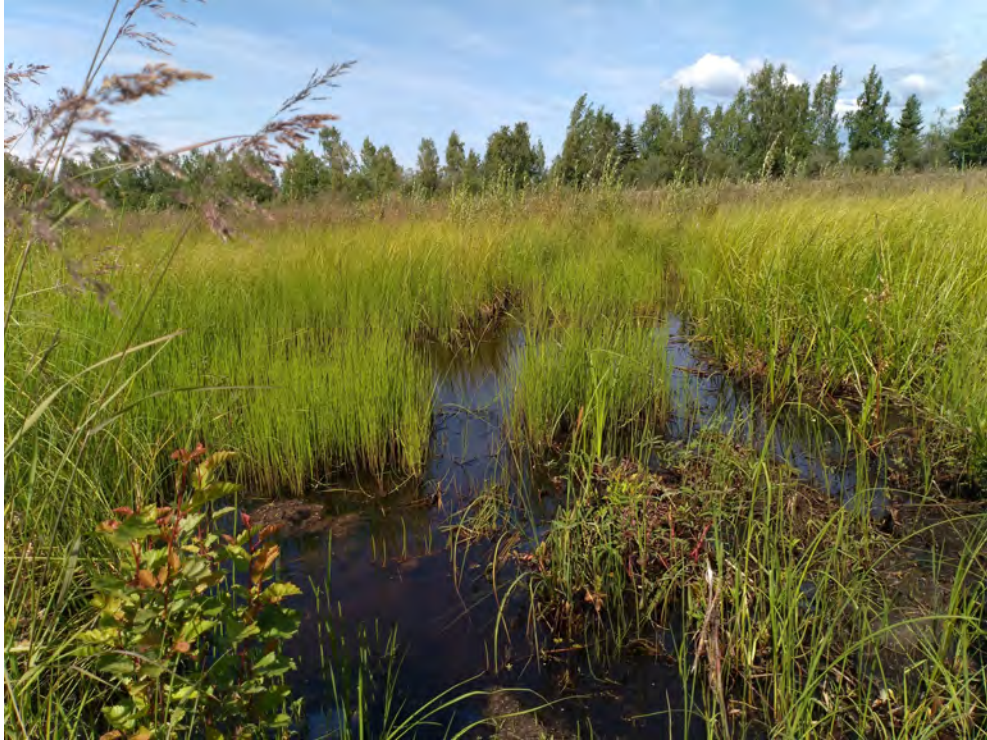
**Sampling Point:** W6-SP1  
**NWI classification:** PEM1F

**Hydric Soil Indicators:** Other (explain in remarks)  
**Wetland Hydrology Indicators:** Surface Water (A1), FAC-Neutral Test (D5), Saturation (A3), High Water Table (A2)

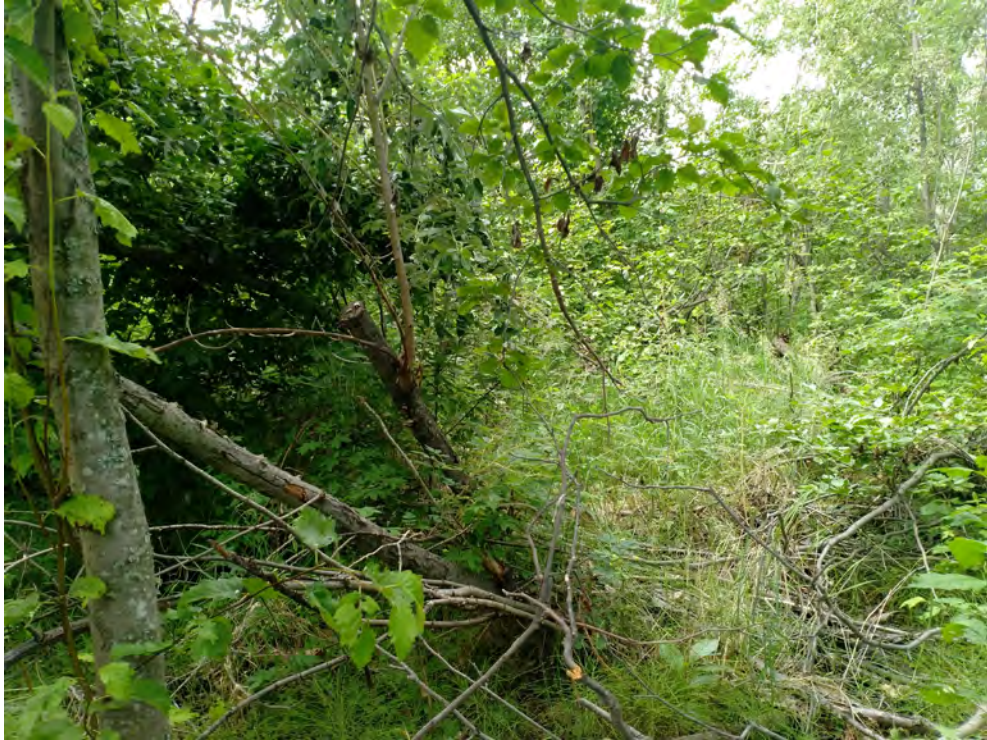
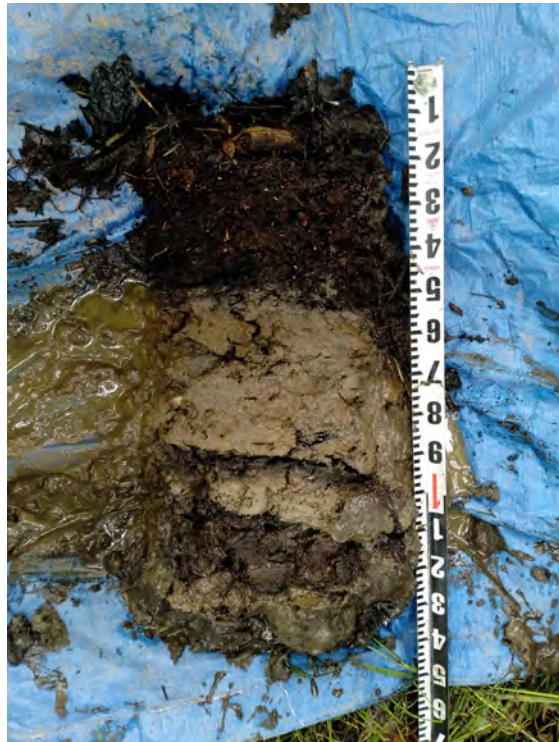
**Sampling Point:** W7-SP1  
**NWI classification:** PSS1B

**Hydric Soil Indicators:** Histic Epipedon (A2)  
**Wetland Hydrology Indicators:** Saturation (A3), Presence of Reduced Iron (C4), High Water Table (A2), Geomorphic Position (D2)

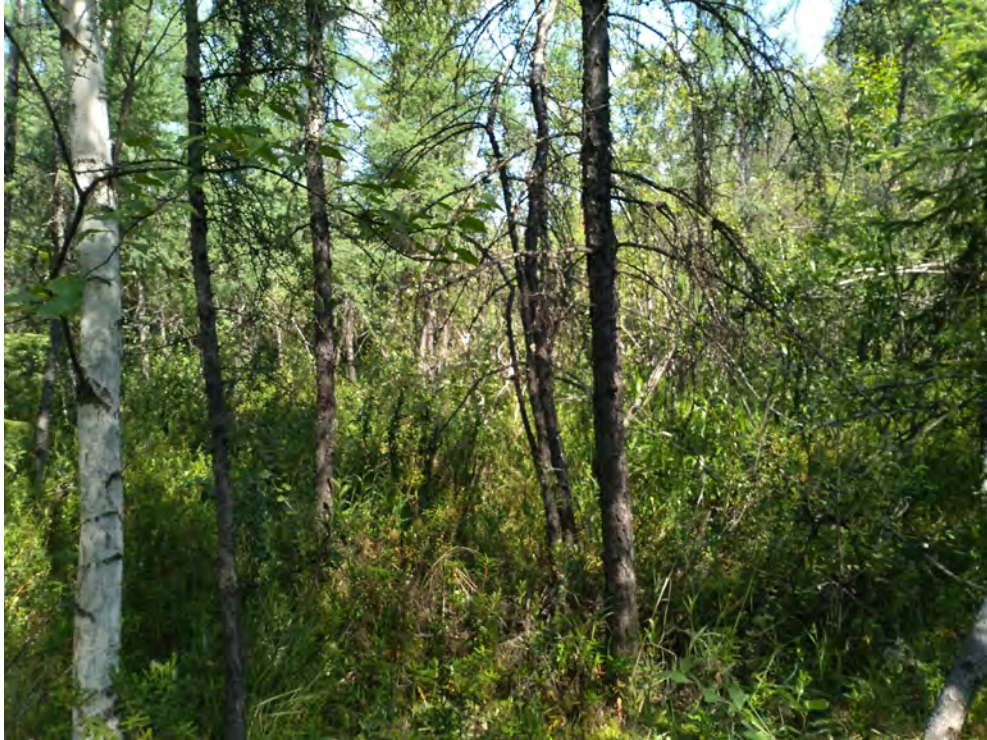
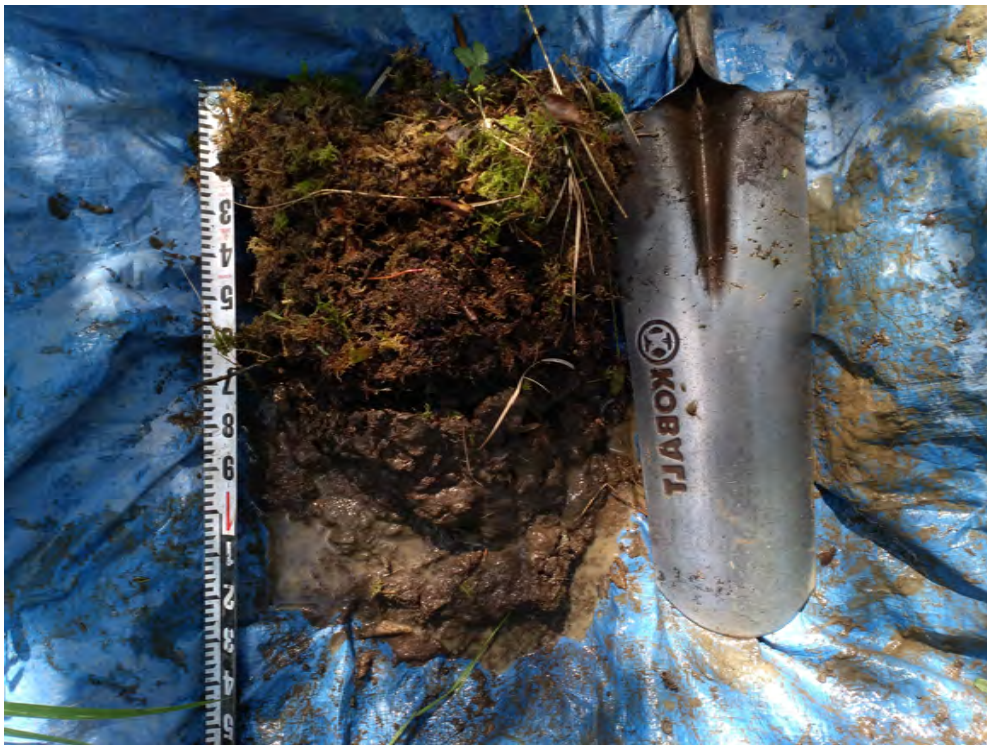
**Sampling Point:** W9-SP1  
**NWI classification:** PFO2B

**Hydric Soil Indicators:** Histosol or Histel (A1)  
**Wetland Hydrology Indicators:** FAC-Neutral Test (D5), Saturation (A3), High Water Table (A2)

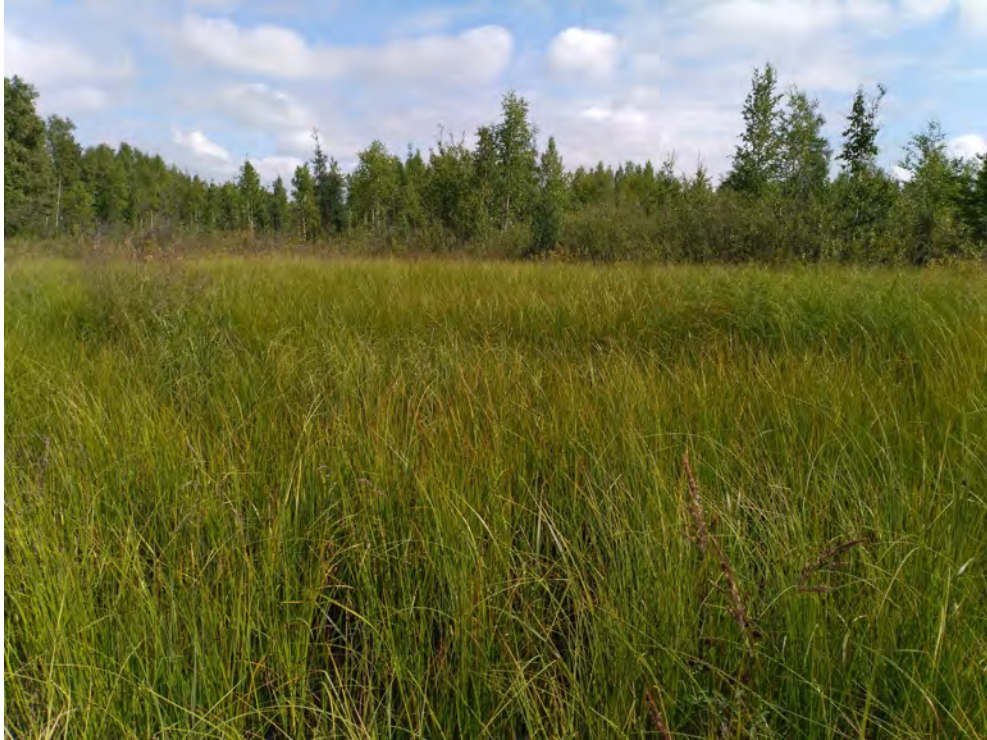
**Sampling Point:** W13-SP1  
**NWI classification:** PEM1F

**Hydric Soil Indicators:** Other (explain in remarks)

**Wetland Hydrology Indicators:** Surface Water (A1), FAC-Neutral Test (D5), Saturation (A3), High Water Table (A2)

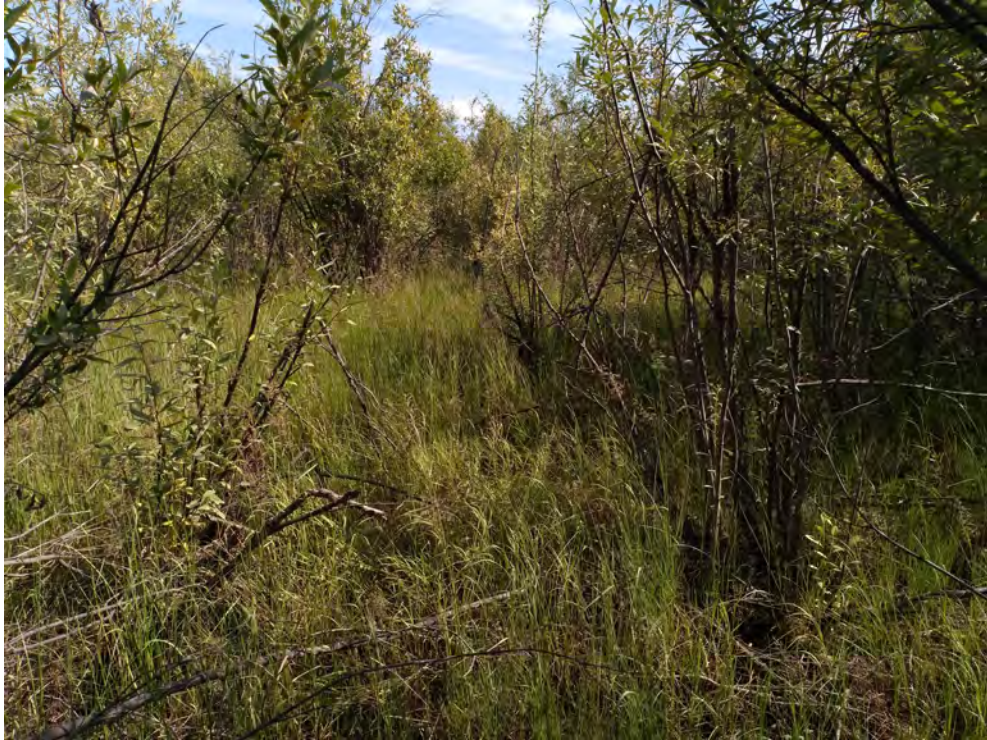
**Sampling Point:** W17-SP1  
**NWI classification:** PEM1/SS1F

**Hydric Soil Indicators:** Other (explain in remarks)

**Wetland Hydrology Indicators:** Saturation (A3), Surface Water (A1), FAC-Neutral Test (D5), High Water Table (A2)

Palustrine Semipermanently Flooded Persistent Emergent/Broad-leaved Deciduous Shrub (PEM1/SS1F) occupies 0.07 acre in the study area (Table 2). This wetland type consists of a wet sedge meadow with interspersed sparse tall shrubs; it occurs adjacent to the Cushman Lake shoreline and along the edge of a PEM1F wetland (see plot W17-SP1 in Appendix A and Figure 2). Co-dominant shrub species are *Salix lasiandra* (Pacific willow), *S. interior* (sandbar willow), and *S. alaxensis*. Important herbaceous species include *Equisetum palustre* (marsh horsetail) and *Calamagrostis canadensis*. The site was inundated at the time of sampling with approximately 5 inches of surface water.

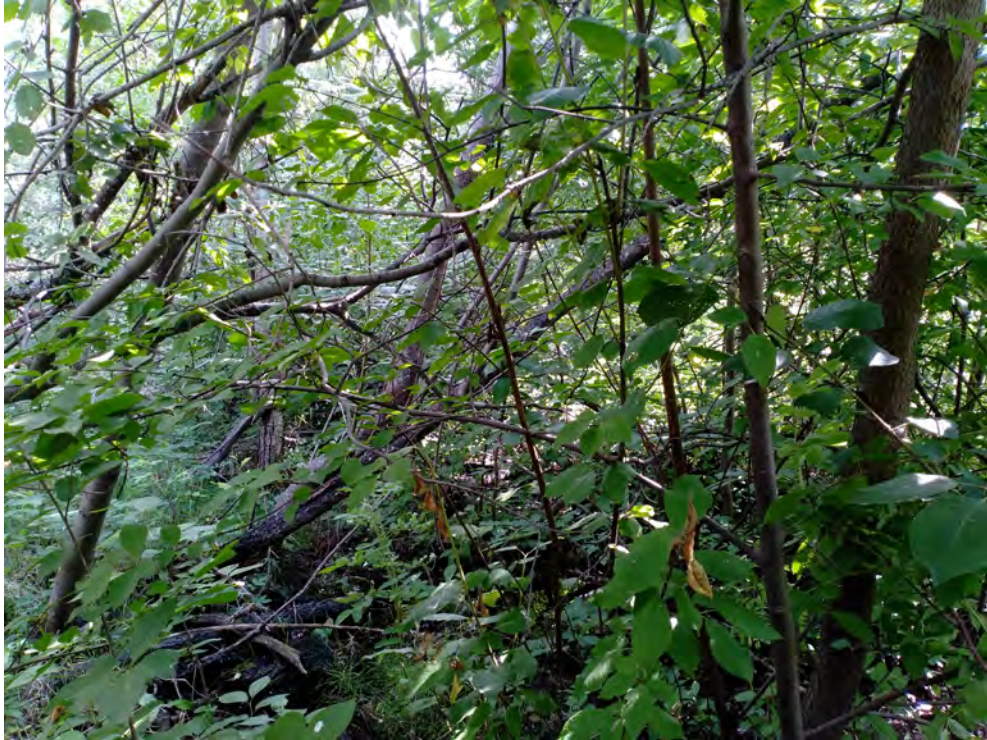
**Sampling Point:** W21-SP1  
**NWI classification:** PSS1E

**Hydric Soil Indicators:** Other (explain in remarks)

**Wetland Hydrology Indicators:** Saturation (A3), Surface Water (A1), Hydrogen Sulfide Odor (C1), High Water Table (A2), Water-Stained Leaves (B9), Geomorphic Position (D2)

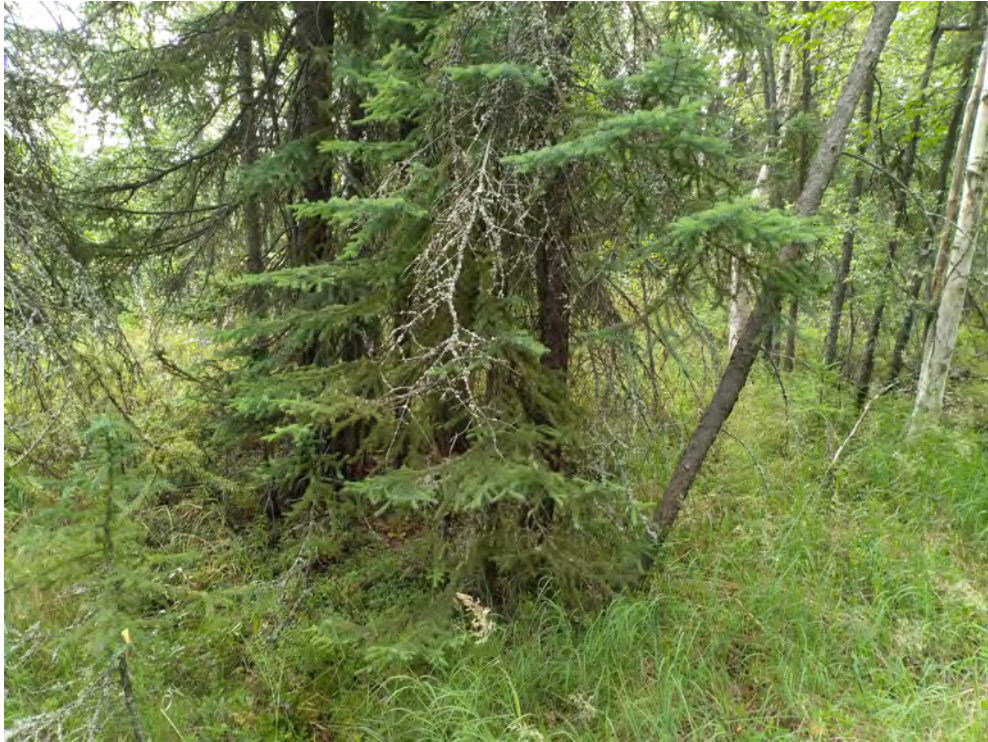
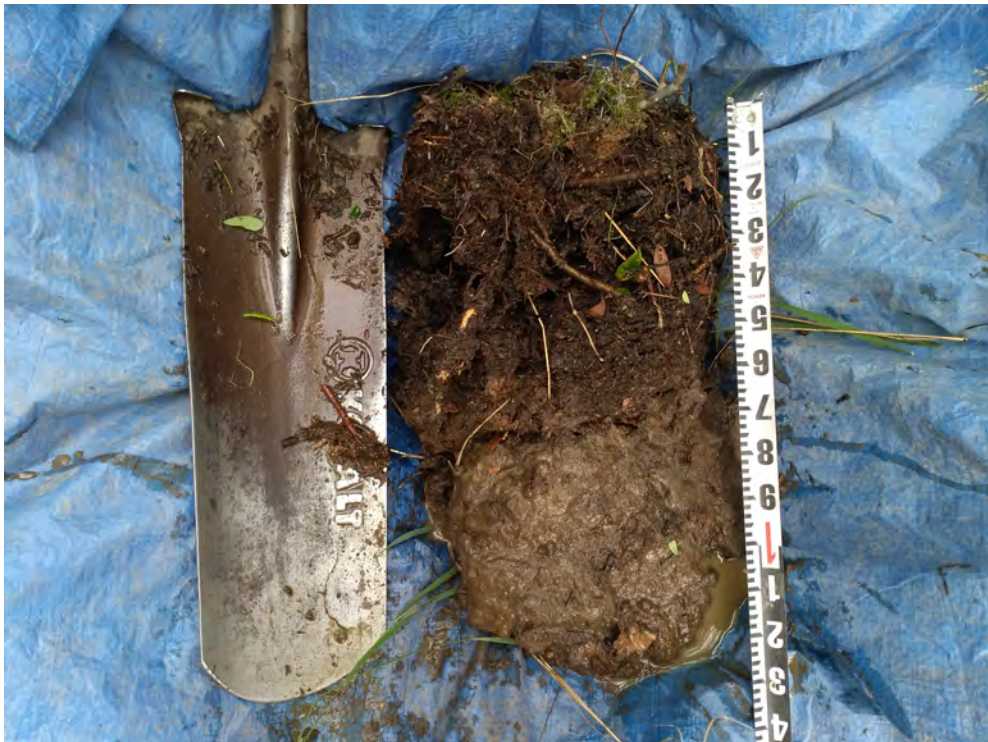
**Sampling Point:** W23-SP1  
**NWI classification:** PFO4B

**Hydric Soil Indicators:** Histic Epipedon (A2)  
**Wetland Hydrology Indicators:** High Water Table (A2), Presence of Reduced Iron (C4), Saturation (A3)

Palustrine Seasonally Saturated Needle-leaved Evergreen Forest (PFO4B) occupies 0.34 acre within the study area (Table 2). This forested wetland type is part of the undisturbed riverine wetland complex along the proposed new road alignment and is dominated by *P. mariana* with an understory of *Ledum groenlandicum*. Soils were saturated histic epipedons with seasonal frost reached at 17 inches (see plot W23-SP1 in Appendix A).

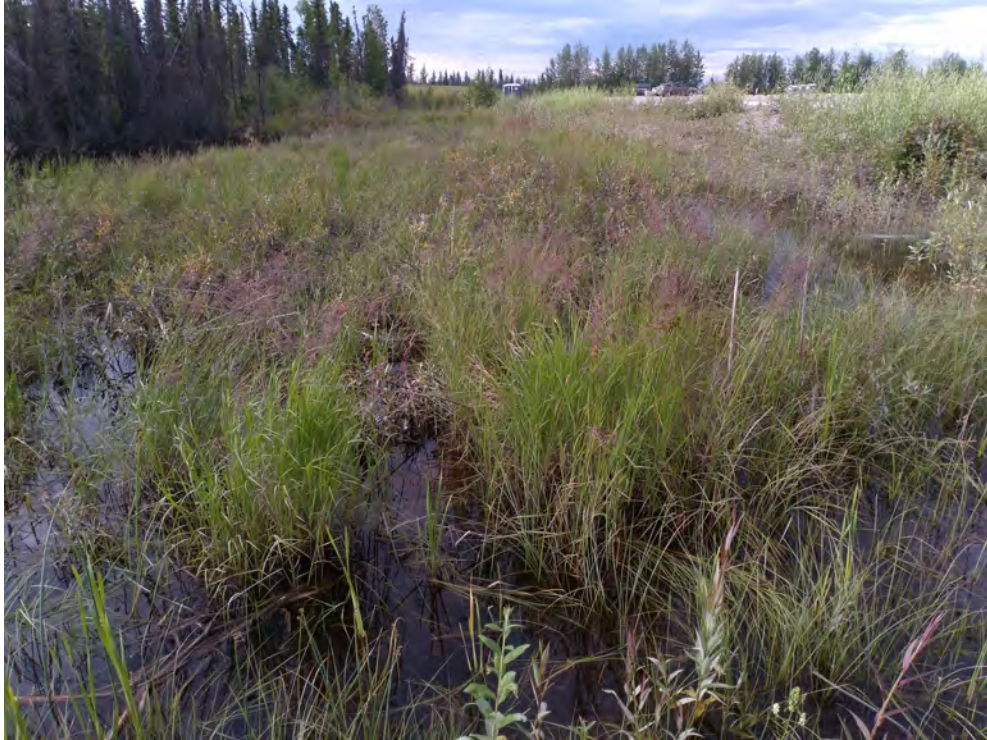
**Sampling Point:** W27-SP1  
**NWI classification:** PSS1F

**Hydric Soil Indicators:** Other (explain in remarks)

**Wetland Hydrology Indicators:** High Water Table (A2), Geomorphic Position (D2), Saturation (A3), Surface Water (A1), FAC-Neutral Test (D5)

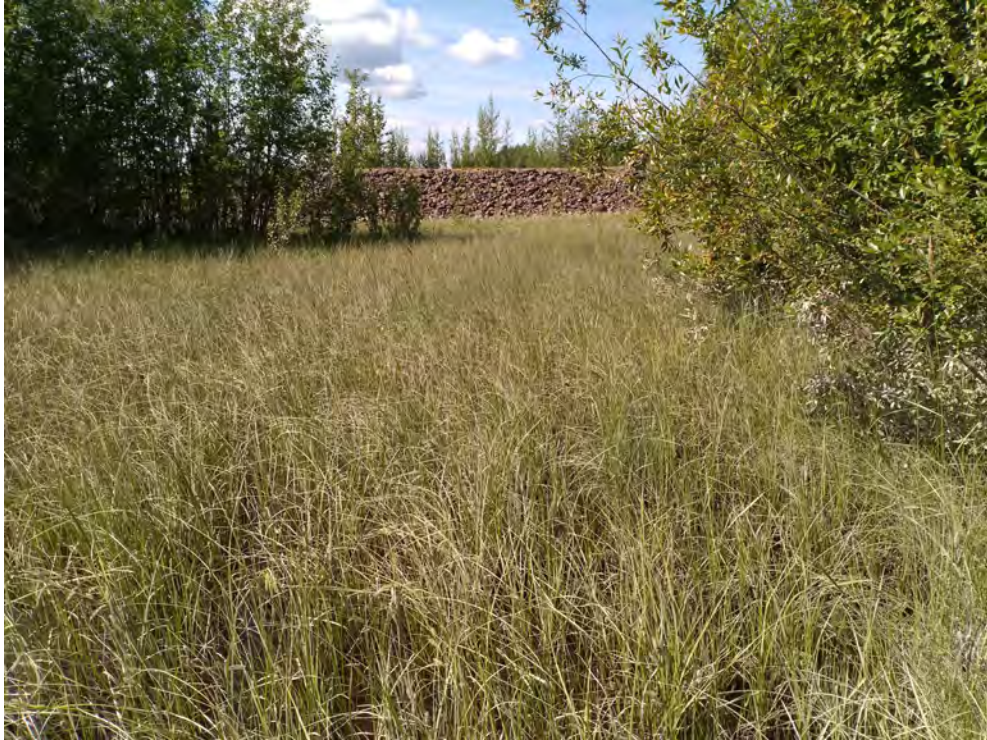
**Sampling Point:** W31-SP1  
**NWI classification:** PEM1F

**Hydric Soil Indicators:** Other (explain in remarks)

**Wetland Hydrology Indicators:** High Water Table (A2), Saturation (A3), FAC-Neutral Test (D5), Surface Water (A1)

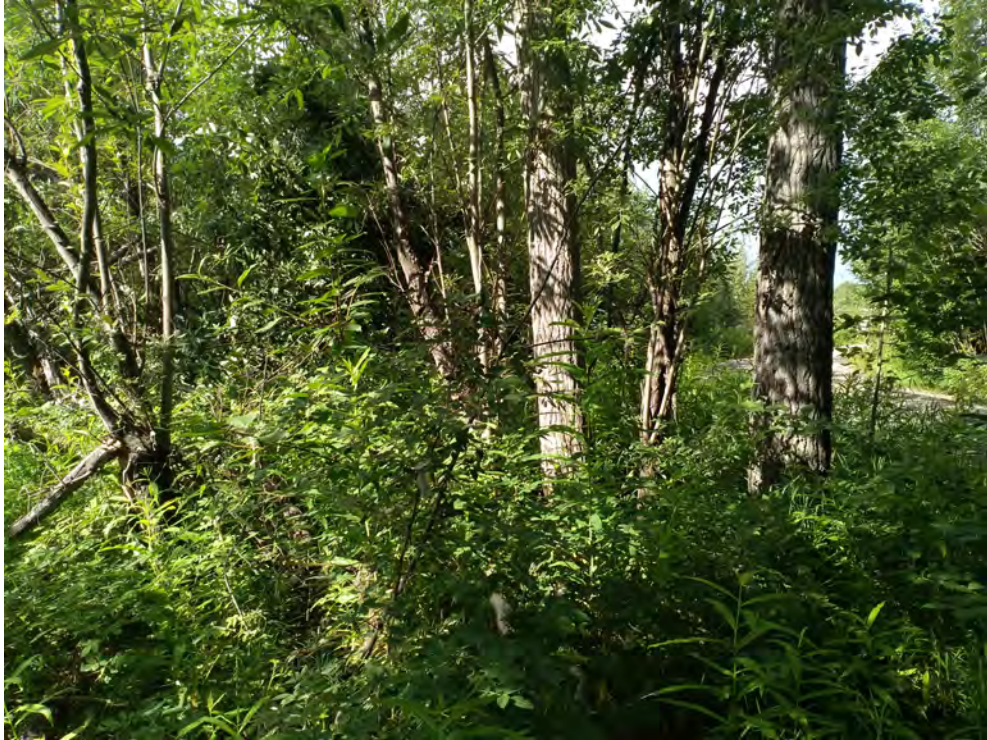
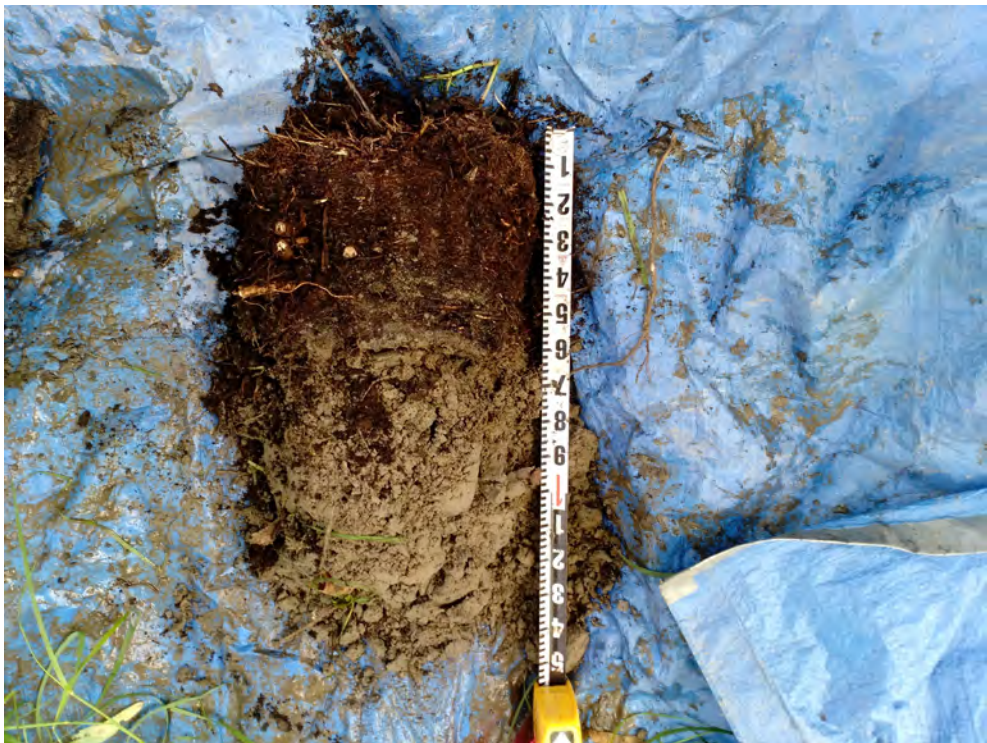
**Sampling Point:** TL-05  
**NWI classification:** U

Remarks: Site is located in active floodplain but no other hydrology indicators are present.

**Hydric Soil Indicators:** None  
**Wetland Hydrology Indicators:** Geomorphic Position (D2)

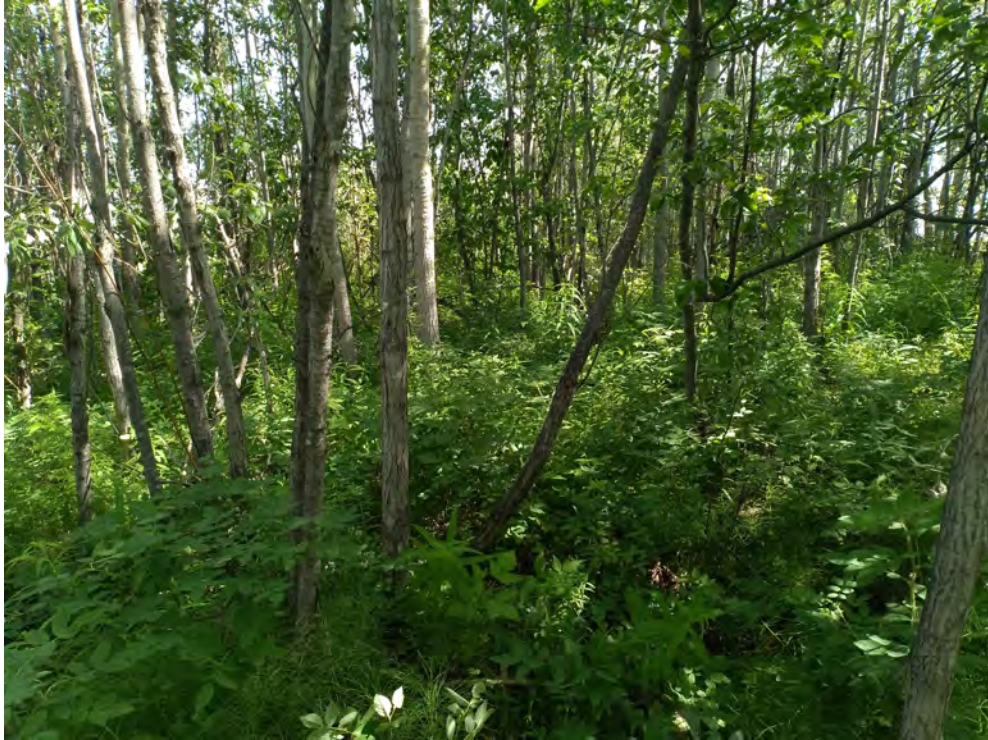
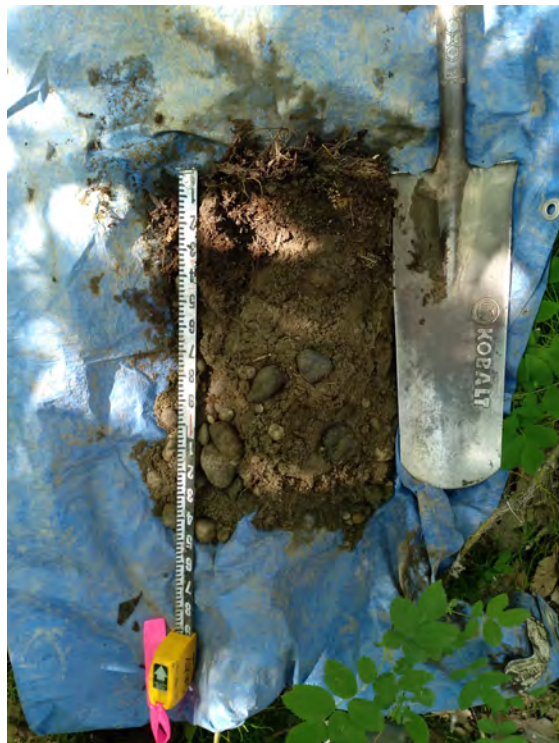
**Sampling Point:** TL-10  
**NWI classification:** U

Remarks: No hydrology indicators, except for small inundated puddle just outside plot radius. Water table is well below the average surface within the forest.

**Hydric Soil Indicators:** None  
**Wetland Hydrology Indicators:** None

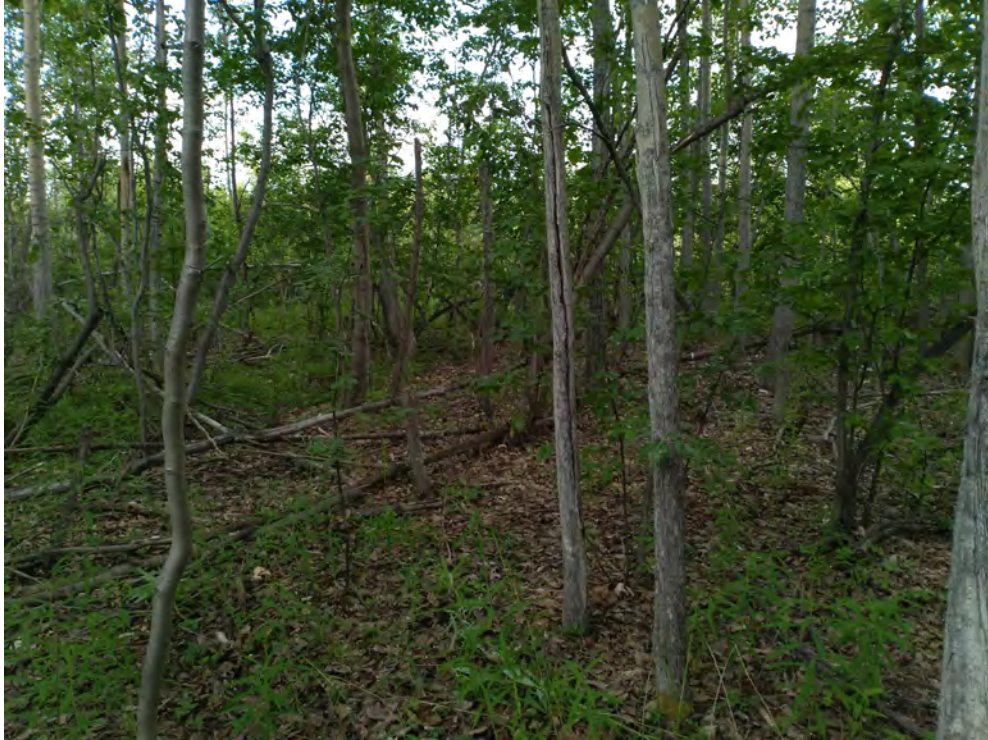
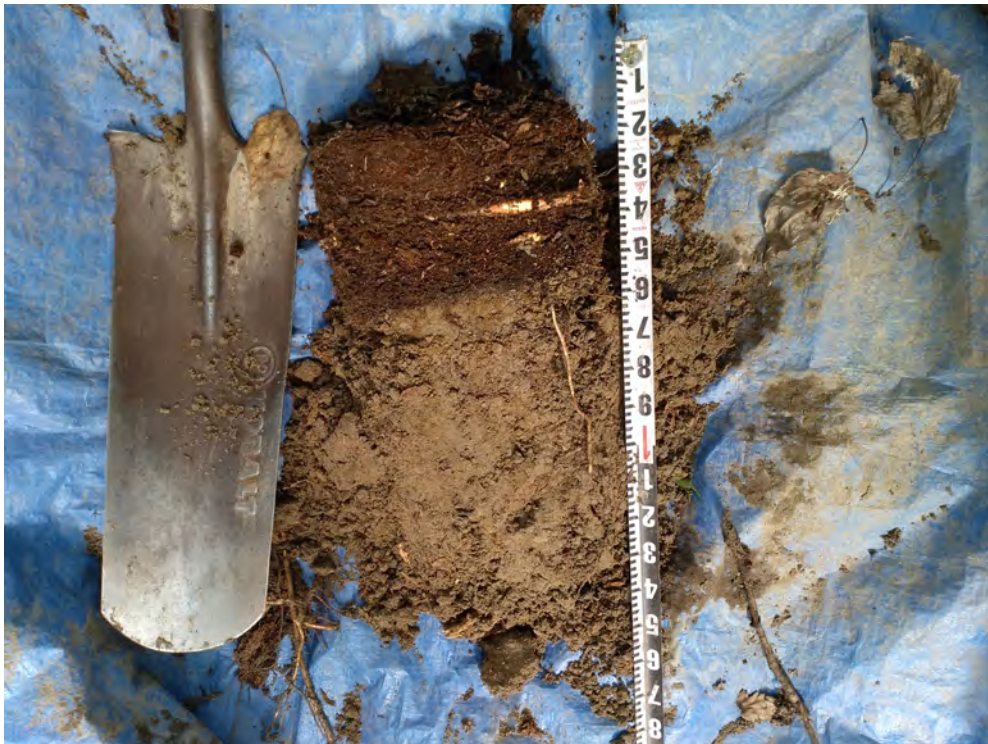
**Sampling Point:** TL-15  
**NWI classification:** U

Remarks: No hydrology indicators observed other than the site being on the active floodplain.

**Hydric Soil Indicators:** None  
**Wetland Hydrology Indicators:** None

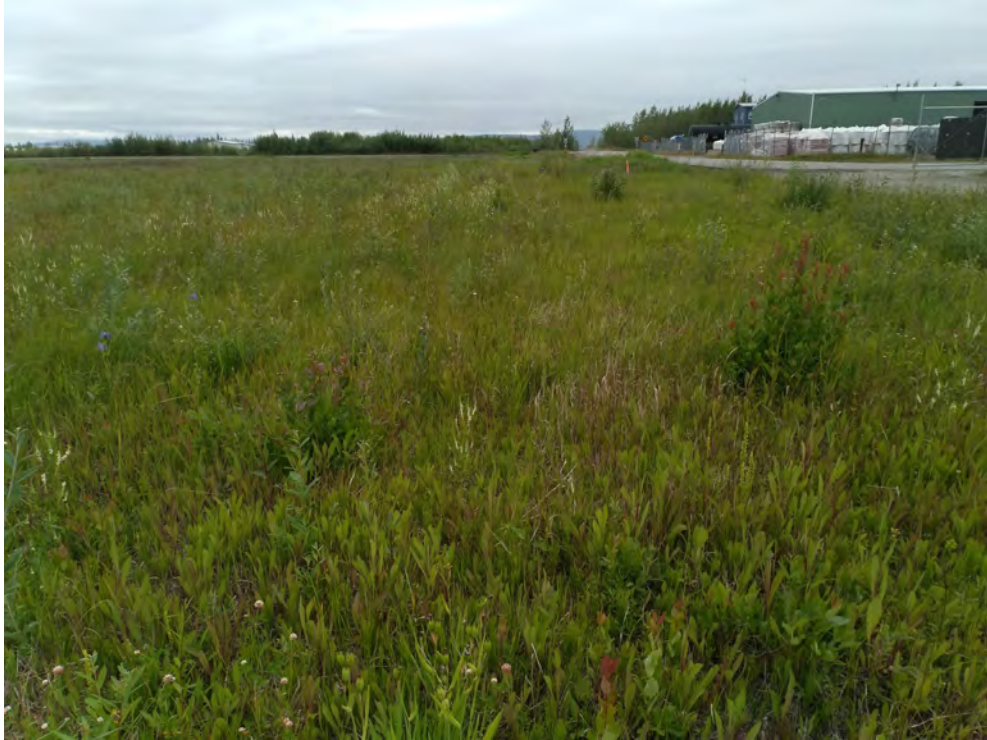
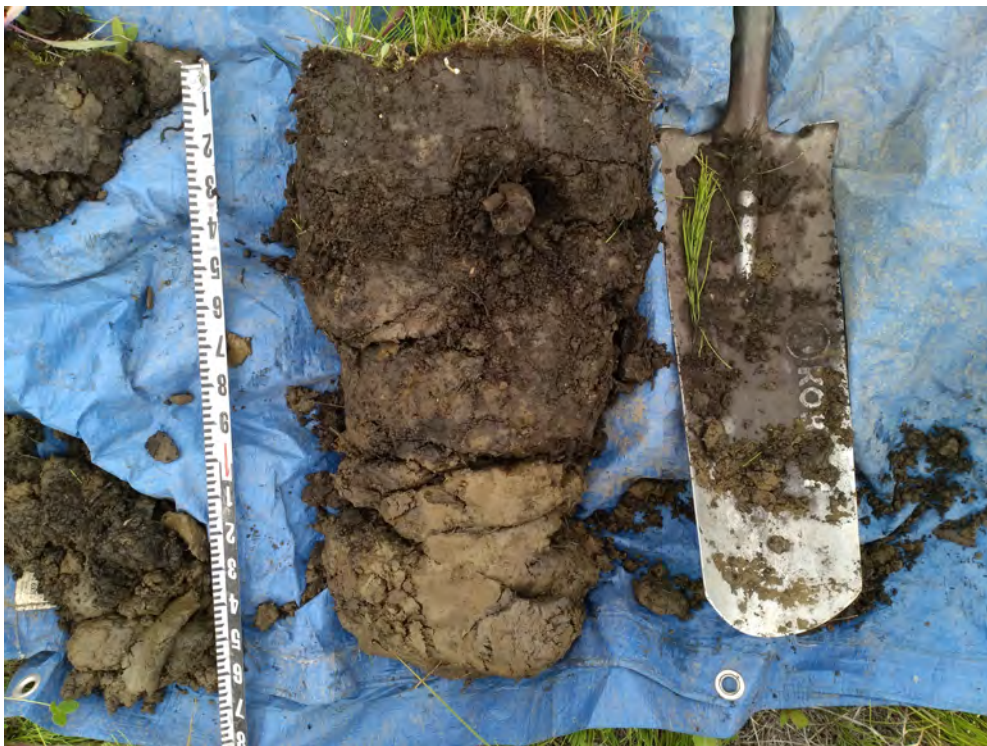
**Sampling Point:** TL-17  
**NWI classification:** U

Remarks: No hydrology indicators observed.

**Hydric Soil Indicators:** None  
**Wetland Hydrology Indicators:** FAC-Neutral Test (D5)

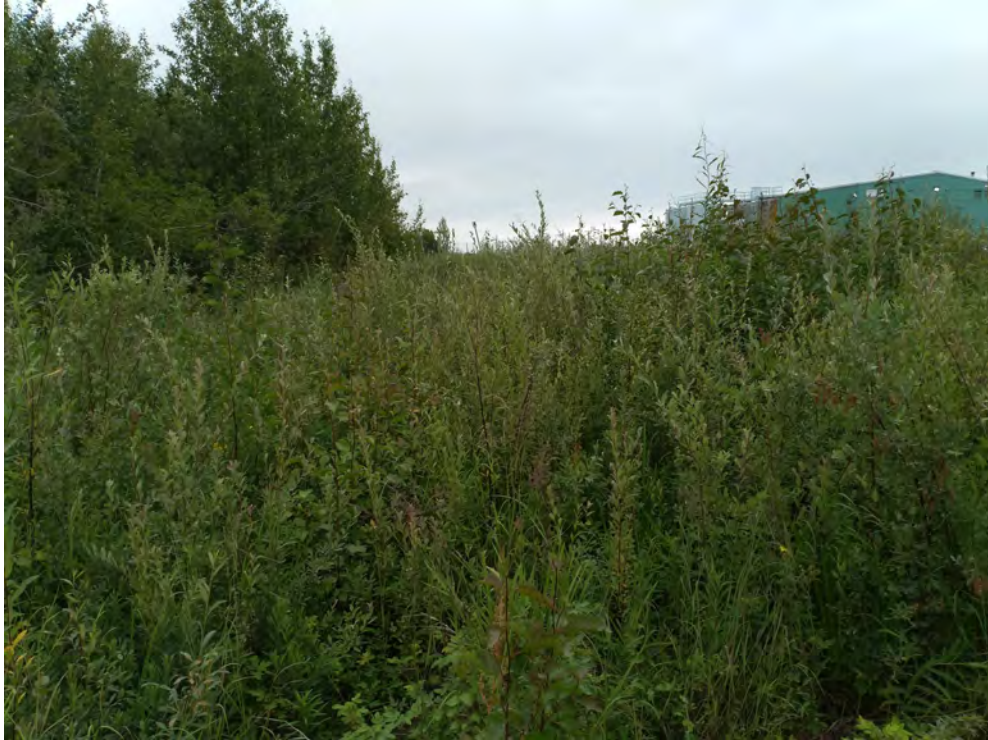
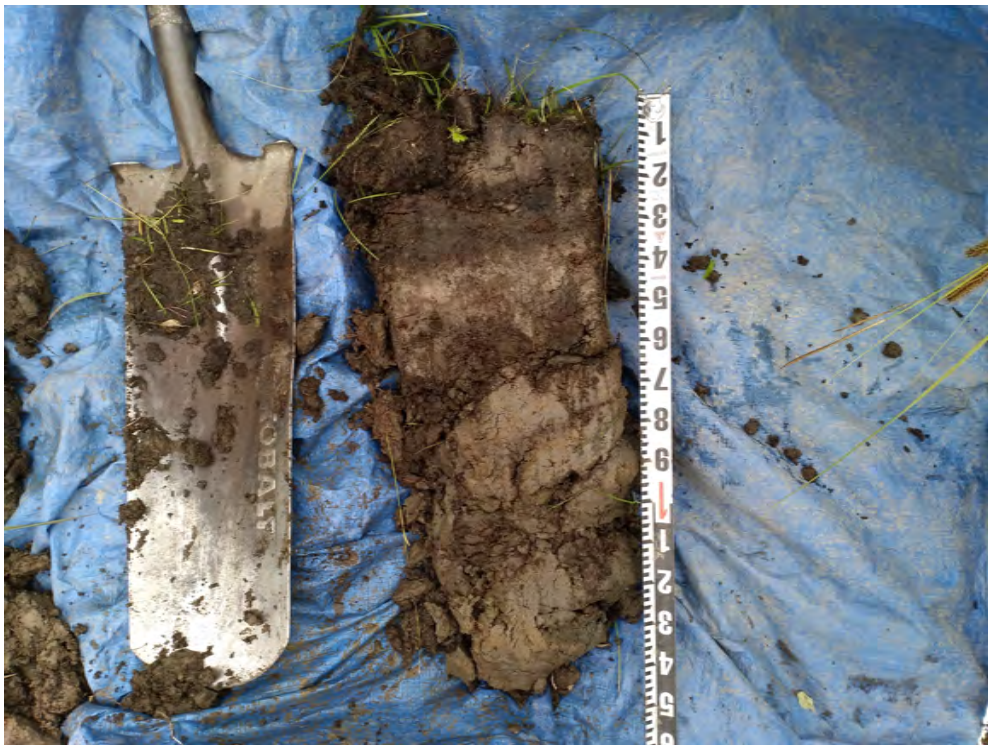
**Sampling Point:** TL-19  
**NWI classification:** U

Remarks: Depressed area beside the road, receiving runoff from road. A few small depressions supporting cattail that may be flooded periodically during growing season. Site should have some hydrology indicators given the wet spring and early summer in Fairbanks.

**Hydric Soil Indicators:** Alaska Redox (A14)  
**Wetland Hydrology Indicators:** None
