## **Appendix B – Wetlands Technical Reports**

**WETLAND AND STREAM DELINEATION FOR THE  
TANANA RIVER RECREATION ACCESS IMPROVEMENTS PROJECT,  
FAIRBANKS, ALASKA, 2020: AK FNSB TANANA(1)**

**ABR, Inc.—Environmental Research & Services**  
P.O. Box 240268  
Anchorage, AK 99518

October 2020

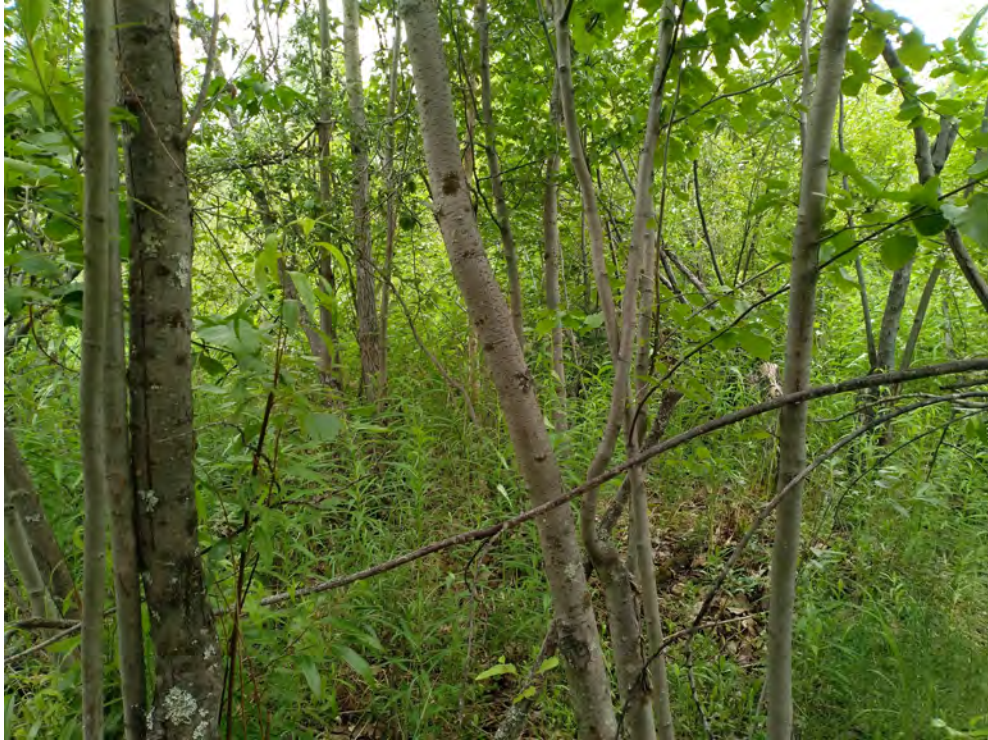
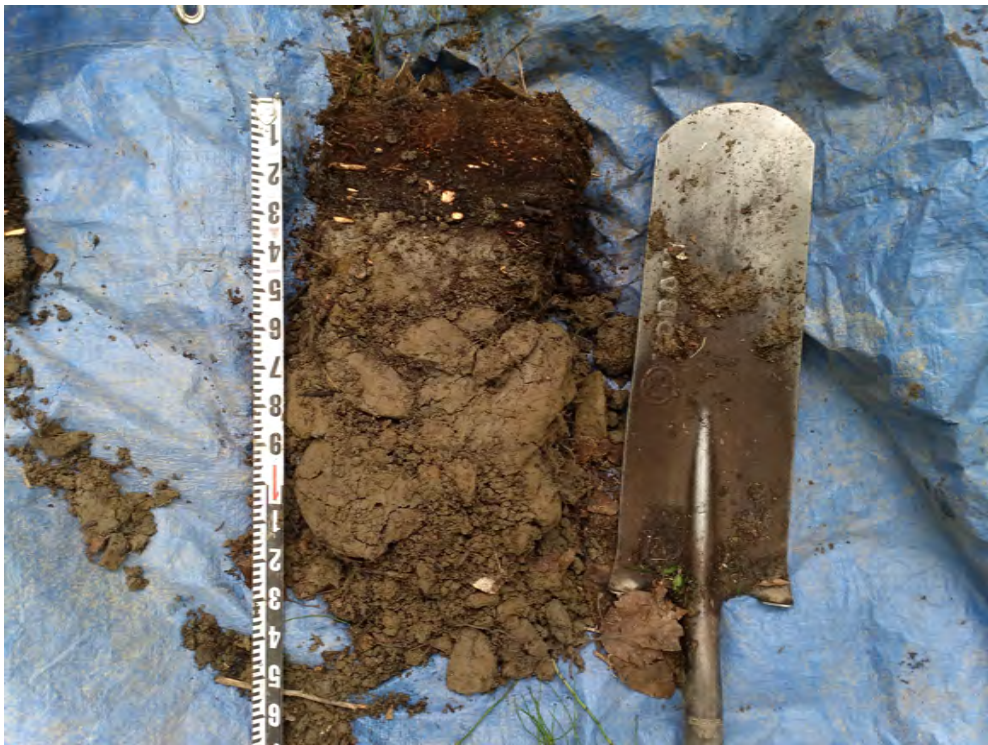
**Sampling Point:** TL-21  
**NWI classification:** U

Remarks: Hydrology indicators absent, alpha alpha negative, no surface evidence of periodic flooding.

**Hydric Soil Indicators:** Alaska Redox (A14)  
**Wetland Hydrology Indicators:** None

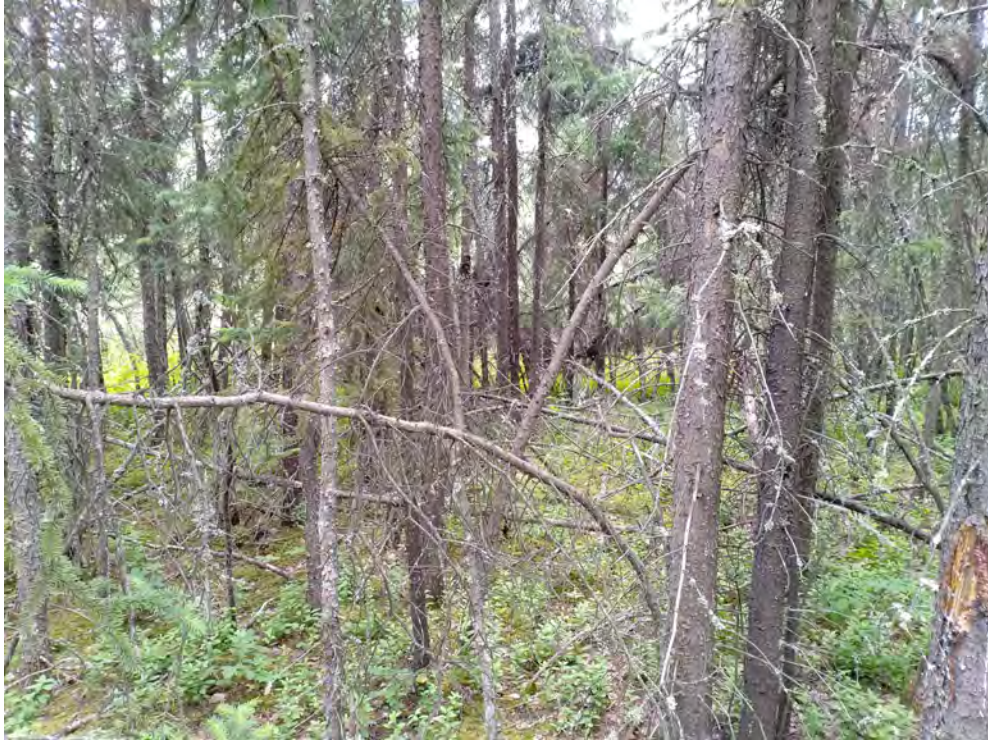
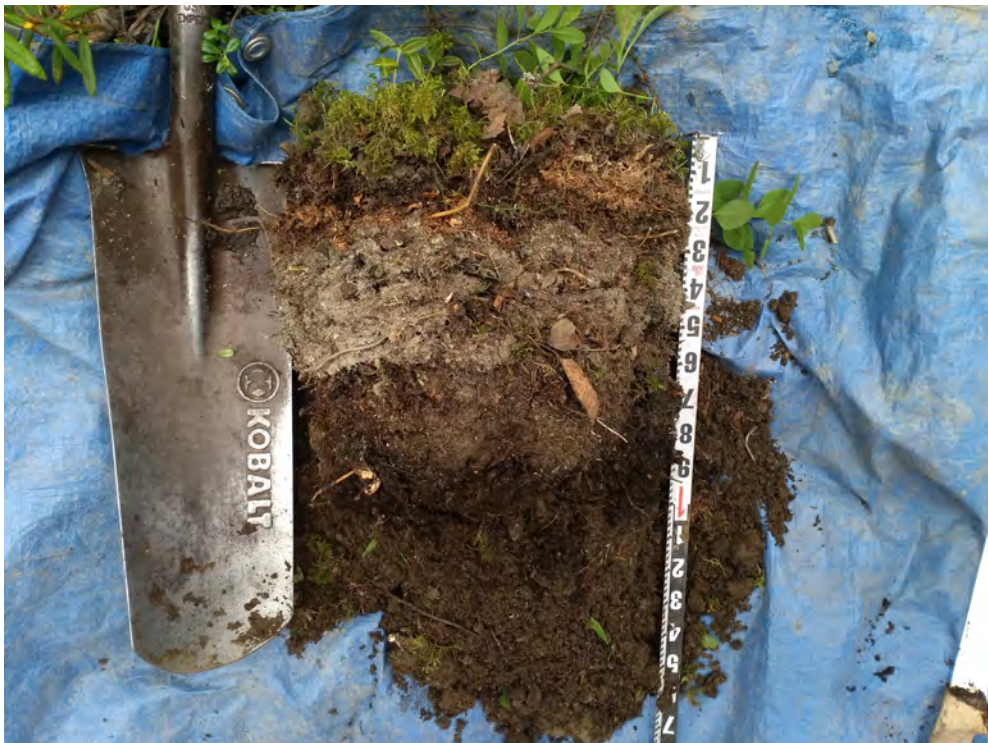
**Sampling Point:** TL-22  
**NWI classification:** U

**Hydric Soil Indicators:** None  
**Wetland Hydrology Indicators:** Shallow Aquitard (D3)

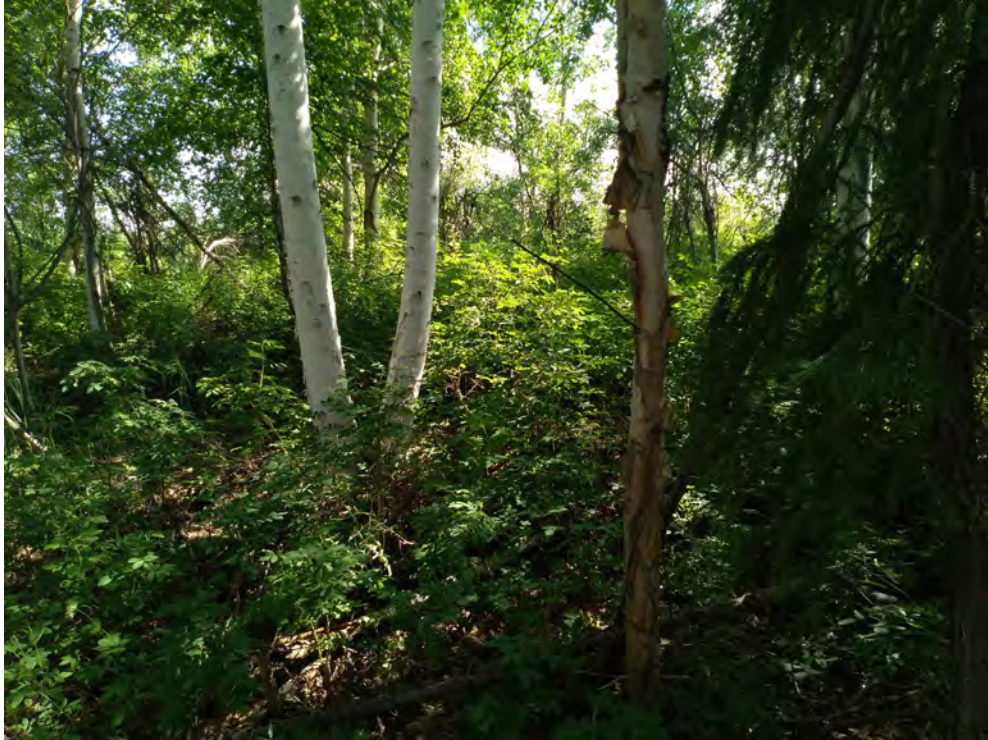
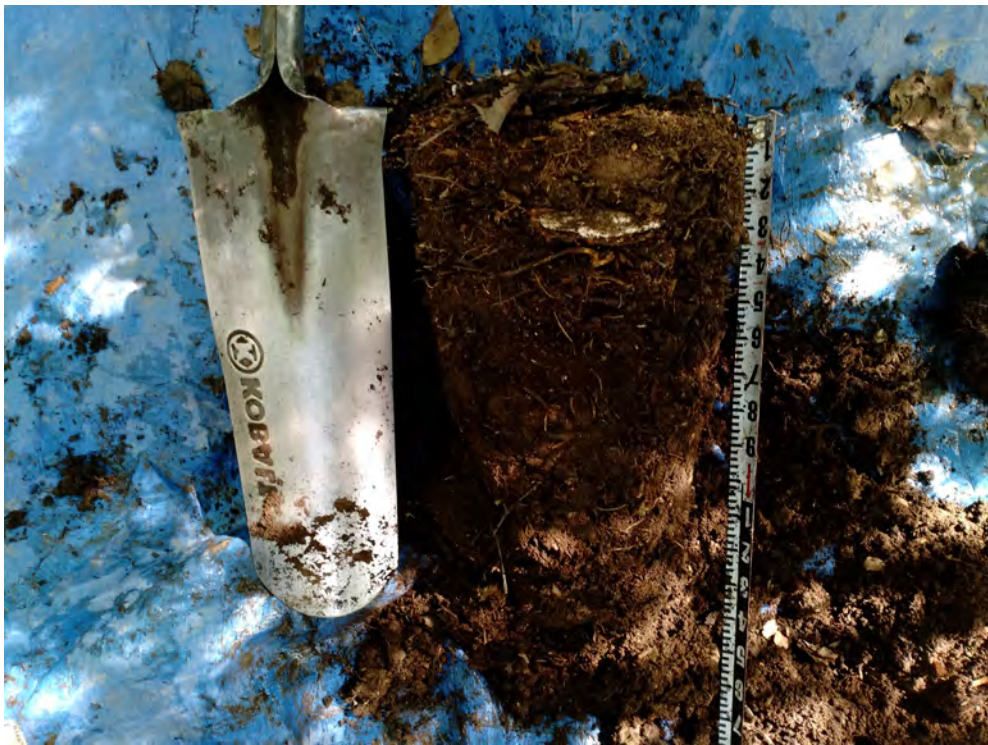
**Sampling Point:** TL-27  
**NWI classification:** U

**Hydric Soil Indicators:** None  
**Wetland Hydrology Indicators:** None

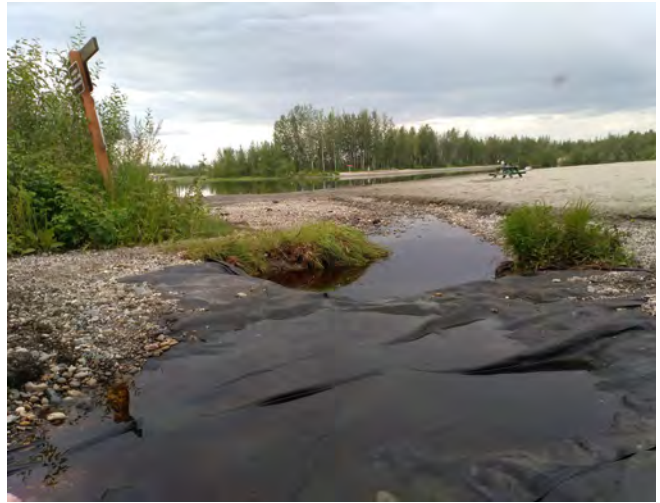
**Sampling Point:** STREAM-1

**Notes:** Site is a constructed drainage channel from up-slope wetland to Cushman lake across the beach. The channel was lined with landscaping fabric but channel bed has been eroded and the fabric is exposed. Assumed that veg, soil and hydrology are significantly disturbed because it's a constructed drainage channel that been degraded from original condition. R4USC

Riverine Seasonally Flooded Intermittent Unconsolidated Shore (R4USC) occupies 0.01 acre in the study area (Table 2). This small channel was constructed with landscaping fabric within the sand of the swim beach to drain the upslope wetland across the beach to Cushman Lake. At the time of the field survey, the landscaping fabric was torn and degraded. No flow was occurring, but stagnant water was present.

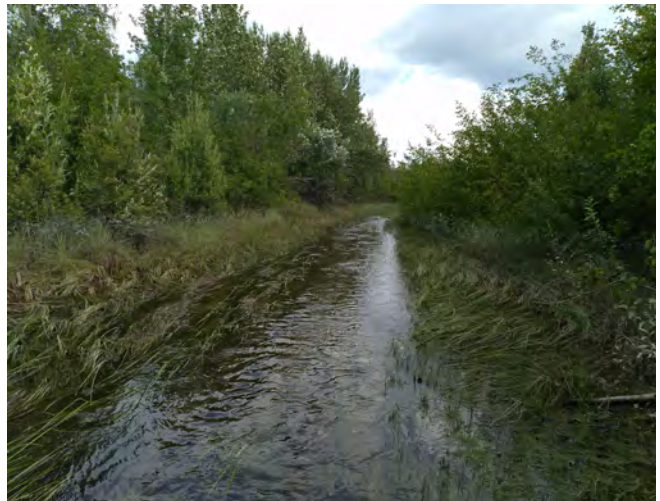
**Sampling Point:** STREAM-2

**Notes:** Flowing slough, water 6 inches deep

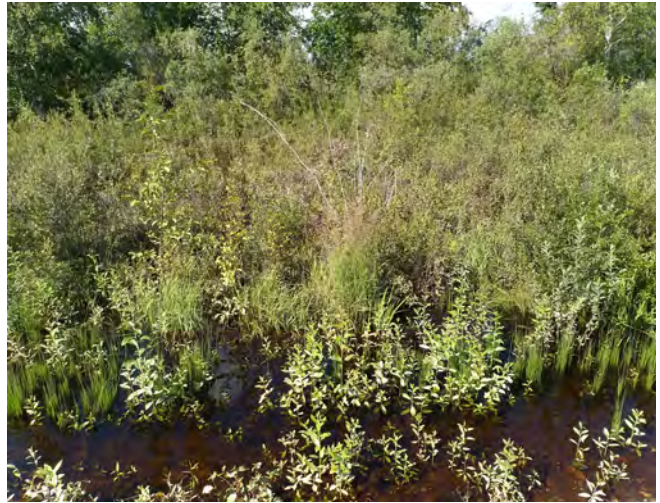
**Sampling Point:** W3-V1

**Notes:** Inundated through the width of study area, not evident in 2019 imagery. Inundation is likely due to the combination of impounded waters accumulating from rainfall and not draining due to high flood stage on the Tanana River. Vegetation is not yet supporting obligate plants and existing shrubs and trees are not yet dying. Flooding may be very intermittent.

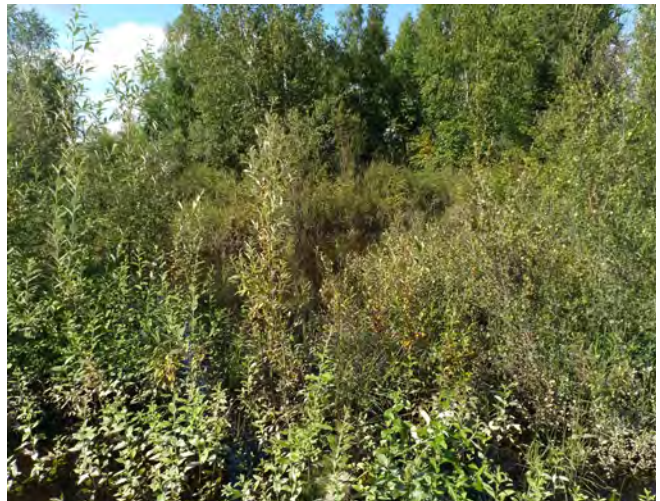
**Sampling Point:** W4-V1

**Notes:** Inundated through the width of study area, not evident in 2019 imagery. Inundation is likely due to the combination of impounded waters accumulating from rainfall and not draining due to high flood stage on the Tanana River. Vegetation is not yet supporting obligate plants and existing shrubs and trees are not yet dying. Flooding may be very intermittent.

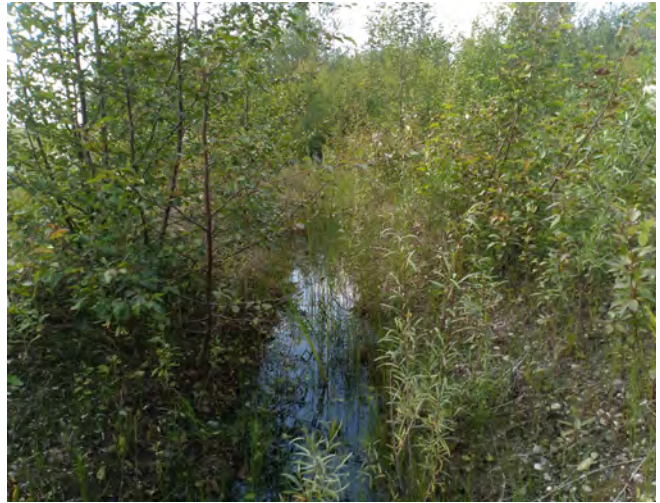
**Sampling Point:** W8-V1

**Notes:** Ditch impounding water supporting obligate plants, likely flooded throughout the growing season in most years.

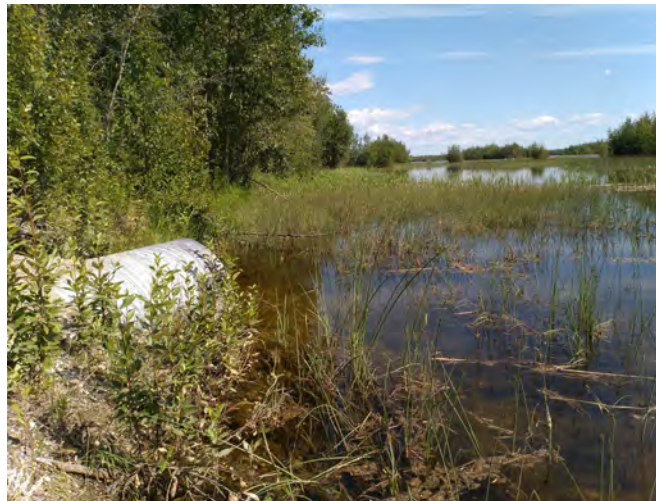
**Sampling Point:** W20-V1

**Notes:** The shoreline of the lake is much higher upslope during the time of sampling than indicated in the 2019 aerial photograph. However the presence of obligate aquatic wetland plants such as scival and typlat indicate that the area is typically flooded.

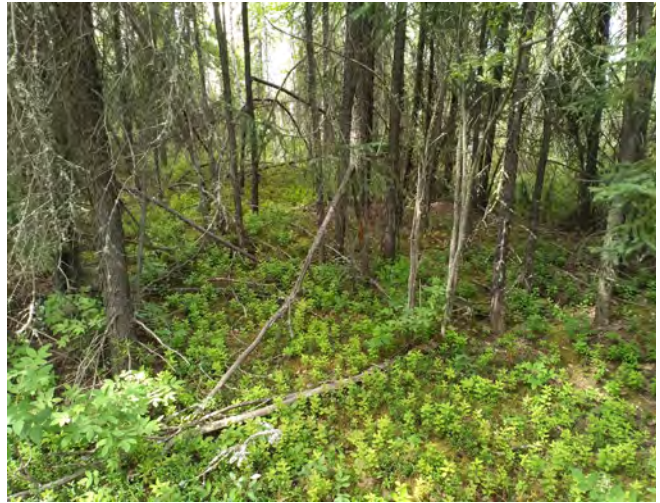
**Sampling Point:** W24-V1

**Notes:** Similar black spruce upland on slightly raised ridge. Assume upland based on veg composition and lack of hydrology.

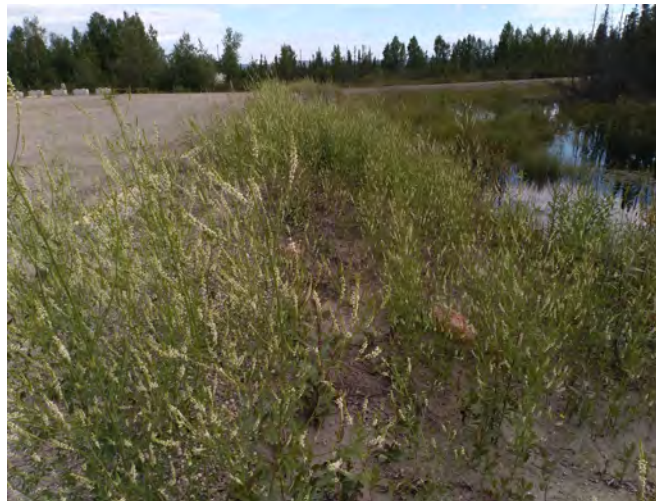
**Sampling Point:** TL-02

**Notes:** Edge of parking lot with a large population of white sweet clover. Verification plot to document invasive population.

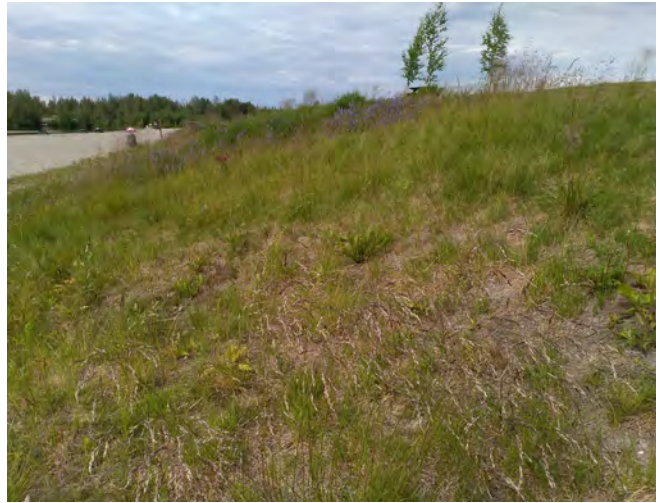
**Sampling Point:** TL-07

**Notes:** Constructed berm above beach area, colonized by some non native plants.

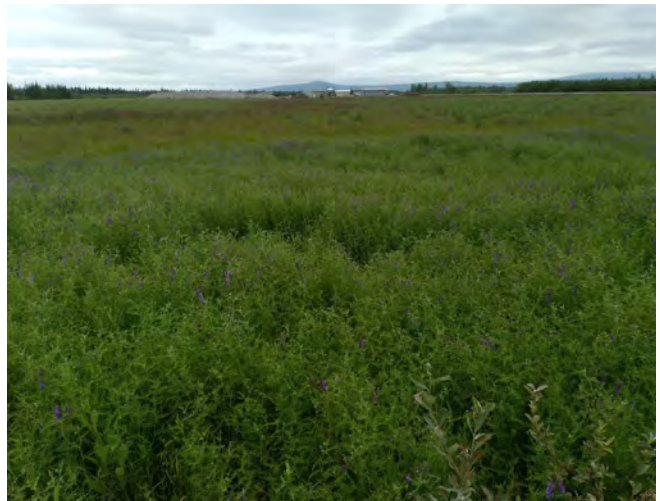
**Sampling Point:** TL-18

**Notes:** Extensive infestation of vicra alongside road and extending into the field.

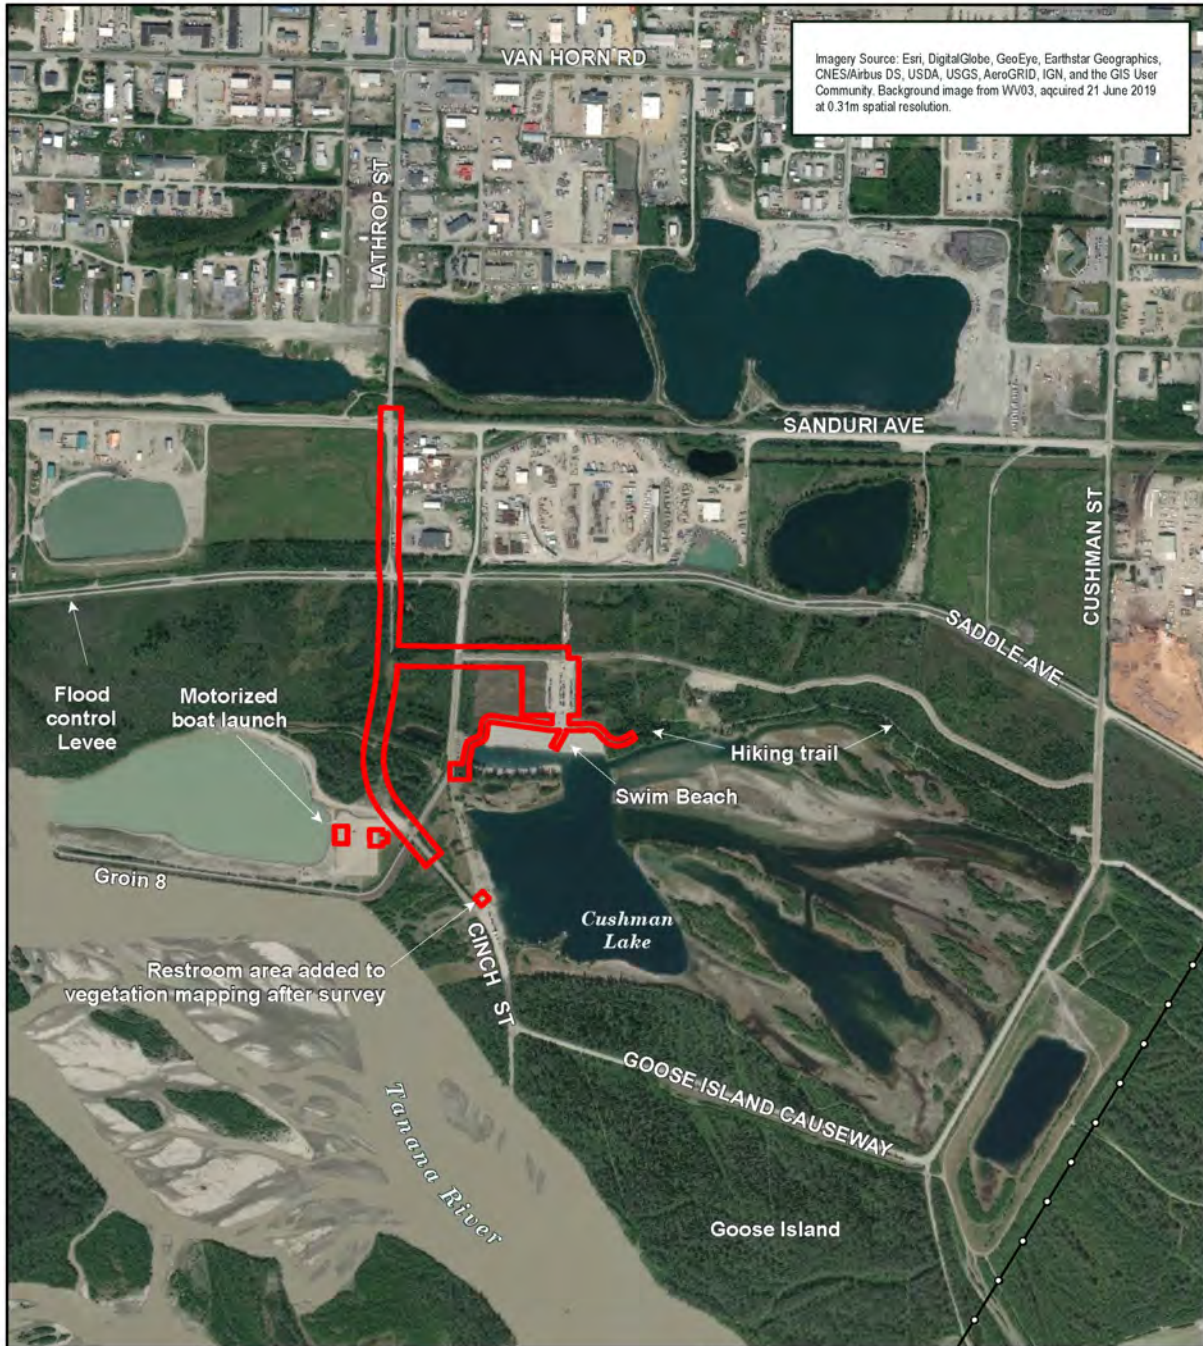
**Figure 1.**  
**Wetland Impacts Study Area**  
**for the Tanana River Recreation**  
**Access Improvements Project**

The TLRA is located on the south (river) side of the Tanana Flood Control levee in south Fairbanks. A small portion of the project study area north of the levee is outside of the TLRA boundary. The recreation area has been established around Cushman Lake, which was formed by the impounded waters of an active slough of the Tanana River (Figure 1). The Goose Island Causeway (a groin extension of South Cushman Street) and Groin 8 (an extension of Cinch Street) were constructed to create the freshwater Cushman Lake, which is suitable for recreation activities and habitat conservation. Groin 8 also protects the motorized boat launch area at the Tanana River. Following the master plan for the area (FNSB 2007), the TLRA was developed after 2012 to include a swimming beach on Cushman Lake, hiking trails, the motorized boat launch on the Tanana River, and the non-motorized boat launch on the shore of Cushman Lake.

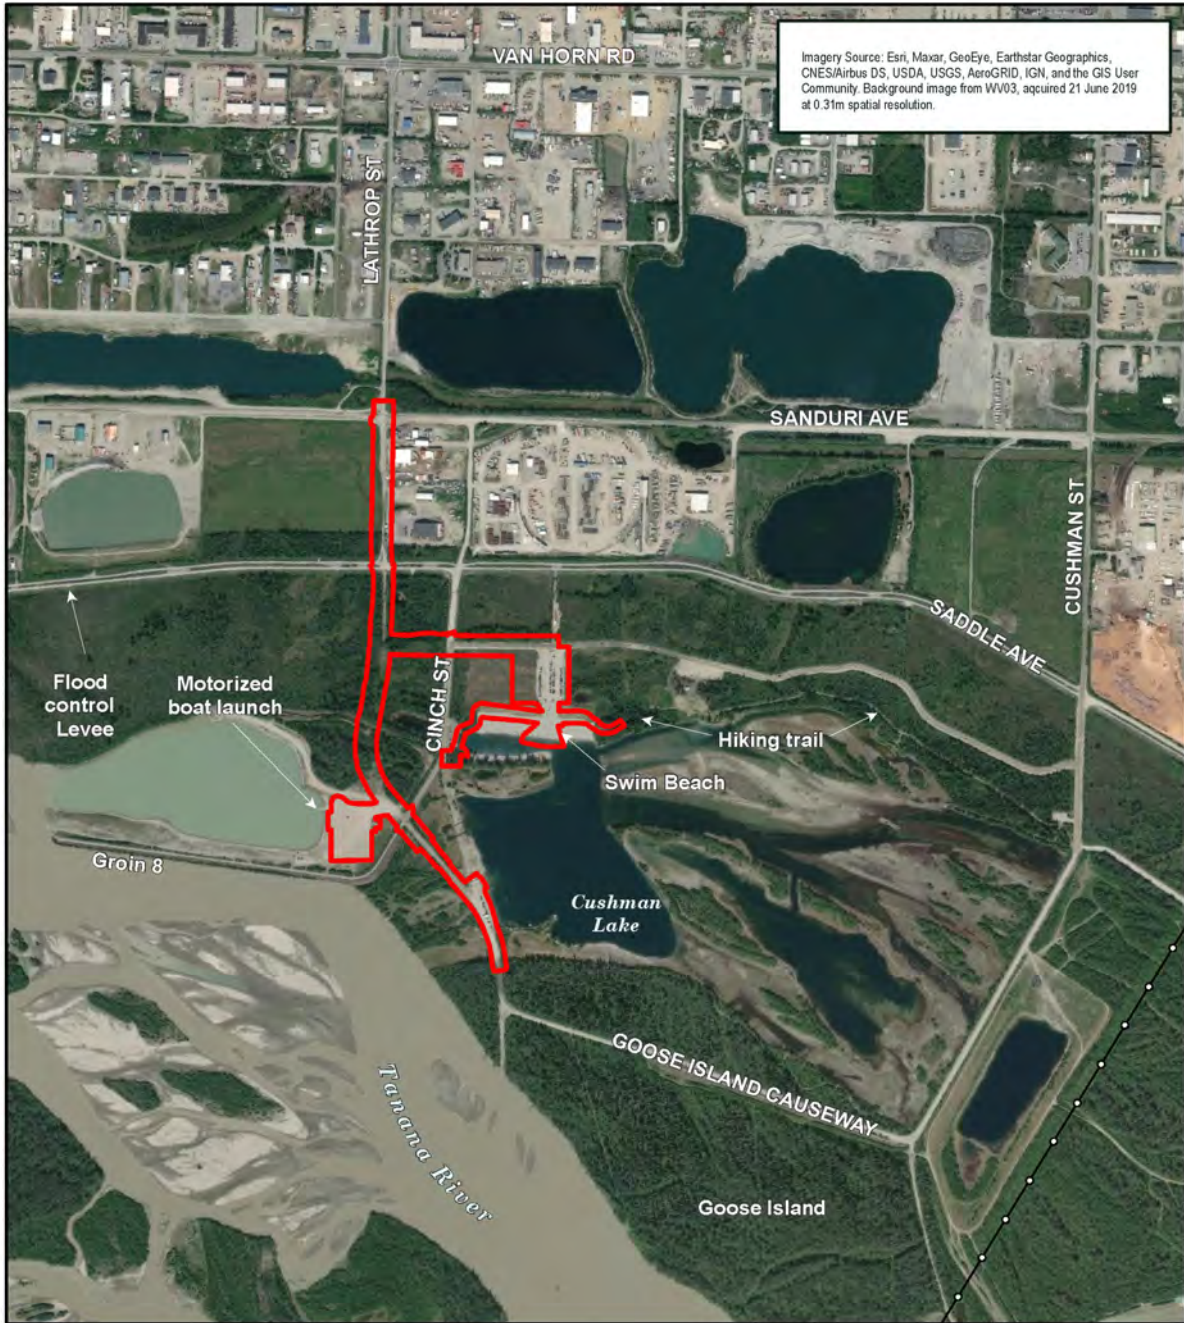
**Figure 1.**  
**Wetland Impacts Study Area**  
**for the Tanana River Recreation**  
**Access Improvements Project**
